North West Wales Dendrochronology Project: Trefadog, Llanfaethlu

Project No. G2113

Report No. 1021

Trefadog, Llanfaethlu, Anglesey. NGR SH 29288613

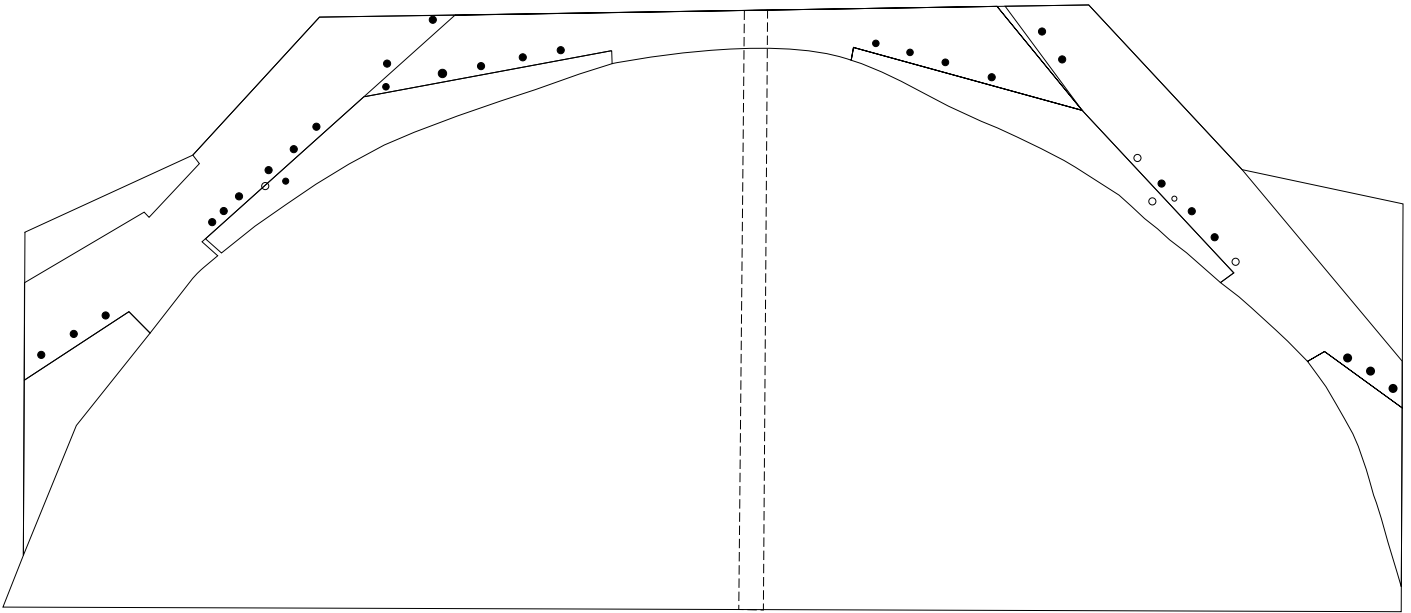
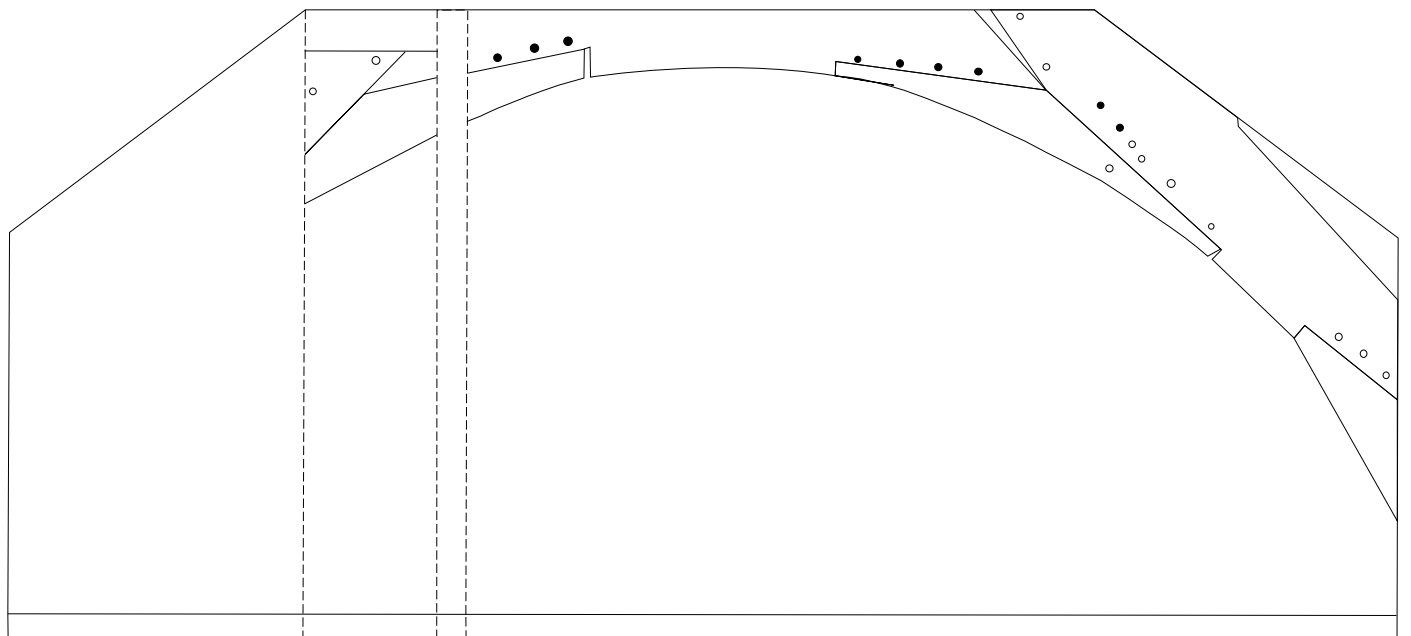
Figure 4 Trefadog, southern cruck

The cruck which divides the hall consists of two principals which disappear into the wall on either side. These have a jointed vertical post which curves onto the principal to form the bend of the cruck. The two are fastened by a wide mortise and tenon joint held with three pegs. It is not possible to see how far the vertical post goes into the wall. None of the vertical posts appear to go below the level of the present first floor, and it is not known if they ever went below that level. An arch-braced collar beam is partly visible below first-floor ceiling level – the remainder hidden by the ceiling. The braces are joined to the collar and principals by mortise and tenon joints (see plates 1 to 6).

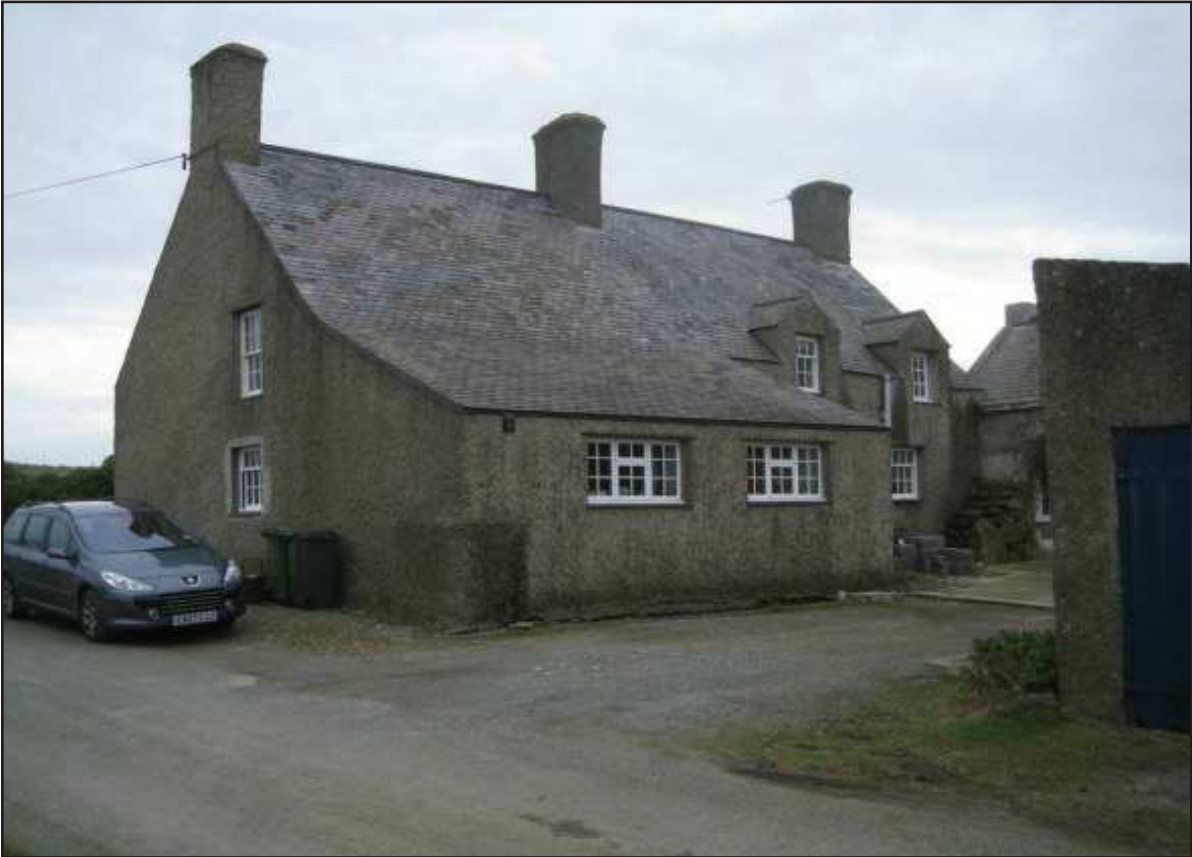
The house is aligned approximately north-south, parallel to the coast edge, and is in a slight hollow 50m from the sea. The house is of two storeys, of rendered stone. The slate roof is modern. There are three rectangular chimney stacks, two at the gables and one to the left (south) of centre. The main front faces east, with an off-centre door to the north, two replaced sash windows to the south and one to the north. Four gabled dormers, all fitted with replaced sash windows, light the first floor. The north side of the house has a catslide addition occupying the north half, of probable 19th century date, though with modern horizontal casement windows in the west wall. The south side of the house is lit by a sash window on the ground floor and two gabled dormers on the first floor. A rear door lies in the corner created by the catslide extension (see plate 2).

Plate 02: The western elevation of Trefadog; view from the northwest.

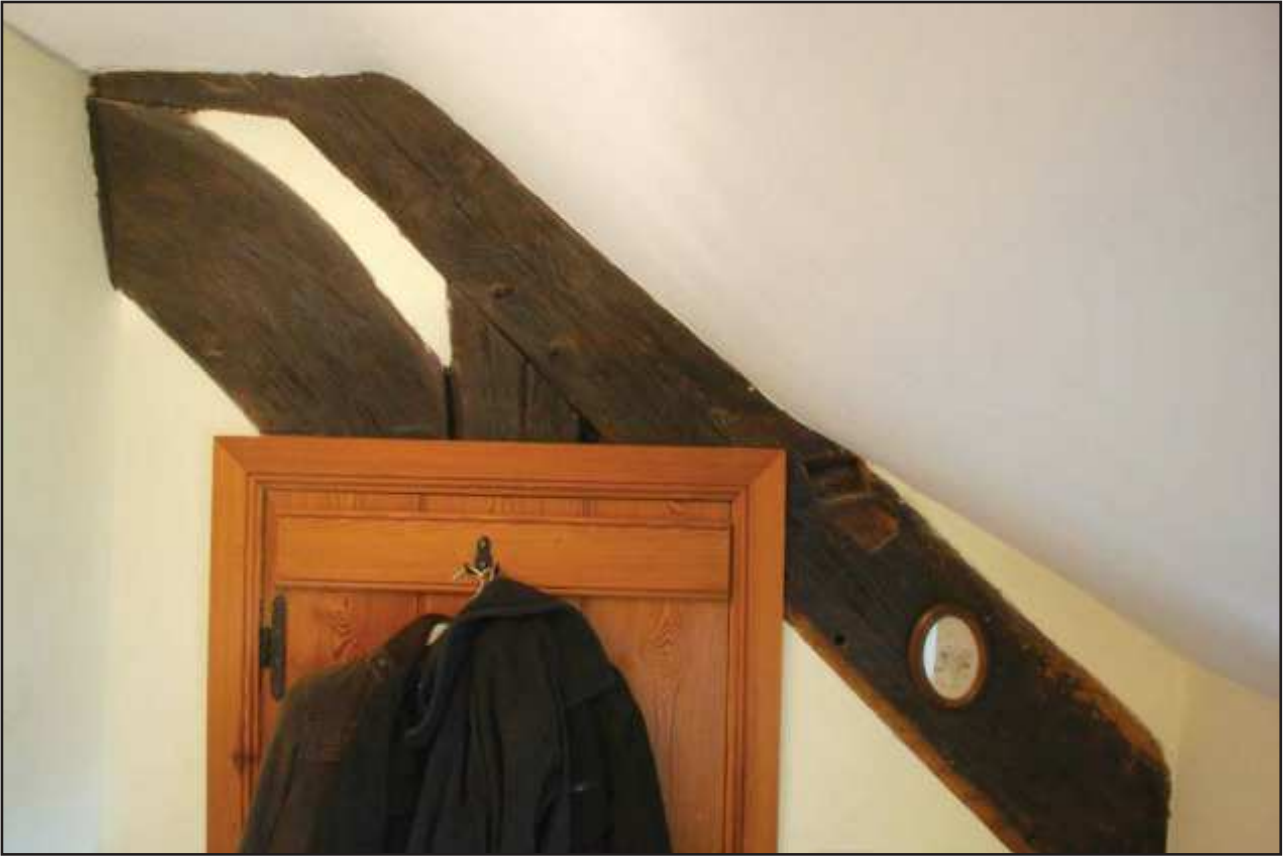
The cruck forming the south side of the screens passage is only partially visible and appears to have been modified on the west side. The arch-bracing to the collar beam on the east side links to a vertical post. There is only a small section left of this, as it has been cut by a door, but it is probable that this vertical post once continued down to ground floor level, and formed part of the screens partition. A vertical wall post, but with less of a curve than on the hall cruck, is linked to the end of the principal, and continues downwards in the lateral wall. This is partly mirrored on the west side, but the vertical post has been replaced with a modern one lower down the principal. Two dowel holes mark the likely location of the original vertical post. There is no evidence for a curving brace to the collar beam, though not enough of the collar beam is visible to confirm if one formerly existed (see plates 7 to 9).

Plate 7: The eastern side of the southern face of the central cruck which forms the south side of the screens passage; view from the south.

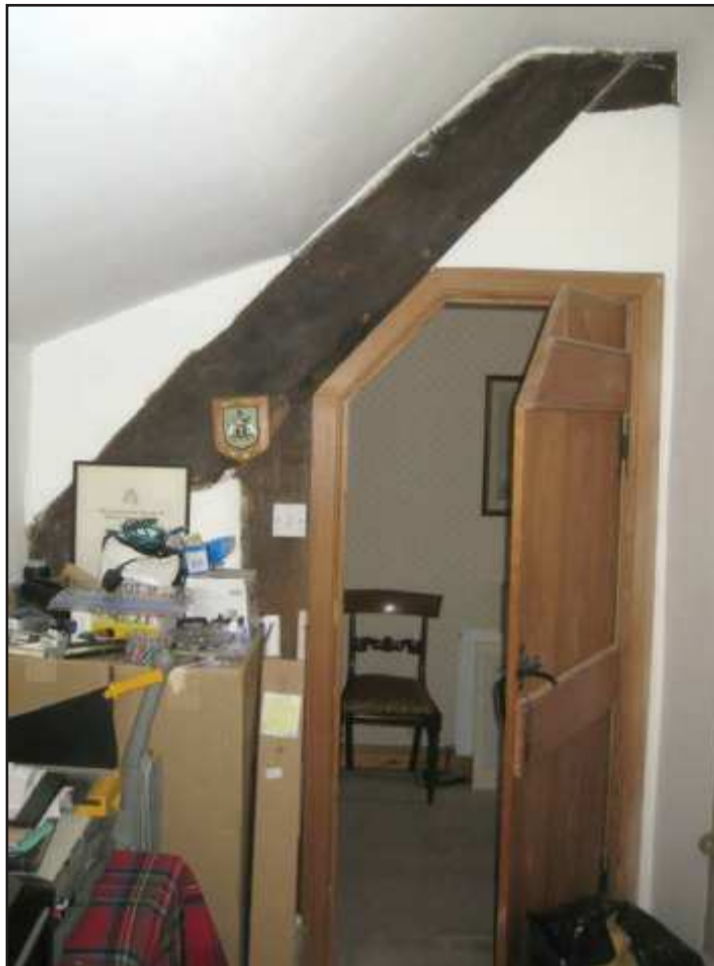
Plate 08: The western side of the southern face of the central cruck which forms the south side of the screens passage

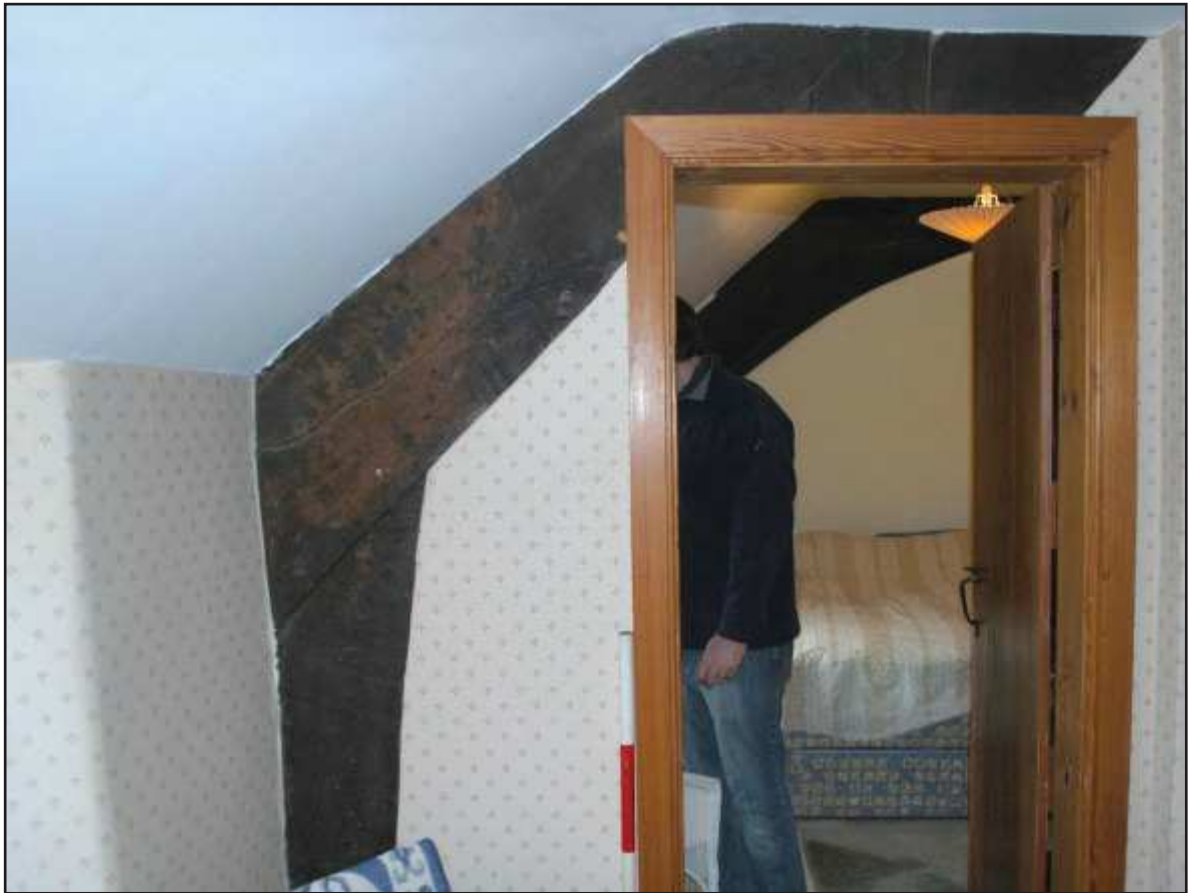
Plate 9: The eastern side of the northern face of the central cruck which forms the southside of the screens passage; view from the north.

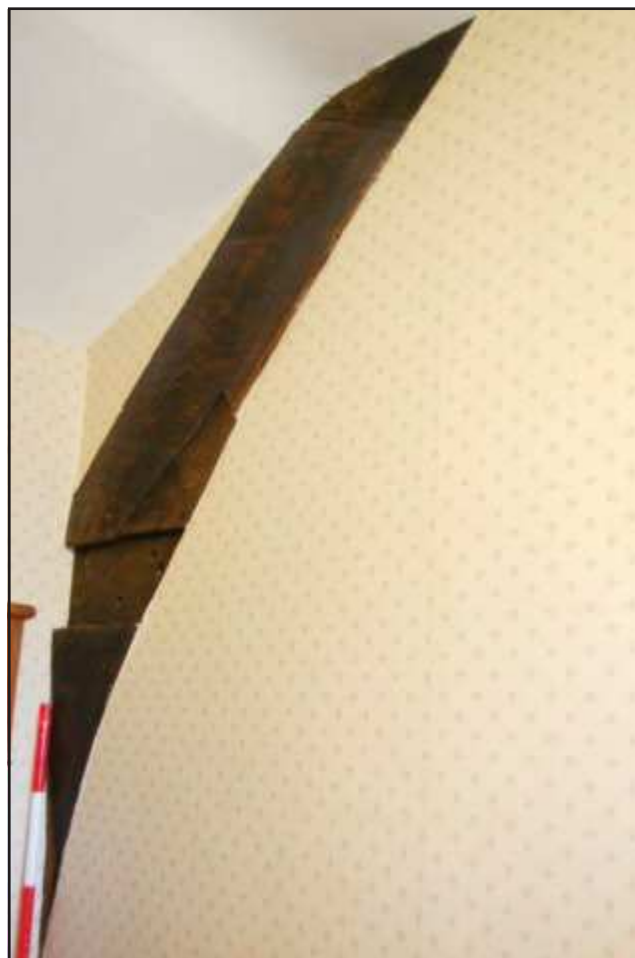
The northern passage cruck is different again. Here the principles are jointed onto vertical wall plates, but there is no collar beam visible, nor any bracing. A housing for a tie beam, however, lies across the cruck joint on the south face – an odd arrangement, but possibly original. The tie beam has been removed, but a housing exists on both east and west sides. The different nature of this truss suggests the outer rooms were two storey (see plates 10 to 12).

Plate 10: The eastern side of the southern face of the northern cruck which forms the southside of the screens passage

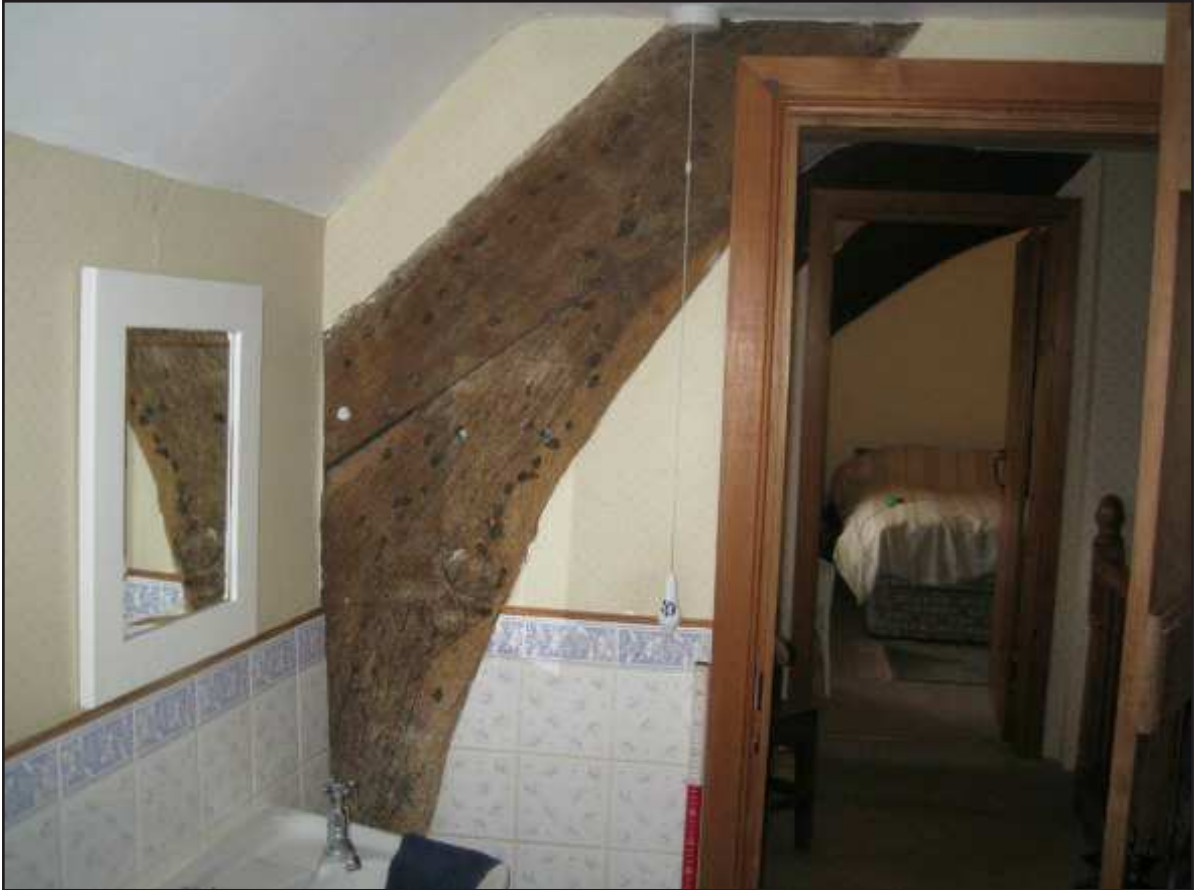
Plate 11: The eastern side of the northern face of the northern cruck which forms the northside of the screens passage; view from the north.
