PLAS YN TROFARTH

Llangernyw, Abergele, Conwy C.B.

Architectural Record, 2016

Report Ref.: 2016_008(b)_v.2 FINAL

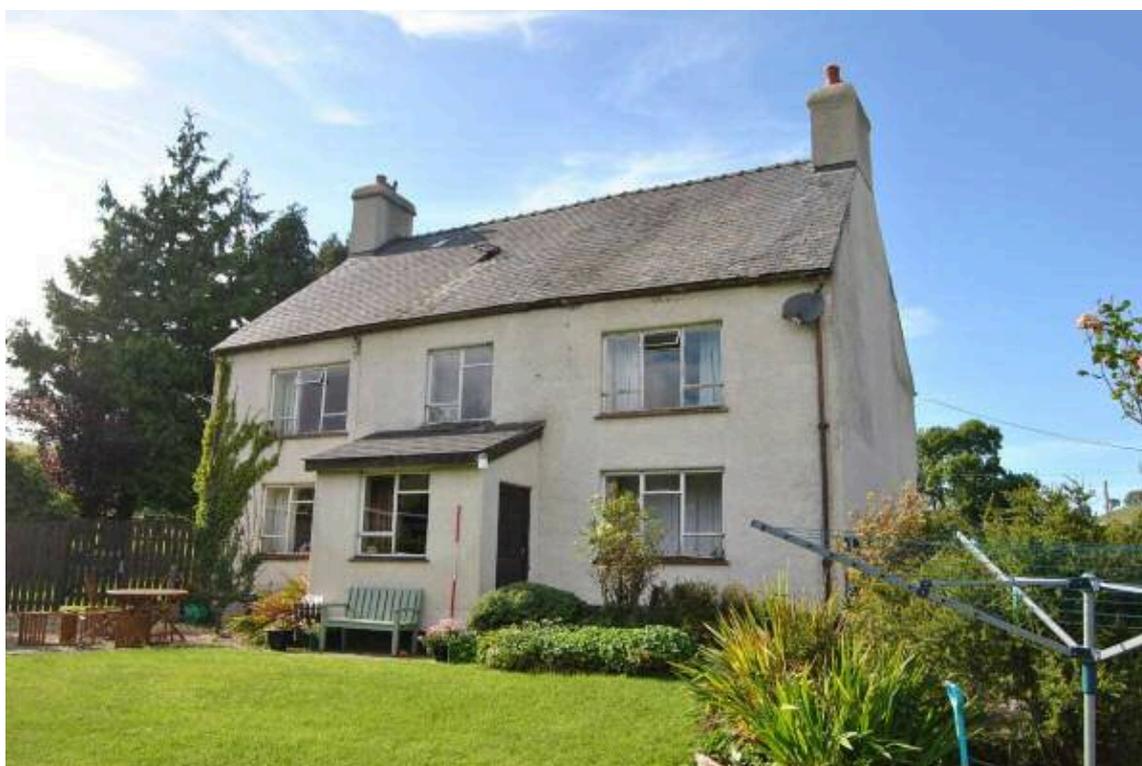
Plate 2: Principal east (original front) elevation, oblique view looking south-west with single-storey porch extension (post-1953; compare Figure 3a).

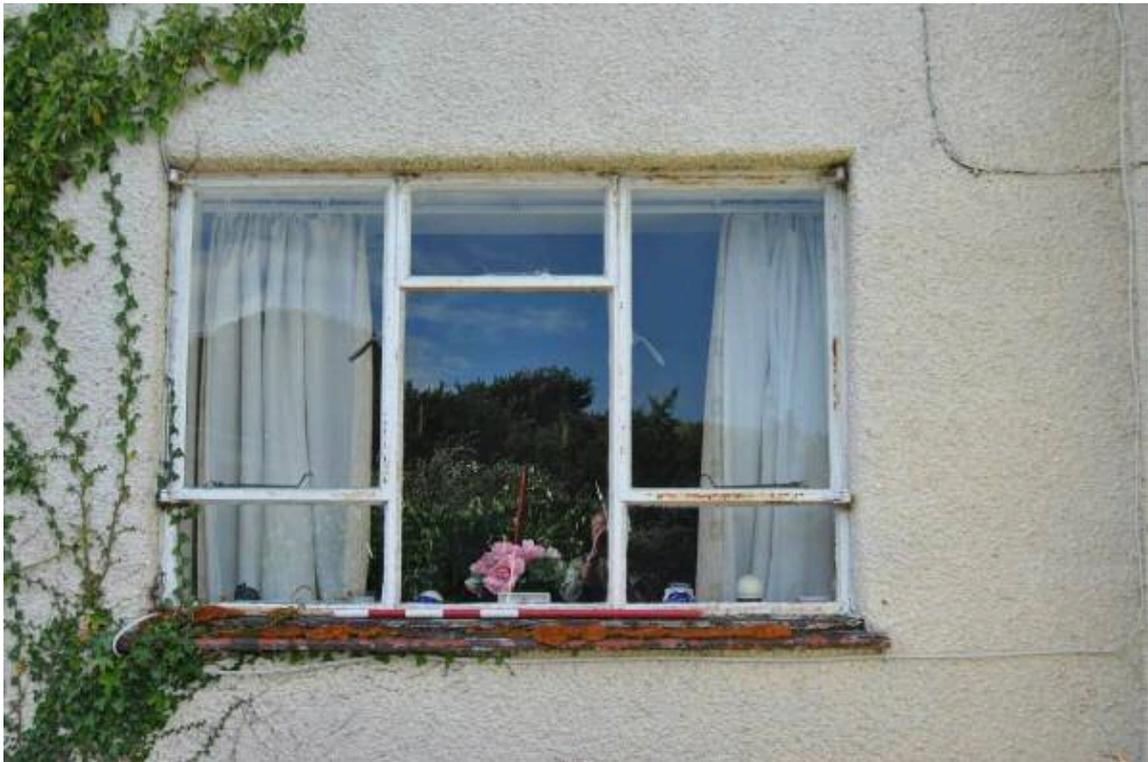
Plate 3: Unsympathetic steel-framed windows, introduced throughout in late 1950s.

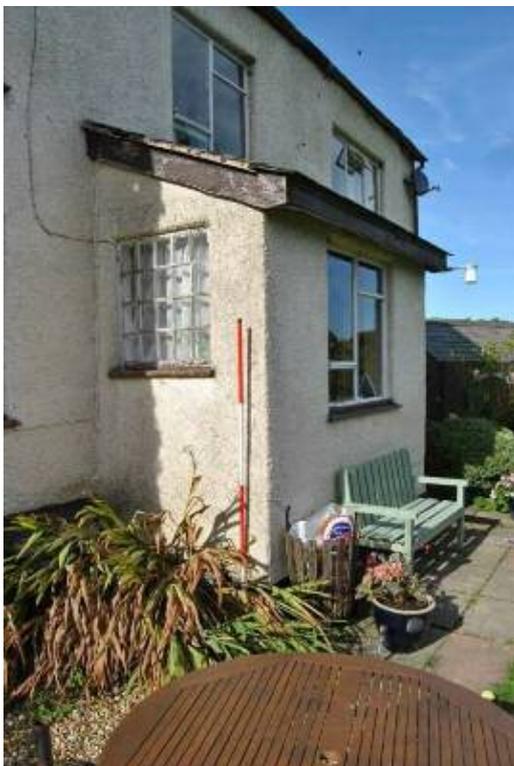
Plate 4: Pent-roofed porch appended to east elevation after 1953.

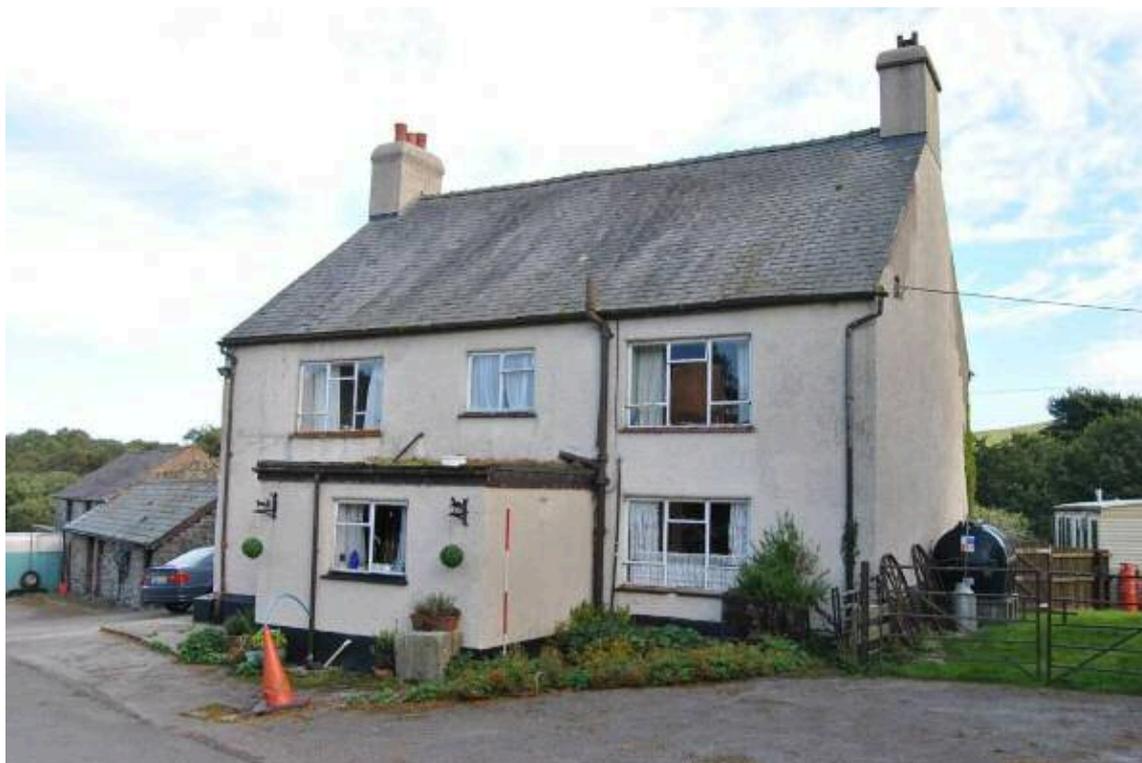
Plate 6: West (original rear) elevation, oblique view looking north-west with single-storey utility extension (post-1953; compare Figure 3b). Note general drop in ground level from south to north (left to right).

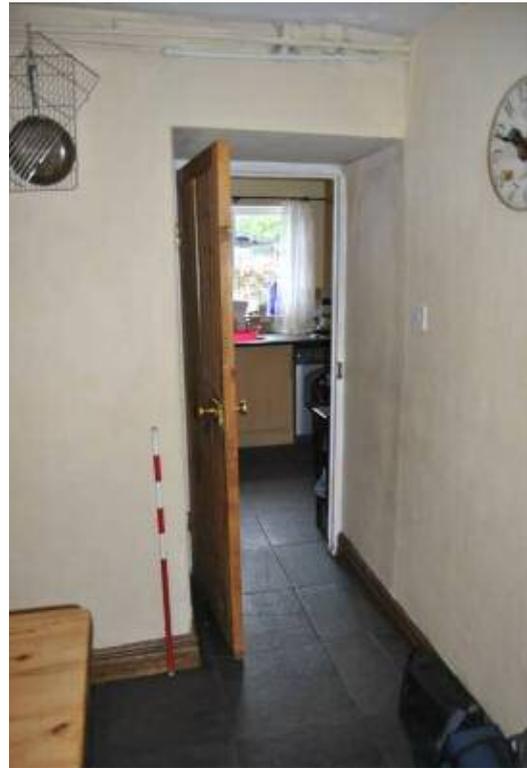
Plate 10: 1950s door opening to west elevation.

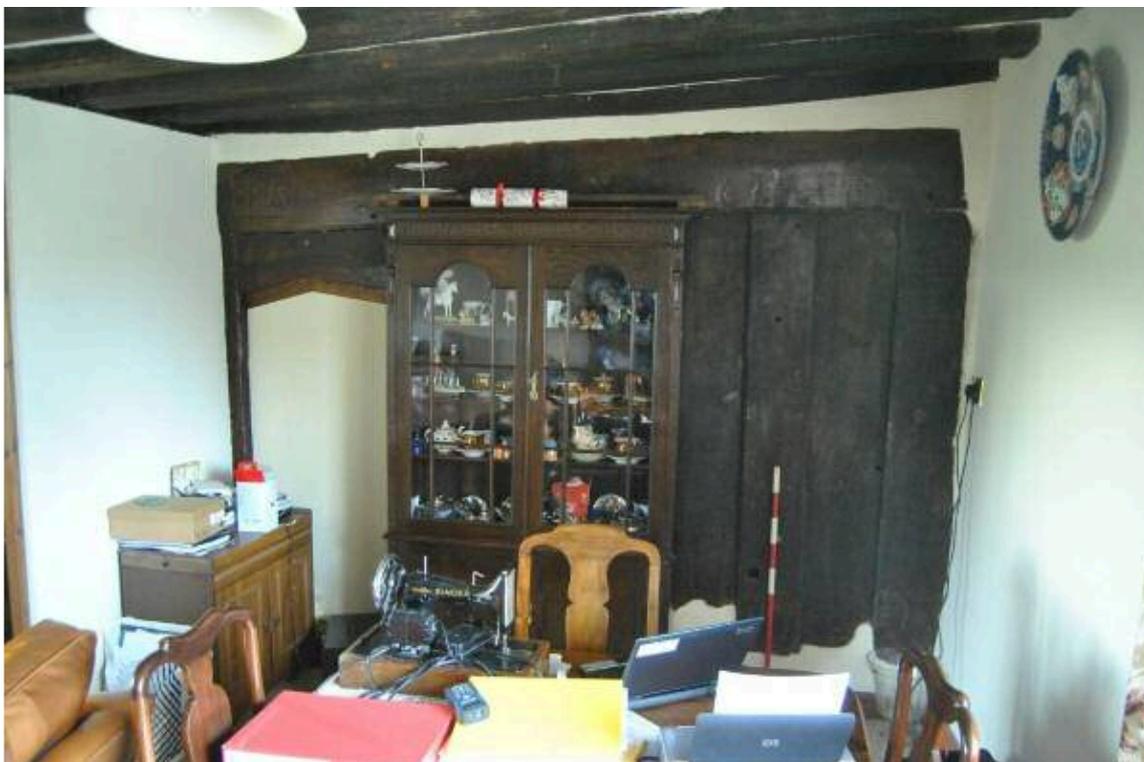
Plate 21: Post-and-panel partition to south side of [G2] (assumed relocated from cross-passage).

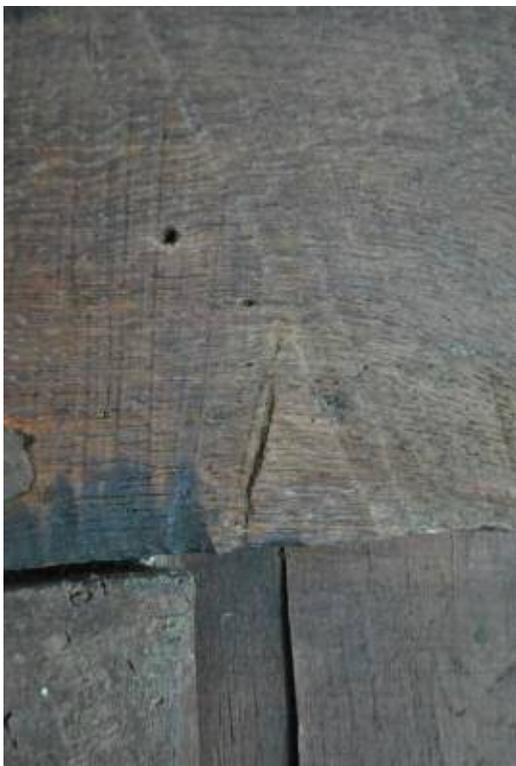
¹⁵ The head-beam of the P&P partition in [F4] displays clear evidence for having been trestle sawn (Plate 27).

Plate 27: Evidence for trestle sawing in head beam of P&P partition.

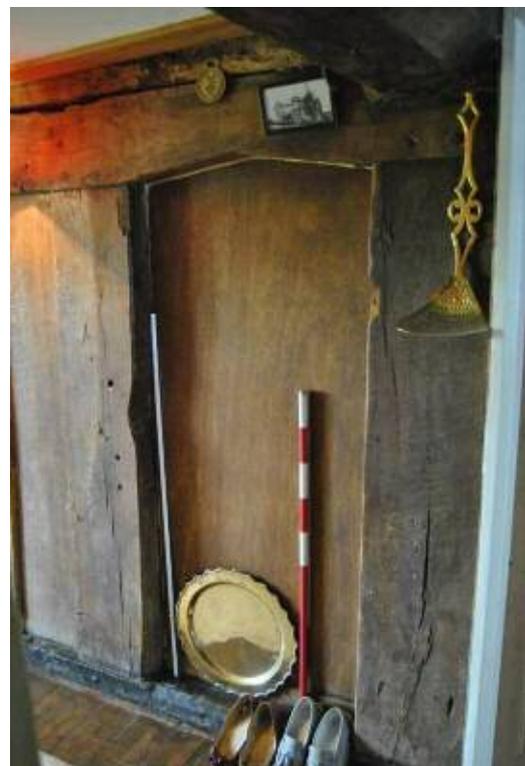
Plate 28: Primary doorway (blocked) within P&P partition [F1].

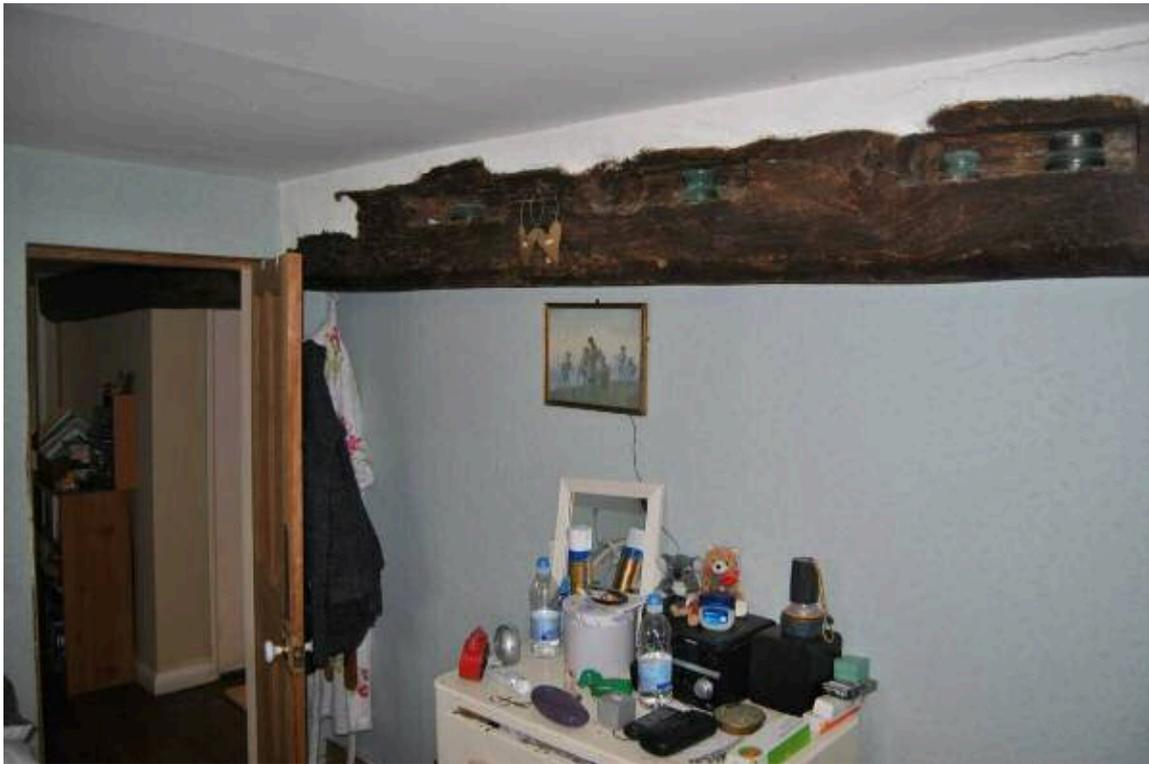
Plate 29: Sockets for 1ft wide ceiling joists in axial beam, exposed below raised ceiling within [F3].

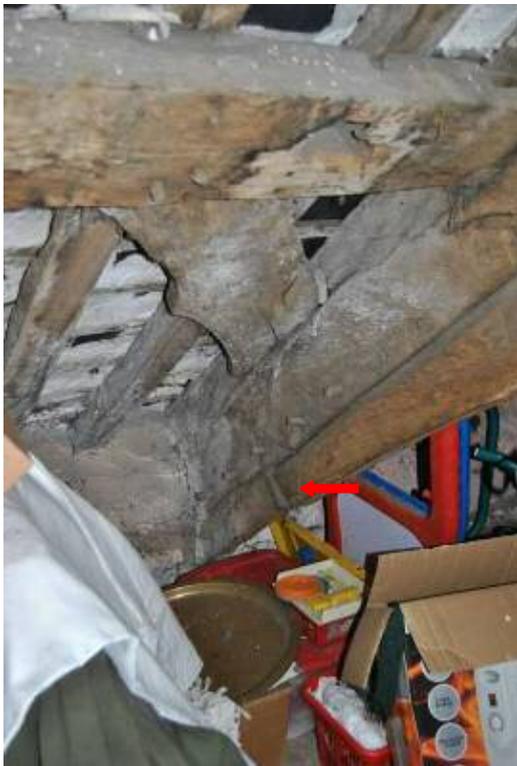
Plate 37: Multiple pegging of arch-brace to principal.
NB. 2-part brace, jointed just above level of wall-head.

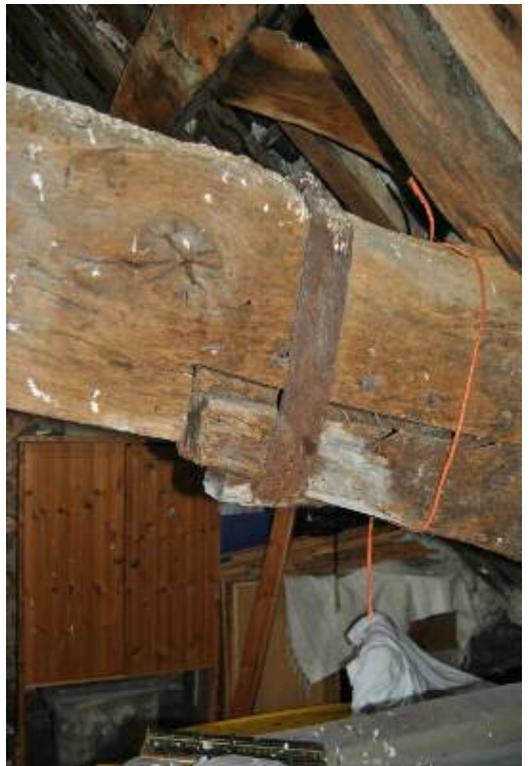
Plate 38: Repair of arch-brace/collar joint with iron strap and wedge.

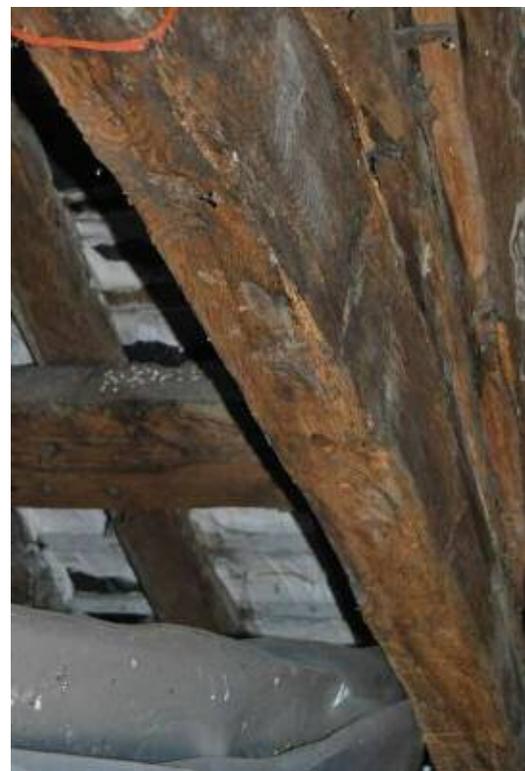
Plate 42: Secondary stave holes to soffit of arch-brace;
Truss **T11**.

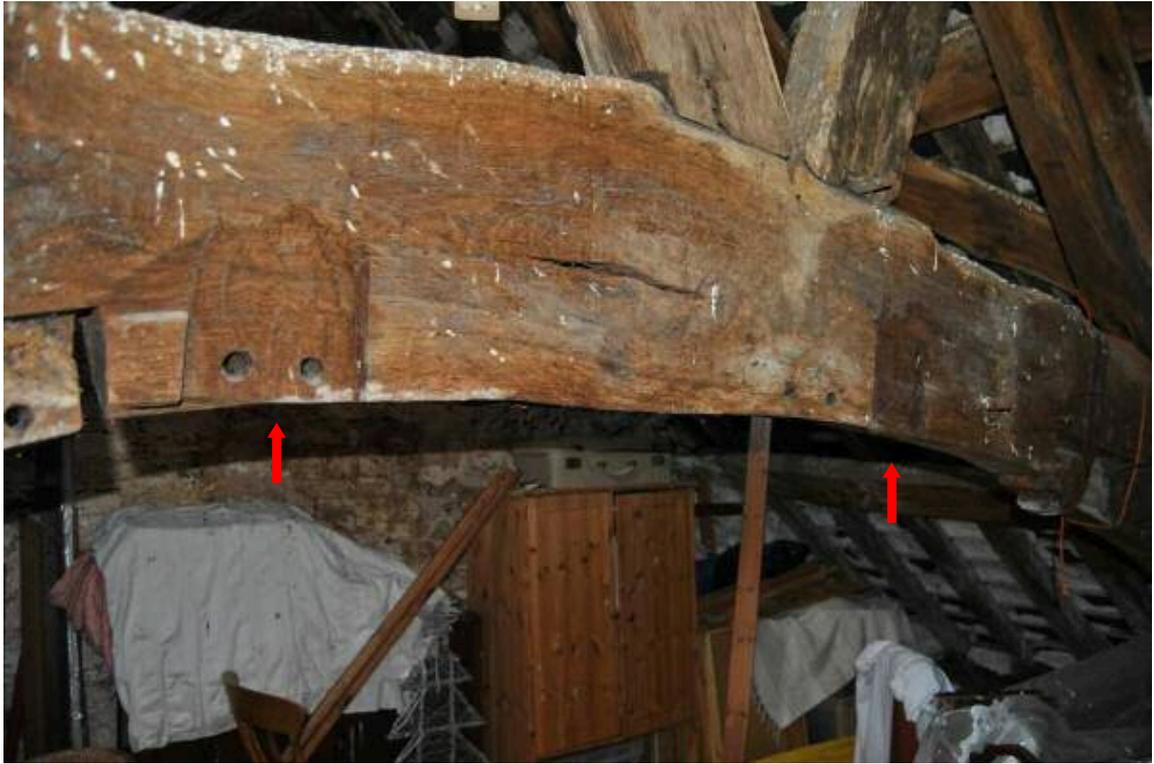
Plate 43: Pegging for secondary infill of truss T1.

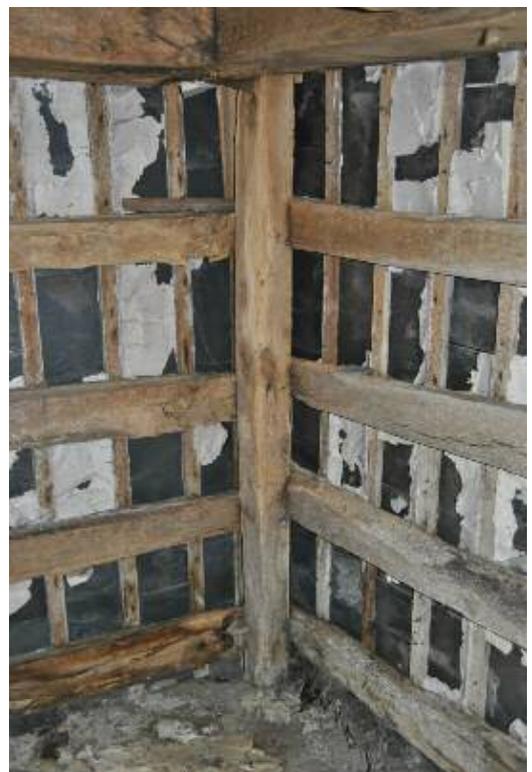
Plate 44: Unpegged common rafters over Bay IV.
