PANT-GLAS (Stable B), YSBYTY IFAN, CONWY

[NPRN 414931]

Architectural Record

FINAL REPORT

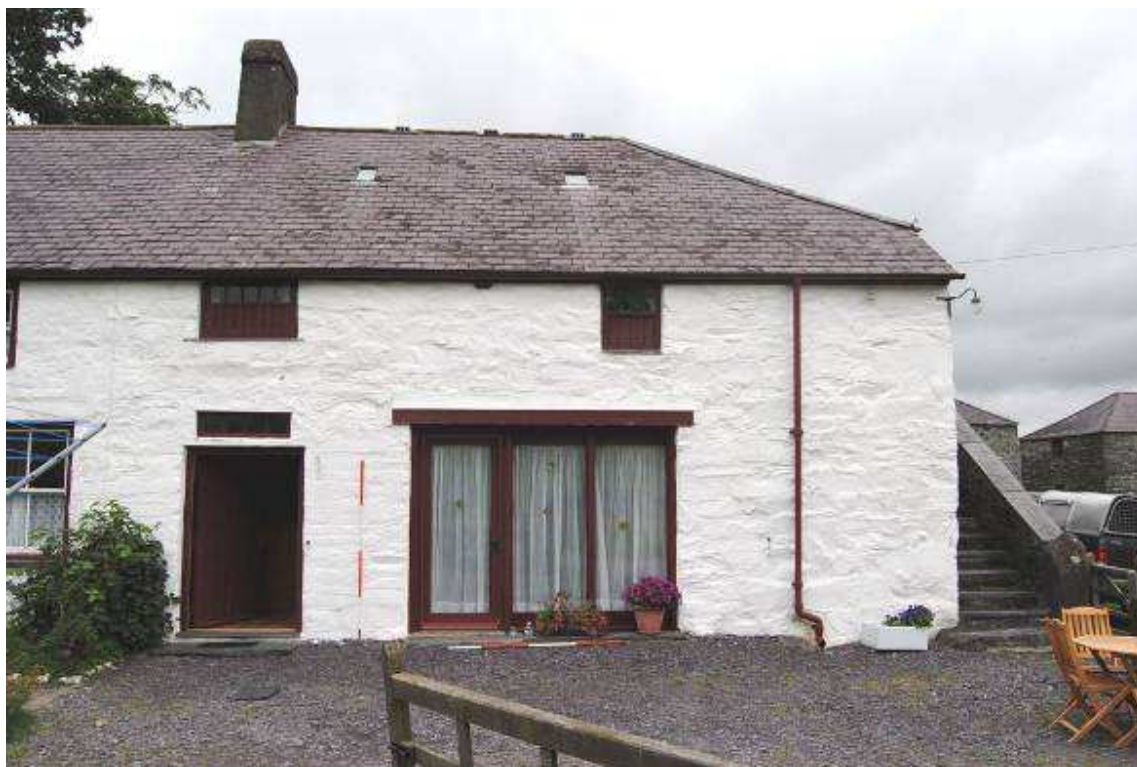
- 4.2.1 The principal **south elevation** (Plate 2) is stone-built, whitewashed, rising through 1½ storeys to a pitched, slate-clad roof, half-hipped to the east; a ridge stack rises immediately west of the stable block section. The roof includes two small, glazed skylights. At ground floor level, two doorways open to the interior. The first, a wide pedestrian door of vertical planks, opens at the west with a shallow four-pane fixed light over, slightly narrower than the doorway opening. To the east, a large (?) carriage doorway opening has been converted to house modern, full length 'French' windows (installed in 2000/1, to replace former timber double-doors). The low upper floor is lit by two windows; that to the east is of eight (4 x 2) fixed-panes over a lower, bottom hinged hopper, that to the west (located directly above the western door) is shorter and wider, with ten fixed-panes (5 x 2) over a vertical slatted vent; both are set hard beneath the eaves.

Plate 2: Stable B; south elevation.

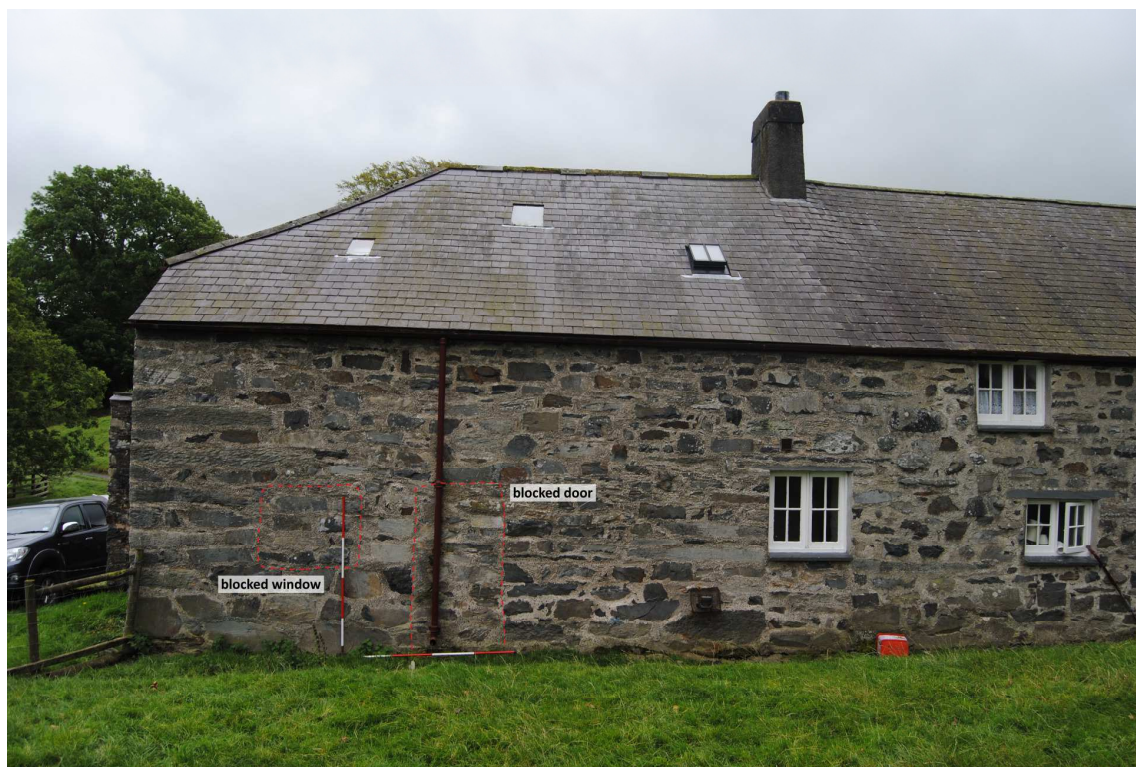
- 4.2.2 The **north elevation** (Plate 3) is stone-built of exposed, un-coarsed rubble masonry, including a number of large blocks, particularly at the north-east angle, up to 1½ m (5ft) in length. The elevation rises through 1½ storeys to a pitched, slate-clad roof, half-hipped to the east with a ridge stack rising to the west. The roof includes three small, glazed skylights. Ground floor level includes a clear blocked doorway (Plate 4) approximately central to the stable block with a blocked window opening to the east.⁵ To the far west, just beyond the interior extent of the stables, a former doorway has been partly blocked and a two-light timber casement inserted (Plate 5), lighting the 'dairy' internally (see §.4.3.1, fn.6).

Plate 3: Stable B; north elevation

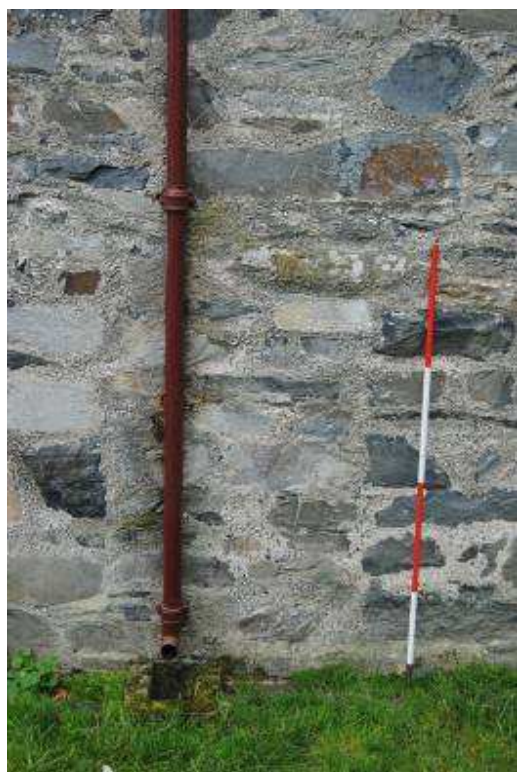
Plate 4: North elevation; blocked door.

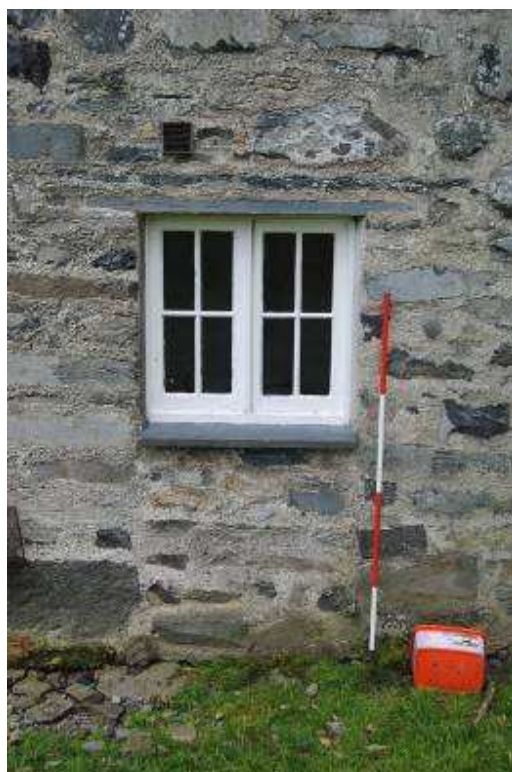
⁶ This space would also have originally have been accessed from the exterior by the partially blocked doorway in the north wall (see §.4.2.2; Plate 5). Hughes (1983) gives its function as the dairy.

Plate 5: North elevation; door converted to window.

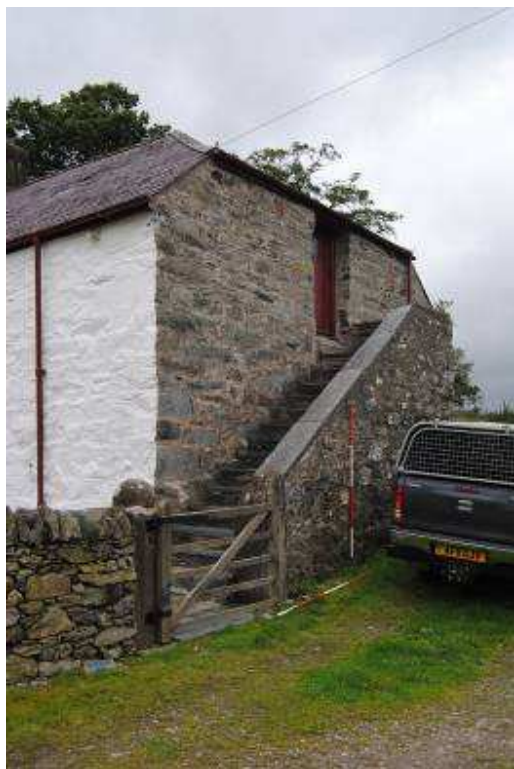
- 4.2.3 The **east elevation** (Plate 6) is again of exposed stone rubble construction, rising through 1½ storeys to half-hipped, slate-clad roof. A central doorway at first floor level, with flat head hard beneath the plate, is accessed via a stone built stair (secondary), rising from south to north against the elevation, with a slate-topped parapet wall.

Plate 6: Stable B; east elevation, oblique.

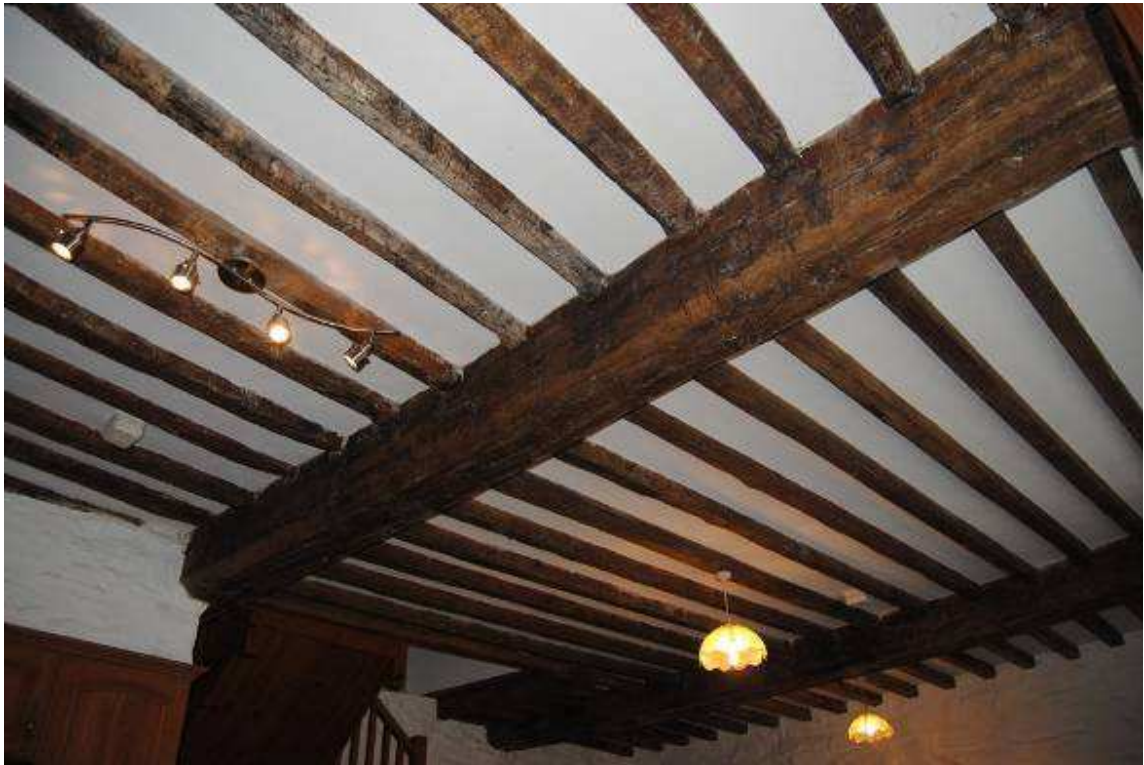
- 4.3.2 Room [**GF01**] is spanned by three substantial (1ft square), plain-chamfered transverse beams (**A-C** from west to east; Plate 8); beams **B** and **C** are stopped with plain run-outs to the south though not to the north, while beam **A**, which rests to the south on the timber lintel over the pedestrian doorway, is unstopped. The carpentry of the ceiling to either side of beam **A** is of superior quality, with plain-chamfered and stopped common joists (3 x 4 in @ 13 in centres.), while those east of beam **B**, while following the spacing of the western joists, are plain and probably renewed; those in the easternmost bay are new. The soffit of beam **A** displays a longitudinal groove, offset to the west side of the timber (Plate 9) indicating, together with a regular series of peg holes (x 7 total @ 20 in. centres) within the west face, a former partition; the location of a wall in this location, offset only 1ft from the stone-built west wall, is problematic and suggests either that the beam and related joists have been re-set or, more likely, that the western wall of [**GF01**] represents a secondary insertion.⁷ Murphy (1983) argues that the area to the west of beam **B** may formerly have

Plate 8: Room [GF01], ceiling structure (beams B and C).

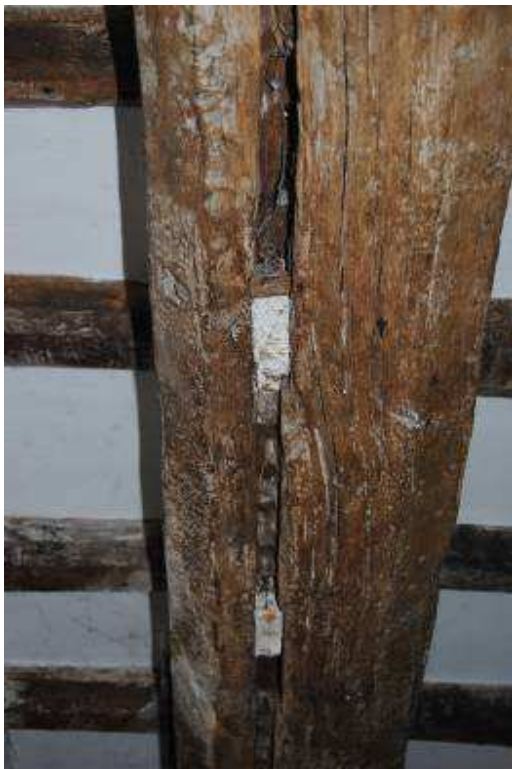
Plate 9: Groove to soffit of beam A.

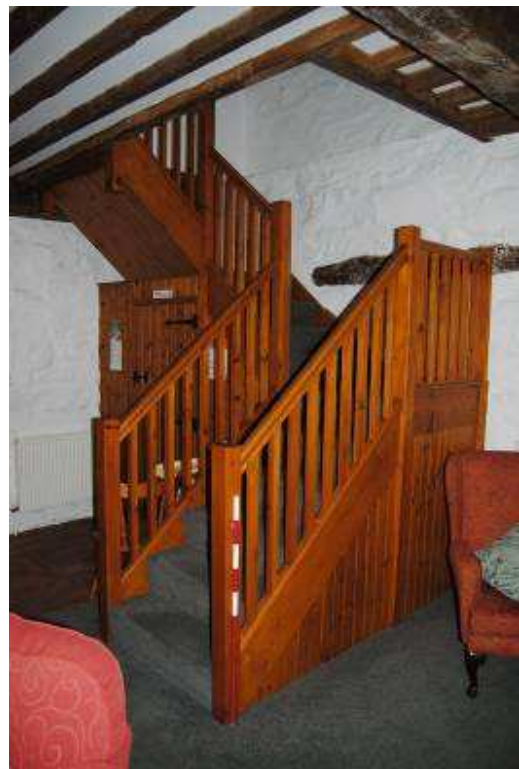
- 4.3.3 At the centre of the north wall, a modern stair has been inserted (Plate 10), the introduction of which has entailed a certain amount of intervention within the ceiling structure at this point (see Figure 5). Behind the stair, two adjacent timber lintels exposed within the masonry of the wall evidence the former door and window recorded externally (see §.4.2.2; Plate 3). A further relic lintel is exposed at the southern end of the east wall with straight joints within the masonry below (Plate 7), though this is not traceable externally due to the secondary stair; its original function remains unclear.

Plate 10: Modern inserted stair.

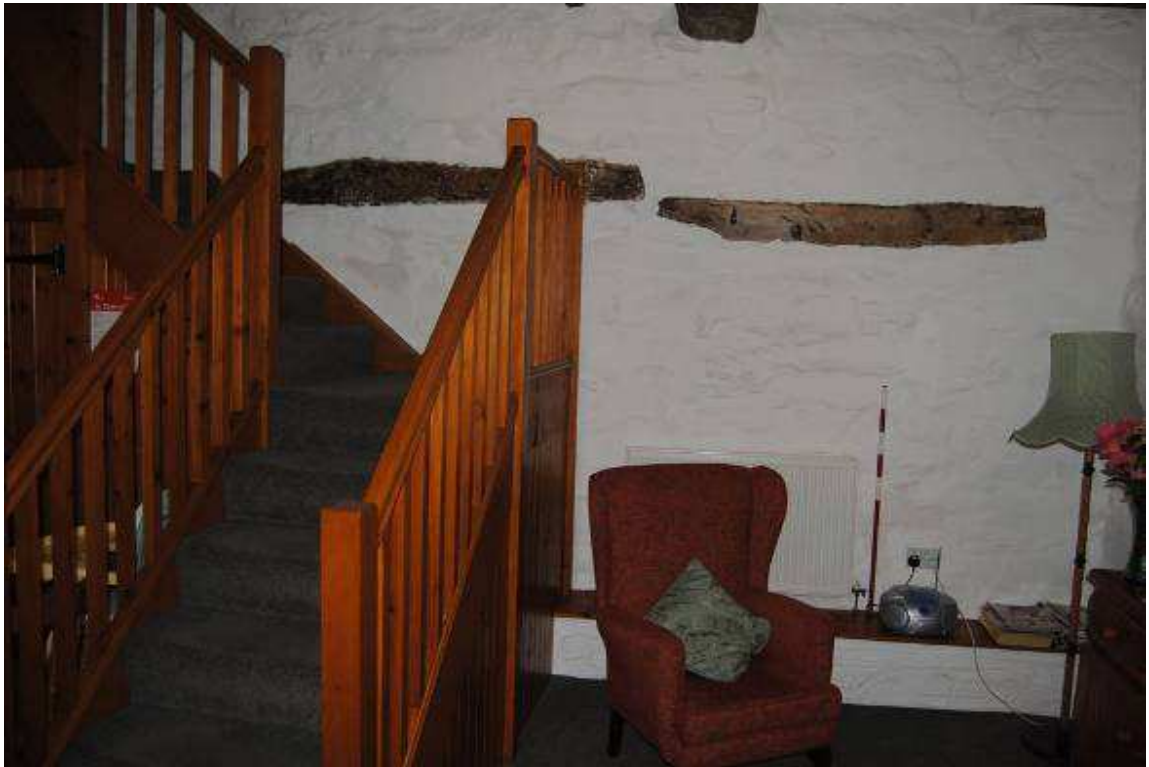
⁵ This feature is only faintly traceable externally, though it is additionally evidenced by timber lintel internally (see §.4.3.3; Plate 11).

Plate 11: Timber lintels within north wall.

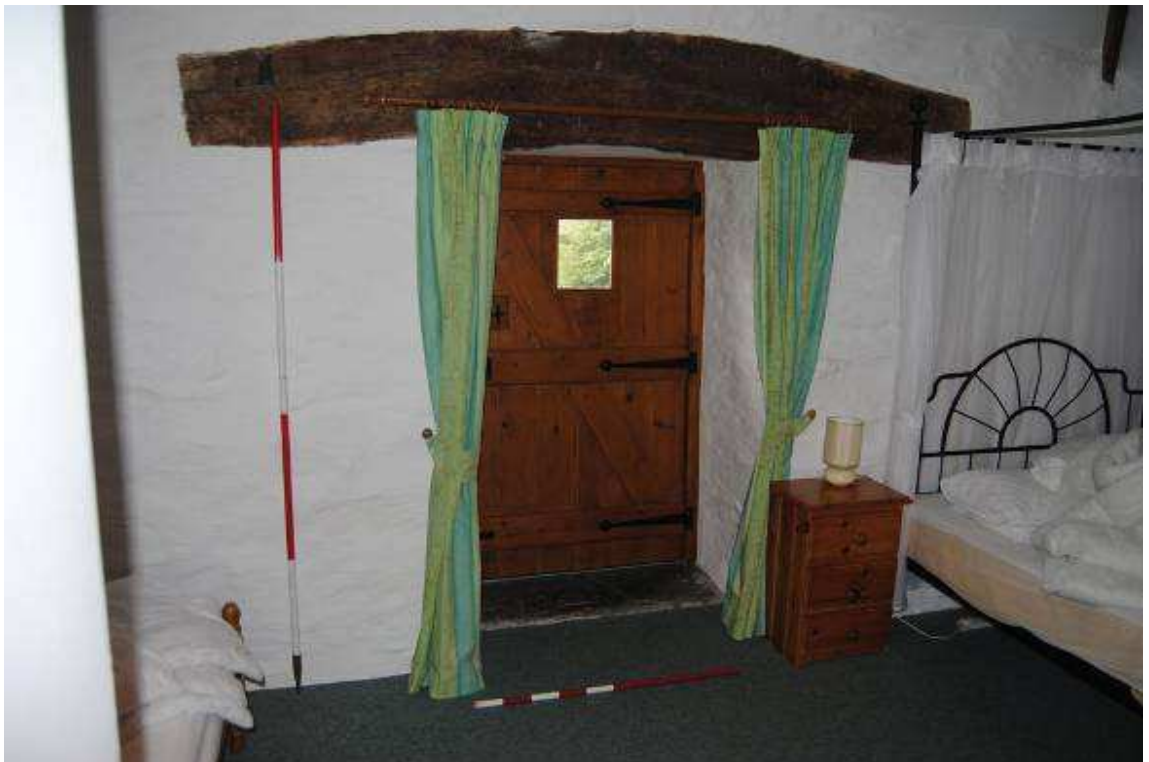
- 4.3.5 The principal room [**1F02**] is located to the east end of the range, lit by a low window in the south wall and by a series of skylights in the northern and southern roof slopes (see Plates 14/15). The central doorway in the eastern end wall of [**1F02**] (Plate 12) opens onto the external stair; it is spanned by a substantial timber lintel, cambered and plain-chamfered to its lower arris, which extends to both north and south of the doorway opening. The lintel displays smoke blackening to its soffit and scorch-marks of candles to its exposed face, suggesting an original function as a fireplace bressumer, though the height of the timber above floor level makes it unlikely that it is *in-situ* (ie. that the doorway has been formed through conversion of a former fireplace), and it most probably represents a reused timber.

Plate 12: [1F02]; doorway to east gable. **NB:** oversized lintel (re-used FP bressumer).

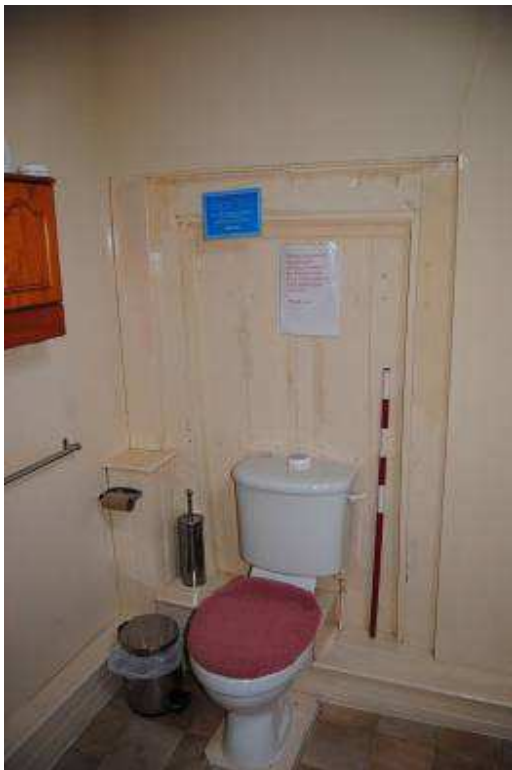
- 4.3.6 Opening off the west side of landing [**1F01**] are too small rooms, [**1F03**] and [**1F04**] to north and south respectively. Room [**1F03**] includes a blocked doorway within its western wall (Plate 13), formerly providing through access to the upper floor of the farmhouse proper. The west face of **T1** is exposed in the east wall, where an inserted prop supports the lower collar (see §.4.3.7 below). Room [**1F04**] is lit by a low window within the south wall, of ten, small fixed-panes (5 x 2) over a vertical slatted vent; **T1** is again exposed within the east wall where another inserted prop was noted (see §.4.3.7 below).

Plate 13: Blocked door to main house [1F03] (W).

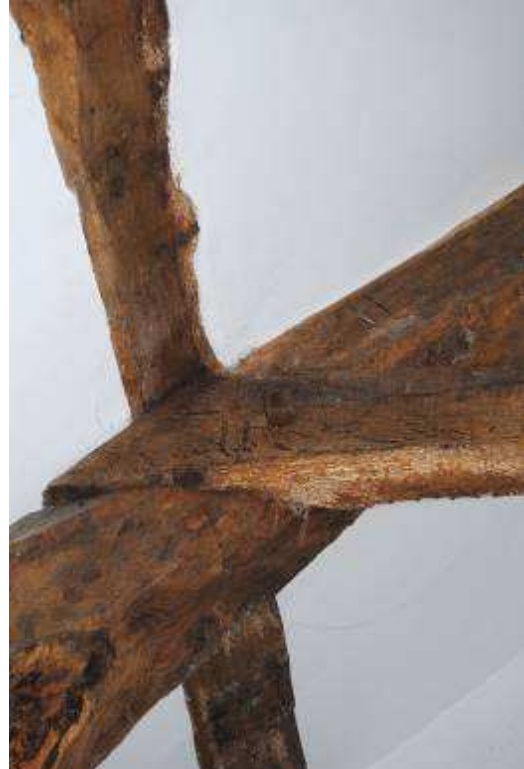
Plate 16: Detail of lap jointing and square pegs;
NB: carpenter's numbering ('11') to collar and principal.

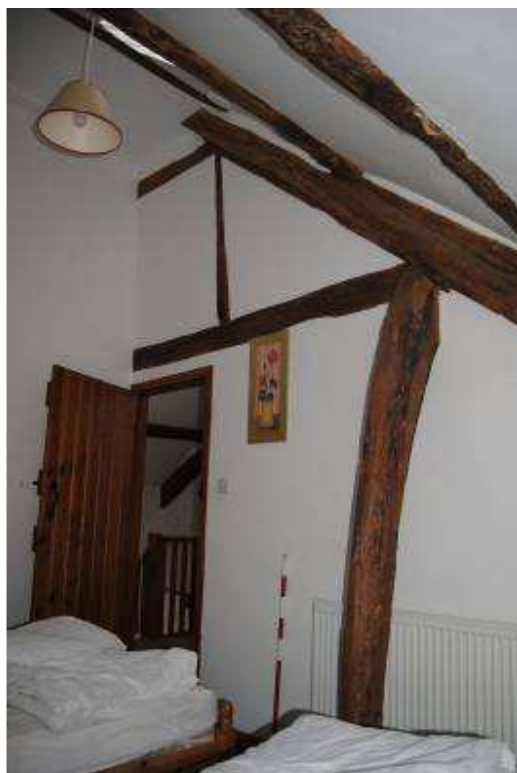
Plate 18: Inserted strut to T2 [1F04].

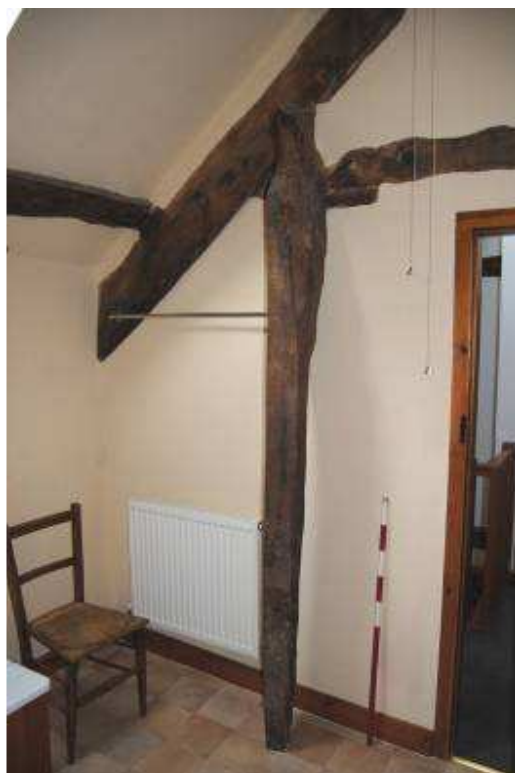
Plate 19: Inserted strut to T2 [1F03].

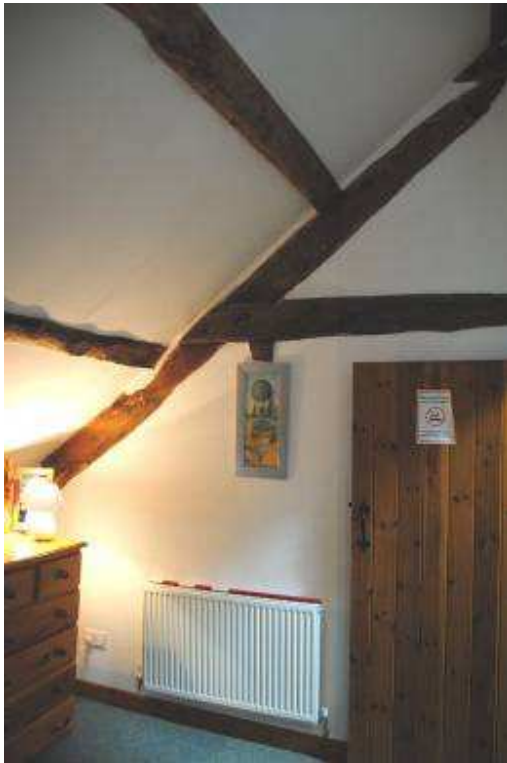
Plate 20: Inserted strut to T2 (south).

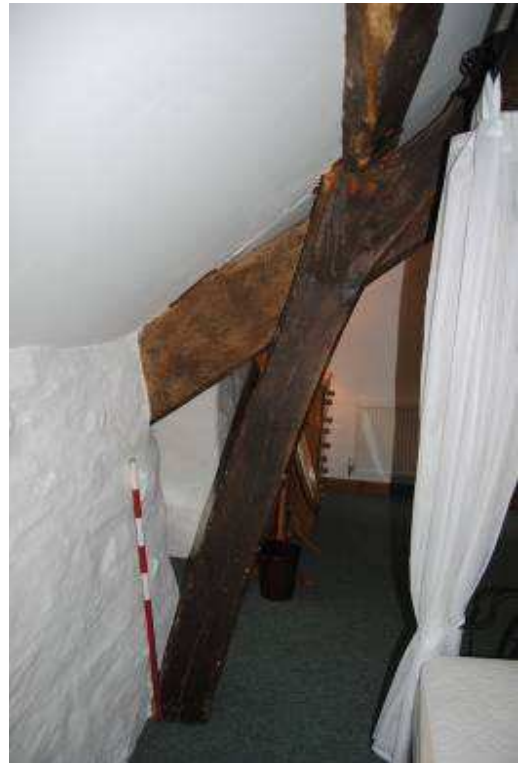
- 4.3.7 The roof is of three bays (here numbered 1 to 3 from west to east) defined by two trusses (**T1** and **T2**; Plates 14/15) of double-collared form supporting three tiers of side purlins. The carpentry of the trusses is unrefined using roughly converted timber and employing notched lap joints at collar/principal,⁸ secured by square section pegs driven through at divergent angles (Plate 16), though mortice and tenoned at the apex (Plate 17); trusses are numbered 'I' (**T1**) and 'II' (**T2**) on the southern principals and collars with short, chiselled Roman numerals (Plate 16). Purlins are lodged over the outer face of the principals and are scarfed at each truss with simple splayed joints, including at **T1**; here the upper purlin extends only 1m (3ft) east of the truss with the implication that they have been truncated and that the half-hipped roof form has been adapted from an original gable end. This is confirmed by the quality of the hip construction where hip rafters are clearly secondary, being of narrow 'plank' section timber. Both trusses display secondary strengthening in the form of vertical, gently curving struts inserted to support the lower collar / principal; in the case of **T1**, opposing struts have been introduced rising from beam **B** to the lower collar adjacent to the principal to both north and south (Plates 18/19); the head of the props are visible beneath the collar as seen from the east (Plate 20). At **T2**, the curving support takes a variant form, rising transversely from the first floor offset in the stonework of the south wall to prop the lower purlin (Plate 21), and extending

Plate 21: Truss T1 (south).
