# Hen Wrych

Llanddulas Road, Abergele, Conwy B. C.

Architectural Record, 2016

## Final Report

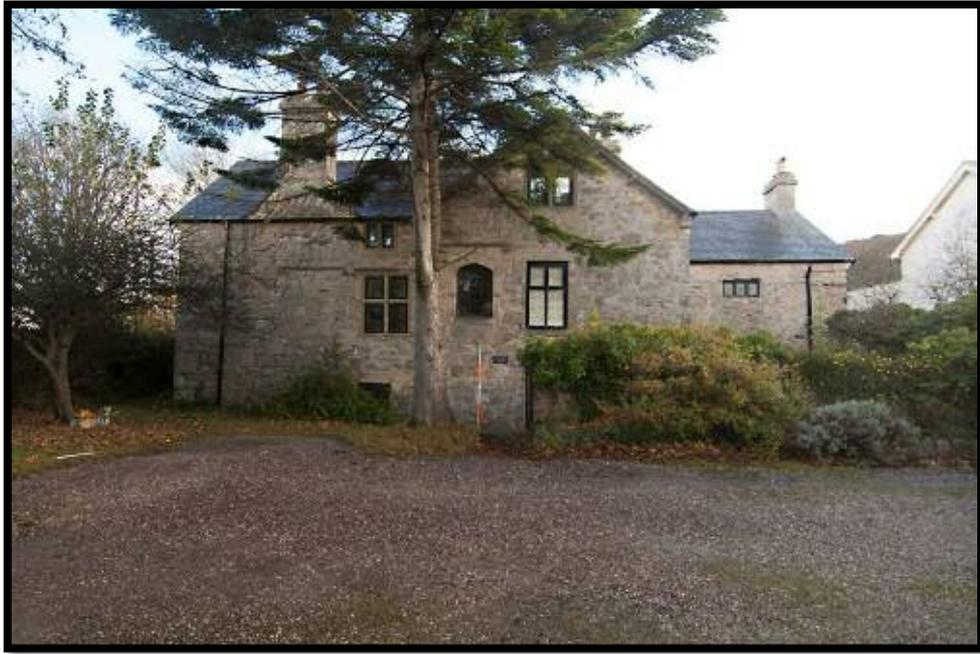
Plate 1: Hen Wrych north Elevation

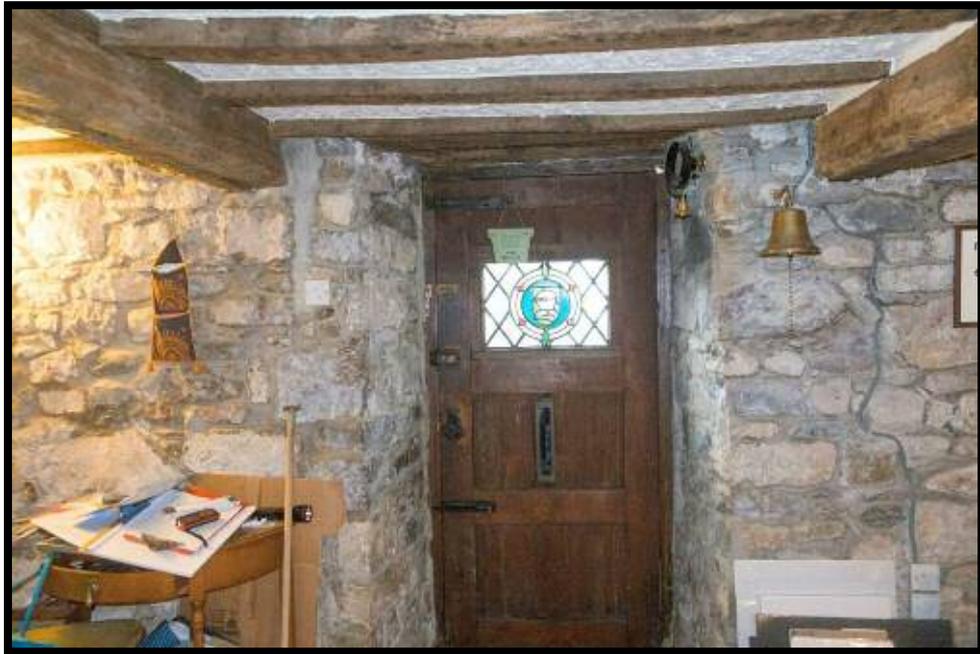
Plate 12: Front door to cross passage. Both passage beams are mortised for posts.

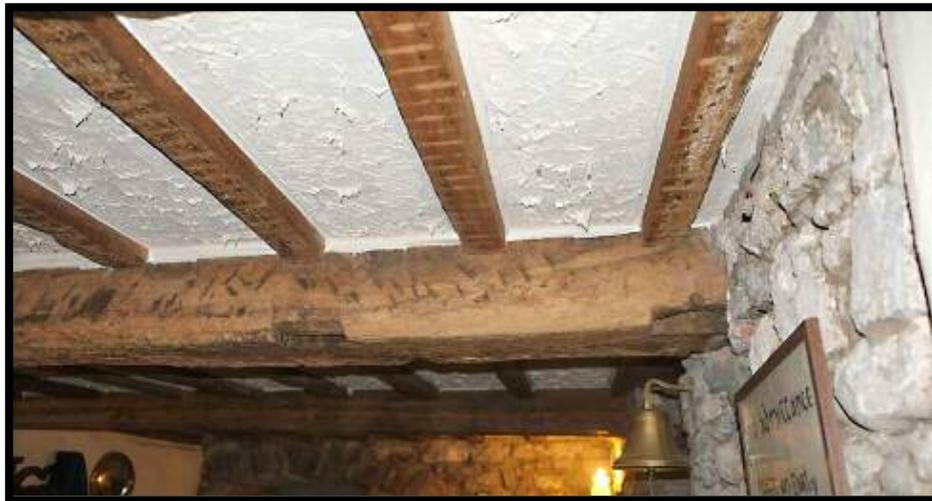
Plate 13: L beam notched for door posts.

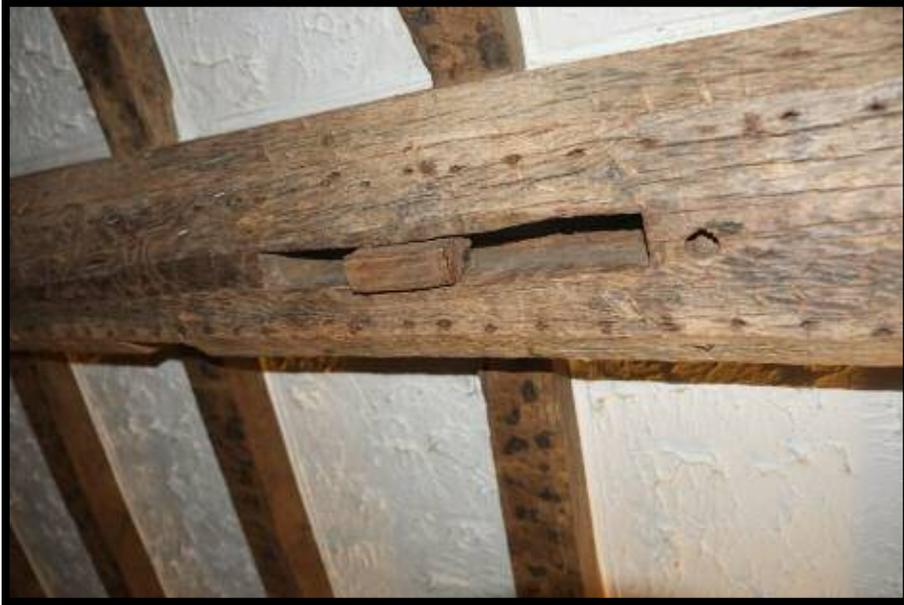
Plate 14: Passage beam mortises.

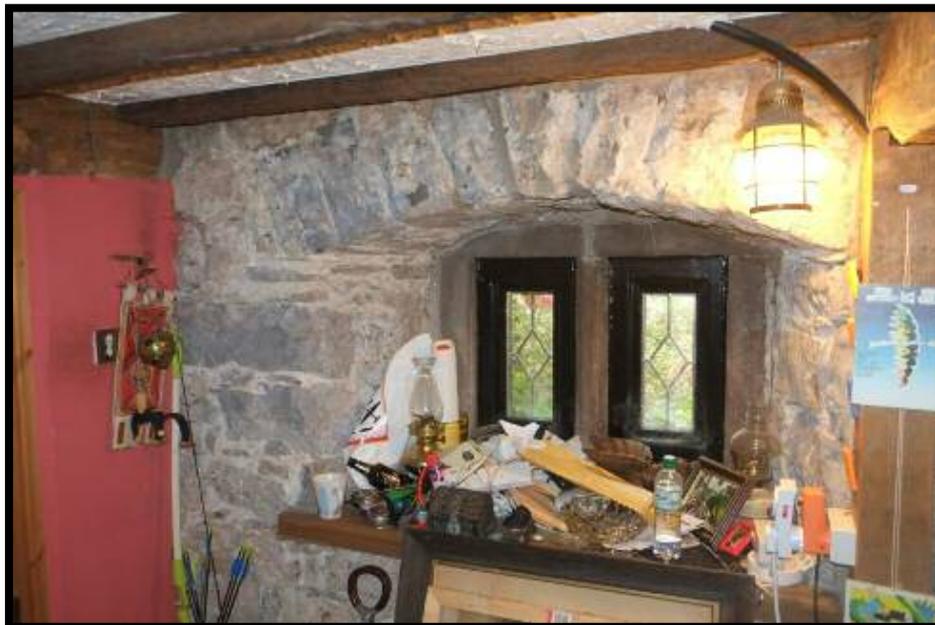
Plate 18: Basement - sandstone window with arch. Common to all early basement windows.

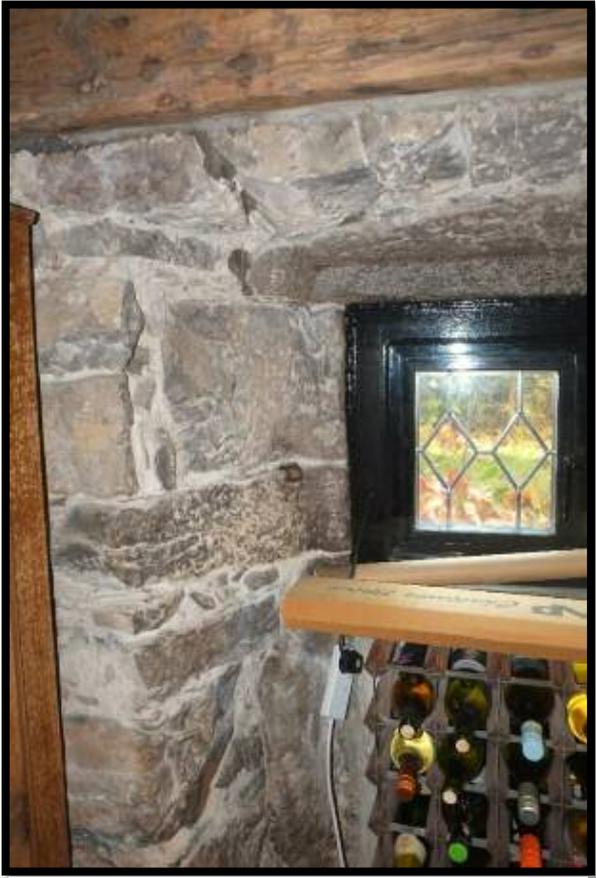
Plate 19: Former doorway with rebates in the stone.

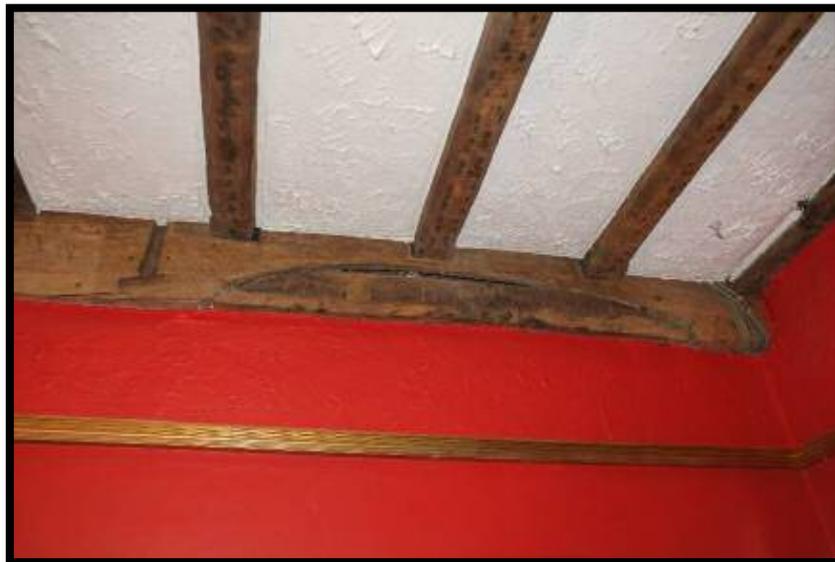
Plate 26: Curious replacement of what appears to be an arch. Suggestion by owner that investigation on other side of wall was a chamber that may have been a stairway now blocked.

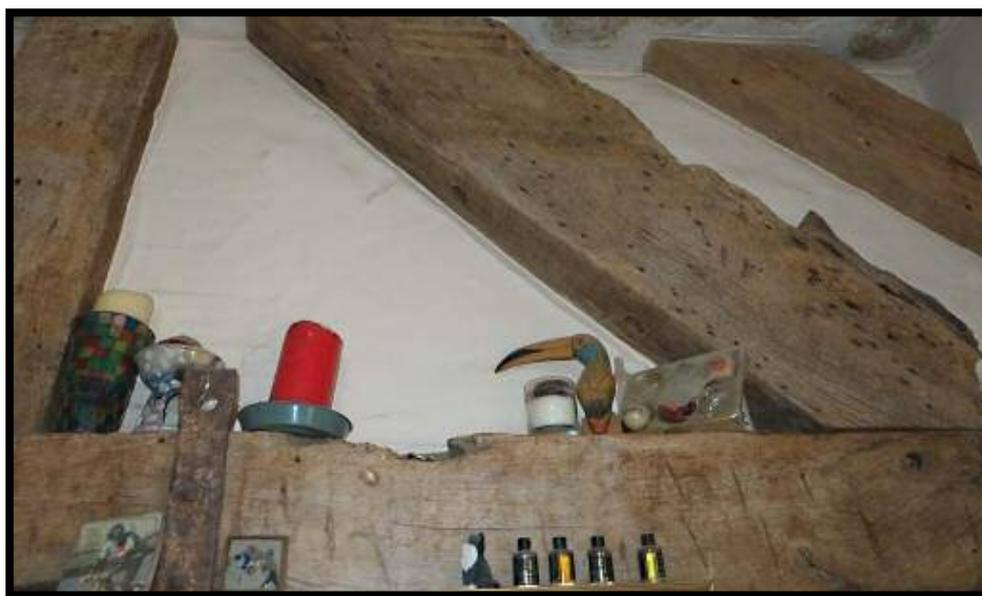
Plate 30: Principal rafter and tie beam detail. Note stave holes on soffit of principal rafters for wattle and daub.

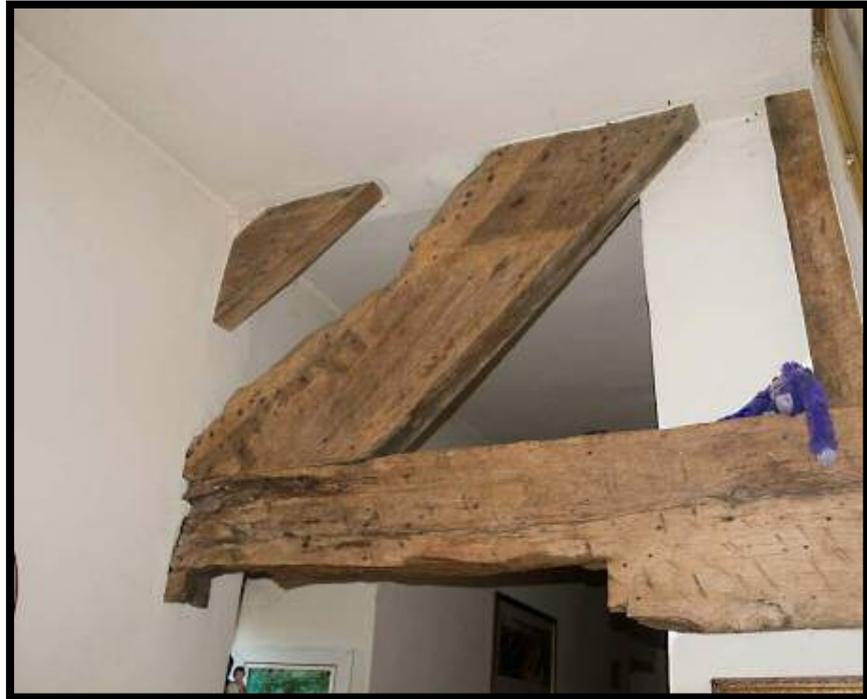
Plate 31: Portion of truss 1 where principal rafter meets ties beam. Heavy notching evident possibly for earlier door before later partitioning of rooms on first floor.

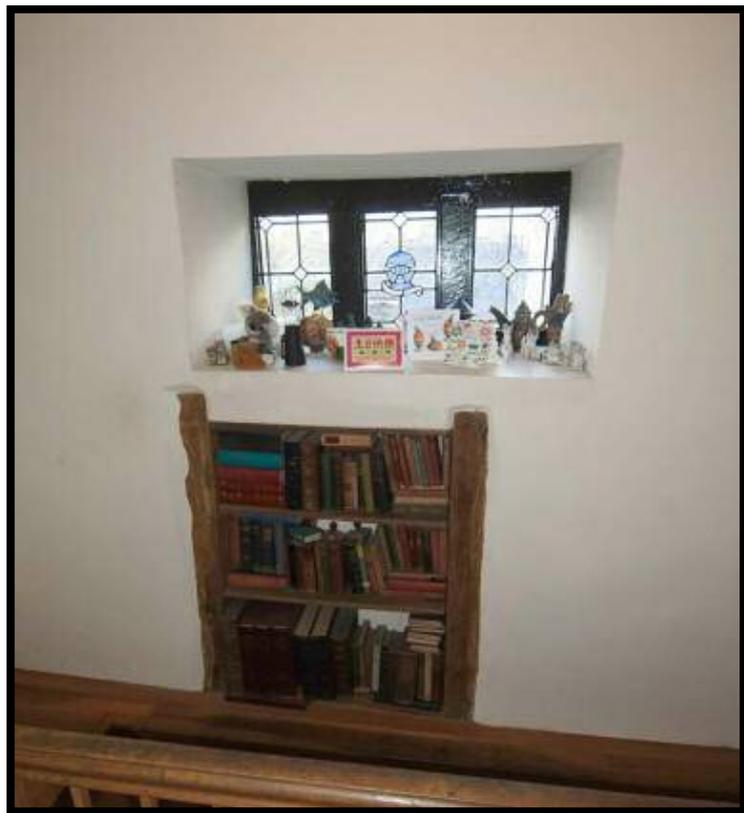
Plate 32: later window set above outline of possible door and mirrored on inside by the bookcase. Does this denote external access from first floor?

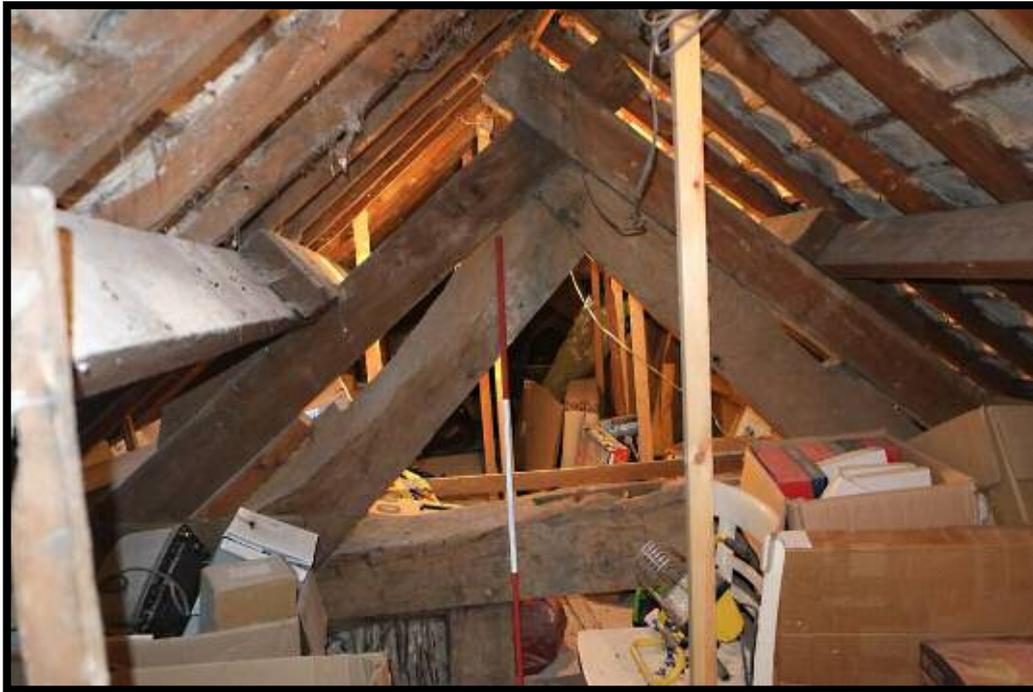
Plate 37: Truss 1. Oak A frame with missing struts no surviving purlins or rafters. Later roof in softwood with slated roof and torched with lime.

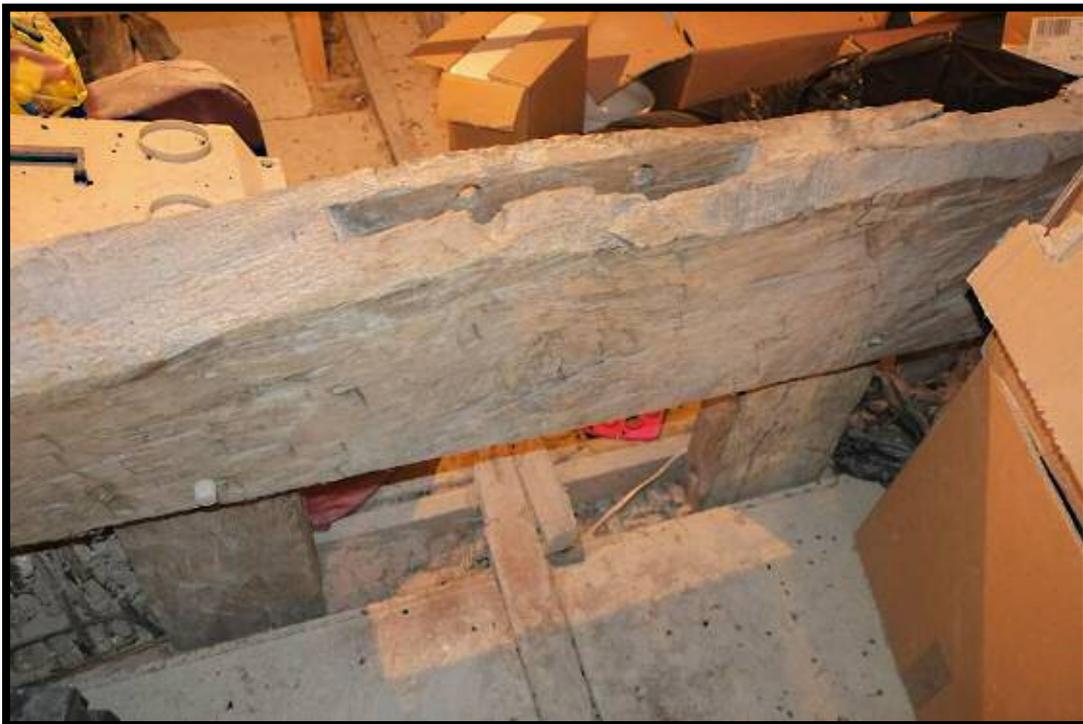
Plate 38: Truss 1. Collar with studs dropping below. Mortised for slanted or raking struts braced to principal rafters. Pegged.

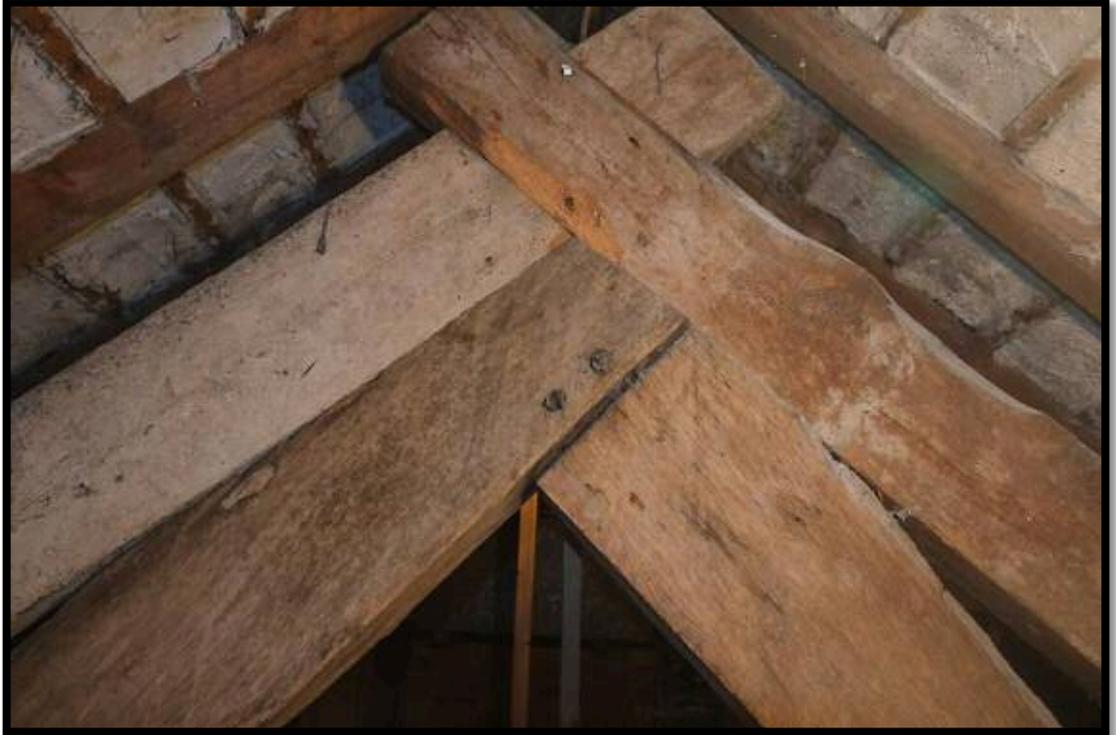
Plate 39: Oak truss trimmed and shaped to improve angle for later softwood truss and roof.

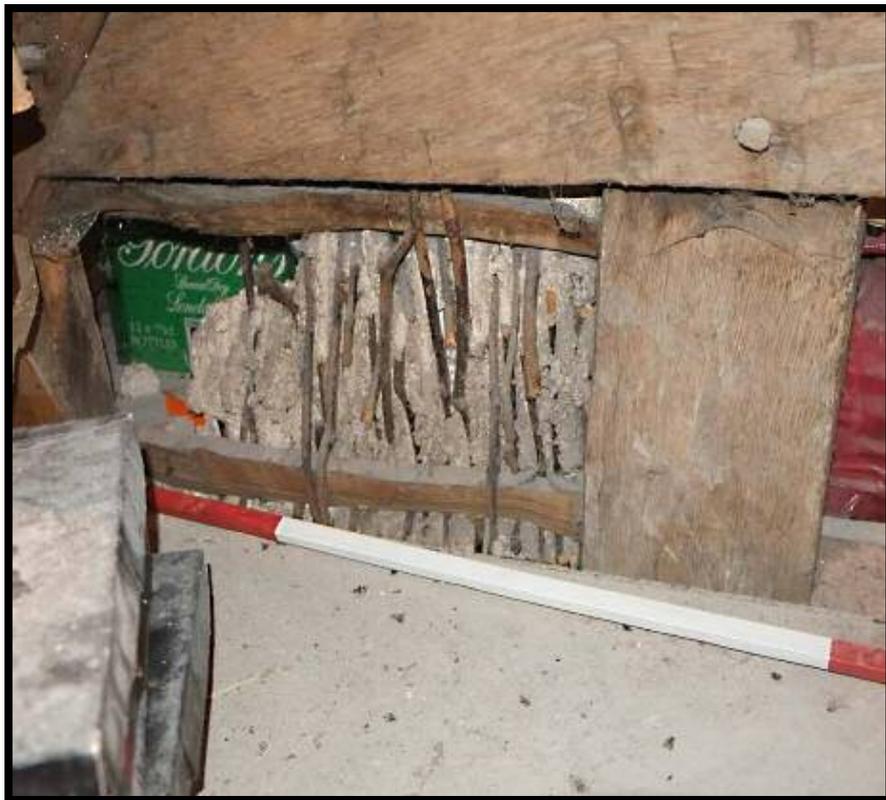
Plate 40: remains of a wattle and daub panel of horizontal oak staves woven with vertical hazel twigs to form a base for lime and horsehair plaster some of which survives.

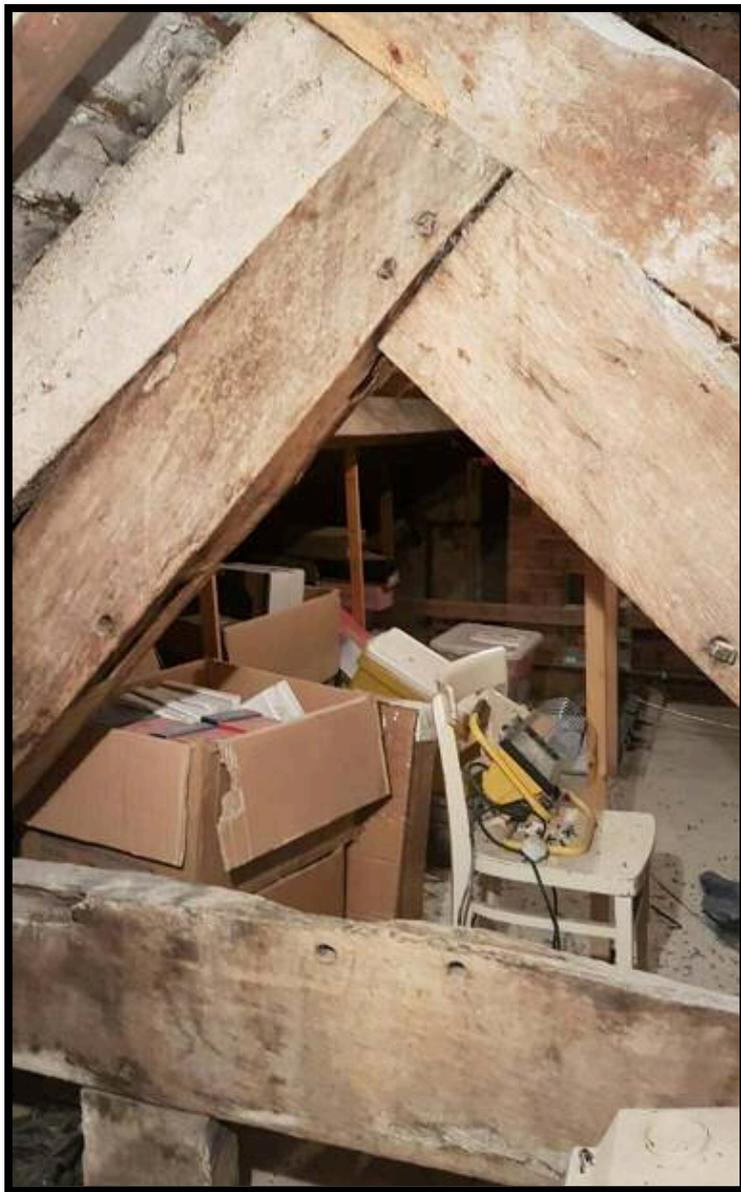
Plate 41: Truss 1 from east. Pegs and peg holes for struts between collar and principals.

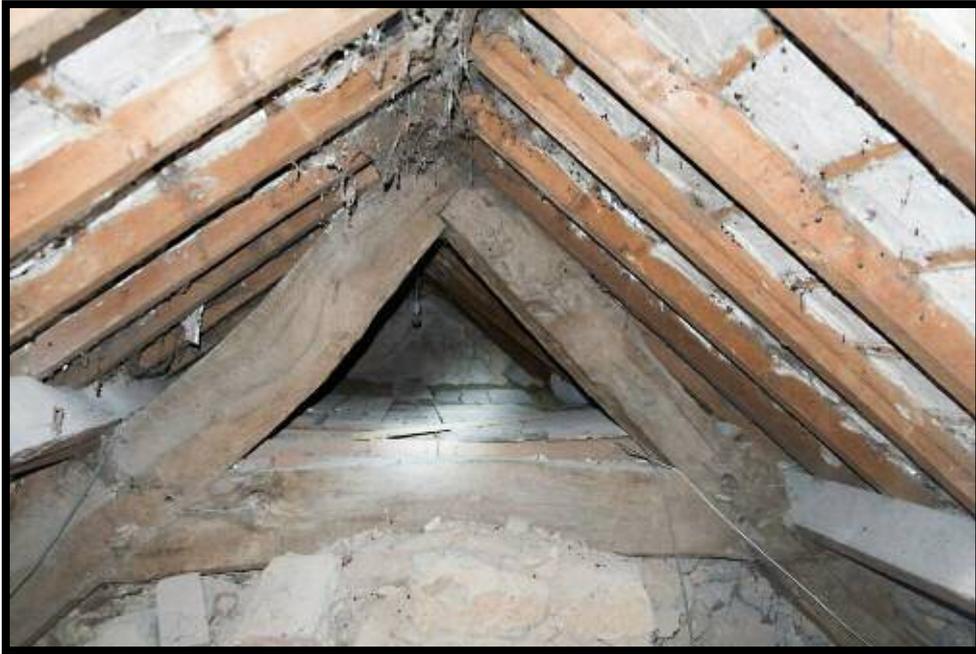
Plate 42: Transverse roof south to north on north range forming gable on facade R. Uncomfortably built over the masonry of the south range northern wall it has been mainly replaced with a later softwood structure leaving just this one truss.
