Cwm Farm, Cwm Cynfal, Ffestiniog, Gwynedd

ARCHITECTURAL RECORD /COFNOD PENSARNIOL

October 2011

Building Record

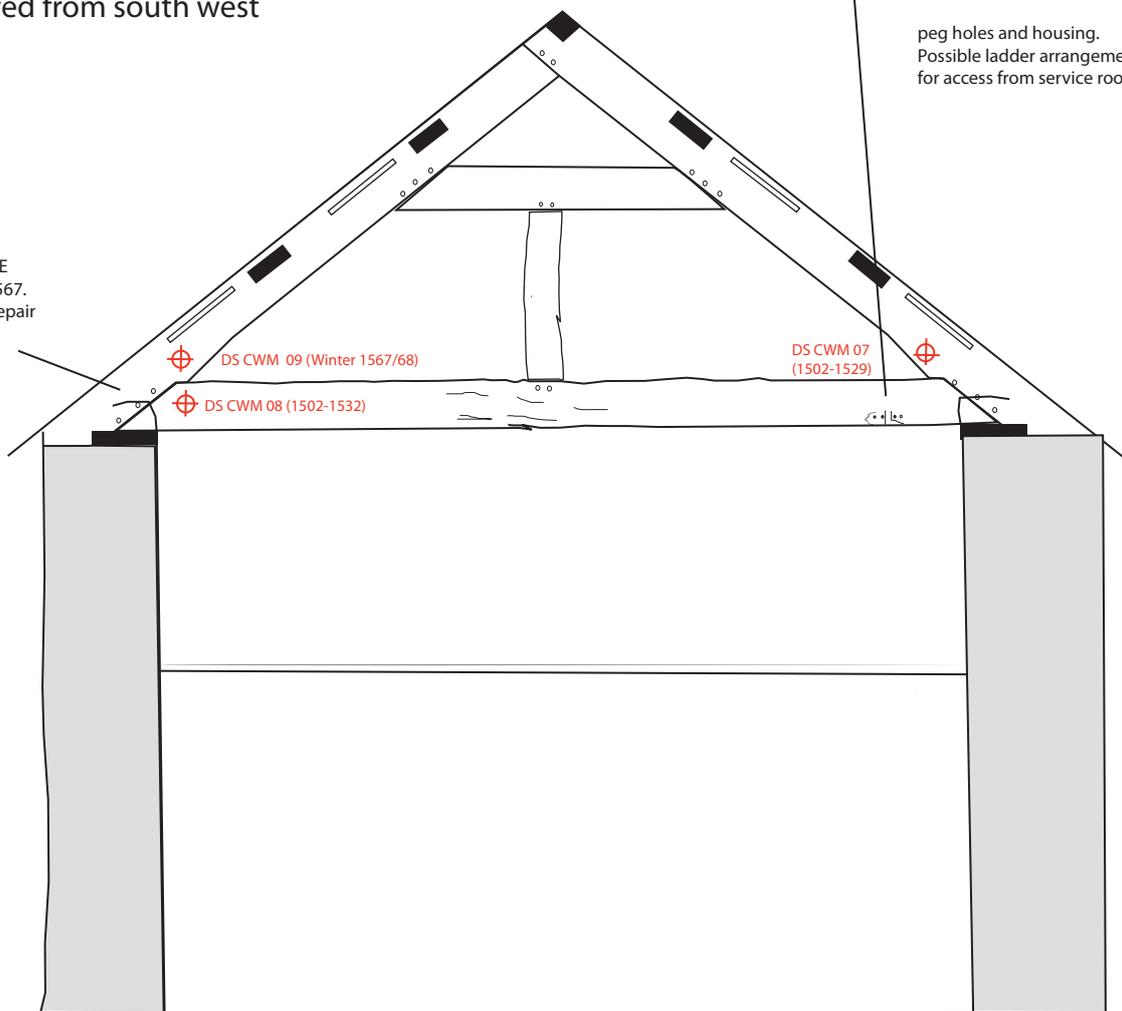
Figure 7 CC - Truss 3 [T3]
Cwm Farm, Cwm Cynfal, Ffestiniog, Gwynedd

Truss 3 viewing northwards
collar, king strut & tie beam.
Evidence of quite severe weather
erosion with PR west replaced c1567.

peg holes and housing.
Possible ladder arrangement
for access from service room

Principal rafter E
dated winter 1567.
Replacement/repair

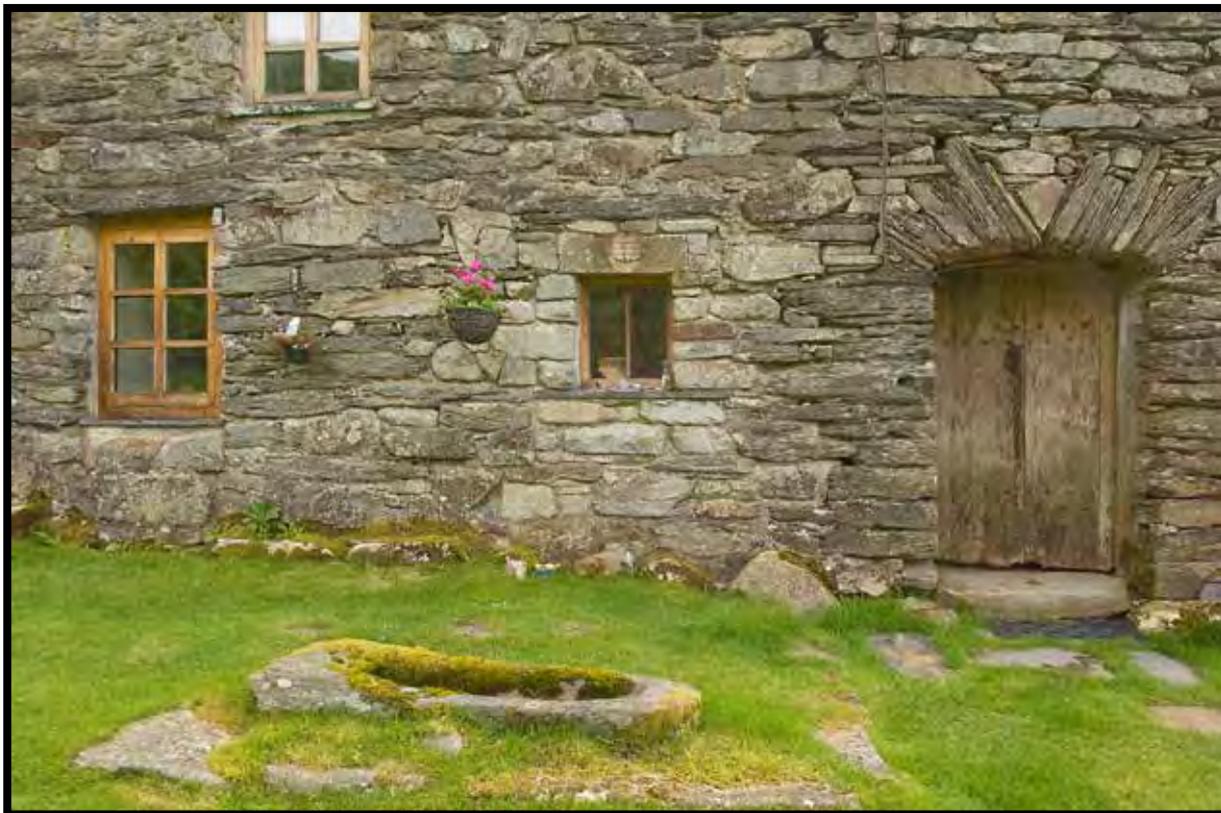
- 4.1.4 The southern elevation shows two alterations and changing window sizes. From the left hand gable facing the wall a small early mullion window lights what was the service room [GF2] (Plate 8). To its right the opposing cross passage doorway has a flat stone lintel and has no decorative features although it shares the chased rebates that are displayed on the 'front' doorway. This doorway had been converted, until recently, to a window, probably 19thC. To the right are a ground floor window that lights the hall. The masonry has clearly been altered and reduced in size. (plate 09) Above this a small metal casement window has been inserted into the wall to eave level at a later date. Disturbed masonry and lintel of re-used timber. A small outshut with pitched roof has been added to the south-east corner of the building. A lean to single storey extension was added to the NE gable in the 19thC. This partially obscures the external chimney. Above the roof of this outshut are two small windows, original phase, either side of the chimney breast with modern oak casements (Plate 7)

Plate 3: Window alterations

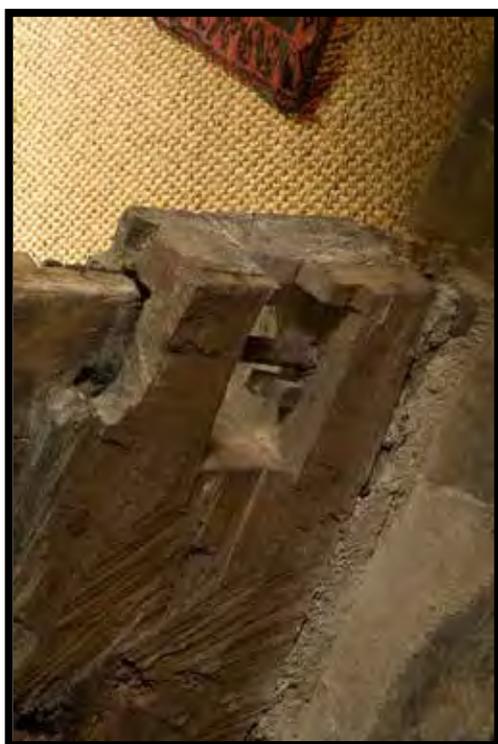
and is fitted with 6 posts and 5 planks/panels. The cill has been crudely truncated at the bottom (Plate 13-16) of the inner door posts of the screen to afford a more convenient circulation. The partition posts are decorated with a plain stopped chamfer while the head beam also has a chamfer interrupted by 'nailhead' bosses. (Plate 16) The head beam and the joists that formerly sat in the housings cut out of the top of the head beam do not now meet, being raised approximately 110mm to sit on later inserted pine beam.) These joists were originally pegged into the head beam and sailed on to meet the bottom of the partition that travelled down from the truss [T1] directly above. This formed a canopy of around 380mm. (Plate 17) A bench was fixed to the partition and is clearly indicated by an arrangement of mortises. The partition has been moved back slightly. The joists over the partitions are now seated into a large, pine beam, squared and chamfered. This beam also supports the widely spaced and rather crude joists of the later floor that divided hall into ground and first floor spaces, running from this beam to the inserted chimney stack.

Plate 15: Truncated cill

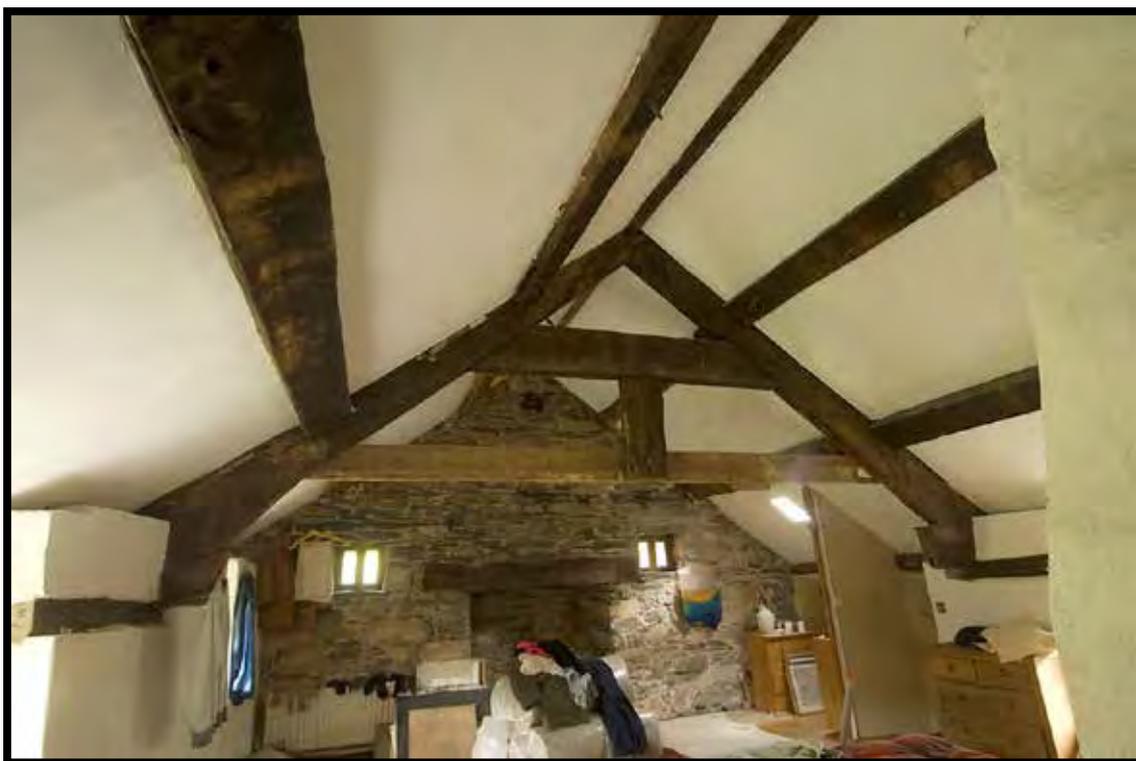
Plate 19: Truss 1. Lost tie beam to collar, post and tie beam truss.

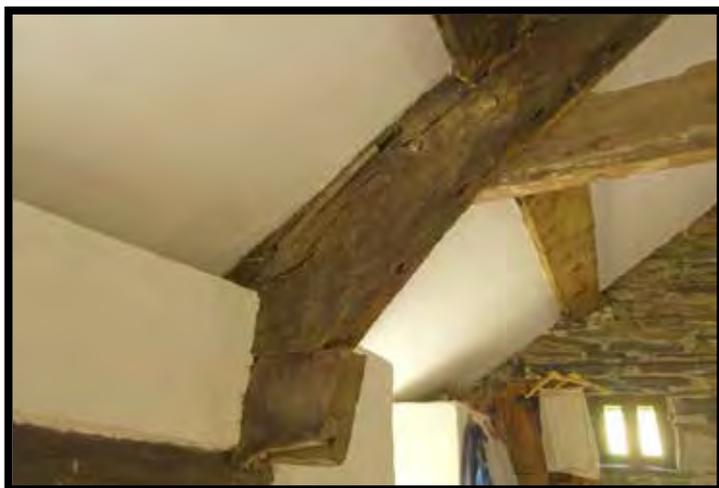
- 4.3.2 Truss [T1] displays holes and grooves for staves and wattle that formed a closed truss within the A frame and a continuous mortise slot underneath the tie-beam for a partition below, possibly boarded rather than wattle and daub or a mixture of post and wattle. This truss has been severely truncated leaving just a stump of the tie-beam at either end. A portion of the post dropping from collar to tie beam was removed at the same time. A softwood, tie beam has been attached with bolts at a higher level to afford a more convenient circulation

Plate 22: T1 – truncated tie beam

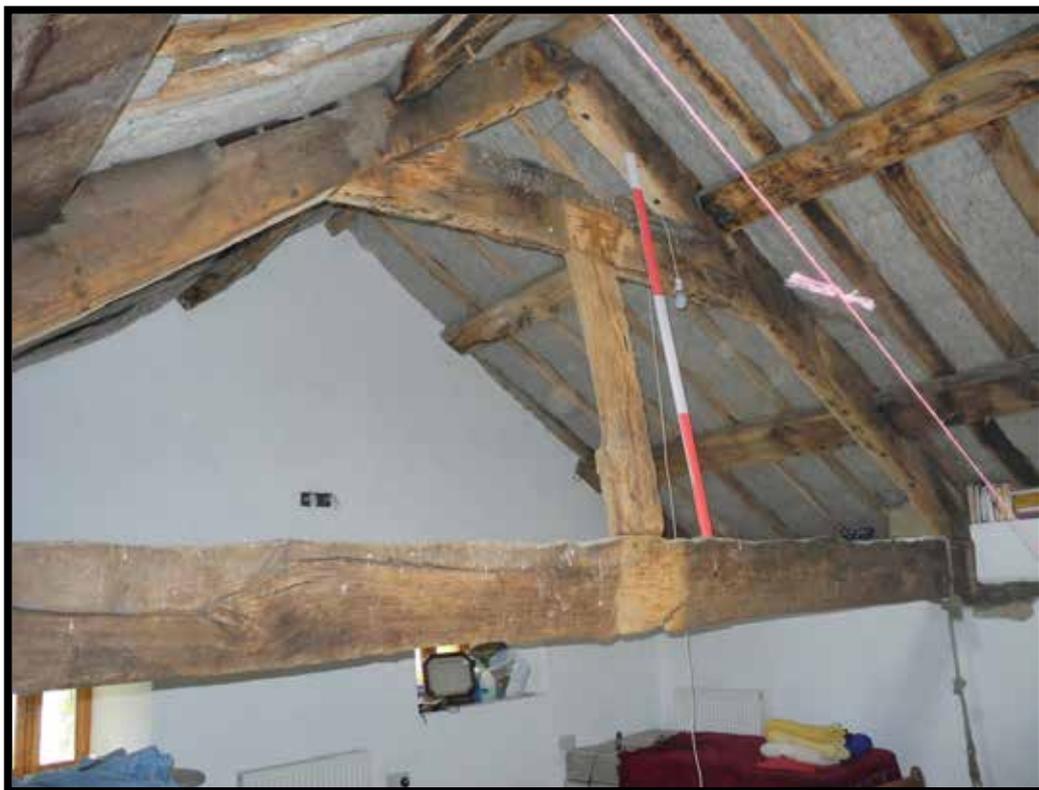
- 4.3.6 Room [FF7] has truss [T3]. Similar to [T1], with collar, post and tie beam but showing considerable signs of wear/ erosion and distortion. (Plates 28, 29) It is holed and grooved in the same way as [T1] for staves and wattle to form another closed screen to ground floor level. It is not clear whether a post and panel or a post and wattle screen dropped below the tie beam. The NW principal of [T3], has dated with dendrochronology, to a precise felling date of the winter of 1567/68. Given the context of the truss and rafters it is probable that this date is explained by a repair/replacement. The rafters have been removed and re-positioned with some replacements. Some rafters 127mm wide.

Plate 28: T3: From NE

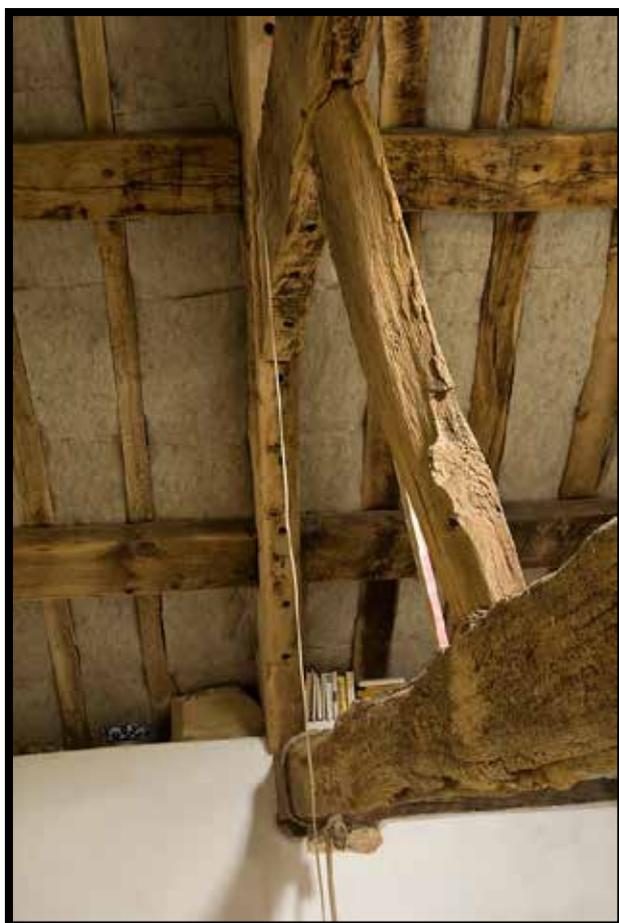
Plate 29: T3: truss showing erosion, stave holes
