North West Wales Dendrochronology Project: Trefadog, Llanfaethlu

Project No. G2113

Report No. 1021

Trefadog, Llanfaethlu, Anglesey. NGR SH 29288613

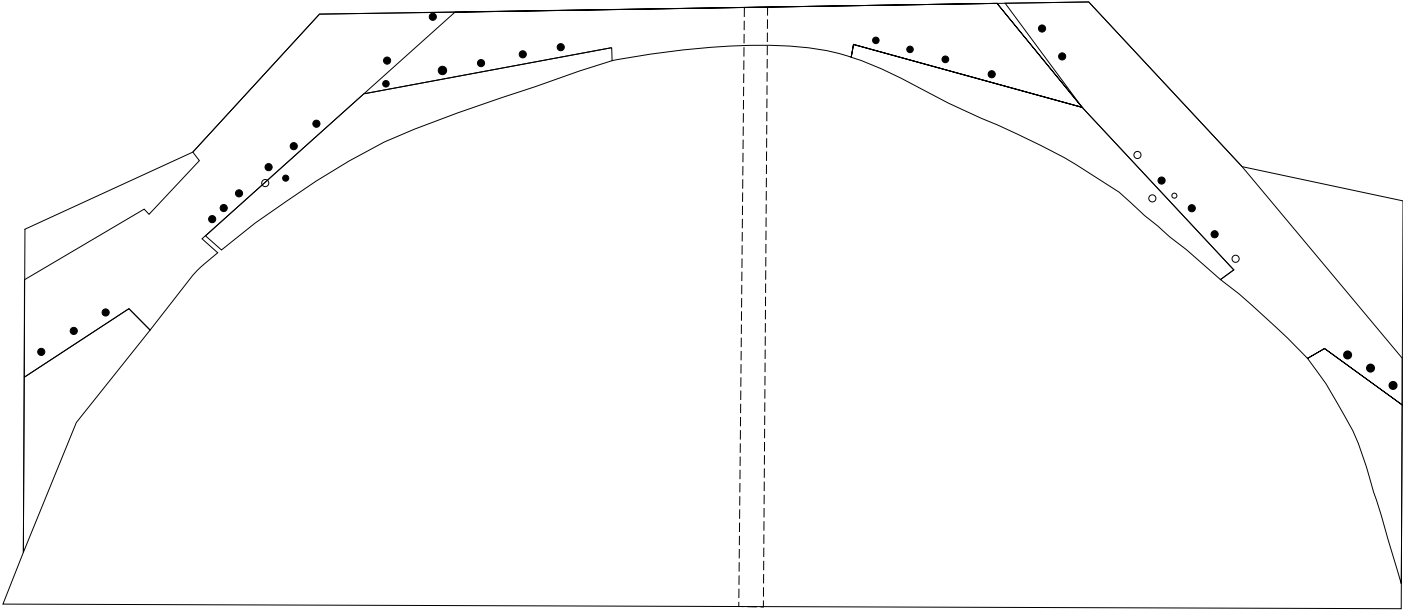
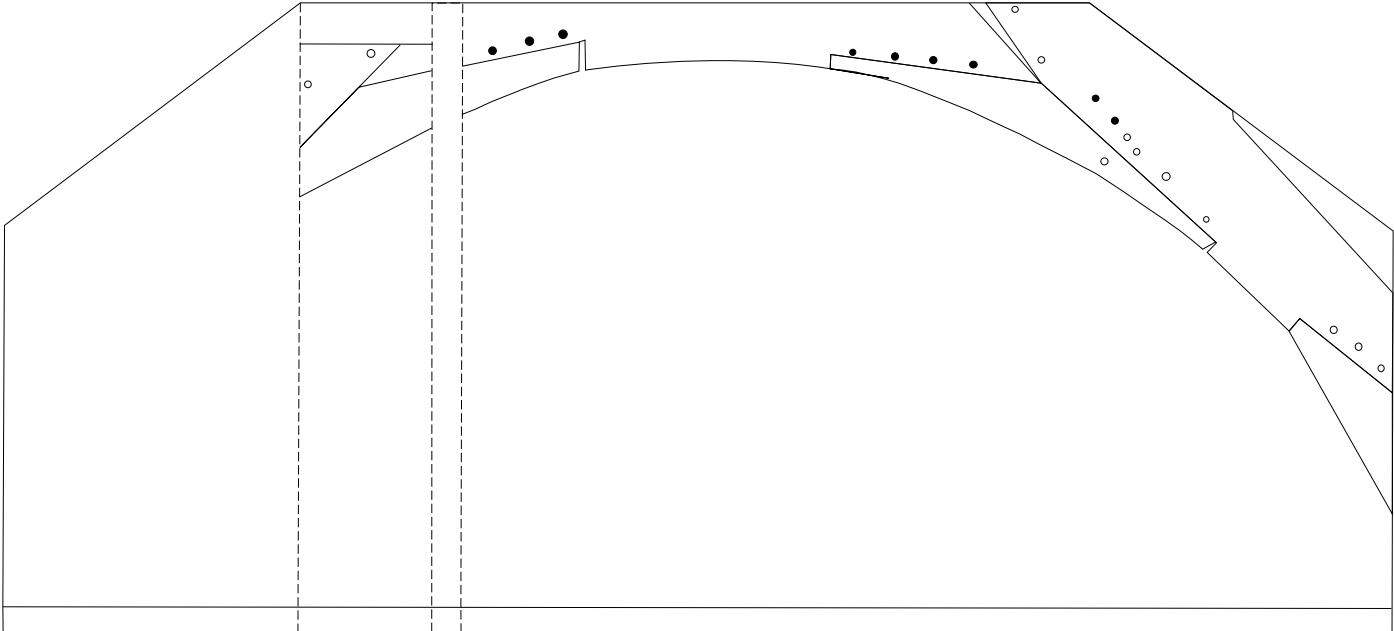
Figure 4 Trefadog, southern cruck

The cruck which divides the hall consists of two principals which disappear into the wall on either side. These have a jointed vertical post which curves onto the principal to form the bend of the cruck. The two are fastened by a wide mortise and tenon joint held with three pegs. It is not possible to see how far the vertical post goes into the wall. None of the vertical posts appear to go below the level of the present first floor, and it is not known if they ever went below that level. An arch-braced collar beam is partly visible below first-floor ceiling level – the remainder hidden by the ceiling. The braces are joined to the collar and principals by mortise and tenon joints (see plates 1 to 6).

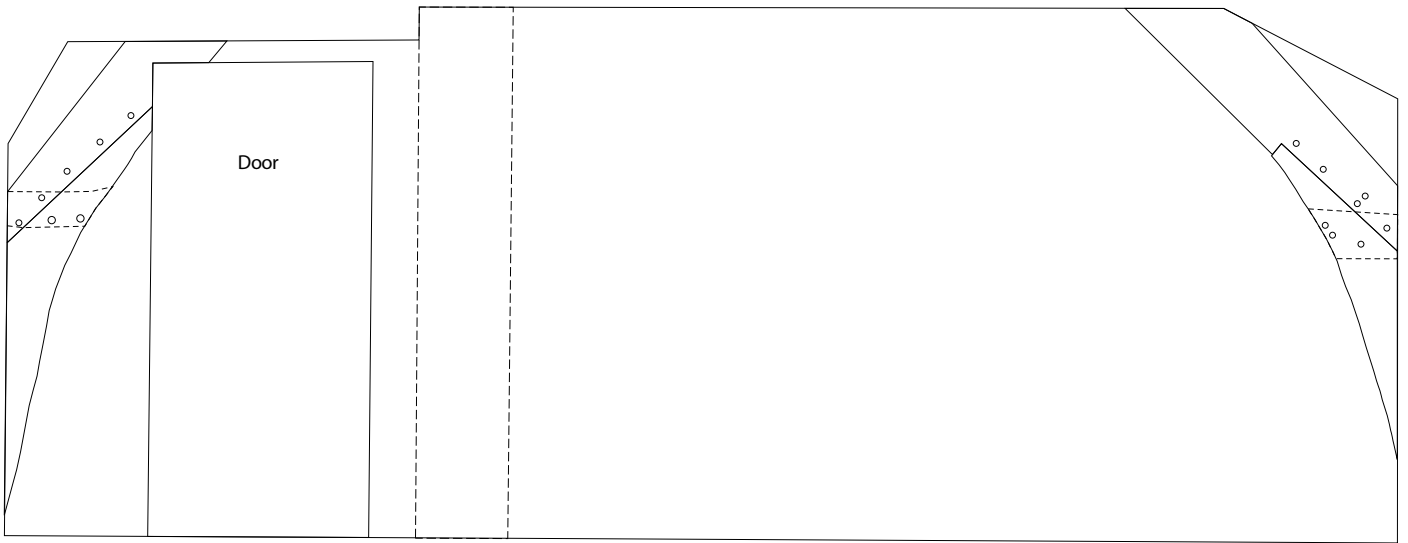
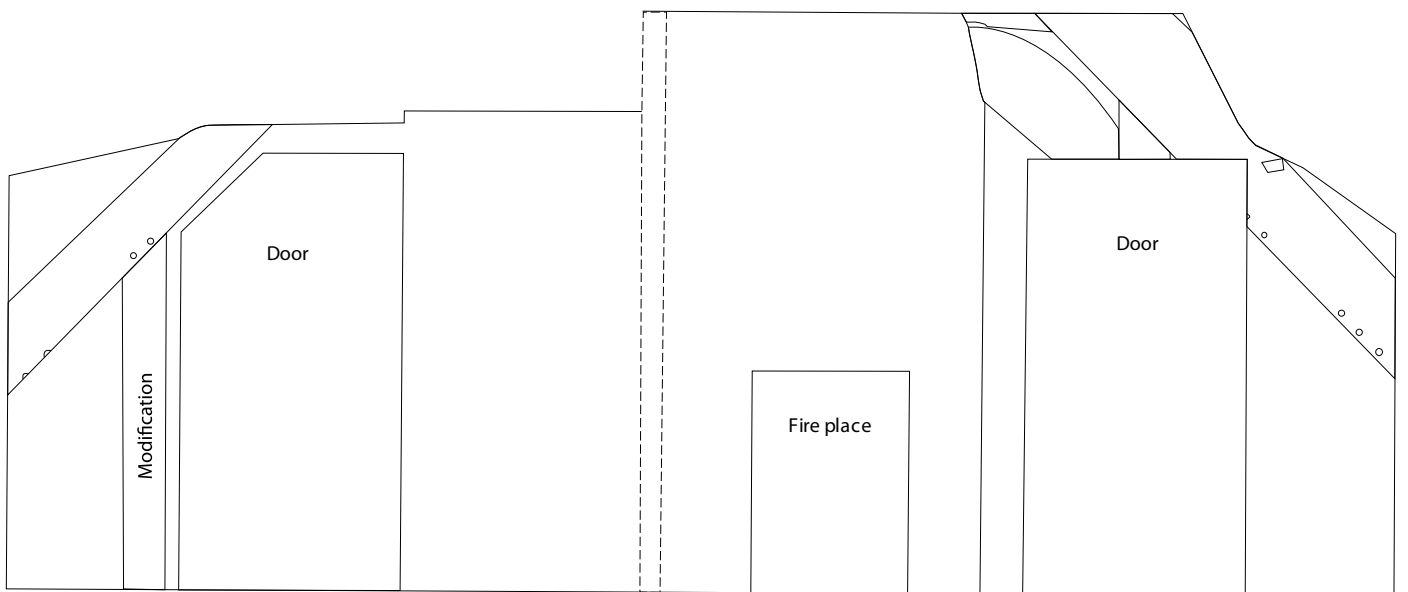
Figure 5: Trefadog, the crucks on the northern and the southern sides of the cross passage

The cruck forming the south side of the screens passage is only partially visible and appears to have been modified on the west side. The arch-bracing to the collar beam on the east side links to a vertical post. There is only a small section left of this, as it has been cut by a door, but it is probable that this vertical post once continued down to ground floor level, and formed part of the screens partition. A vertical wall post, but with less of a curve than on the hall cruck, is linked to the end of the principal, and continues downwards in the lateral wall. This is partly mirrored on the west side, but the vertical post has been replaced with a modern one lower down the principal. Two dowel holes mark the likely location of the original vertical post. There is no evidence for a curving brace to the collar beam, though not enough of the collar beam is visible to confirm if one formerly existed (see plates 7 to 9).

The northern passage cruck is different again. Here the principles are jointed onto vertical wall plates, but there is no collar beam visible, nor any bracing. A housing for a tie beam, however, lies across the cruck joint on the south face – an odd arrangement, but possibly original. The tie beam has been removed, but a housing exists on both east and west sides. The different nature of this truss suggests the outer rooms were two storey (see plates 10 to 12).

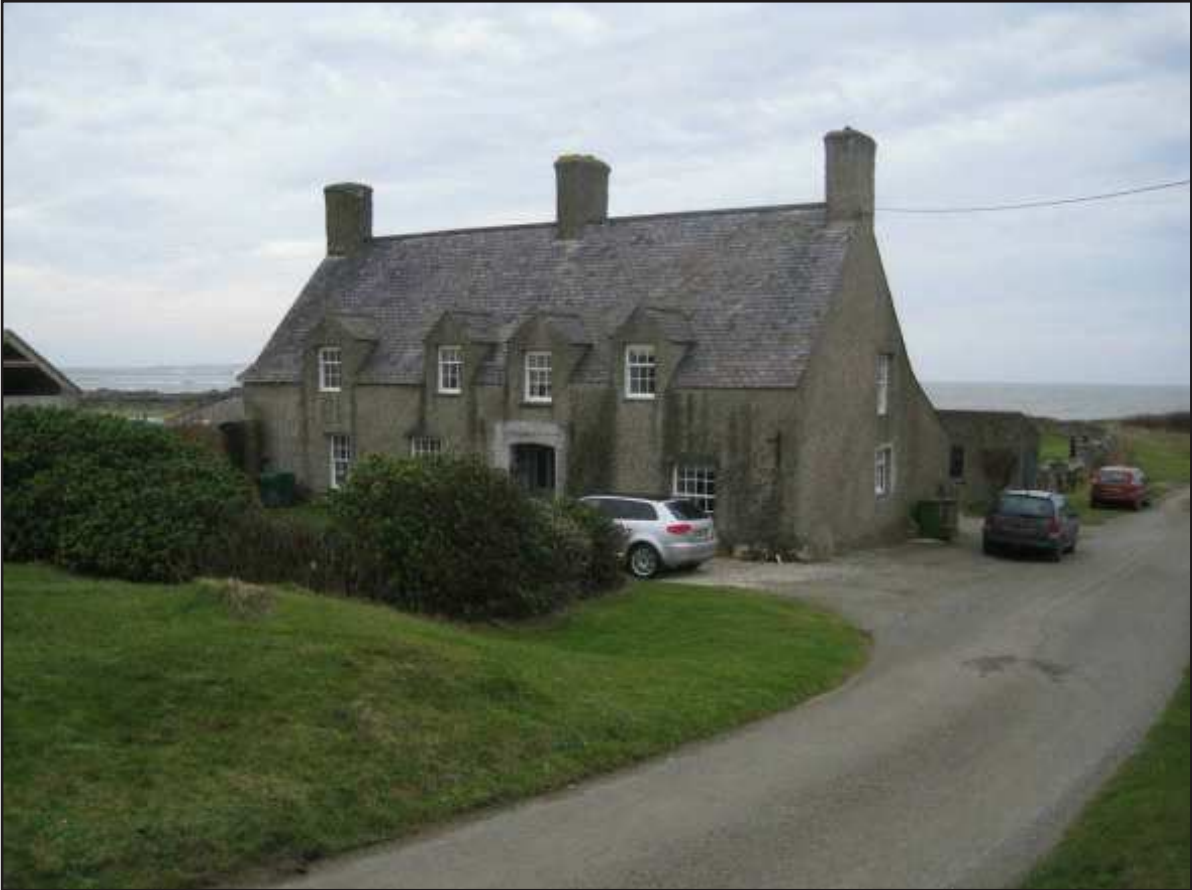
Plate 01: The eastern elevation of Trefadog; view from the northeast.

The house is aligned approximately north-south, parallel to the coast edge, and is in a slight hollow 50m from the sea. The house is of two storeys, of rendered stone. The slate roof is modern. There are three rectangular chimney stacks, two at the gables and one to the left (south) of centre. The main front faces east, with an off-centre door to the north, two replaced sash windows to the south and one to the north. Four gabled dormers, all fitted with replaced sash windows, light the first floor. The north side of the house has a catslide addition occupying the north half, of probable 19th century date, though with modern horizontal casement windows in the west wall. The south side of the house is lit by a sash window on the ground floor and two gabled dormers on the first floor. A rear door lies in the corner created by the catslide extension (see plate 2).

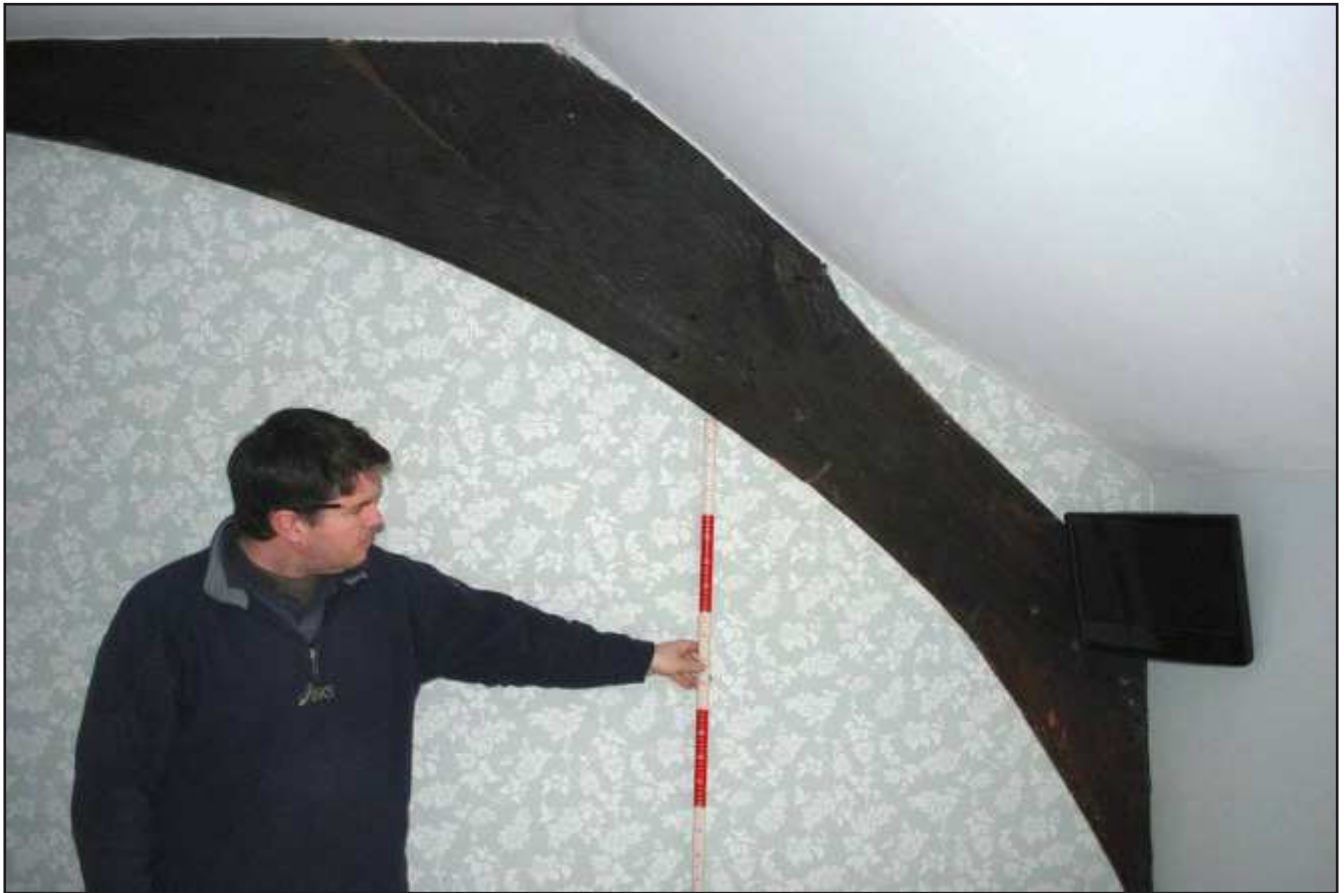
Plate 3: The eastern side of the southern face of the southern cruck which divides the hall; view from the south.

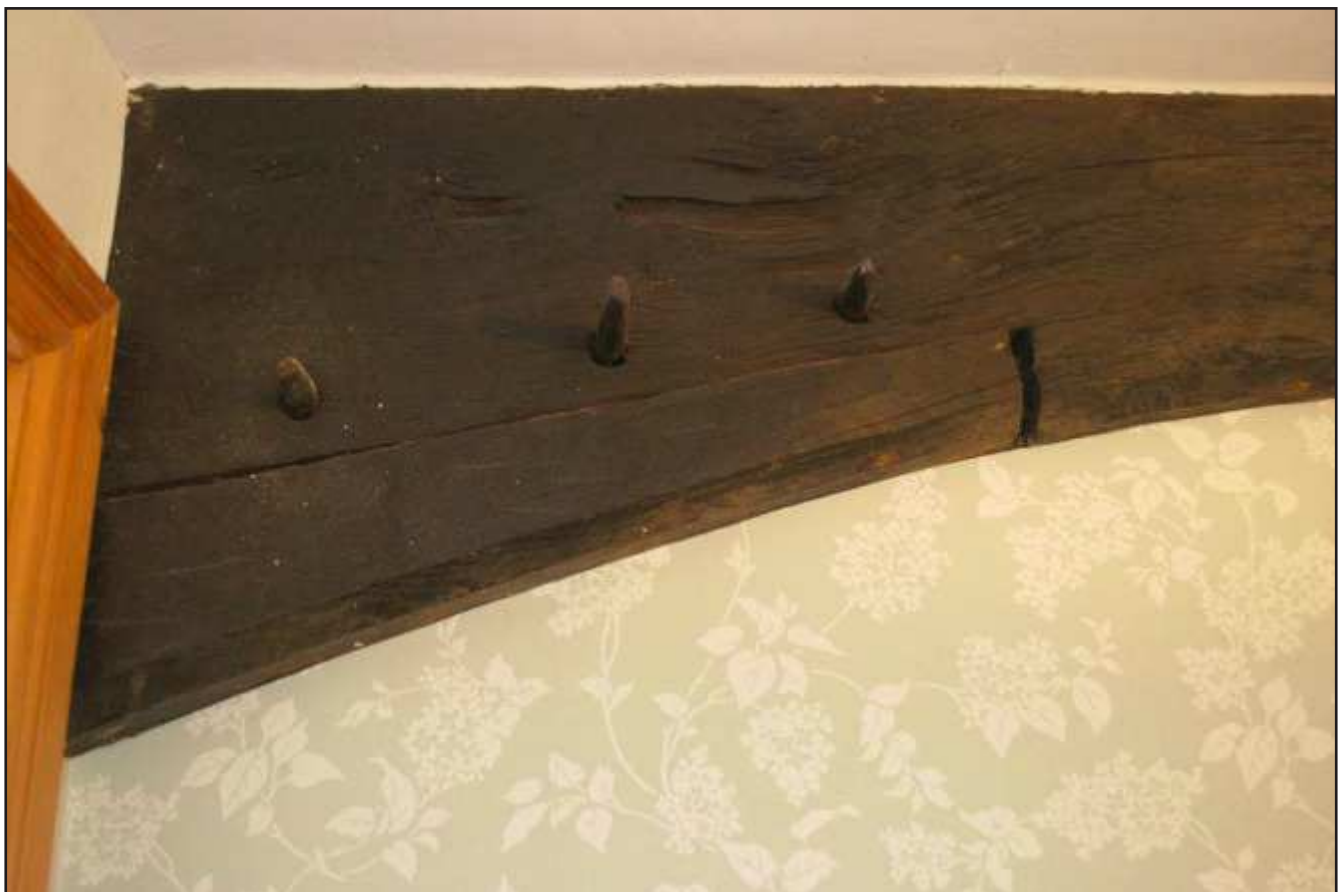
Plate 4: Close up of the pegs which join the jointed vertical post with the principal to form the bend of the southern cruck. This is the western side of the southern face; view from the south.

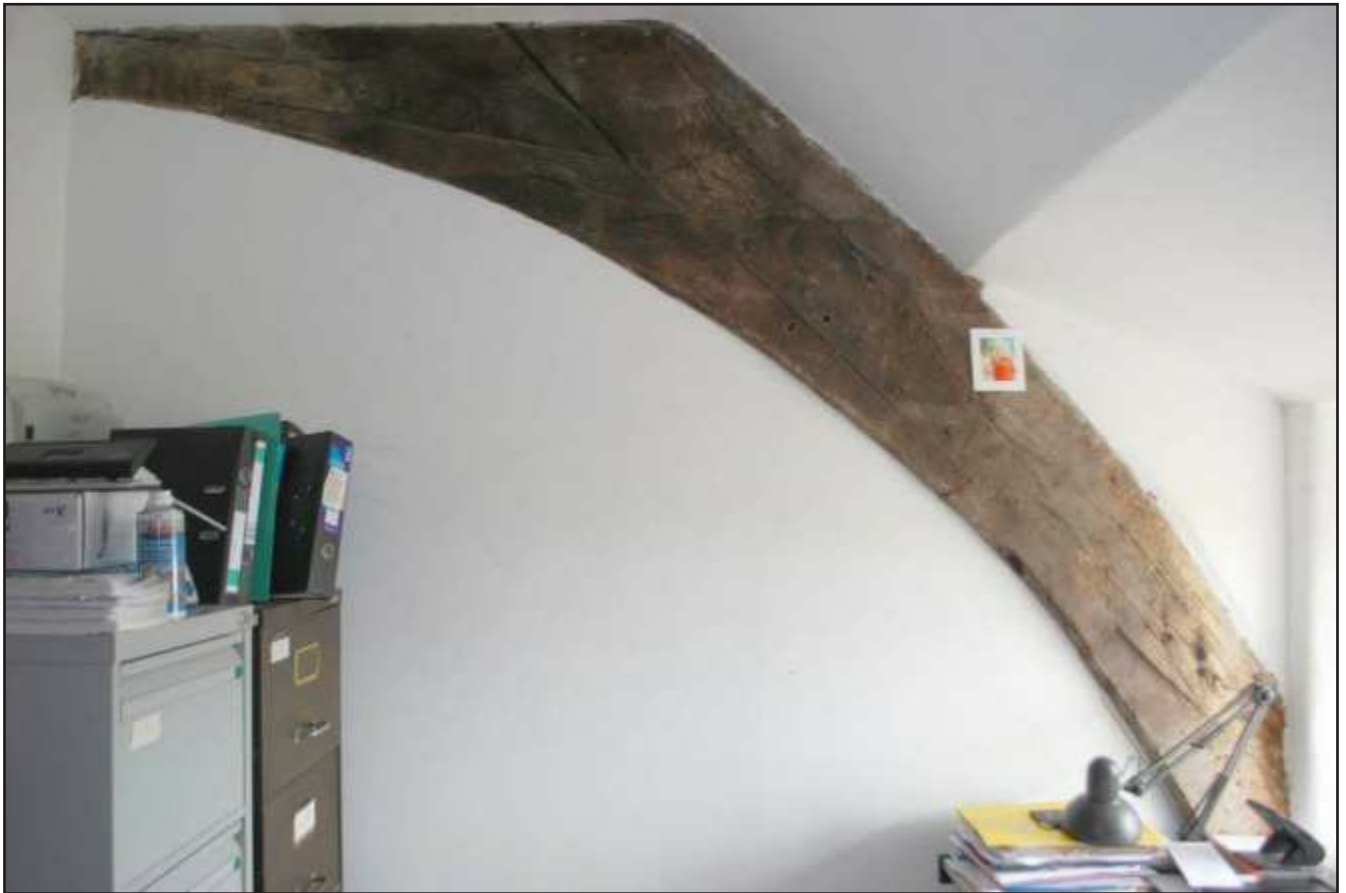
Plate 5: The western side of the northern face of the southern cruck which divides the hall; view from the north.

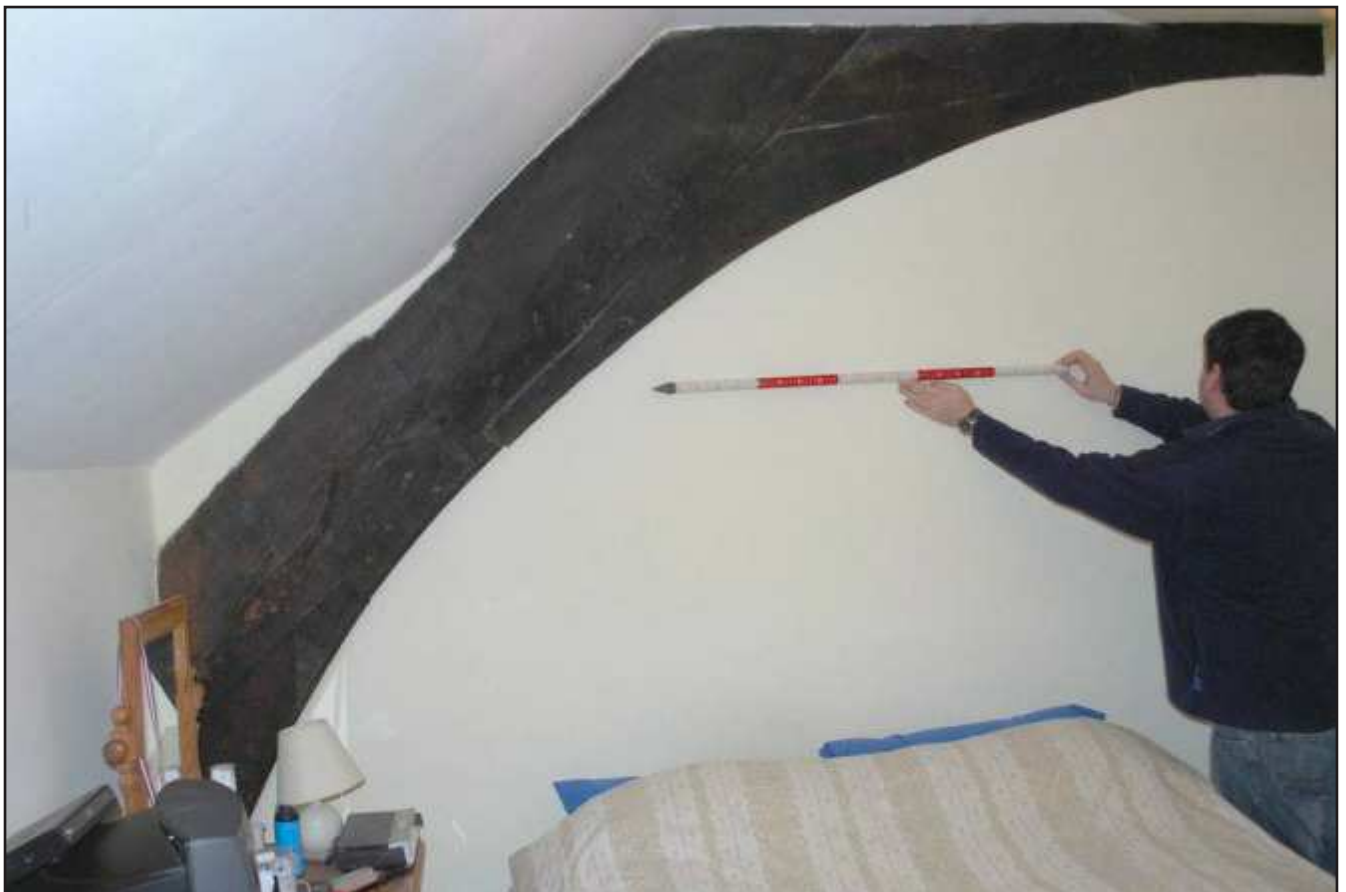
Plate 6: The eastern side of the northern face of the southern cruck which divides the hall; view from the north.

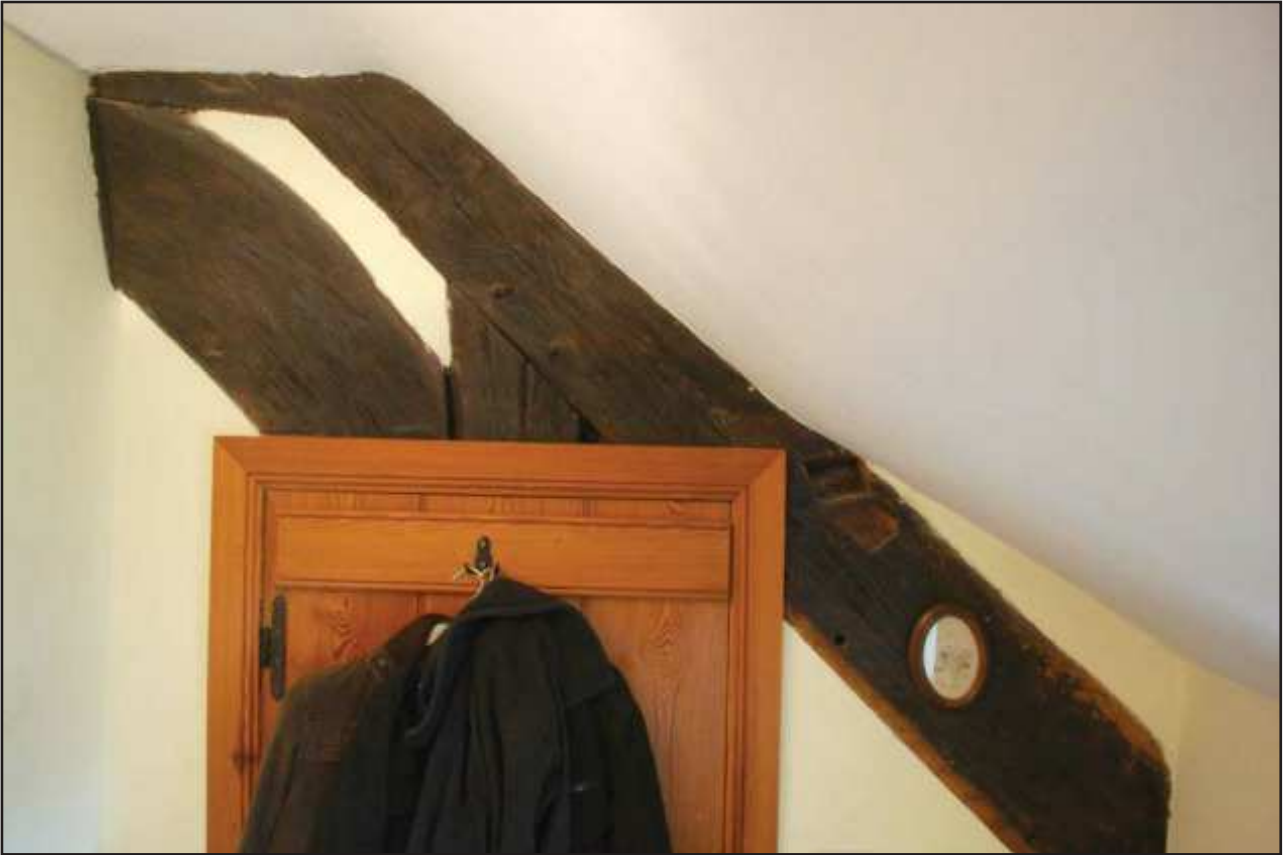
Plate 7: The eastern side of the southern face of the central cruck which forms the south side of the screens passage; view from the south.

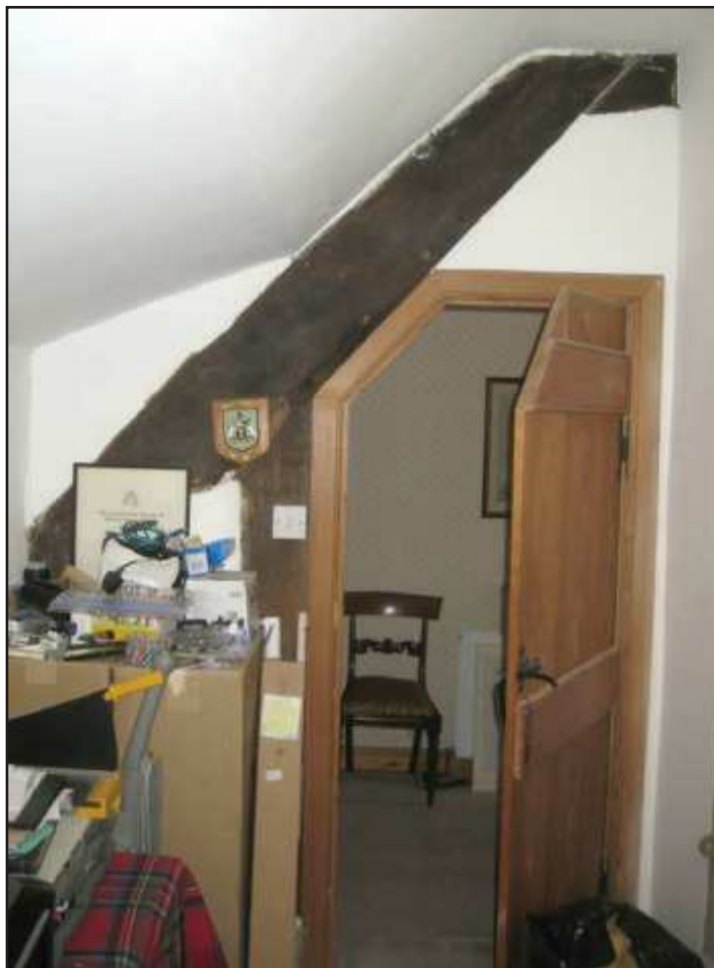
Plate 08: The western side of the southern face of the central cruck which forms the south side of the screens passage

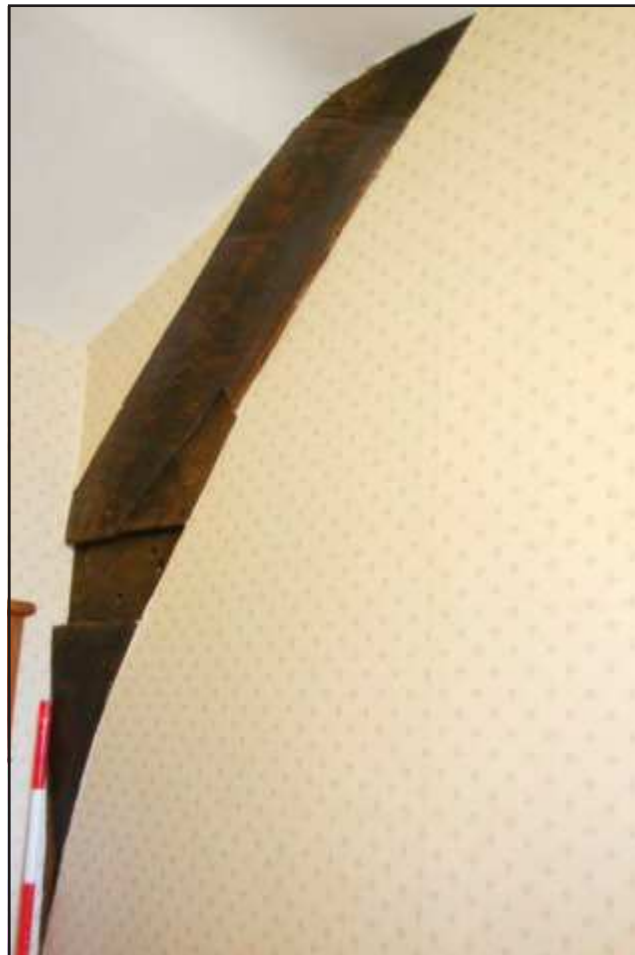
Plate 10: The eastern side of the southern face of the northern cruck which forms the southside of the screens passage

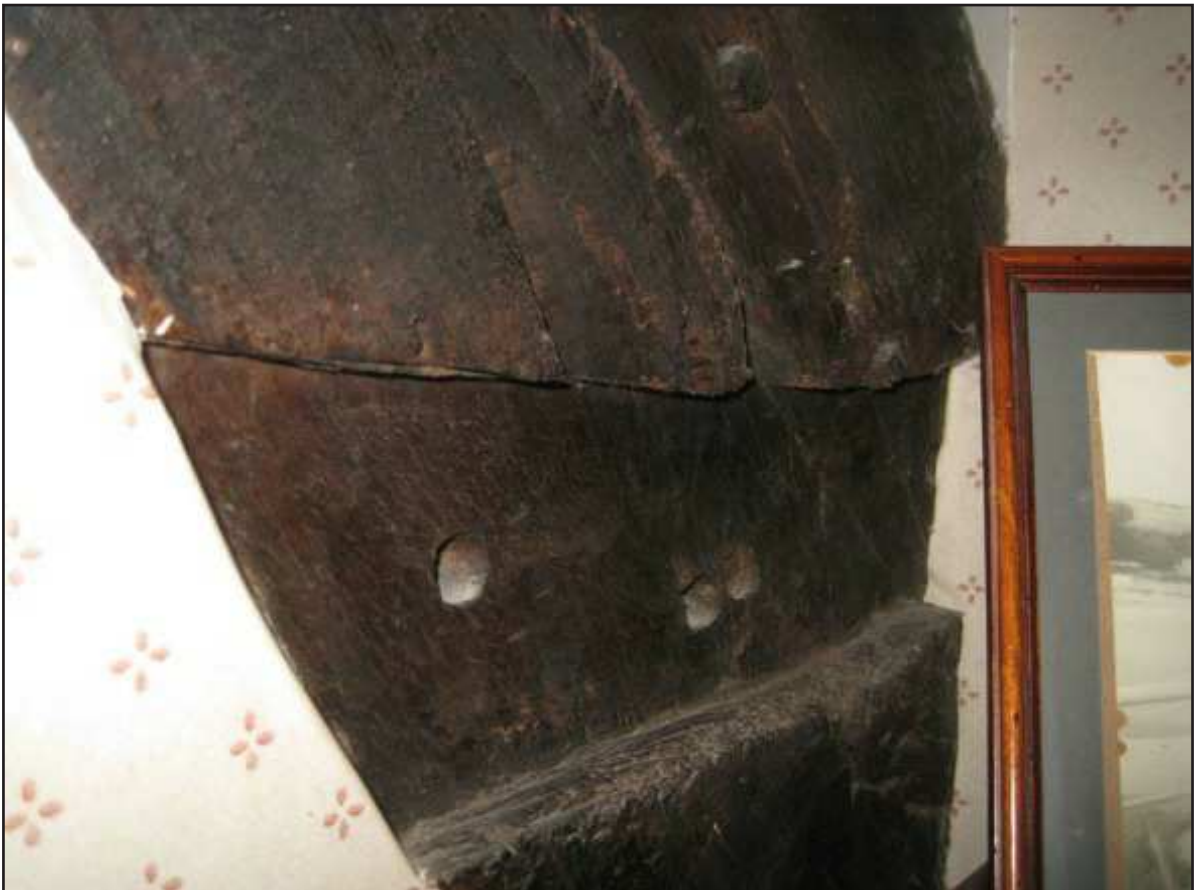
Plate 12: Close up of the housing for a tie beam on the eastern side of the southern face of the northern cruck, which forms the southside of the screens passage; view from the south.
