North West Wales Dendrochronology Project: Trefadog, Llanfaethlu

Project No. G2113

Report No. 1021

Trefadog, Llanfaethlu, Anglesey. NGR SH 29288613

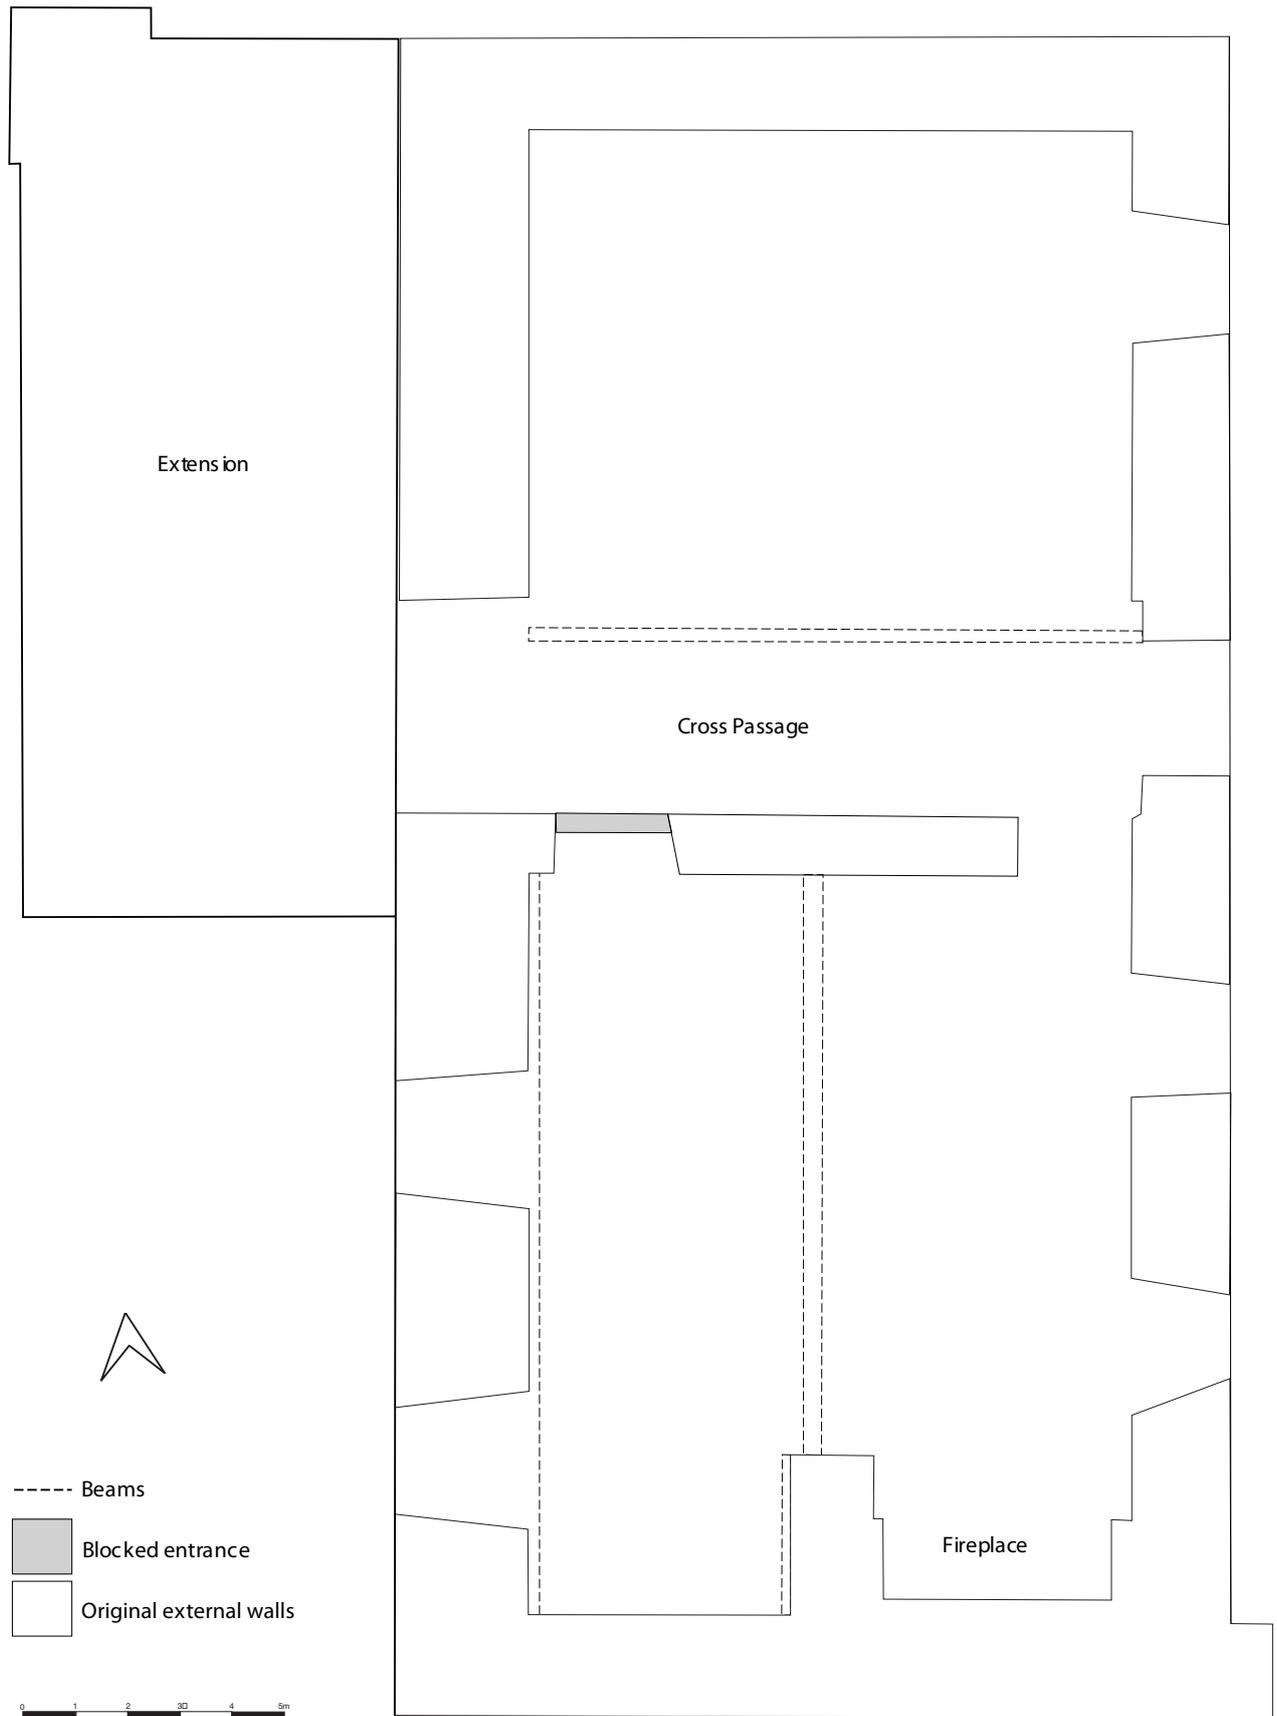
Figure 2 Trefadog, ground floor plan

The east front door opens into the medieval cross-passage, now a hall with stairs. The downstairs plan layout reflects the original medieval house. To the left of the front door is access to the two-bay hall, with an open fireplace on the south gable wall, and another blocked chimney in the east passage wall. The date of the latter is not known. The ceiling is supported by a large central longitudinal beam and another beam running the full length of the east wall, both put in during the modern refurbishment. The present bressumer over the south gable fireplace is a re-used timber, with three mortise holes in the north face. There is a simple chamfer, with no stops, on the lower corner, which looks clean and relatively late. The surface of the beam has been roughened to take a coat of plaster.

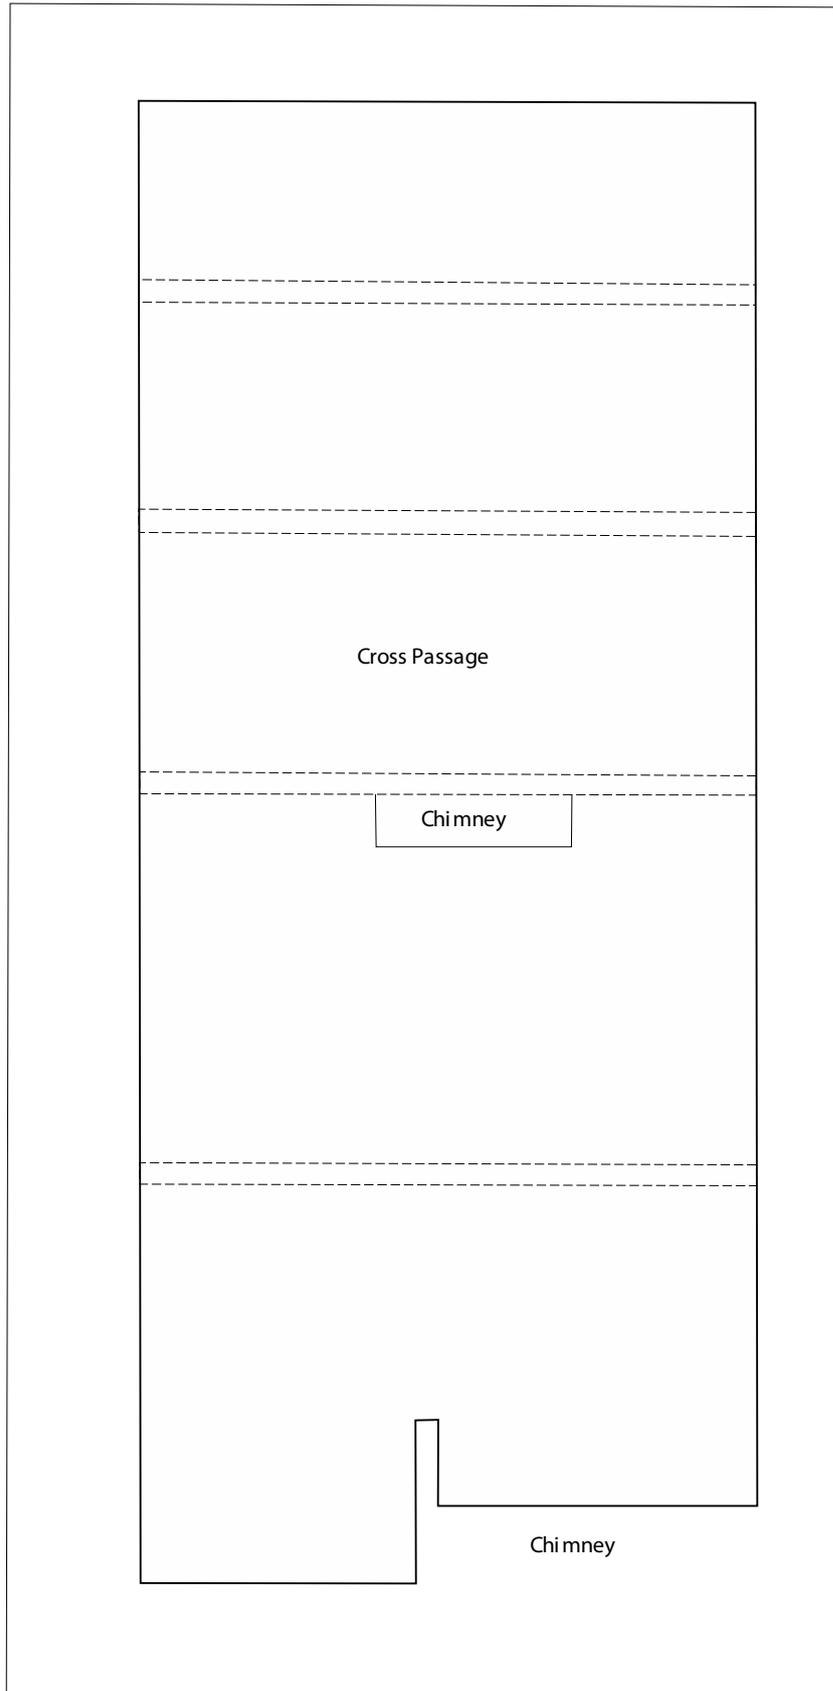
Figure 3: Trefadog, first floor plan

The modern hall stairs provide access to the northern part of the first floor. Above the south bay of the living room (the medieval hall) lie two rooms – currently a bedroom and office. Beyond the cross-passage lie another bedroom and bathroom.

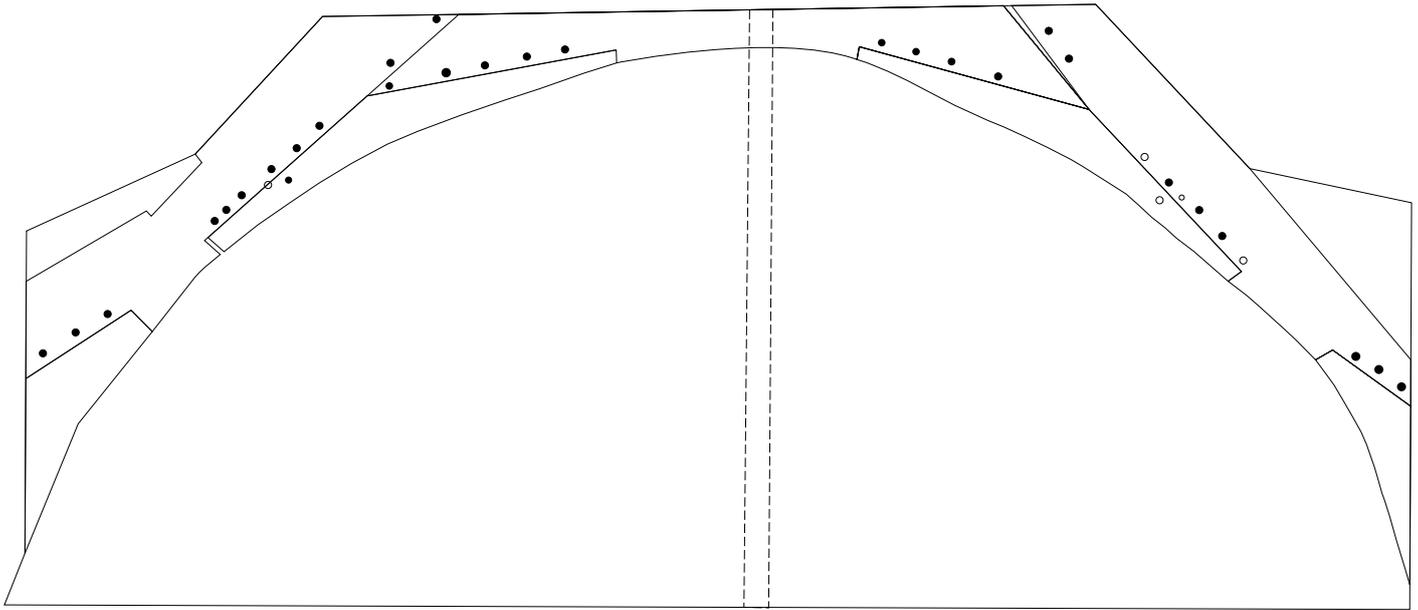
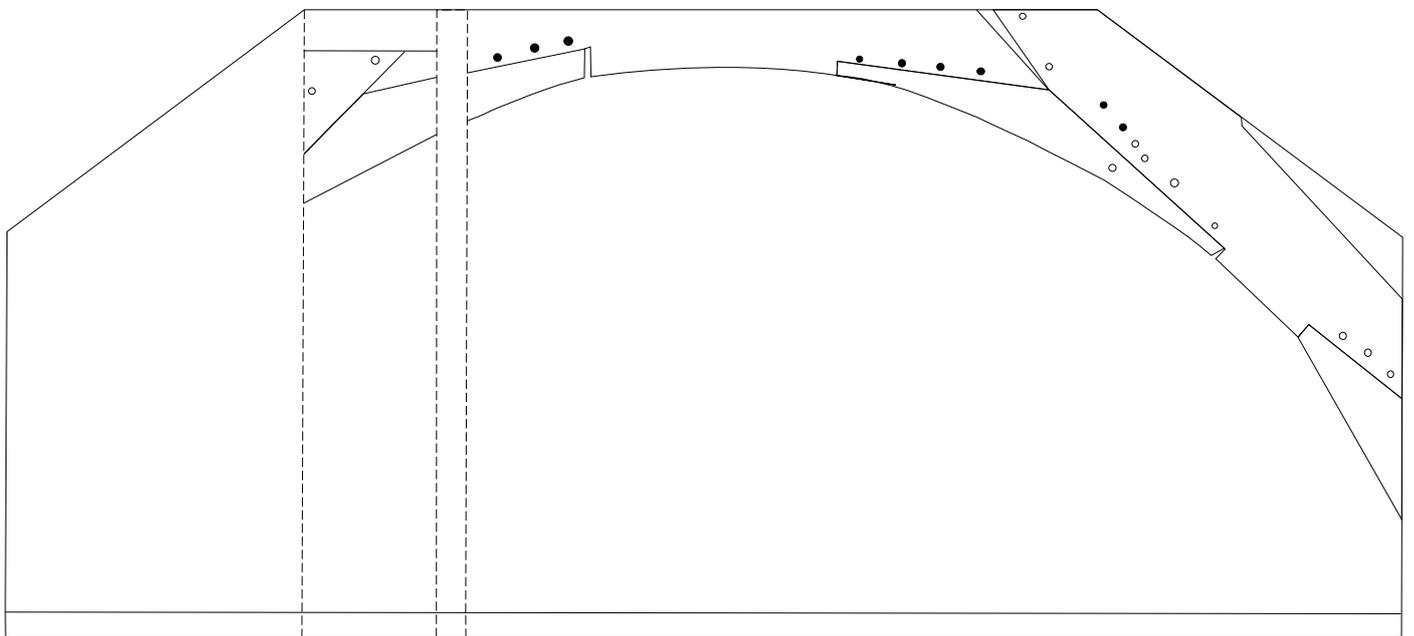
Figure 4 Trefadog, southern cruck

The cruck which divides the hall consists of two principals which disappear into the wall on either side. These have a jointed vertical post which curves onto the principal to form the bend of the cruck. The two are fastened by a wide mortise and tenon joint held with three pegs. It is not possible to see how far the vertical post goes into the wall. None of the vertical posts appear to go below the level of the present first floor, and it is not known if they ever went below that level. An arch-braced collar beam is partly visible below first-floor ceiling level – the remainder hidden by the ceiling. The braces are joined to the collar and principals by mortise and tenon joints (see plates 1 to 6).

The northern face of the southern cruck which divides the hall

The southern face of the southern cruck which divides the hall

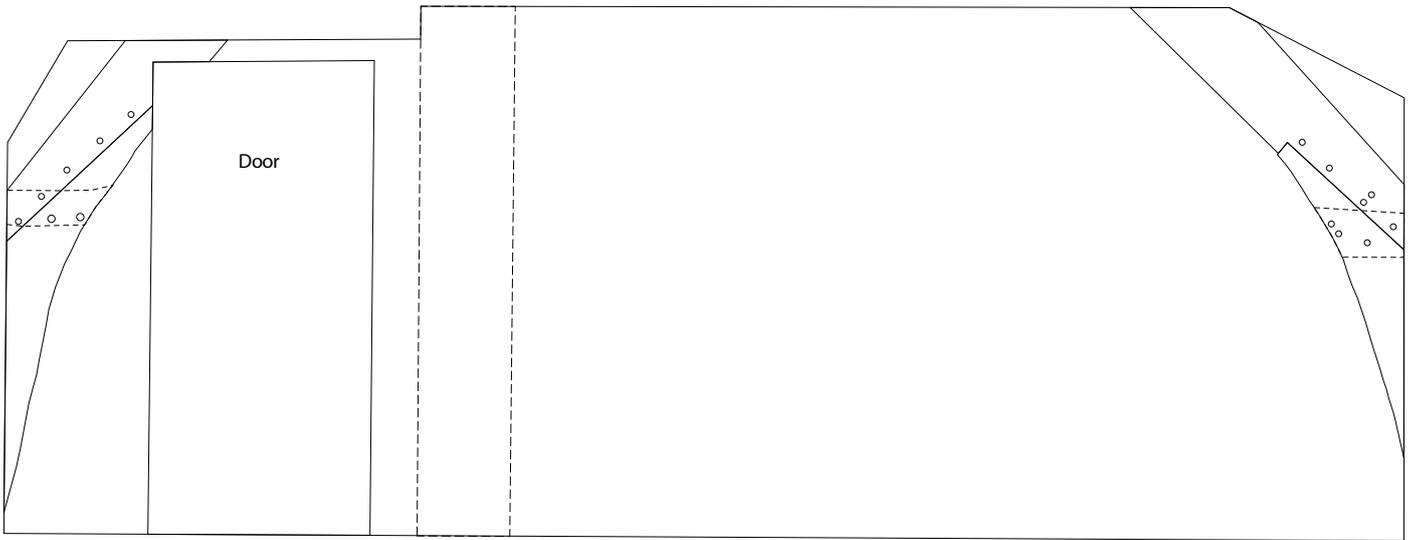
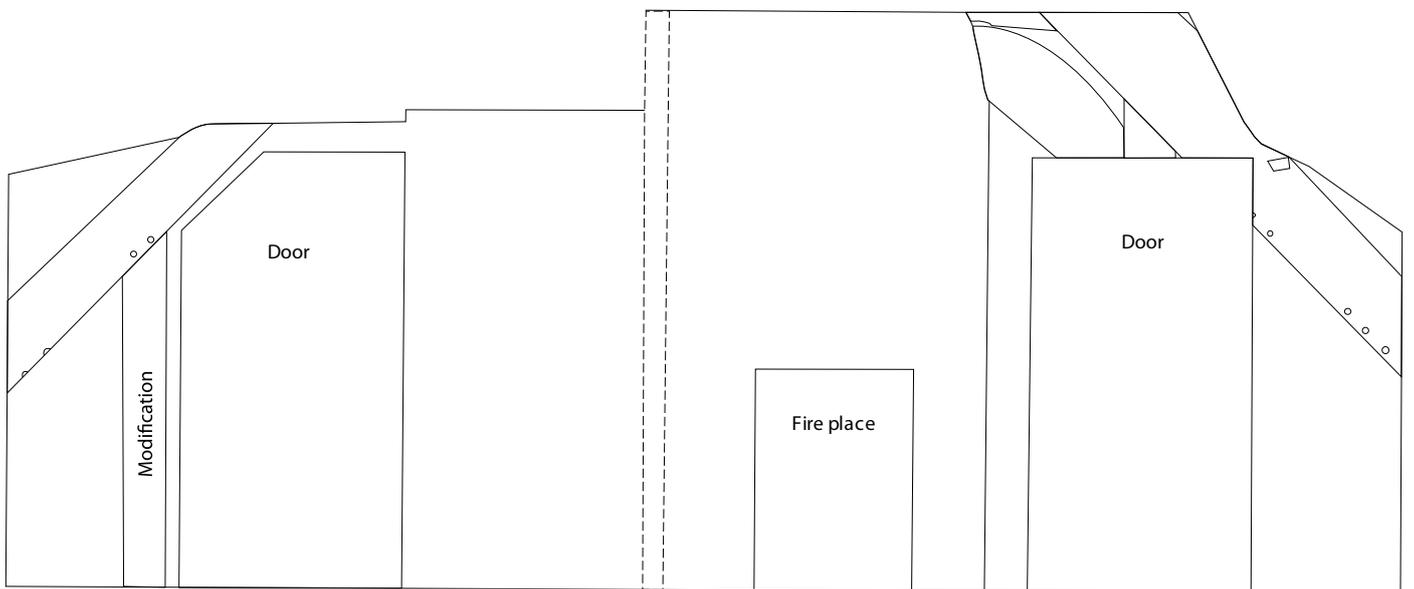
Figure 5: Trefadog, the crucks on the northern and the southern sides of the cross passage

The cruck forming the south side of the screens passage is only partially visible and appears to have been modified on the west side. The arch-bracing to the collar beam on the east side links to a vertical post. There is only a small section left of this, as it has been cut by a door, but it is probable that this vertical post once continued down to ground floor level, and formed part of the screens partition. A vertical wall post, but with less of a curve than on the hall cruck, is linked to the end of the principal, and continues downwards in the lateral wall. This is partly mirrored on the west side, but the vertical post has been replaced with a modern one lower down the principal. Two dowel holes mark the likely location of the original vertical post. There is no evidence for a curving brace to the collar beam, though not enough of the collar beam is visible to confirm if one formerly existed (see plates 7 to 9).

The northern passage cruck is different again. Here the principles are jointed onto vertical wall plates, but there is no collar beam visible, nor any bracing. A housing for a tie beam, however, lies across the cruck joint on the south face – an odd arrangement, but possibly original. The tie beam has been removed, but a housing exists on both east and west sides. The different nature of this truss suggests the outer rooms were two storey (see plates 10 to 12).

The southern face of the cruck on the northern side of the cross passage

The southern face of the cruck on the southern side of the cross passage

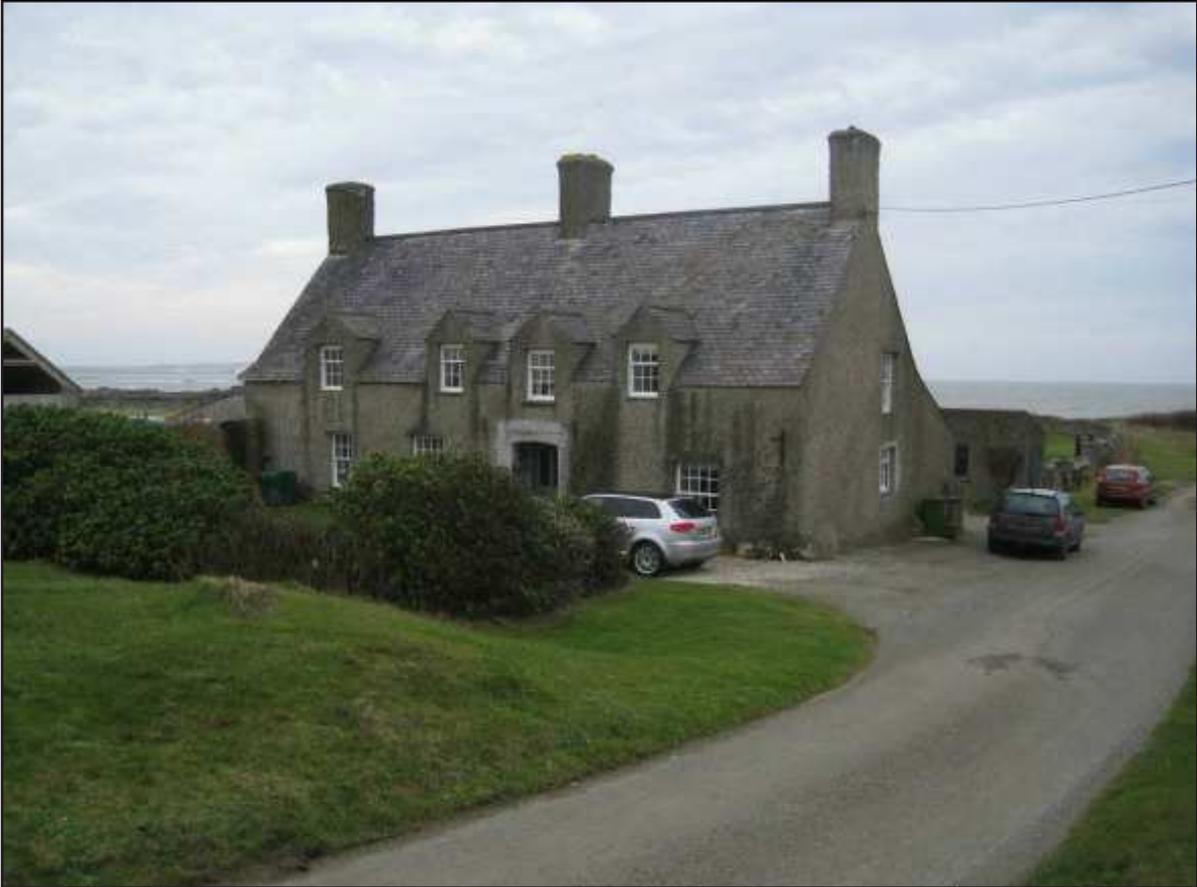
Plate 01: The eastern elevation of Trefadog; view from the northeast.

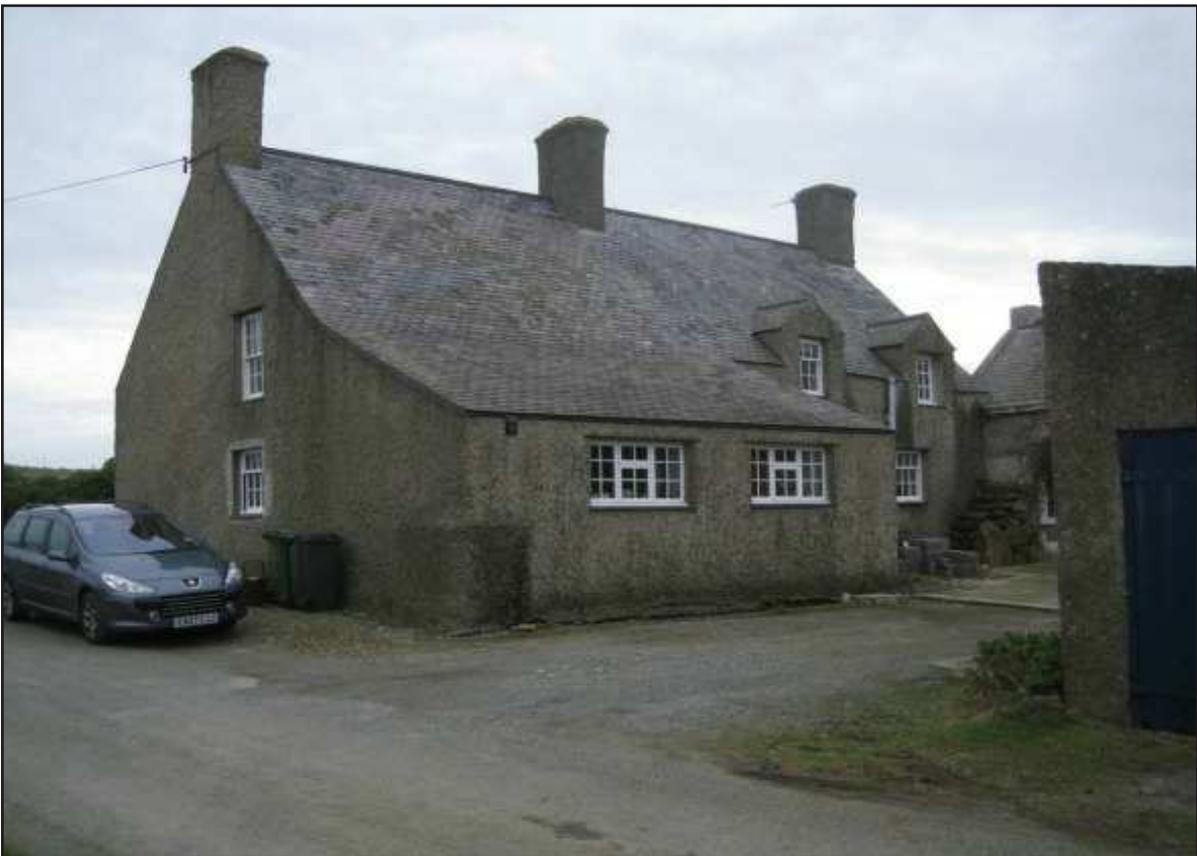
The house is aligned approximately north-south, parallel to the coast edge, and is in a slight hollow 50m from the sea. The house is of two storeys, of rendered stone. The slate roof is modern. There are three rectangular chimney stacks, two at the gables and one to the left (south) of centre. The main front faces east, with an off-centre door to the north, two replaced sash windows to the south and one to the north. Four gabled dormers, all fitted with replaced sash windows, light the first floor. The north side of the house has a catslide addition occupying the north half, of probable 19th century date, though with modern horizontal casement windows in the west wall. The south side of the house is lit by a sash window on the ground floor and two gabled dormers on the first floor. A rear door lies in the corner created by the catslide extension (see plate 2).

Plate 02: The western elevation of Trefadog; view from the northwest.

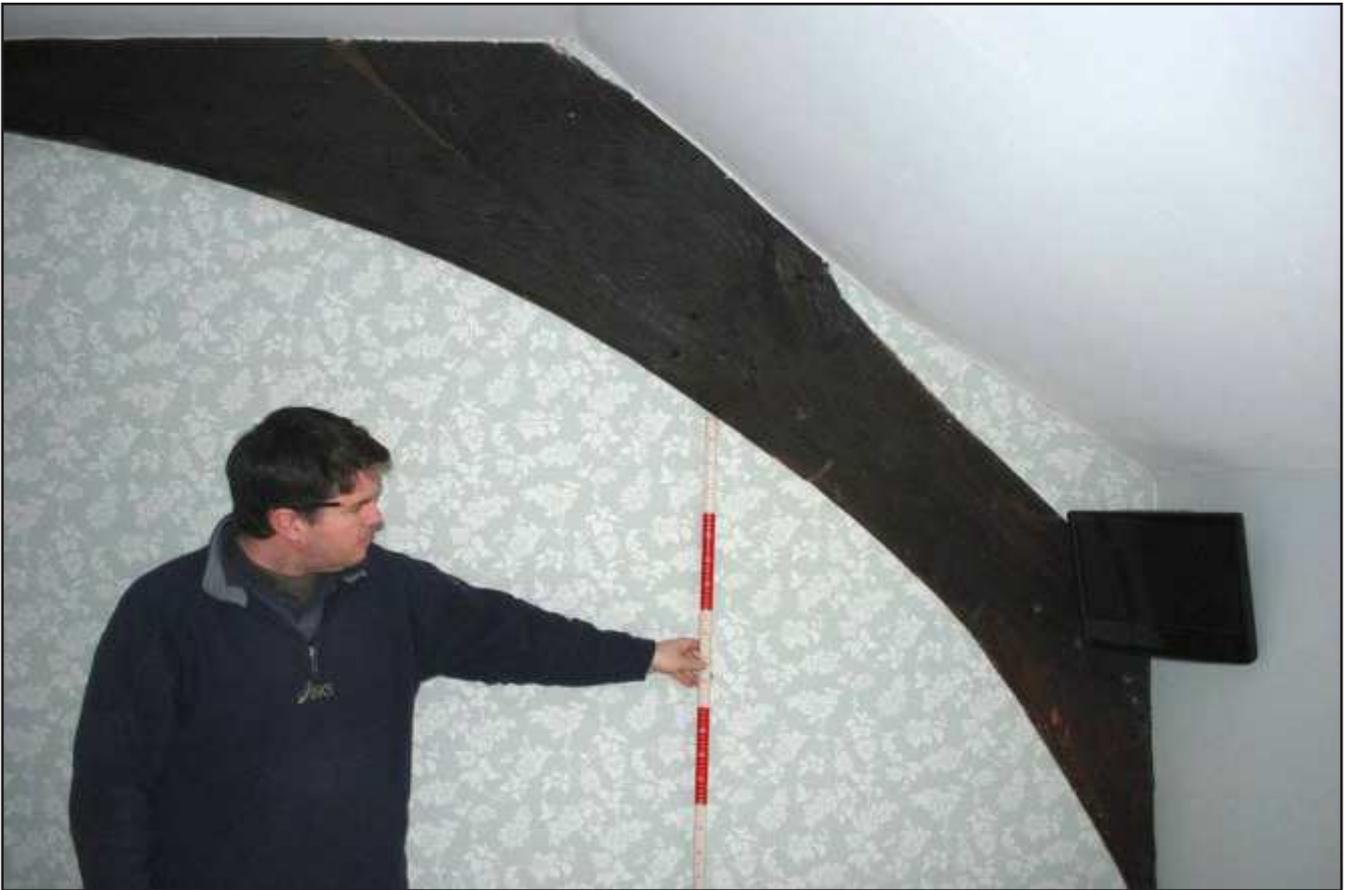
Plate 3: The eastern side of the southern face of the southern cruck which divides the hall; view from the south.

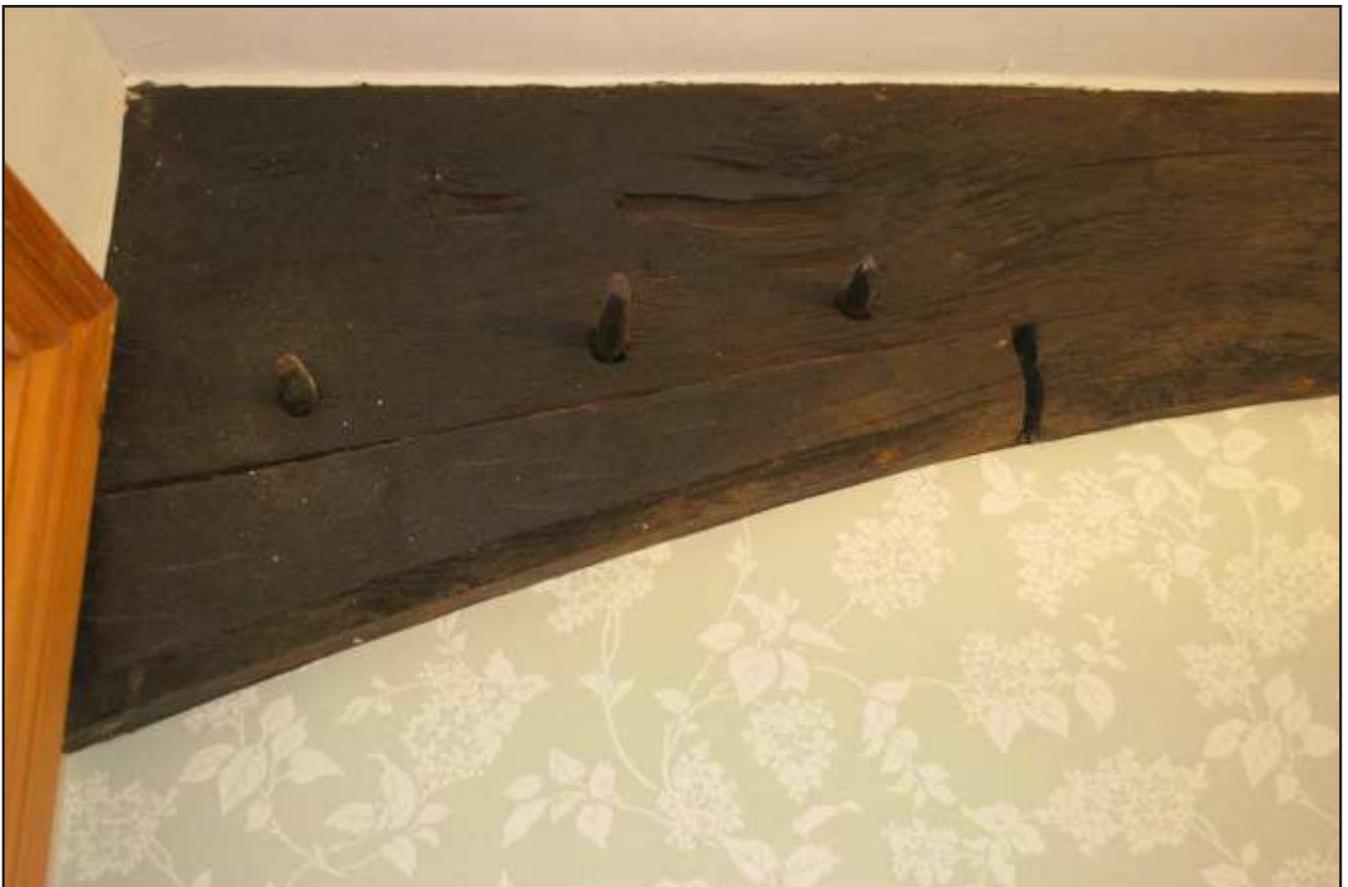
Plate 4: Close up of the pegs which join the jointed vertical post with the principal to form the bend of the southern cruck. This is the western side of the southern face; view from the south.

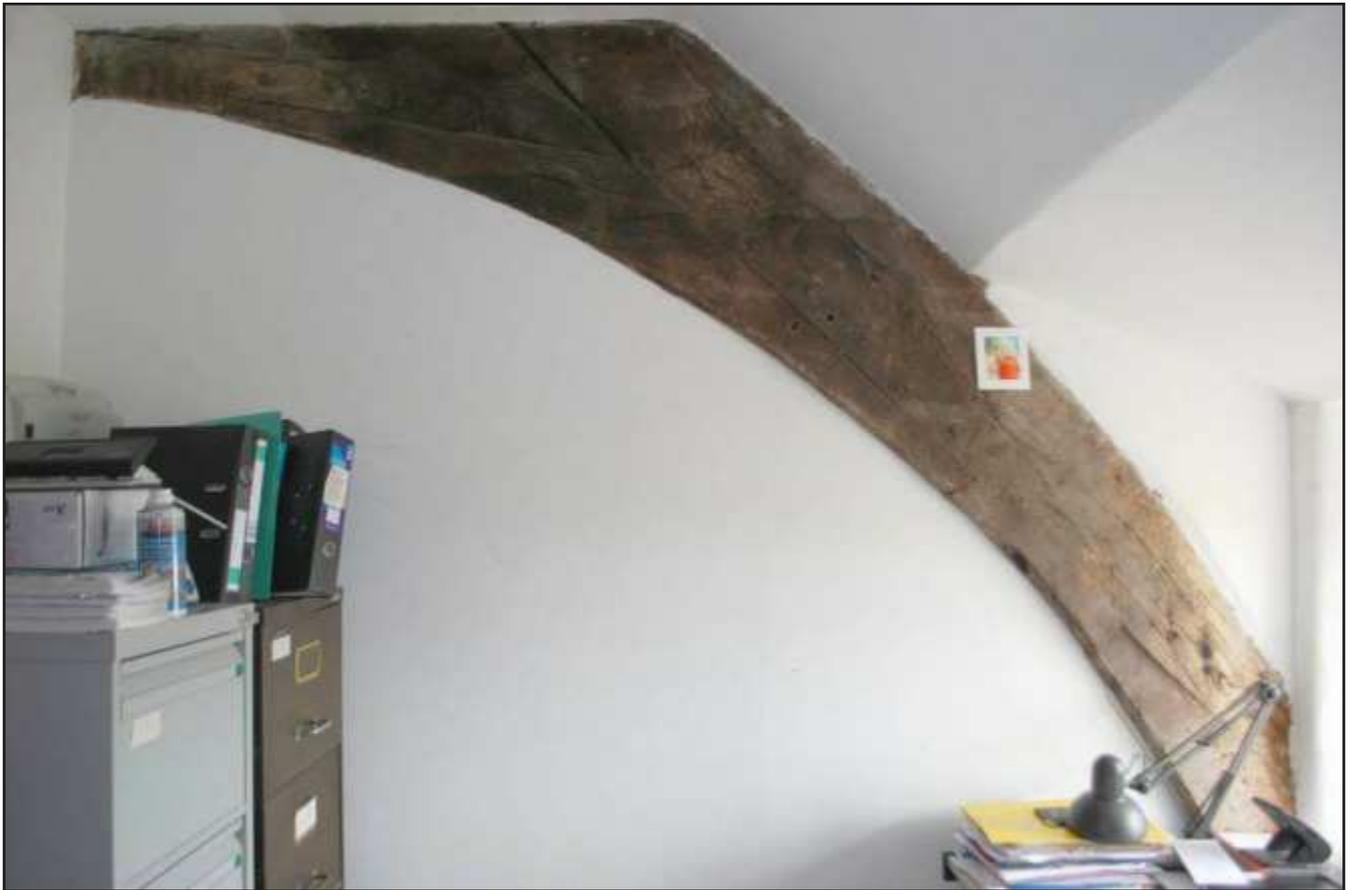
Plate 5: The western side of the northern face of the southern cruck which divides the hall; view from the north.

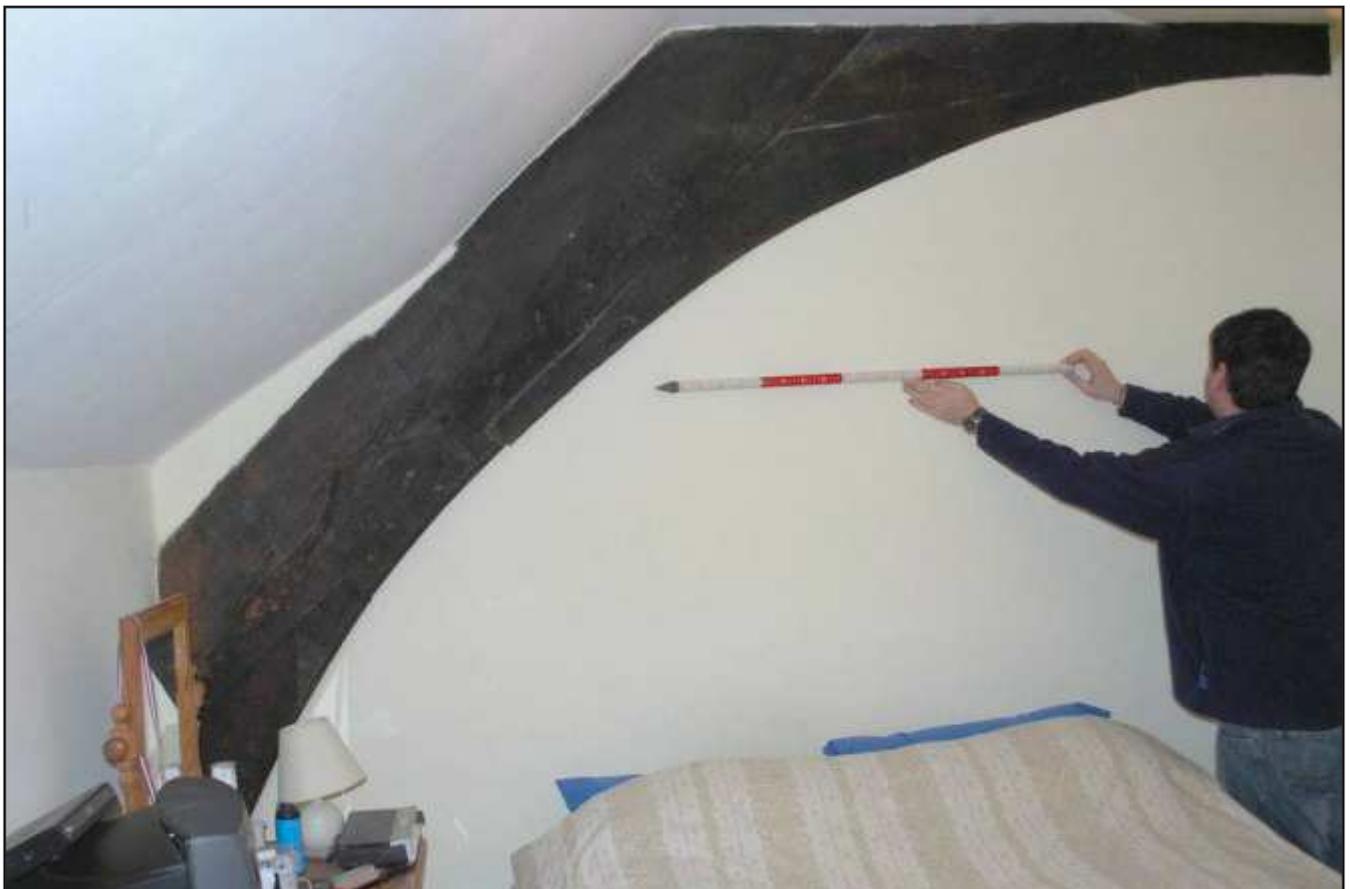
Plate 6: The eastern side of the northern face of the southern cruck which divides the hall; view from the north.

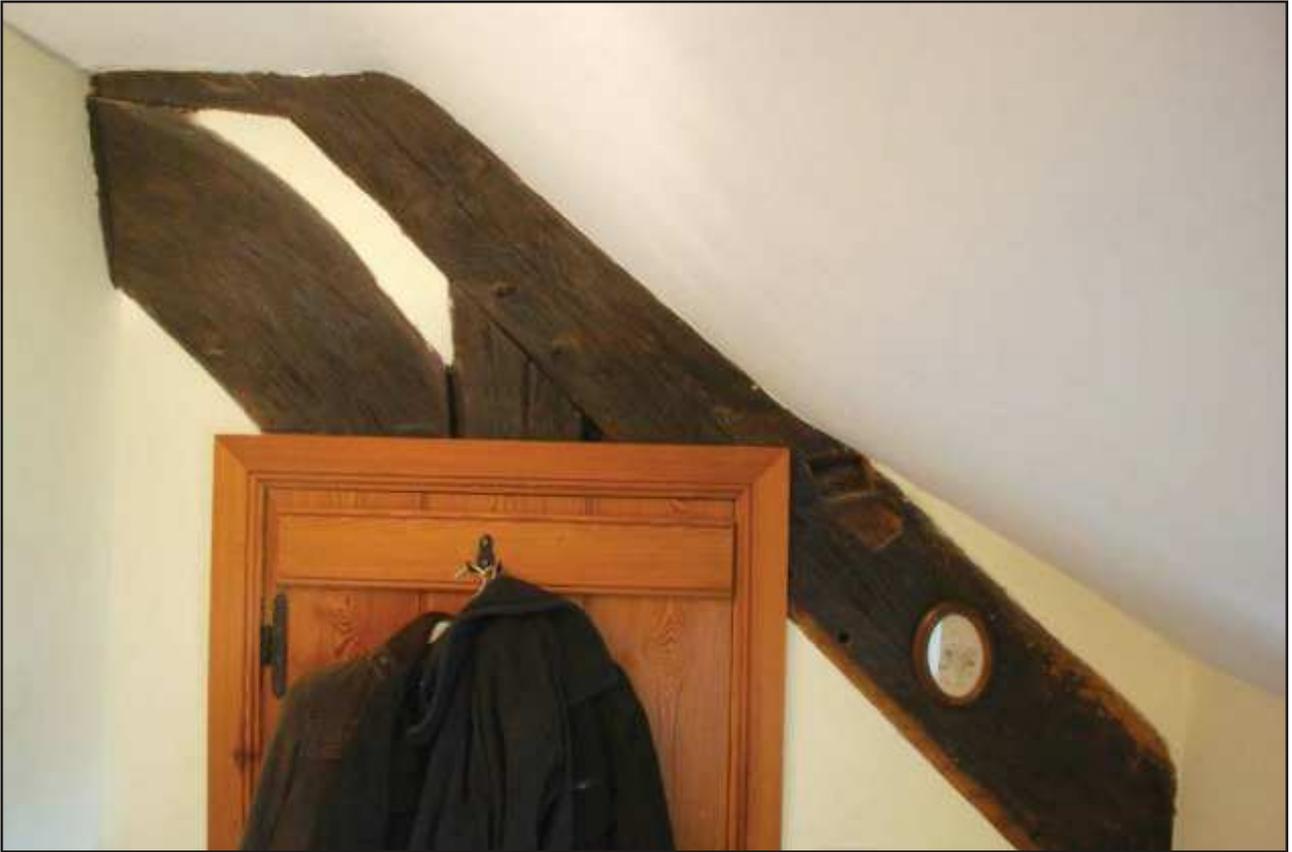
Plate 7: The eastern side of the southern face of the central cruck which forms the south side of the screens passage; view from the south.

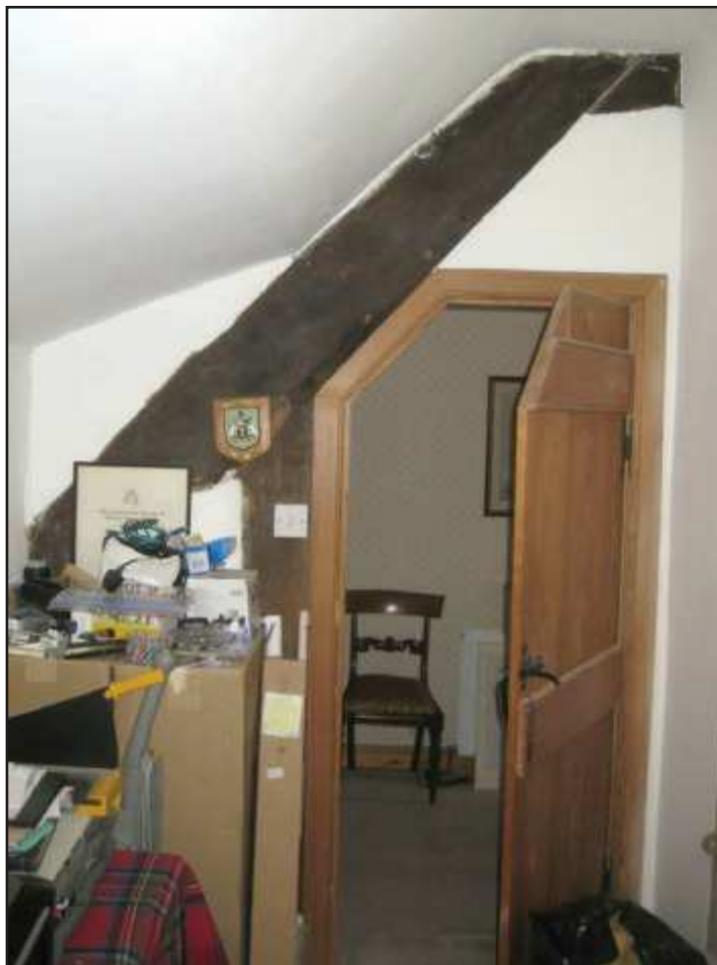
Plate 08: The western side of the southern face of the central cruck which forms the south side of the screens passage

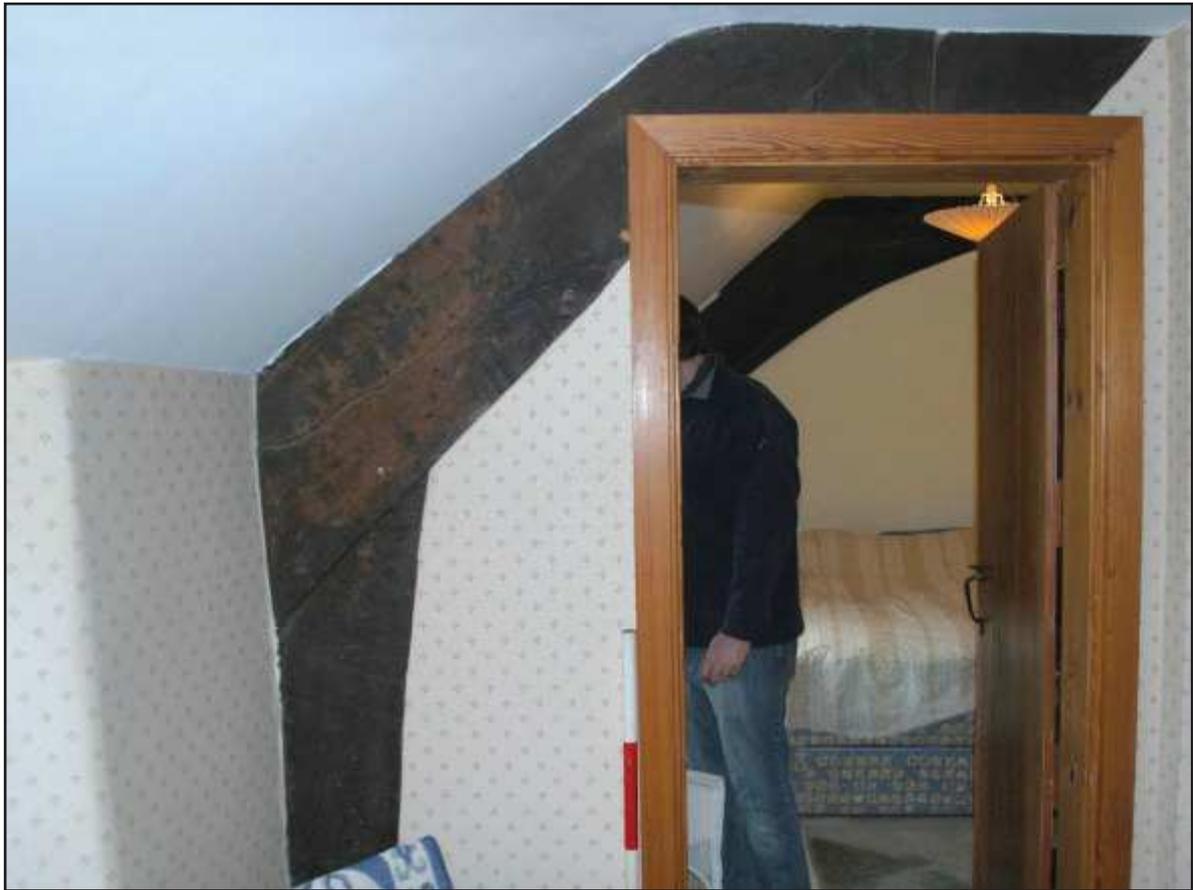
Plate 9: The eastern side of the northern face of the central cruck which forms the southside of the screens passage; view from the north.

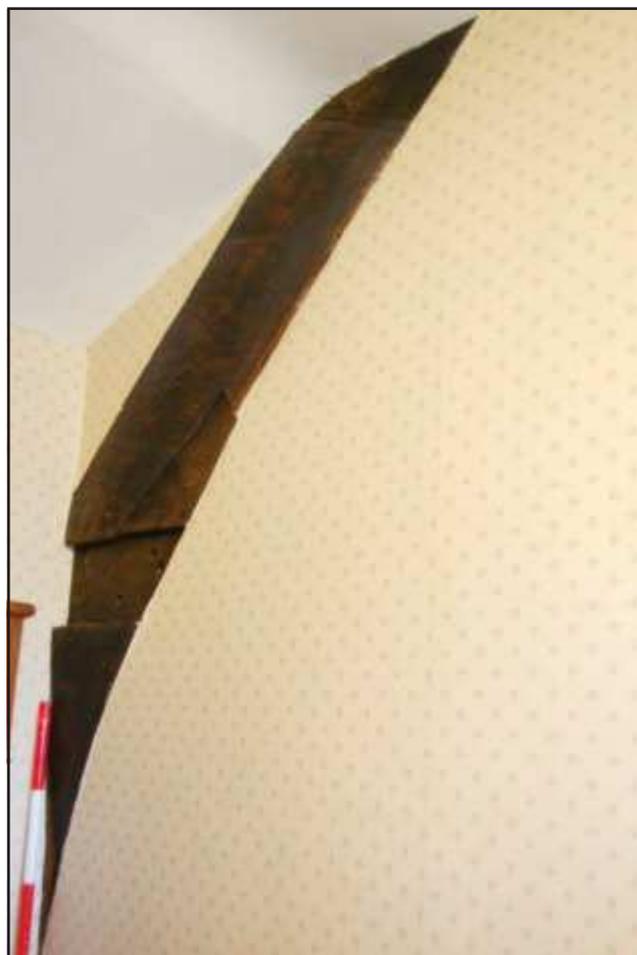
Plate 10: The eastern side of the southern face of the northern cruck which forms the southside of the screens passage

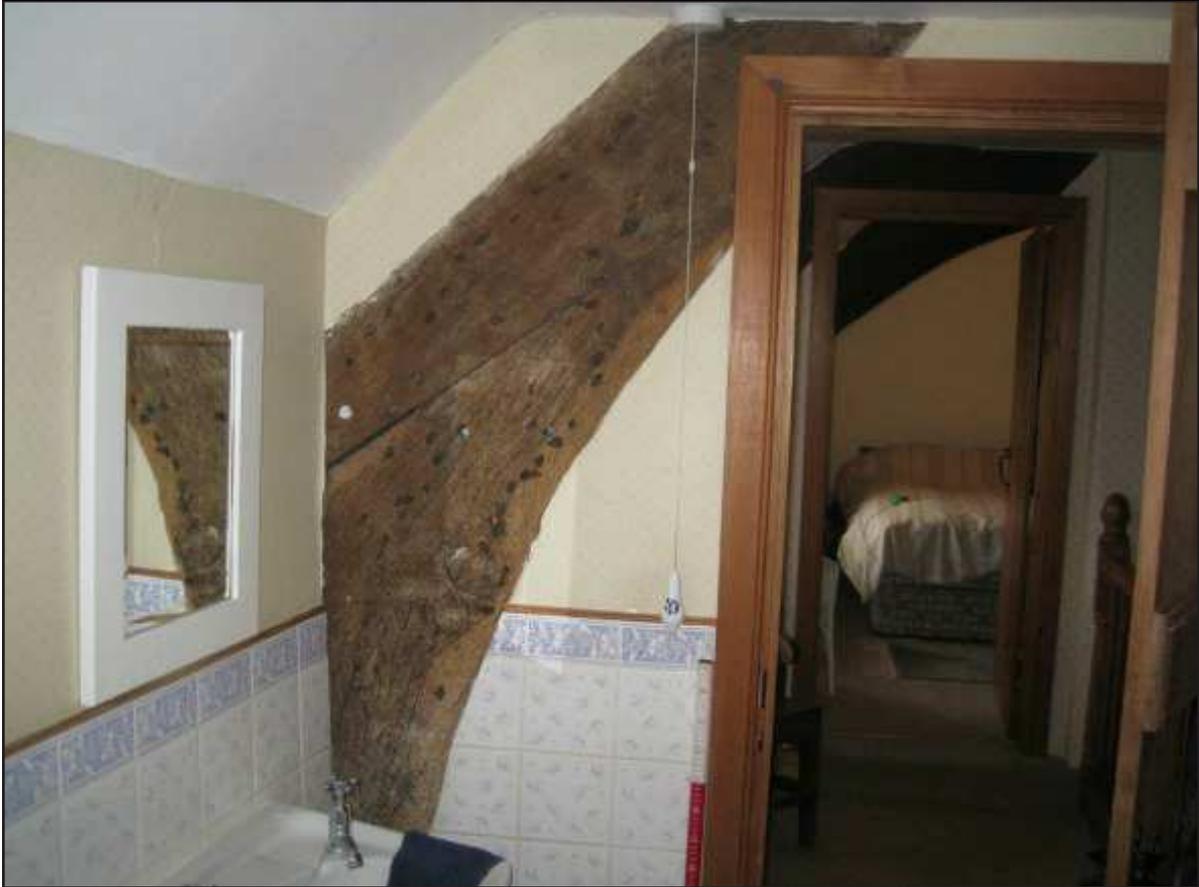
Plate 11: The eastern side of the northern face of the northern cruck which forms the northside of the screens passage; view from the north.

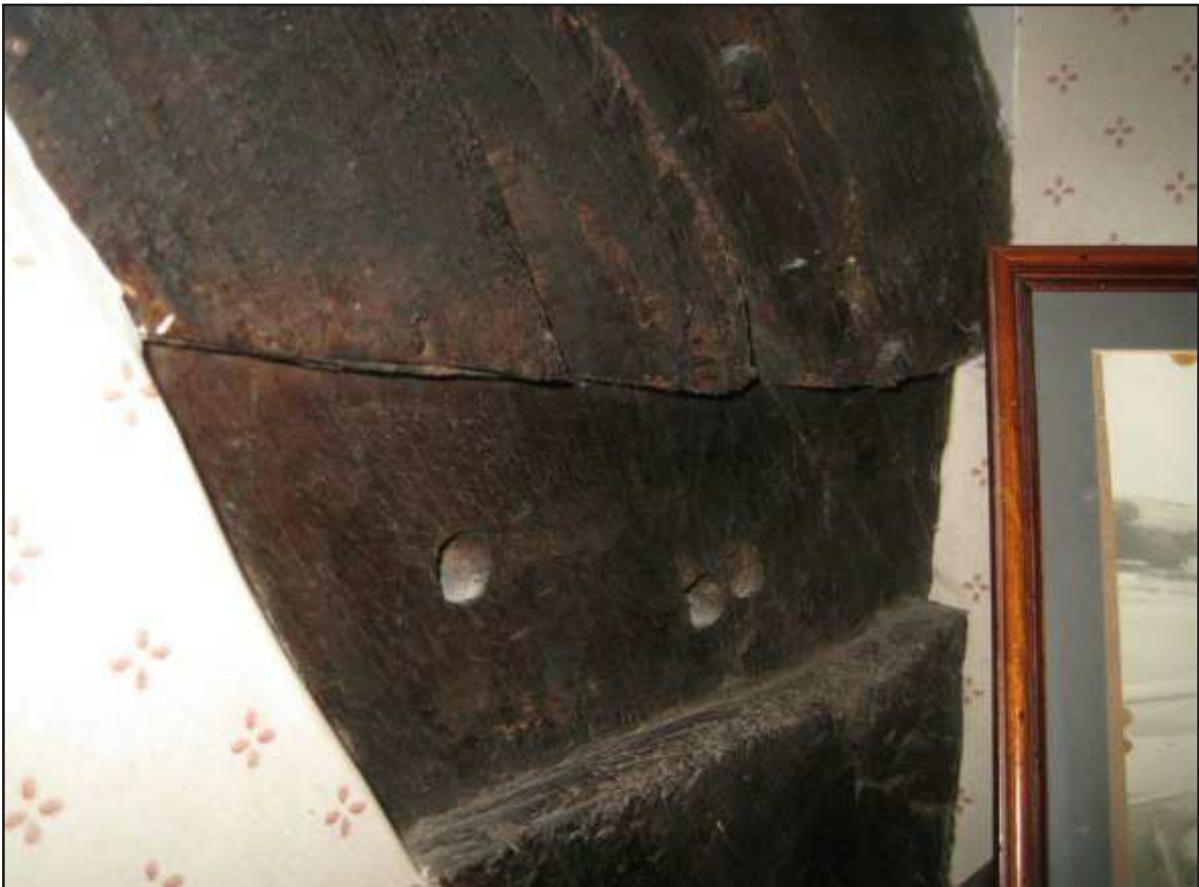
Plate 12: Close up of the housing for a tie beam on the eastern side of the southern face of the northern cruck, which forms the southside of the screens passage; view from the south.
