Barn at Hendre Farm Gwyddelwern

Denbighshire

Historic Buildings Record

September 2019

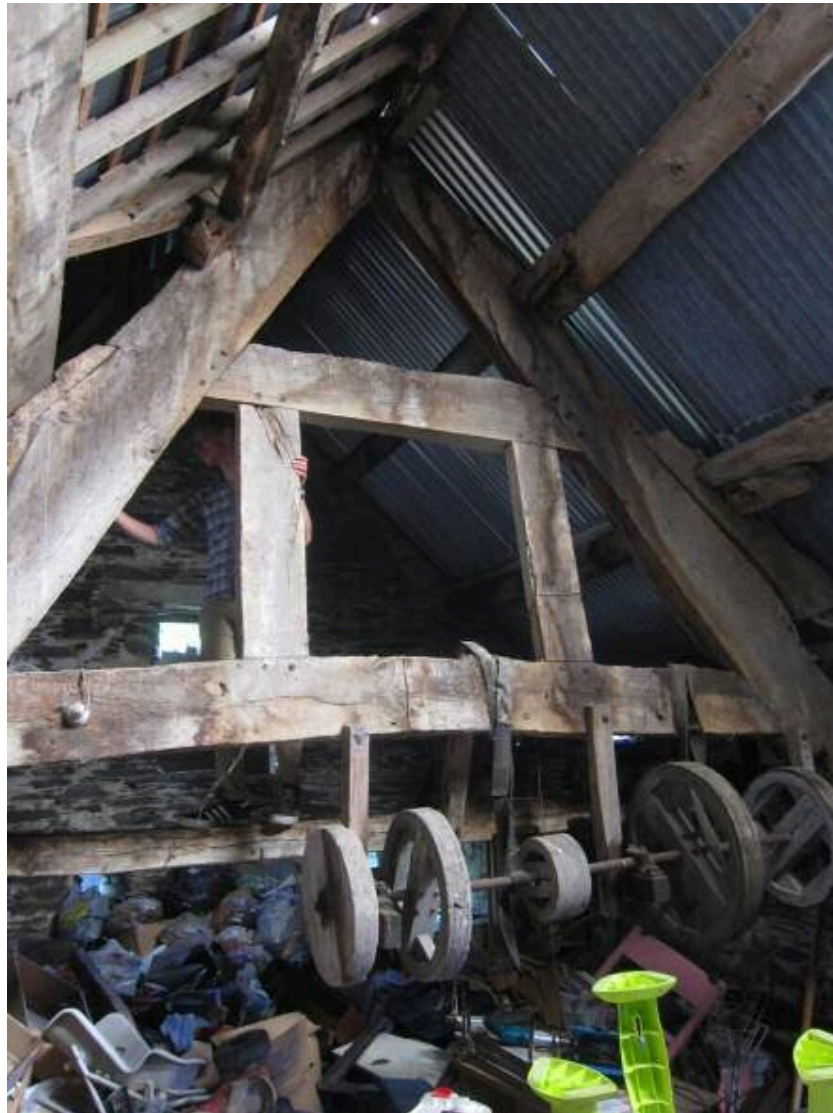
Fig. 1 - Cruck truss T1 with equipment associated with the Pelton water wheel.

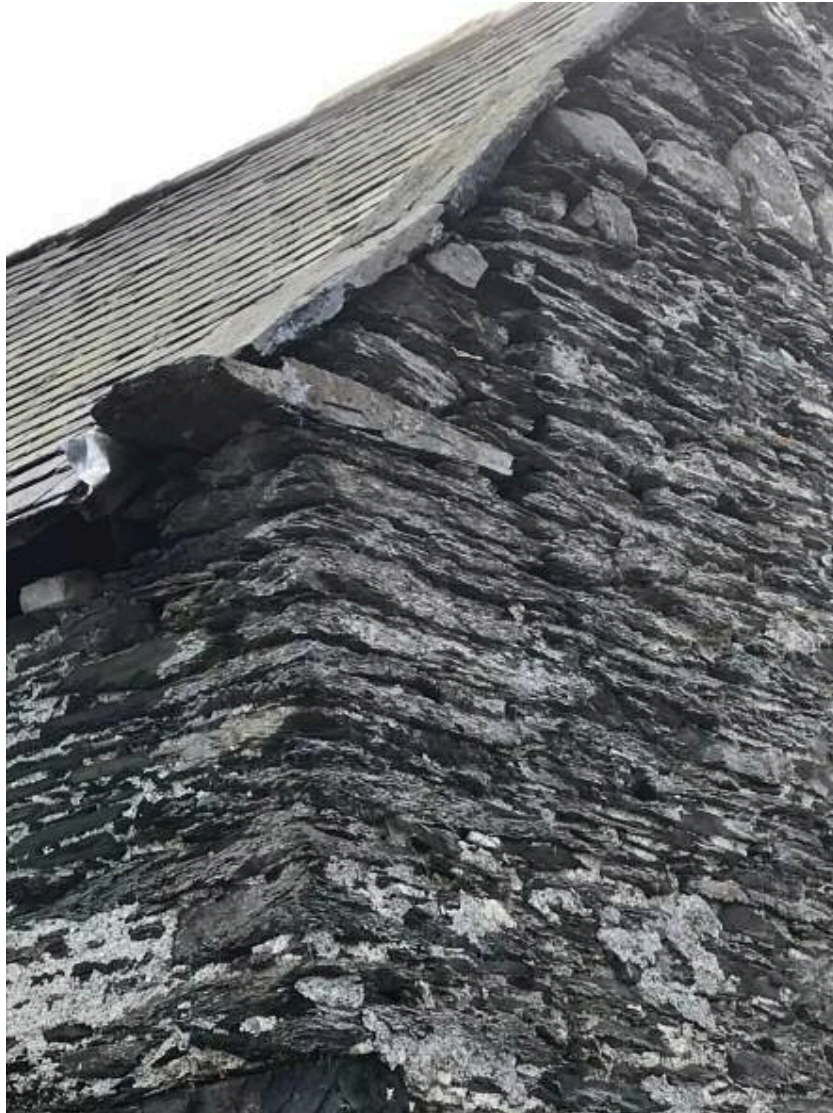
Although the stone cladding was carried out in stages, the earliest walls so treated were most likely the 'show fronts', that is the walls facing the house, farmyard and principal approach: the small rubble stones are carefully coursed and the gable adorned with large flat stones resembling kneelers (Fig. 2). The fact that the plinth of the gable wall extends beyond the line of the original side wall suggests that the 19th-century extension to the SW replaced an earlier structure.

Fig. 2 - The western gable, carefully coursed with a large flat stone intended to imply a simple kneeler, faced the house and farmyard and was meant to be seen and admired.

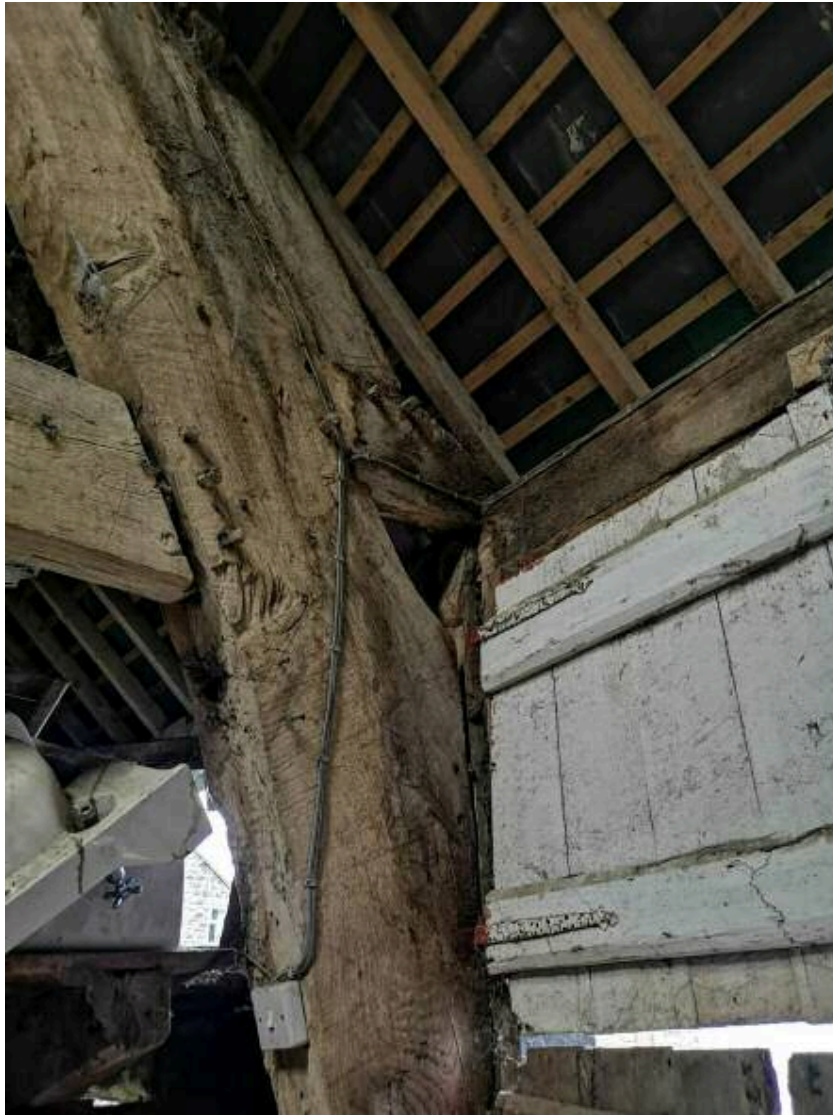
Fig. 3 - Detail of horn and packing piece.
