**North West Wales Dendrochronology Project
Felin Moelfre, Llanaelhaearn,
Gwynedd**

**EAS Client Report 2010/07
March 2010**

**By
I.P. Brooks and K. Laws**

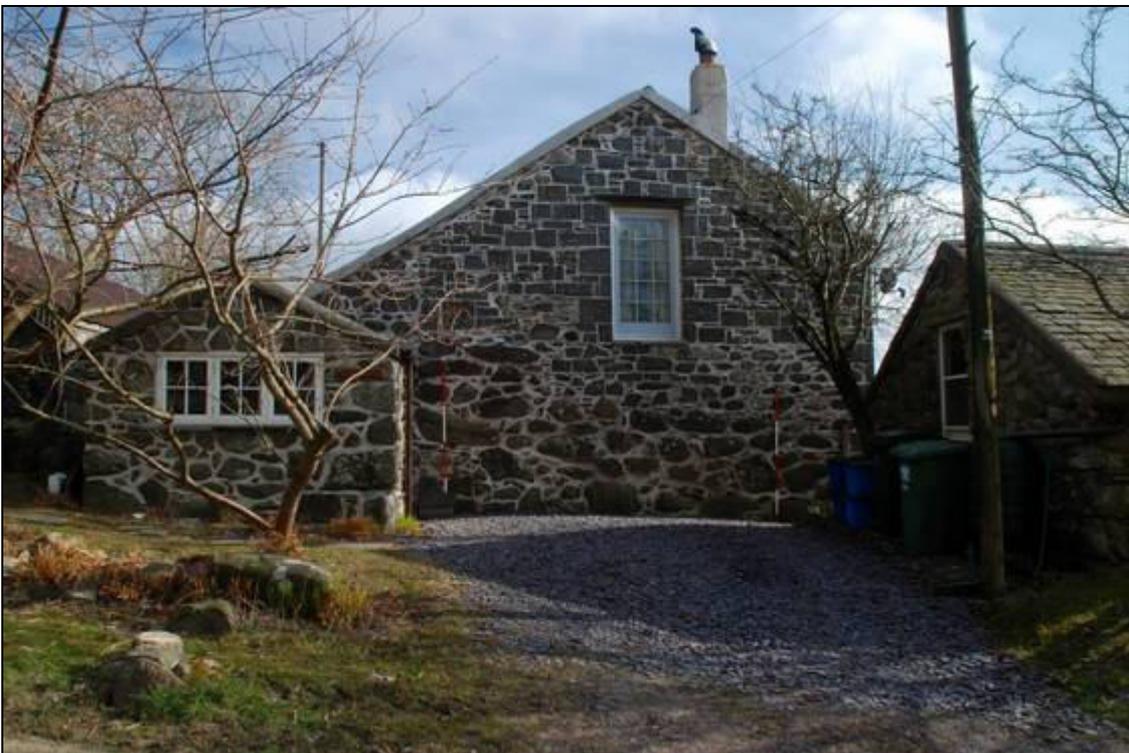
Plate 2: Western gable end

lights, but is a late replacement roof constructed after a period of collapse. This collapse is clearly seen at the western end of the building where much of the gable end (Plate 2) is constructed of roughly coursed, squared stone blocks. Given the degree of collapse it is likely that the chimney has also been reconstructed. There is also a partially blocked opening in the eastern gable end (Plates 4 and 6) which may have been a doorway.

A relatively late addition to the building is the porch on the western end of the extension (Plate 2). This has two modern replacement windows, one in the gable end and one in the northern wall and is entered by a door in its south east corner. There is some suggestion that there may have been an earlier structure as the northern wall of the porch partially sits on a thicker section of walling with a similar thickness to that of the extension.

There was clearly a catastrophic collapse of the western gable wall suggesting a phase of abandonment and then reconstruction (Phase 4) into the current configuration. This period of abandonment also resulted in the original roof structure and first floor being lost (*Burns pers comm.*)

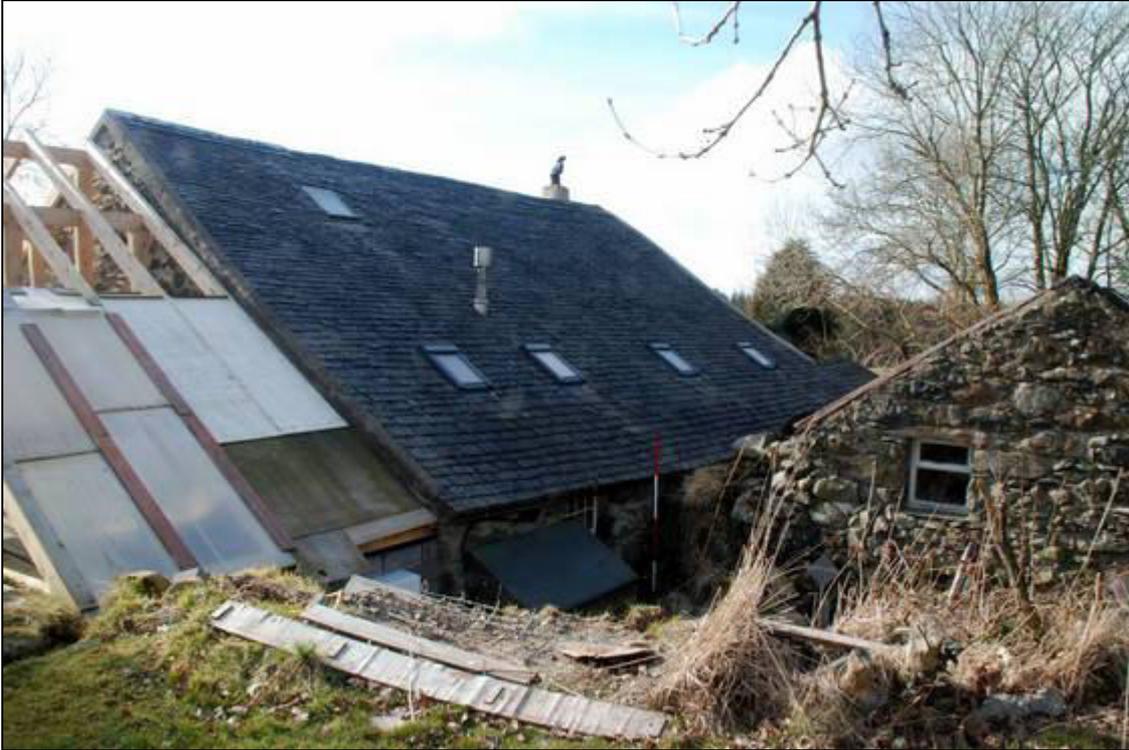
Plate 3: Rear of building, looking SW

To this original building a lean to extension was added on the northern side (Plates 2 and 3). This was constructed of rather rough, roughly coursed boulders with two small windows in its northern wall. This extension is clearly associated with the construction of the wheel pit and the building immediately to the north which held the mill mechanism. The quality of the stonework used for the extension is noticeably poorer behind the waterwheel, possibly a reflection of the degree of wear on this part of the building. The water wheel was probably a high breast shot wheel, it has a metal frame with wooden spokes and buckets. The shaft of the waterwheel did not directly drive the mill machinery as there is a gear wheel attached to the waterwheel from which the drive was taken. The two windows are small openings designed to allow the monitoring of the waterwheel and the outlet leat.

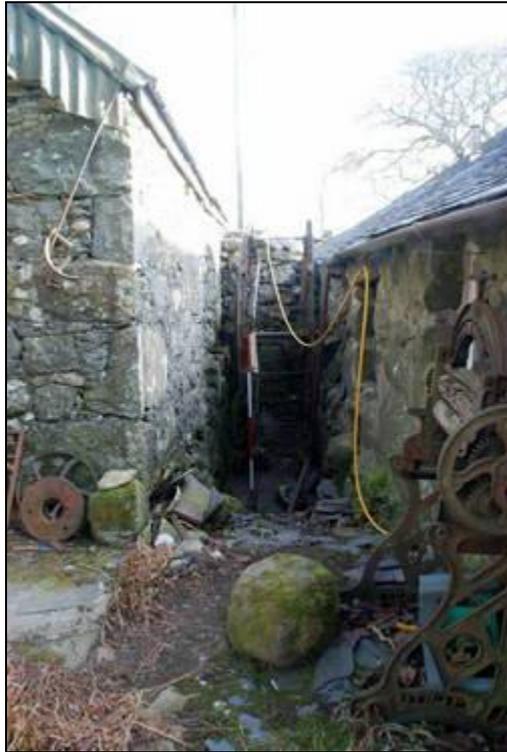
Plate 5: Wheel pit looking east

Felin Moelfre is located approximately 1.3 km south east of the village of Llanaelhaearn, Gwynedd (Figure 1) at the foot of the hill known as Moelfre. It is in close association with the farm of Moelfre Mawr (Figure 2) which is assumed to be a replacement for the house now known as Felin Moelfre. The property has a range of buildings including the house itself and a semi-industrial range which held the mill mechanism. The wheel pit (Plate 5) is between these two buildings. The house has not previously been recorded.

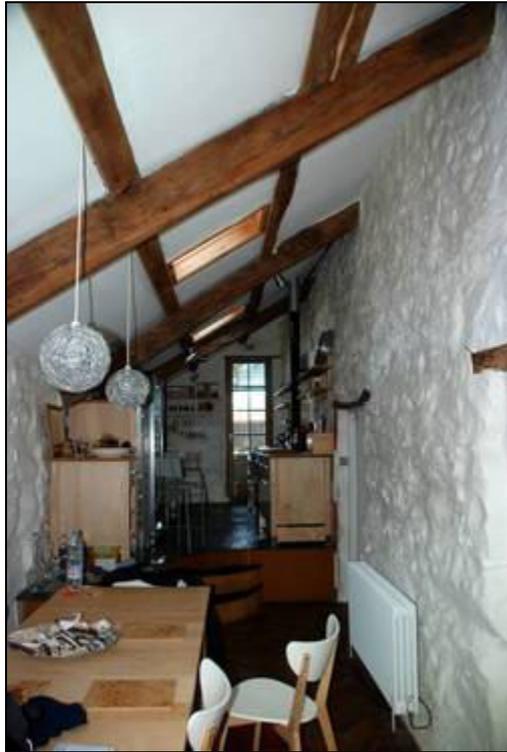
Plate 7: Roof structure of the extension, looking NE

Internally the extension consists of a single room running the length of the building. Three principal rafters are exposed, with linking purlins, but as this is a lean to no further support was required (Plate 7). There are two doorways into the main range of the house, the western of which is partly blocked and now used as a cupboard. There is also a niche cut into the western wall of the extension.

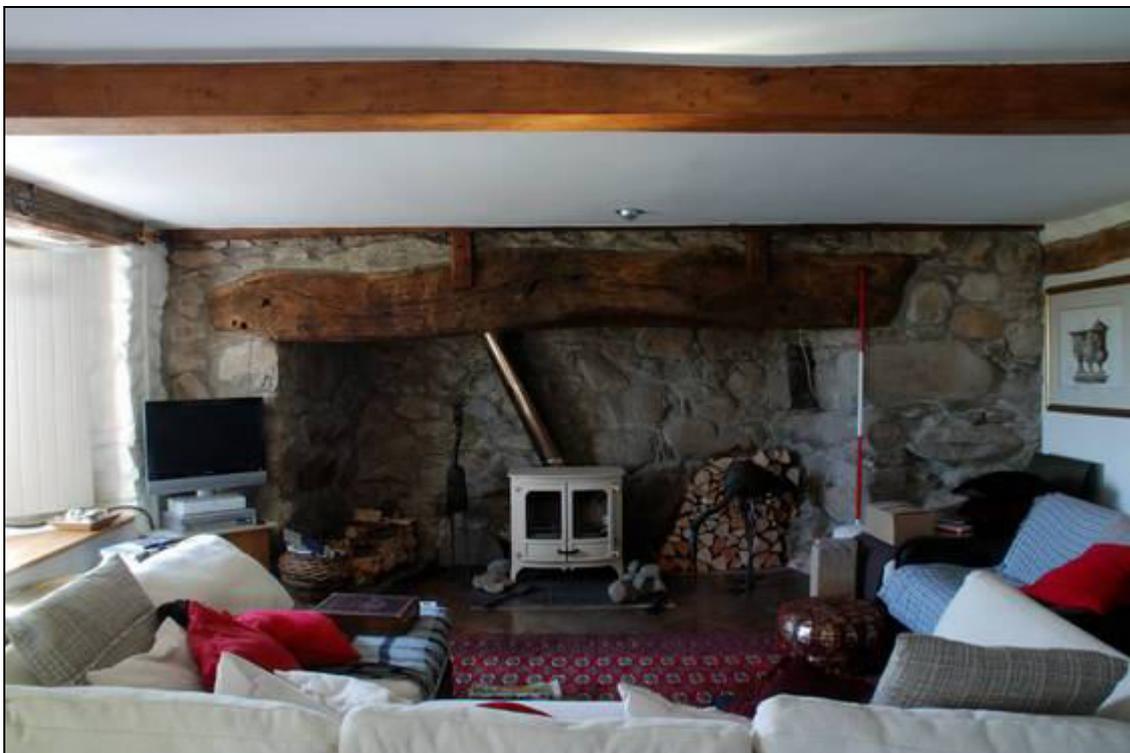
Plate 8: Fireplace at western end

The main range is now a single room, but was presumably sub-divided into at least two rooms with a dividing corridor leading to a staircase in the past. The room is dominated by the large fireplace at the western end with a large wooden bressumer (Plate 8). In the north western corner of the fireplace is an oven (Plate 9). The oven is roughly circular and has a disused mill stone as its base. This stone is a fine grit, top stone with a large eye (Plate 10). It is well worn, now being only 60 mm thick in places (Figure 4.2). It also has two rough holes which appear to have been chiselled into the stone after its use.

Two samples were taken from the bressumer over the main fireplace.

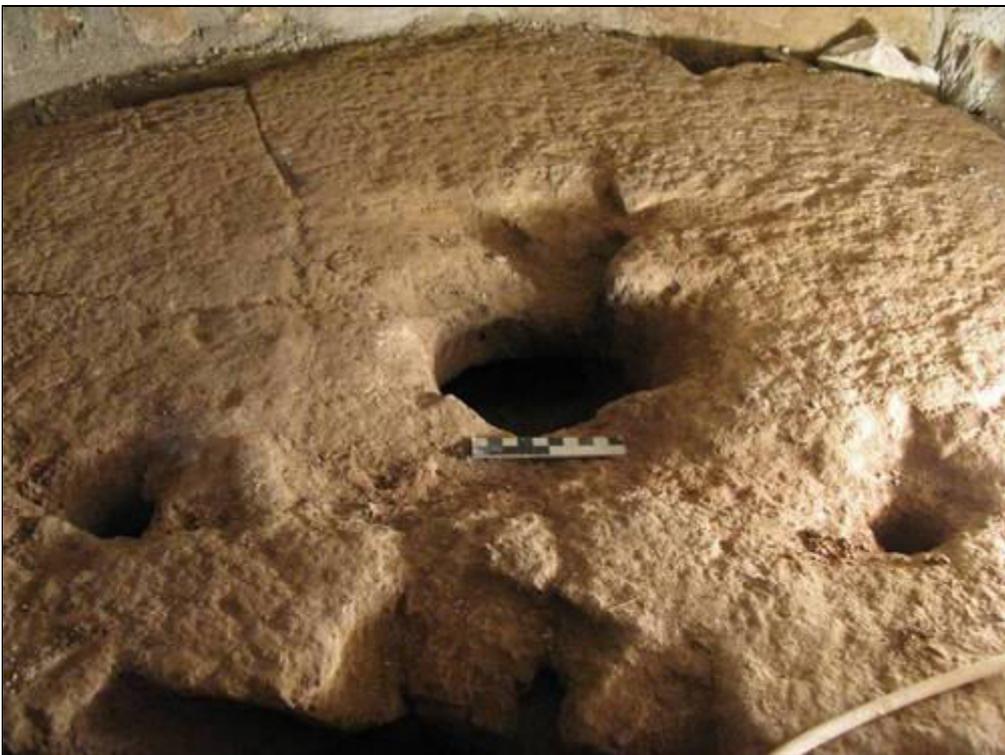
Plate 10: Detail of the mill stone in the base of the oven

Felin Moelfre has clearly developed over a period of time (Figure 5). The initial house would appear to have been a two storey house with a large fireplace at its western end (Phase 1). It is assumed that this was a domestic building; however the presence of a mill stone in the base of the oven would suggest that there may have been a mill in the immediate area, if not integral with the initial building. Further research on the mill stone may suggest a broad date for this initial phase of construction.

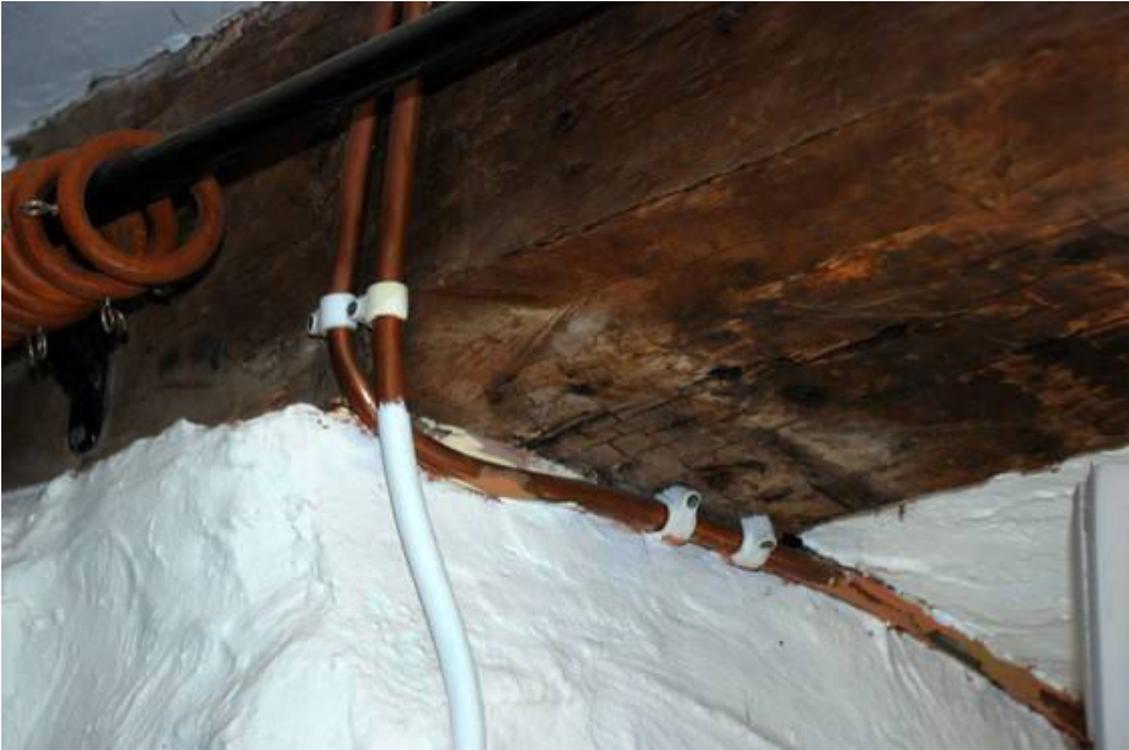
Plate 11: Broach stop and chamfer on re-used tie beam

Some indication of the nature of the previous division of the house is shown in the lintel above the south western window. This is a section of a tie beam which was chamfered and had broach stops (Plate 11). It also had a series of empty half face housing joints presumably to hold the posts for a post and plank

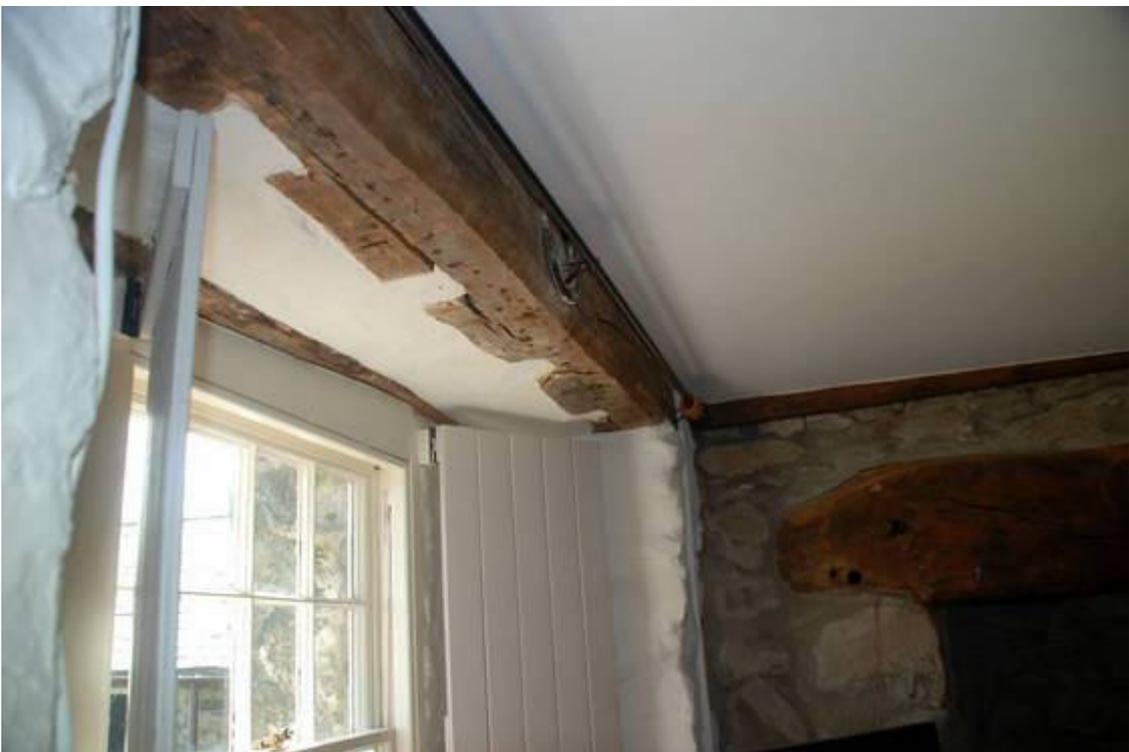
Plate 12: Re-used tie beam

partition (Plate 12, Figure 4.1). Other features in this part of the house include the blocked doorway in the northern wall, adjacent to the fireplace (Plate 13) the safe in the northern wall and a disused fireplace in the eastern gable wall. The safe is a wall mounted safe made by J.T. Meeds of Bond Street, London and is presumably 19th century in date. The staircase is a modern structure and does not occupy the original position.

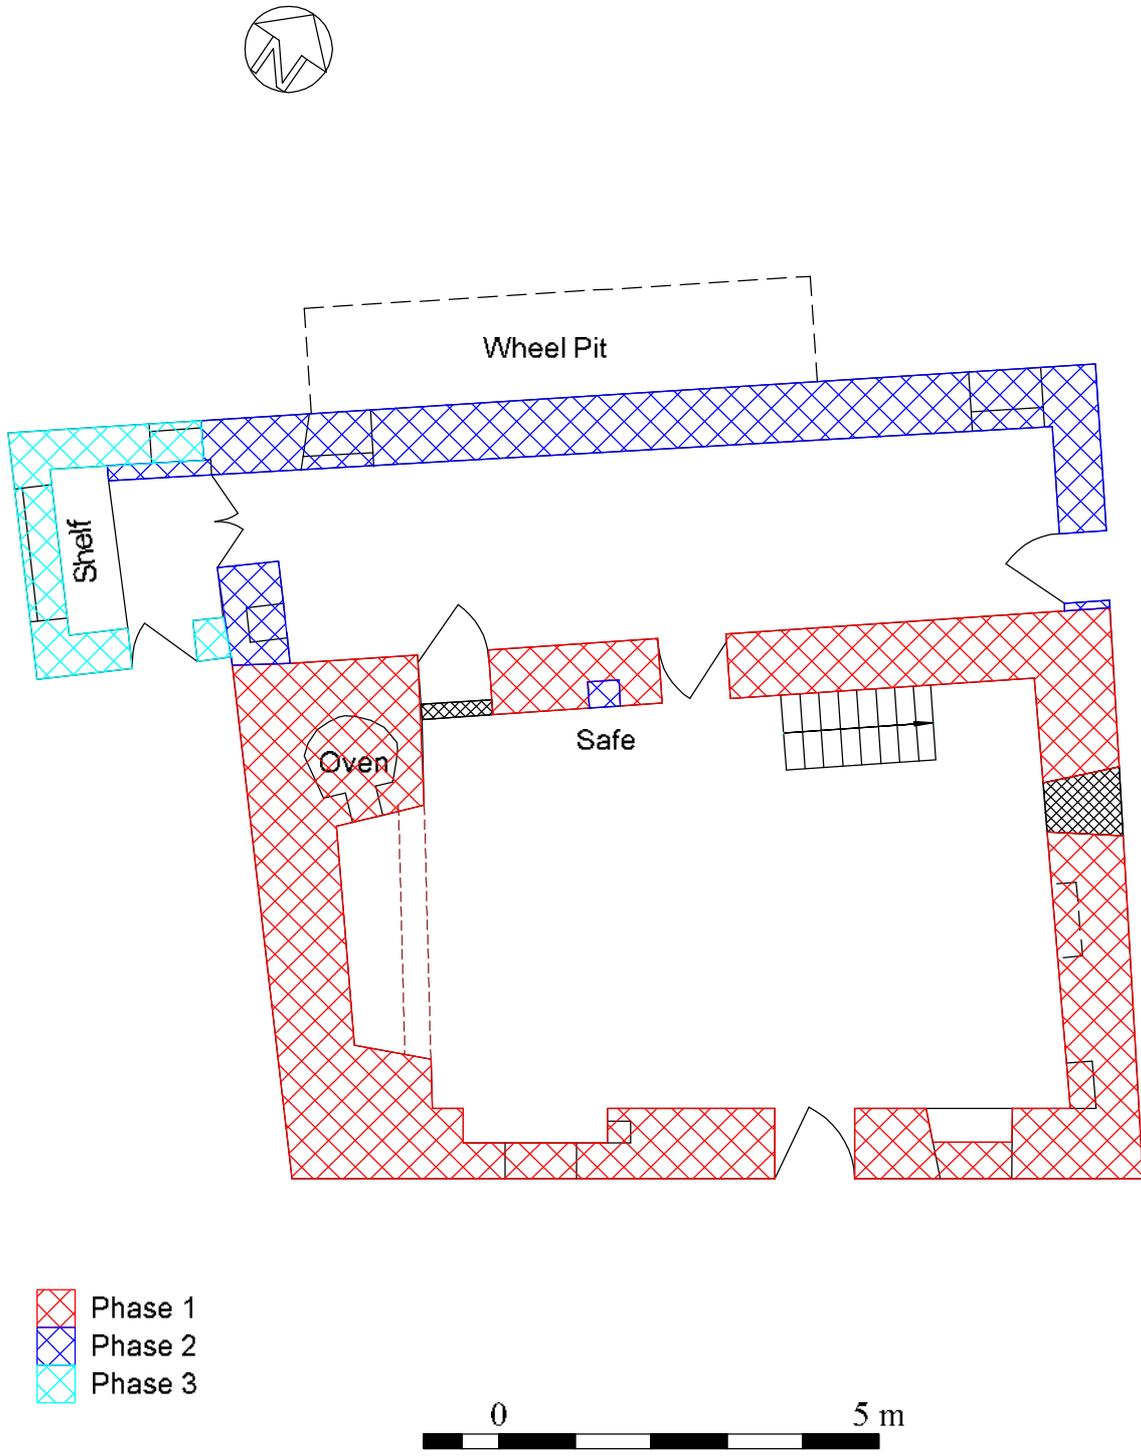
Figure 6: Felin Moelfre, Llanaelhaearn
Possible phasing

The house was then extended to the north (Phase 2). This phase was contemporary with the water mill immediately to the north and probably suggests it was the accommodation and offices associated with the mill. It is possible that the wall safe may also be part of this phase of development. A porch was then added (Phase 3) to the western end of the extension, possibly incorporating part of an earlier structure.
