Hafod Lwyfog

Nant Gwynant Beddgelert,
Gwynedd

Building Report

HAFOD LYWYFOG
A HISTORICAL, ARCHITECTURAL AND
DENDROCHRONOLOGICAL
ANALYSIS OF A SNOWDONIA HOUSE

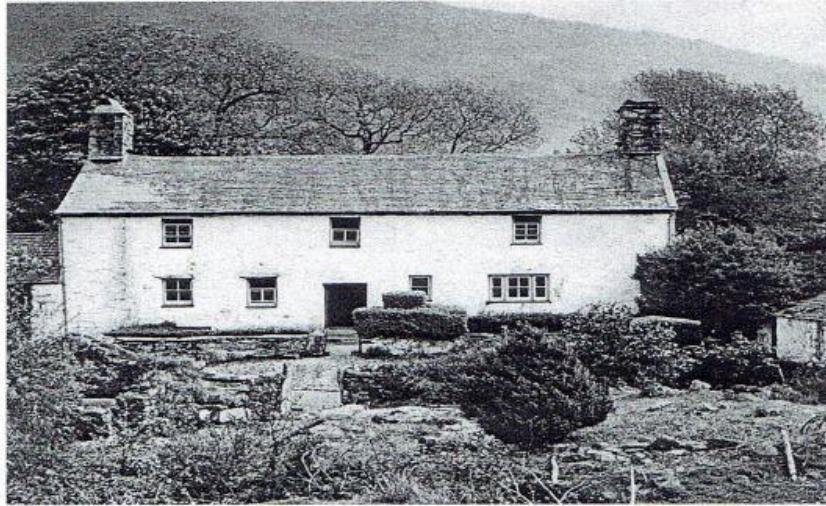
Figure 10. The house in 1953.

Hafod Lwyfog has a modern roof with industrial slate tiles. The pitch of the roof is very low, indicating that it was designed originally for stone slates (Hughes, 1908). However, it would appear that the roof has been replaced at least twice in the past, as photographs taken in 1953 and 2000 show a change from rough slates to machine cut slate tiles.

These large inglenook fireplaces first become fashionable in the early 16th century. However by 1953 photographs show that both inglenook fireplaces had been blocked up and a cast iron range had been installed in the kitchen and a stove in the parlour. Today, the stove has been removed from the parlour and has been replaced by a solid fuel open fireplace and the kitchen fireplace has been opened up and a wood burning stove insert. Photographs from this time also show that the chimneys have been capped with a triangle of slate.
