DATING OLD WELSH HOUSES

Tudor Rose

15th and 16th century hall-house
32 Castle Street, Beaumaris

GAT Project No. 000
prepared by
David Longley
for North West Wales Dendrochronology Project
March 2010

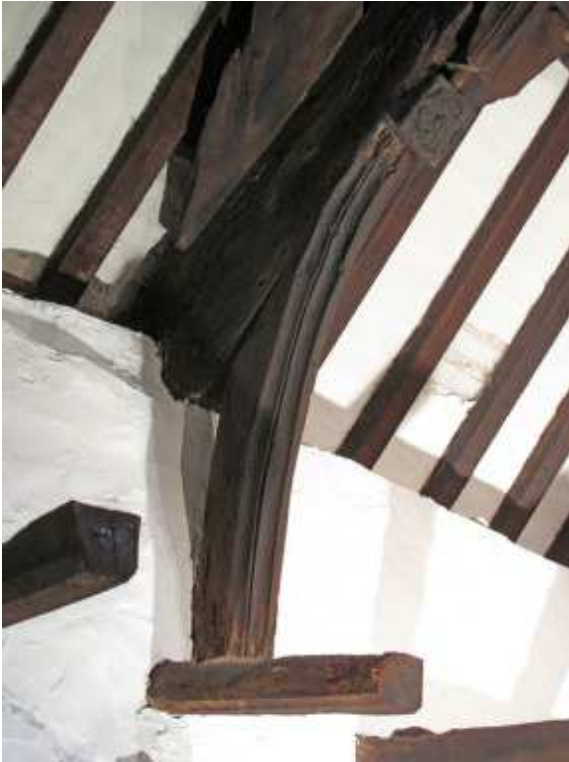
Truss 2 arched brace and first-floor joists, truncated

- The principals meet at the apex of the truss with a mortice and tenon joint and are pegged with two pegs.
- The collars are cranked beams and are supported by arched braces in the angle between the collar and principal, continuing onto the face of the walls. The braces are truncated at their base to accommodate the first floor, although, presumably, originally attached to wall posts.

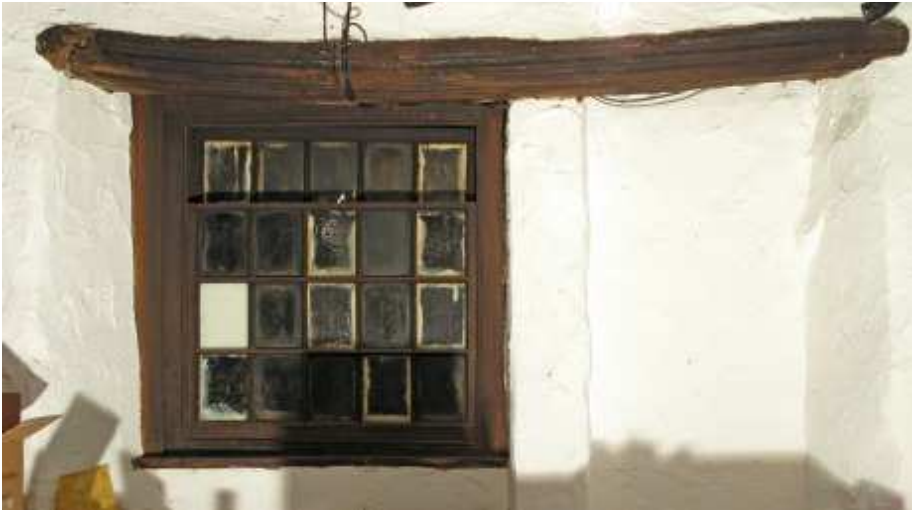
opening in west wall with elaborately decorated lintel

- The braces are attached to the collar and principles by pegged mortice and tenon joints at between six and eight pegs to the joint.
- There are openings in both the west and east walls on the ground floor which accommodate windows. Two wide, splayed, openings, facing each other in the central area of the hall may represent the doors of a cross-passage. Both openings are now blocked although a late, window in the west wall occupies a part of the original opening on the west side. The lintel over this opening carries a particularly elaborate moulding (see detail).

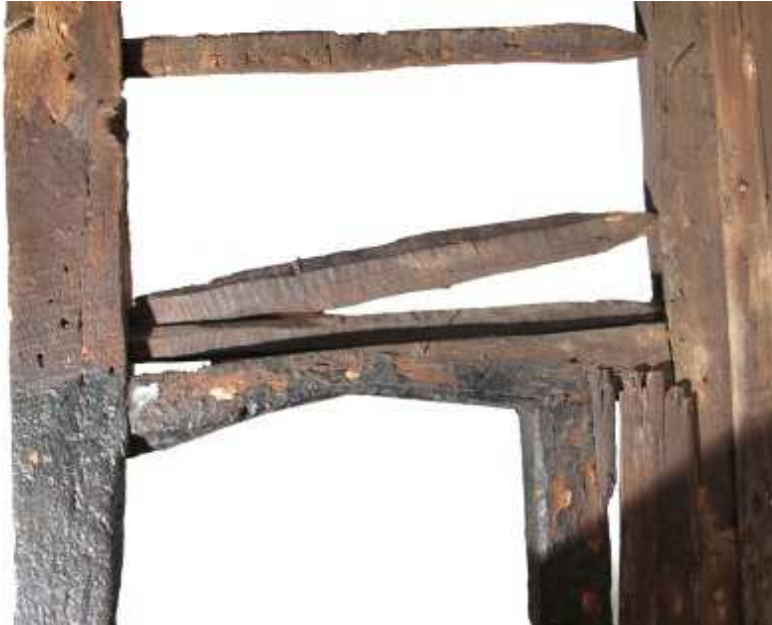
ground floor partition;
false four-centred door head;
staves for wattle and daub

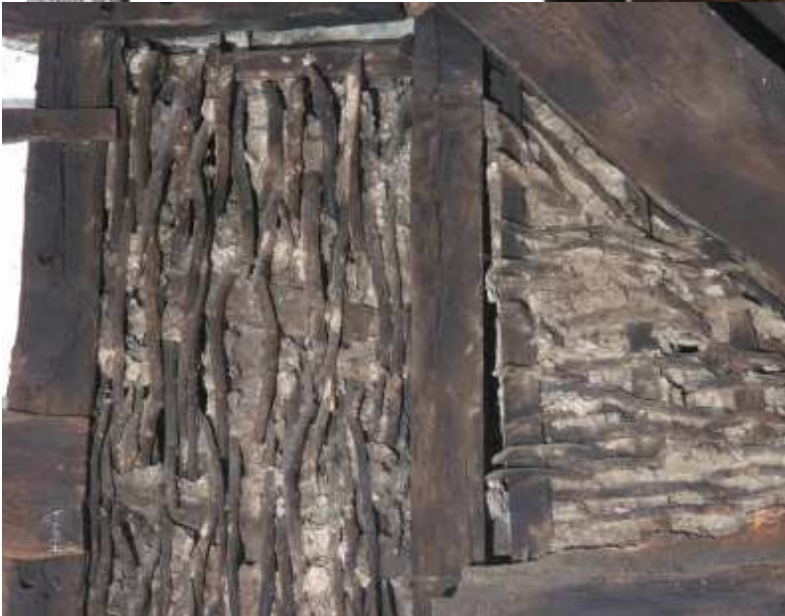
gable truss partition;
staves and wattle and daub

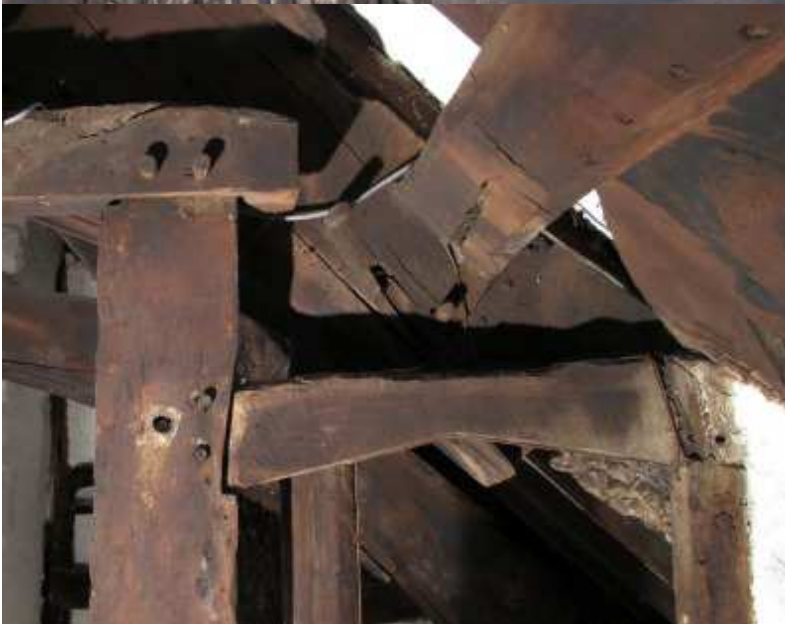
first floor partition;
false four-centred door head and
carpentry

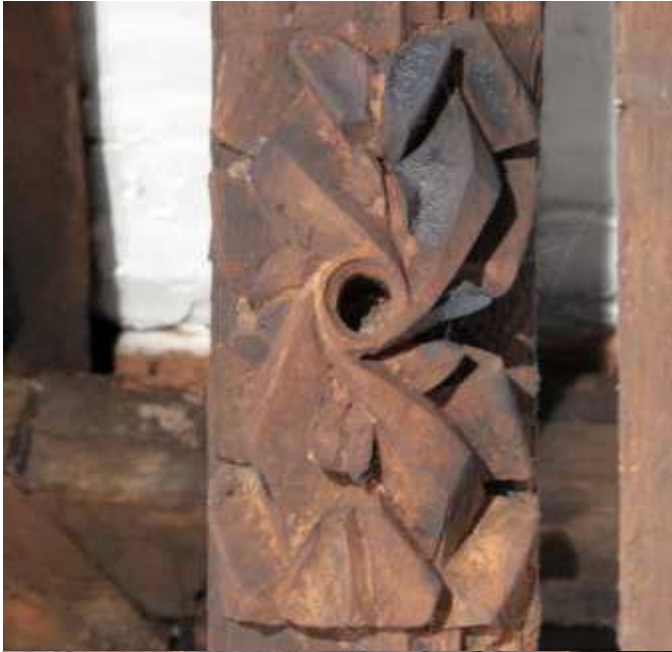
Truss 3: central foliate boss

- The two central trusses carry elaborate mouldings continuously from the wall brace to the underside of the collar, with the exception that foliage bosses have been included in the design at the base of the collar and at the junction of the two arched braces where they meet the principals (see details).

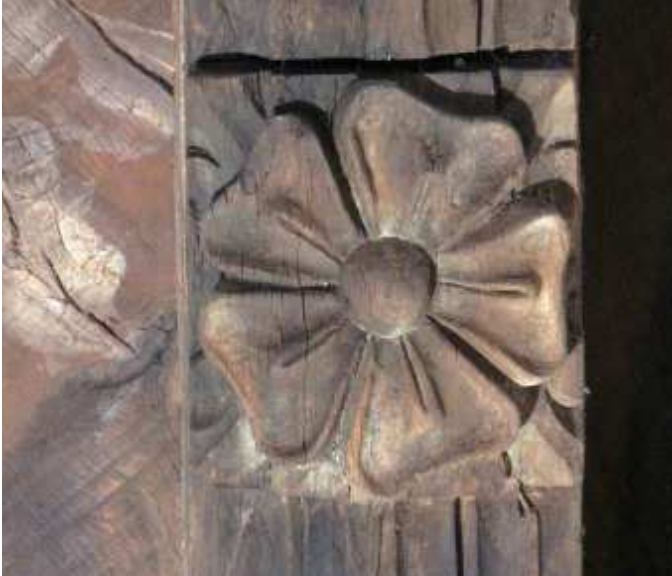
Truss 2: west rose

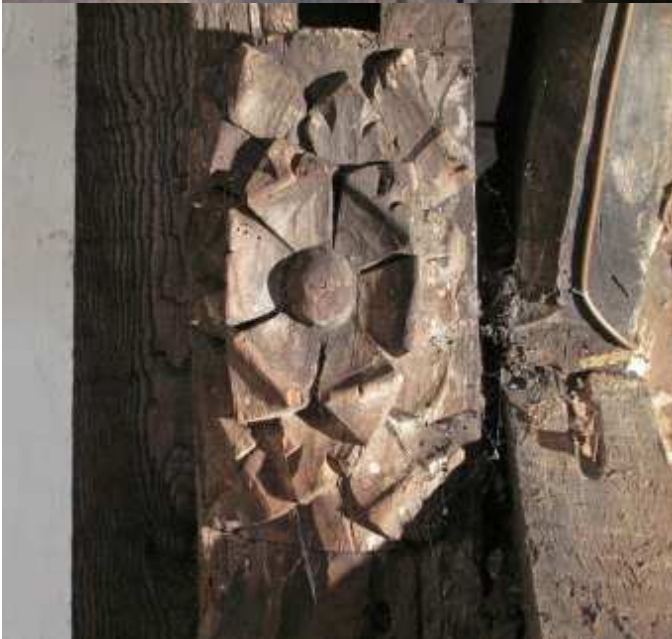
Truss 3: east rose

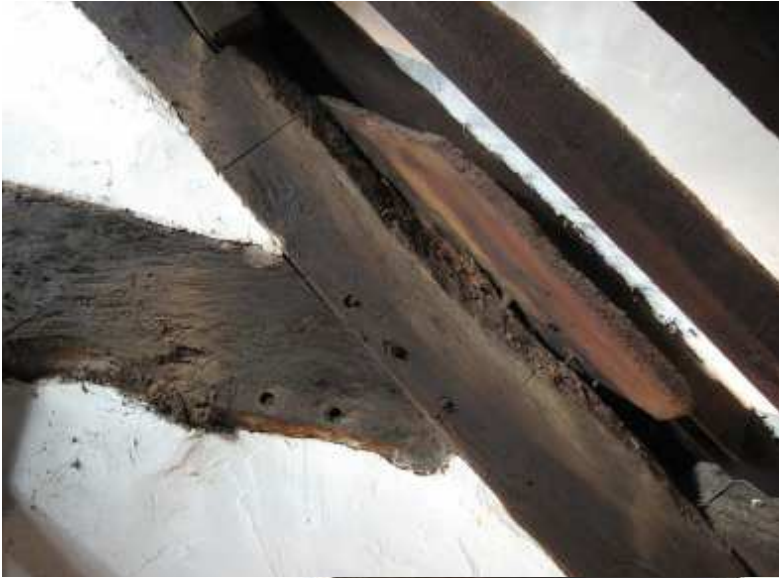
Truss 4: carpenter's marks
on principal

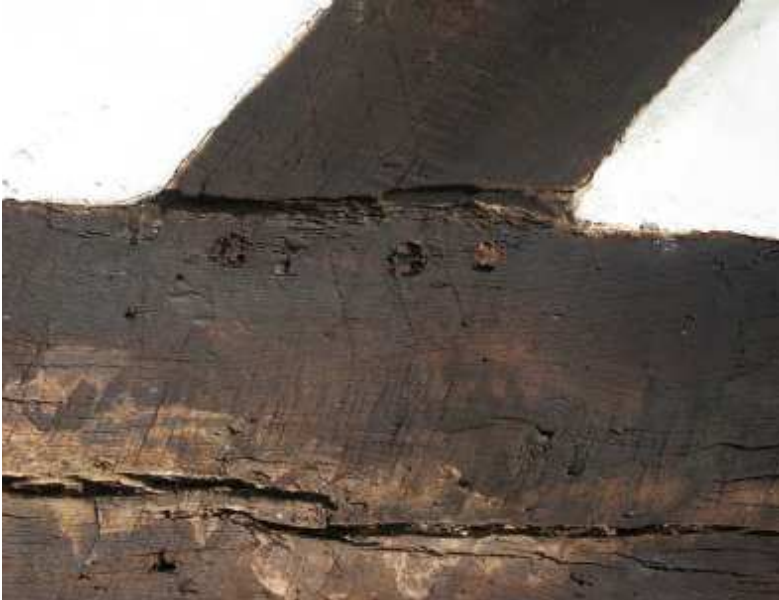
wing truss 4:
carpenter's marks on tie-beam
and strut

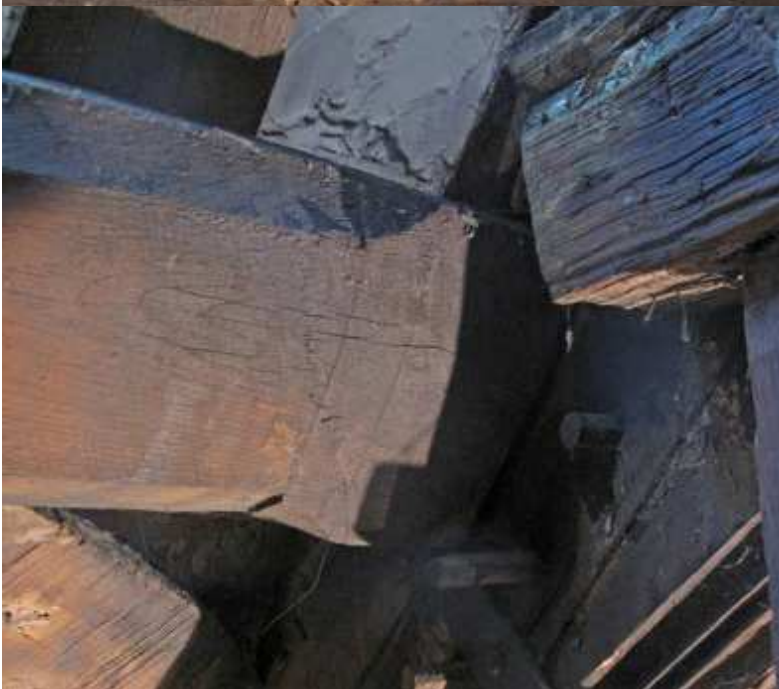
chamfered purlin at truss 3:
carpenter's marks

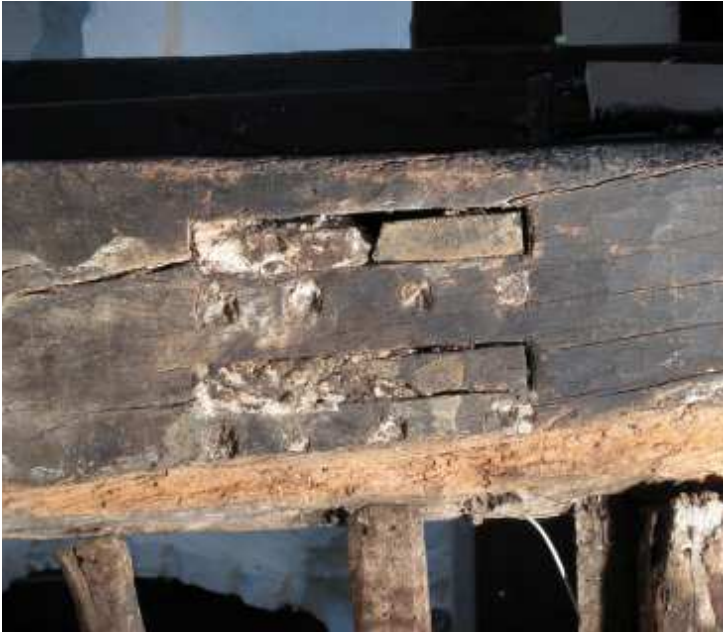
lateral beam at first floor level in the hall; mortices for perpendicular beam on south side.

- There are two massive chamfered beams (309 mm deep, 300 mm wide) which extend laterally and longitudinally across the axes of the hall. The lateral beam extends 5.2 m across the hall. The longitudinal beam extends 3.8 m to the face of the chimney stack at its south east corner. The longitudinal beam is morticed for joists on both sides and pegged with single pegs from the top. The joists (eight on the east side and six on the west

- There are indications that the area to the south of the lateral beam was also floored at the same height. There are residual fragments of floorboard at that level, on the south side. The lateral beam is also morticed on the south side with, apparently, cut-off tenons remaining. Two windows occupy a position high in the wall of the third bay. If a stair existed in the position that the stair occupies now, the window in the west wall would have lit it. However, a window in the east wall, if it were of the early phase, would have been cut across, should the floor remain at that level. Whatever- the level of the first floor of the third bay was reduced, commensurate to that of the adjacent wing to the south.

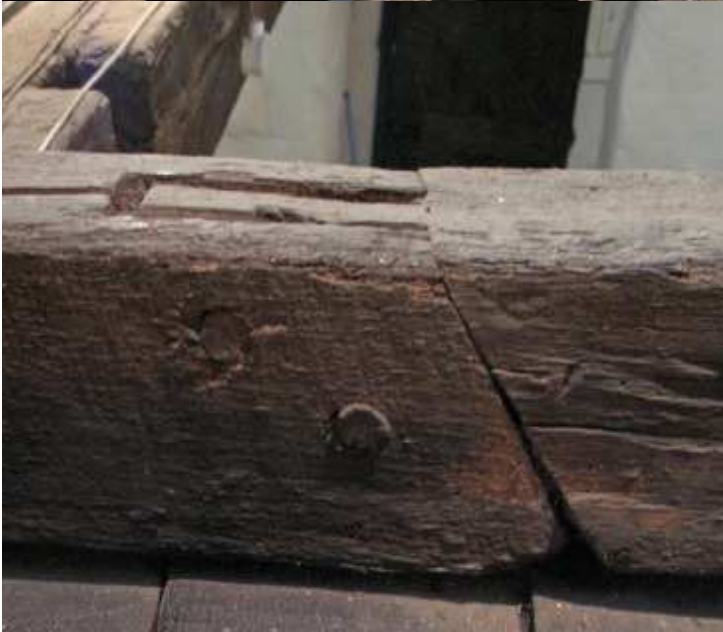
scarf joint in base plate of first floor partition

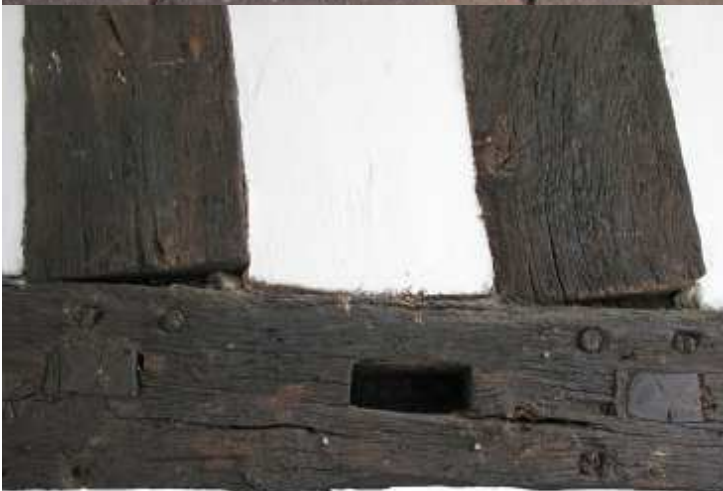
pegged mortice and tenon joints on beam supporting the western first floor room in the south wing; mortices beneath indicate a stud and wattle wall below.
