North West Wales Dendrochronology Project  
DATING OLD WELSH HOUSES

Nº 60 , Castle Street  
Beaumaris  
Anglesey  
C16th town house

*David Longley  
for North West Wales Dendrochronology Project  
Octob 2011*

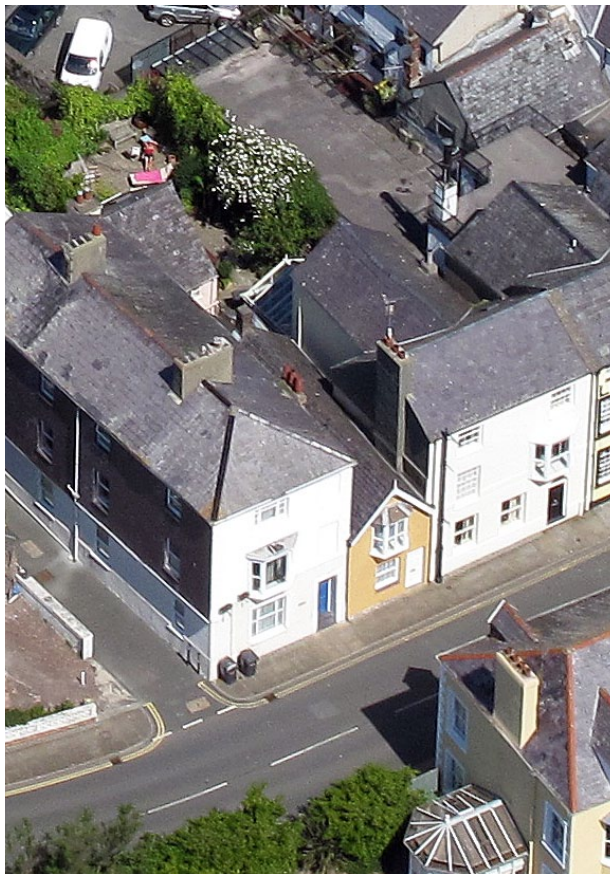
Nº 60 in 2011

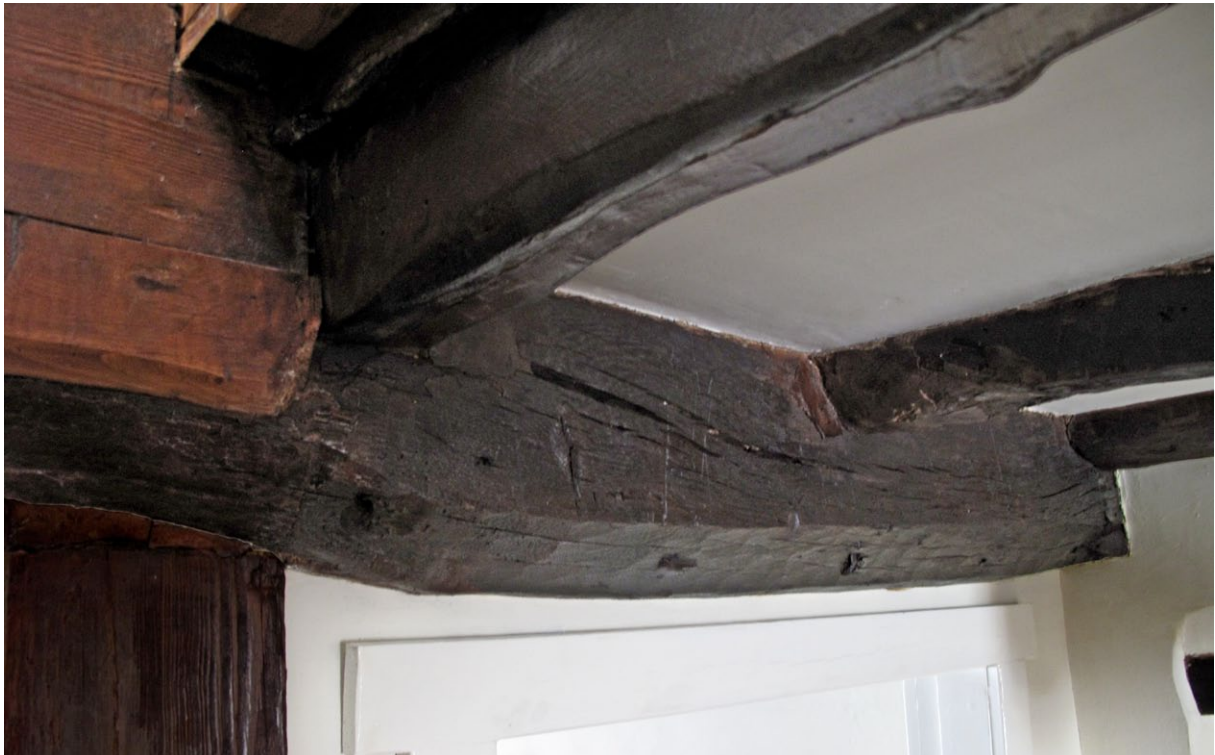
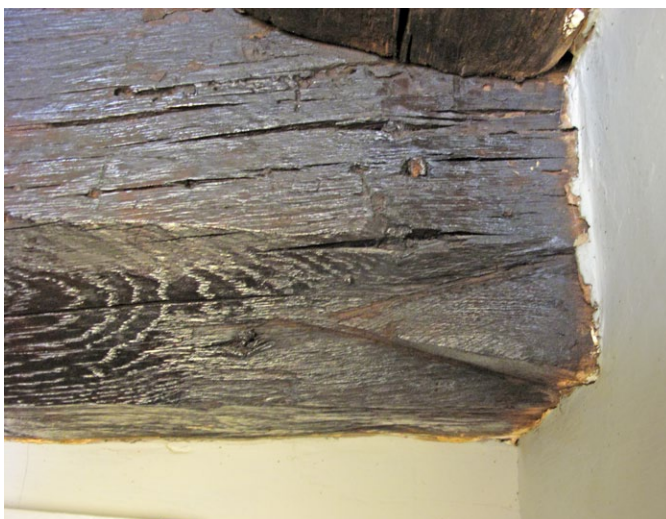
The north, lateral, beam is 280 mm deep and 260 mm wide with broad chamfers either side and a broach stop on the south side. There are dowel holes in the chamfer but much of the length of the beam is obscured by modern panelling.

*Large beam on the north side of the passage with broad chamfer and broach stop at east end*

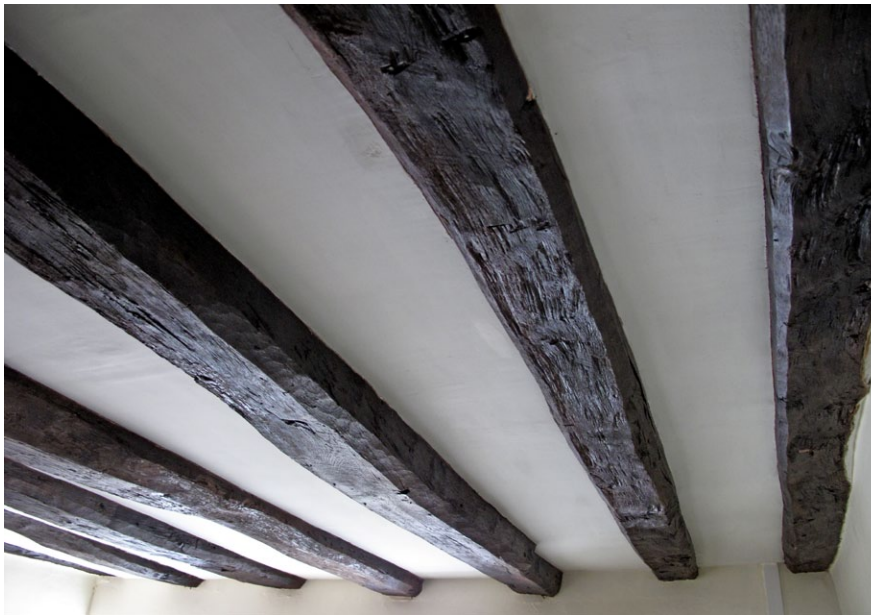
*large joists  
in the kitchen  
supporting  
the first floor  
room above*

The north ground floor room, is square, 3.22 m north-south and west-east. There are window openings and a back door in the north wall. The central opening, however, may have occupied a fireplace, lately removed. There are seven large joists, visible in the kitchen ceiling, which support the first floor above. The joists are 215 mm wide with broad chamfers. The joists project around 80 mm below the present ceiling. There are recesses in the thick of parts of the west wall which may have been openings but are now blocked. There is a blocked door in the east wall.

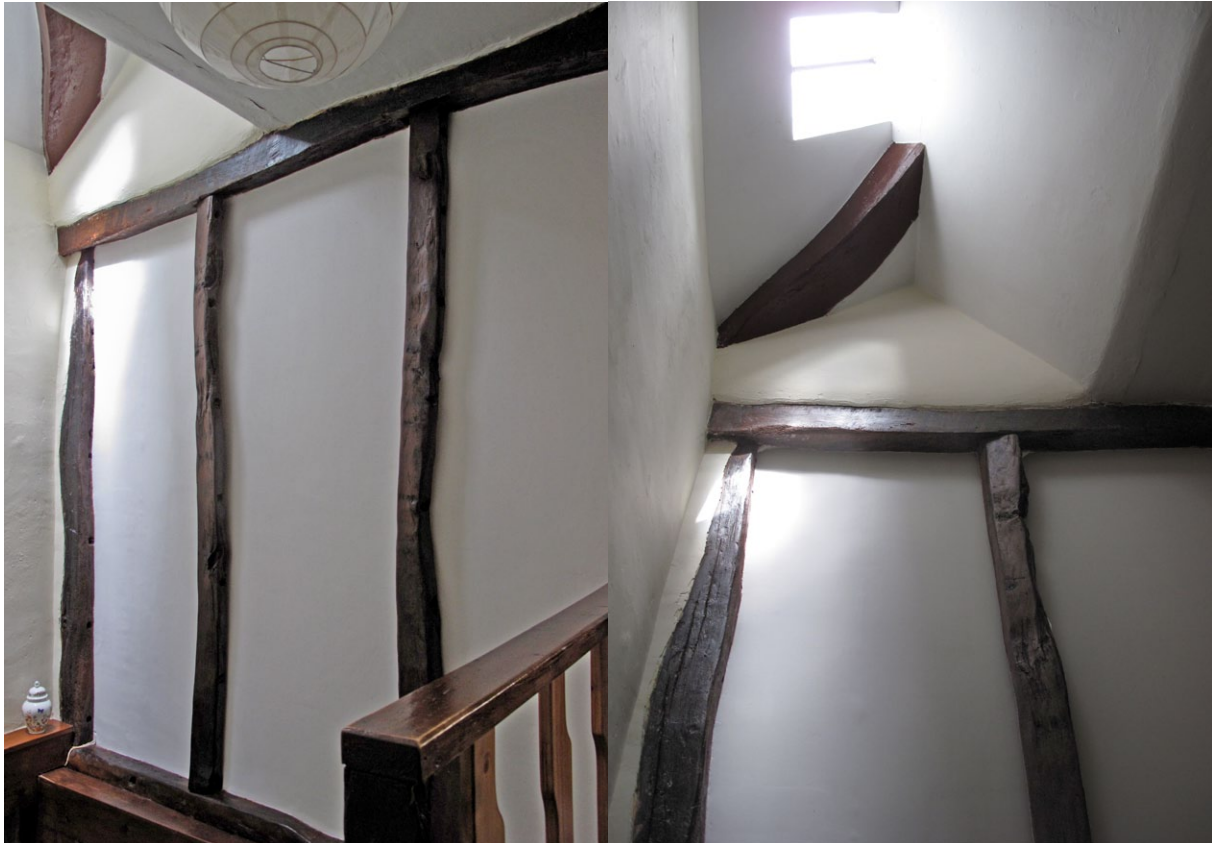
*stud and rail partition with holes for staves, wattle and plaster*

*stud and rail partition with wind brace - attached to second truss, now masked by plaster.*

A modern partition separates the south room with a bathroom adjacent. The passage discussed at ground floor level is carried up to the first floor. The north wall of the passage retains elements of a tall stud panel with dowel holes for horizontal staves and infilled with wattle and plaster and top and bottom rails. The early components are fixed to a modern stud wall.

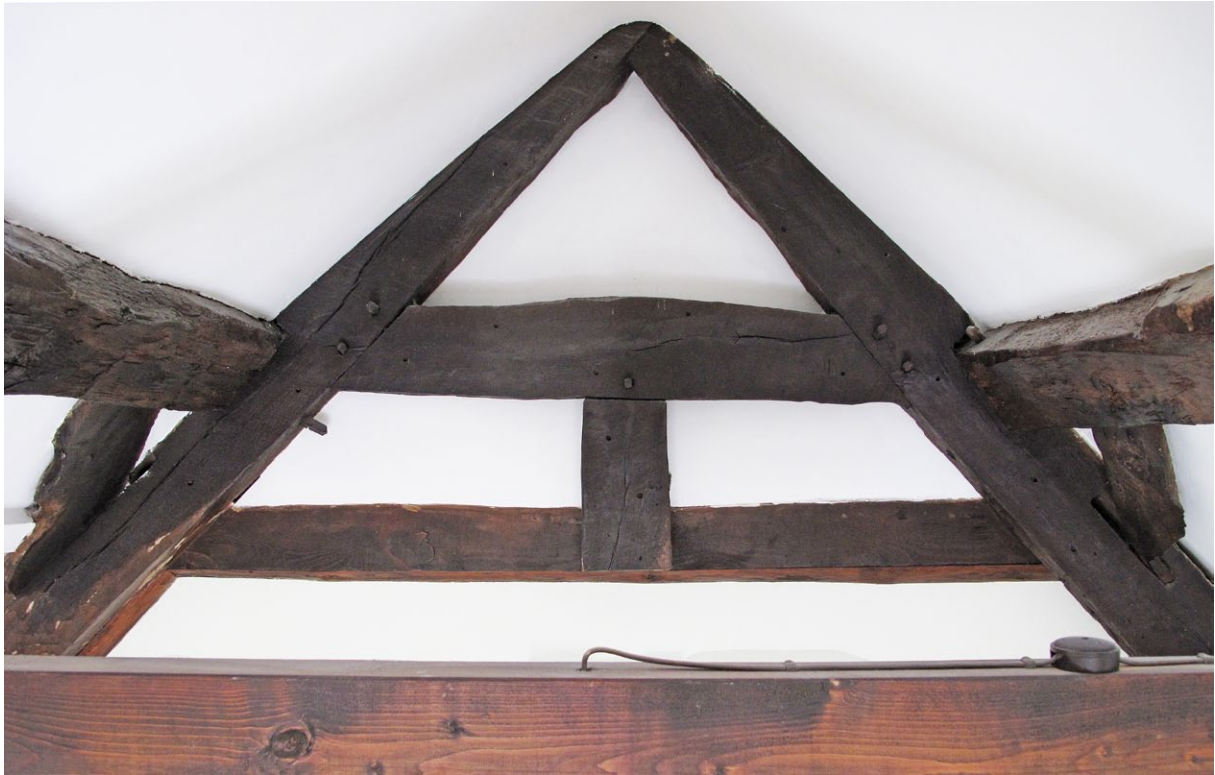
Collar-beam truss against the north wall of the south upper room. The near, square beam is modern and nothing to do with the truss. The lower of the two collars is a secondary feature, fixed behind the principals. A tie-beam has been cut away and the crown post, down from the original collar, has been truncated

The most conspicuous feature on the upper floor, south room, is a collar-beam truss which once rested on a now truncated tie-beam and a crown-post, itself truncated, which once linked the crown-post and the tie-beam. There is now, a makeshift beam or secondary collar fixed to the back of the principals and the truncated crown-post. On the assumption that the modern bathroom had foreshortened the south room there might have been some logic in having removed the tie-beam of the truss to provide additional headroom.

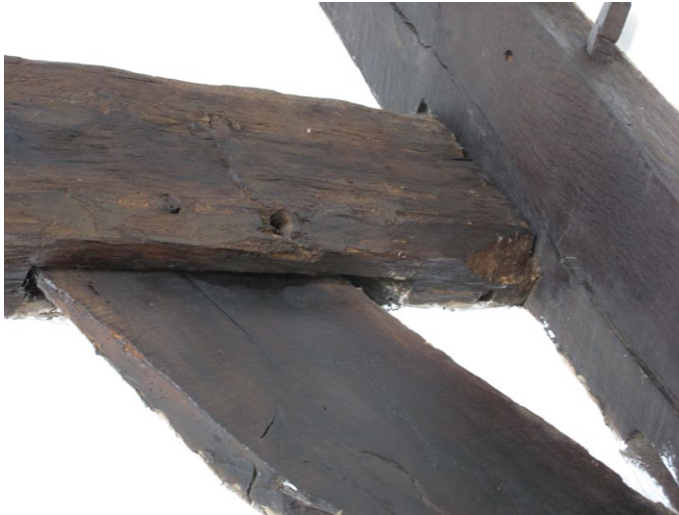
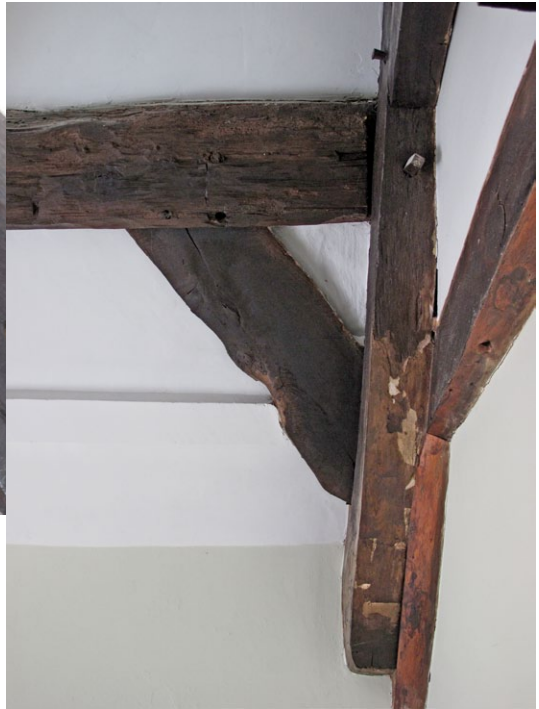
*Collar-beam truss, principal,  
purlin and wind brace joints*

*Hypothetical reconstruction  
of door on first floor, tenoned  
and pegged into mortice on  
wall-post*

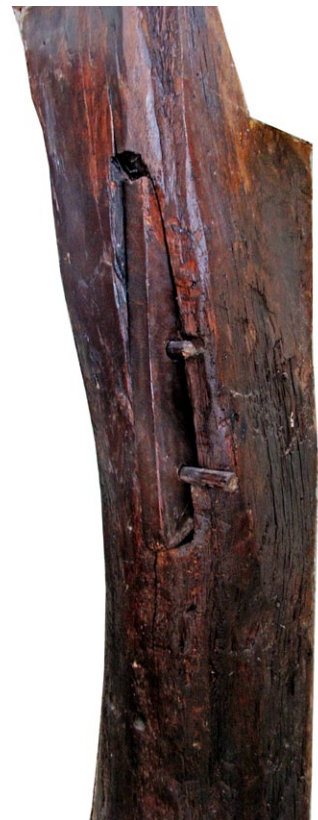
*wall-post with mortice,  
tenoned and pegged joint*

The mortice, tenon and pegged joint on the south-east wall-post below the tie-beam might indicate the presence of a door on the first floor. The style of the doors in this reconstruction is hypothetical but the position of the doors is likely to be correct.
