Plas Glasgwm, Penmachno, Conwy

**EAS Client Report 2012/13
December 2012**

**North West Wales Dendrochronology Project
Plas Glasgwm, Penmachno, Conwy
NPRN 16743**

Survey Report

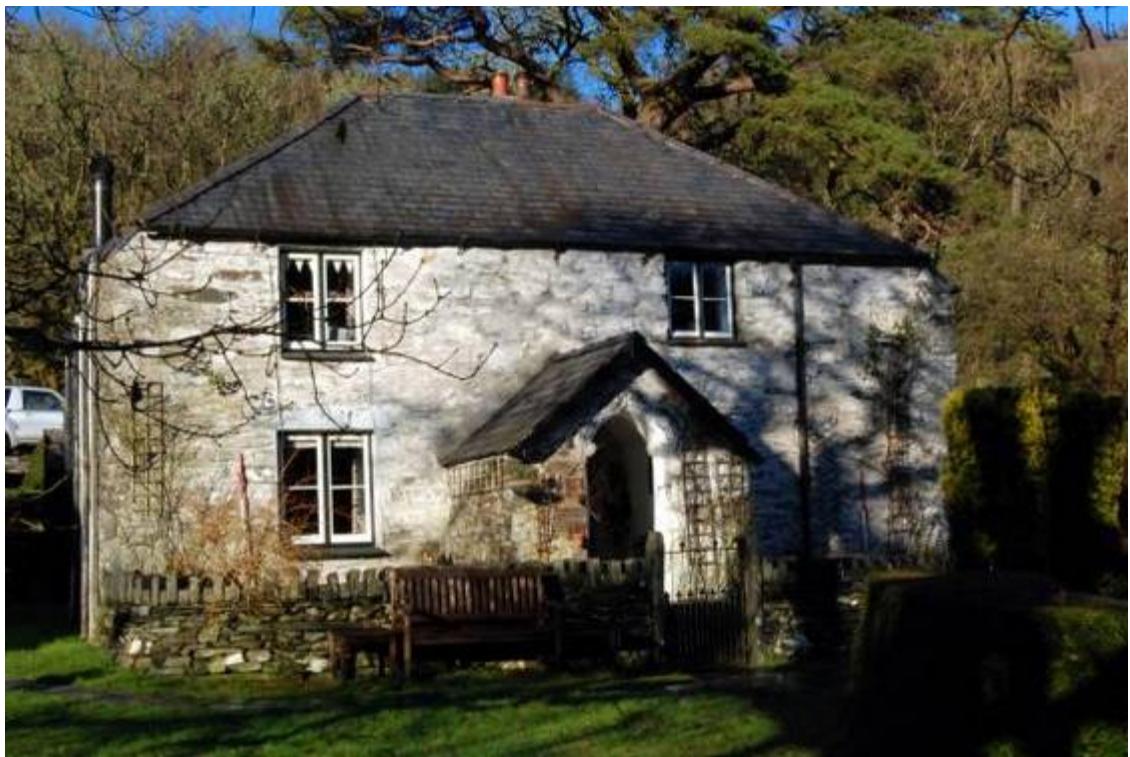
Plate 1: Front elevation

The main ranges form an “L” shaped plan, however, a range of ancillary rooms have been added to largely fill the space between the main ranges (Figure 3). The front range runs at right angles to the natural slope of the river valley. It is a two story building with a hipped roof and a centrally placed stone porch (Plate 1). The roof is covered in slates and has ceramic ridge tiles and “V” shaped hip tiles. Faced with, largely coursed, large stone blocks, with no quoins, this elevation forms a consistent, symmetrical façade with a central porch and four windows. The porch has a two centred pointed arch opening supported on crude cushion

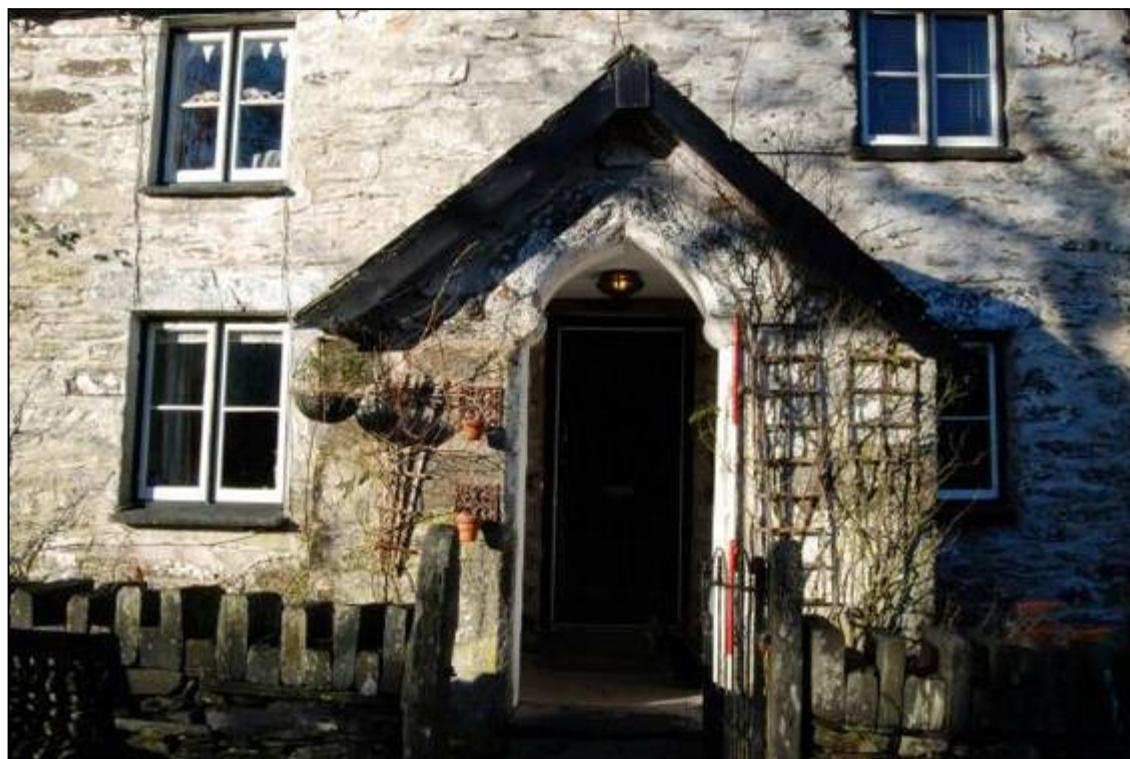
Plate 2: Porch

shaped capitals (Plate 2), although there are no columns with the capitals forming the top of the reveal. The four windows in the front elevation are regularly placed, each with a four pain casement windows under stone lintels.

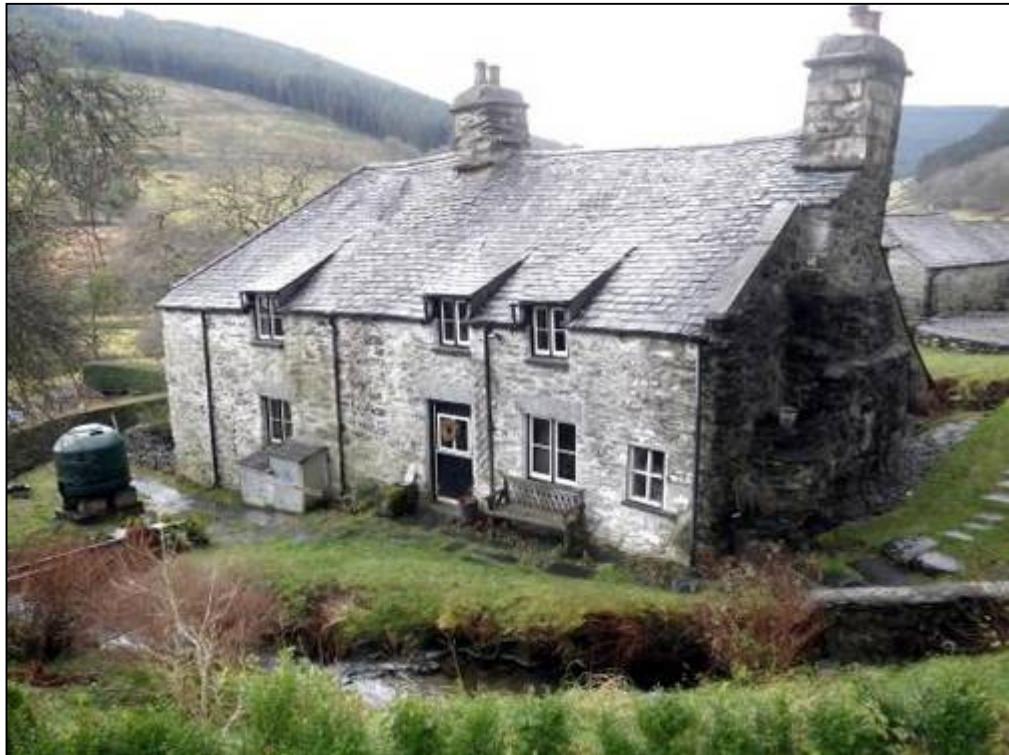
Plate 3: The eastern elevation

The second range runs parallel with the hill slope alongside a leat. It is a storey and a half high with a gabled roof and a stepped gable end chimney (Plate 3). The roof is slated with partial, stone gable parapet running along the northern gable end. The ridge tiles are "V" shaped and ceramic. There is a marked difference between the slates used on the front range and those on the rest of the building with much finer slates being used on the front range. Built of random stonework, using smaller stones, this range is clearly of a different phase from the front elevation. The eastern elevation has three first floor windows under single, low pitch dormers and three, four pane casement, windows on the ground floor. These have stone lintels, although the windows themselves are modern replacements. There is a single doorway placed behind the central chimney stack (Plate 4), however there is also a blocked opening towards the southern end of the eastern elevation (Plate 5) and the northern ground floor window appears to have been placed within a partially blocked opening (Plate 6). There is a marked change in the stonework to the south of the doorway. This corresponds with the central chimney, possibly suggesting that the chimney has been inserted into a previously existing range.

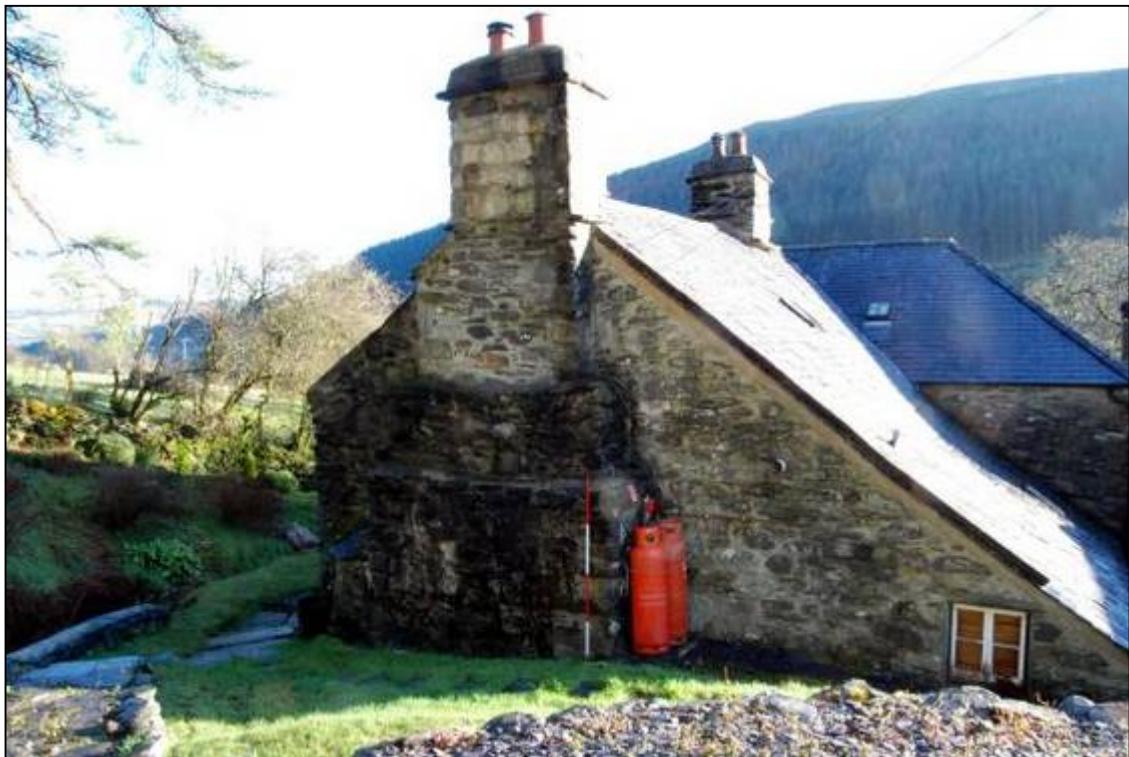
Plate 7: Northern gable end

The northern gable end is dominated by the gable end chimney (Plate 7). This has a stepped stack and incorporated a bulge for an oven on its eastern side. The stack leans noticeably towards the north (Plate 8), particularly in the section that project above the level of the roof.

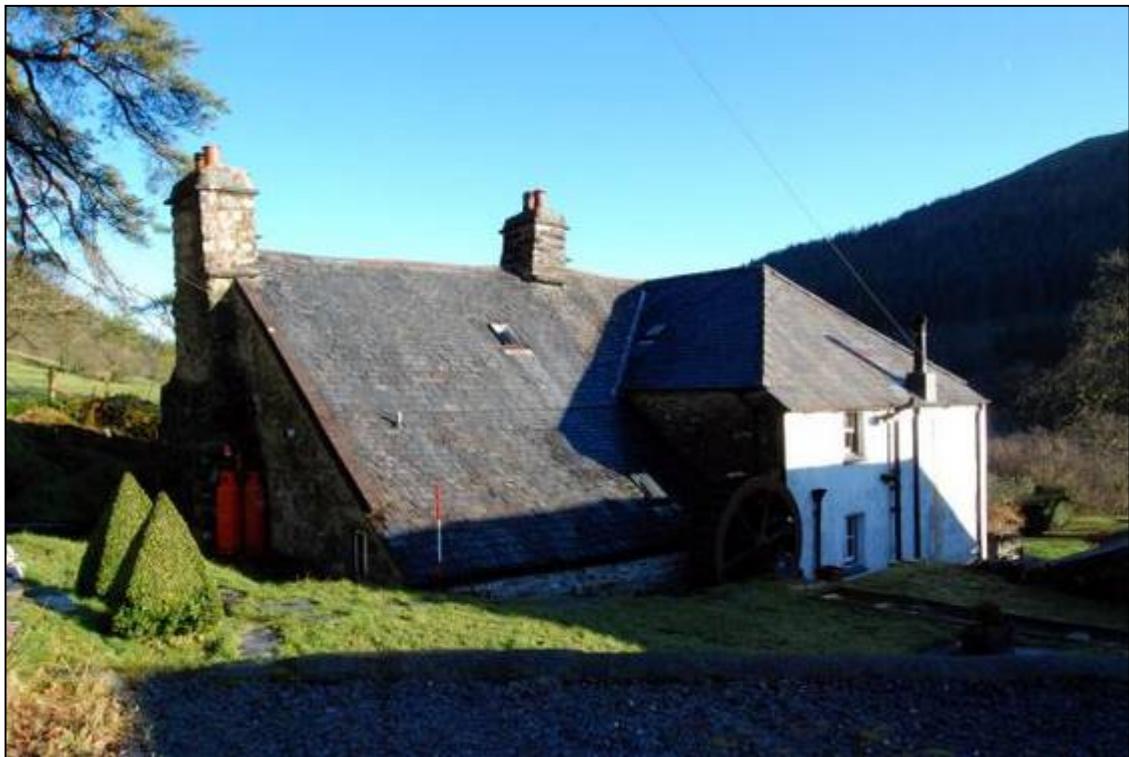
Plate 9: The western elevation

Between the two legs of the "L" shaped house is a single storey, ancillary range (Plate 9). This is under a continuation of roof of the main north-south range and contains what was probably the dairy in the nineteenth century. There is water tabling both on the chimney stacks and on the northern wall of the east west aligned range (Plate 10) giving protection to the flashing between the roof and these features. The western elevation of the east-west aligned range has been rendered (Plate 11). This range has a slight gablet to the roof line along this western elevation and there is short chimney with a tall stove pipe on the gable end wall. It is noticeable that the only windows in this elevation are in the northern section, consisting of two windows, one above the other.

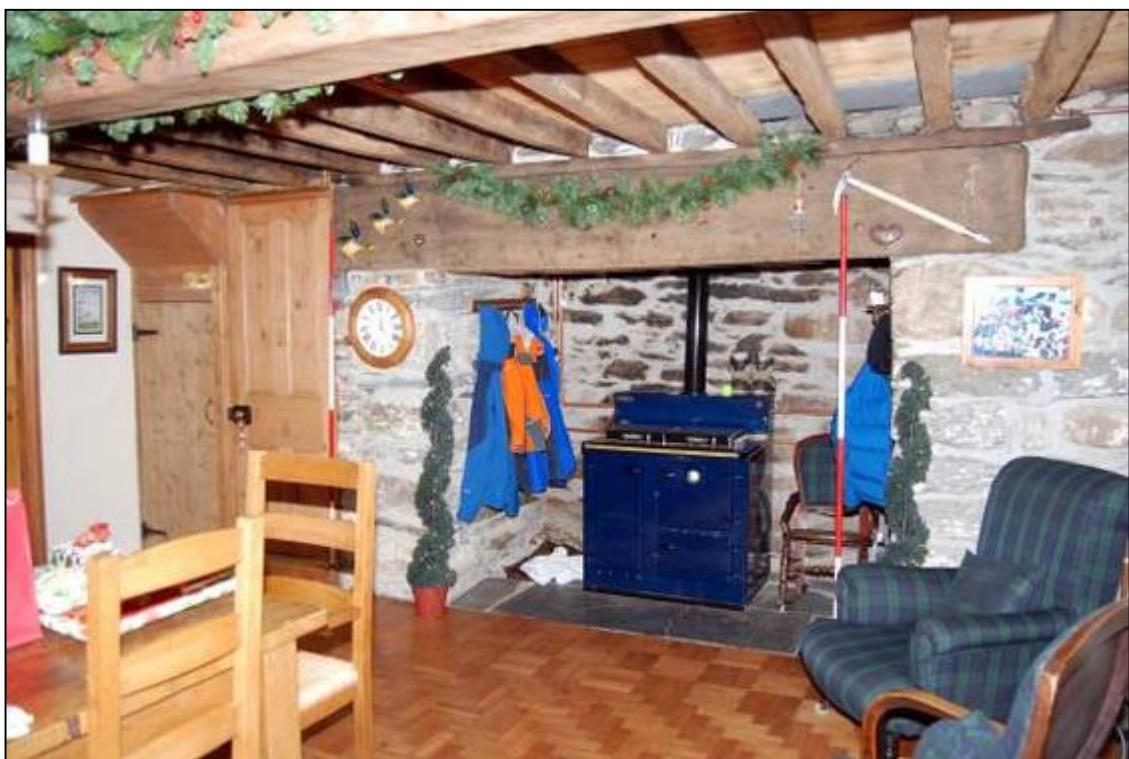
Plate 12: The bressumer in the “best kitchen”

The front door opens onto the south western corner of the "best kitchen" This room is dominated by the large fireplace (Plate 12) along the northern wall. This

has a wooden bressumer. The ceiling is supported by a transverse beam into which the joists are joined with barefaced soffit tenons (Plate 13). The joists are chamfered and have run out stops. The ceiling beam has an area cut out of its western end (Plate 14). This is reported to have been the previous position of a dresser which was too tall for the space so the ceiling beam was modified to accommodate the furniture (T. Dixon *pers. comm.*). The floor above this room has been levelled on the southern side with the ends of the joists lifted out of their sockets to rest on the top of wall beam (Plate 15).

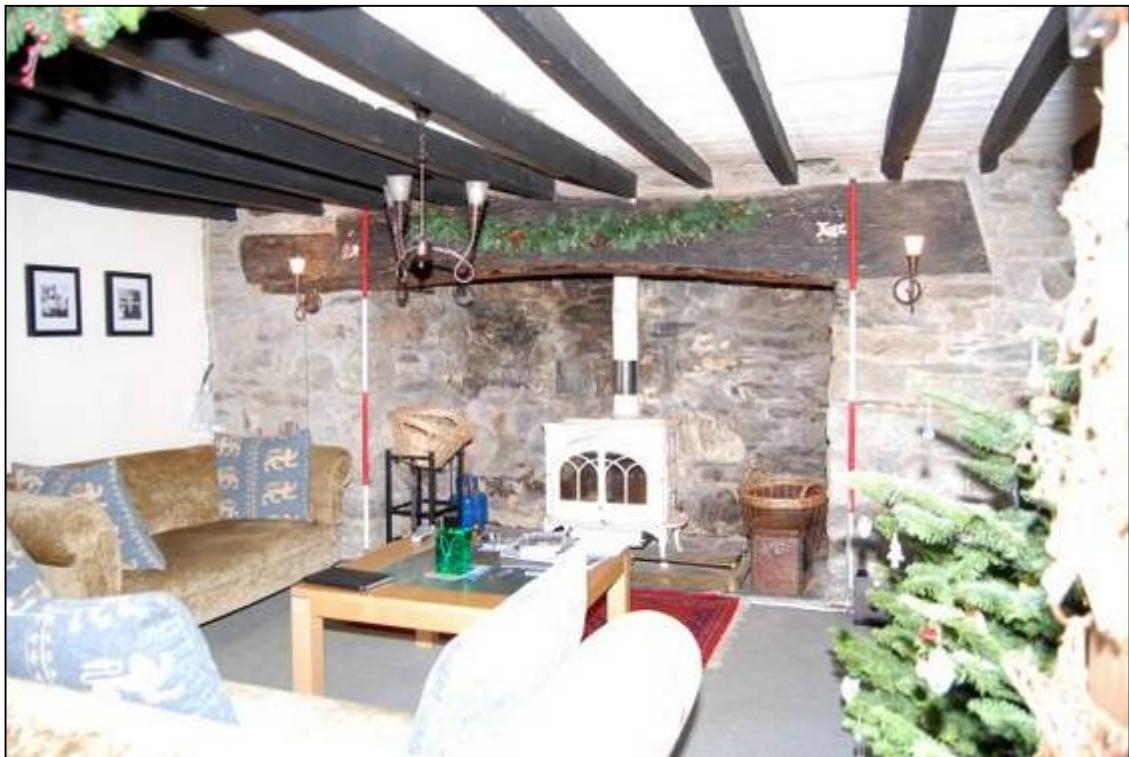
Plate 19: Fireplace in the “rear kitchen”

The “rear kitchen” occupies the whole of the ground floor of the northern range. It is dominated by a fireplace on the northern wall with a large wooden bressumer (Plate 19). Within the eastern wall of the hearth is a circular oven (Plate 20) which is lined with bricks and would appear to a secondary feature within the hearth. The ceiling has a transverse beam which is rather worn so that it is difficult to determine whether it was originally chamfered or was a rough round timber (Plate 21). Into the top of this are a series of cogged joists. The majority of these have been replaced, although the few surviving joists suggest that they were chamfered and had straight stops. A door in the western wall gives access to the ancillary range. This has a wooden lintel with a mortice suggesting the re-use of a timber for this lintel (Plate 22). There is also a modern staircase along the southern wall of the “rear kitchen” which gives access to the bedroom above.

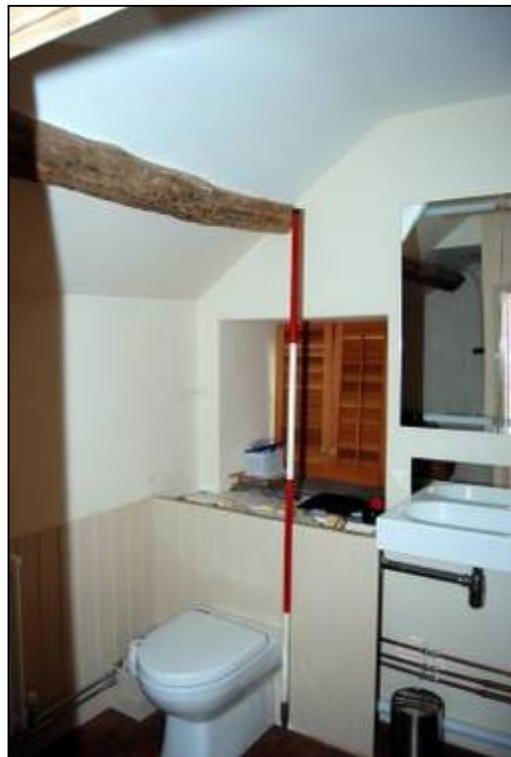
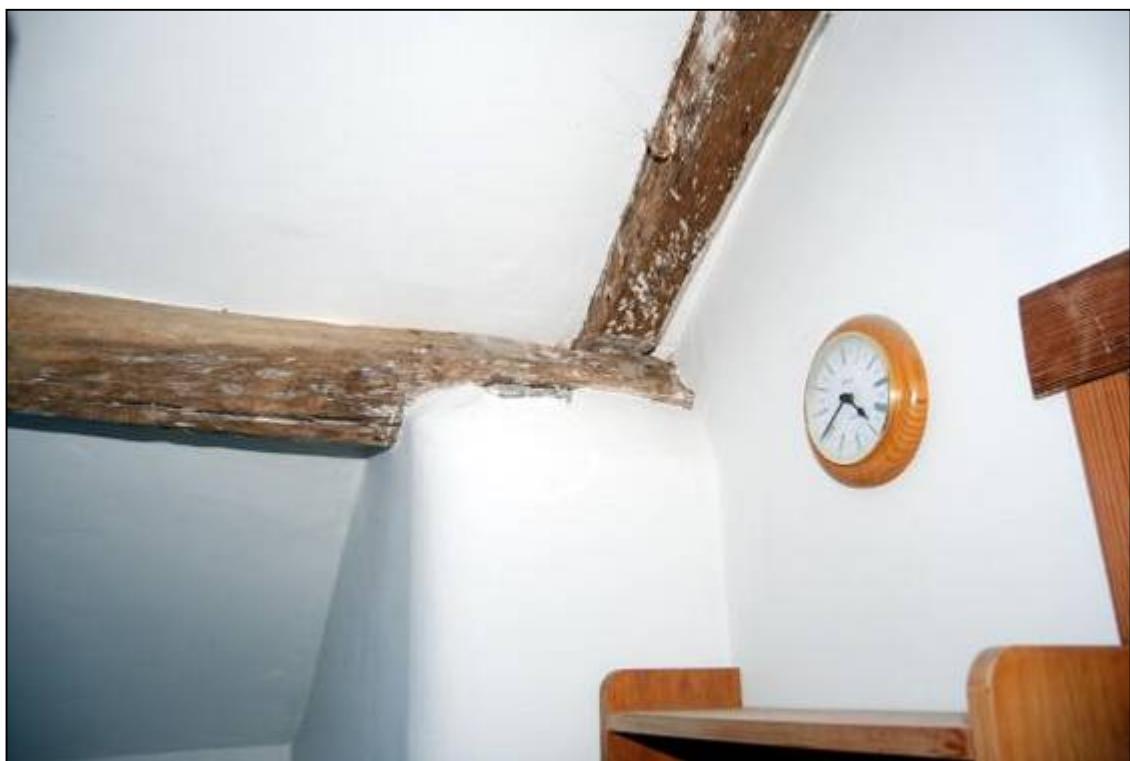
Plate 23: Exposed purlin in the ancillary range

The ancillary range includes two rooms assumed to have been a dairy. Little of the structure of this range is visible except for a purlin which is exposed in both rooms (Plates 23 and 24).

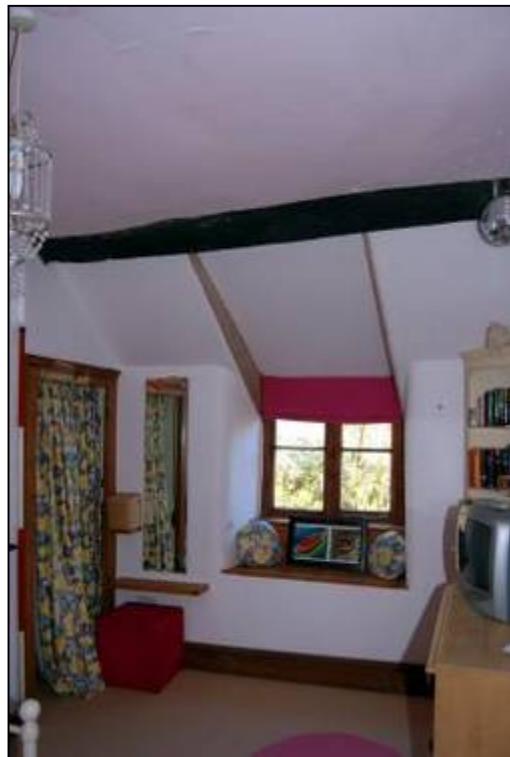
Plate 25: Exposed purlin in the north eastern bedroom of the southern range

On the first floor, four rooms occupy the southern range, all opening off a central landing. These contain few features except for an exposed purlin in the bedroom in the north western corner (Plate 25) and wooden lintel to the window in the bathroom (Plate 26). The bedroom above the northern range, however, has an exposed truss (Figure 6.2, Plate 27). This is a relatively lightweight structure with a simple, low collar which would appear to be a later replacement. The purlins, however, are more substantial timbers which may be from an earlier roof. Indeed the lower western purlin is heavily warped towards its southern end (Plate 28). There is also a blocked fireplace with a slate lintel in the northern wall of this room (Plate 29).

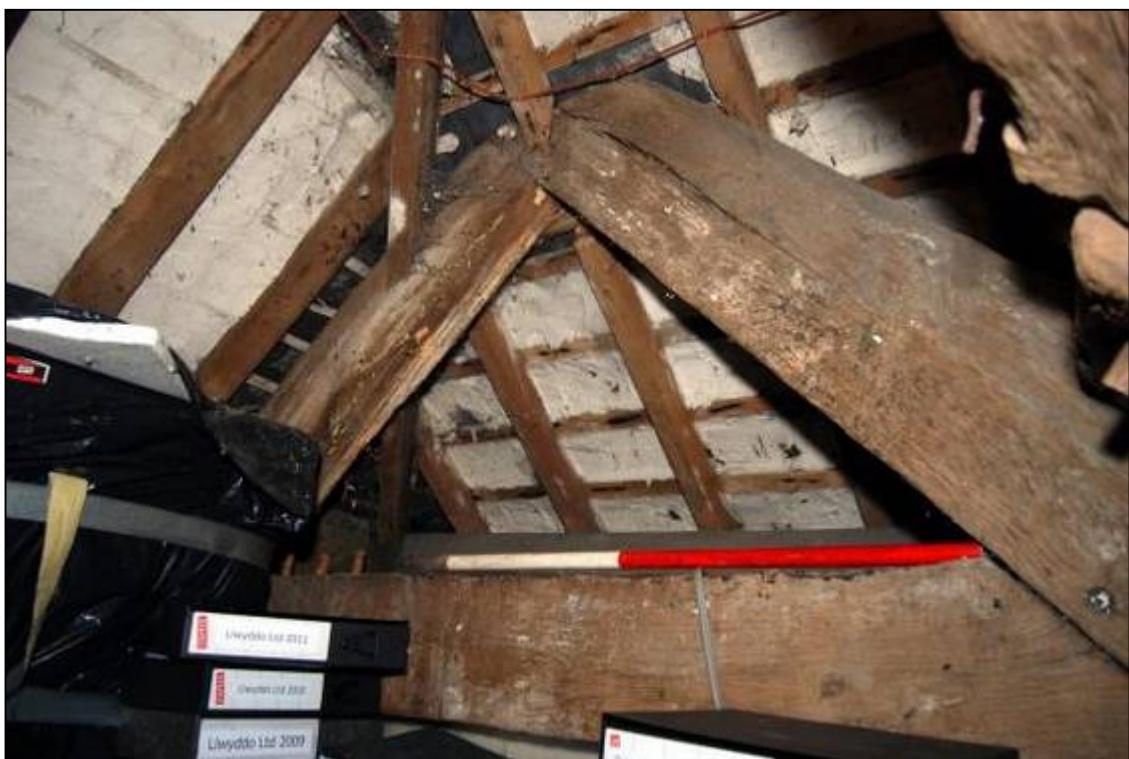
Plate 30: The truss above the southern range

In the attic above the southern range is a second truss (Figure 6.1, Plate 30). This has a simple straight collar and trenched purlins. It is constructed of

significantly more robust timbers than the truss in the northern range; however, it is aligned parallel with the southern range rather than spanning it. It is therefore possible that this truss relates to an early phase of the building prior to the construction of the southern range and the central chimney. It was not possible to explore the attic in detail, however, both of the purlins on the western side of the truss have scarf joints (Plates 31 and 32) fairly close to the truss possibly suggesting that these timbers originally ran further to the south and have been truncated with the construction of the hipped roof over the southern range.
