North West Wales Dendrochronology Project Plas Tirion, Llanwrst, Conwy

**EAS Client Report 2012/10
November 2012**

EAS Client Report 2012/10

**By
I.P. Brooks**

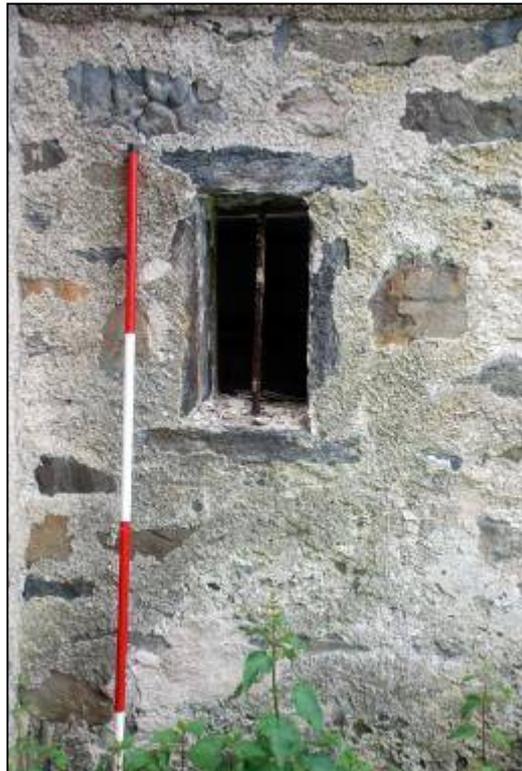
Plate 2: Window in the northern face of the southern range

Although the drive now approaches from the south Plas Tirion faces WSW, with a rough "F" shaped plan consisting of two ranges set at right angles and a three storey porch on the front elevation. To the rear there is a further projection to incorporate the stairs. The front elevation (Plate 1) consists of three main elements, the southern range, the main range and the double storeyed porch. At the time of the original survey the upper storey was partly rendered with a cement based render, however, since the survey this has been removed and the whole of the house has been lime washed. The southern range projects from the front elevation and is constructed of roughly coursed stonework with no evidence for the use of quoins. Whilst the windows on the western gable end of this range are multi-paned windows with slate lintels, which are later insertions, a small window on the ground floor of the northern face (Plate 2) may be original. This window has a slate lintel and cill together with an iron bar dividing the opening. Above this window, although

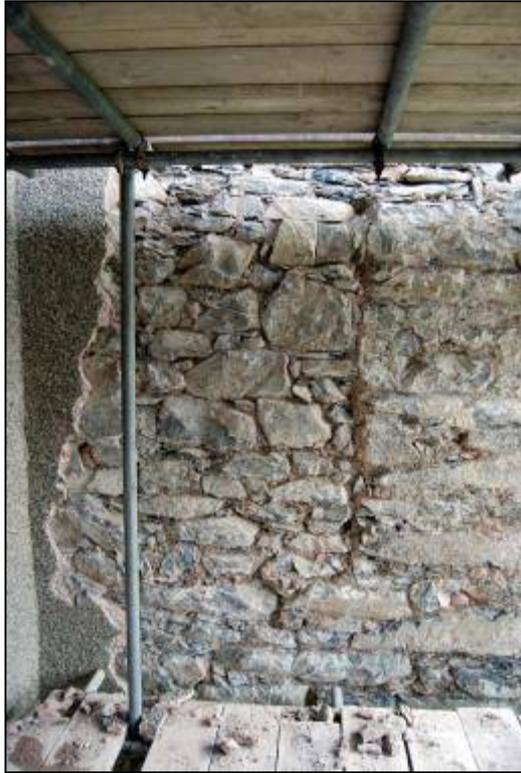
Plate 3: Blocked doorway in the northern elevation of the southern range

not evident before the render was removed, was a blocked doorway (Plate 3). The position of this door is curious; it is at first floor level with no obvious related features. It is not certain as to whether this was an external door, possibly accessed by a wooden stair flight, or if this door gave access to a range which is now lost. There are two ridge chimneys on the main range, both of which have tall square stacks. They are positioned on the northern gable end of the main range and over the join between the southern range and the main range.

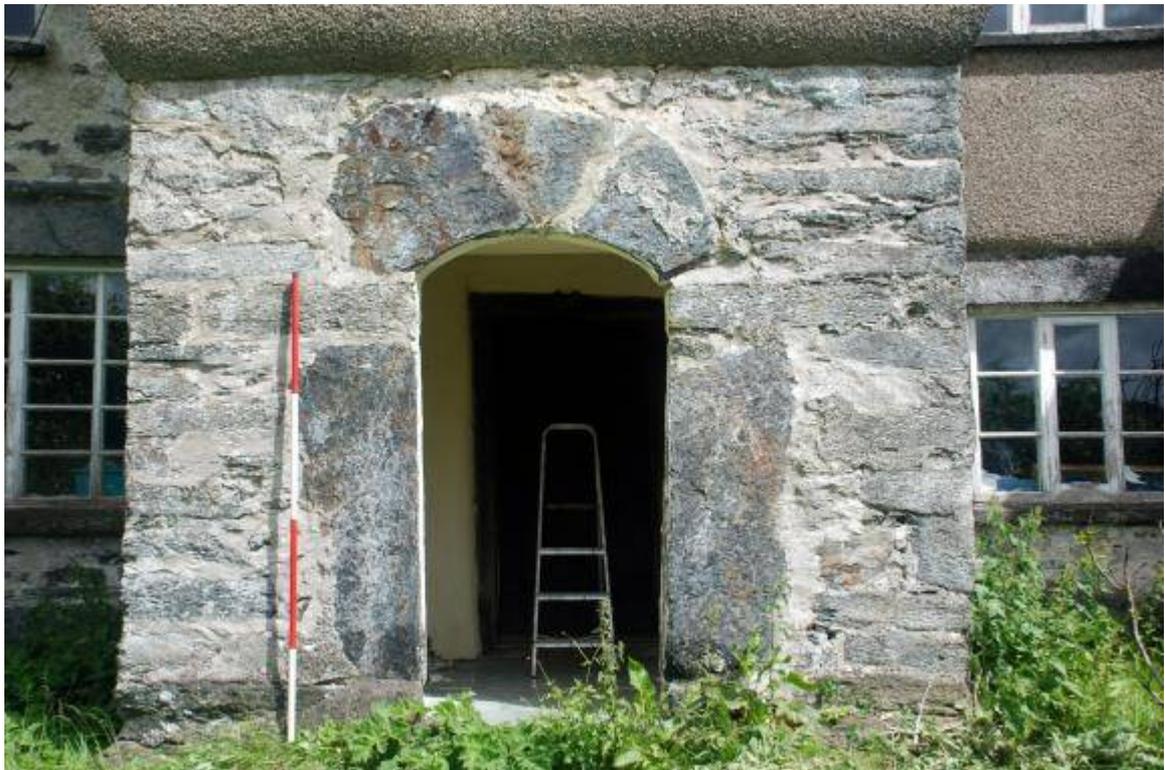
Plate 4: The porch

The porch is a three storey extension to the main range. It has a cyclopean door head with large stone jambs (Plate 4) defining an open porch. The windows on the first and attic floor levels are later insertions as is shown by the brick packing which was revealed when the render was removed.

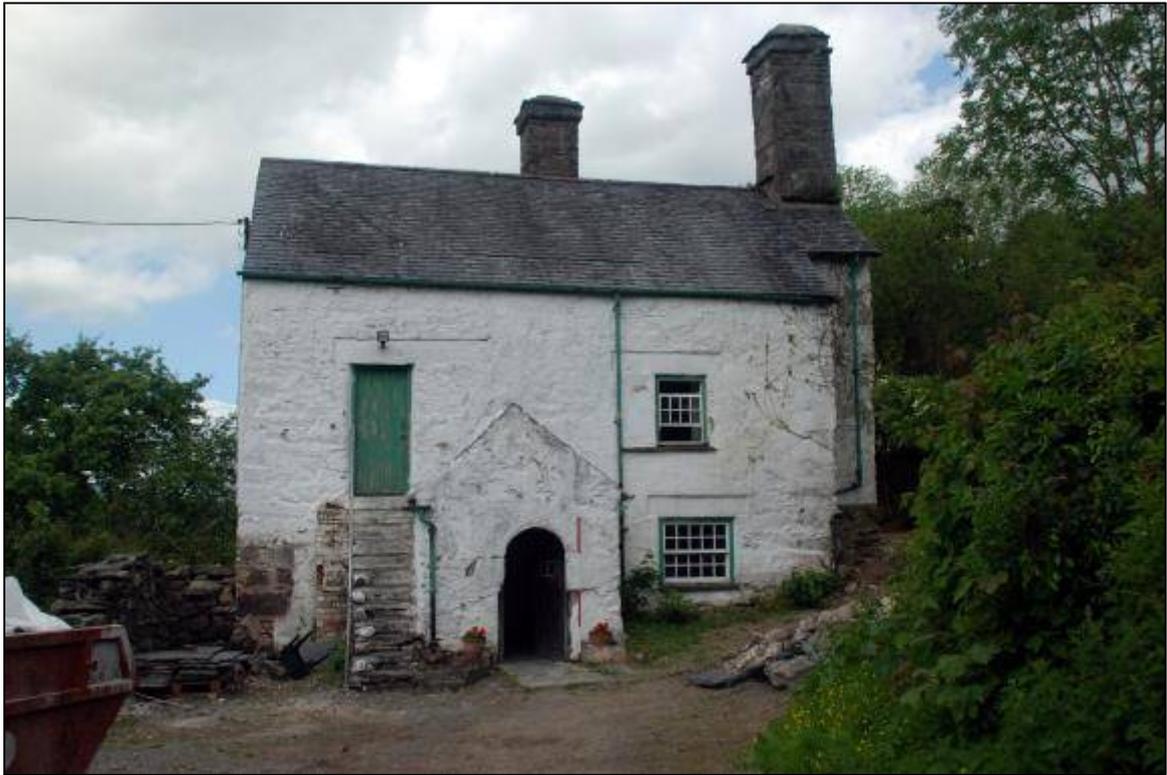
Plate 5: The southern elevation

The southern elevation (Plate 5) was not rendered, revealing the poorly coursed stonework of its construction. There is a stone staircase attached towards the western end which gives access to the first floor level of the building. Partly built over these stairs is a single storied porch (Plates 6 and 7). Although this is limewashed, it would appear that there is a stone cyclopean, arch to the opening and large stone jambs. It has a gabled roof covered in, thick, moss slates (Plate 8), some of which show signs of having been re-used with nail holes on their distal ends.

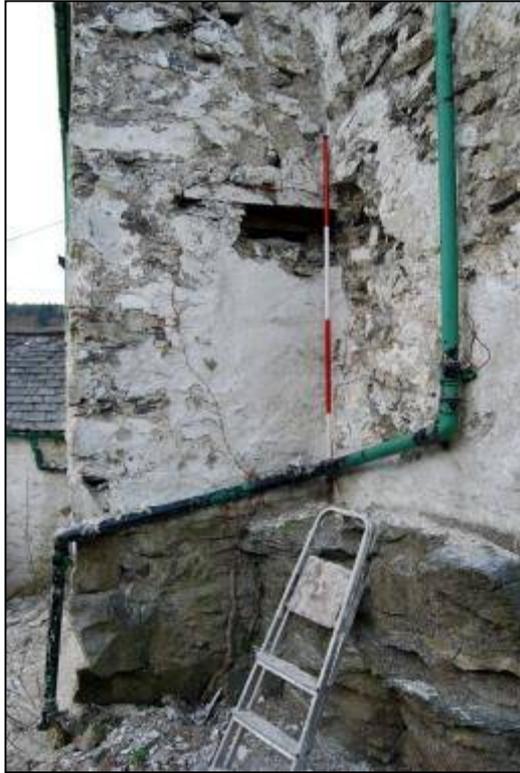
Plate 9: Blocked window in eastern gable end of the southern range

The eastern gable wall of the southern range has a blocked opening, apparently a window (Plate 9), which is partly blocked by the construction of the later chimney on this end of the building. During the course of the restoration part of the blocking was removed, revealing a wooden frame, still *in situ*, with ovolo mouldings (Plate 10). The position of this window is curious, as occupies a space between the floors. It is possible that this opening relate to either a lost stair case or a possible wardrobe. There is no evidence on the inside of the building of this window, however, the later construction of the chimney on this end of the building has obscured or destroyed any internal evidence. The chimney has a straight joint between its structure and the gable end of the southern range. It also has a tall square stack

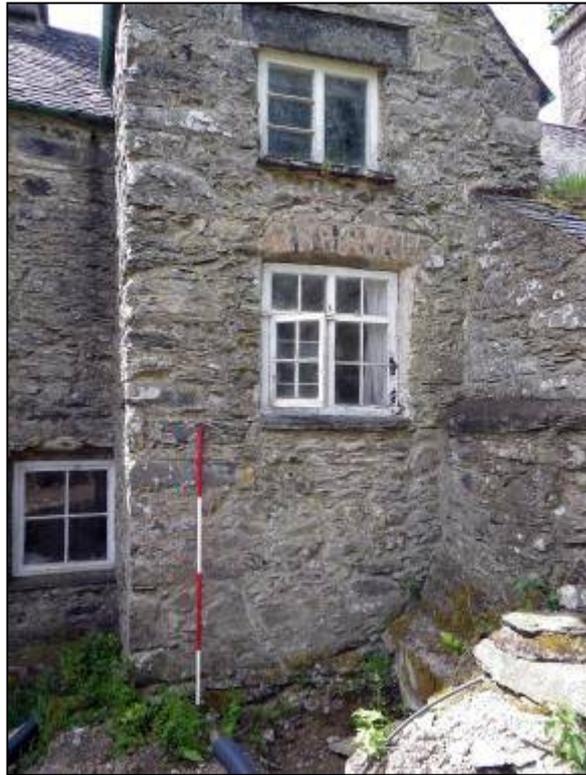
Plate 11: The stair tower

The three storey, stair tower on the rear elevation (Plate 11) is clearly a later addition to the main range as there is a straight joint in the masonry between the two structures. Externally the stair tower is constructed of random stonework with larger stone blocks used as quoins. There are two window openings in the eastern gable end, the lower of which has a segmental brick arch, whilst the upper window has a slate lintel. The lower window would appear to be a later insertion and there is a hint in the stonework that this opening may have been much taller. Attached to the northern end of the stair tower is a two storey extension, the lower floor of which appears to have been a service room; whilst above there is a bathroom. This range has straight joints between it and both the stair tower and the main range of the house demonstrating that it is a relatively late in the development of the house. The relationship between the extension and the main range is rather uncomfortable, with the northern wall of the extension joining the main range immediately adjacent to the windows (Plate 12). These windows are multi paned with ovolo moulded mullions and slate lintels.

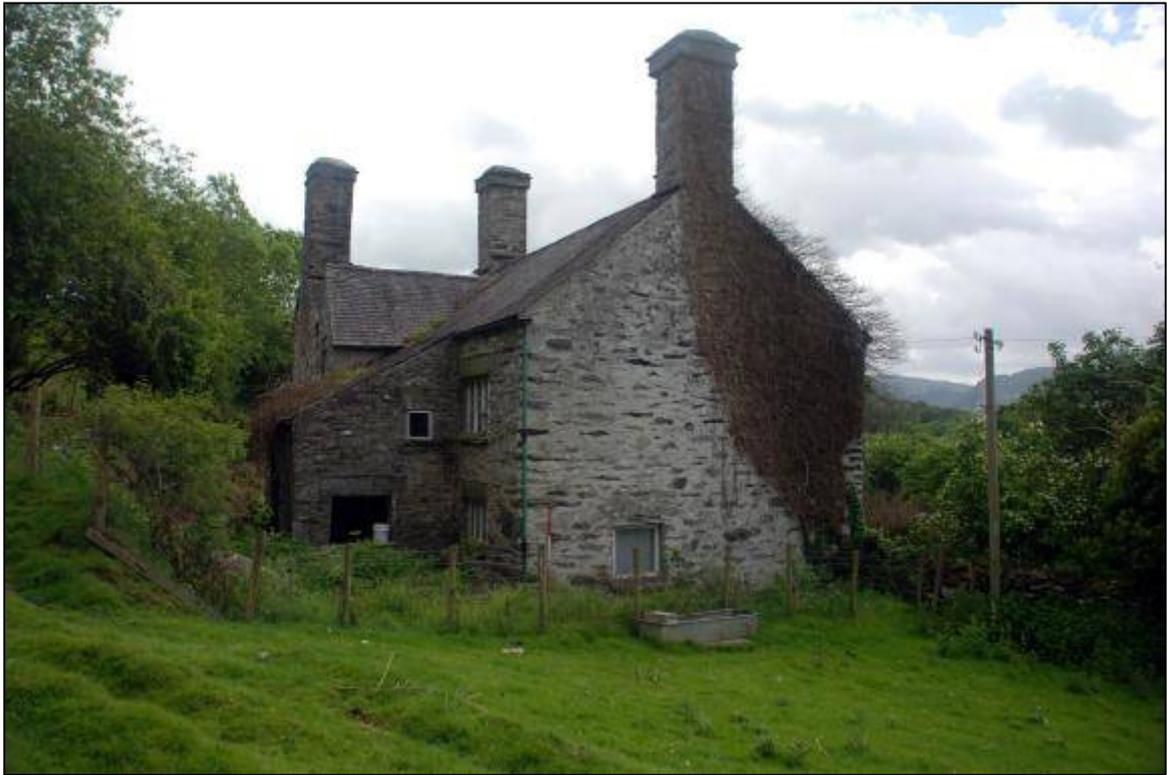
Plate 13: The northern gable end

The northern gable end of the main range (Plate 13) has a single opening on the ground floor. This is a window; however, there is a scar below the window suggesting this opening may have been a doorway. This opening led to the theory that there may have been a northern wing to the house to complete a "E" shaped plan (Hubbard 2003, 238). A recent geophysical survey and watching brief, however, has shown that even if this range was planned it was never built (Brooks 2011). There is also a gable end chimney on this end of the main range with a tall square stack.

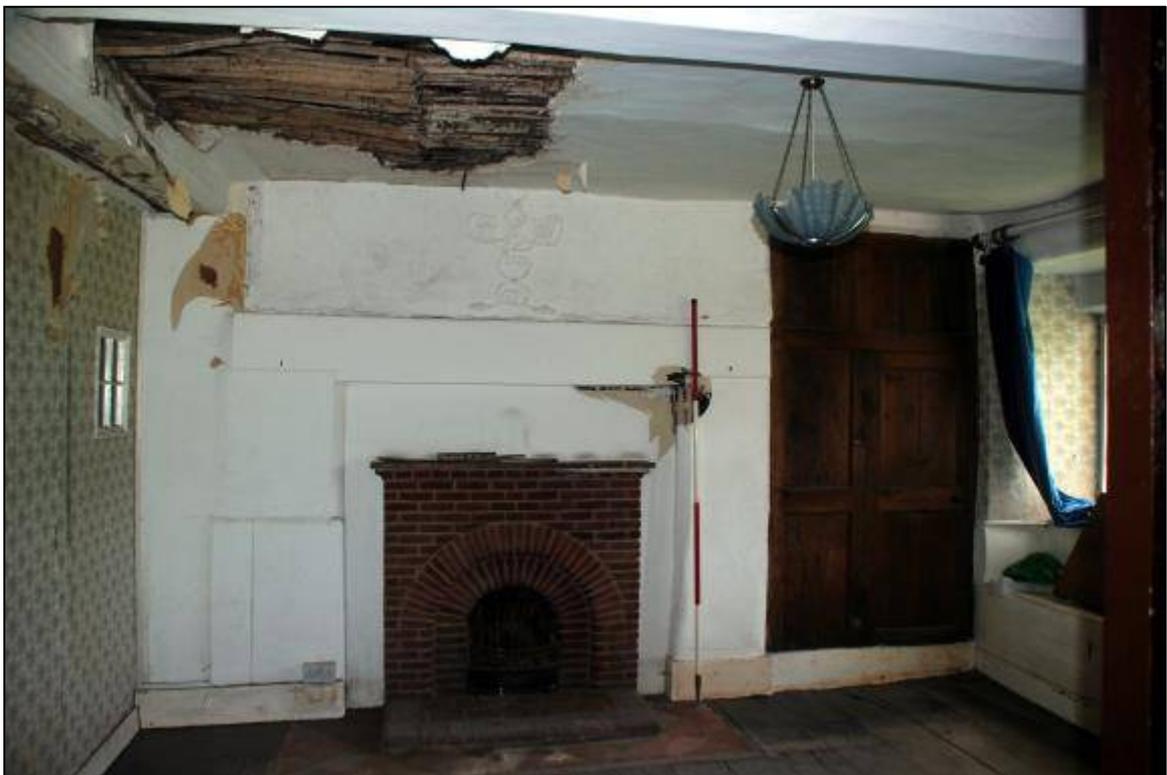
Plate 22: The hall fireplace before restoration

The hall is dominated by the fireplace with its plaster overmantle (Plate 22), consisting of the interlinked initials R, W and K (Plate 23). Before the restoration this design was truncated by the ceiling; however the full design extended beyond the level of the lath and plaster ceiling. The restoration of this fireplace revealed the extent of the wooden bressumer and fragments of plaster ovolo mouldings (Plate 24) which originally surrounded the fireplace.

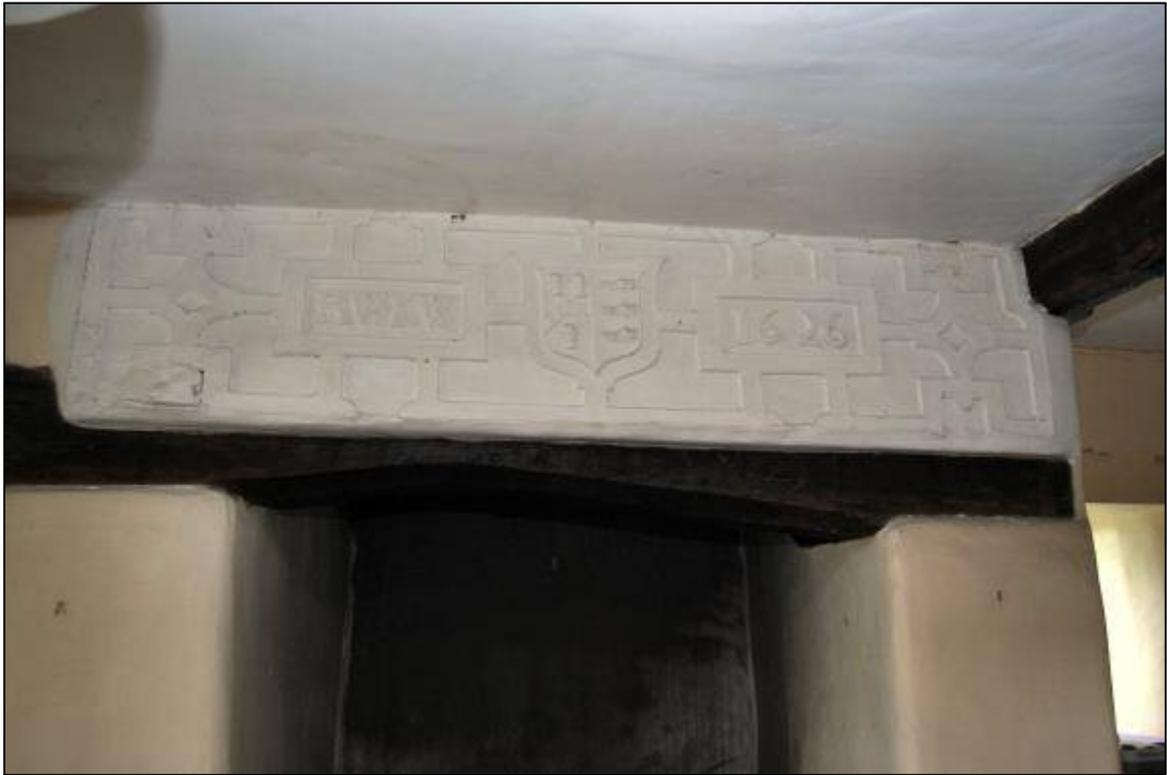
Plate 25: The overmantle in the parlour

The parlour at the northern end of the main range has a more complex plaster overmantle (Plate 25). This incorporates an armorial together with the initials

“RW KW” and the date 1626 within a strap work design. To the west of this overmantle is a cupboard (Plates 26 and 27) with twin doors and a double bowed head. The hinges on this feature (Plate 28) are H-hinges of late seventeenth century type (Alcock and Hall 1994, 25).

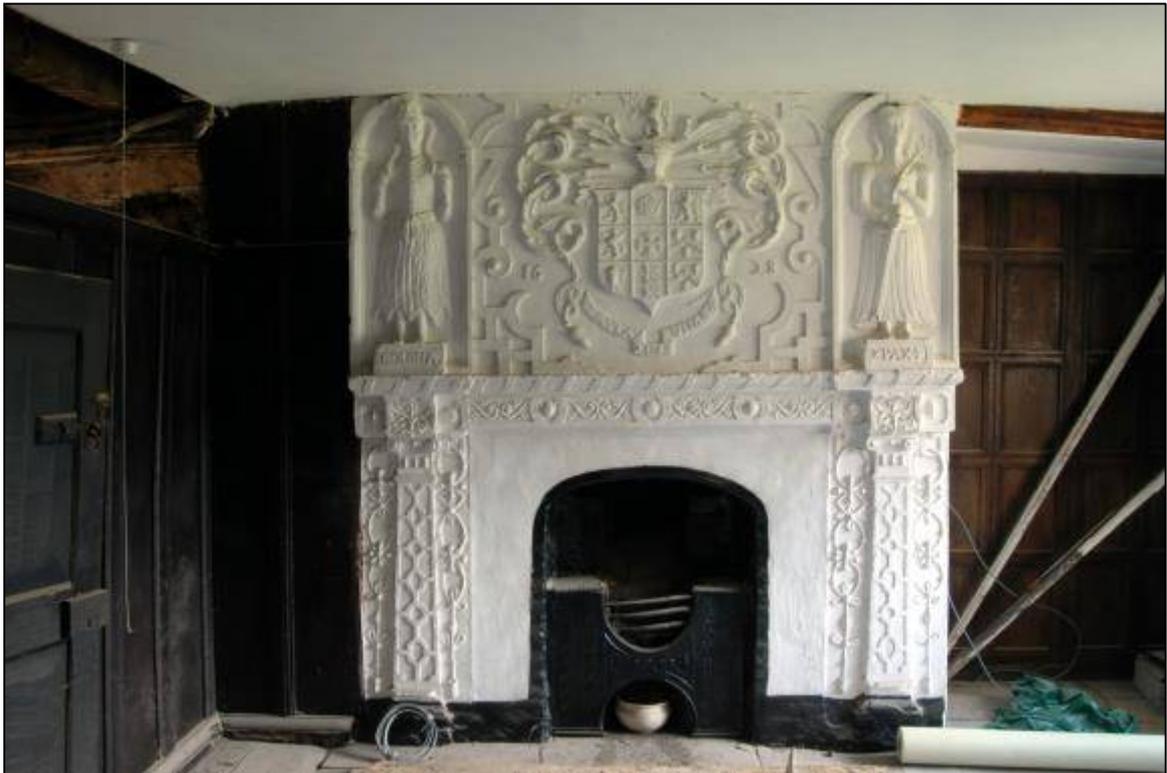
Plate 30: Plaster overmantle in Room 3

Room 3 was clearly a first floor hall. It contains an impressive, plasterwork, overmantle (Plate 30). An armorial is centrally placed over the hearth incorporating the motto “SINGULA IN UNO” within a ribbon. The date 1628 is incorporated within the design which is framed with strapwork (Plate 31). Flanking the armorial are figures of “War” and “Peace” shown as female figures (Plates 32 and 33). “Peace” holds a palm frond whilst the lower arms of “War” are missing, but presumably originally held a sword. Both characters are within arch topped niches. Below the overmantle the hearth is framed by mock columns supporting the figures and a frame of strapwork incorporating some floral designs. As with the overmantles on the ground floor, the ceiling in Room 3 truncates the top of the plasterwork suggesting that the original ceiling was at a higher level.

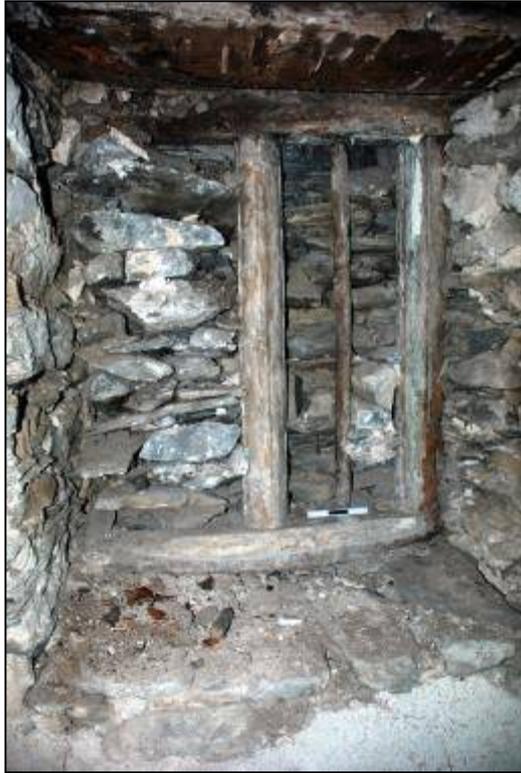
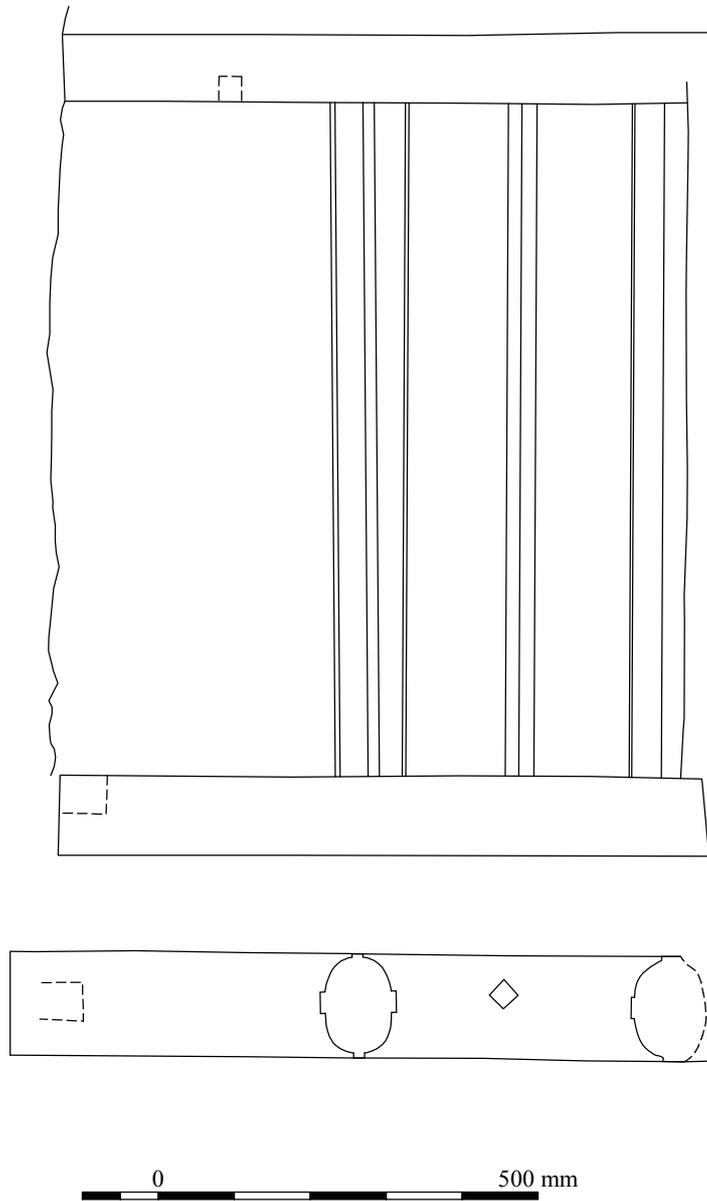
Plate 40: Blocked first floor window

original window frame (Figure 8, Plate 40) was found *in situ*, although the northern end of this frame had been truncated by the construction of the stair tower. The frame had ovolo moulded jamb and chamfered lintel and sill. The surviving mullion was also ovolo moulded (Figure 9) and there was also an intermediate, rectangular bar set diagonally.

Restoration work within the first floor corridor re-opened a window which was probably blocked when the stair tower was constructed or modified. The

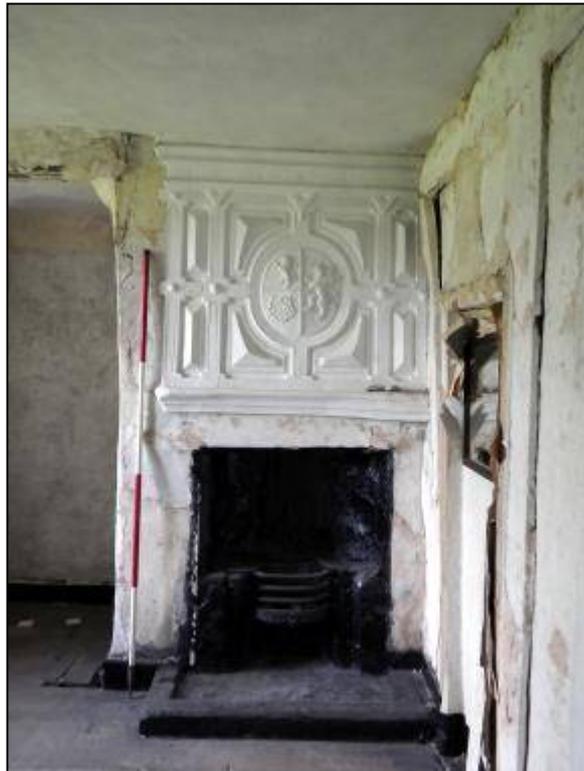
Plate 41: Overmantle in Room 4

Room 4, in the north western corner of the first floor, has a plaster overmantle incorporating an armorial within a strapwork design (Plate 41). The wall between Rooms 4 and 5 initially appears to be a post and panel partition (Plate 42), however the “posts” prove to be of plasterwork and this is an attempt at disguise the wall as a more complex construction than it really is.

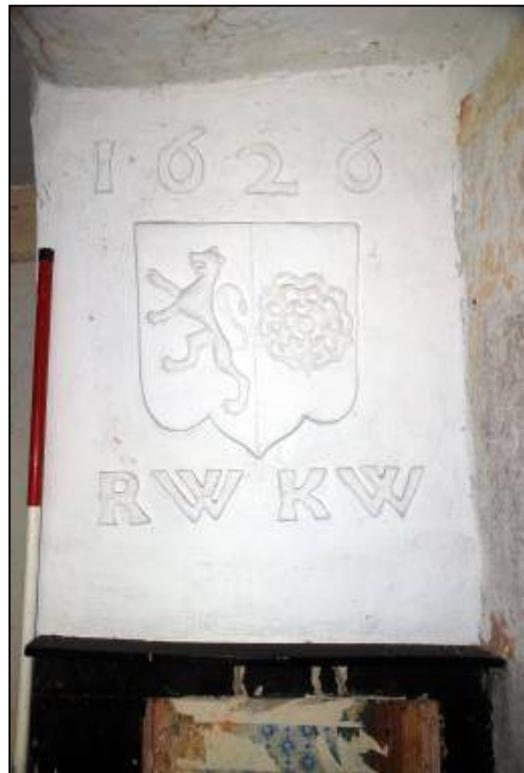
Plate 43: The overmantle in Room 5

Room 5, also has a plasterwork overmantle (Plate 43). This incorporates an armorial with the date “1626” above and the initials “RW KW”. The window in this room has three ovolo moulded mullions (Plate 44).

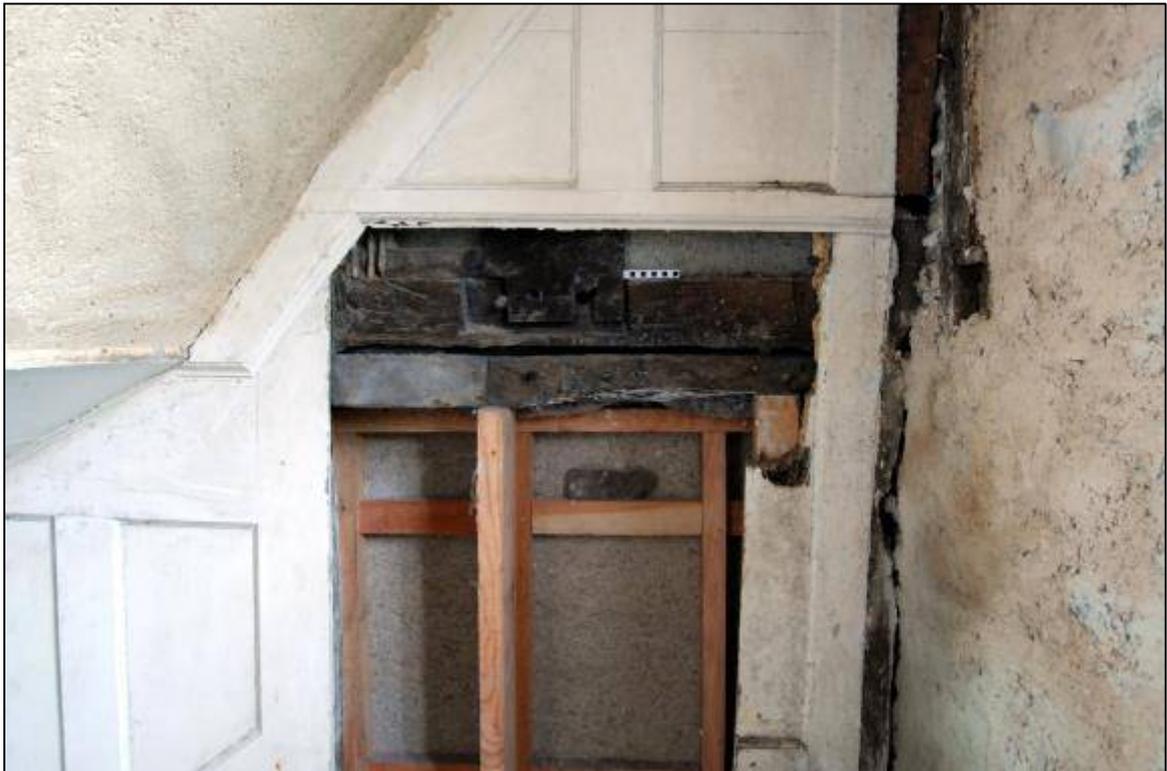
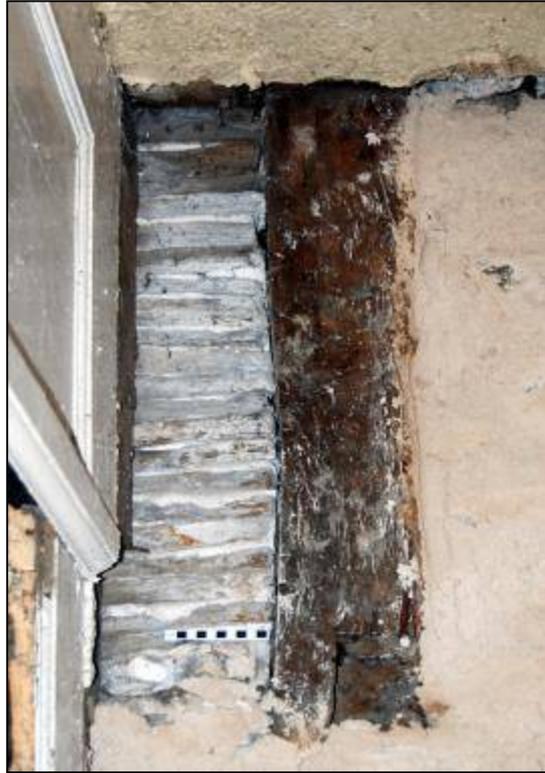
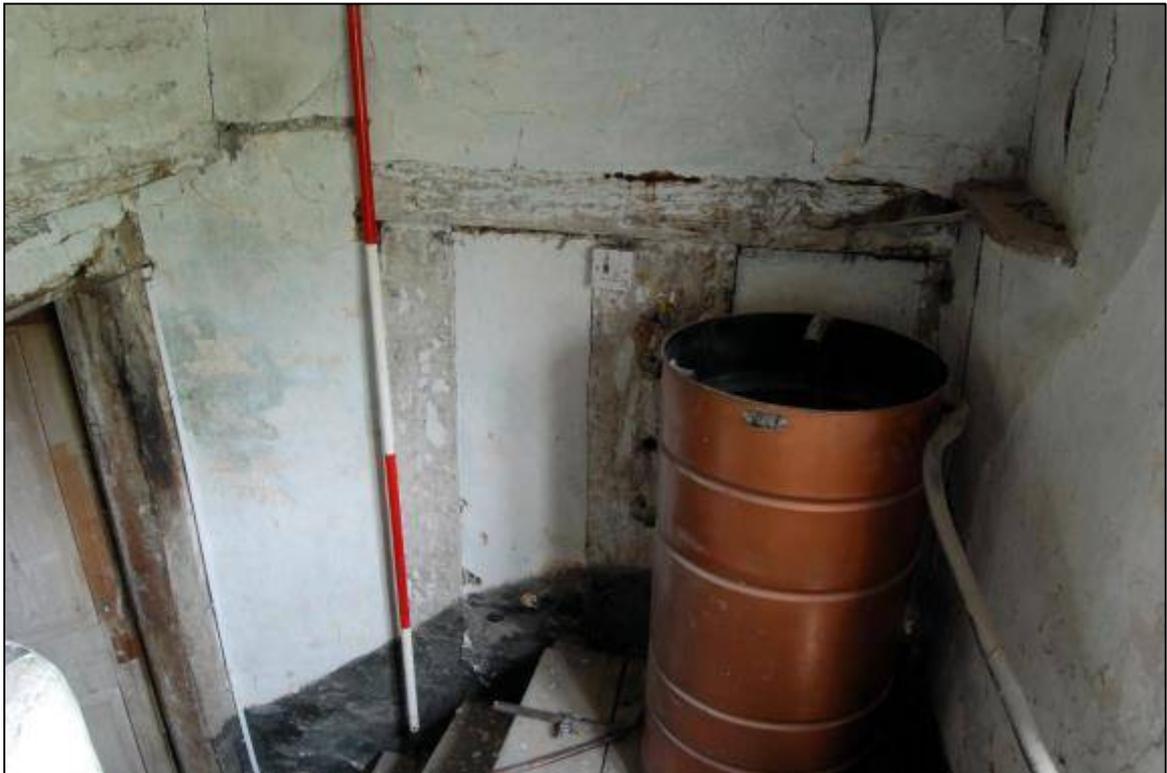
Although externally the stair tower would appear to be constructed of stonework, internally there is some evidence for a timber framed structure (Plates 45 – 47). It is possible that an initial timber framed stair tower was later clad in stonework, although this remains speculative. The stairs themselves proved to be later replacements as the restoration recovered a series of ovolo moulded mullions which had been used to support the stair case (Figure 9).

The stair tower would appear to be a later addition; however it is possible that it was a timber framed construction to which a later skin of stonework was added. This stonework also required a first floor window to be blocked leaving the first floor corridor without a direct source of light. A further extension to the north of the stair tower is probably nineteenth century in date.

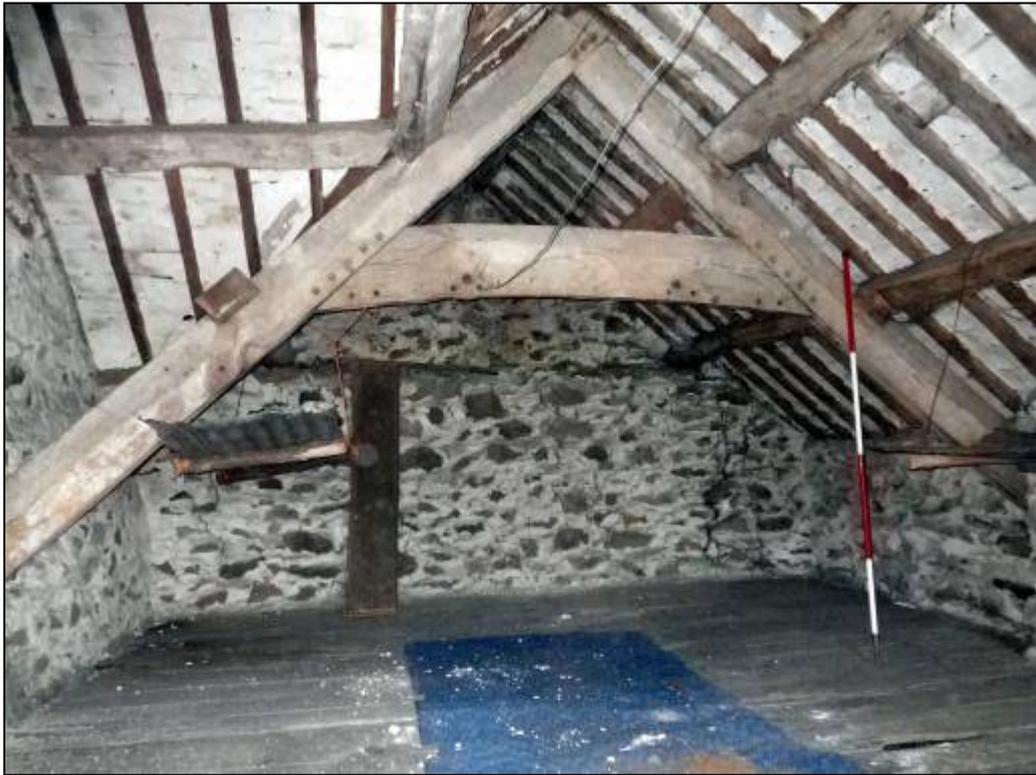
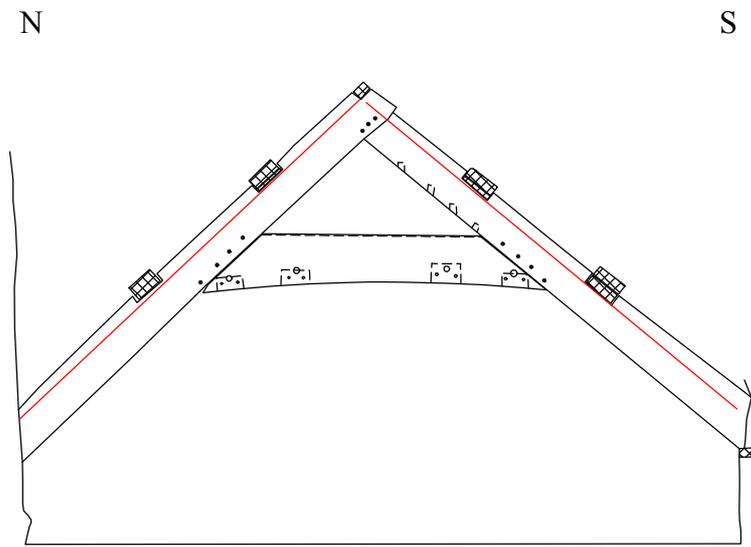
Plate 48: Truss 1

The attic consists of five interlinked rooms (Figure 5). Attic 1 is within the southern range and it contains Trusses 1 and 2 (Figure 11, Plate 48). Both of these trusses are of simple collar beam type with trenched purlins and a slightly curved collar. They also retain red chalk carpenters markings defining the depth of the trenches for the purlins. Truss 1, however, also has a series of dowel holes (Plate 49) above the collar and mortice holes below suggesting the presence of a partition below this truss (Plate 50). Truss 2 is slightly chamfered below the level of the collar, both on the principal rafters and the lower edge of the collar. There is also some scratch marking (Plate 51) which appear to be a series of “1”s and “0”s

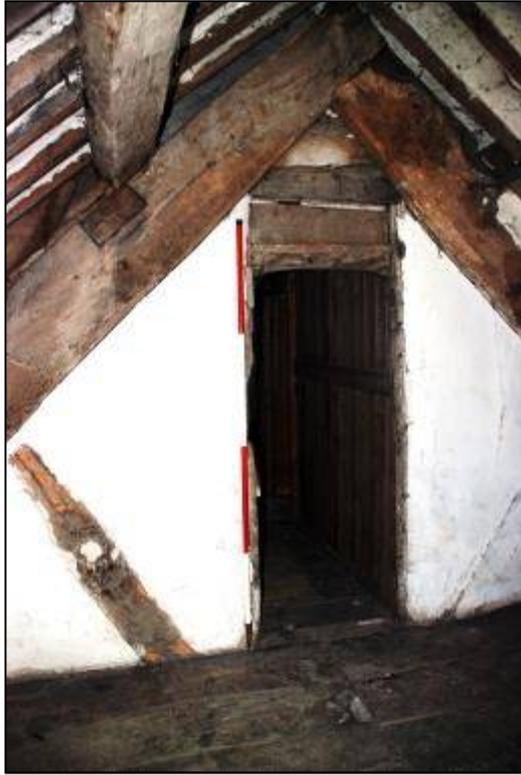
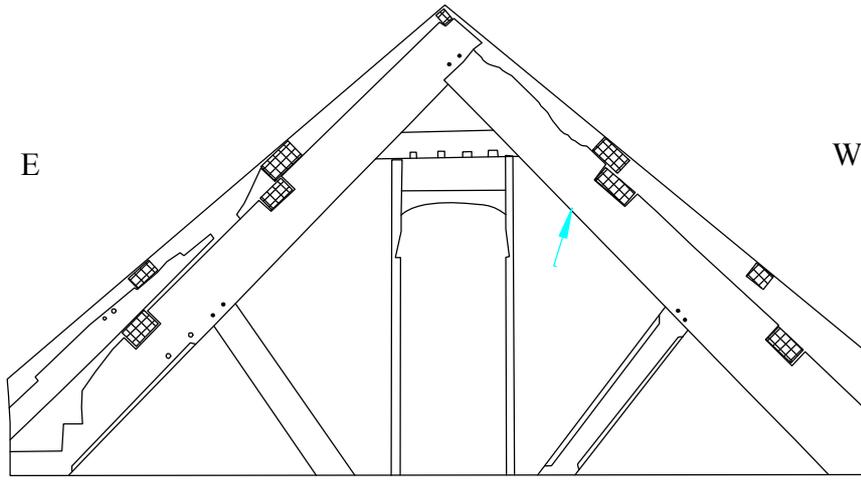
Plate 52: Truss 3

Truss 3 (Figure 12, Plate 52) separates Attic 2 from Attics 3 and 4. This truss, like Truss 4, is a tie beam structure with raking struts. There is a doorway below this truss which has a wooden door head with segmental arch (Plate 53). This door head would appear to have been lifted by about 0.28 m. There are also a series of mortice holes in the beam above the door head suggesting the presence of a wattle and daub partition above the door. The roof in this wing has been lifted and a second set of principal rafters added on top of both Trusses 3 (Plate 54) and 4. The date of this lifting is hinted by the scratched date of 1836 together with the initials “WH” in the plasterwork of above the stair head (Plate 55).

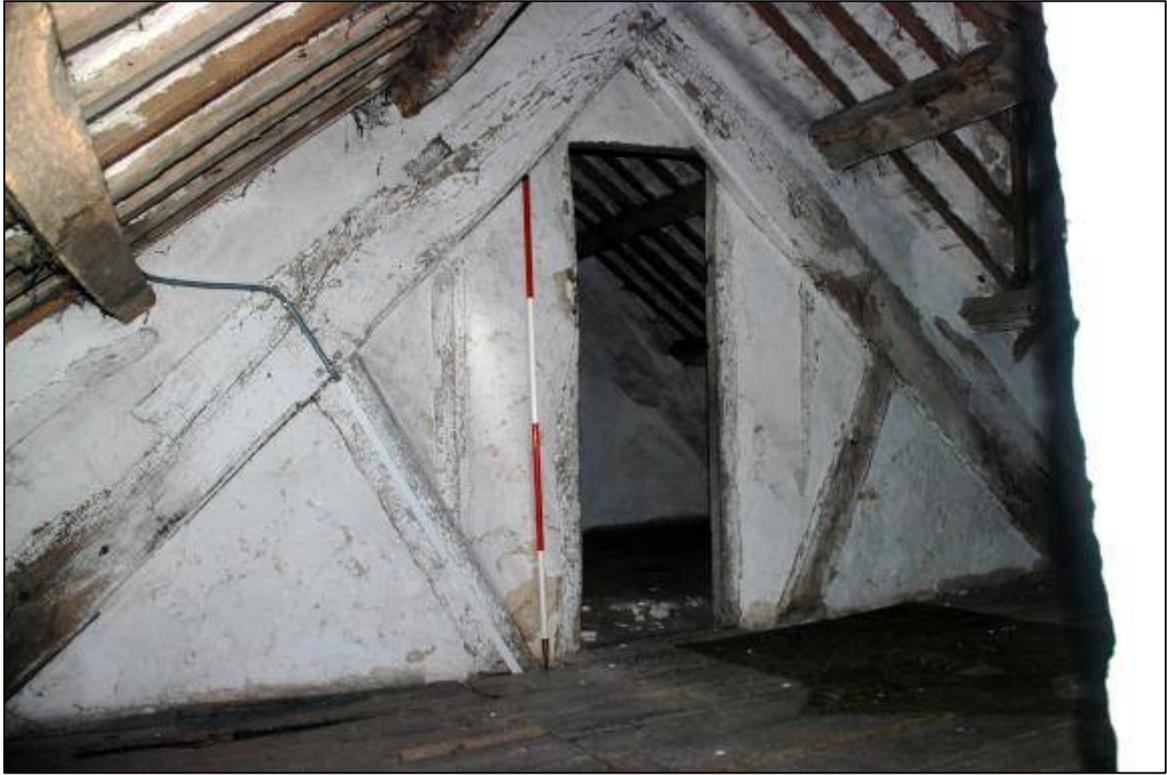
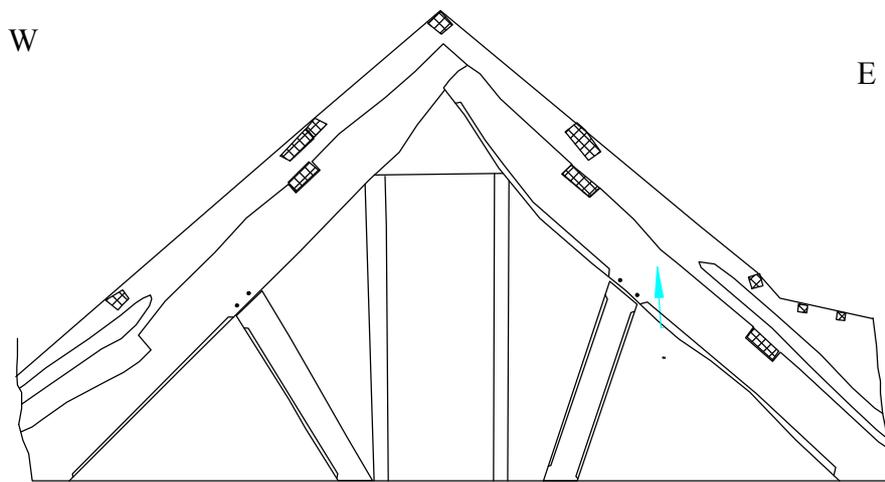
Plate 56: Truss 4

Truss 3 (Figure 12, Plate 56) is between Attics 3 and 4 and Attic 5. It has similar characteristics to Truss 3, although there is no door head, even though there is an opening below this truss.

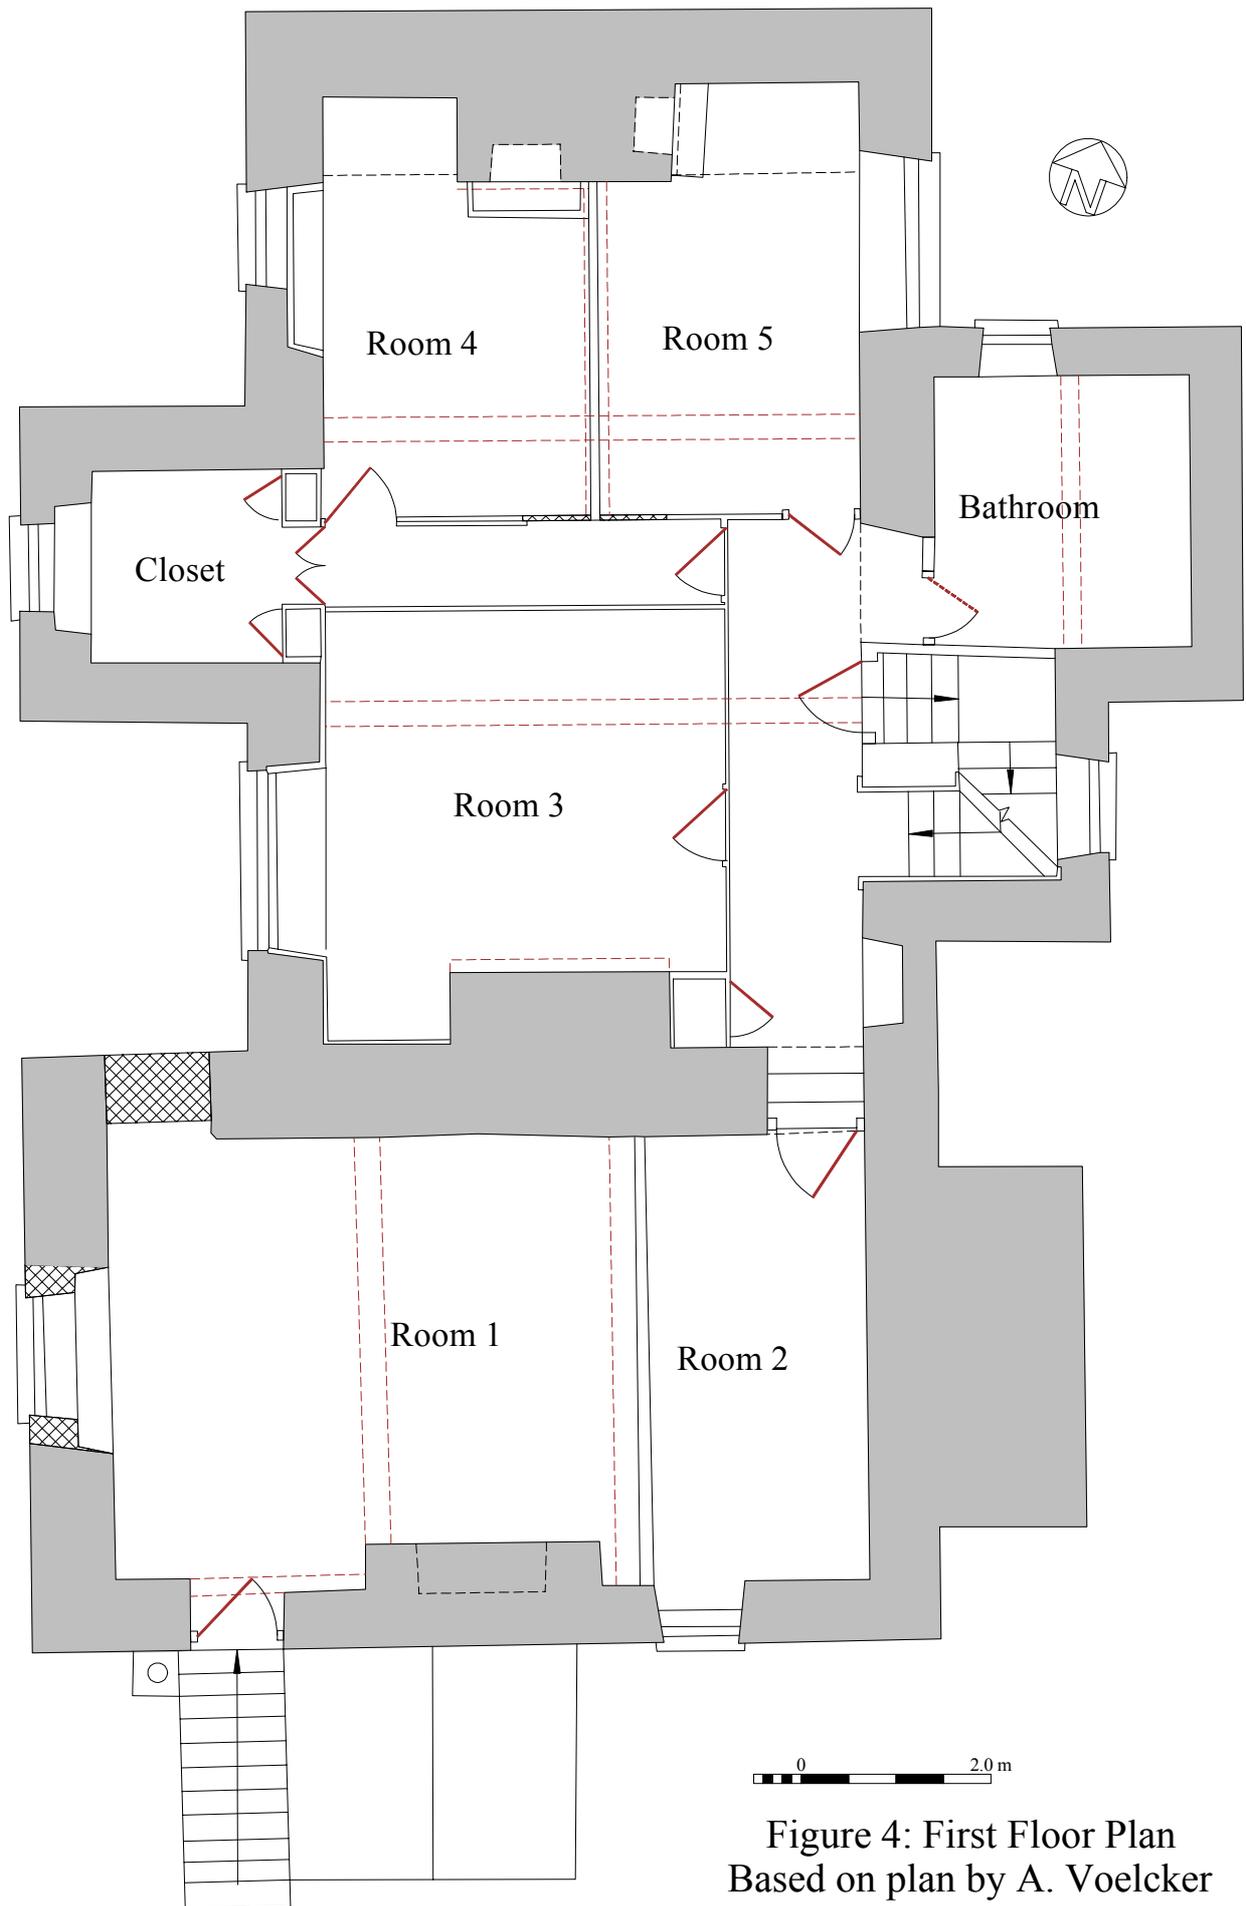
Figure 4: First Floor Plan
Based on plan by A. Voelcker
Scale 1:80

On the first floor (Figure 4), the southern range is divided into two rooms. These two rooms are not interconnected, leaving the western room (Room 1) only accessible via the stone step on the southern elevation of this range. Although there is no external evidence for a chimney stack there is a block fireplace in the southern wall (Plate 29). This fireplace is also above the current entrance to the kitchen so there is no evidence for a ground floor fireplace in this location. A recess in the north west corner corresponds with the blocked doorway seen on the outside of the building.
