# North West Wales Dendrochronology Project Cymryd Isaf, Gyffin, Conwy

**EAS Client Report 2011/10  
June 2011**

# **North West Wales Dendrochronology Project Cymryd Isaf, Gyffin, Conwy**

**By  
I.P. Brooks**

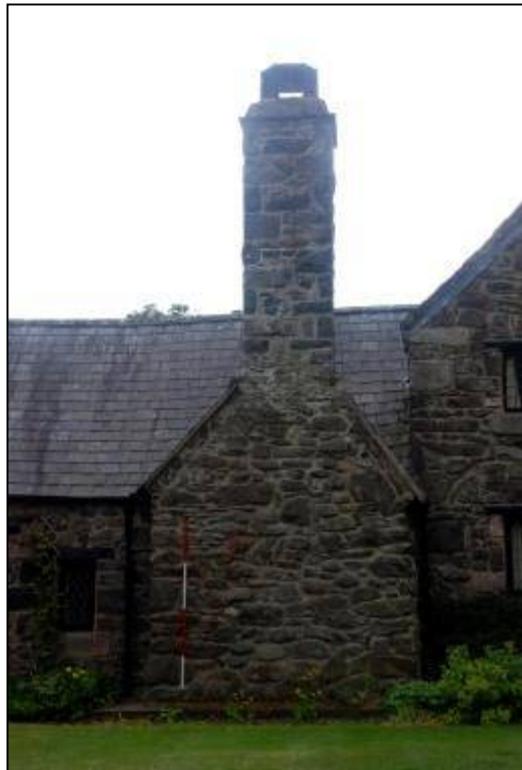
**Plate 2: The lateral chimney**

The original hall appears to have been a four bay open hall with a cross passage defined by post and plank partitions. The lateral chimney on the northern wall (Plate 2) is presumably added, allowing the addition of an upper floor to the hall. The hall is constructed of uncoursed stonework with some squared blocks defining the doors and windows, although in general the quoins are not particularly stressed. The lateral chimney is similarly constructed at its base, although the tall slender stack is of more regular stonework and is therefore probably a later replacement. There is also a concrete base to the stack where it has been underpinned in 1973 (D. Glynne *pers. comm.*). Originally the chimney little or no foundations, unlike the main wall of the hall, strengthening the view that it was a later addition (D. Glynne *pers. comm.*). The flue is protected by two stone slabs supporting a slate cap. The stack is surrounded by a slate roof, covering the shoulders of the lower stack and forming a gablet extending from the roof of the hall. Both the gablet and the main roof are covered by modern slates and have ceramic ridge pieces. The main roof also has stone copings. The re-roofing of the this wing took place about 1958 (D. Glynne *pers. comm.*). On the southern elevation of the hall, there is a gabled dormer (Plate 3) which is partly blocked by the kitchen wing. It is assumed that this feature originally held a window lighting the first floor of the hall. The doors and windows in the hall are of relatively modern design, however it is assumed that they may occupy original opening. The eastern gable end of the hall range is now obscured by vegetation (Plate 4), although a similar construction to the rest of this range was observed together with a small window opening thought to be of an earlier style than other windows in the house (D. Glynne *pers. comm.*).

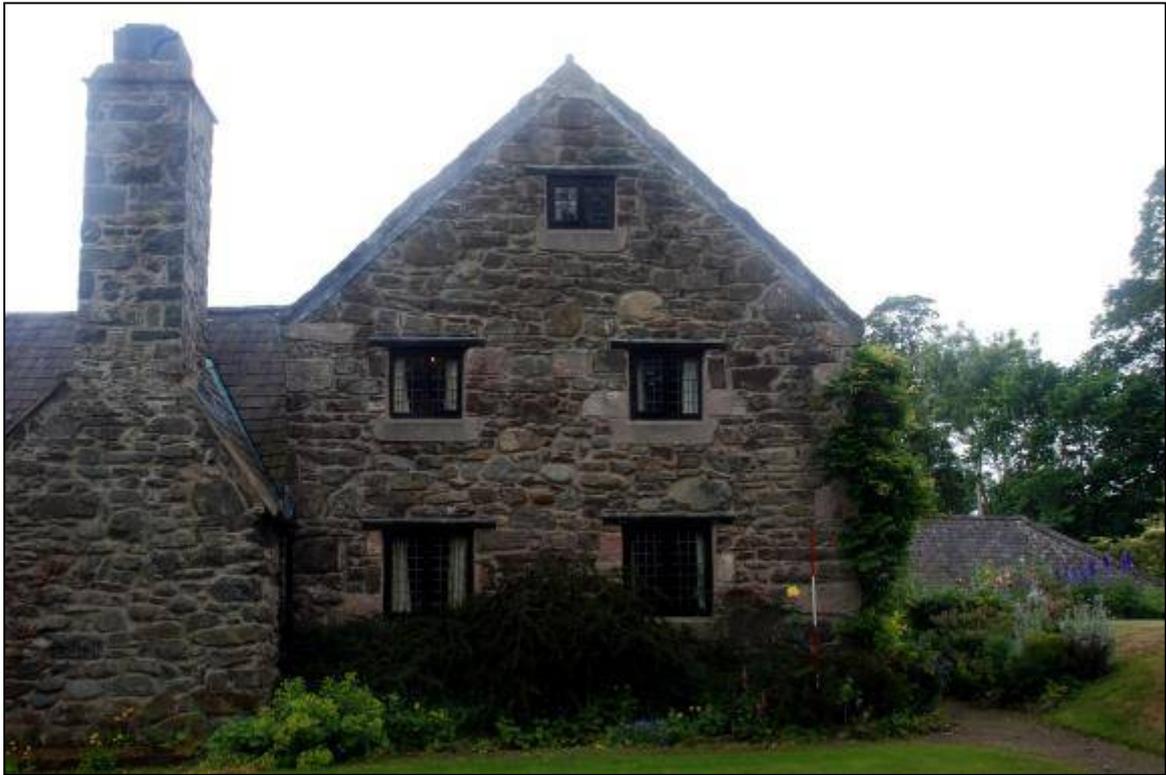
**Plate 5: Northern gable of the cross wing**

The cross wing was added to the western end of the hall, probably removing the western bay of the original house in its construction (Plate 5). It is constructed of random stonework with some squared blocks defining the windows and the quoins (Plates 5 – 7). The roof is of modern slate with ceramic ridge pieces dating from the re-slating in 1975 (D. Glynne *pers. comm.*). The gables have stone kneelers and ridge coping. The windows vary between wooden and stone framed windows with the stone framed windows occupying the southern gable end. The ground floor stone window frames have the sockets for metal bars which presumably protected these windows (Plate 8). The doorway between the cross wing and the conservatory is thought to occupy the site of a previous window. There is an inscription on the northern gable wall of the cross wing (Plate 9) which reads:

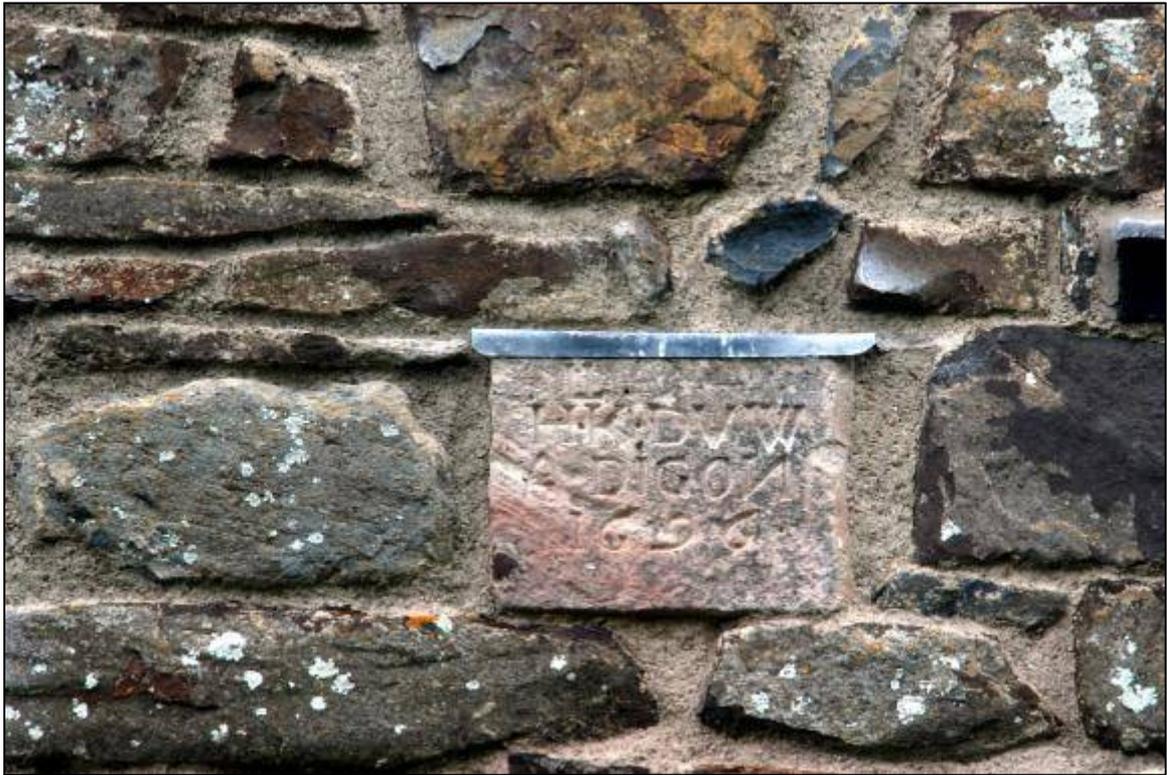
**Plate 9: Inscription on northern gable wall of the cross wing**

LL  
HK DVW  
A DIGON  
1696

The initials are assumed to be those of Henry and Kathrine Lloyd (Royal commission on the Ancient and Historic Monuments of Wales and Monmouthshire 1956, 162). It is not entirely clear whether this inscription documents the construction of the cross wing or marks either an important family occasion or a re-fit of the house. There is a single gable end chimney on the southern gable of the cross wing. This is constructed of roughly

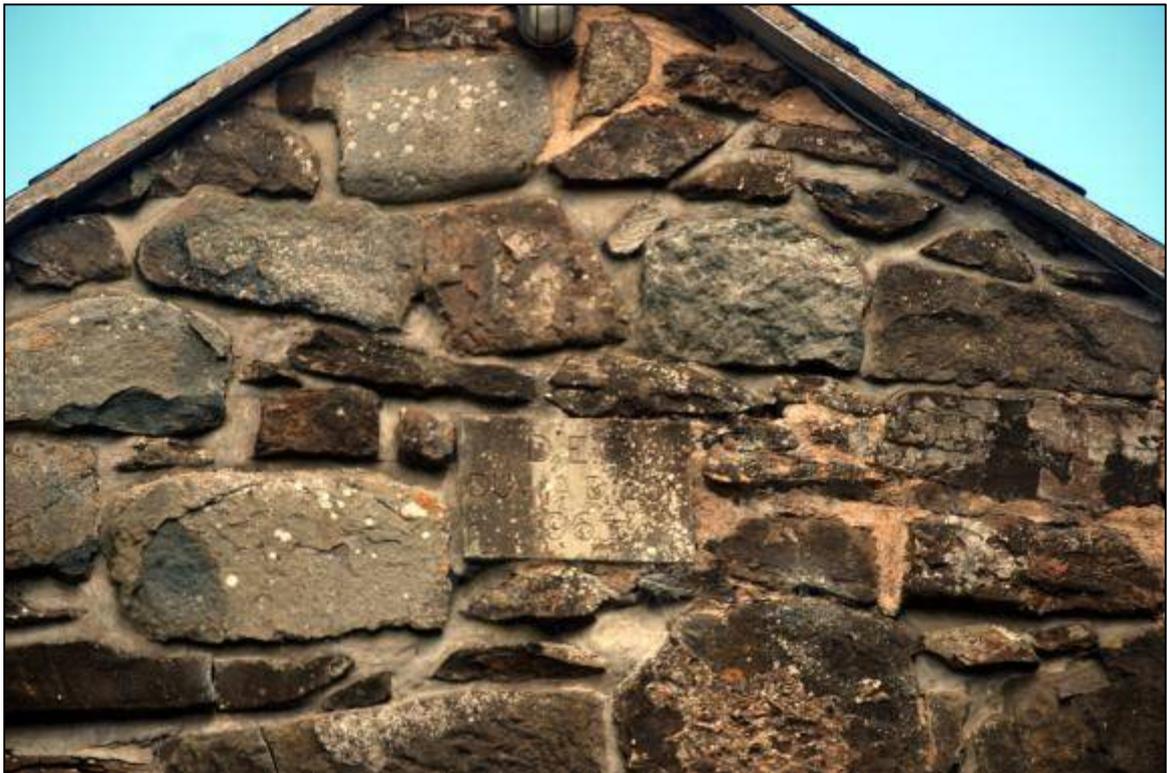
**Plate 10: Inscription on the southern gable wall of the 1965 extension**

The kitchen wing, at the eastern end of the property, is assumed to be eighteenth or nineteenth century in date; however, it was certainly constructed by 1890 as it appears on the First Edition Ordnance Map (Figure 2). The extension of this wing to the south was built in 1965 and has an inscription on its southern gable in a similar style to the 1696 inscription (Plate 10).

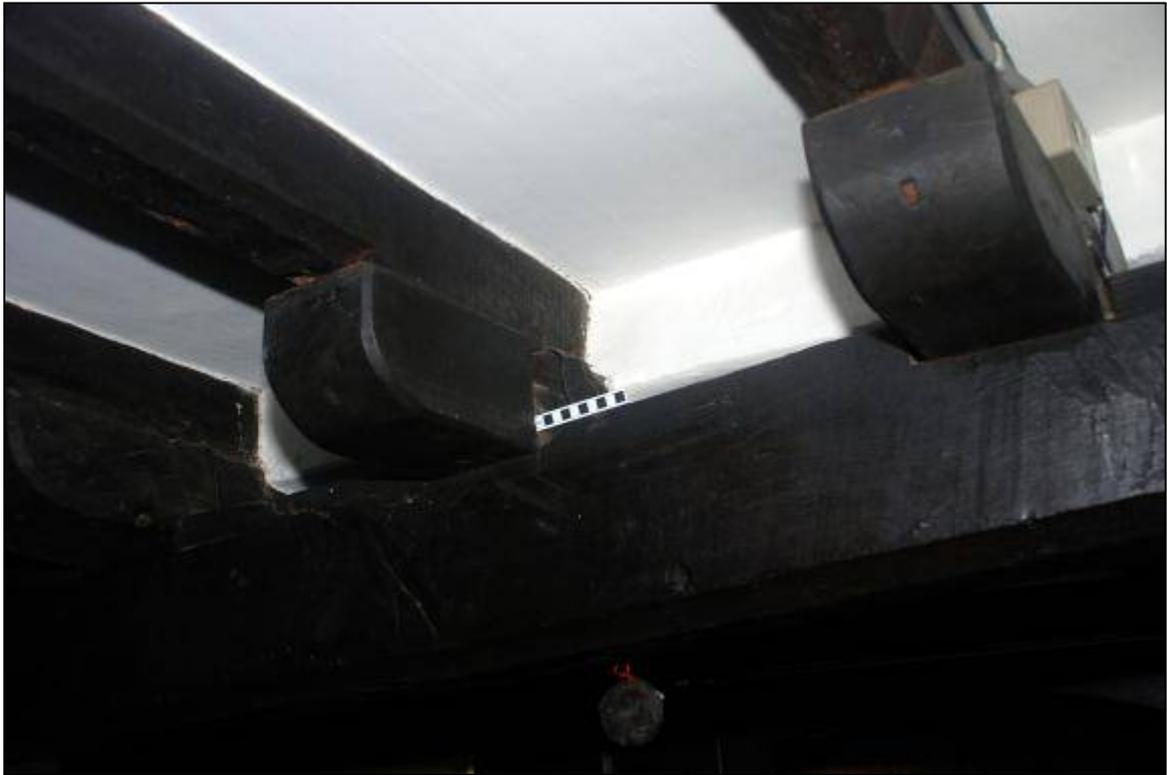
**Plate 15: Two level of joists in the hall**

Internally, the ground floor of the hall (Figure 3) is divided into two rooms and a cross passage. The pantry at the eastern end of the hall is divided from the cross passage by a post and plank partition (Figure 5, Plate 11). This extends into the room above (Plate 12) demonstrating that it was in existence before the insertion of floor. Sitting directly below Truss 1 the partition is constructed of upright planks, approximately 0.24 m wide, supported by intervening posts 0.17 m wide (Plate 11). Both the post and the planks are also retained by rails at the top and bottom of the partition. Two doorways originally pierced the partition, although only one of these remains open. Both doorways have wooden door heads with depressed pointed heads which are grafted into posts within the partition (Plates 13 and 14). The northern door is still open (Plate 13), whilst the southern door has been blocked with similar post and planking and the rest of the partition (Plate 14). It is also noticeable that the southern (blocked) door head is set approximately 0.1 m below that of the northern head. The reason for two doorways is uncertain as there is no evidence for the pantry having been divided and it is possible that the northern doorway was only ever a dummy. Within the pantry, a trimmer joist marks the position of a hatchway which presumably allowed access to the room above. It is thought that a floor was inserted at this end of the hall at an early stage, but that this loft only extended partly across the length of the hall, a view which is supported by the step in the floor levels seen in the upper floor room between Trusses 1 and 2 and in the two levels of joists seen in the main room of the hall (Plate 15)

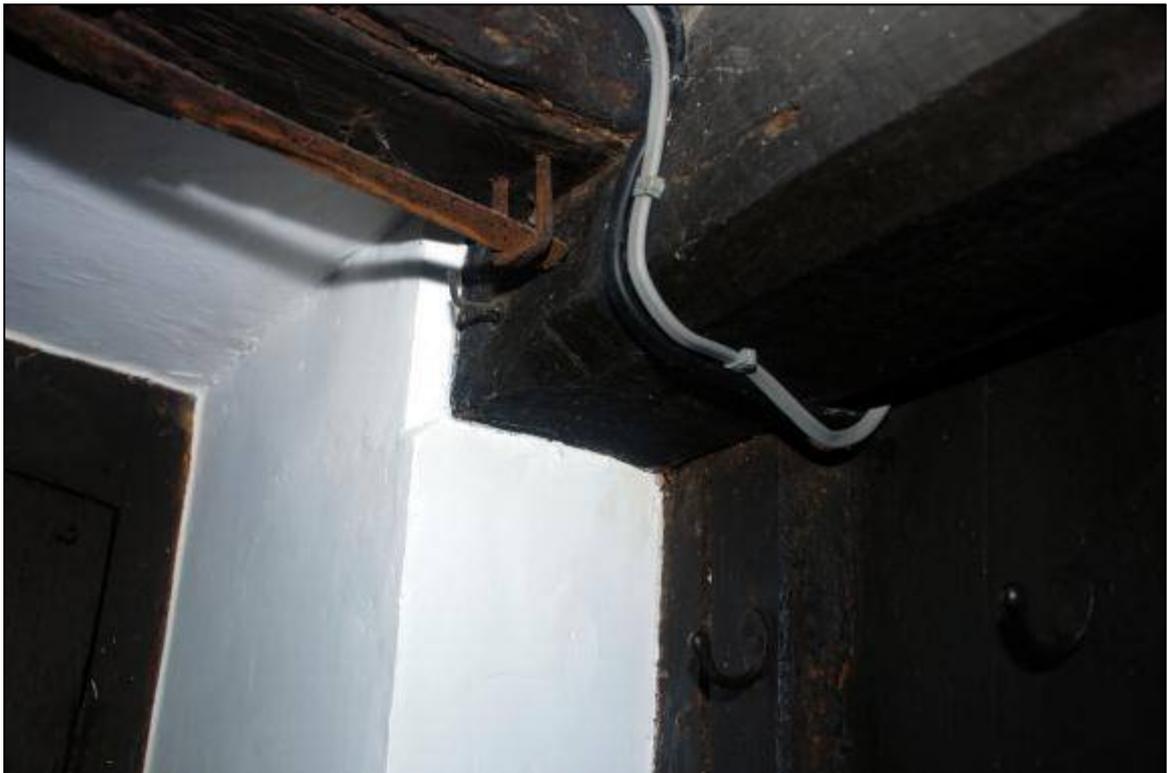
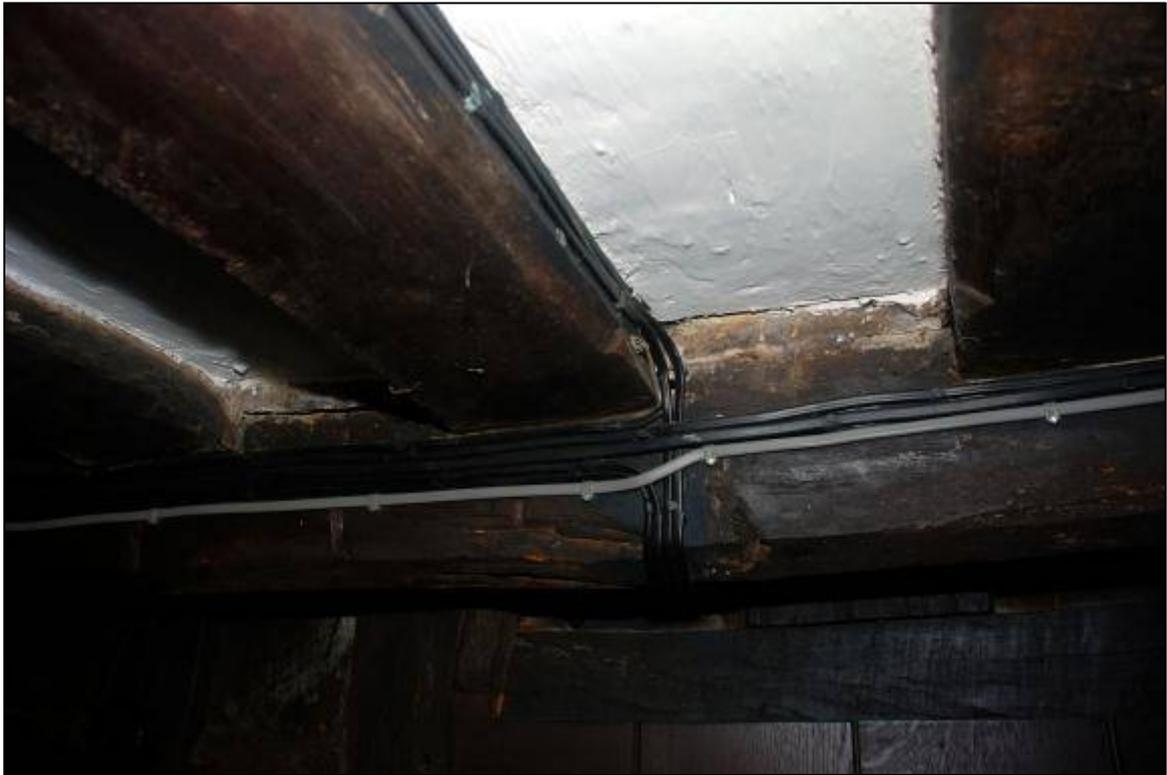
In front of the partition, within the cross passage, is a beam that supports the floor above. Both this (Plate 16) and the associated joists are chamfered and have stops that are stepped (Plate 17).

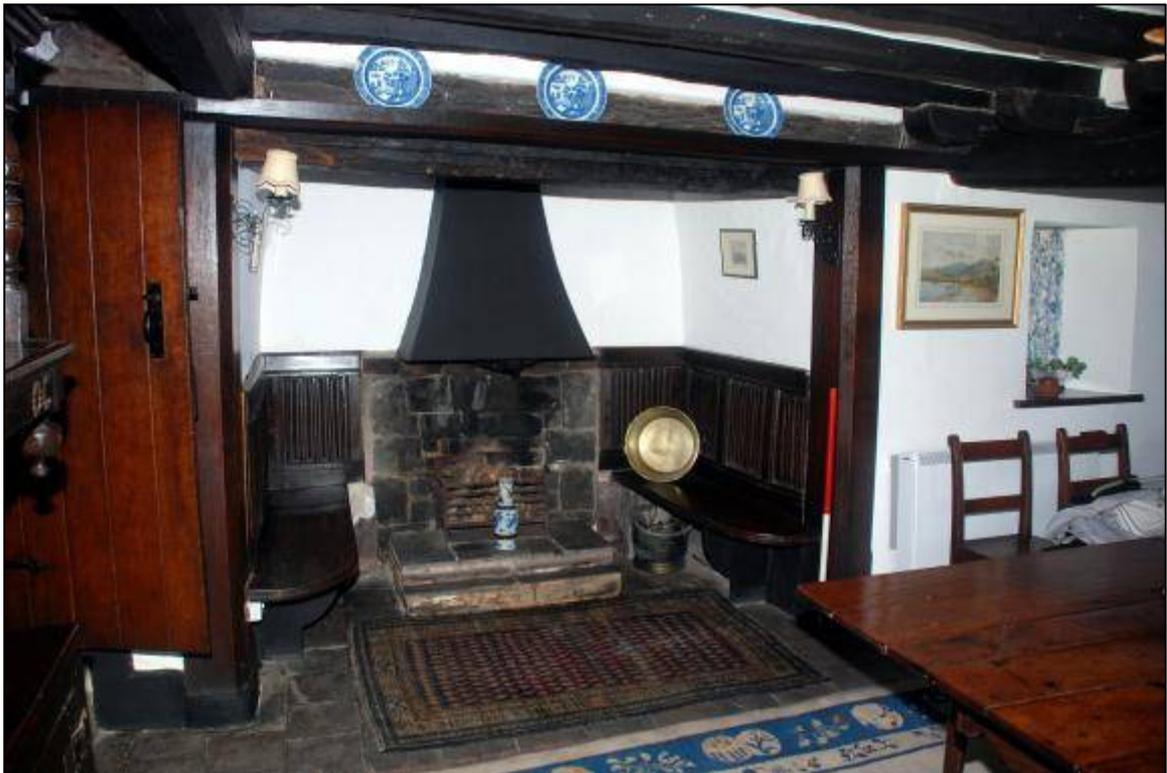
**Plate 18: The lateral fireplace in the hall**

The main room of the hall has the lateral chimney in the north western corner (Plate 18). The angle of which contains sections of linen fold panelling which is reputed to have come from Maenan Abbey (Hughes 1984). Similar sections of linen fold panelling has also been used over the fireplace in the cross wing (Plate 19) which is also assumed to come from the same source. Family tradition suggest that the great-great-grandfather of the current occupant was Elias Jones of Gorswen was steward to Lord Newborough at Maenan Abbey and it is possible that this was the source of the linen fold panelling. (D. Glynne *pers. comm.*). The ceiling of the hall has a central beam which is chamfered and has simple run out stops (Plate 20). This supports the joists of floor above, as has been already discussed there is an overlap above the central beam giving rise to a step in the floor and suggesting that the insertion of the floor in the hall was a two phase operation.

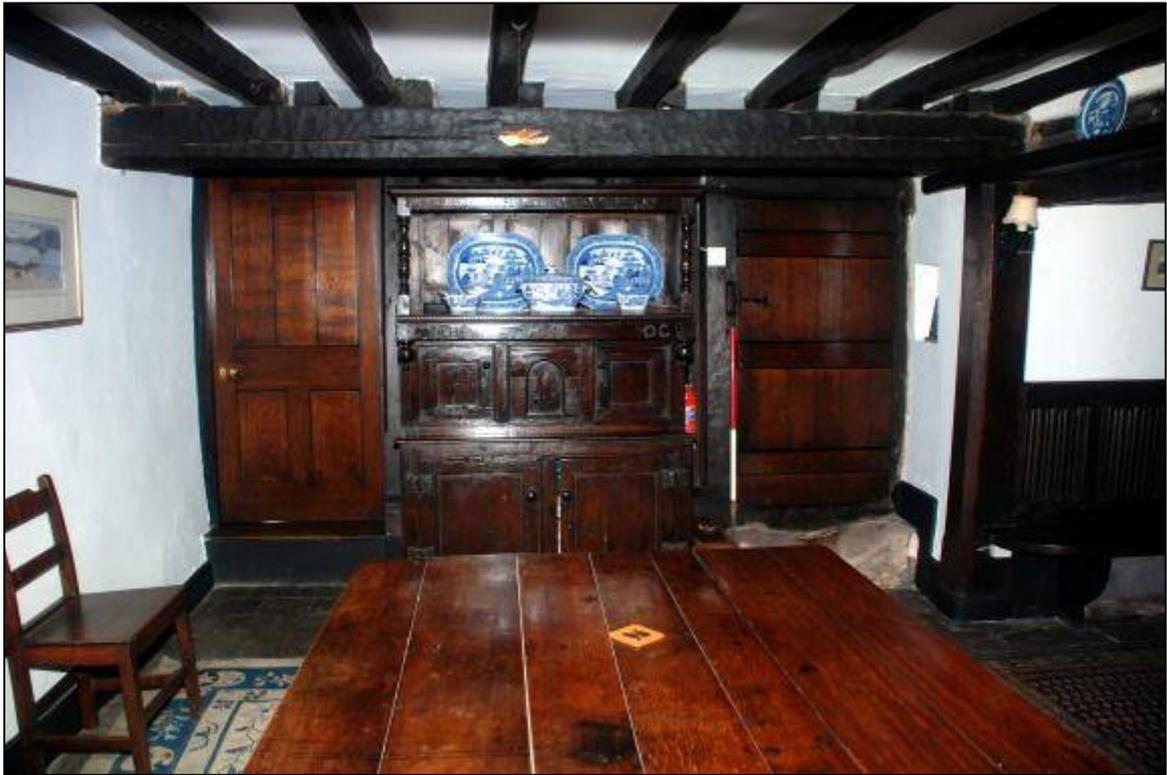
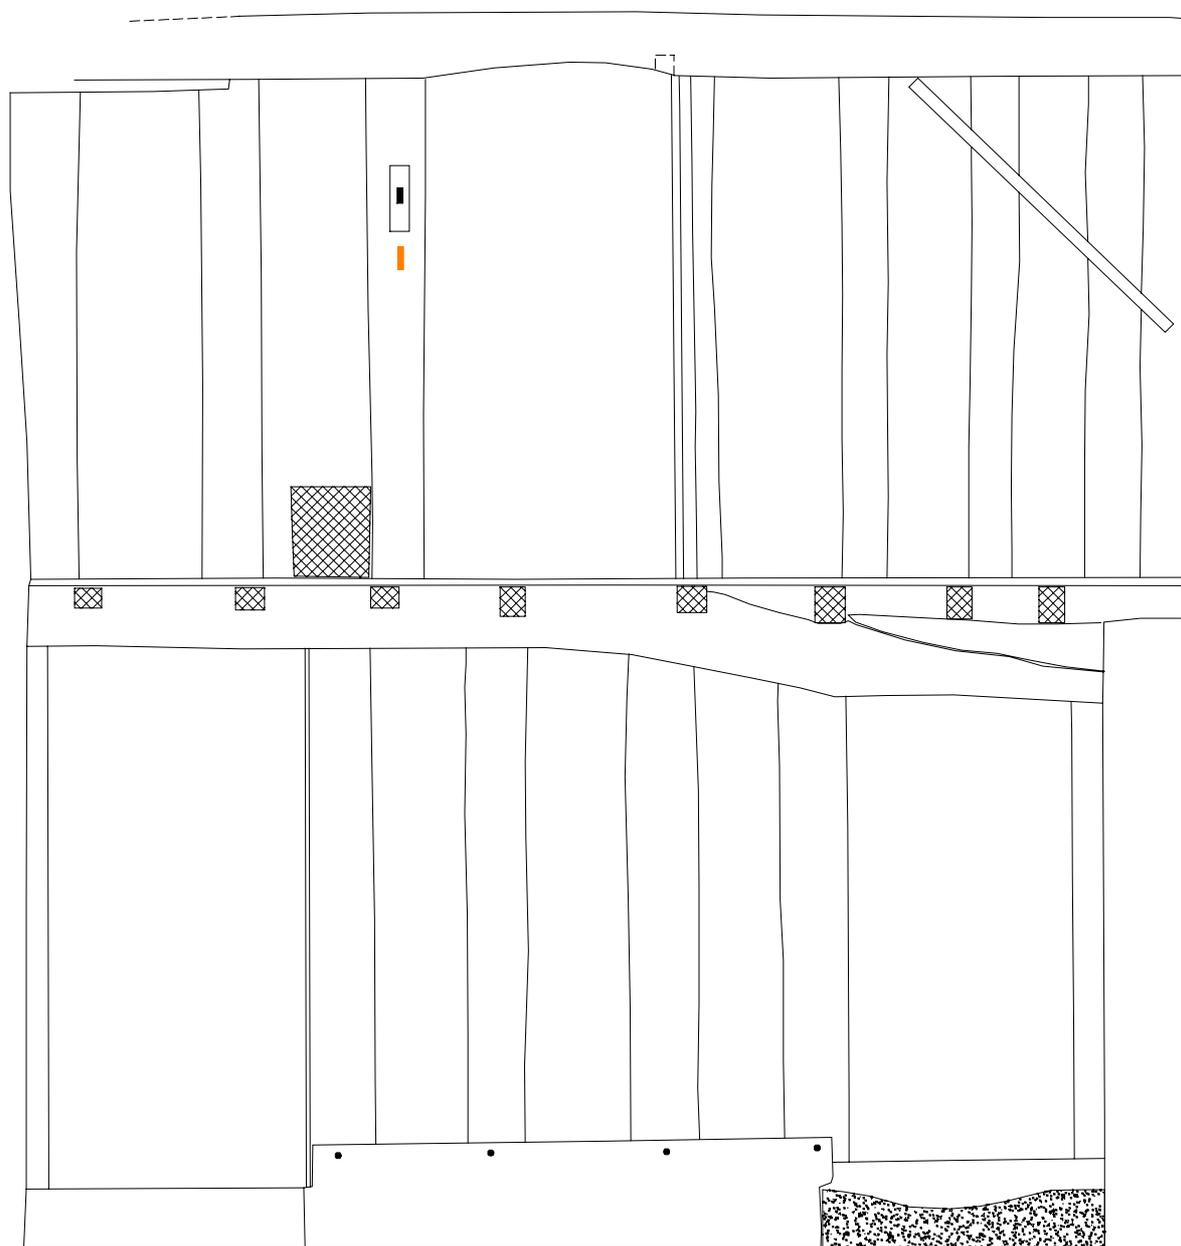
**Plate 21: The western end of the hall**

At the western end of the hall there is a plank and post partition dividing the hall from the cross wing (Plate 21, Figure 8). This partition extends to divide the first floor room of the hall from the stairway. The partition on the ground floor, however, would appear to be of a slightly less refined nature. The lower partition consists of a series of upright posts, approximately 0.19 m wide supporting planks approximately 0.3m wide. Both the posts and planks are set in a sill with each of the posts being pegged into position. The head rail is somewhat twisted at its northern end requiring the insertion of a filler in order to level floor above. On the first floor the partition divides the room above the hall from the staircase. Although having relatively plain face in the room (Plate 22), on the staircase (Plate 23) the posts are chamfered (Plate 24) and finished to a higher standard. Each of the posts has carpenter's marks on the stair side of the partition. These consist of a series of gouge strikes (Plate 25) with the posts numbered, in order, from one to seven, from the southern end.

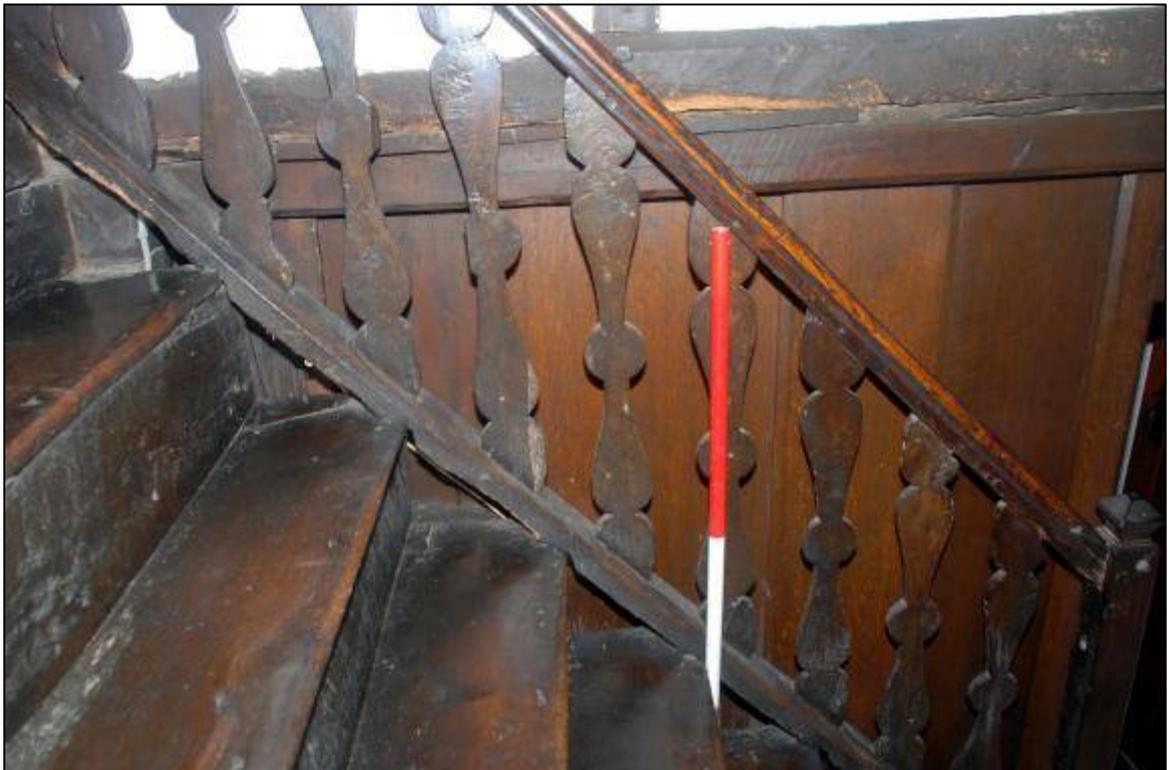
**Plate 26: Splat Balusters**

The stairs have splat balusters (Plate 26), a moulded handrail and a square cut newel with moulded capping (Plate 27). Carved or pieced flat balusters have been documented from the middle of the 16<sup>th</sup> century, but are more typical of Jacobean or baroque staircases (Callow, 2005, 35 and 66). Balusters of a similar form to those in Cymryd Isaf have been recorded from a dated context in Wiltshire where they dated from 1653 (Alcock and Hall 1994, 6).

**Phase 5:** Refitting of the house in or around 1696 which included the staircase. The staircase would appear to date to the re-fitting of, the cross wing with the splat balusters and square newel post which have parallel with other staircases dated to the second half of the seventeenth century (Alcock and Hall (1994). It is likely that the inscription on the north gable wall of the cross wing would relate to this re-fit.

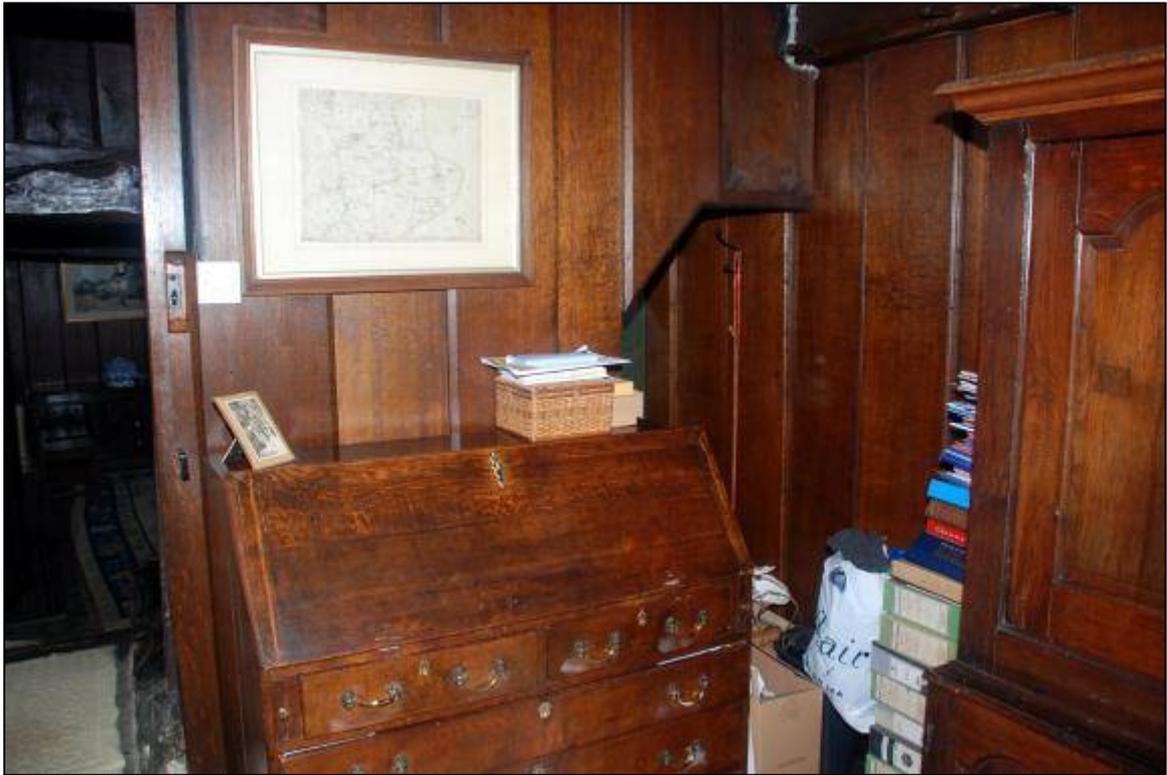
**Plate 33: the access to the under stair space**

The northern, ground floor, room of the cross wing is largely defined by the modern plank partitions between it and the southern room. The ceiling beam along the southern wall is chamfered and has a series of wooden pegs which do not appear to directly relate to the partition between the rooms, although they may relate to an earlier partition (Plate 32). This room also gives access to the space below the staircase (Plate 33)

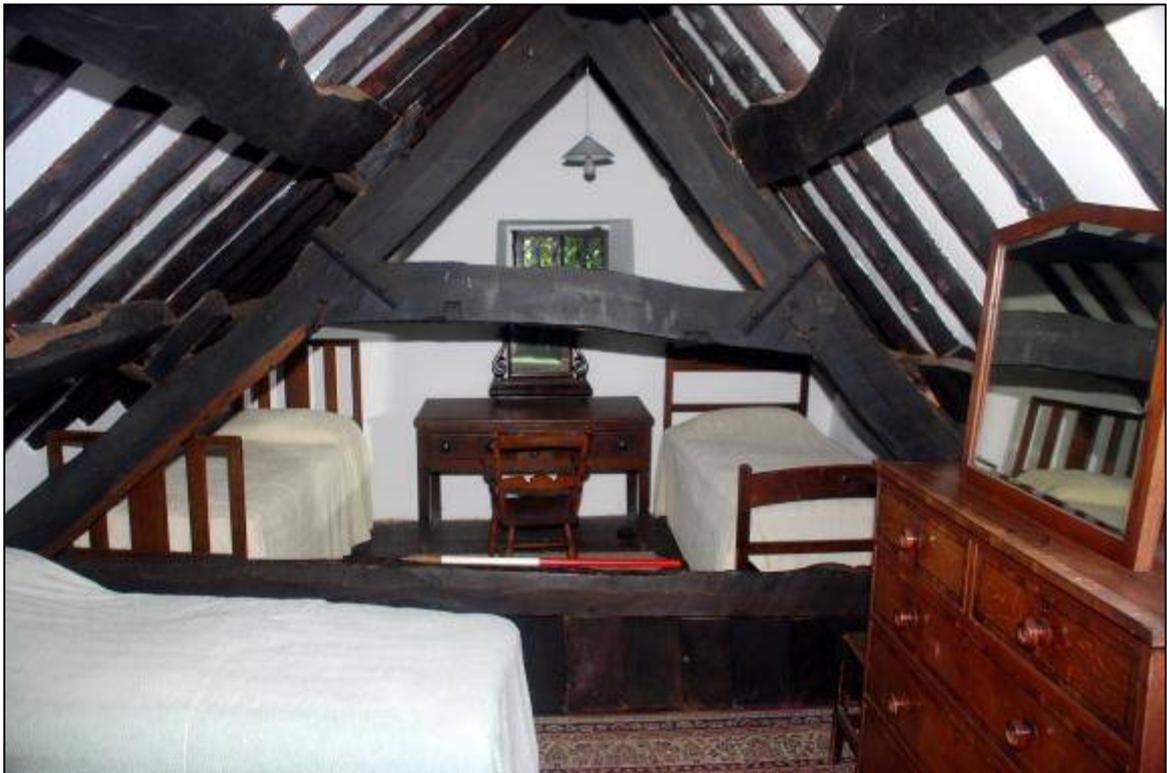
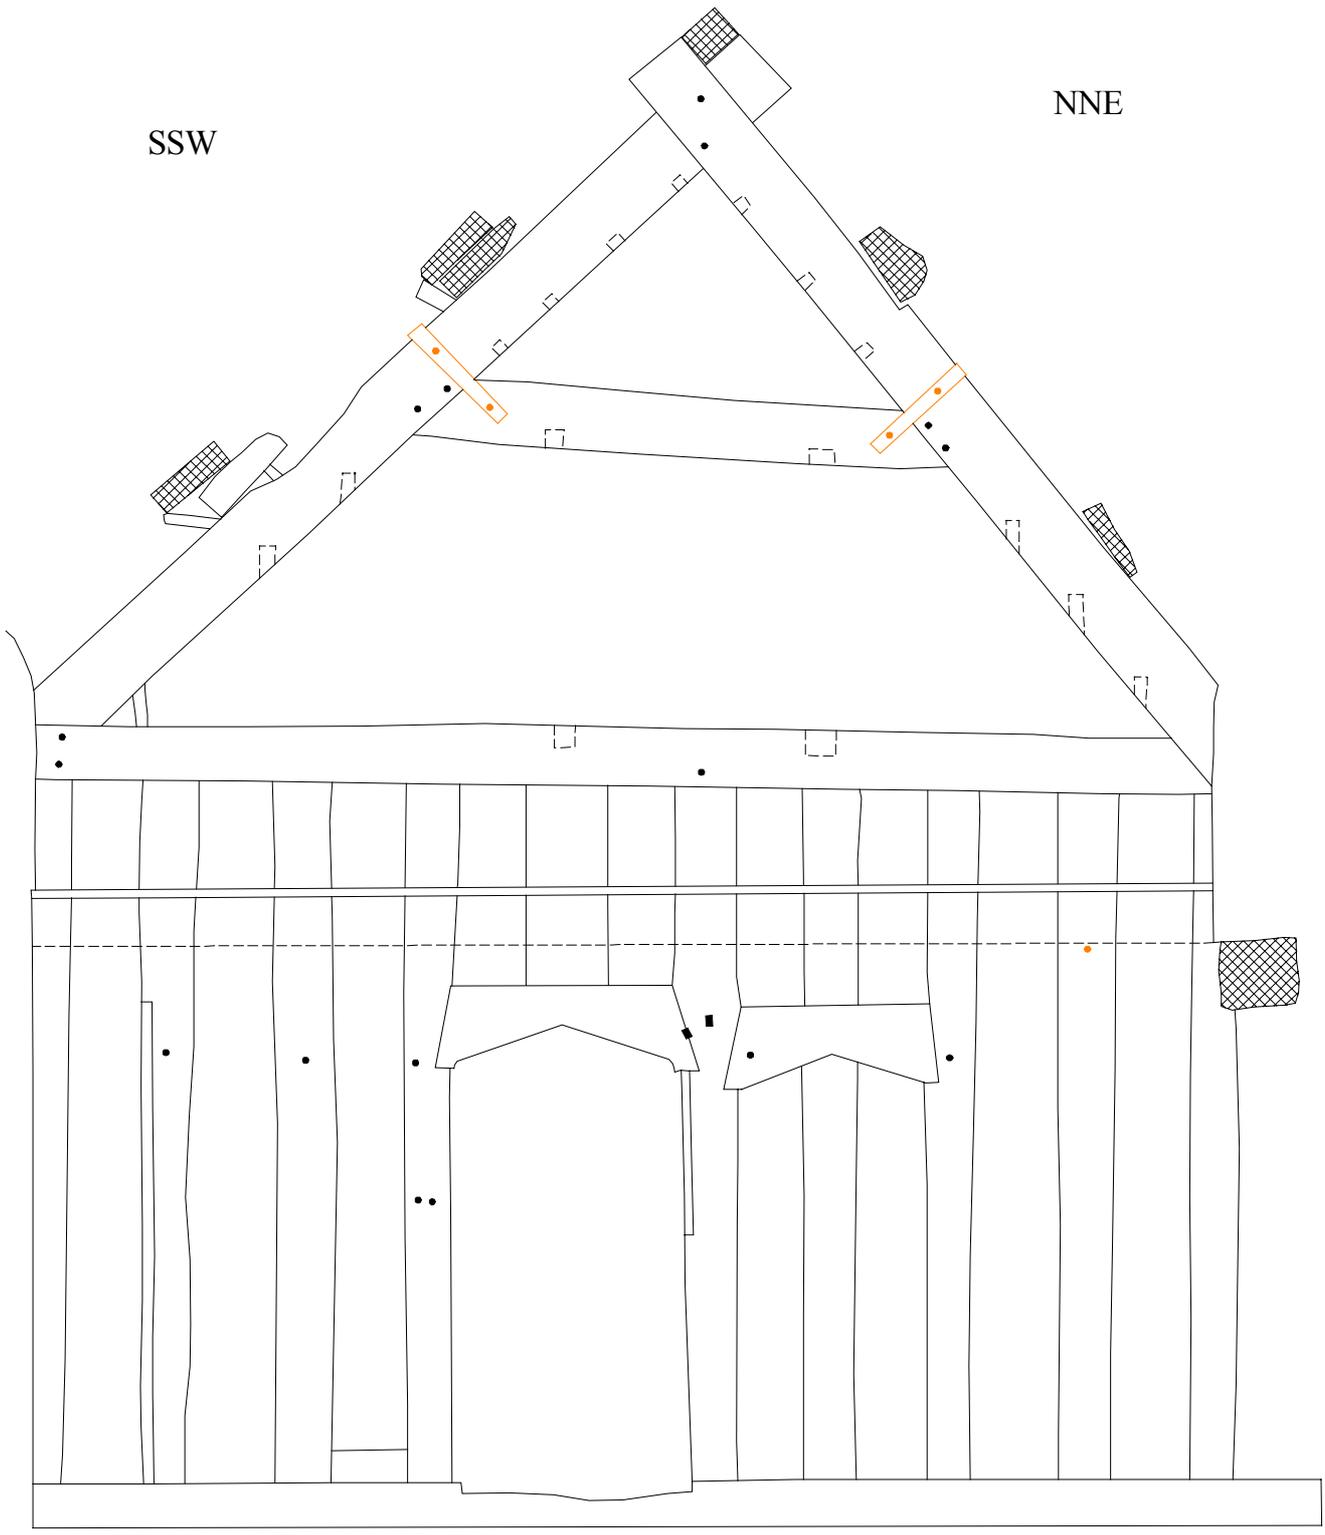
**Plate 34: Truss 1, looking east**

On the first floor, the room above the hall has three trusses exposed. Truss 1 (Figure 5, Plate 34) has a simple collar and half lapped principal rafters. The purlins sit on top of the principal rafters and are pegged to keep them in position. The lower northern purlin also has a peg below the purlin supporting it and a packing piece between the principal rafter and the purlin. The space below the truss had a wattle and daub partition with an access hatch. There

**Phase 1:** An open hall with post and plank partition at service end extending up to the height of the collar in Truss 1. Above this was probably a wattle and daub partition filling the space within the truss. It is likely that there was a further bay, at the upper end, possibly separated from the hall by a plank and post partition, the lower part of which may be still in position. The early date of 1474–88 from a joist in the hall (Bridge 2011) may be a reused joist from the upper end which was re-used when the hall was finally closed and the cross wing added.

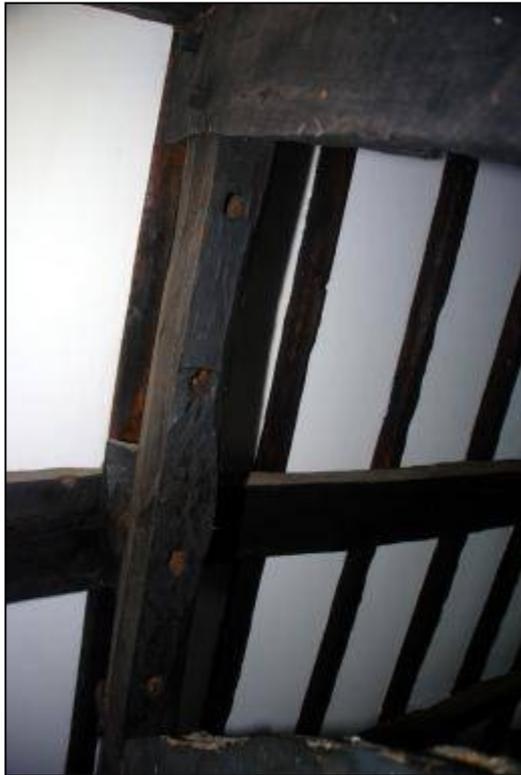
**Plate 35: The sockets for staves below Truss 1**

are a series of sockets for the staves of the partition (Plate 35) both above and below the collar and larger sockets for timbers in the bottom of the collar and in the top of the head rail of the post and plank partition. This defines the position of the possible hatchway. One of the staves for the wattle and daub partition survives below the collar (Plate 36). The top of the head beam of the post and plank partition (which extends into the ground floor where it defined the eastern side of the cross passage) also has a groove to secure the lower portion of the missing partition (Plate 37).

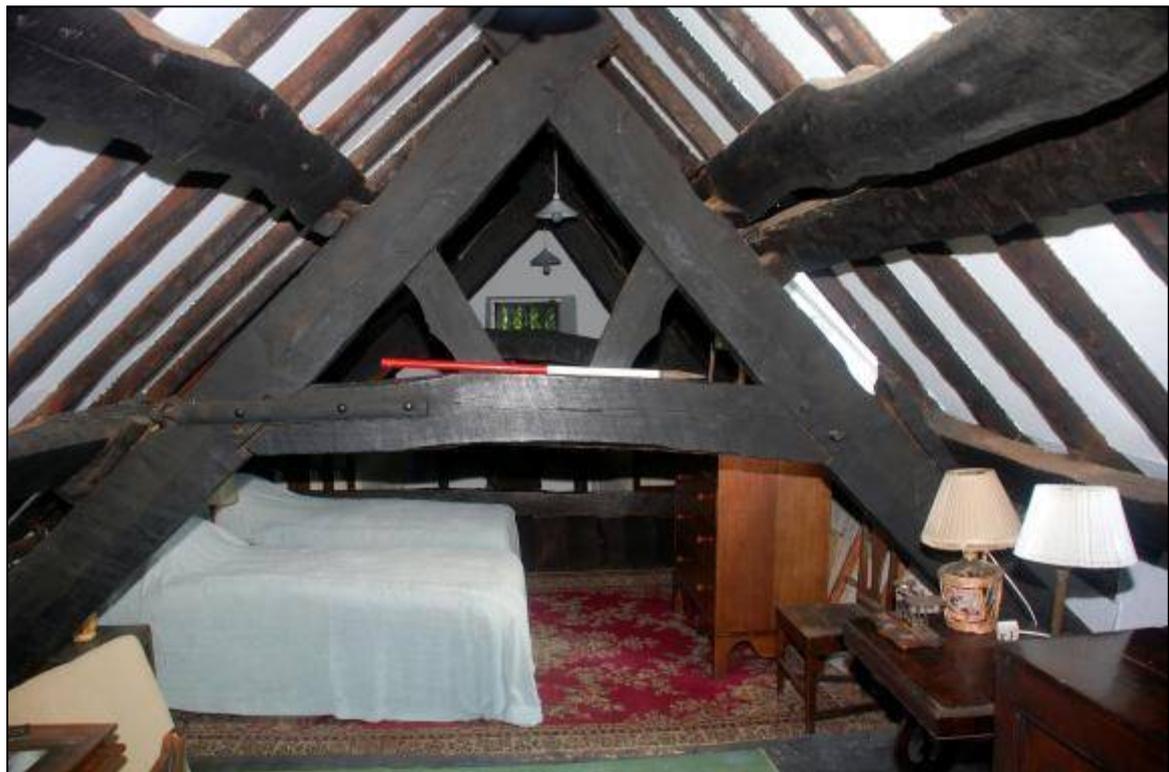
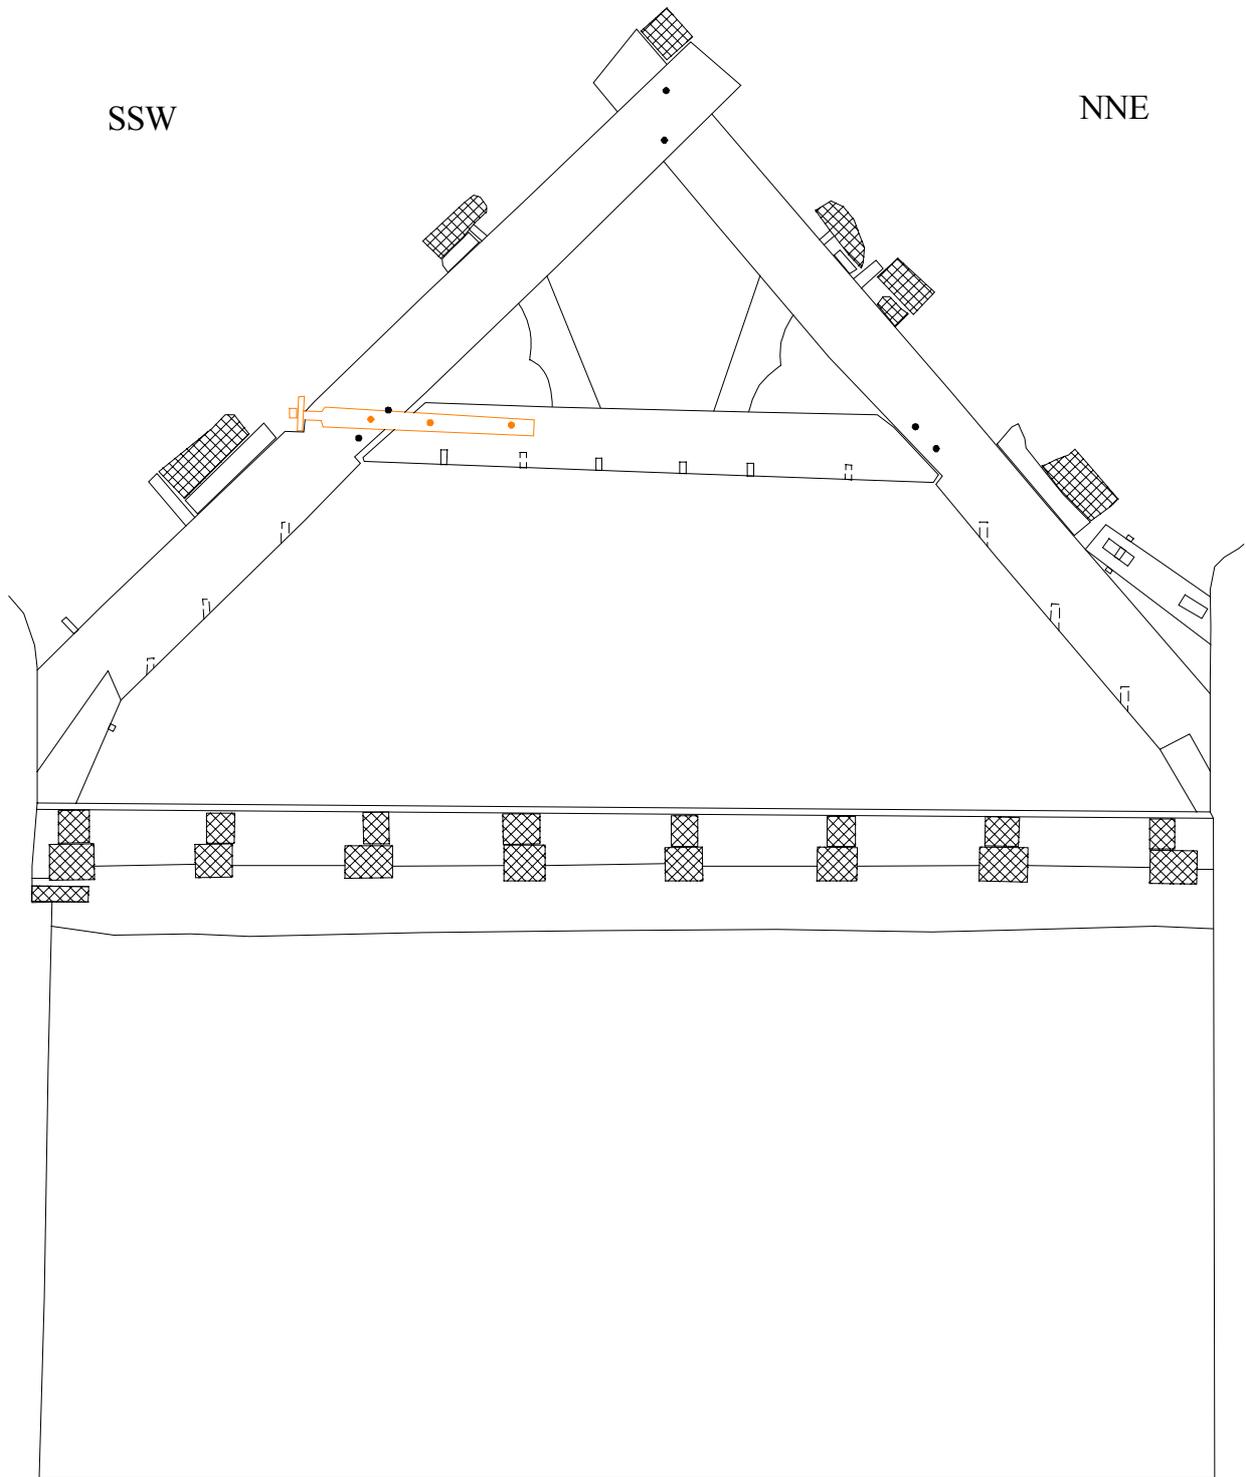
**Plate 38: Truss 2, looking east**

Truss 2 is distinctive having cusped, splayed braces between the collar and the principal rafters (Figure 6, Plate 38). The principal rafters are half lapped at their peak with a ridge purlin running between the overlap. At their foot, however, they are grafted to timbers (Plates 39, 40) which are, either the remains of earlier principal rafters, or repairs of the current principals. The purlins are pegged to the principal rafters, although the lower purlins have packing pieces below them. The northern, lower, purlin also has a separate peg below, it giving it more support (Plate 41). There is also a short, re-used, timber running between the southern blade of the truss to the wall. This is pegged into the principal rafters and has two mortice holes in its width (Plate 42). There are a series of dowel holes below the collar which suggest that there was a wattle and daub partition below this truss at some point (Plate 43).
