# North West Wales Dendrochronology Project Cymryd Isaf, Gyffin, Conwy

**EAS Client Report 2011/10  
June 2011**

# **North West Wales Dendrochronology Project Cymryd Isaf, Gyffin, Conwy**

**By  
I.P. Brooks**

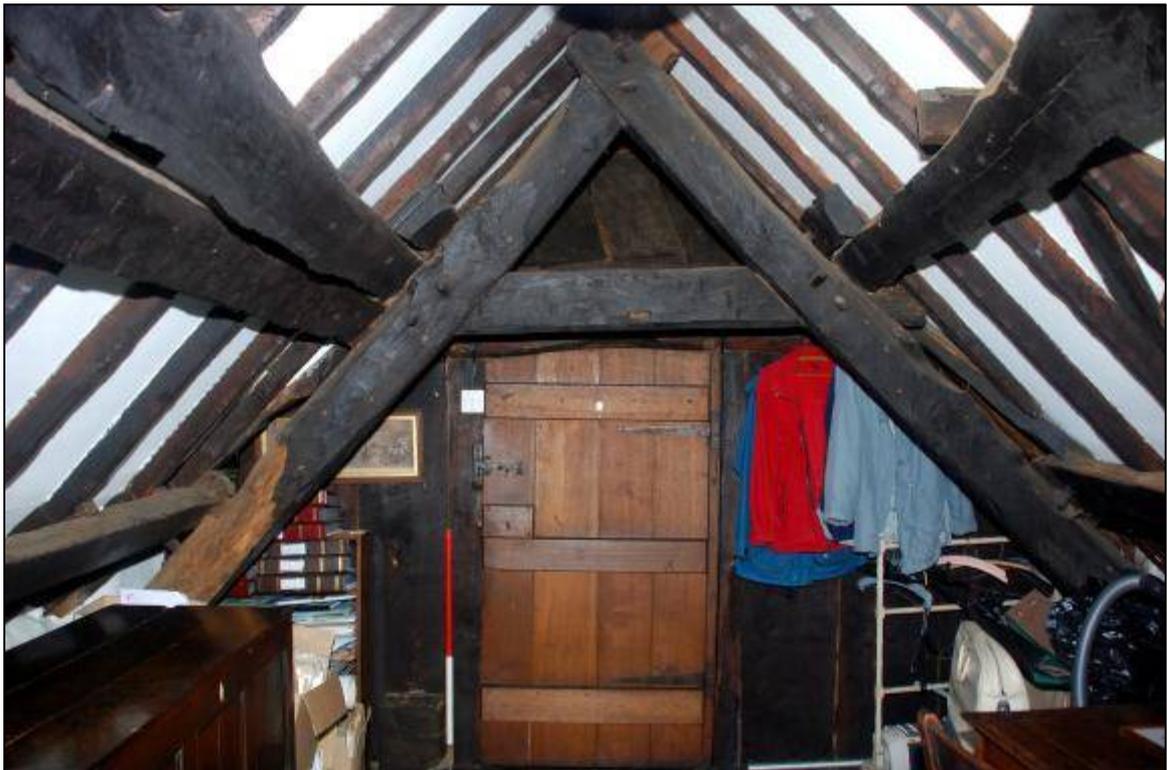
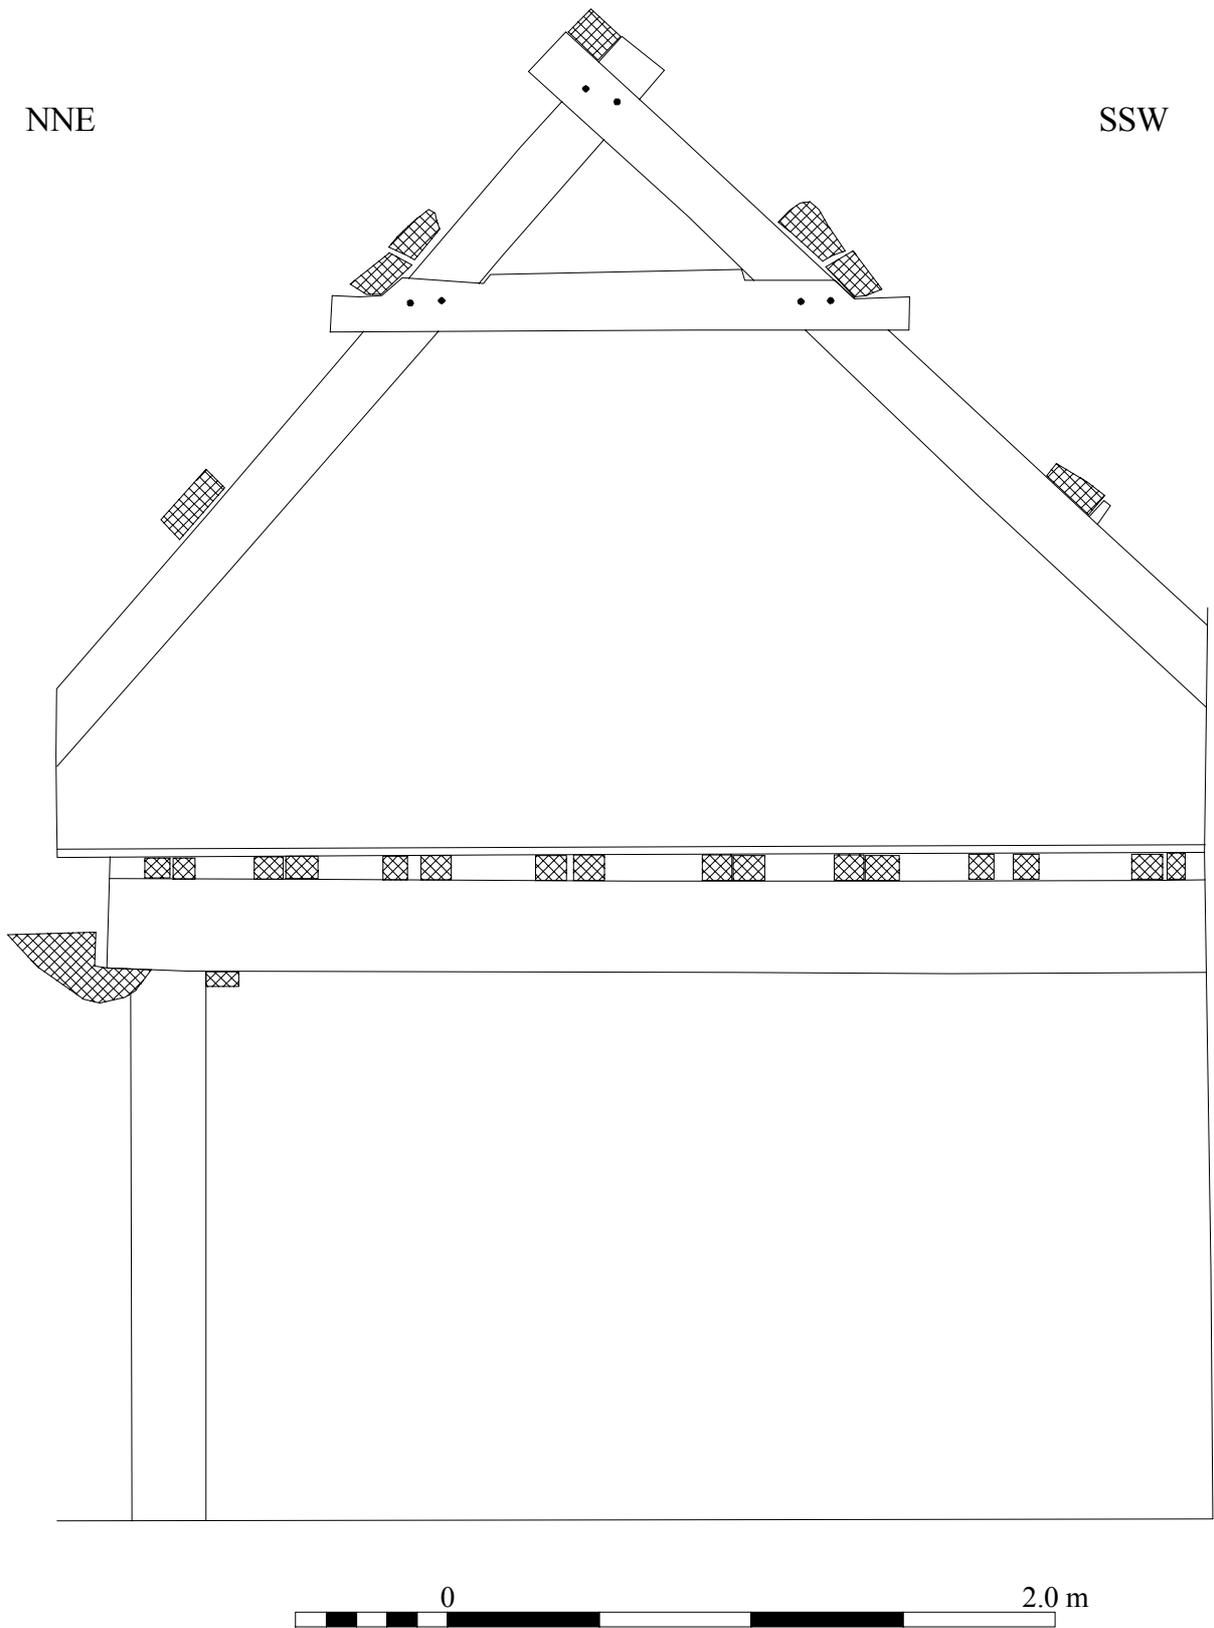
**Plate 44: Truss 3, looking west**

Truss 3 (Figure 7, Plate 44) has a high collar, allowing access to this room from the staircase. The purlins rest on to the principal rafters and are pegged through their width into the principals. The lower southern purlin also has a separate peg supporting its lower edge. The principal rafters are half lapped at their peak and the ridge purlin rest between the overlap. It is possible that this truss is later than Trusses 1 and 2, having been inserted to allow unimpeded access to the room above the hall.

**Phase 4:** Addition of the cross wing and the closing of the hall. This involved the removal of the upper end of the hall and replacing Truss 3 in the hall with a truss with a high collar to allow access from the staircase in the cross wing. As part of this, a beam was inserted, below Truss 3 which cut into the bressumer of the lateral fireplace.

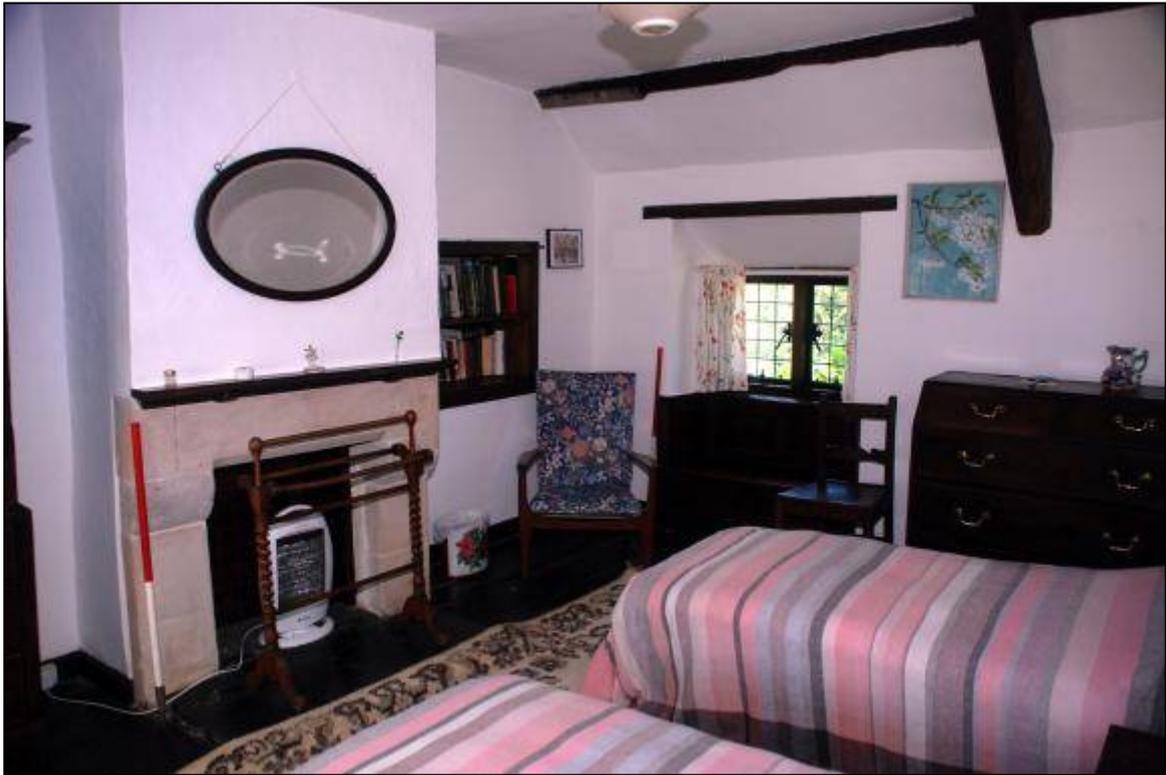
**Plate 45: The fireplace in the southern bedroom of the cross wing**

The cross wing is divided into two bedrooms on the first floor. The southern bedroom has a fireplace on the southern gable wall (Plate 45). Within both of the bedrooms the ceiling is at the level of the lower purlins and thus the principal rafters of Trusses 4 and 5 extend into the bedrooms below (Plates 46 and 47). The nature of the wall between the two bedrooms is uncertain; however the partition between the staircase and the northern bedroom has a series of studs separated by wattle and daub panels (Plate 48). The nature of the wattling is shown in an exposed section on the staircase (Plate 49), it has horizontal staves and vertical withes. The door frames to the bedrooms have scroll stops on their uprights (Plates 50, 51).

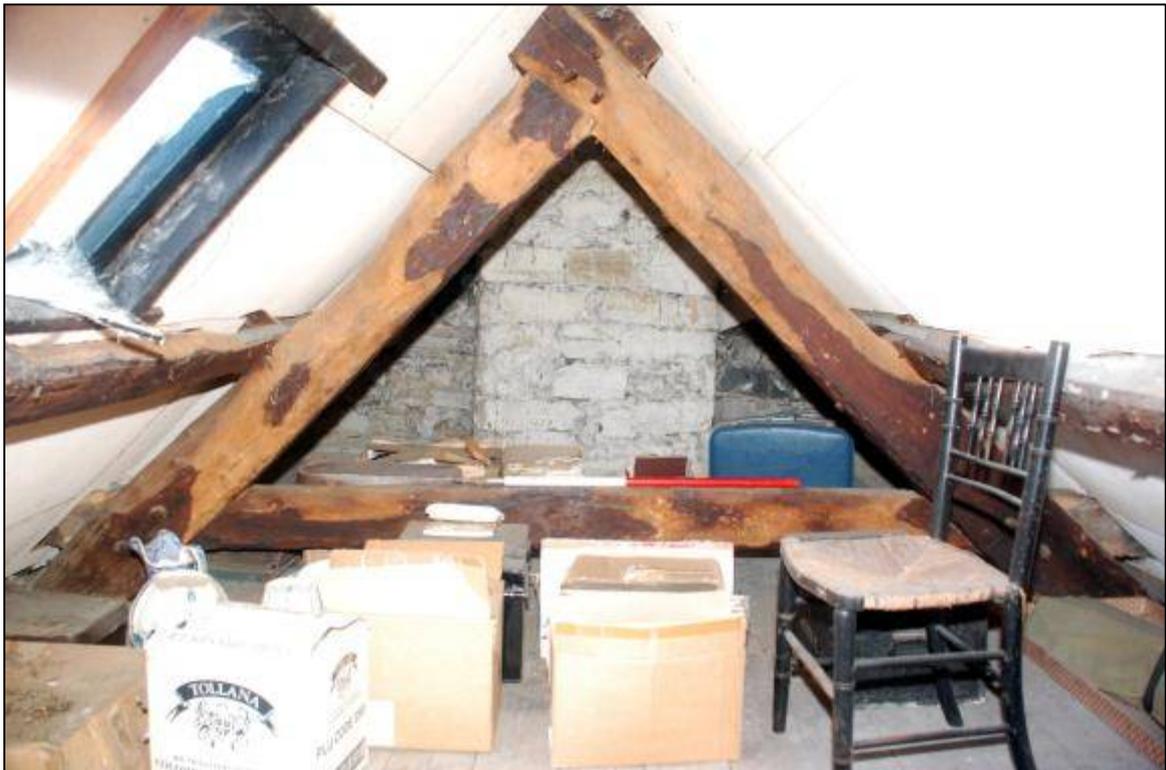
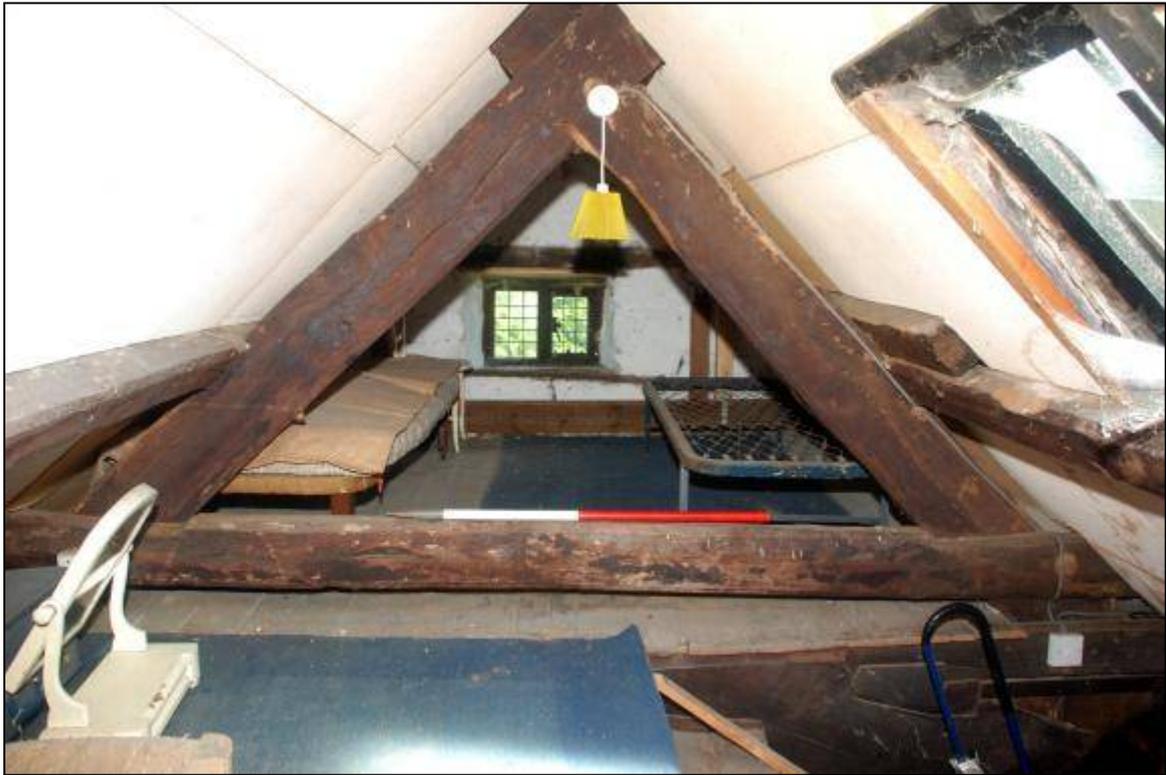
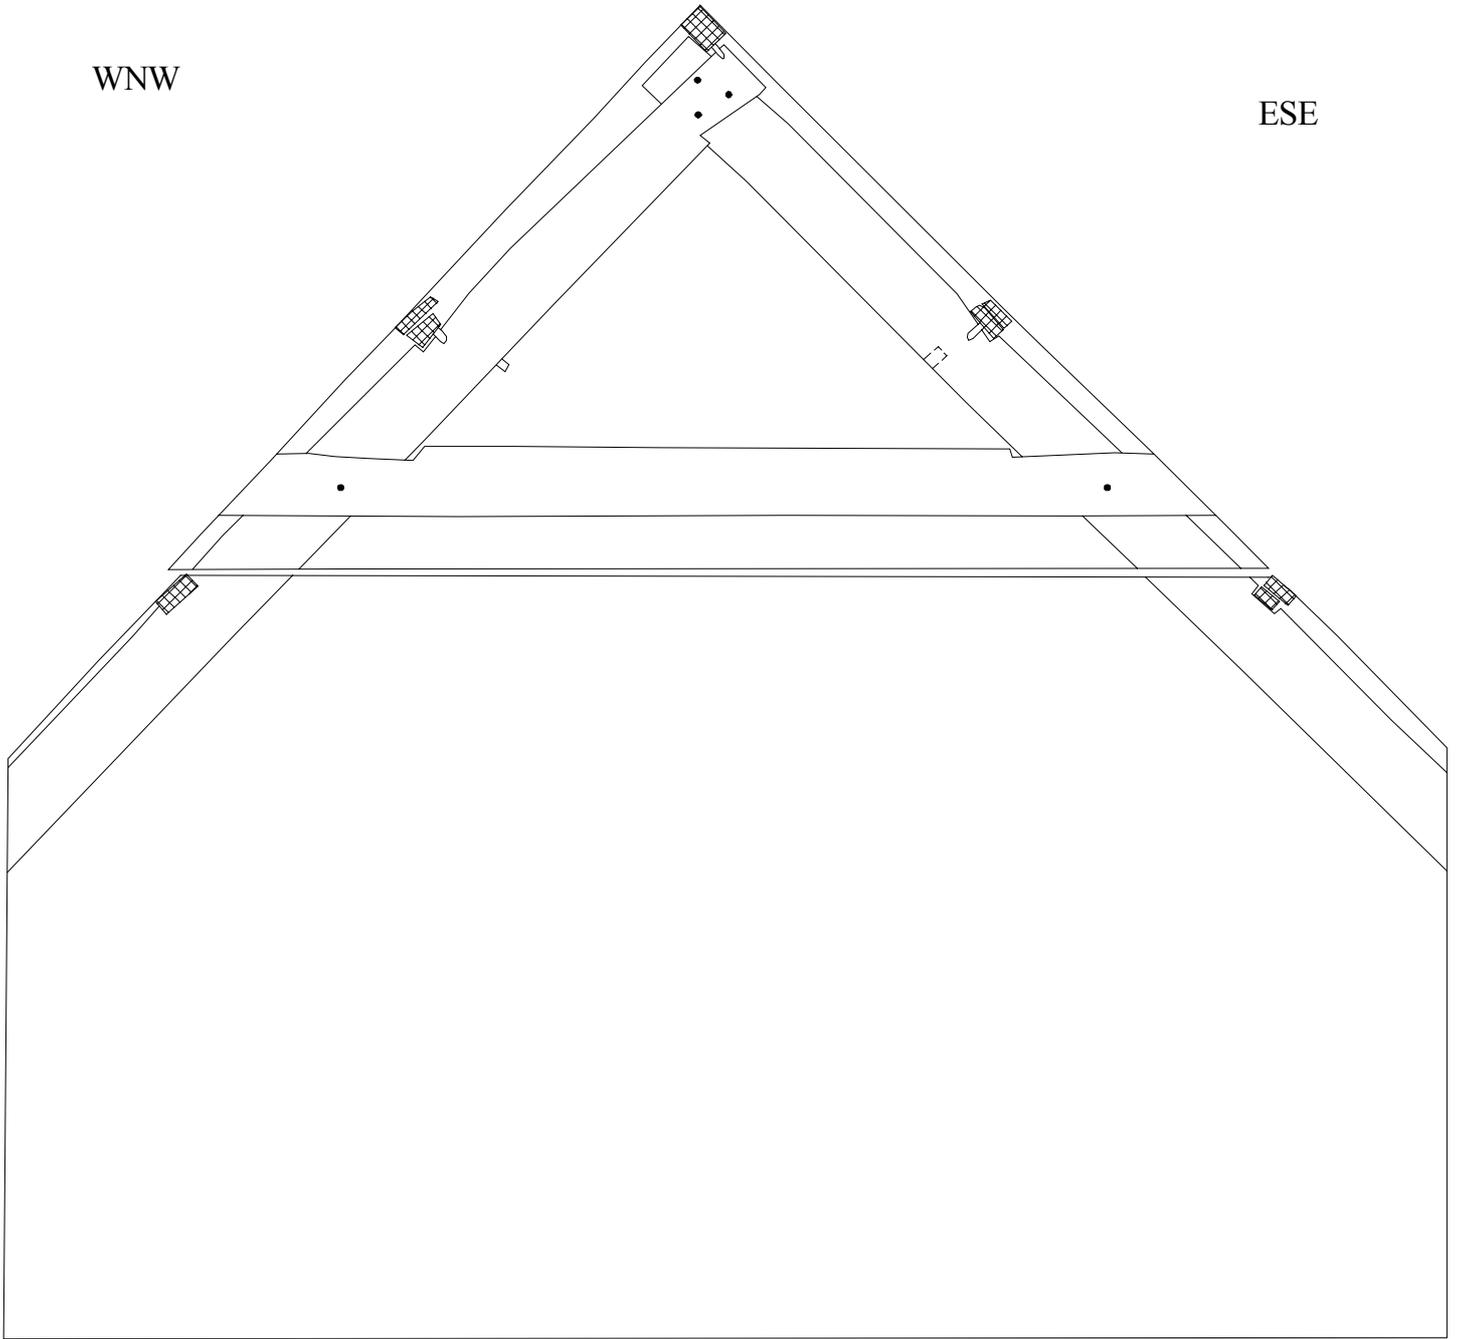
In the attic of the cross wing there are two trusses (Figures 9 and 10, Plates 52, 53). Both of these trusses are relatively simple with collars which extend beyond the extent of the principal rafters. The principal rafters are joined by notched-lap joints which are pegged and the purlins are housed in shallow trenches. There would appear to have been some access to the attic as the upper purlins are chamfered and have run out stops where they meet the trusses. (Plate 54). Another possibility is that these purlins are re-used rafters from elsewhere.

There is some evidence that the attic to the cross wing was much more heavily used as the purlins are chamfered and have run out stops, although where the access point to this space is unknown. The quality of the work on these purlins may also suggest that the space may have been used by a member of the family rather than servants.

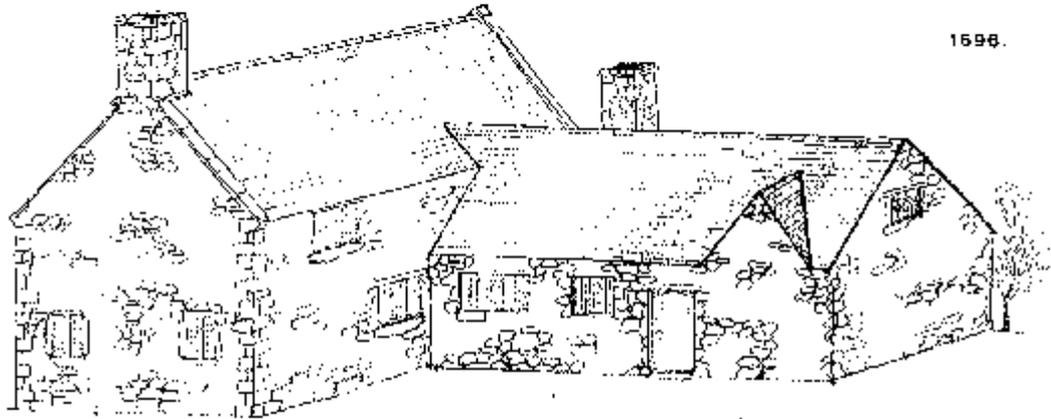
Reconstruction Sketches.

What was built as an extension in a later and cruder style appears to have been restyled in the late 19th century in order to blend better with the 17th century features of the earlier wings.

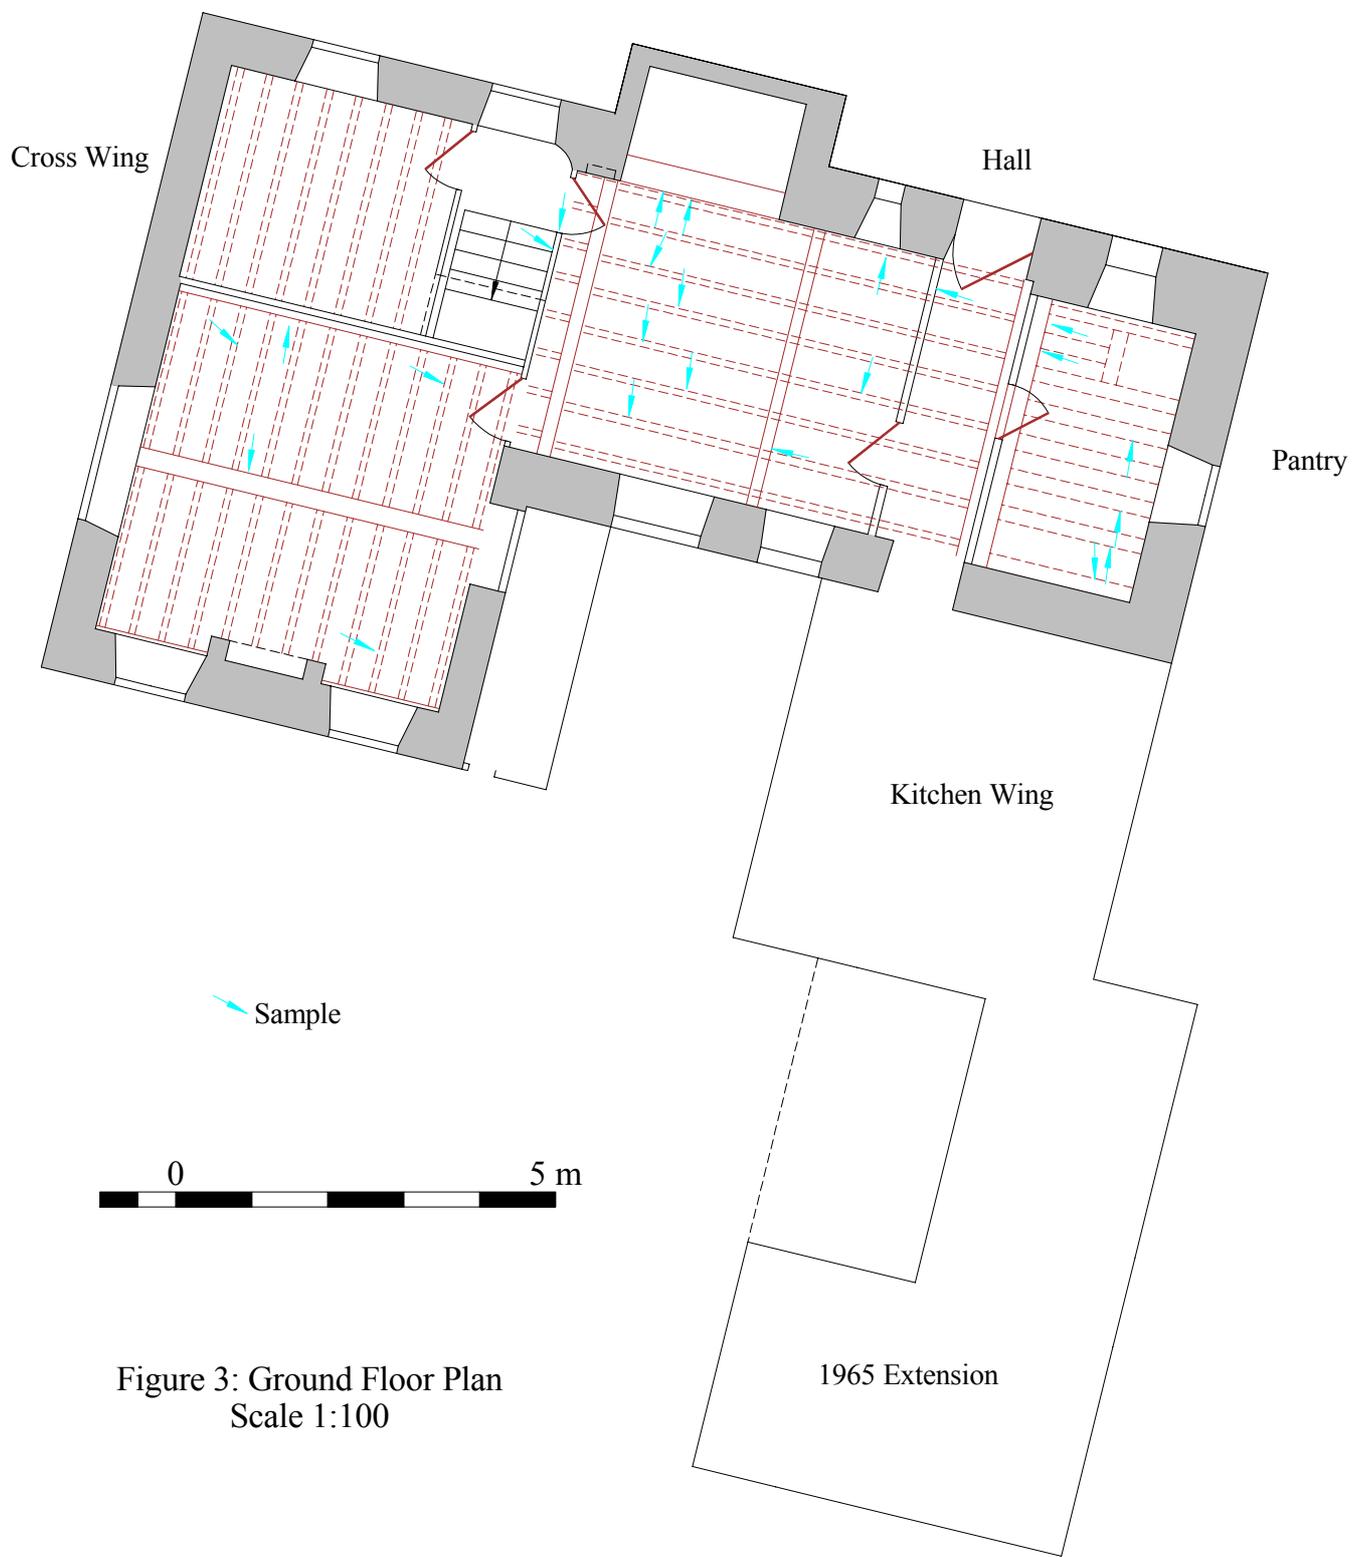
Figure 3: Ground Floor Plan  
Scale 1:100

The house consists of four major elements (Figure 3). The original house was a single storey hall aligned approximately WNW – ESE, to this a cross wing was added at the western end (Plate 1). More recently, although before 1890 (Figure 2), a kitchen wing was added to the eastern end and in 1965 this kitchen wing was extended.

Internally, the ground floor of the hall (Figure 3) is divided into two rooms and a cross passage. The pantry at the eastern end of the hall is divided from the cross passage by a post and plank partition (Figure 5, Plate 11). This extends into the room above (Plate 12) demonstrating that it was in existence before the insertion of floor. Sitting directly below Truss 1 the partition is constructed of upright planks, approximately 0.24 m wide, supported by intervening posts 0.17 m wide (Plate 11). Both the post and the planks are also retained by rails at the top and bottom of the partition. Two doorways originally pierced the partition, although only one of these remains open. Both doorways have wooden door heads with depressed pointed heads which are grafted into posts within the partition (Plates 13 and 14). The northern door is still open (Plate 13), whilst the southern door has been blocked with similar post and planking and the rest of the partition (Plate 14). It is also noticeable that the southern (blocked) door head is set approximately 0.1 m below that of the northern head. The reason for two doorways is uncertain as there is no evidence for the pantry having been divided and it is possible that the northern doorway was only ever a dummy. Within the pantry, a trimmer joist marks the position of a hatchway which presumably allowed access to the room above. It is thought that a floor was inserted at this end of the hall at an early stage, but that this loft only extended partly across the length of the hall, a view which is supported by the step in the floor levels seen in the upper floor room between Trusses 1 and 2 and in the two levels of joists seen in the main room of the hall (Plate 15)
