**North West Wales Dendrochronology Project**  
**Llanerch y Felin, Rowen, Conwy**  
**NPRN 26709**

**EAS Client Report 2012/11**  
**December 2012**

## **Llanerch-y-Felin**

This report details the recording of Llanerch-y-Felin, Rowen, Conwy, undertaken to compliment both the dendrochronological sampling, undertaken by Oxford Dendrochronology Laboratory, and the documentary study undertaken by volunteers for the North Wales Dendrochronology Project. The fieldwork took place on 10<sup>th</sup> December 2012. The house is listed as Grade II\* as a late sixteenth century storied house retaining much of its original interior detail ([http://jura.rcahms.gov.uk/cadw/cadw\\_eng.php?id=3175](http://jura.rcahms.gov.uk/cadw/cadw_eng.php?id=3175)). It is also described in the Inventory for Caernarvonshire (Royal Commission on the Ancient Monuments in Wales and Monmouthshire 1956, 25-26) and is mentioned in Haslam, *et al.* (2009, 514 - 515). It is also noted in Smith (1988 175, Figure 82) and Hughes and North (1908, 39, 46 and xxxvi). This report only covers the front range of the building which was dated for the project.

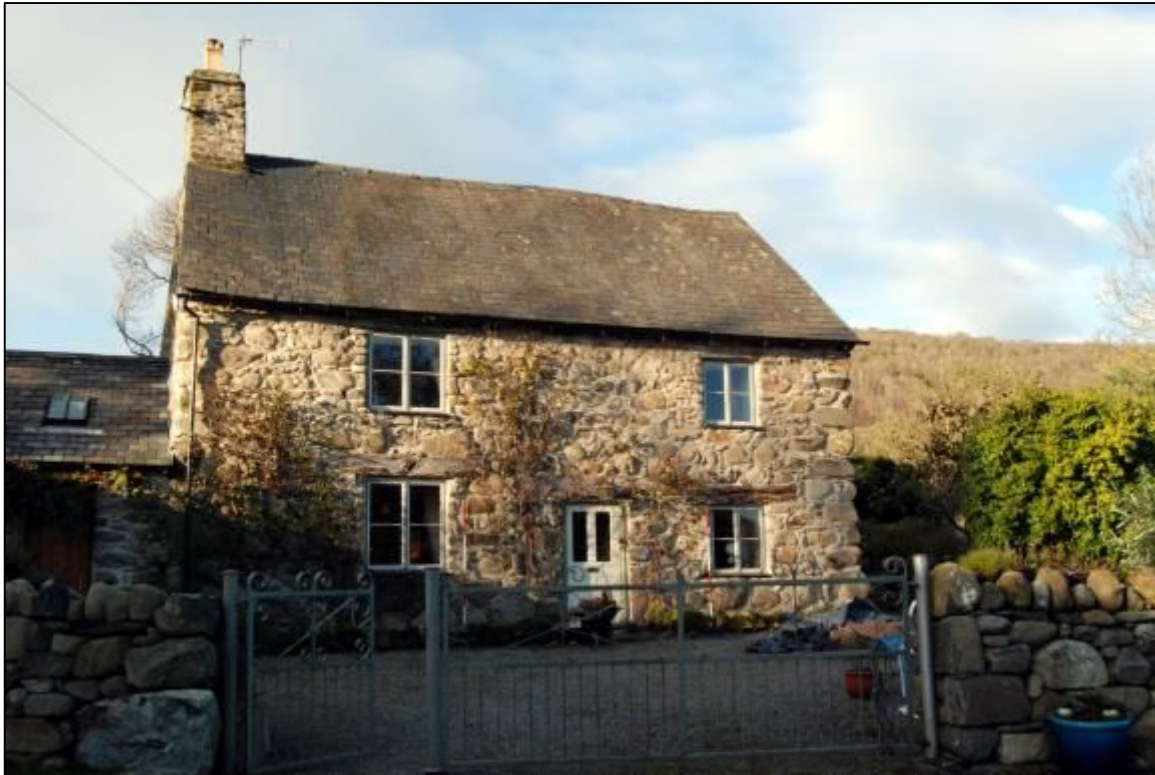
Plate 1: Front elevation

The front elevation (Plate 1) has modern replacement windows occupying earlier openings. The lower openings all have large oak lintels (Plates 4 – 6). These are arranged at slightly different levels with each of the lintels being slightly lower to the south. The lintel over the centrally placed front door (Plate 5) extends noticeably to the north suggesting that the original opening was much wider. This view is supported by the narrowness of the wall to the north of the doorway (Figure 3).

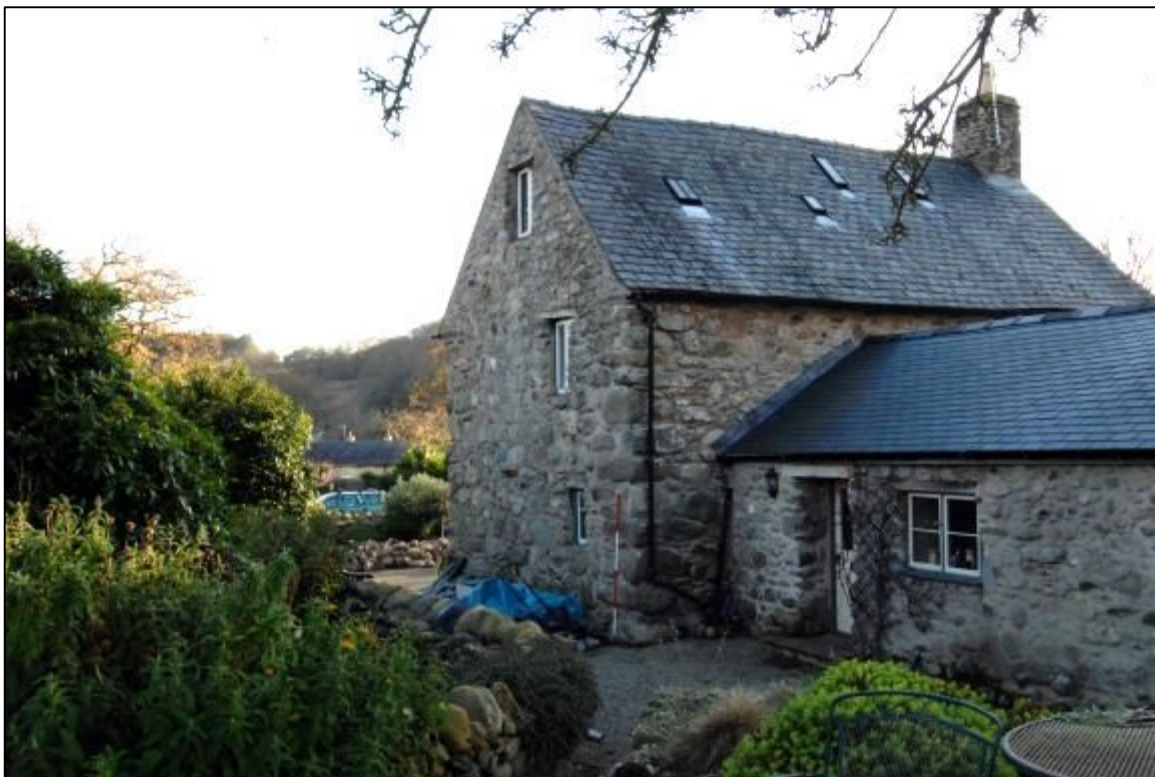
Plate 2: The northern gable end

The northern gable end has three window opening, each lighting a different floor. Once again these contain modern replacement windows, although they are probably in earlier openings. There is a marked bulge in the wall at first floor level associated with the window which might suggest this window may have been replaced.

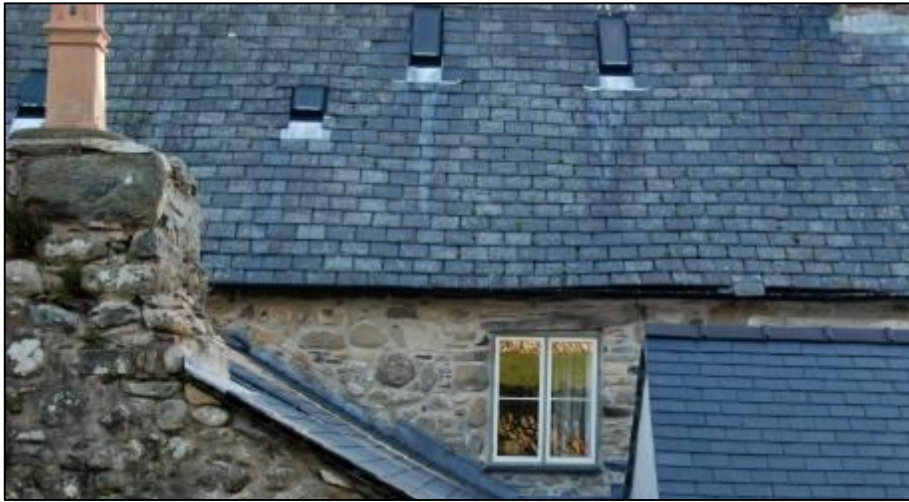
Plate 8: Window in the rear elevation

The rear of the building is largely masked by later extensions (Plate 7), although a single window giving light to the first floor landing is visible (Plate 8). This has a slightly twisted oak lintel, although the window itself has been replaced.

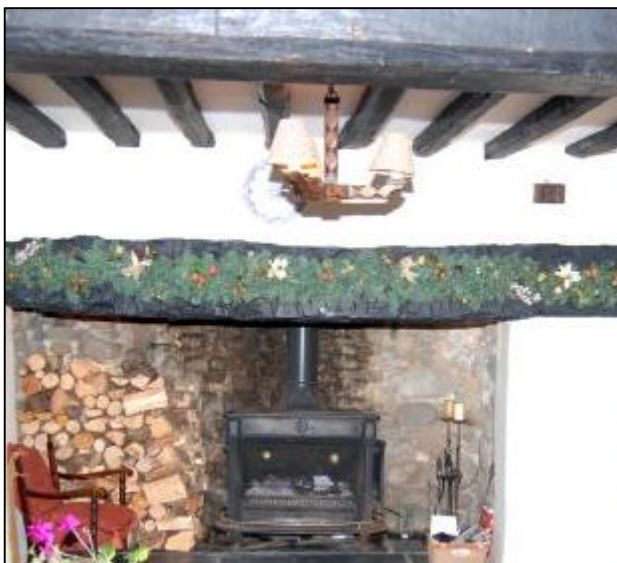
Plate 9: The fireplace in the ground floor hall

On the ground floor (Figure 3) the house is divided into two rooms by a post and panel partition. To the south is a ground floor hall. This is dominated by large open fireplace with a heavy bressumer (Plate 9) which extends from the eastern wall of the house to the edge of the partially blocked stair to the west (Plate 10). Originally the site of a winding mural stair adjacent to the fireplace, it was partly cut into the western wall and southern gable. The opening for this feature is braced with a diagonal beam from the end of the bressumer to the western wall of the house. The staircase can be traced in the structure of the house leading to the attic suggesting that at least one end of the first floor was ceiled. The ceiling of the ground floor hall has a central beam which is moderately chamfered and has straight stops (Plate 11). The joists, however, are also chamfered, but have ogee stops (Plate 12) and are coggled into the main beam.

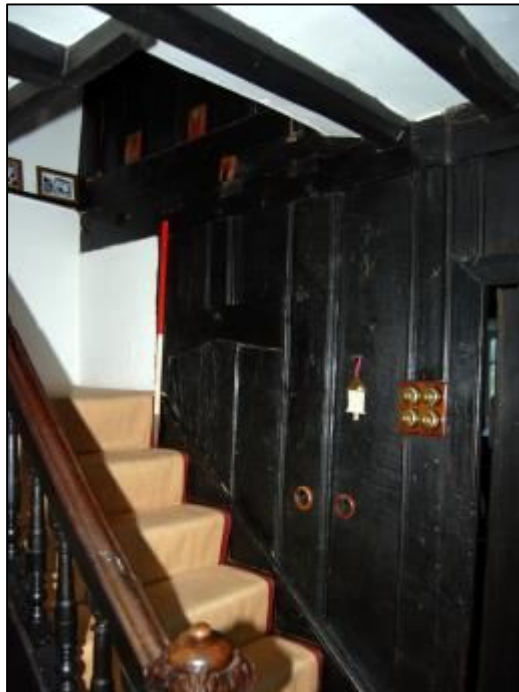
Plate 15: Doorway blocked by the staircase

The staircase blocks an original doorway in the partition between the ground floor hall and the parlour, which is now used as a dining room (Plate 15). The door head (Plate 16) has a flattened pointed arch of sixteenth century type (Alcock and Hall 1994, 20). The partition originally spanned both the ground and first floors, although on the first floor level it is now largely recorded by a series of peg holes in one of the ceiling beams. On the ground floor level, the face onto the hall has posts with reed- moulded edges (Plate 17), although the panels are plain. At the western end of the partition there are a series of stamped carpenter's marks (Plates 18 – 20) identifying each of the posts. The partition has been cut by a centrally placed, later doorway which was presumably constructed at the same time as the stairs were inserted.

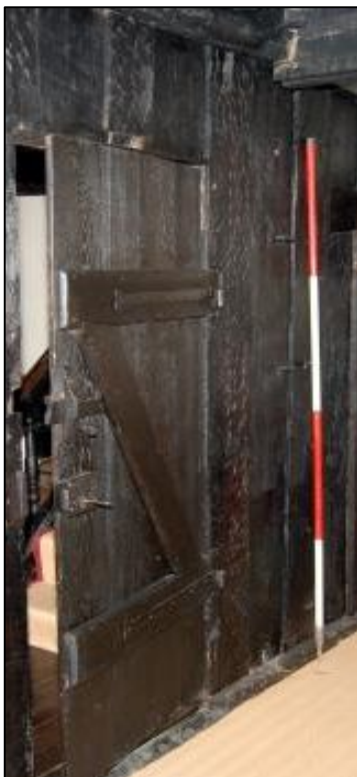
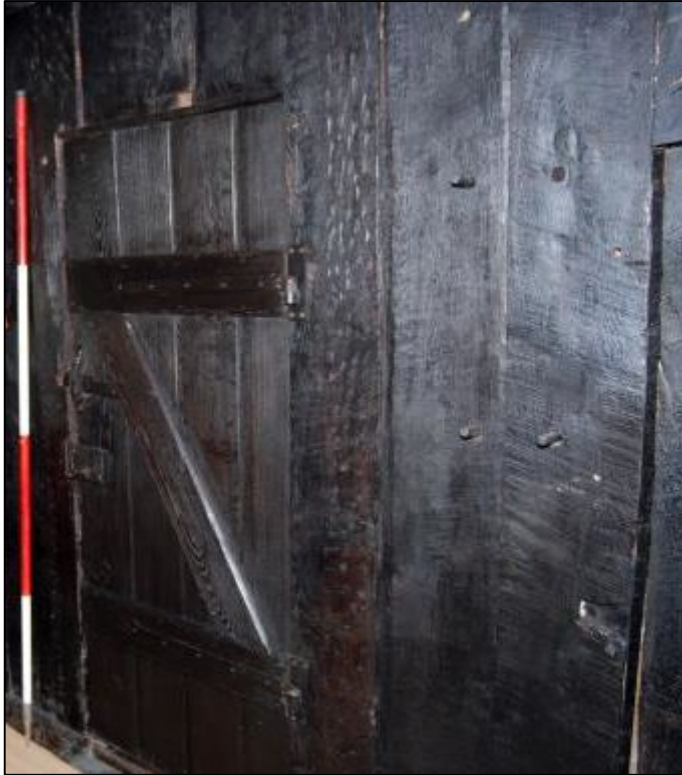
The parlour shows the back surface of the partition (Plates 21 and 22) showing the full extent of the blocked doorway (Plate 23) and a further later opening which gave access to the under stair space. What is now a single room was originally divided in two with a partition as is shown by the joist with a slot in its lower surface (Plate 24). As with the hall the joists in this room are chamfered and have ogee stops (Plate 25).

Plate 21: The partition in the parlour looking SW

Plate 22: The partition in the parlour, looking SE

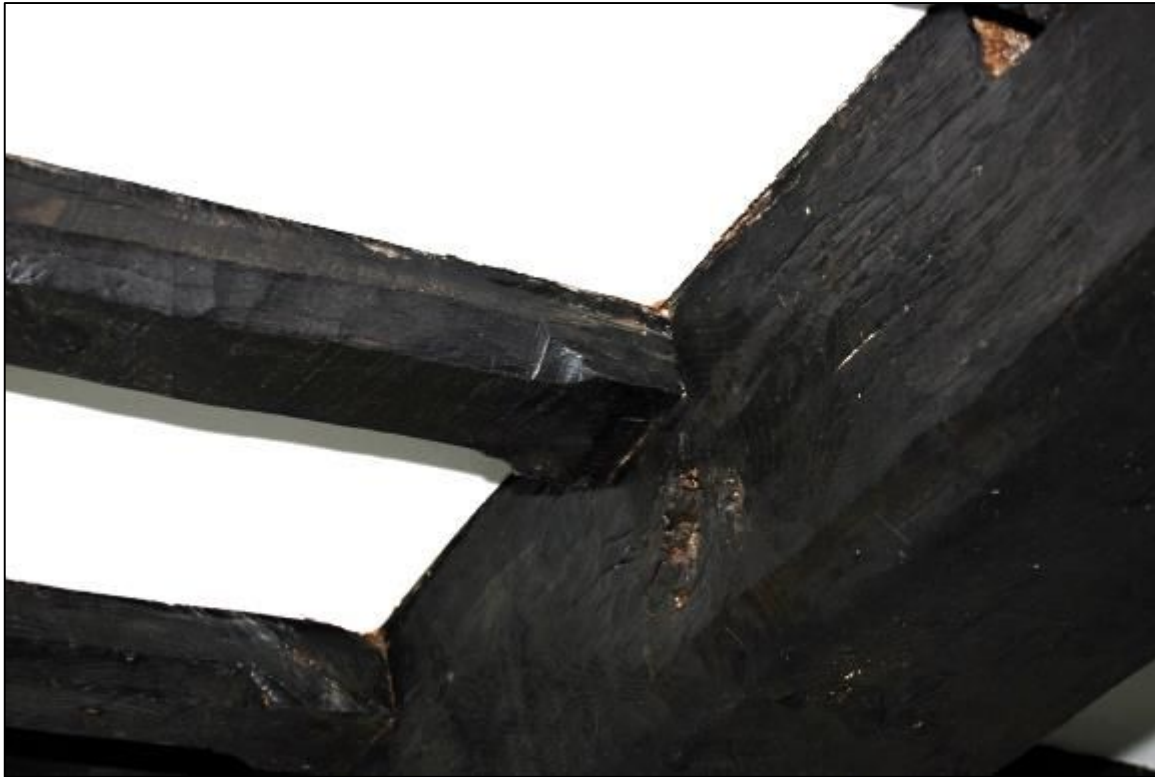
Plate 28: The joists in the bathroom

The first floor (Figure 4) now consists of three bedrooms and bathroom opening off a landing. The bathroom is in the south western corner of the house and includes the sub-circular chamber which originally held the mural staircase (Plate 26). Over this space is a ceiling beam set at an angle supporting the floor of the attic and a short spacer which defines the southern end of the rafters (Plate 27). The rafters are all chamfered and have ogee stops (Plate 28).

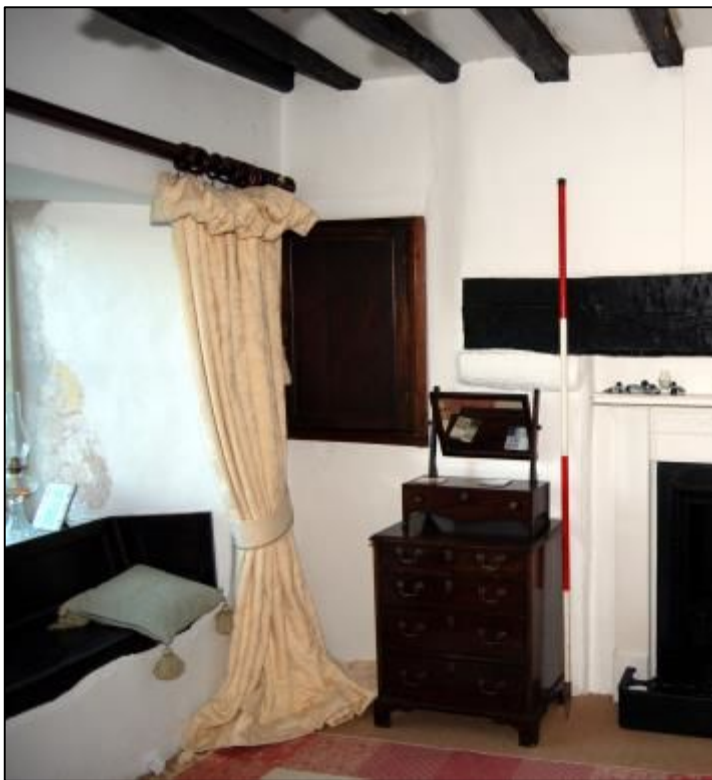
Plate 29: South eastern bedroom

The south eastern bedroom (Plate 29) has a fireplace with a wooden bressumer on its southern wall. This feature sits uncomfortably with the partition forming the western wall of the room demonstrating that this partition is a later feature. On the same wall as the fireplace and slightly to the east is a cupboard (Plate 30). This is reputed to have originally had a carved door (Chambers *pers. comm.*), although it now has much plainer furniture. The ceiling beam in this room runs through the western wall and across the landing. It is chamfered and has stepped stops (Plate 31). The associated joists are also chamfered but have simple straight stops (Plate 32).

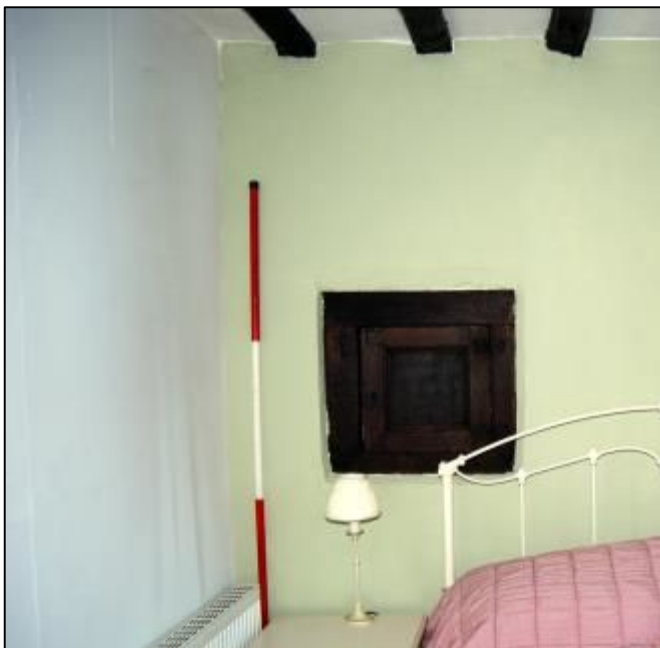
Plate 33: The north eastern bedroom, looking north

The north eastern bedroom (Plate 33) also has a built in cupboard, the door and frame of which, however, is of cruder work than that in the south eastern bedroom (Plate 34). It has handmade, butterfly hinges similar to seventeenth and early eighteenth century types illustrated by Alcock and Hall (1994, 24). The

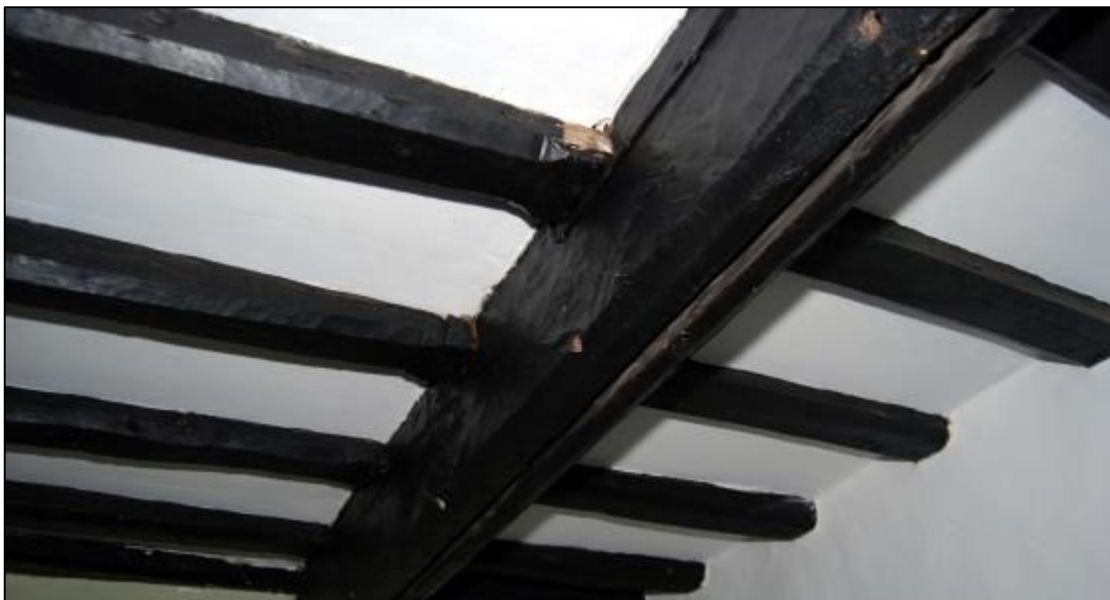
Plate 35: The ceiling beam in the north eastern bedroom

ceiling beam is chamfered and is slotted to take a partition (Plate 35). The joists in this room are also chamfered and have ogee stops (Plate 36).

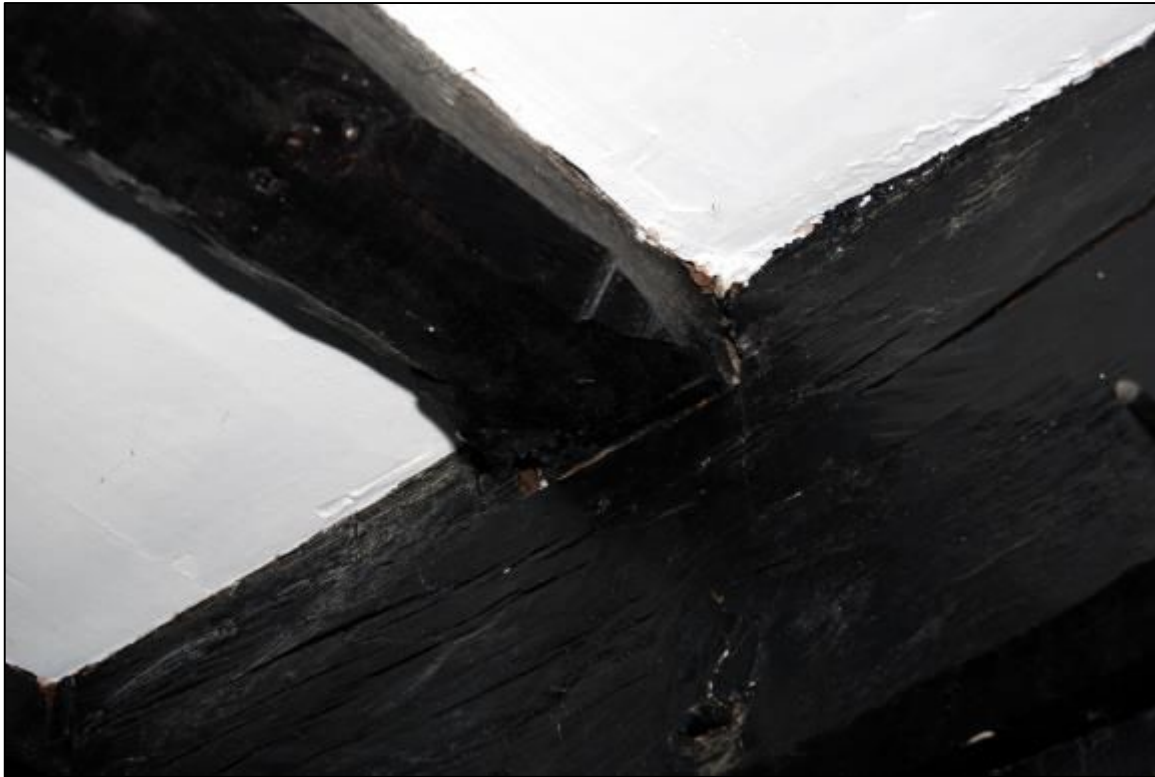
Plate 38: Detail of joist in the north western bedroom

Within the north western bedroom, part of the partition removed from under the ceiling beam in the north eastern bedroom survives. It is of post and panel construction without the reed mouldings seen on the ground floor (Plate 37). The joists within this room are similar to those elsewhere on this floor with moderate chamfering and ogee stops (Plate 38).

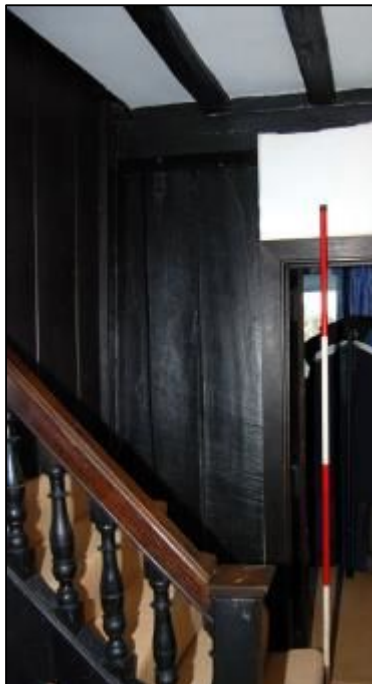
Plate 39: First floor landing

The landing (Plate 39) contains the staircase to the attic (Plate 40). This is simpler than that on the ground floor, retaining the turned balusters, but having a square sectioned newel with a flat cap. These stairs were constructed against the pre-existing post and panel partition which is partly exposed in the stairwell (Figure 7, Plate 41). The presence of sockets for floor joists within the stairwell also demonstrates that the current stairs are a secondary feature and that this part of the attic had a floor in the original design.

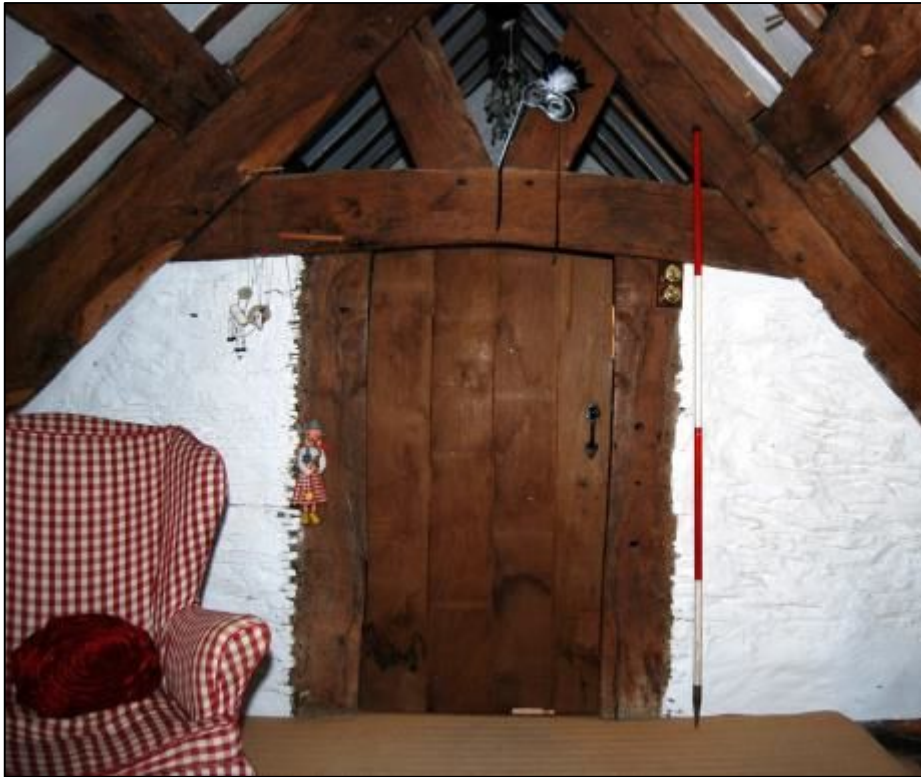
Plate 42: Wattle and daub partition below Truss 1

The attic is divided into three bays by Trusses 1 and 2 (Figures 6 and 7). The southern bay is a separate room defined by a wattle and daub partition below Truss 1 (Plate 42). Within the stair well, below Truss 1, there are the sockets for the rafters (Plate 43) originally sealing the floor of the attic and below this three upright panels which may be the remnant of a partition however these planks do not extend below this level.

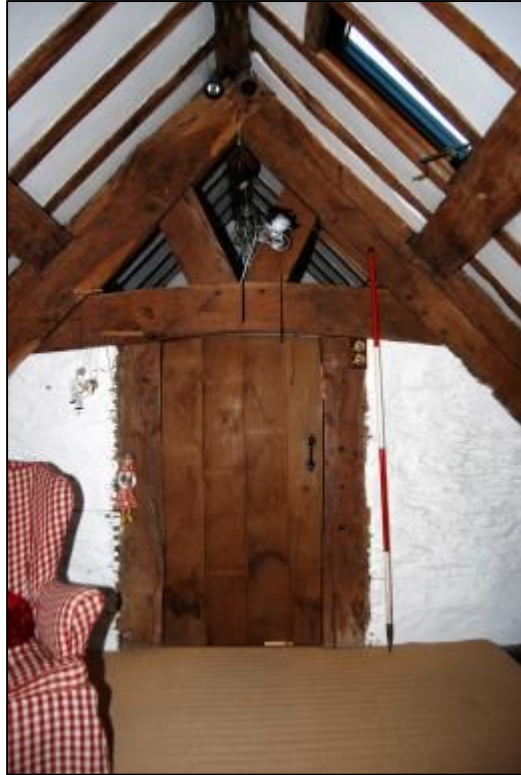
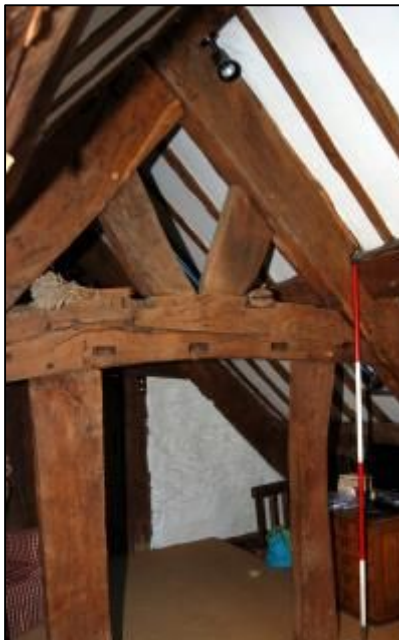
The two trusses are of similar design; both are cambered collar trusses with raking struts (Plates 47 and 48). On both trusses the purlins appear to be original and they are all trenched into the top surfaces of the tresses. On the southern face of Truss 1 are a series of struck carpenter's marks on the raking struts, collar and post for the doorway (Plates 49 and 50). These marks are relatively simple compared to those on the collar and struts of Truss 2 (Plates 51 and 52) which are a mixture of upright chisel strikes and scratched horizontals. The northern face of Truss 2 (Plate 48) has a series of sockets following the curve of the lower edge of the collar, possibly suggesting an elevated, slightly barrelled ceiling for the original bedroom below. The two further sockets cut into the top of the collar would also suggest there may have been a load bearing platform above the possible ceiling.

Plate 47: Truss 1 looking south

Plate 48: Truss 2, looking south east
