Discovering Old Welsh Houses

**North West Wales Dendrochronology Project
Coed y Ffynnon, Penmachno, Conwy
NPRN 26304**

EAS Client Report 2012/07

**By
I.P. Brooks**

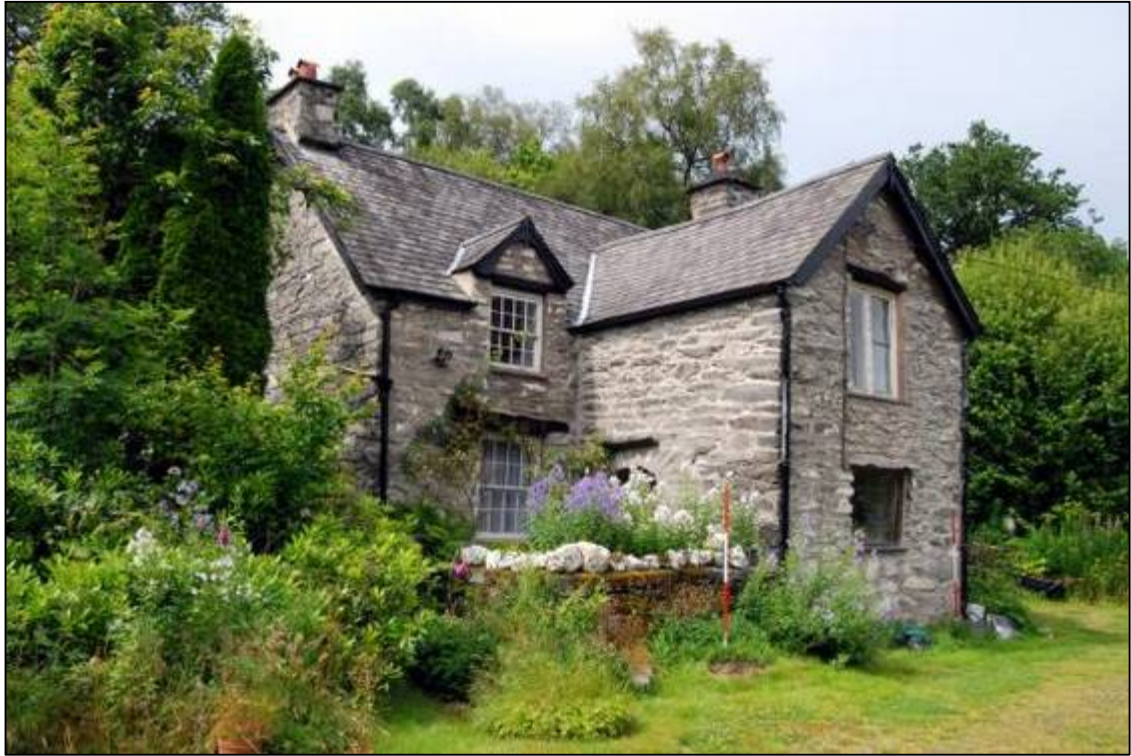
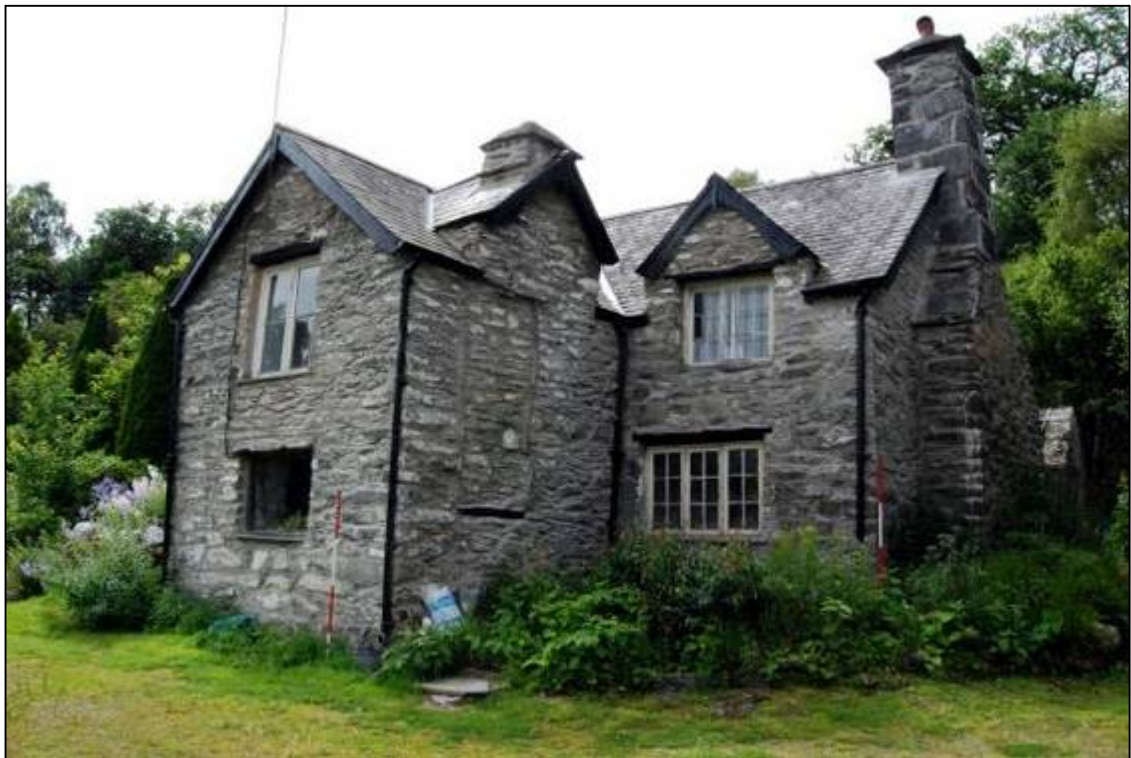
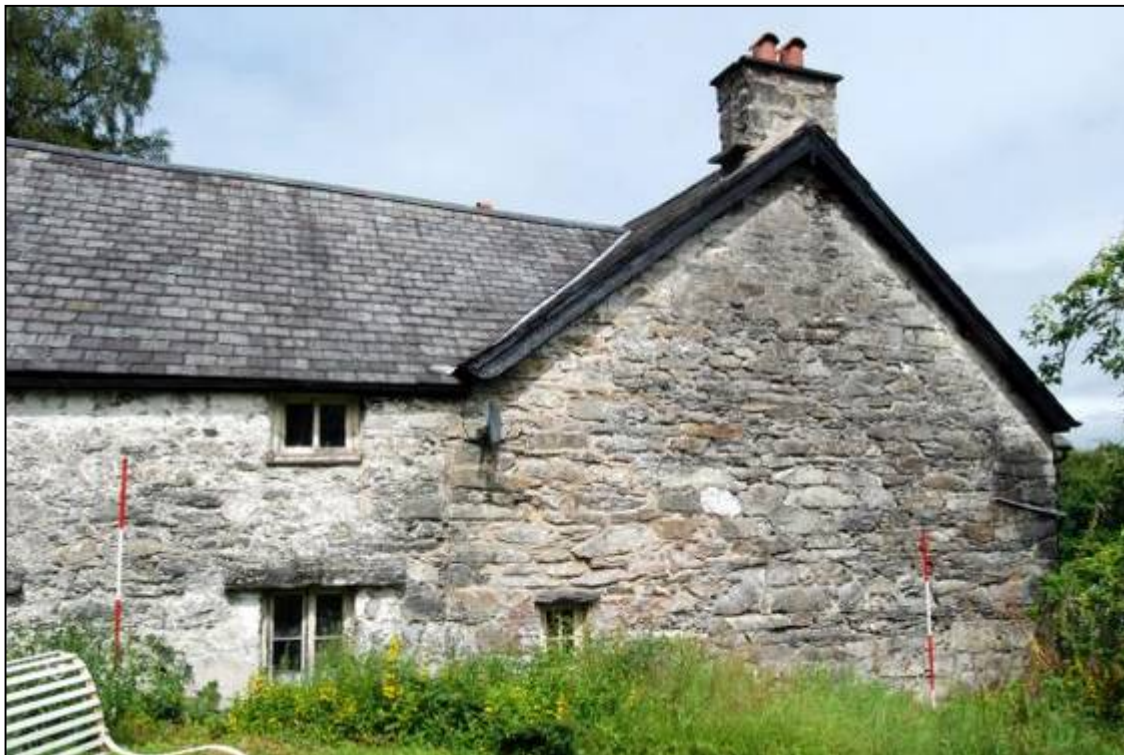
Plate 1: Front elevation looking north

The house is constructed of largely coursed stonework with little emphasis of the quoins (Plates 1 – 3). There is a projecting, shouldered chimney, with tall square stack; on the northern gable and a gable end chimney on the southern gable. It is

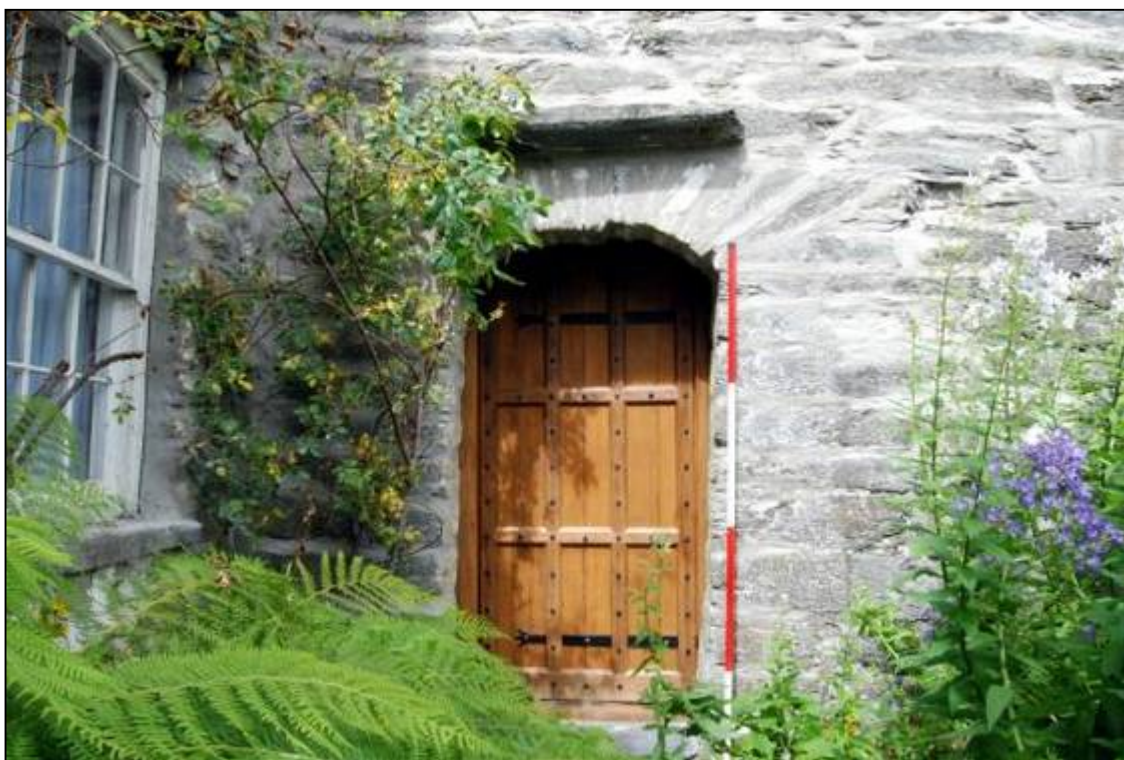
Plate 4: The front door in the porch

The double storeyed porch is built of roughly coursed stone work and is centrally placed with its door facing south. This has a segmental arched opening with stone voussoirs (Plate 4). On the northern side there are blocked openings suggesting that there were windows on both the ground and first floors (Plate 5). There is also a blind dormer on this side of the porch with a short chimney stack on its gable end. The porch is roofed with similar slate to the main house.

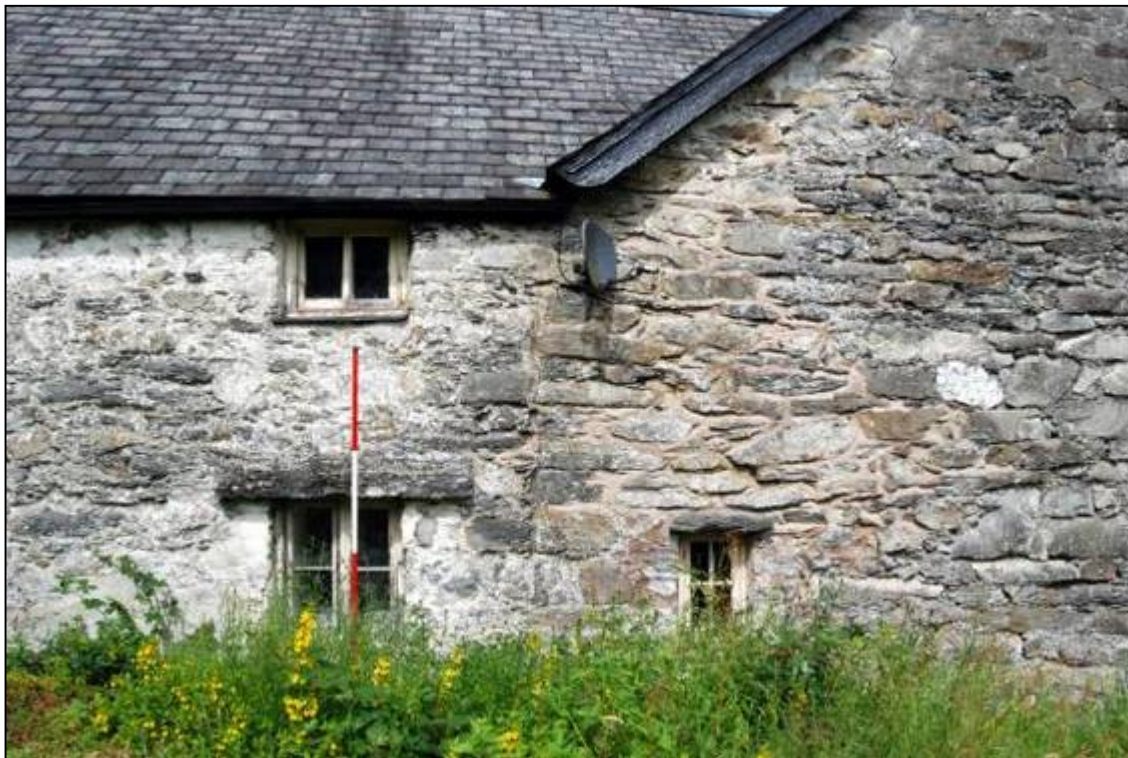
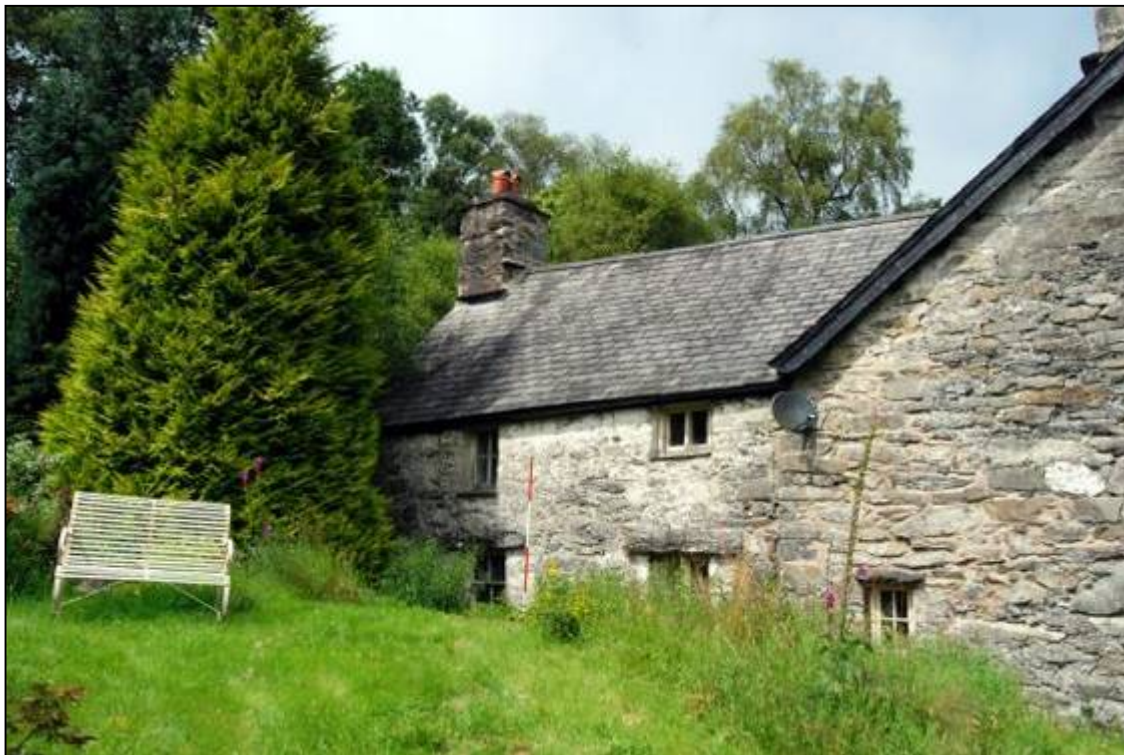
Plate 6: The junction between the main house and the kitchen range on the southern elevation

The kitchen range is attached to the south eastern end of the main house and runs to the west (Plates 6 and 7). It is a two storey range with a gable end chimney on its western gable. Constructed of random stonework under a slate roof, the southern elevation has two small windows on each of the floors, whilst the northern elevation (Plate 8) has a door and a single window on the ground floor and two windows on the first floor. The western, first floor window is in a dormer which springs from above the eaves. There is a blocked opening, on the first floor, in the junction between the kitchen range and the main house on the northern elevation (Plate 9). The function of this opening is not certain; however it may have lit either a stair case or a garde robe. There appears to have been a wheel pit in the space between the kitchen range and a later agricultural building, to the north, which is assumed to be a relatively late feature in the development of the house and its associated agricultural buildings.

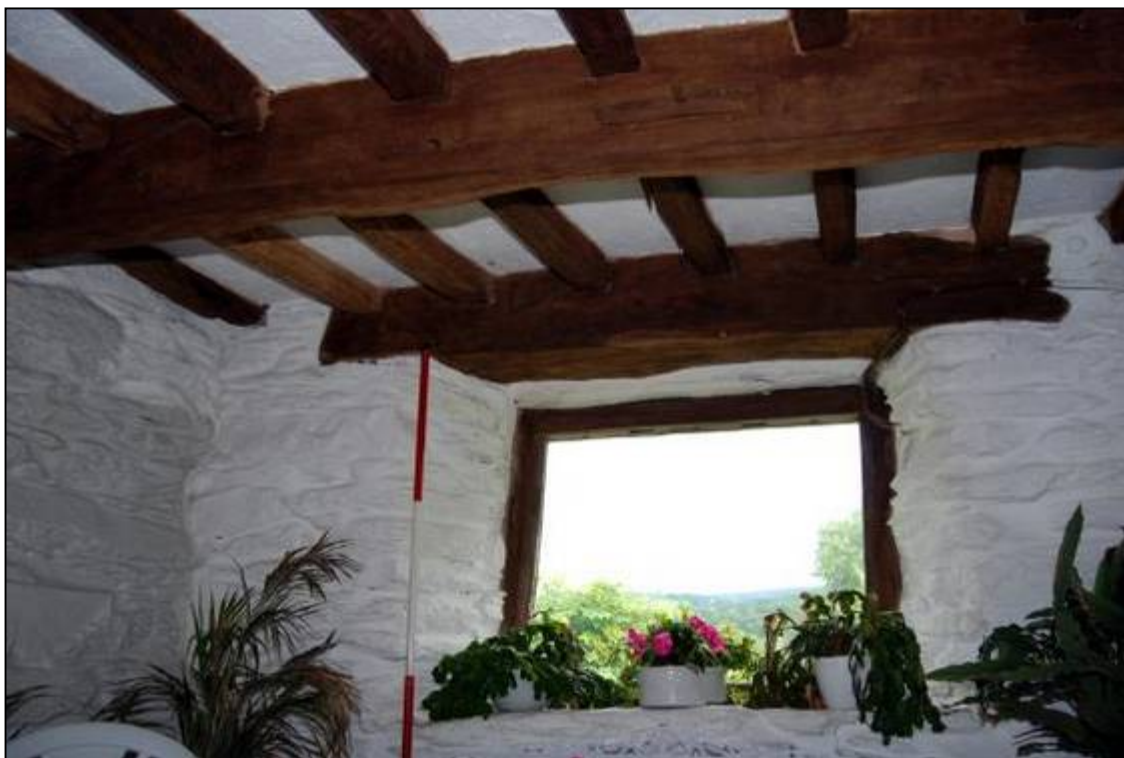
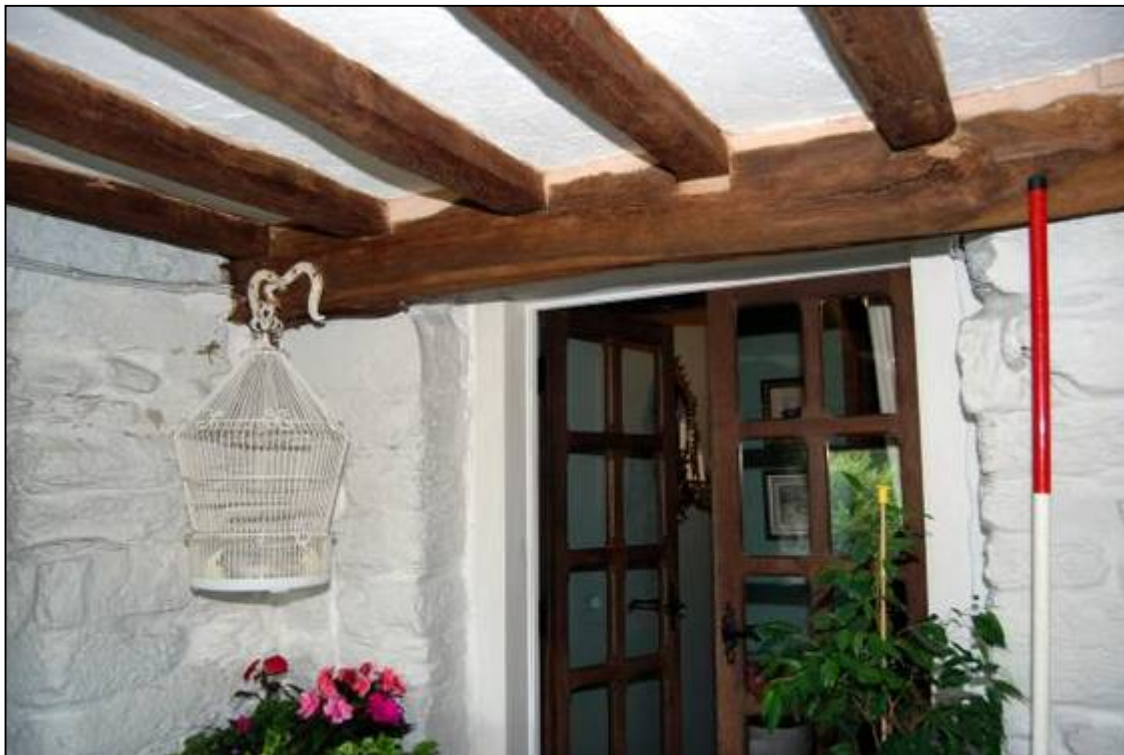
Plate 10: Ground floor of the porch, looking east

On the ground floor (Figure 3) the porch (Plates 10 and 11) has two beams supporting a series of cogg'd joists, both the beams and the joists are chamfered and have straight cut stops (Plates 12 and 13). Attached to the central beam is a wooden peg projecting from a short wooden rail (Plate 14) which presumably acted as a hook. The window in the gable wall (Plate 10) has a large wooden lintel, whilst the frame has a series of mortice holes marking the positions of the two mullions and intervening bars. The door to the main house is a modern, glazed, double door, opening (Plate 11). There is also the socket for a draw bar in the jamb of the door to the porch.

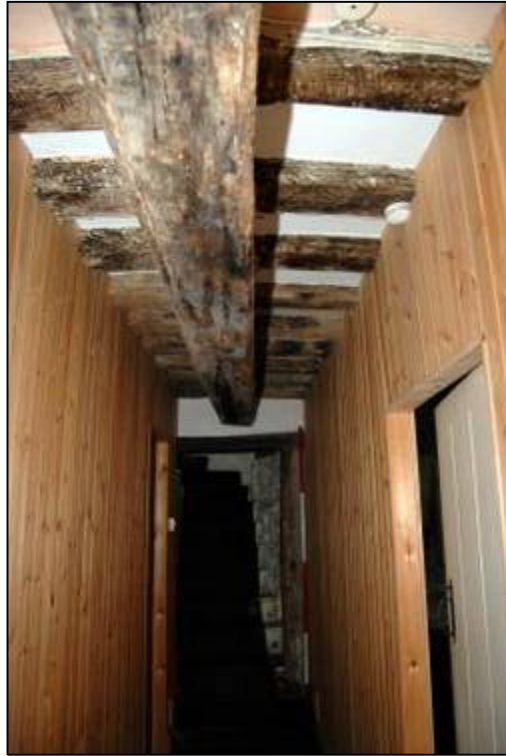
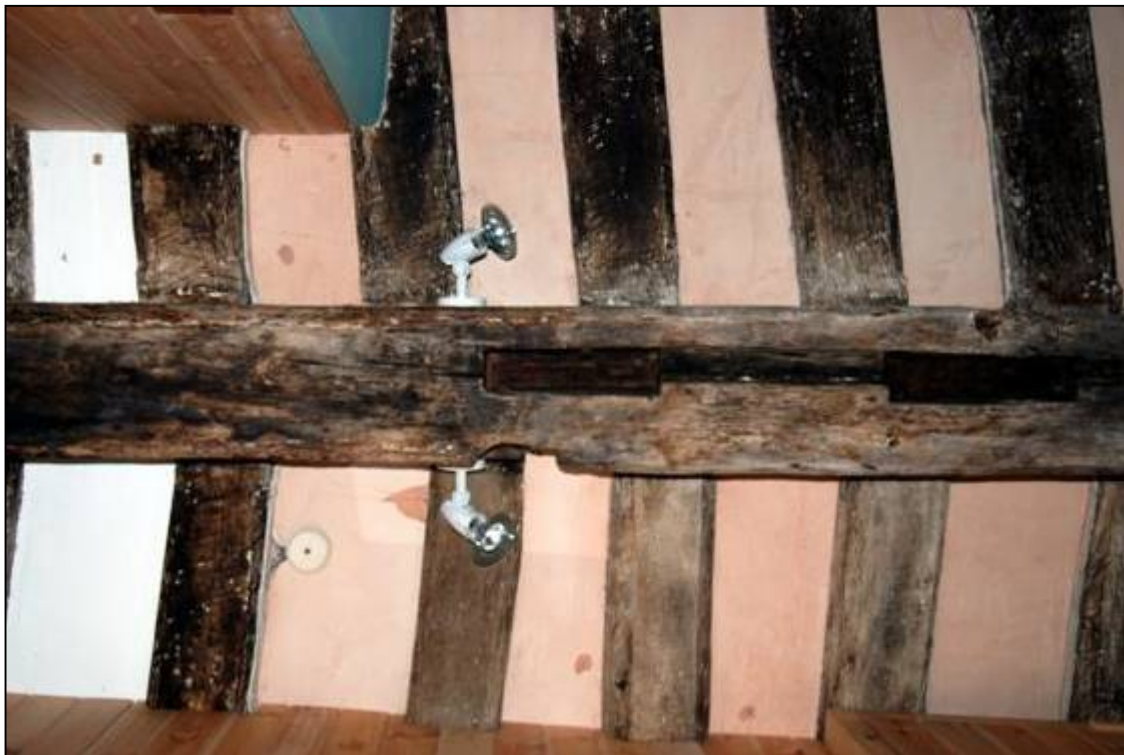
Plate 15: Beam in the cross passage looking west

The ground floor of the main house is divided into two rooms with a dividing cross passage (Figure 3). The position of this cross passage has been moved from its original position, possibly when the porch was added to the front of the building, as there is a beam running along its length with the sockets for a plank and

muntin partition in its lower surface (Plates 15 - 17). This partition (Figure 9) consists of the sockets for a series of muntins, between 0.26 and 0.36 m wide and 0.07 m thick separated by narrow sockets (0.05m) for planks between 0.31 and 0.36 m wide. There is a wide gap of 2.18 m in the centre of the beam marking the assumed position of the door to the hall. This size of this gap might suggest a double door into the main room of the house. Cogged joists run from both sides of the beam. Those running to the north can be traced through the modern partition, to join the cross beam in the hall. Those running south, however, appear to have been truncated, or at least covered, beyond the modern partition forming the southern side of the cross passage. The southern side of the original cross passage is shown by the beam in the southern, ground floor, room. This, also, has the sockets for a plank and muntin partition (Figure 9, Plates 18 and 20). The muntins were between 0.32 and 0.37 m wide and up to 0.07 m thick and each was held in place by two pegs (Plate 20). The separating planks were between 0.33 and 0.37 m wide and 0.05 m thick. The doorway into the southern end of the house was only 0.61 m wide.

The position of the cross passage has been moved slightly to the north and it has been narrowed from 1.4 m to 1.0 m at its narrowest point. This movement is assumed to have taken place at the same time as the porch was added to the front elevation to allow the porch to be centrally placed. The kitchen range was then added to the rear of the property. This allowed the construction of the staircase, although the relationship between the two ranges is a little compromised as the wall of the kitchen range had to be thinned to allow the stairs to be constructed. A blocked opening on the first floor level between the

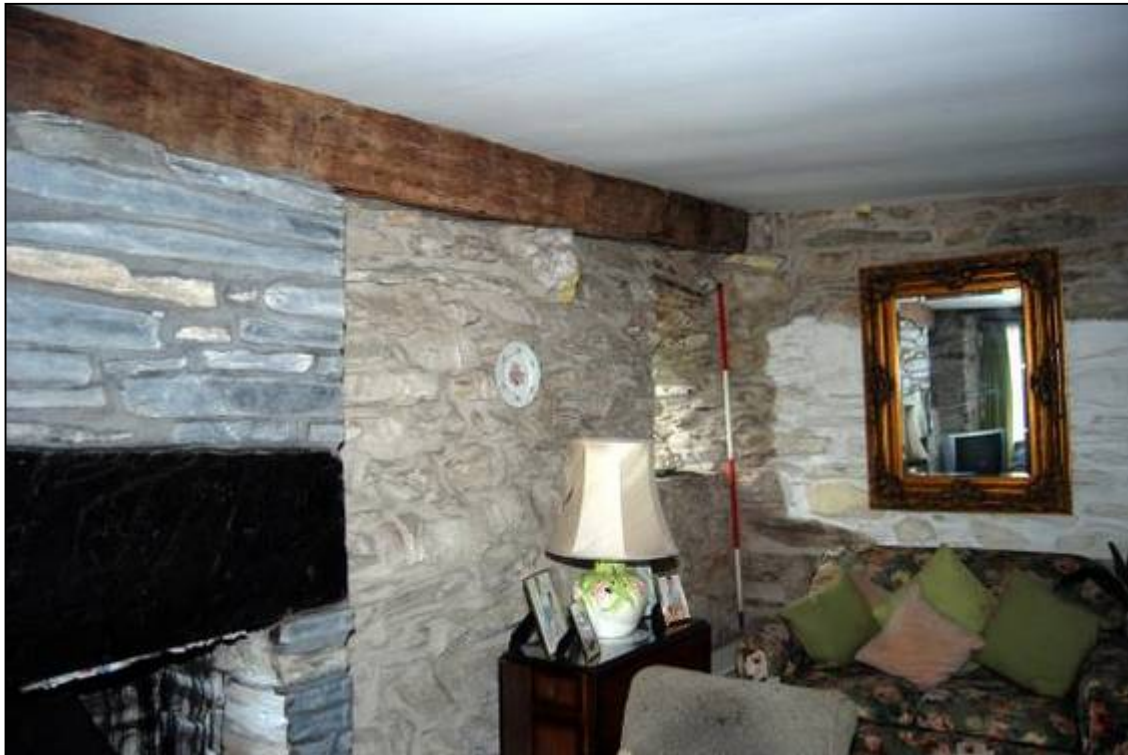
Plate 21: Beam along the southern wall of the parlour

The parlour also contains a second beam along the southern wall which is supported by a series of crude corbels (Plate 21). It now runs over the top of a modern fireplace, the breast of which is constructed of slate slabs. The doorway to the kitchen range is in the western wall of the parlour. This is clearly a later feature as it is below the beam forming the southern side of the original cross passage. The kitchen range has a cross beam and cogged joists which run only from the beam to the eastern gable wall. This wall also contains a large range.

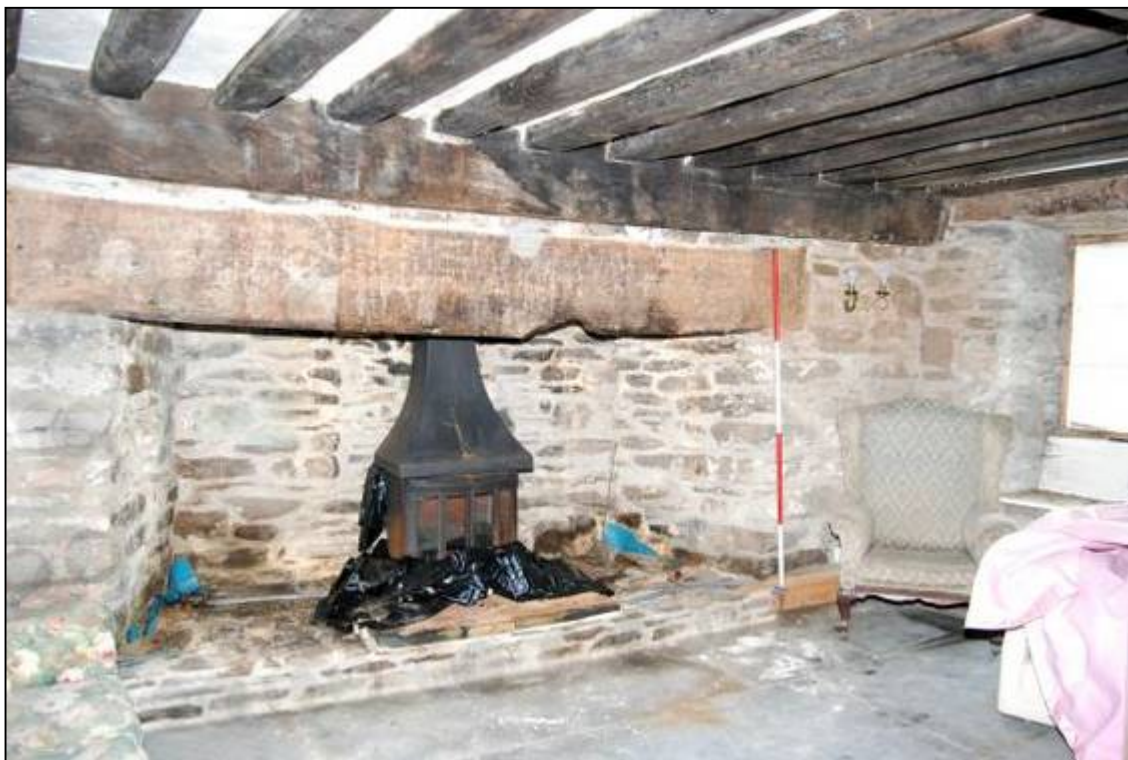
Plate 22: The hearth in the hall

The hall is dominated by a large hearth (Plate 22) with a large wooden bressumer up to 0.4 m thick. The room is crossed by two beams, one in the centre of the room and the other just in front of the hearth. These support a series of cogged joists all of which are slightly chamfered and have straight cut stops as do the beams (Plates 23 and 24). The beams are further decorated with dispersed nail head decoration on the south face of the (Plate 25).

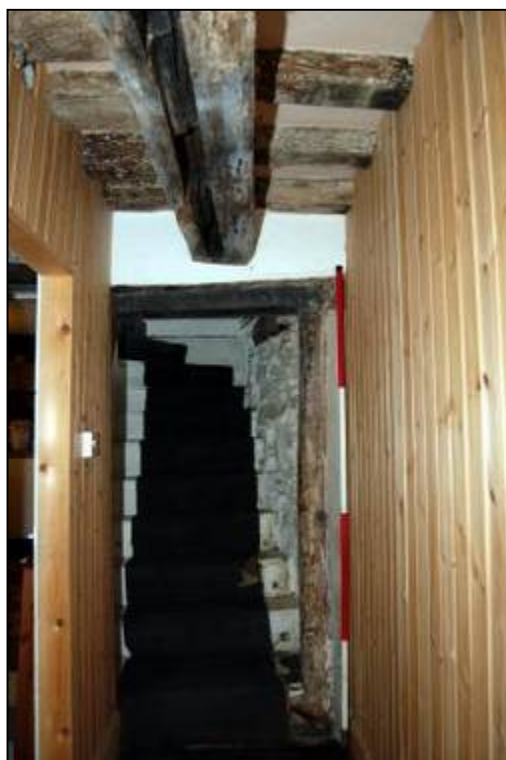
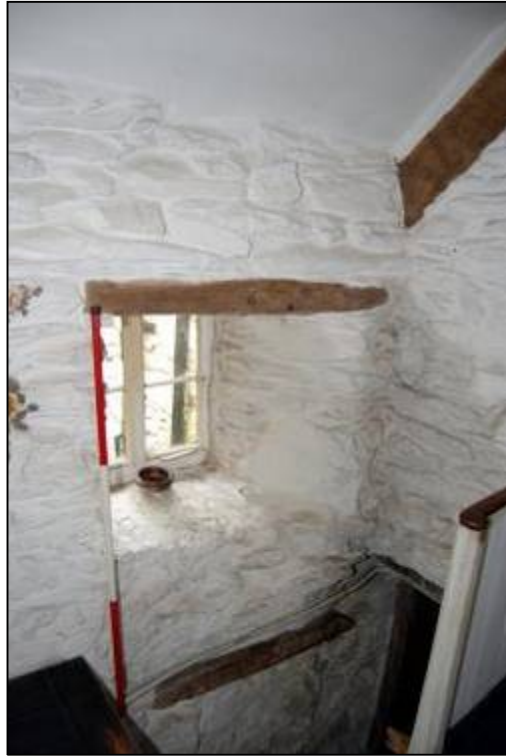
Plate 26: The stairs

The stairs are at the western end of the cross passage (Plates 26 and 27). They sit somewhat uncomfortably with the northern wall of the kitchen range which had to be slightly thinned in order to accommodate the main flight before the short quarter turn at the head of the stairs. The stairwell also contains a window with a wooden lintel which sits above a rail embedded within the wall. Within the first floor of the kitchen range the lower portions of Trusses 4 and 5 are exposed (Plates 27 and 28), at least on the northern side of the range. The wall between the kitchen range and the main house, on the first floor, has timbers exposed which are partly encased within the stone wall (Plates 29 and 30). On the northern side of the landing (Plate 29) there is a stud exposed which appears to relate to a rail which appears to extend into the wall. There is also a wall plate exposed which can be shown to link into the base of Truss 2. On the southern side (Plate 30, two rails appear to be embedded in the wall. These are separated by a short horizontal spacer. These timbers may suggest that there could have

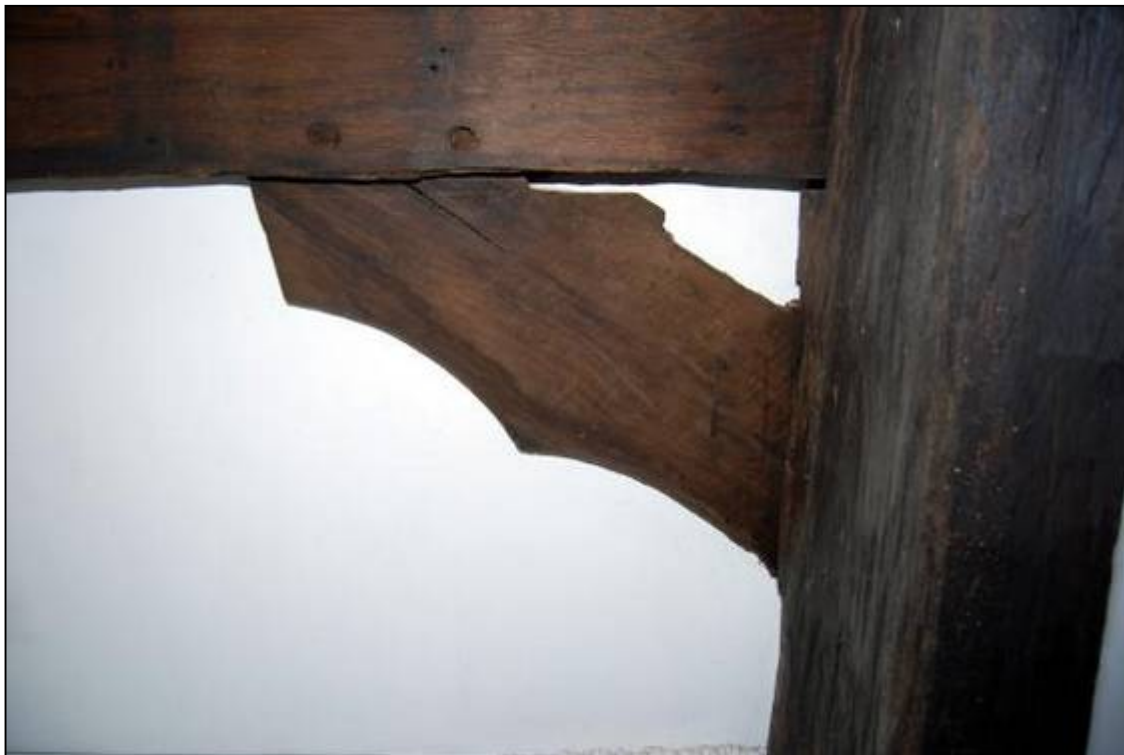
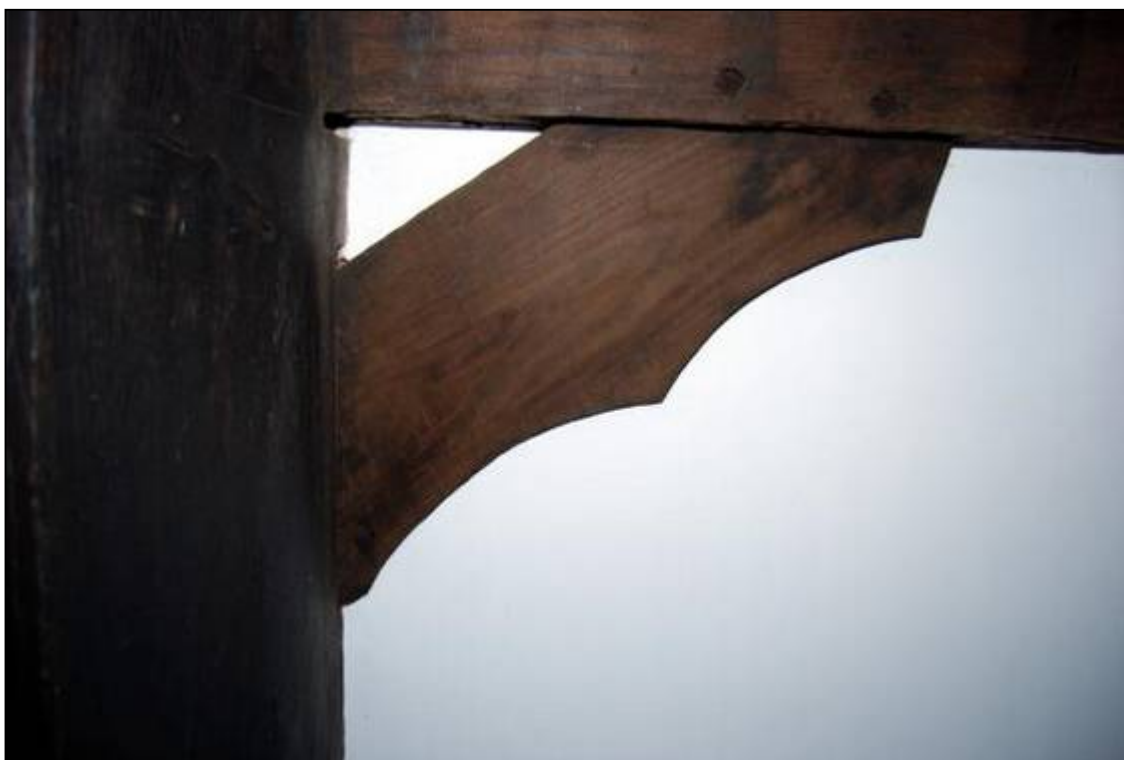
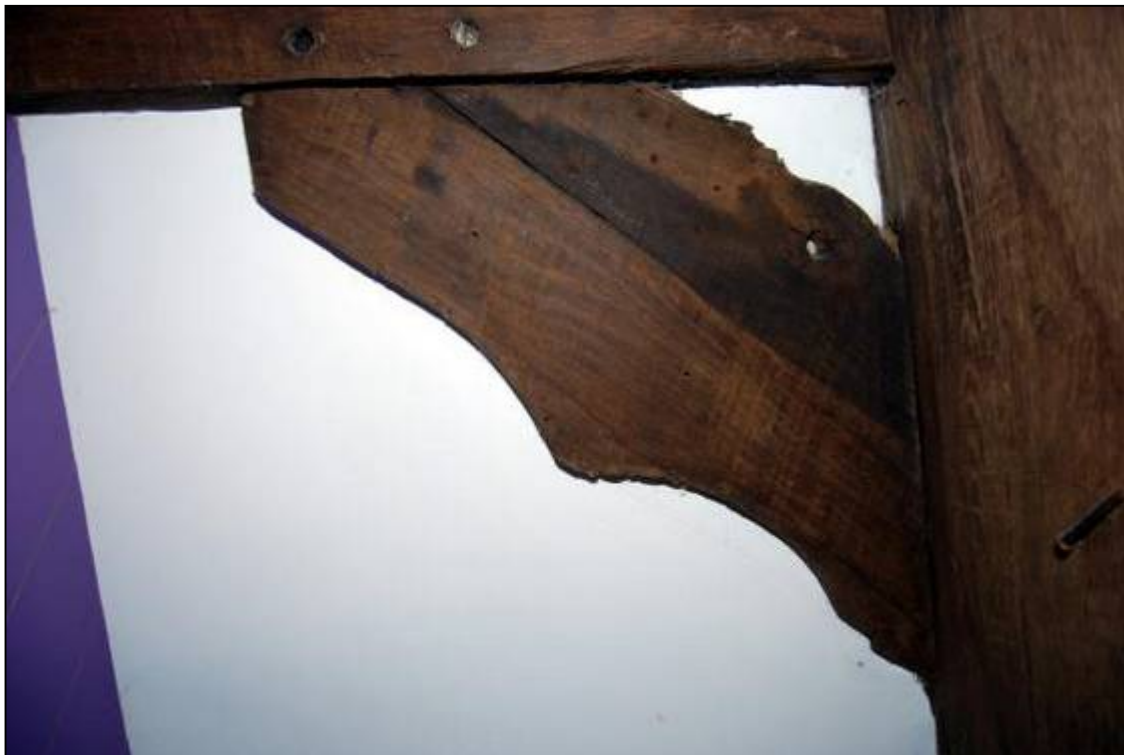
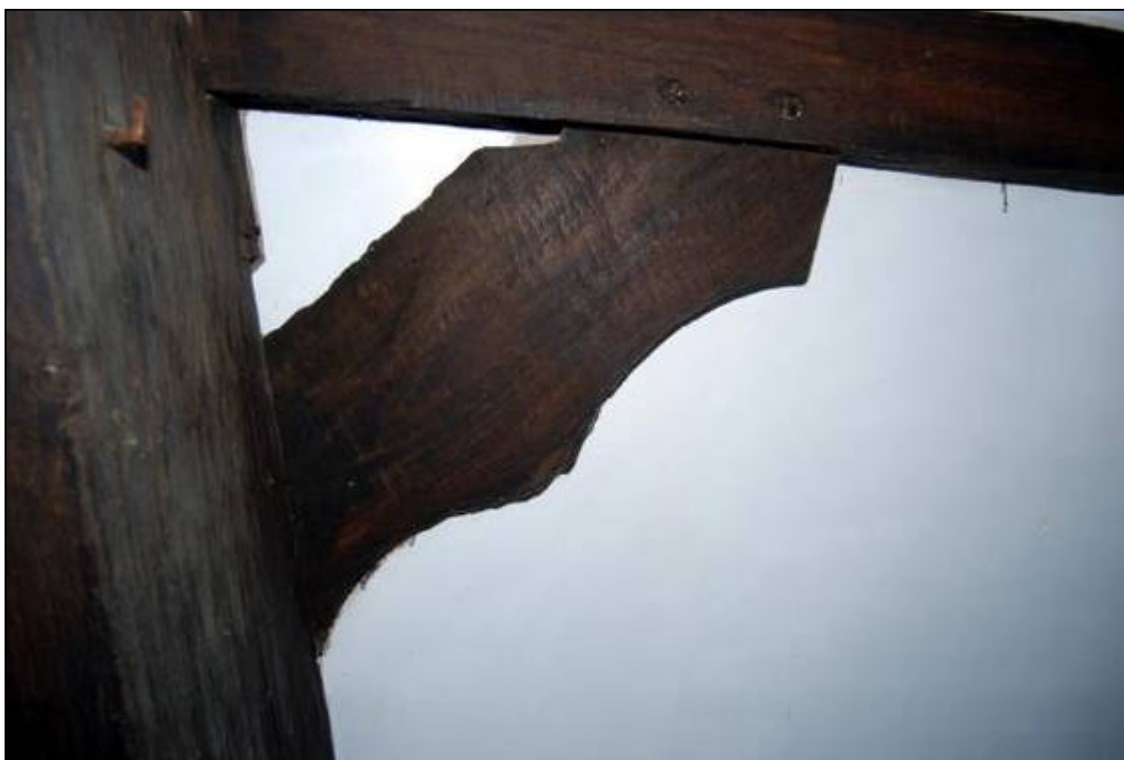
Plate 41: The northern windbrace at the eastern end of Truss 3

The lower portions of Trusses 1, 2 and 3 are all exposed on the first floor of the house range. Truss 1 is partly exposed in the southern bedroom, where it is plastered and painted and the eastern end sits on a stone corbel (Plate 31). Truss 2 is exposed, both on the landing and in the corridor leading to the upper room of the porch. At its western end (Plate 32) the foot of the truss sits on a wall plate embedded in the wall. It is also supported by a cusped windbrace (Plate 33). A tie beam has been removed from this truss as is shown by the socket (Plate 34) and above this tie beam there was a wattle partition demonstrated by a series of dowel holes. The level of the tie beam suggests that, at the very least, there was no access between the two halves of the house range on the first floor and possibly that the floor is a later addition. A similar pattern is seen at the eastern end of Truss 2 (Plates 35 -38) where it is exposed in the corridor to the upper room of the porch. A matching cusped windbrace on the northern side of the truss is exposed in the northern bedroom (Plate 38). The base of Truss 3 is exposed, both in the northern bedroom and in the bathroom (Plates 39 and 40). Sitting on a wall plate on both walls this truss is supported by cusped windbraces both to the north and south at both ends of the truss (Plates 41 – 44).

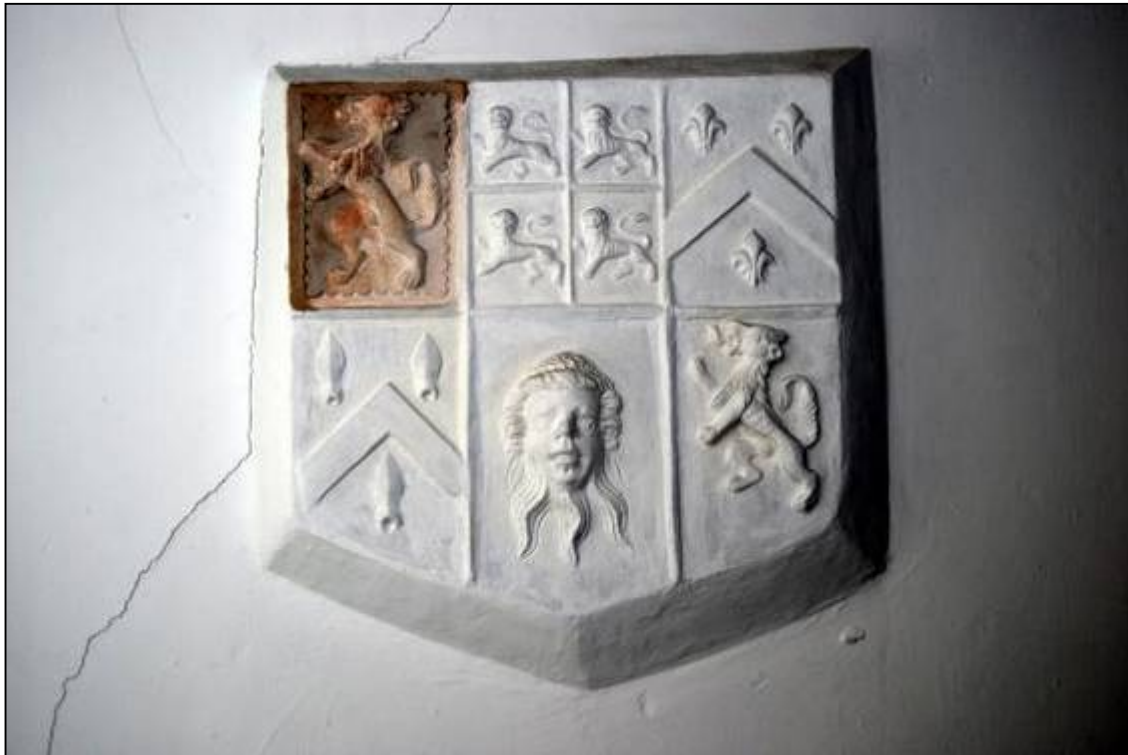
Plate 45: Plaster heraldic shield in the southern bedroom

Within the southern bedroom, above the fireplace is a plaster heraldic shield (Plate 45). The complex iconography is beyond the scope of this report; however see the descriptions in Appendix 1.

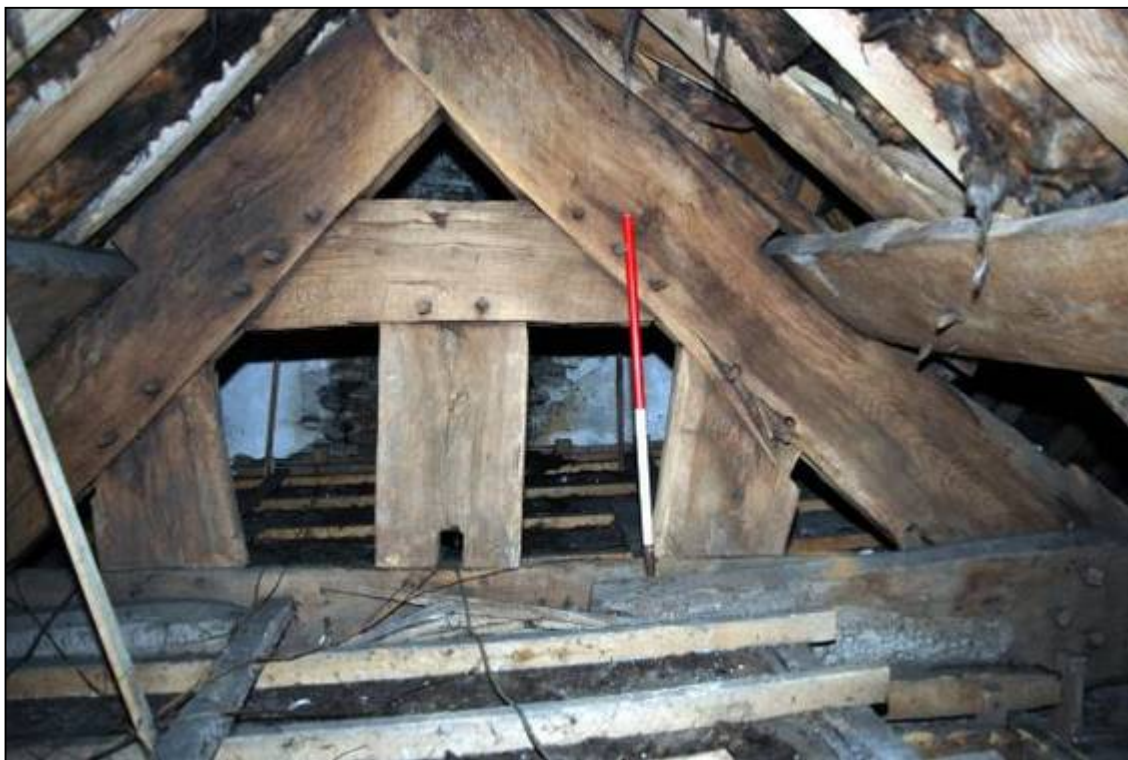
Figure 5: Truss 1
Scale 1:50

In the attic space the tops of the trusses are exposed. Truss 1 (Figure 5, Plate 46) has a short crown strut between two collars together with two slightly raking braces. Both sets of purlins are trenched and there is a ridge purlin. There are windbraces on the upper purlin to the east which are cusped. (Plates 47 and 48), however because of the relationship between the roof spaces of the kitchen range and the house only a plain windbrace between the lower purlin and the truss was recorded (Plate 49). This purlin has a series of mortice holes in its upper surface (Plate 50), suggesting a complexity to the roof at this point which is not reflected elsewhere.

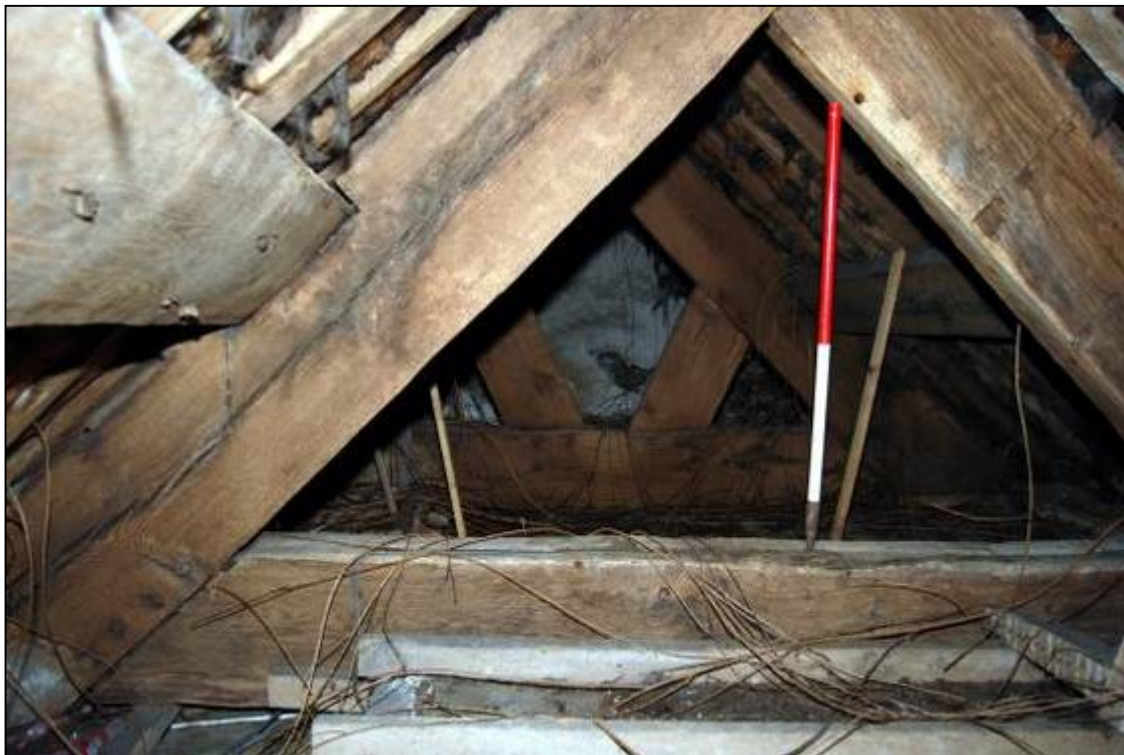
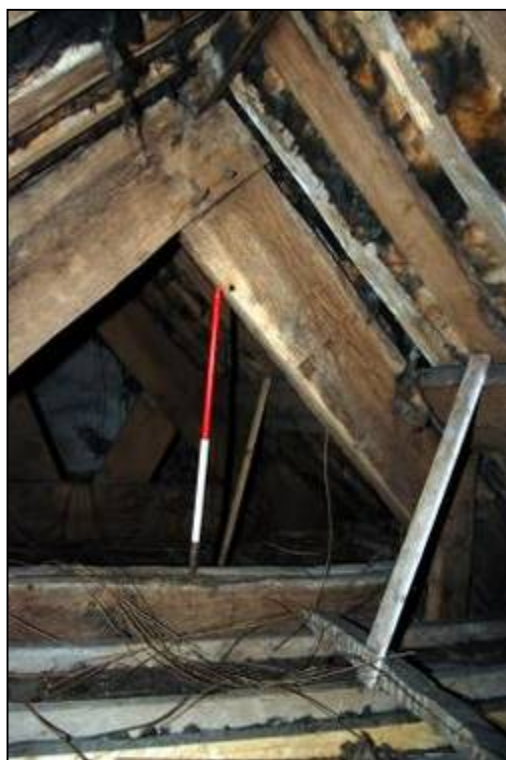
Figure 6: Truss 2
Scale 1:50

Truss 2 (Figure 6, Plates 51 and 52), has a single collar, trenched purlins and a ridge purlin. The principal rafters have a series of dowel holes, both above and below the collar suggesting the presence of a wattle partition. Above the collar the base of the wattles were housed in a slight trench in the upper surface of the collar. There are also three sets of peg holes near to the base of the collar marking the positions of studs below the level of the collar. It is not known if these studs extended below the level of the now missing tie beam, however this truss sits above the beam in the cross passage with the sockets for the plank and muntin partition between the hall and the passage. The upper windbraces survive with those on the eastern side (Plates 53 and 54) being cusped, whilst those to the west (Plate 55) are either broken or were plain.

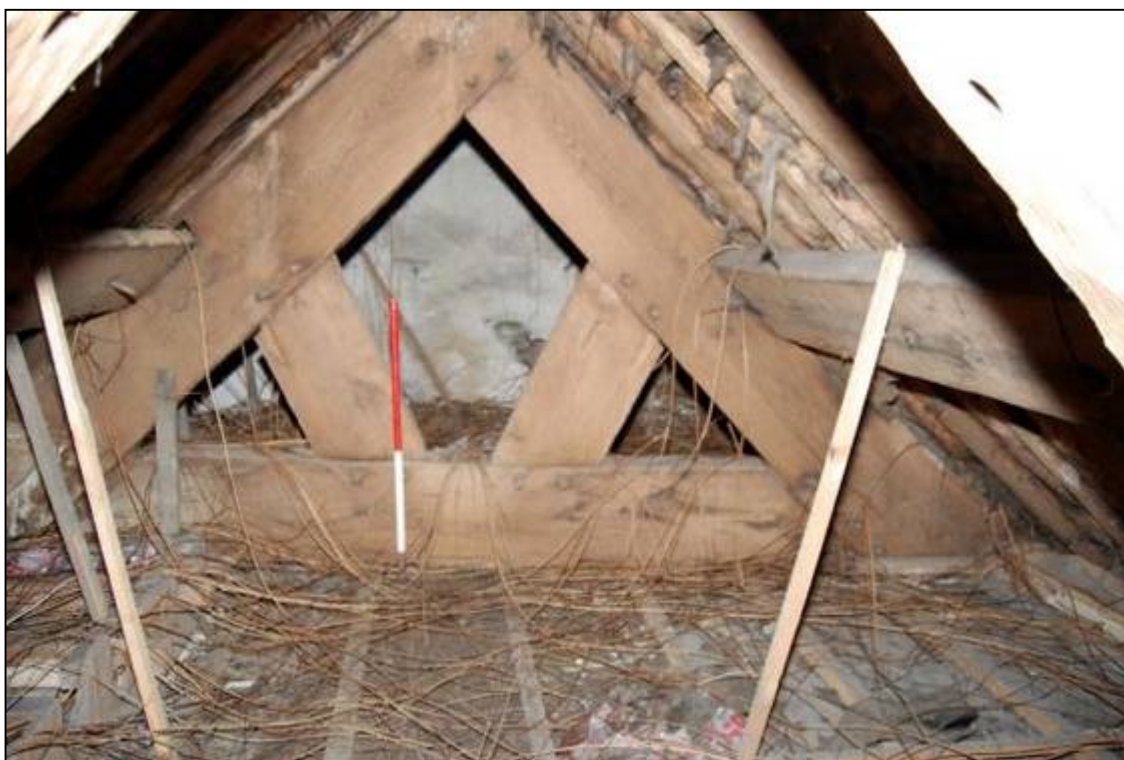
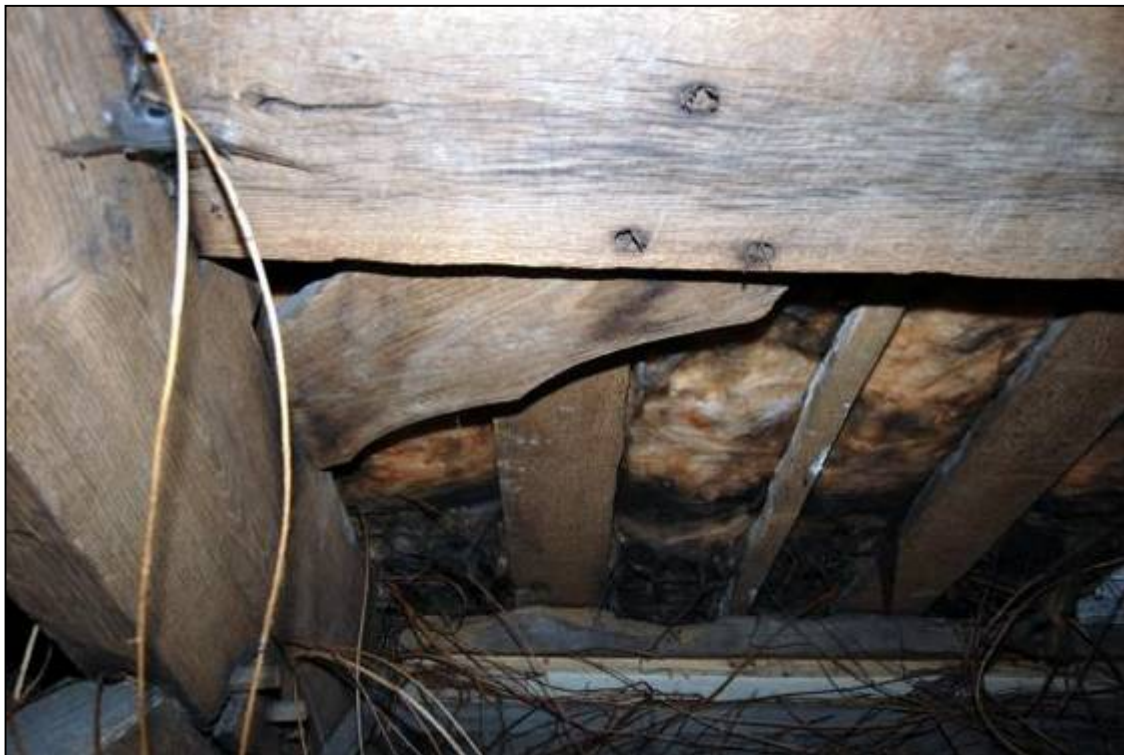
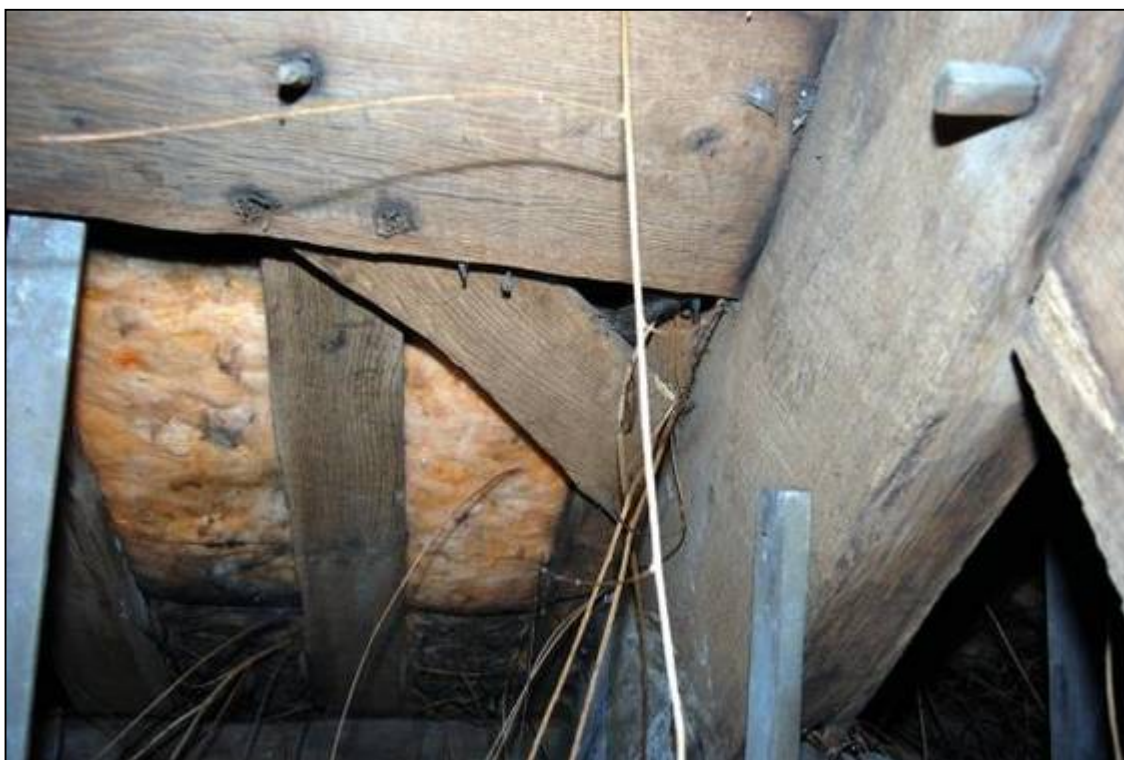
Figure 7: Truss 3
Scale 1:50

Truss 3 (Figure 7, Plate 56) has raking queen posts above the collar, trenched purlins and a ridge purlin. Once again the upper eastern windbraces are cusped (Plate 57) whilst the western windbraces are plain (Plate 58).
