Discovering Old Welsh Houses

**North West Wales Dendrochronology Project
Coed y Ffynnon, Penmachno, Conwy
NPRN 26304**

EAS Client Report 2012/07

**By
I.P. Brooks**

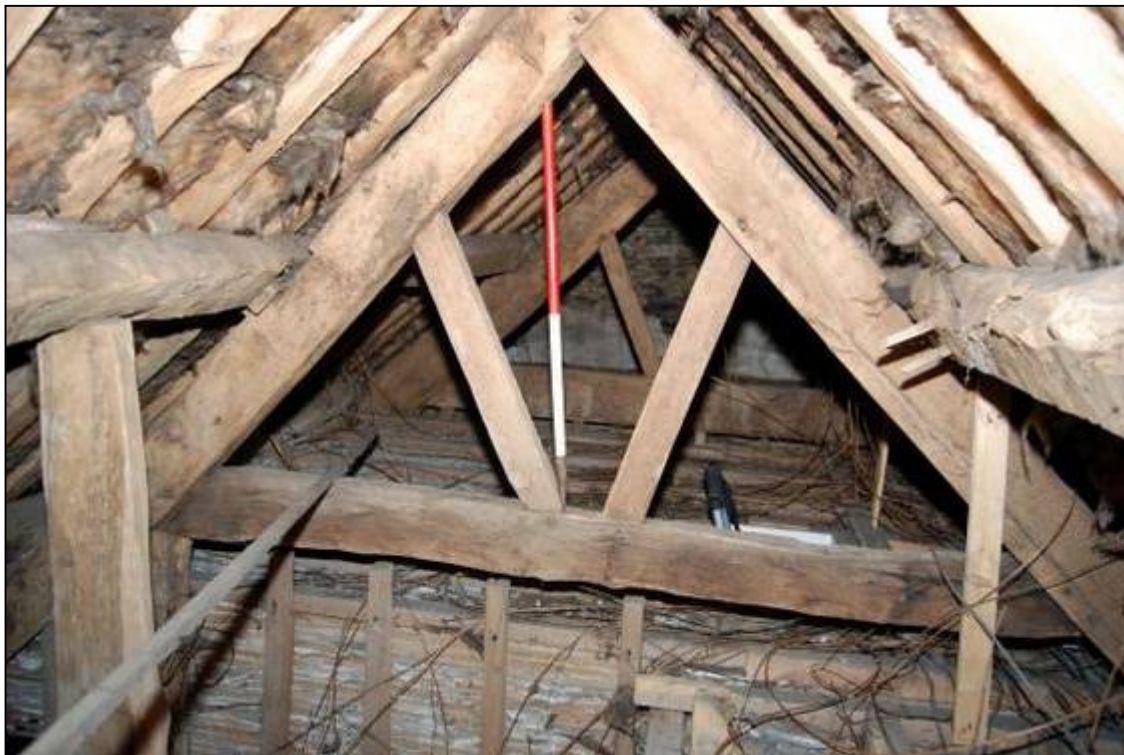
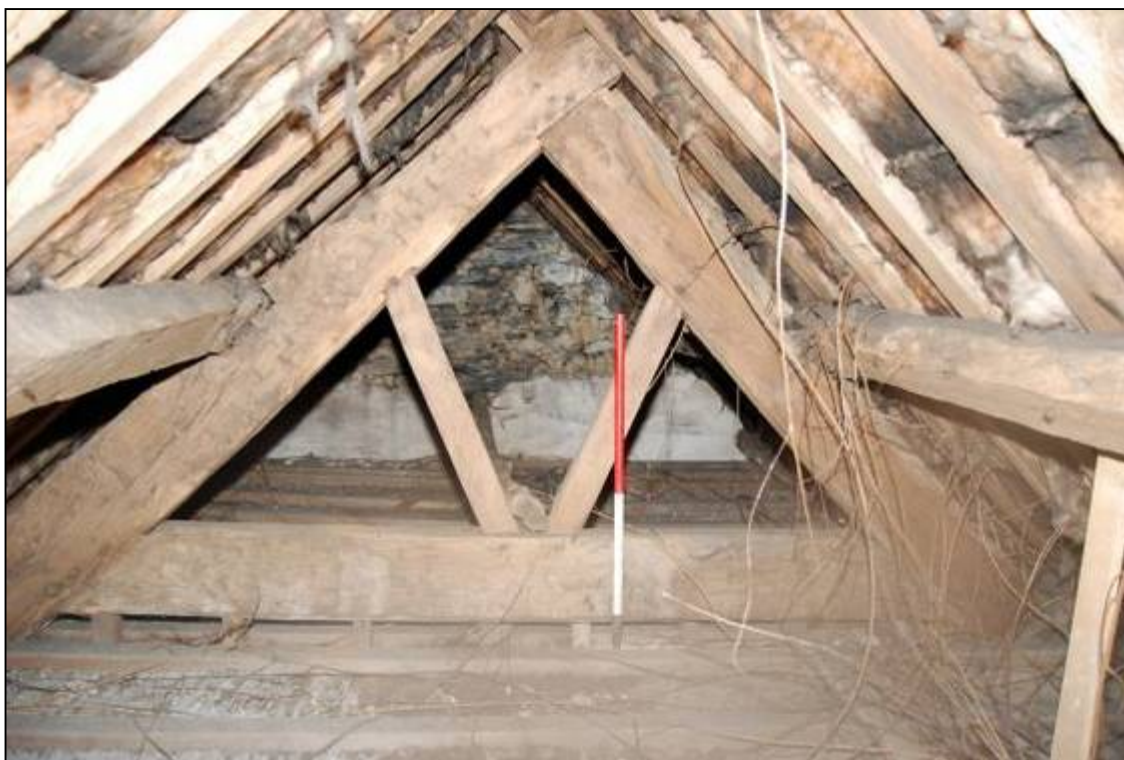
Figure 8: Trusses 4 and 5
Scale 1:50

The trusses within the kitchen range (Figure 8, Plates 59 and 60) are very similar to each other with a collar and raking queen struts. The size of the timbers used for these trusses is notably smaller than those used in the timbers of the roof structure of the main house. The principal rafters overlap with the southern principal rafters over sailing the joint with the northern principal rafters. The purlins are trenched and there is a ridge purlin. No windbraces were associated with this roof structure.

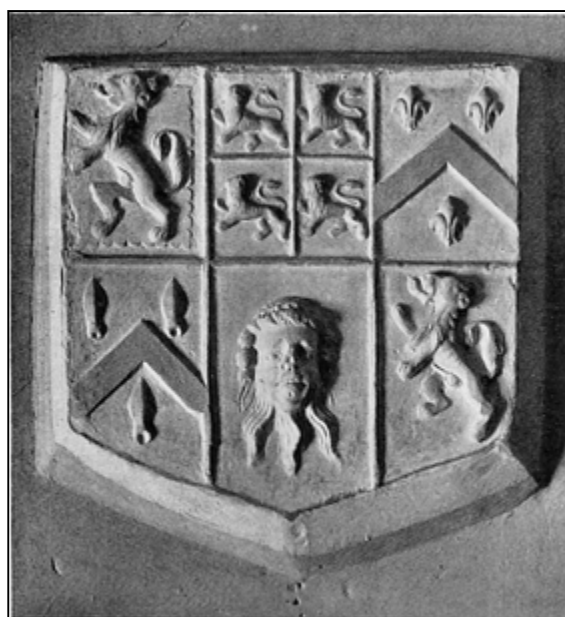
(615, p. 172b), Coed-y-ffynnon. Plaster shield-of-arms.

16th-century.
