**North West Wales Dendrochronology Project  
Branas-uchaf, Llandrillo,  
Denbighshire**

**EAS Client Report 2009/21  
December 2009**

**Commissioned by  
Margaret Dunn  
For  
North West Wales Dendrochronology Project**

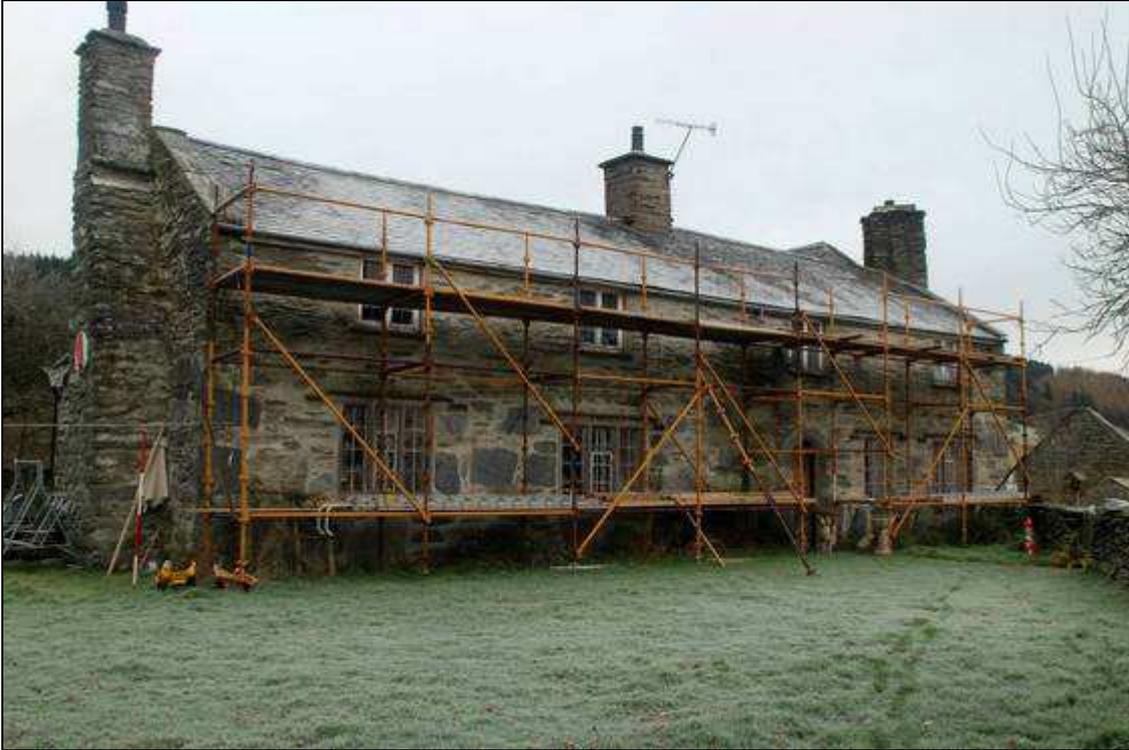
Plate 1: Branas-uchaf looking north.

The main range is a two storey, stone built range constructed of random stone work with large long and short work quoins, particularly on the lower portion of the walls (Plate 1). The upper portions of the walls are of smaller stones suggesting that the house has been heightened. There are three chimneys in this range, one on each gable end and a third as a central ridge chimney. The north eastern chimney is particularly noteworthy. It is clearly an addition to the original building; however it is very prominent and has a marked diagonal shaft with lateral ribs (Plate 2). This is very similar to that recorded at Maes Tyddyn only 1.5 km to the east.

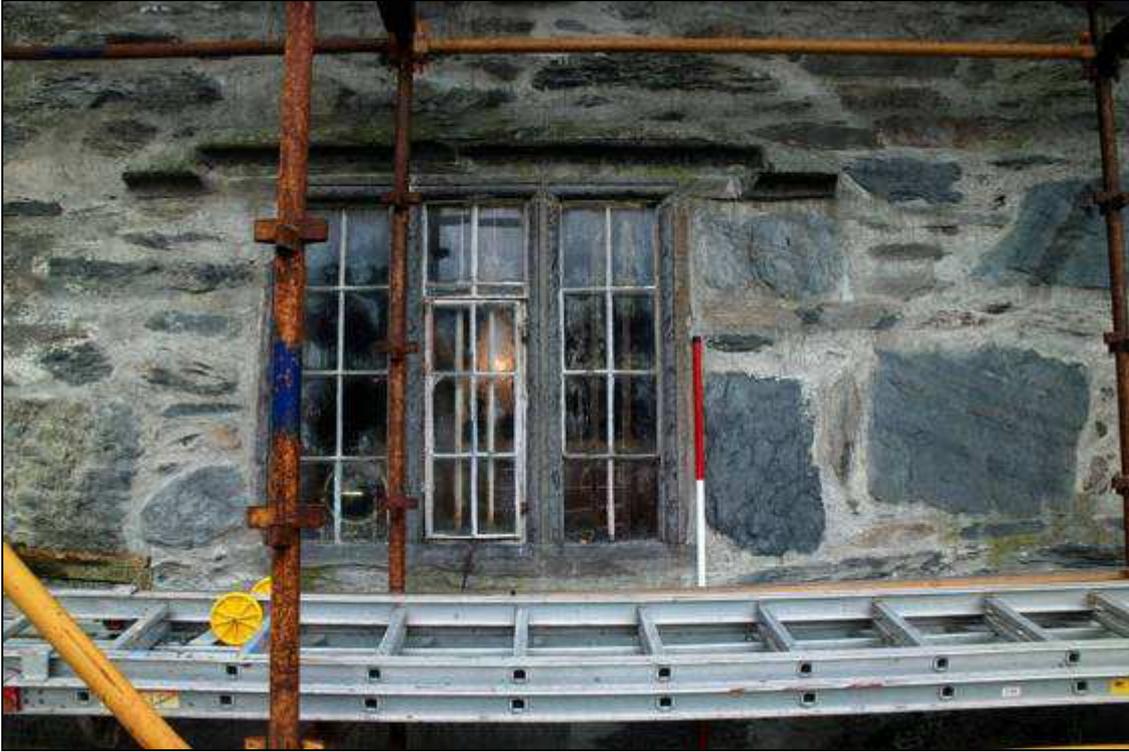
Plate 3: Three light mullioned window, looking NW

The ground floor windows consist of a series of stone ovolo moulded mullions (Figure 6) with relatively thin, tall openings. The majority of the windows have three lights (Plate 3), although the windows to the north east of the door and opposite the door, on the NW wall, have only two lights (Plate 4). The windows have flat, hoodmoulds. The larger window in the northwest wall, of this range, has been blocked, but on the outside retains the stone frame and hoodmould (Plate 5). The smaller window is partly blocked by the later extension (Plate 6).

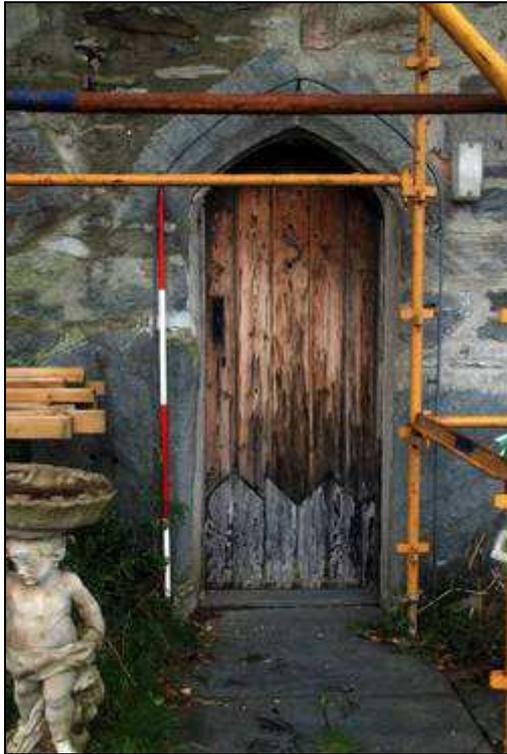
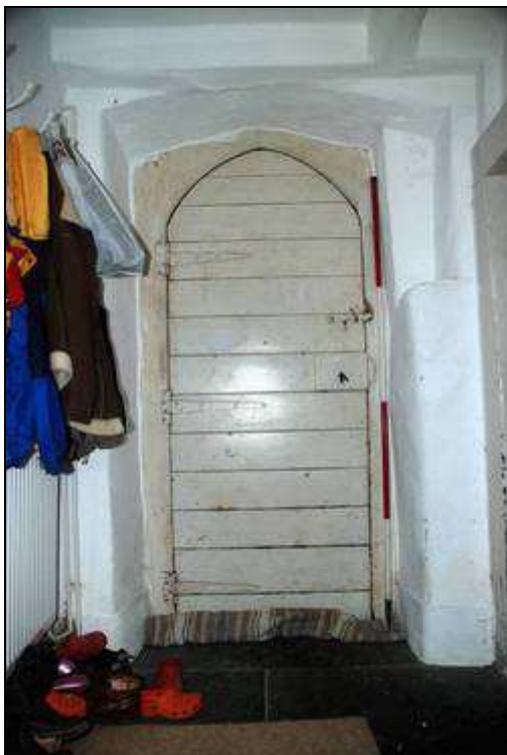
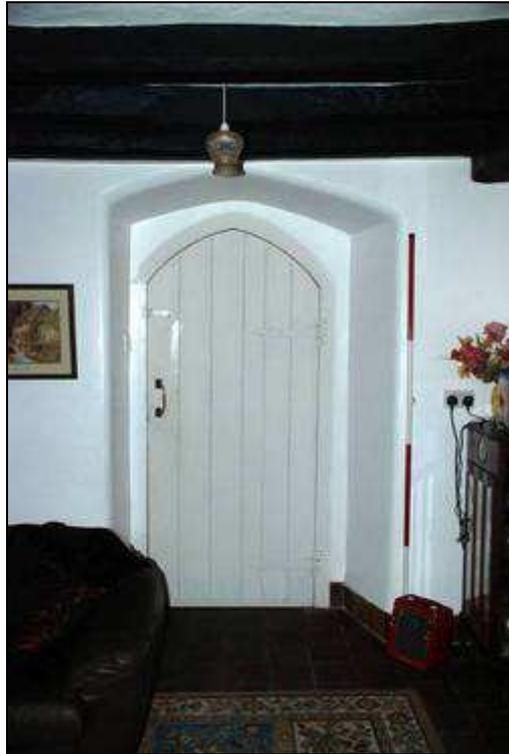
Two doors were recorded, only one of which now gives access to the outside. These have cyclopean door jambs and pointed, stone, doorheads (Plates 7-9). An opening low down at the southwest end of the building suggests there is a cellar below, at least, at this end of the building (Plate 10).

Plate 7: Main door, looking NW

Plate 8: Main door, looking SE

Plate 9: Door between main range and the kitchen, looking NW

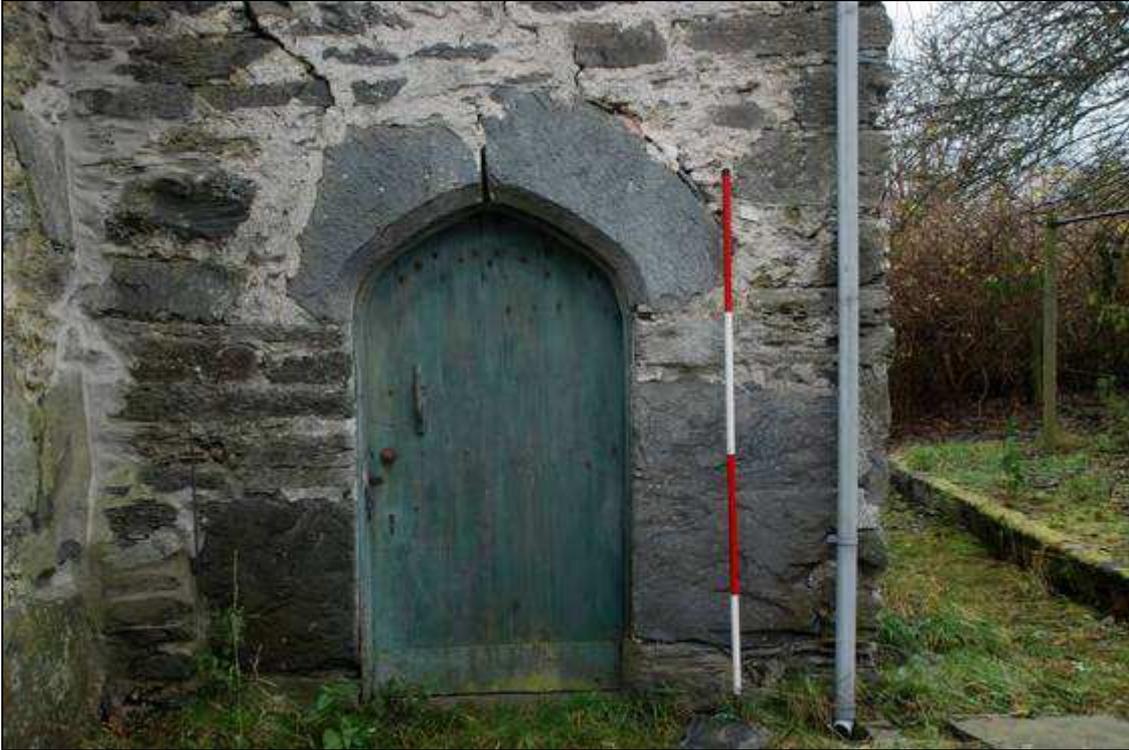
Plate 13: Door to the SW wing, looking SW

The small added wing at the south western end of the house is constructed of random stonework, it has two windows and an external door, although it has no direct access to the main range. The window in the south west face is small with a stone slab casement (Plate 11) whereas that on the ground floor of the gable end (northwest) is a 'two light', mullioned window plain mullions (Plate 12). The door is very similar in character to that in the main range with cyclopean jambs and a pointed stone head (Plate 13).

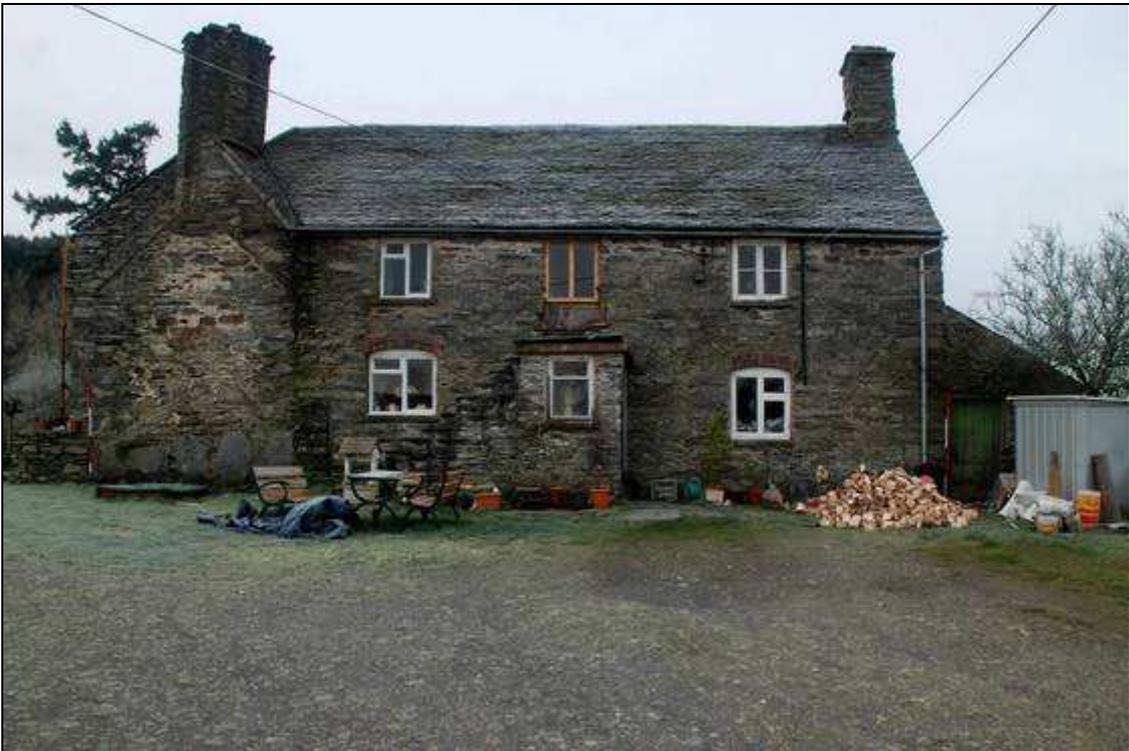
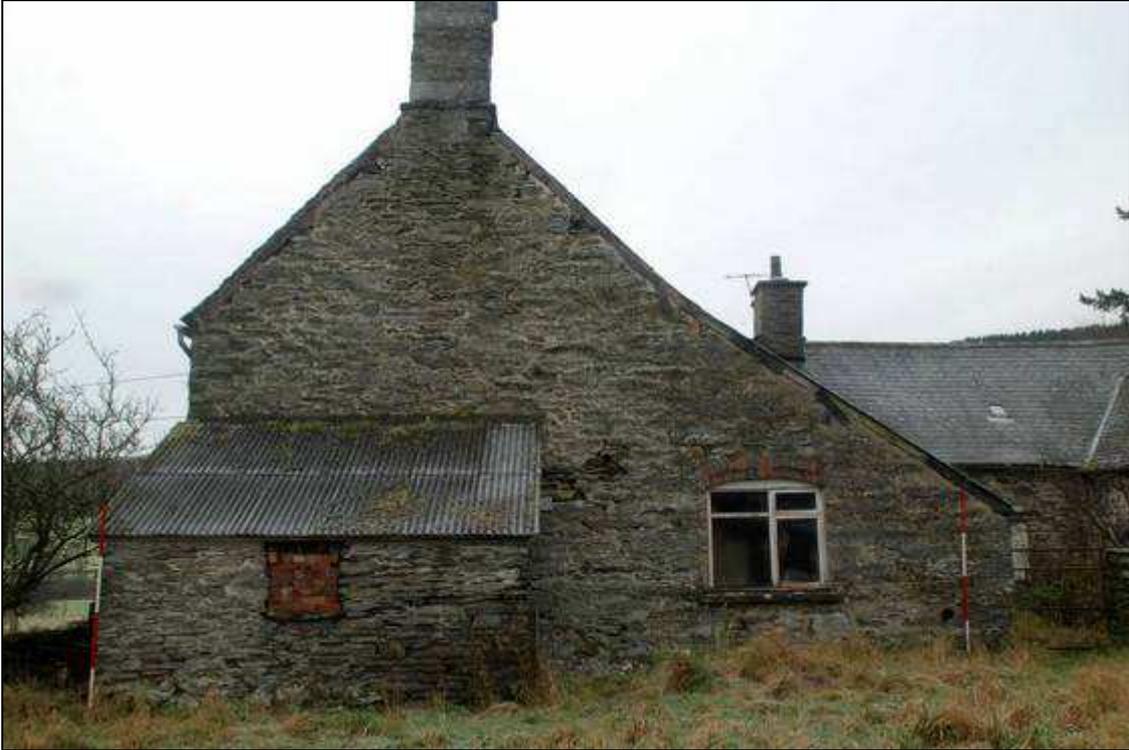
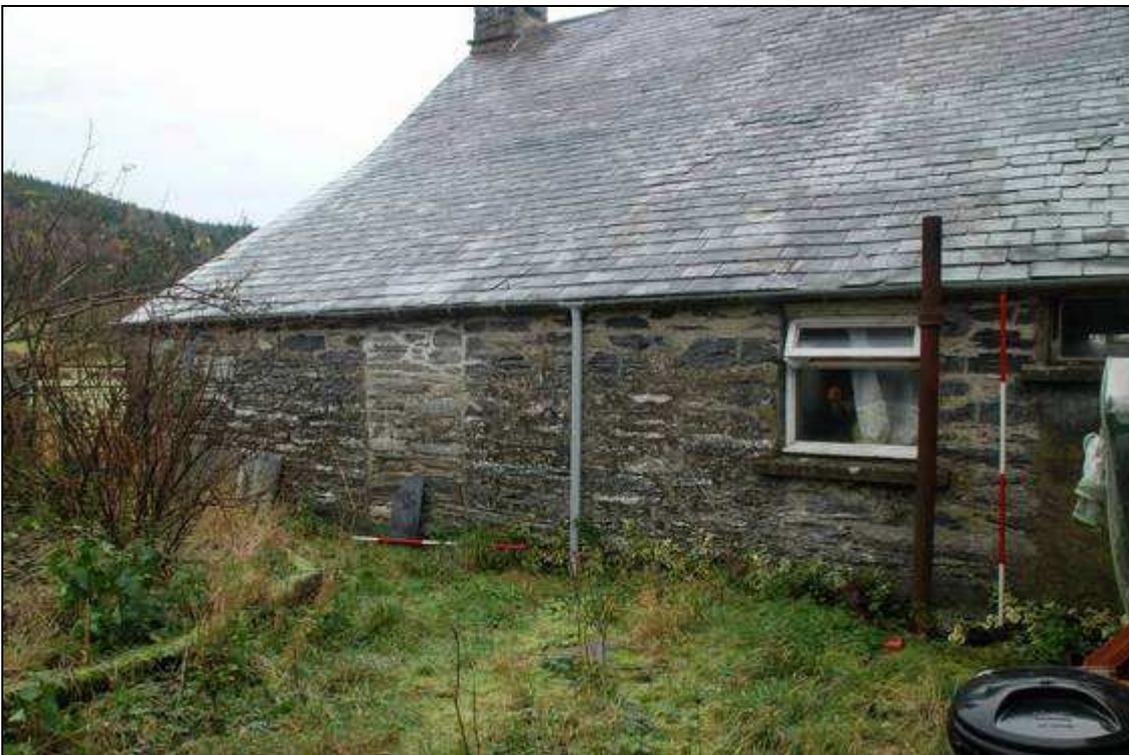
The northeast wing is clearly a late addition, with at least two phases of its own (Plates 14 – 16). The first phase was attached to the north eastern end of the original range. It has a set of external steps which presumably gave access to servant accommodation on the first floor. This wing has a single chimney on the gable end. The wing was then extended to the northwest with a single storey extension. This gave rise to a somewhat uncomfortable relationship between the NE wing and the main range as it partly blocked the window giving light onto the hall and stair well (Plate 17). There are two blocked opening on the northwest side of this wing which relate to blocked doorways no longer in use. There is also a curious blocking between the main gable end chimney and the NE wing (Plate 2) which seems too small to have been a doorway and it is positioned in what would have been the north west corner of the original house making it structurally unlikely that there was a door in this position. It is possible that this blocking is simply filling an awkward gap created by the construction of the NE Wing.

Plate 14: NE Wing, looking NW

Plate 15: NE wing, looking SE

Plate 16: NE wing, looking NNE

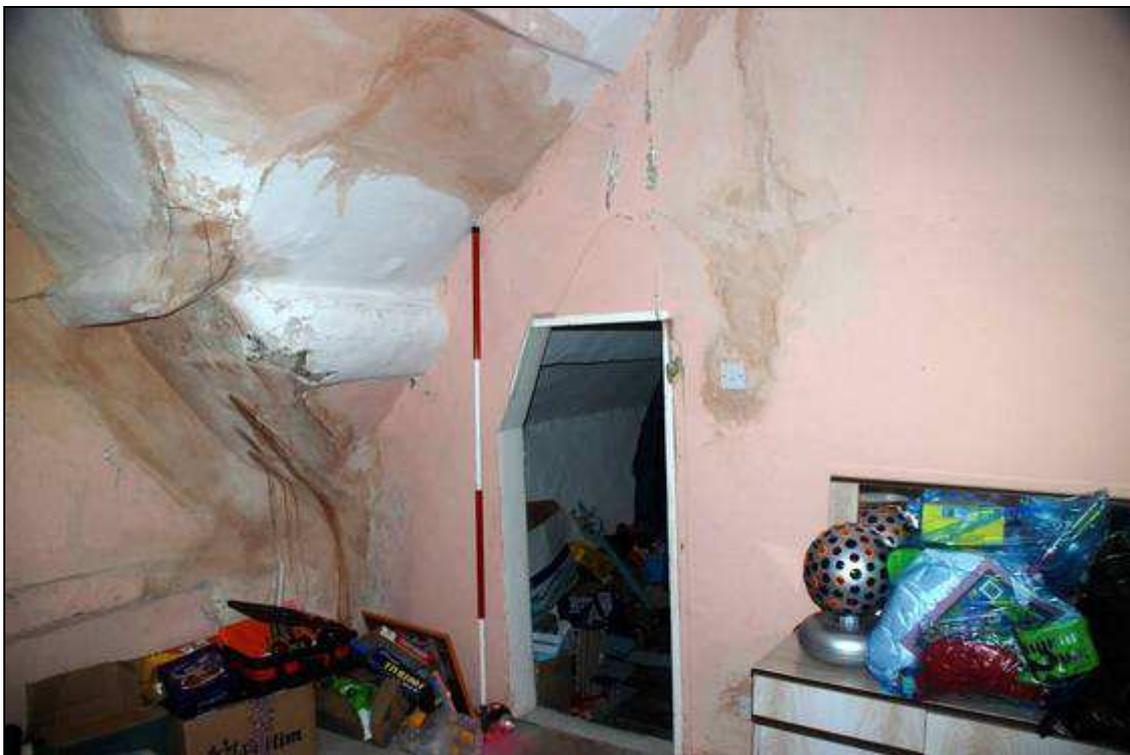
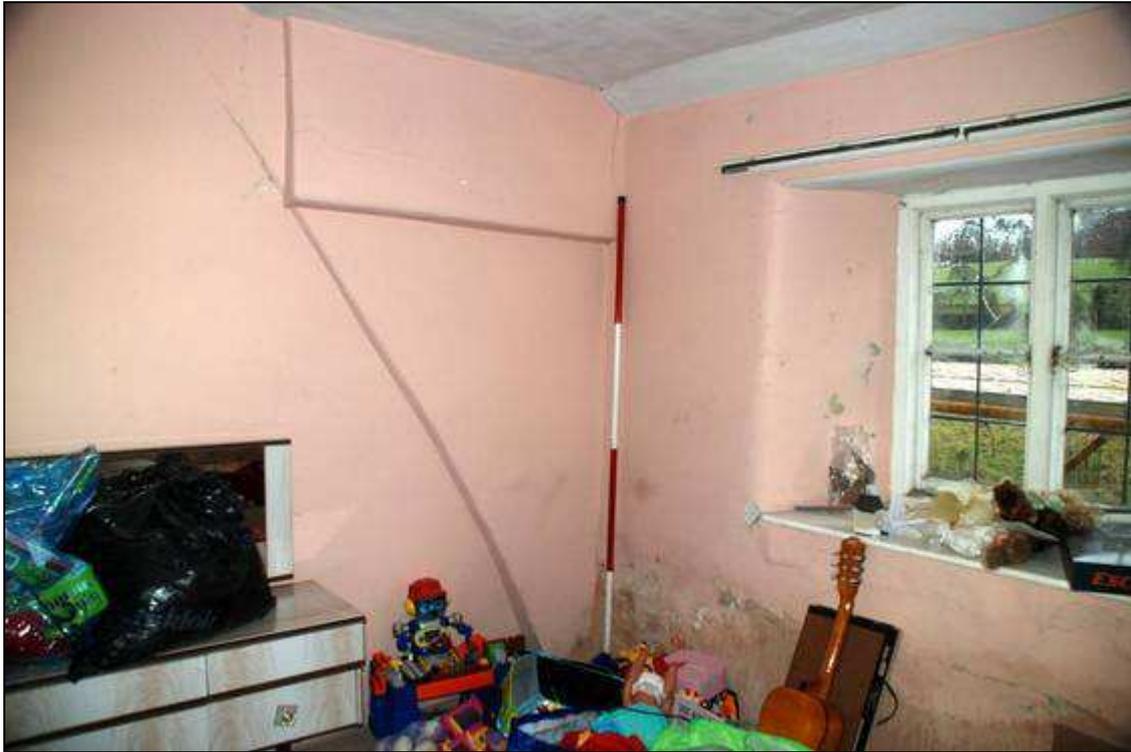
Internally the majority of the trusses are either hidden or heavily coated in plaster making them difficult to record. The best exposure is for Truss 1 (Figure 3, Plates 18 and 19) towards the northwest end of the main range. Although heavily plastered the general form of the curved principal rafters is evident suggesting the use of cruck frames for at least part of the construction. The lower purlin on the north side of the range is exposed (although covered in plaster) along the upper hallway. It has straight, windbraces (Figure 3, Plates 20 and 21) linking it to Truss 2 and 3 and the upper purlin has evidence for windbraces to Trusses 3 and 4 (Plate 22). Truss 2 only has limited exposure; however, in the roof space it was visible from an inspection hatch. There is a cusped insert between the peak of the principal rafters (Plate 23) which appears to be restricted to this truss only.

Plate 18: Truss 1, looking north

Plate 19: Truss 1, looking east

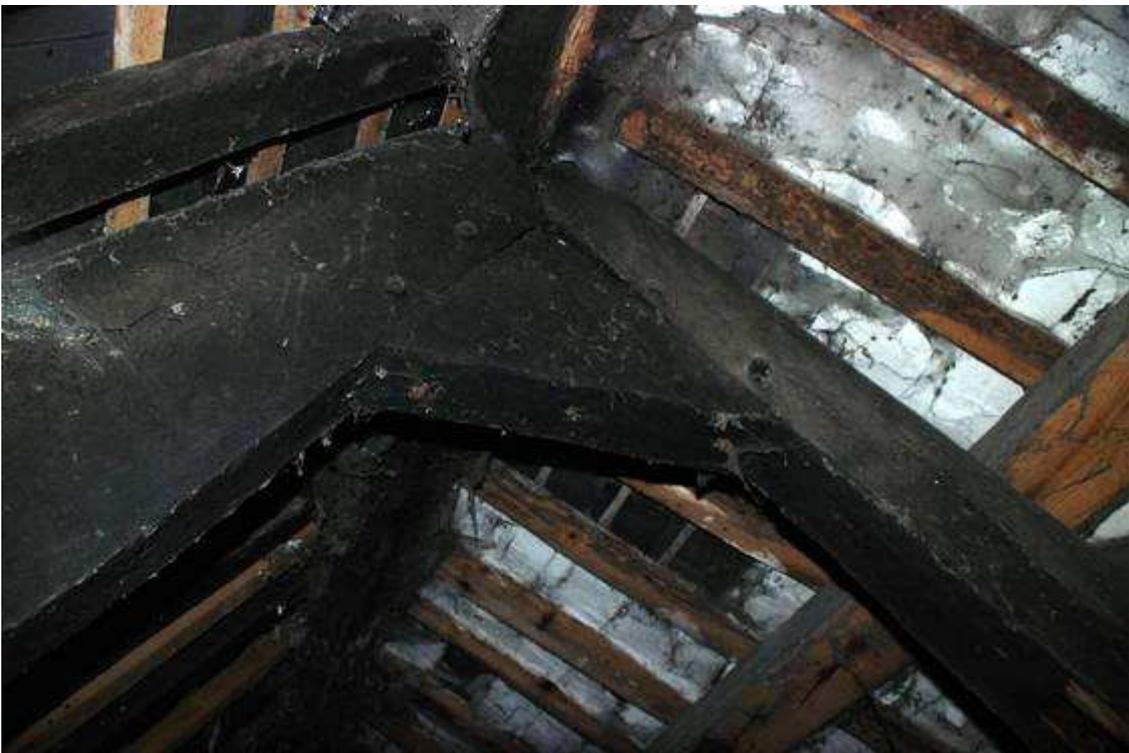
Plate 24: Straight insert at the peak of Truss 3, looking SW

Where it was possible to inspect the other trusses the equivalent insert was a straight piece of timber (Plate 24).

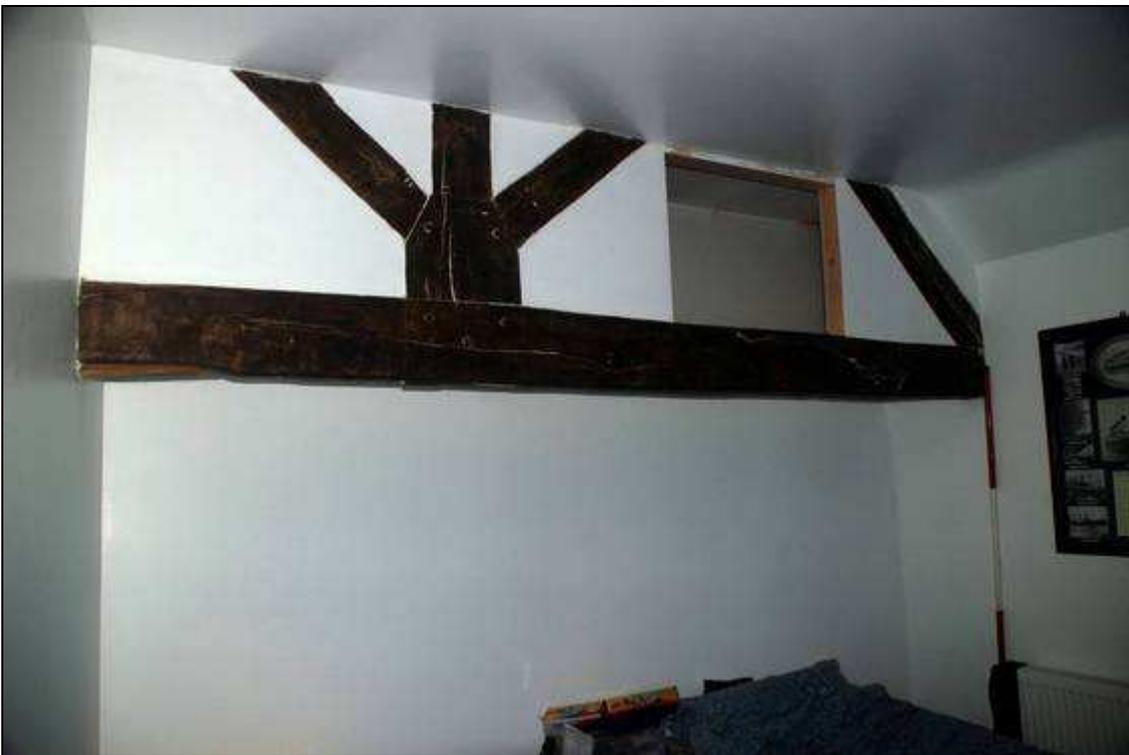
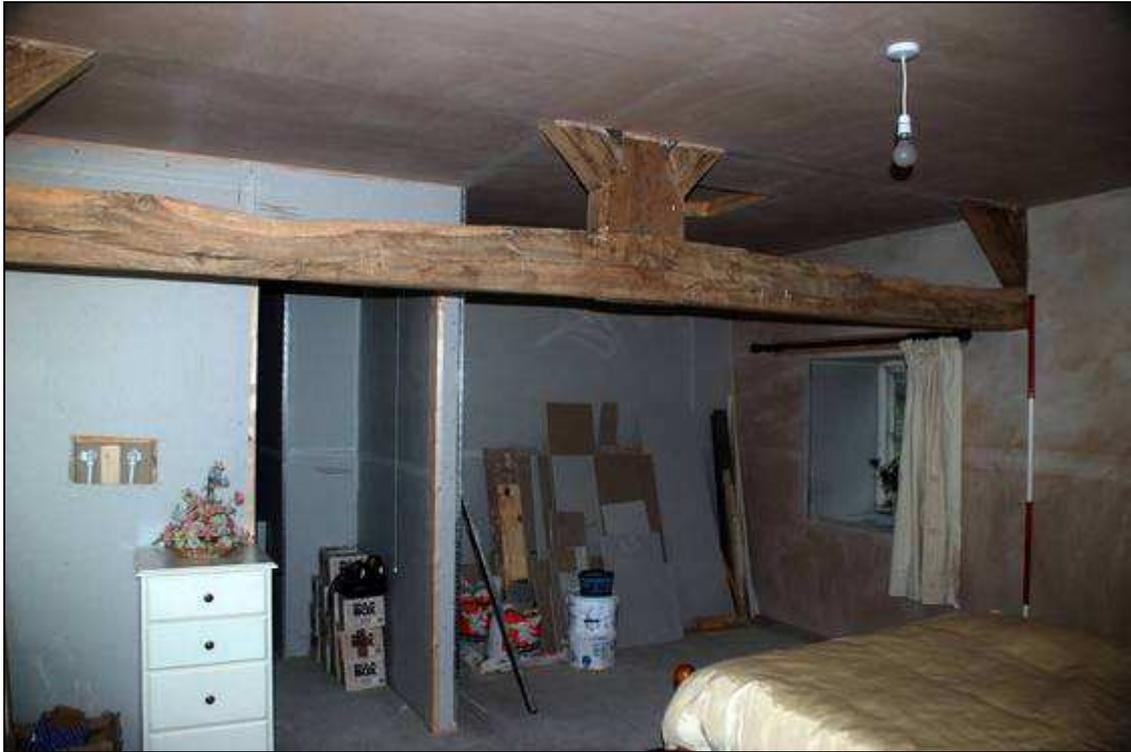
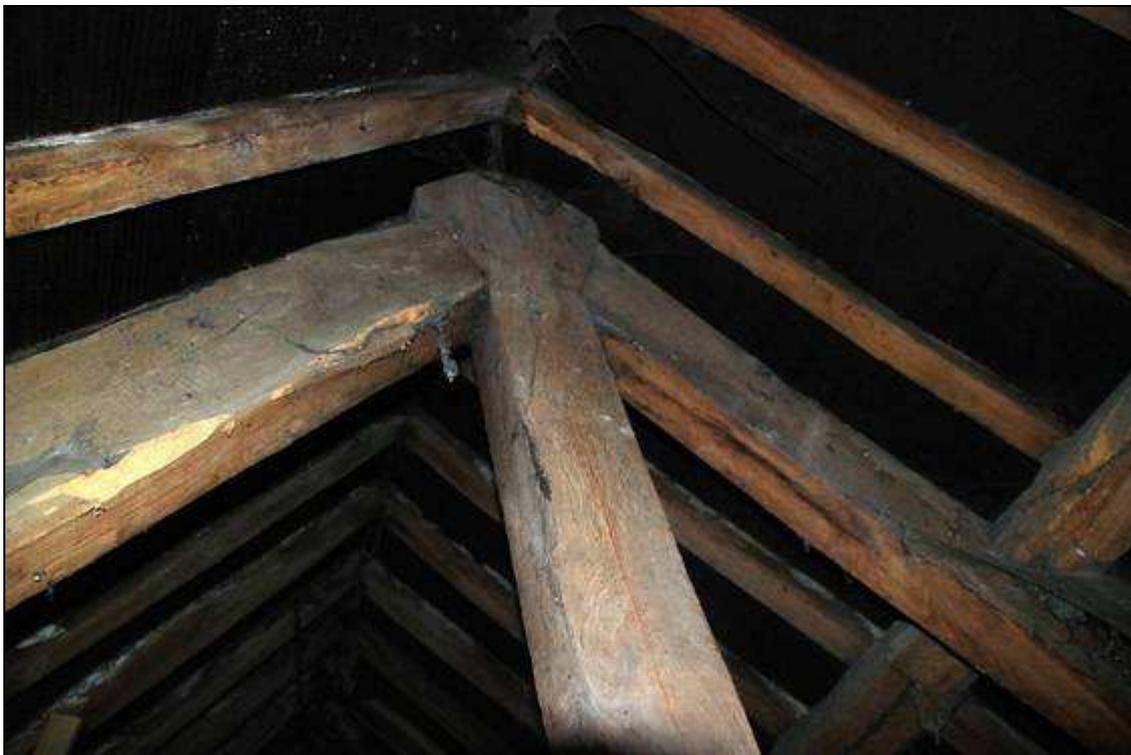
The trusses within the northwest wing (Figure 5, Plates 28 - 30) are king post trusses with raking braces. The braces join the king post at carefully crafted bosses. The king post itself rests on a tie-beam and is also shaped at its top to allow the principal rafters to join (Plate 30). The most southerly of the trusses (Truss 7) also has carpenter's marks on the base of the king post and on its braces in the form of chiselled slots (Plate 31).

Plate 28: Truss 7 looking north

Plate 29: Base of Truss 8, looking north

Plate 30: Top of Truss 8, looking SE

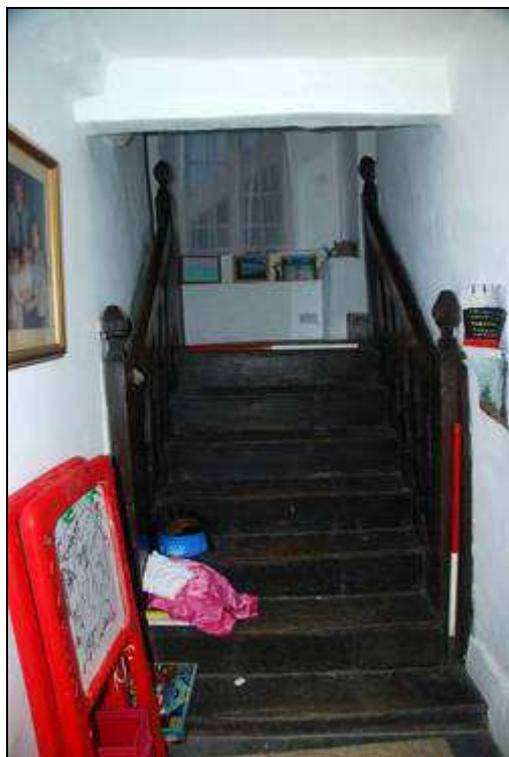
Plate 32: The staircase, looking NW

The ground floor of the main range consists of three main rooms and the entrance hall/staircase. The staircase (Plate 32) has a short straight flight to a half landing where two further flights give access to passageways running along the north western side of the range. It has flat splat balusters (Plate 33) and a carved newel post (Plate 34). It appears to have been constructed in what was originally the cross passage and now sits behind the central chimney, which was presumably added at a similar date. The form of the balusters and newel post would suggest a seventeenth century date (Alcock *et al* 1994, 6, Calloway, 2005, 66).

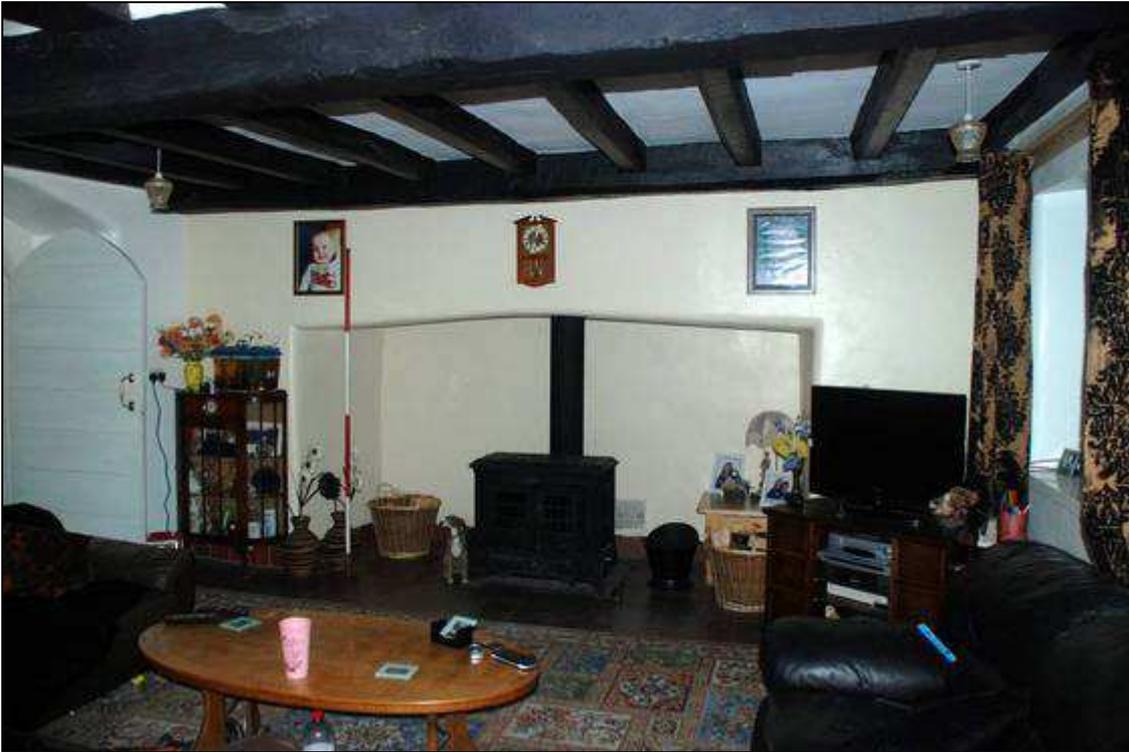
Plate 35: The fireplace at the NE end of the main range, looking NE

The north eastern room in the main range has the large fireplace which is related to the gable chimney with the diagonal shaft (Plate 35). It is likely that this room acted as the kitchen after the construction of the gable end chimney. The ceiling of this room is timbered with a main beam in the middle of the room and a series of joists running longitudinally. The main beam has a second timber attached to its eastern side forming a ledge against which it is possible that there was a partition at some point in the past (Figure 7). There are also blocked, mortice holes on the under side of the main beam also suggesting a lost partition (Plate 36). The dismantled post and plank partition, now stacked in the south west ground floor room may have come from here, however Suggett (*pers. comm.*) suggests they were from the partition between the southwest and central ground floor rooms. The joists are in a different pattern on either side of the main beam with those between the beam and the fireplace having a more regular pattern. There are also the remains of a lower joist or beam in the SW wall of the room (Plate 37) suggesting that the ceiling may have been raised.

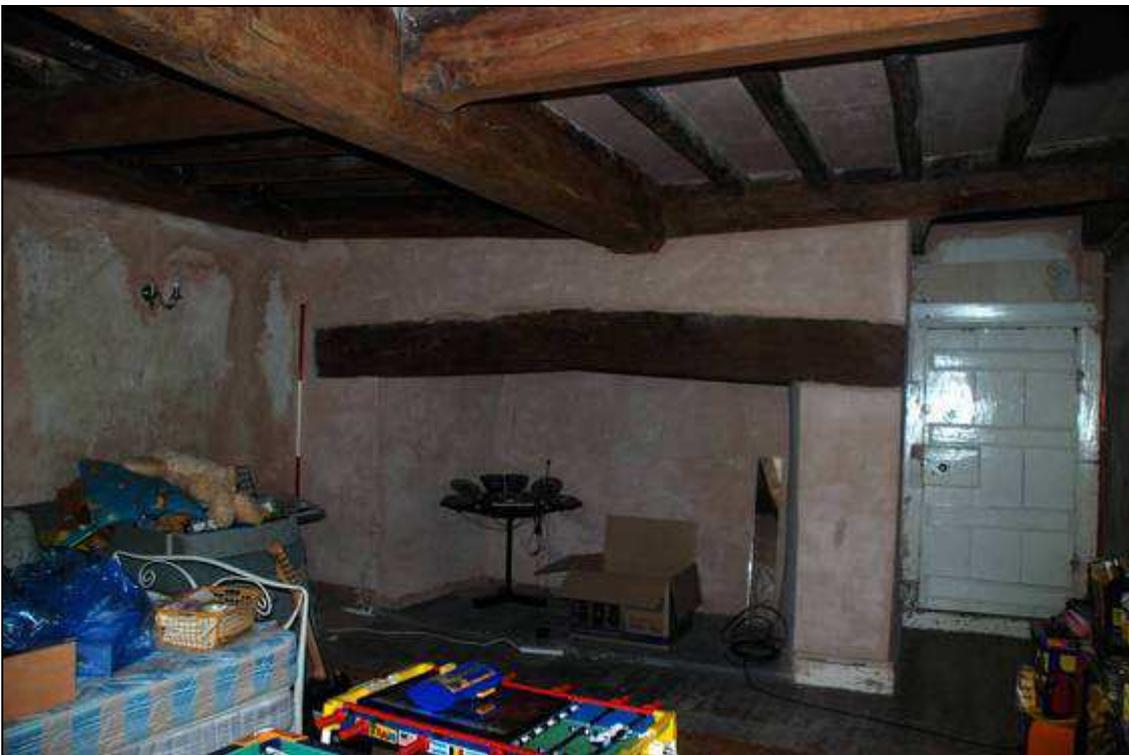
Plate 38: Fireplace in central ground floor room, looking NE

The central ground floor room has an inserted fireplace (Plate 38) which sits between the cross passage and Truss 2, the foot of which is visible in the southern wall of this room (Plate 39). The ceiling in this room has counter changing joists between a framework of chamfered longitudinal beam and lateral coffers (Figure 7, Plate 40). Both the coffers and the beam have angled stops.

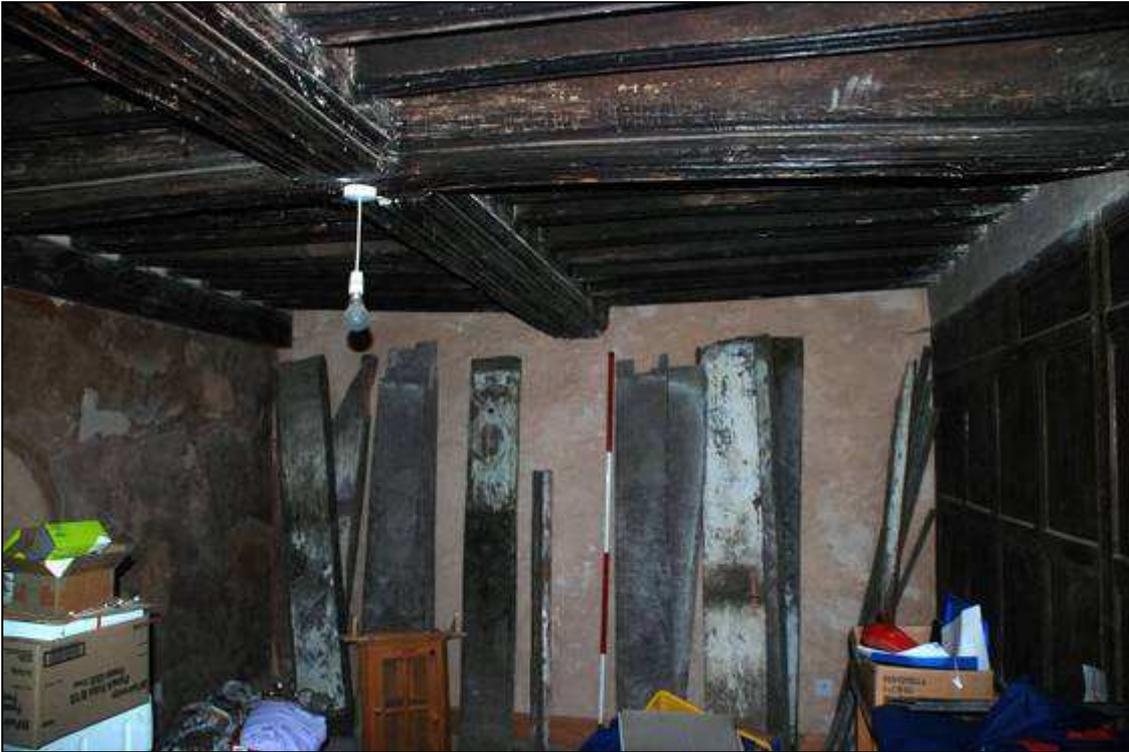
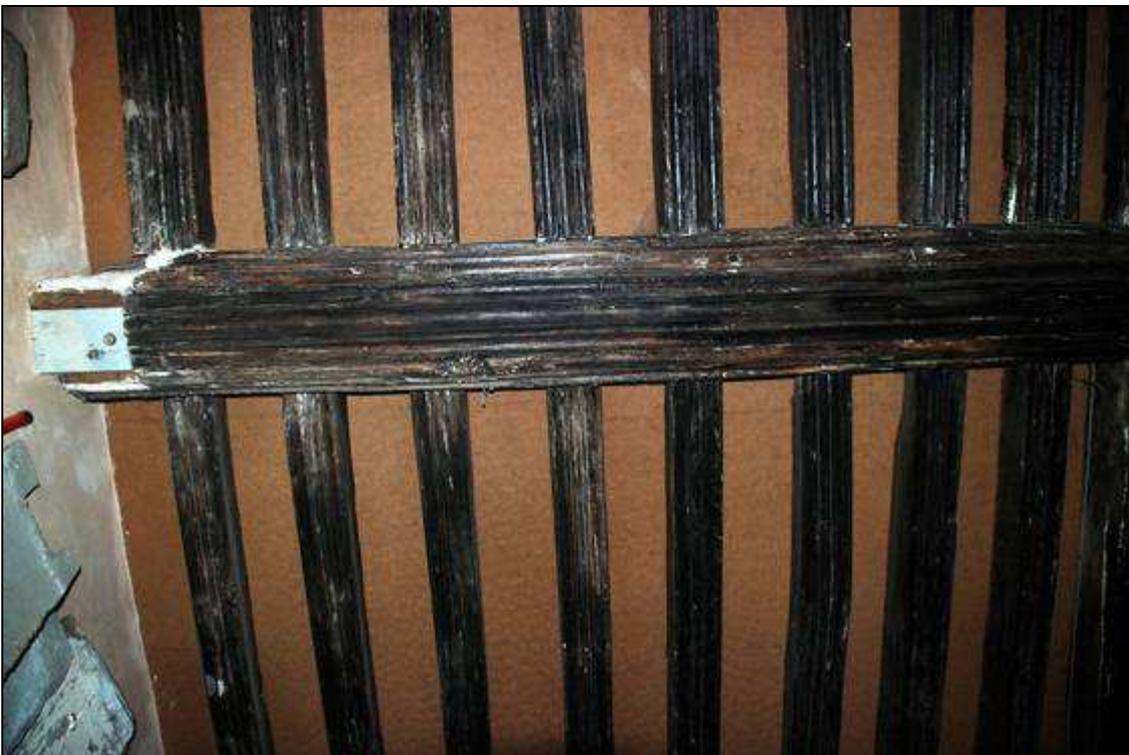
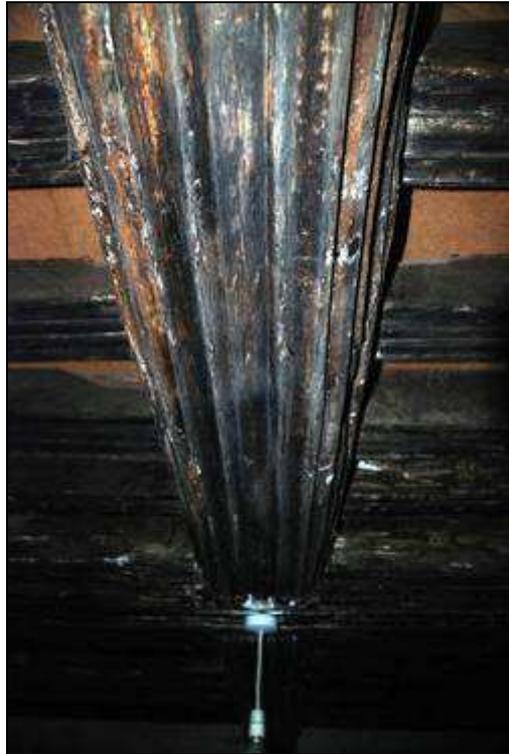
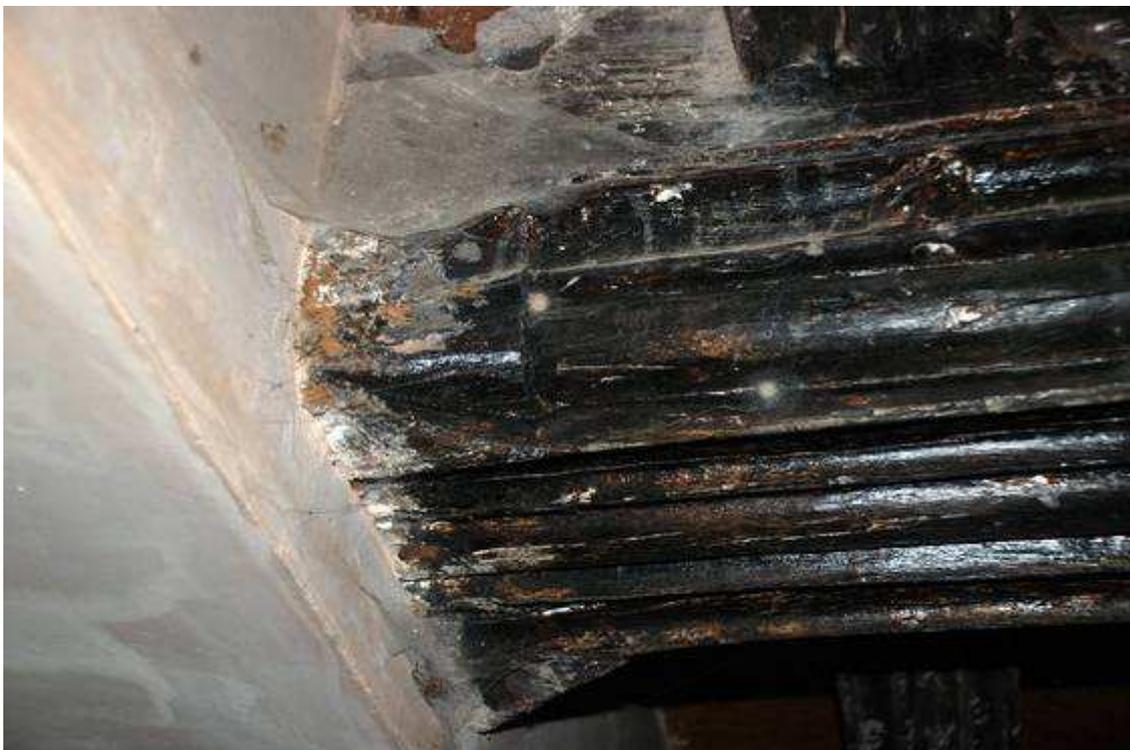
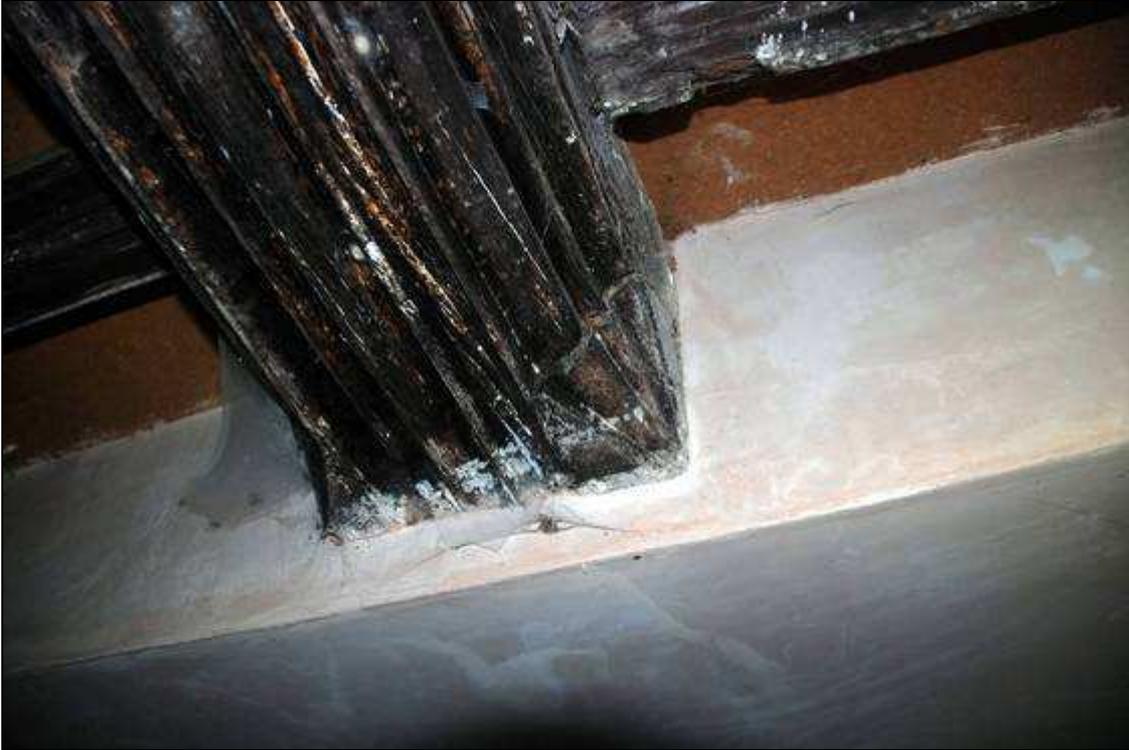
There is a step up into the south western room of the range, presumably to accommodate the cellar below. This room has a fine timbered ceiling with moulded beams and joists (Figure 7, Plate 41 - 45). Three of the joists are later (plain) replacements. It is possible that there was access to the upper floor at this point as there are the mortice holes for a trimmer on the surviving joists either side of the replaced joists (Plate 46). The partition between the central and SW rooms is panelled (Plate 47), although it is thought that this panelling replaced an earlier post and plank partition, the mortice holes for which are still visible above the doorway between the two rooms (Plate 48).

Plate 41: SW ground floor room, looking NW

Plate 42: Moulded beam and joists in SW ground floor room, looking up

Plate 43: Detail of moulding on ceiling beam in SW ground floor room, looking NW

Plate 44: Detail of moulding on ceiling beam in SW ground floor room, looking SE

Plate 45: Detail of stop on ceiling beam in ground floor SW room, looking SE

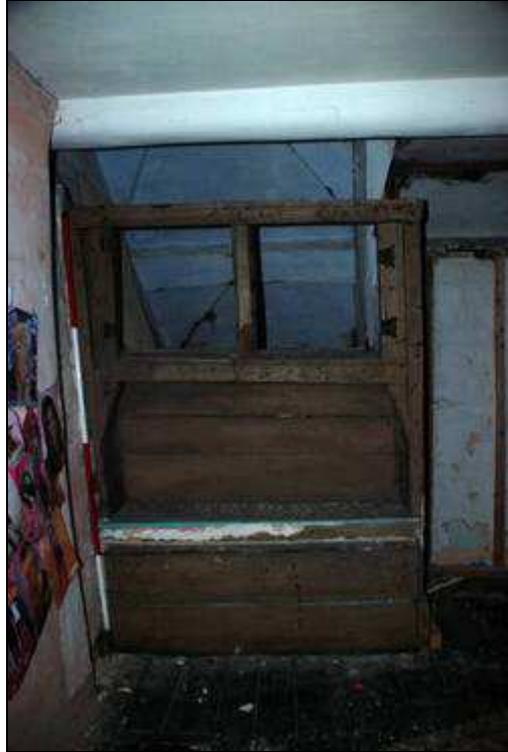
Plate 49: Partitioned shelf over the stairwell, looking NW

Above the stairwell there is a timber partition (Plate 49) forming a wide shelf. Whilst part of this is constructed of timber the panels are of woven laths which have been plastered (Plate 50). The structure is attached to Truss 4 (Plate 51) and runs back to the back of the inserted central chimney and the line of Truss 3.

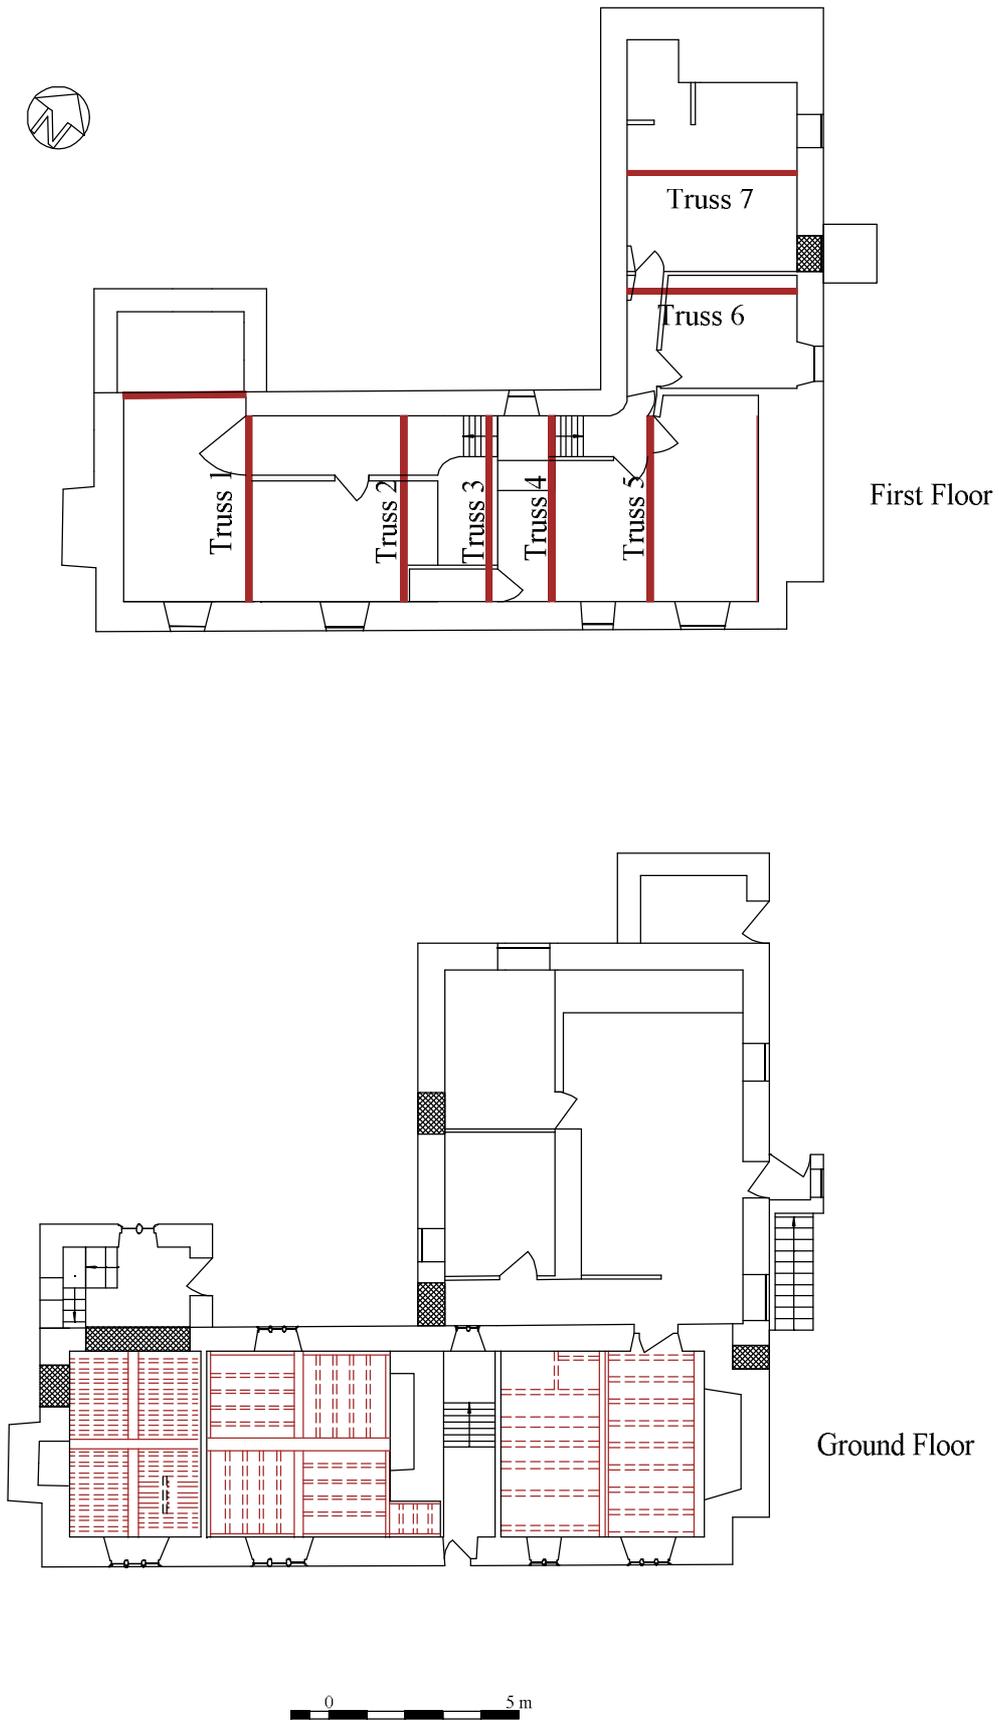
Figure 2: Branas-uchaf, Llandrillo  
Scale 1:200

Branas-uchaf sits on the floodplain north of the River Dee, approximately 2 km west of Llandrillo (Figure 1). Whilst no longer part of the farm it is approached along a lane through a series of agricultural building to which it was once linked. The original house was a single range aligned approximately NE – SW, however a large wing has been added to the north-east end and a small wing to the north-west end (Figure 2).

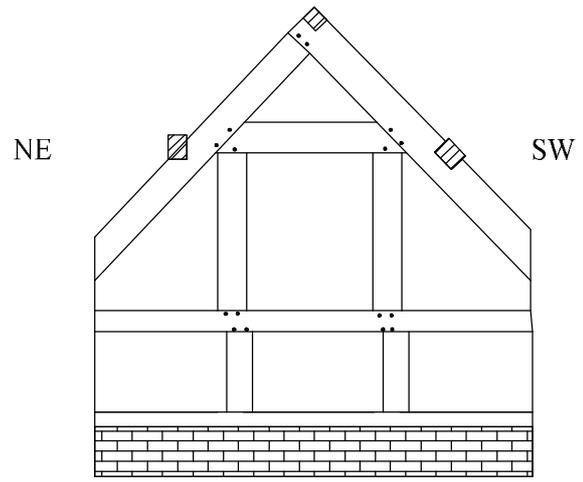
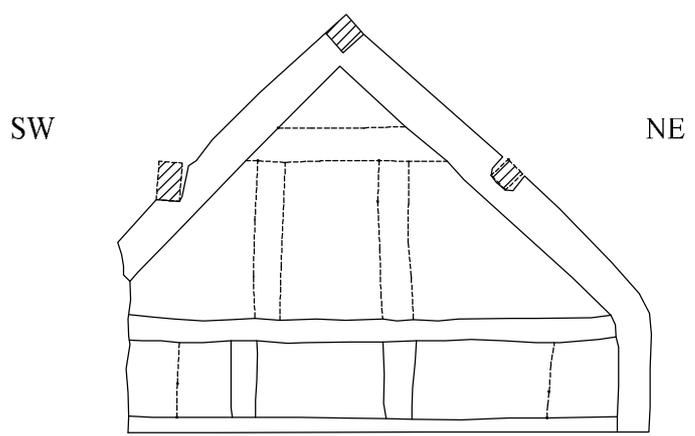
Figure 4: Branas-uchaf, Llandrillo:  
Truss between Main Range and Southwest Wing  
Scale 1:50

Between the main range and the south west wing, on the first floor the separation consists of a timber framed partition which also forms a roof truss for the added wing (Figure 4). In the main range this has been heavily plastered, although its form is discernable (Plate 25). When viewed from the wing, however, its form is clear (Plate 26). There is a tie-beam with queen struts linked to a straight collar with studs below the tie-beam. These studs are now very short running as far as a wall plate sitting on a brick wall made of modern bricks. The relationship between the wing and the main range on the ground floor is uncertain as this face has a coating of modern render. There is also a short flight of, dog legged, stone stairs (Plate 27) within this wing.
