**North West Wales Dendrochronology Project  
Branas-uchaf, Llandrillo,  
Denbighshire**

**EAS Client Report 2009/21  
December 2009**

**Commissioned by  
Margaret Dunn  
For  
North West Wales Dendrochronology Project**

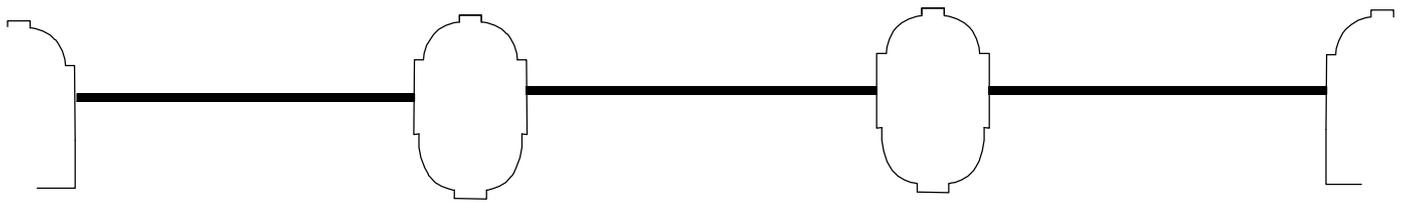
Figure 6: Branas-uchaf, Llandrillo:  
Section through Window Mullions  
Scale 1:10

The ground floor windows consist of a series of stone ovolo moulded mullions (Figure 6) with relatively thin, tall openings. The majority of the windows have three lights (Plate 3), although the windows to the north east of the door and opposite the door, on the NW wall, have only two lights (Plate 4). The windows have flat, hoodmoulds. The larger window in the northwest wall, of this range, has been blocked, but on the outside retains the stone frame and hoodmould (Plate 5). The smaller window is partly blocked by the later extension (Plate 6).

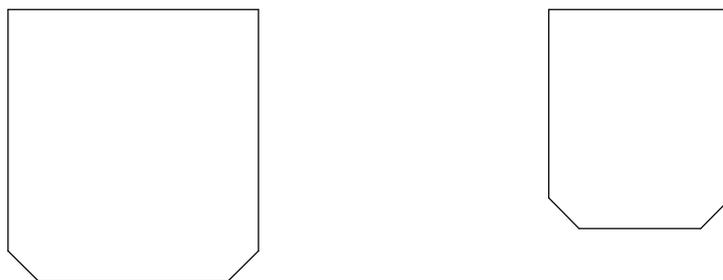
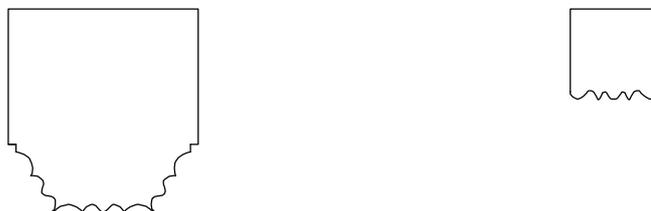
Figure 7: Branas-uchaf, Llandrillo: Section through Ceiling Beams

There is a step up into the south western room of the range, presumably to accommodate the cellar below. This room has a fine timbered ceiling with moulded beams and joists (Figure 7, Plate 41 - 45). Three of the joists are later (plain) replacements. It is possible that there was access to the upper floor at this point as there are the mortice holes for a trimmer on the surviving joists either side of the replaced joists (Plate 46). The partition between the central and SW rooms is panelled (Plate 47), although it is thought that this panelling replaced an earlier post and plank partition, the mortice holes for which are still visible above the doorway between the two rooms (Plate 48).

Main ceiling beam and coffer in groundfloor central room

Moulded beams in ground floor SW room
