**North West Wales Dendrochronology Project
Maes Tyddyn, Llandrillo,
Denbighshire**

**EAS Client Report 2009/19
December 2009**

**Commissioned by
Margaret Dunn
For
North West Wales Dendrochronology Project**

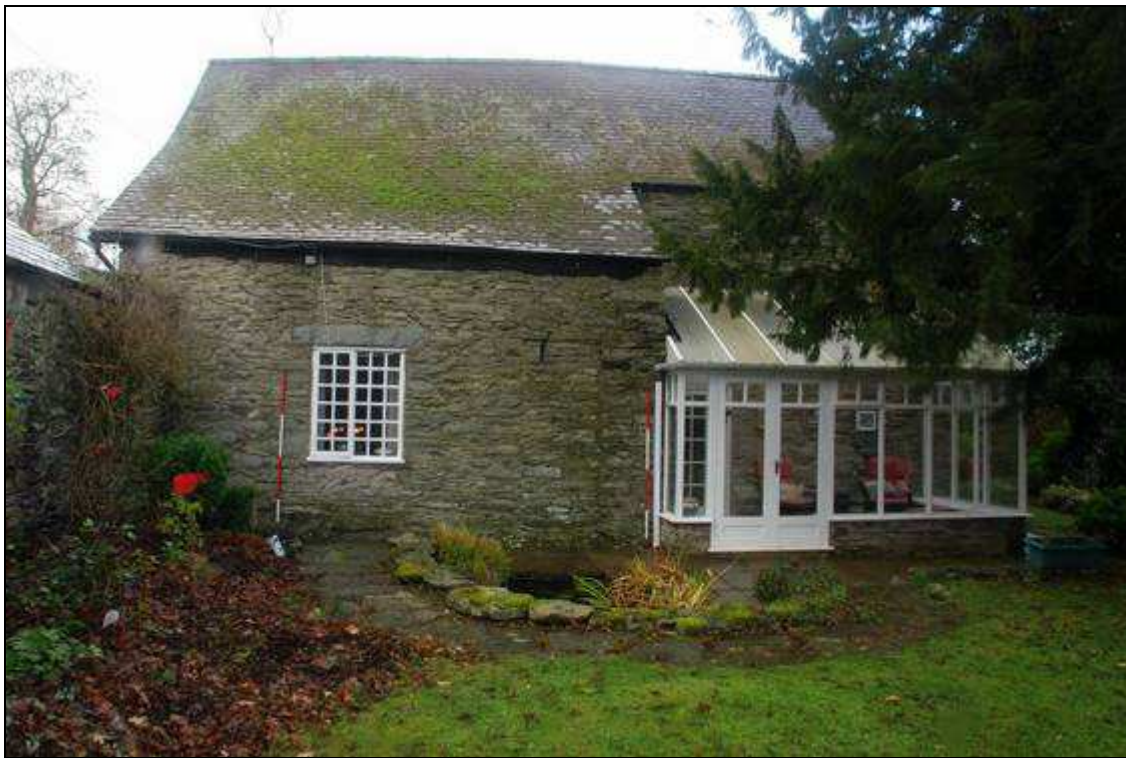
Plate 4: Southern Aspect, looking north

With the exception of the window in the upper storey of the eastern gable end, all of the windows are relatively modern in appearance. The gable window, however, has wooden ovolo mullions (Figure 5) of a form thought to be in used between 1567 and 1741 (Alcock and Hall, 1994, 38). There is clearly a blocked doorway in the southern wall of the short southern wing which may represent an earlier entrance to the property (Plate 4).

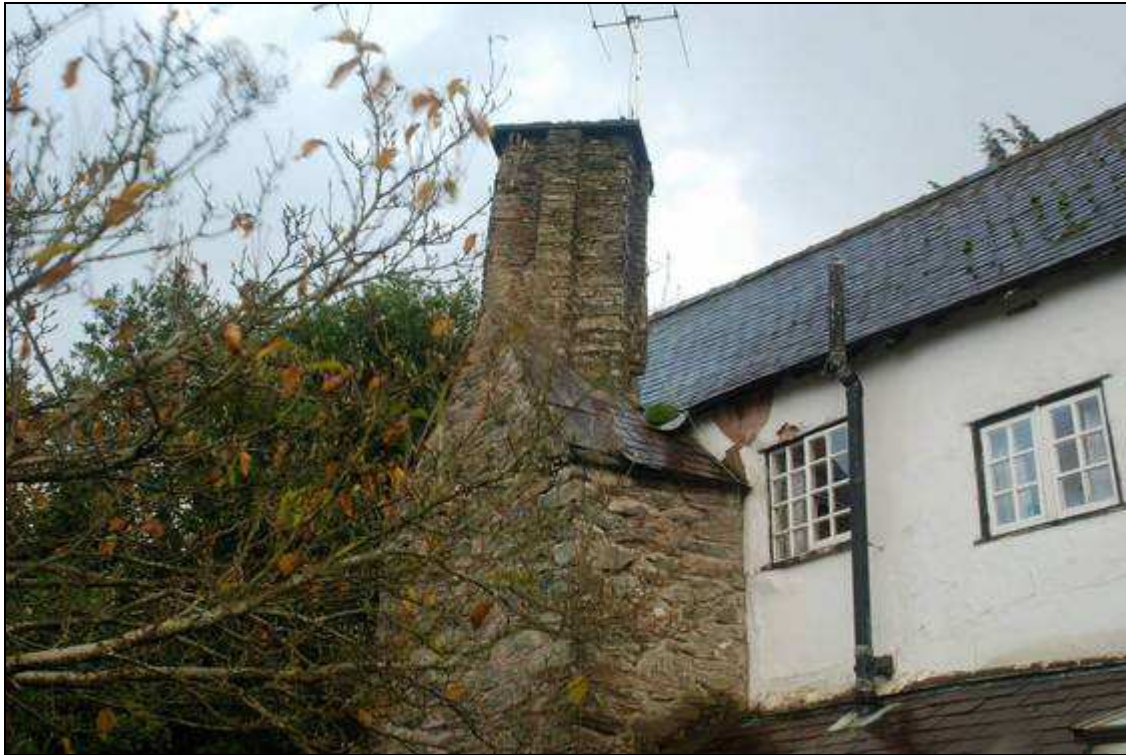
Plate 5: Detail of the chimney, looking SE

Maes Tyddyn sits within the valley of the River Dee, approximately 500 m west of the village of Llandrillo (Figure 1). It is immediately adjacent to the property of Tyddyn-Ilan and is assumed to be its predecessor. Externally the walls are partly rendered and partly of roughly coursed stonework forming a house with an “L” shaped plan (Figure 2, Plates 1-4). There is also a modern kitchen extension attached to the northwest corner of the property. The roof is gabled with a gabled extension over the short southern wing and is covered by modern slates. Projecting from the northern, lateral, wall is a chimney (Plate 5). It has a diagonally set shaft with square ribs very similar to that on Branas-uchaf only 1.5 km to the west.

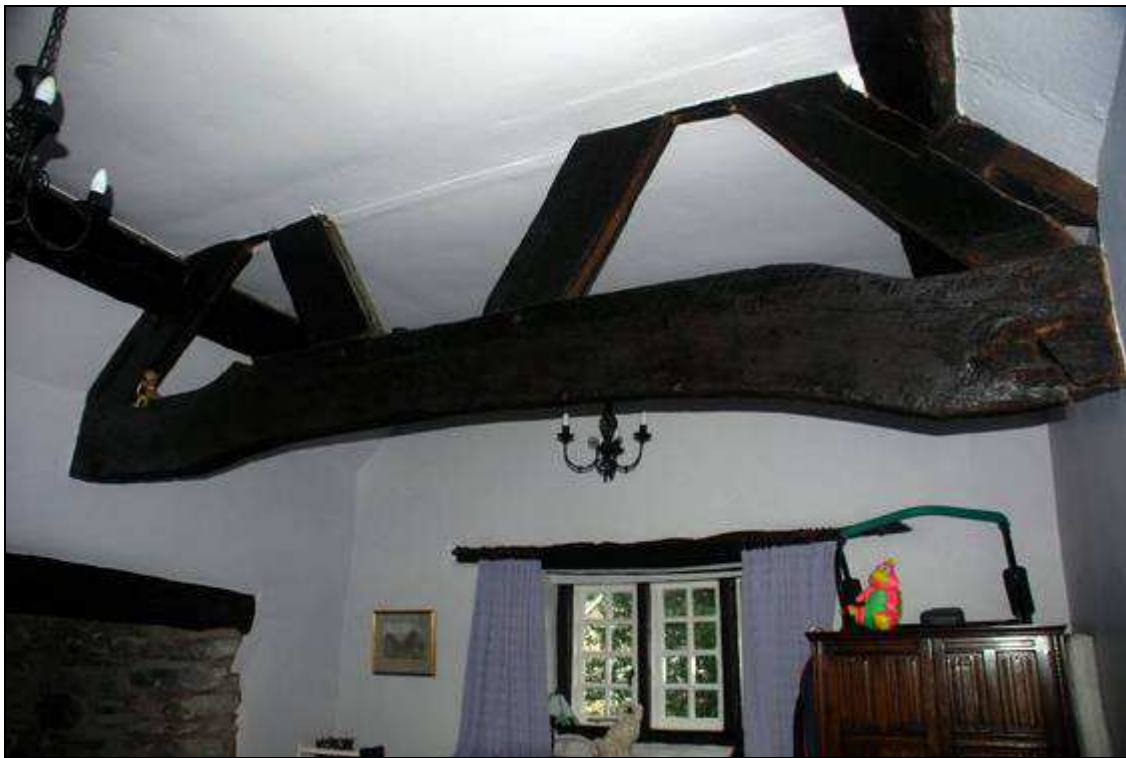
Plate 6: Truss 1, looking NE

Internally the house consists of two rooms on the ground floor and three on the first floor. Three trusses were evident, which although similar differ in detail. Truss 1 (Figure 3, Plate 6) runs from above the fireplace in the eastern bedroom

across the width of the building. Only the lower portions were visible, but this showed a tie-beam with raking queen struts above. Slots in the principal rafters below the lower pair of purlins suggest the positions of windbraces which have been lost. The tie beam has a slight upward curve.

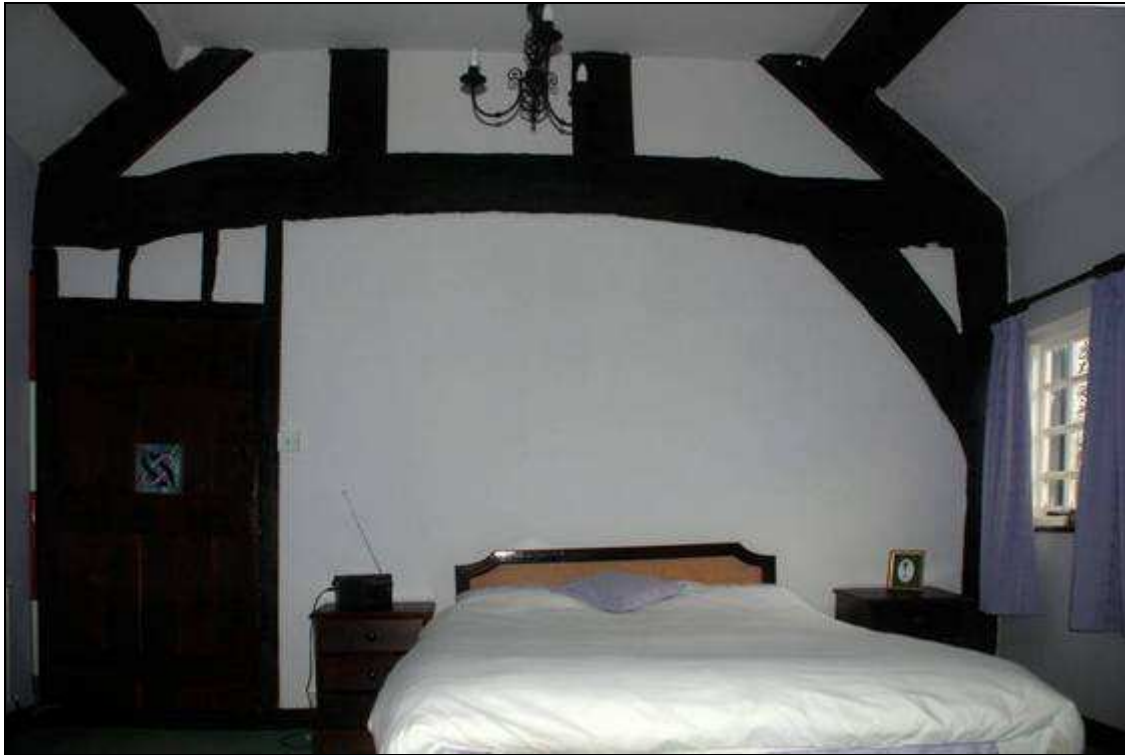
Plate 7: Truss 2, looking west

Truss 2 (Figure 4) runs through the middle of the house and can be traced in the dividing wall between the two ground floor rooms and between the bathroom and the eastern bedroom on the first floor (Plate 7). The full extent of this truss was visible. It consists of a collar and tie-beam truss with slightly upward curved tie-beam and collar. There are straight queen struts between the collar and tie beam and raking struts above the collar. There is also a diagonal strut between the northern post and the tie-beam. Slots in the principal rafters suggest the presence of windbraces below both pairs of purlins, now lost. The post on the southern side can be traced almost down to ground level and there is a second tie-beam at a height of 2.33 m from ground level (Plate 8) cut by a modern doorway. The post has been slightly modified to allow for the door way between the two ground floor rooms. Although it has been truncated before it reaches the floor the southern post appears to relate to a curious stone mound projecting from the wall between the two ground floor rooms (Plate 9). Both the post and the stone probably mark the southern extent of the original house suggesting that the short southern wing is an extension. It also suggests that the original building was timber framed, possibly sitting on a low stone plinth. Further evidence of the timber framed nature of the original building is shown in the western bedroom, where a series of studs are evident in the northern wall (Plate 10).

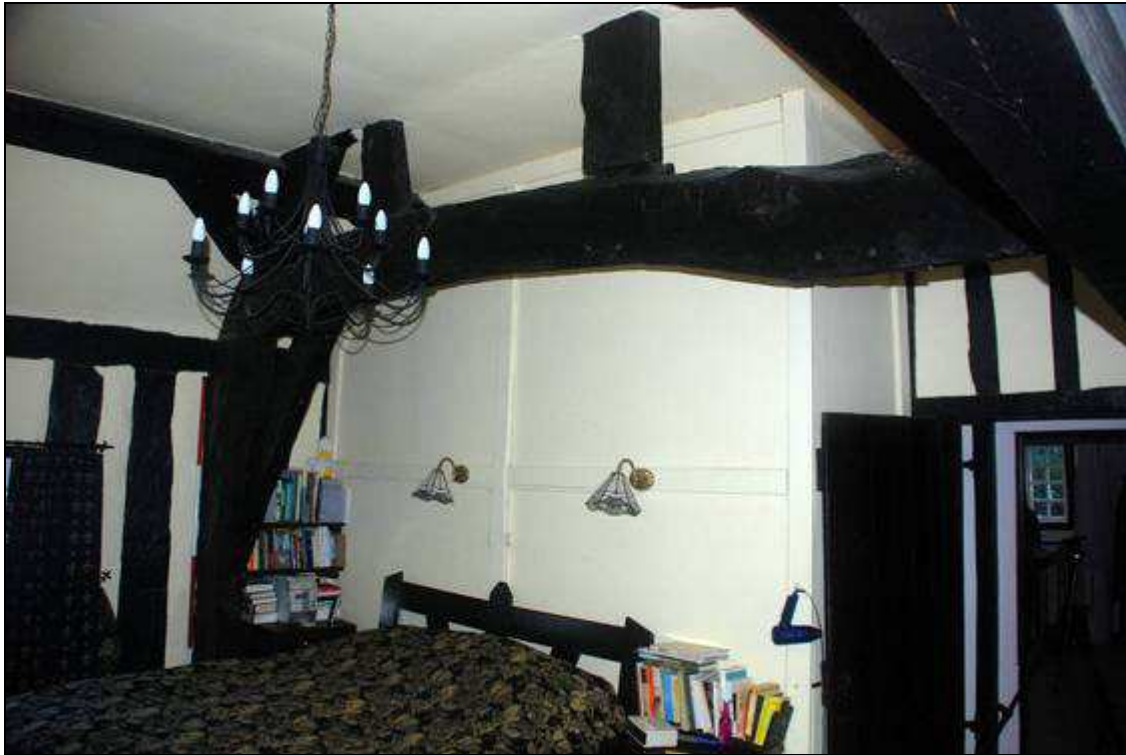
Plate 11: Truss 3, looking NE

Truss 3 (Figure 3, Plate 11) is in the western bedroom, the southern end of which is supported by a longitudinal beam which may have been a wall plate, but is more likely a structural timber related to the building of the short southern wing and partly acted as a purlin at the break of slope between the roofs of the main house and the added wing. In such it can also be seen to extend as far as Truss 2. The truss is a tie-beam and collar truss with slightly upwardly curved tie-beam and collar. There are slightly raked queen struts between the tie-beam and collar and raked struts above the collar. There is also a diagonal brace between the surviving northern post and the tie-beam. A mortice slot at the southern end of the tie-beam suggests that there was a matching brace to a southern post. Slots in the principal rafters below the lower purlins suggest that there were windbraces at least at this lower level. There are also a two mortice slots and a series of dowel holes on the underside of the tie-beam suggesting the presence of a partition at some time (Plate 12).

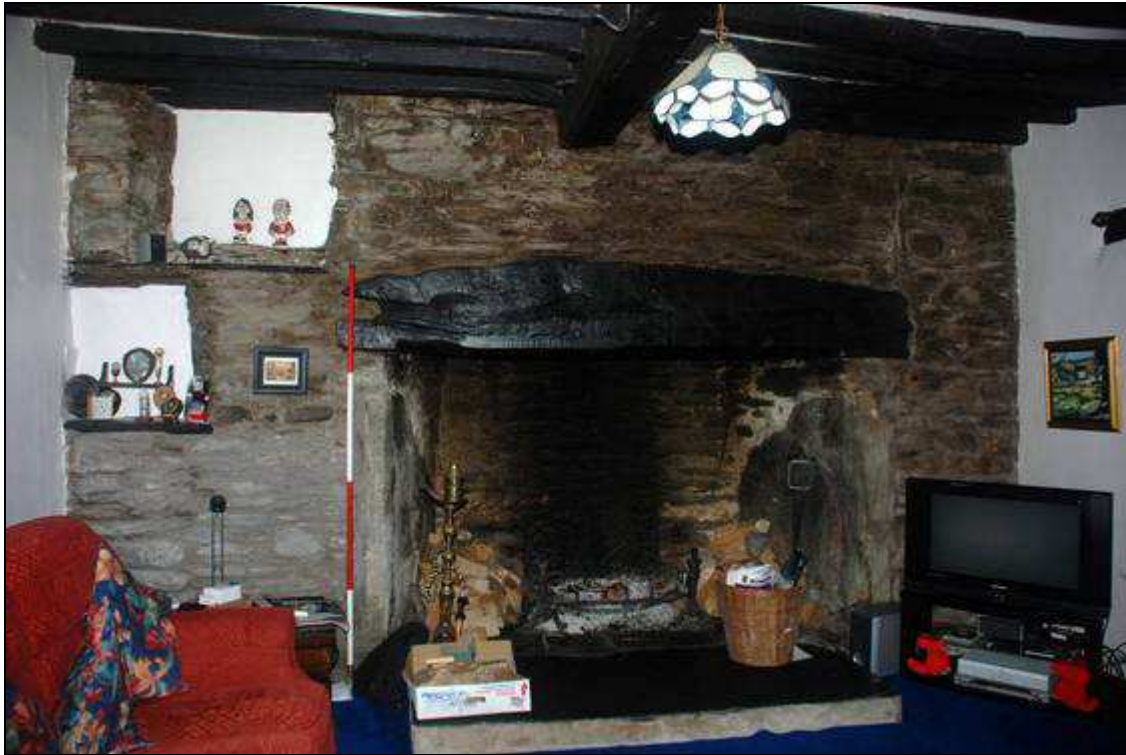
Plate 13: Chimney breast in eastern ground floor room, looking north

The ceilings in the ground floor rooms may be of slightly different dates. The main lateral beam in the eastern room is embedded in the chimney breast (Plate 13). It has a moderate chamfer and lamb's tongue stops (Plate 14). The joists are closely set and are joined to the main beam by a series of tenons on the lower half of the joists mated into mortice slots in the main beam. The joists have a slight chamfer and are stopped only where they meet the main beam with straight cut stops (Plate 15).

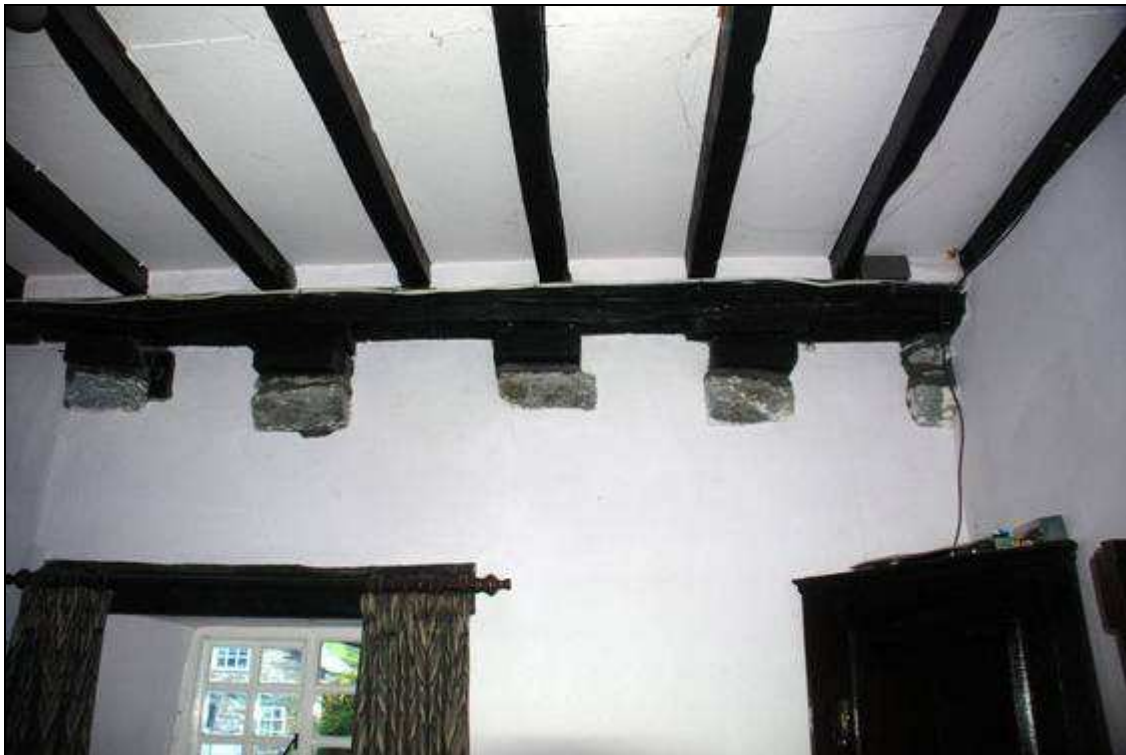
Plate 16: Stone corbels in western wall, looking west

The ceiling in the western room appears to be a later insertion, possibly related to the addition of the short southern wing. There are a series of five stone corbels (Plate 16), high in the western wall which is assumed to relate to the original ceiling in this room. The existing ceiling has a main lateral beam which extends across the width of the south wing. This beam is moderately chamfered with no stops. The joists are slightly offset in the beam (Plate 17) and join with a series of mortice and tenon joints.

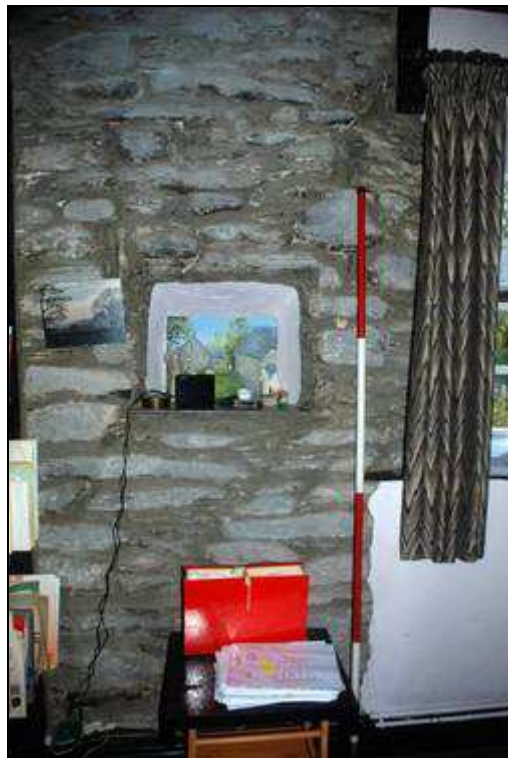
Plate 18: Blocked opening in SW corner of western room, looking west.

Also within the western ground floor room there is some evidence for a blocked opening in the south west corner of the room (Plate 18). This possible opening was not visible on the outside wall of the property and the function and full extent of the opening is uncertain.

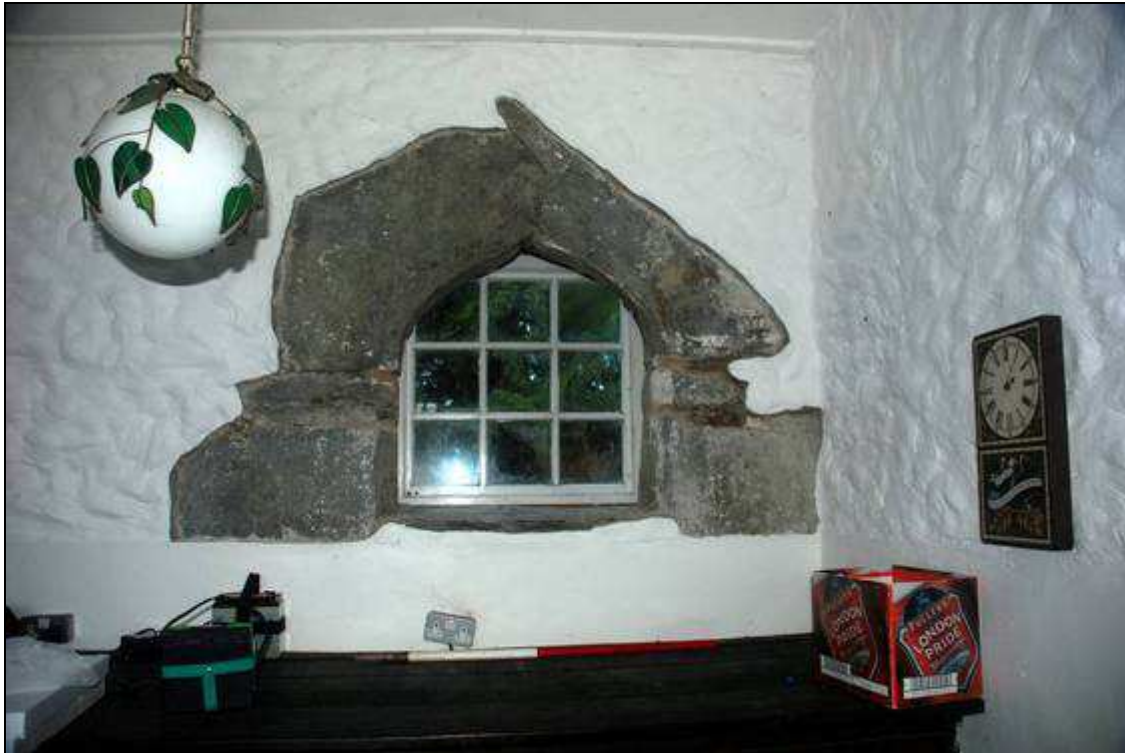
Plate 19: Cyclopean door head in the out building, looking east

Within an out building, running roughly at right angles to the house a cyclopean door head was noted. Now framing the inside of a window (Plate 19), it is clear from the outside of the building that this was once a doorway (Plate 20). It is uncertain whether this door head is *in situ* or has been moved from elsewhere.
