# **Coed-y-Foel, Derwen, Corwen Denbighshire**

**EAS Client Report 2016/03**

## **Coed-y-Foel, Derwen, Corwen**

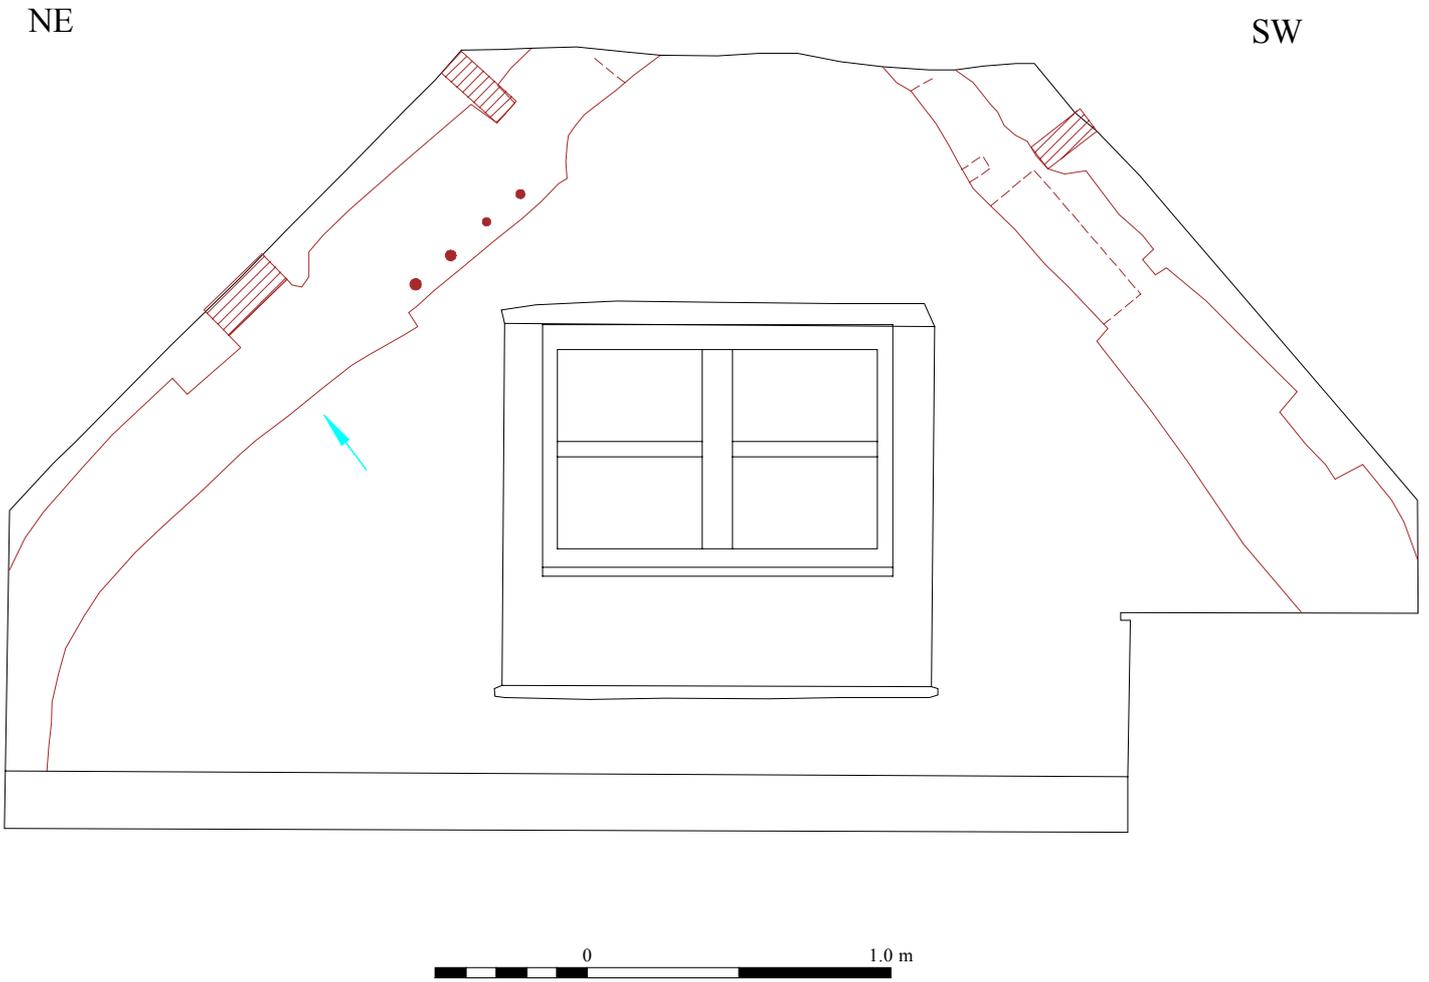
Figure 5: Truss 1  
Scale 1:25

On the first floor, Truss 1 (Plate 26, Figure 5) is exposed in the south eastern gable end of the house. It is clearly the upper section of cruck frame, although the number of modifications to its upper surfaces would suggest the roof level has been modified several times. The truss is also missing its collar, which was presumably removed to accommodate the window in the gable wall. Its position

is marked by a mortice (Plate 27) in each of the blades. Above this the underside of the blades are shaped and there is the remains of blocked mortices near to the current ceiling level, possibly suggesting decorative cusping once occupied the peak of the truss. The upper purlins are late in the development of the roof and relate to a change in the profile of the roof. The one surviving lower purlin (Plate 28), however, is a plank lying parallel with the line of the roof whose line can be traced through to Truss 3. This sits on top of the truss and there are a series of trenches in the top surfaces of both of the blades which suggests that there have been multiple phases of purlins and roof modifications.

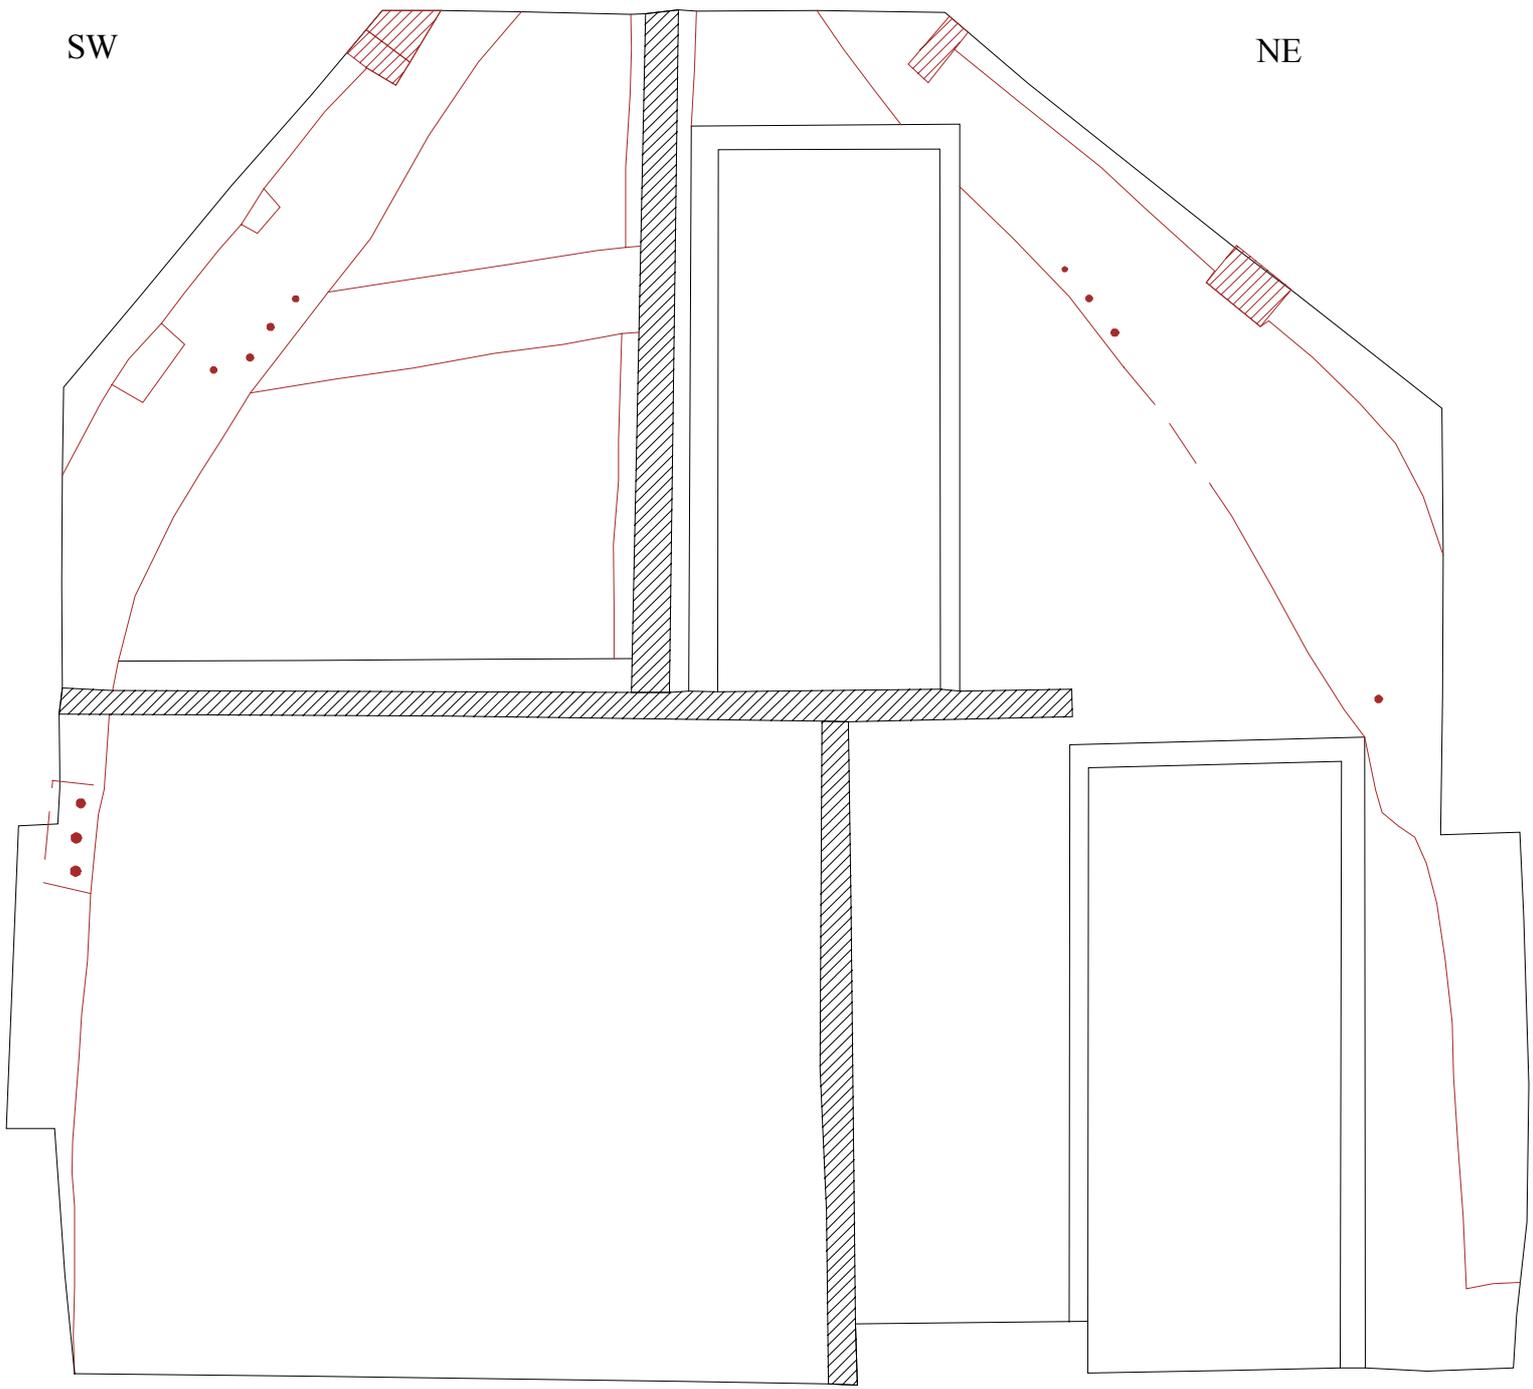
Figure 6: Truss 3  
Scale 1:25

The house is entered through a lobby which now contains the staircase to the first floor and is open. Just inside the door the foot of the northern blade of Truss 3 (Plate 11, Figure 6) is exposed. A peg hole at a height of 2.3 m above the current floor suggest there may have been a tie beam which has now been lost, probably on the insertion of the central fireplace into an earlier structure.

The hall also contains lower section of Truss 3 in the western wall of the house (Plate 22, Figure 6). This has a mortice 1.59 m above the current floor level (Plate 23) which corresponds with a marked kink in the profile of the eastern blade of the truss. These mark the position of a tie beam, now lost. The relatively low position of this tie beam would suggest that the current floor level may be above that of the original floor as it would have crossed the centre of the hall.

Truss 3, is exposed at the other end of the landing and in the bathroom (Plates 30 and 31, Figure 6) as well as on the ground floor (see above). The truss is a cruck frame which originally had a cranked collar, although this has been truncated by the insertion of the door to Bedroom 2. There are, however, peg holes in the north eastern principal rafter which marks its position. The cut end of the collar is supported by a post which appears to run between the tie beam and the peak of the truss. The north eastern principal rafter has two, trenched, purlins, the upper of which is set at right angles to the line of the roof and is probably a late insertion modifying the line of the roof. The south eastern blade of the cruck has two, empty, trenches for purlins together with the surviving upper purlin which is also trenched.

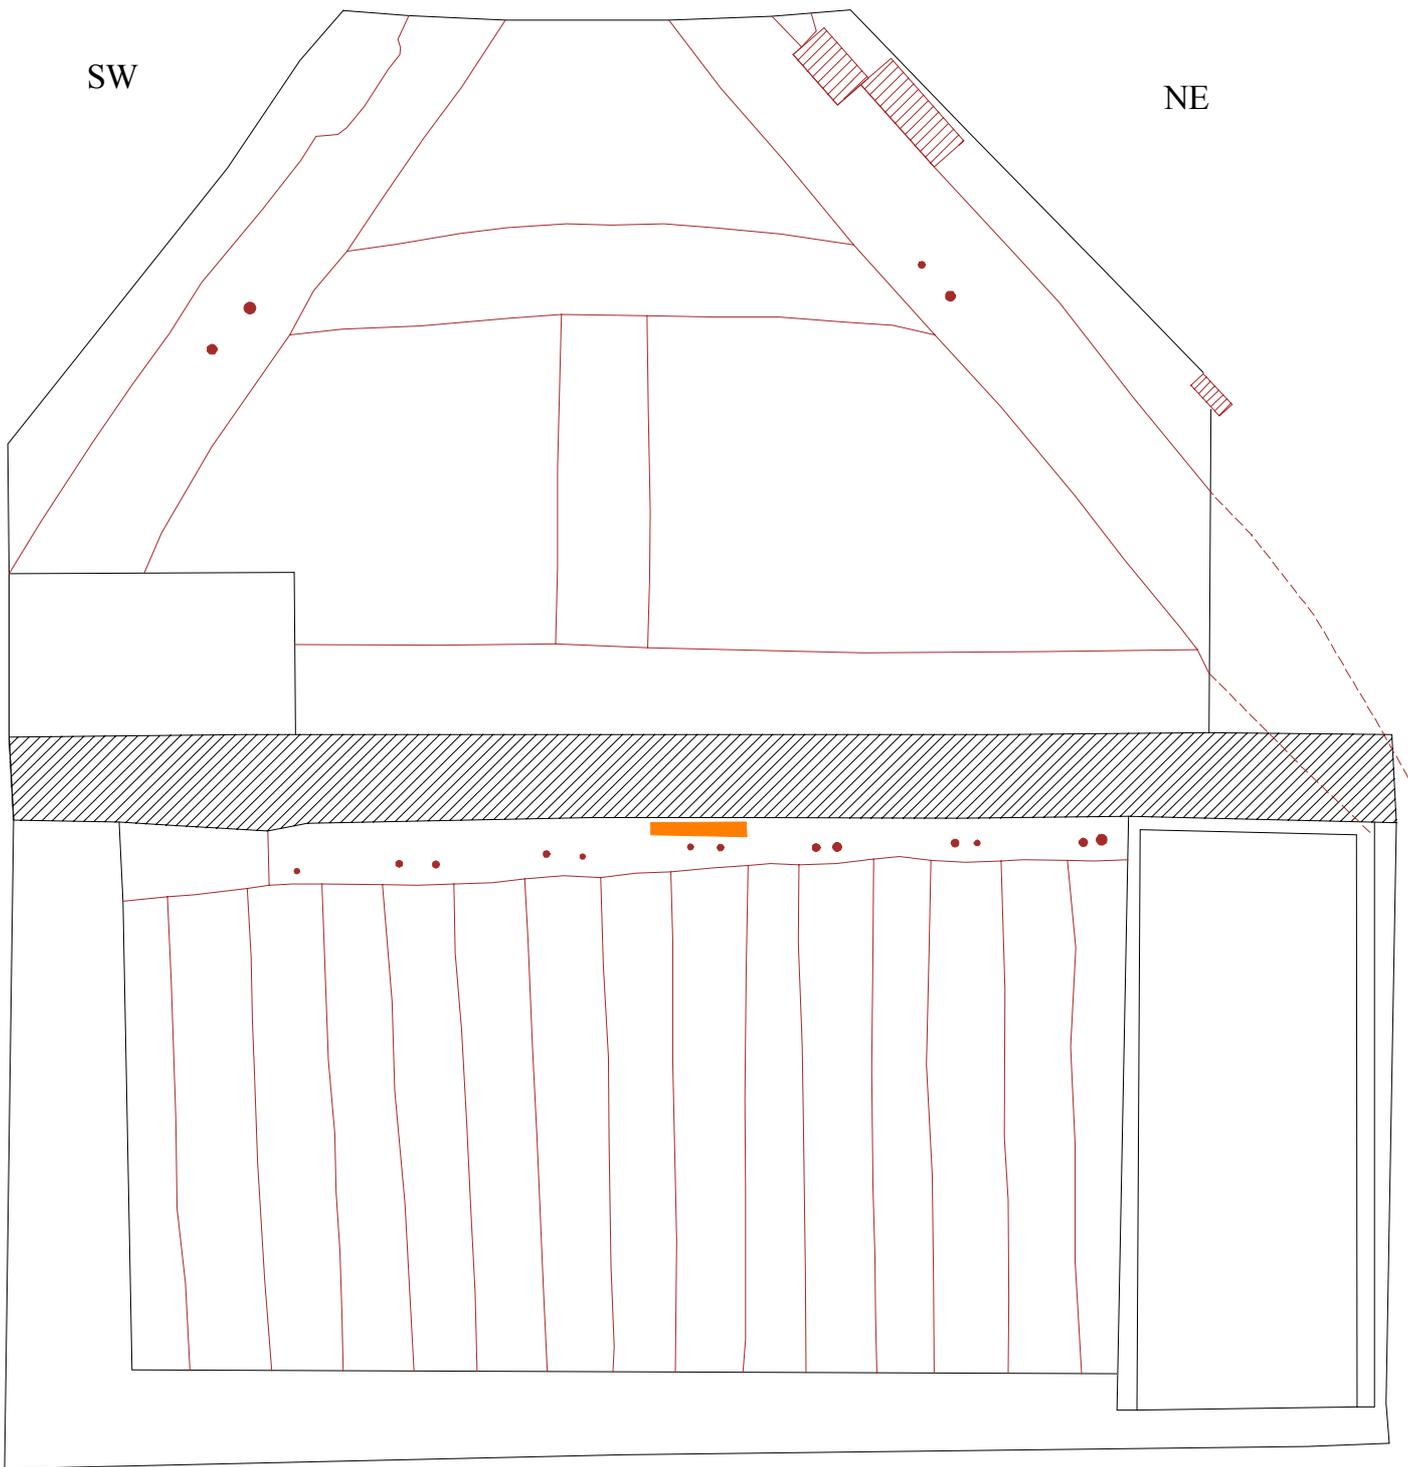
Figure 7: Truss 4  
Scale 1:25

To the north of the lobby, the Hall is dominated by the fireplace, to the south, (Plate 18) and a post and panel partition, to the north (Plate 19). The fireplace has a large wooden bressumer with a slight downward bow in the middle of its length. The partition at the other end of the room, (Plate 19, Figure 7) consists of a series of vertical planks (approximately 0.25 m wide) set in two, staggered, offset rows. They are held in place by a head rail with every other plank held in place by two pegs. The planks which face the hall have quarter round mouldings along both edges (Plate 20) and it is these planks which are held in place by two pegs in the head rail. The moulding only appears on this side of the partition. There is also an iron plate centrally placed on the head rail. This is the retaining plate for a fitting (Plate 21) securing another partition running at right angles to the north west. There is currently one doorway through the partition at its north eastern end, however, an inserted block in the headrail at the south western end may mark the position of a second doorway. This would correspond with the layout on the north western side of the main partition which was divided into two spaces by the partition secured by the iron fitting.

Truss 4 (Plates 32 and 33, Figure 7) incorporates the main, lateral, partition at the north western end of the hall (see above) and marks the separation between Bedrooms 2 and 3. Once again it is a cruck frame with a cranked collar and a tie beam. There is also a short stud between the collar and the tie beam which is centrally placed. The insertion of a plaster ceiling in the hall has hidden the relationship between the tie beam and the head rail of the partition, however a single stud, exposed in the stairwell to Bedroom 3 (Plate 34) suggests there are a series of short studs linking these two elements. The south western principal rafter has one, empty trench which presumably originally held an upper purlin. The north eastern principal rafter, however, has one trenched purlin which overlaps with another purlin which sits on top of the principle rafter. The lower purlin on this side of the house is set well away from the principle rafter and represents a change in the slope of the roof.

Five samples were taken from two of the trusses and three of the purlins, however only two of these proved to be dateable with samples from the tie beam to the northern truss (Truss 4) and the eastern purlin in the second bay from the south suggesting a likely construction date for the initial phase of the house in 1512 (Bridge 2016)

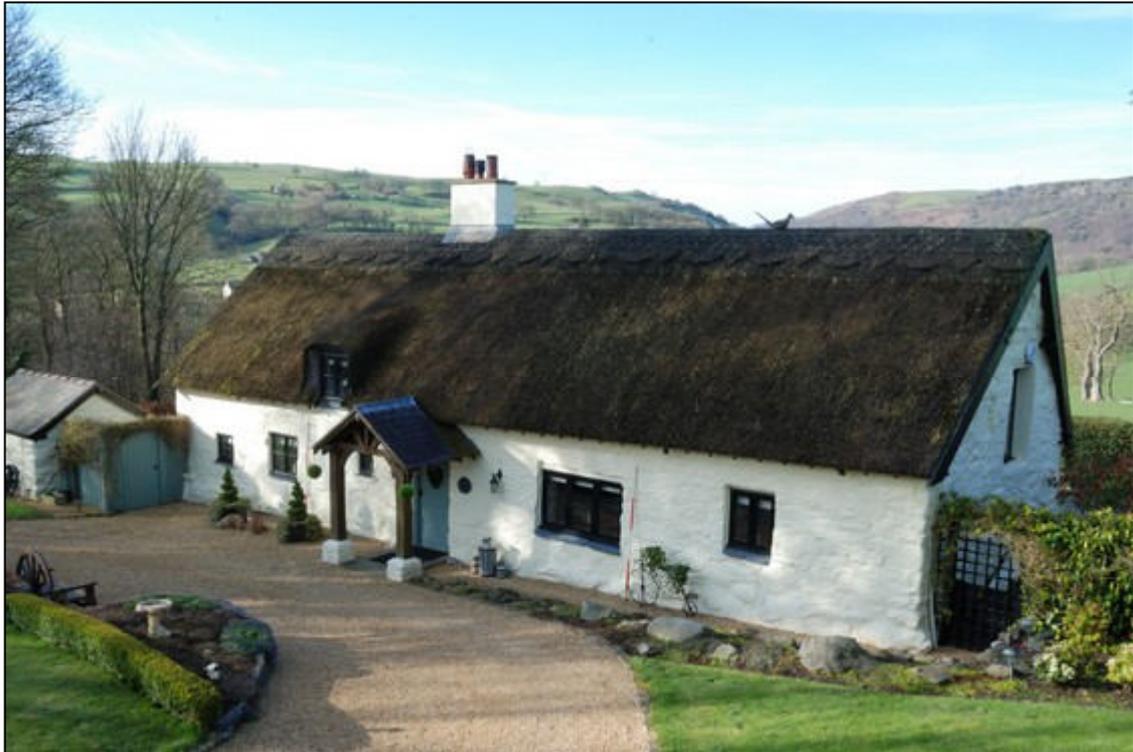
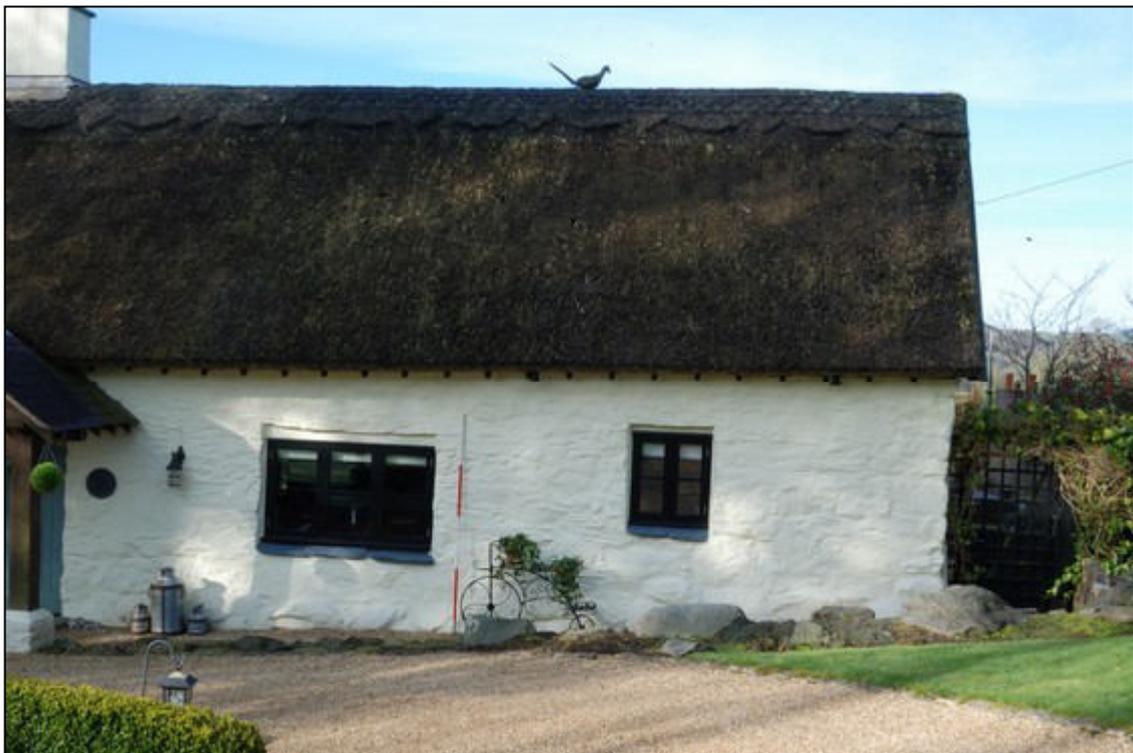
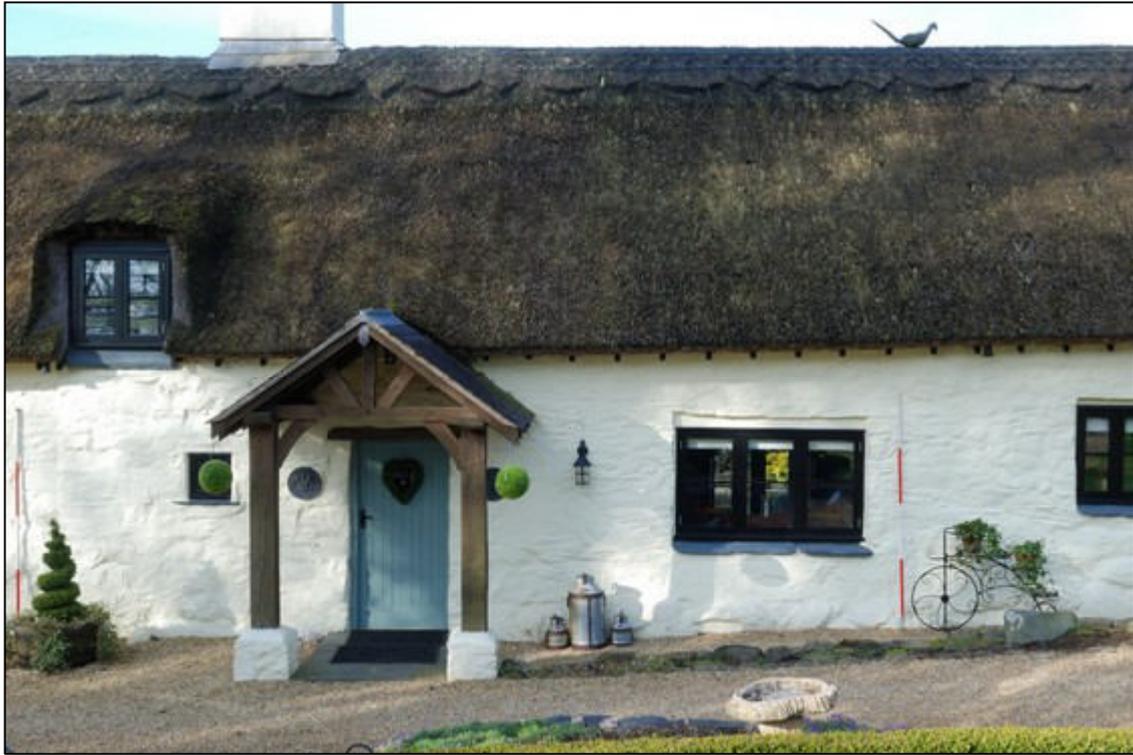
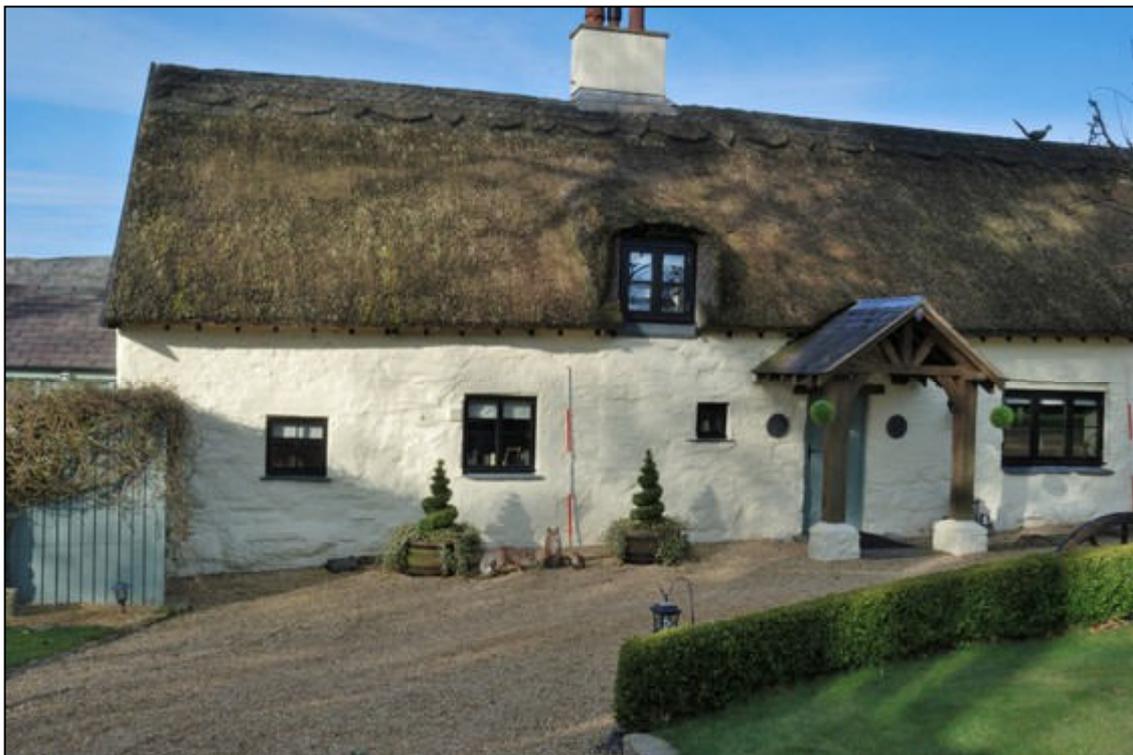
The cottage consist of a single range under a thatched roof, forming a storey and a half cottage. The front elevation (Plates 1 - 5) has single door placed slightly off centre with four ground floor and one first floor windows. All of these have modern wooden frames and fittings, however, they occupy a series of openings

of different sizes which possibly suggests a range of dates for the openings (Plates 2 – 4). There is one very small opening to the south east of the door which is assumed to be from an early phase in the development of the house. The two slightly larger opening and the single opening with three panes are assumed to be later insertions, possibly from several different phases. The stonework is covered by a layer of lime putty and whitewash, slightly obscuring the details of the stone walls, however the coverage allows some features to be determined. The middle of the windows, to the south east of the door, would appear to occupy a partly blocked opening (Plate 5) which corresponds with a door featured on the photograph in the regional inventory (RCAHMCWM 1914, Figure 1). There is also a marked break in the stonework (Plate 5) which aligns with the back of the ground floor chimney (Figure 3), possibly suggesting that the south eastern end of the building may be an extension or that major works have taken place in this area of the house. The north eastern gable (Plate 6) has an offset window on the first floor, however there is also a first floor blocked opening on the eastern side of the gable which presumably marks the position of an earlier window.

Plate 1: Front elevation

Plate 2: North western end of the front elevation

Plate 3: Middle section of the front elevation

Plate 4: South eastern end of the front elevation

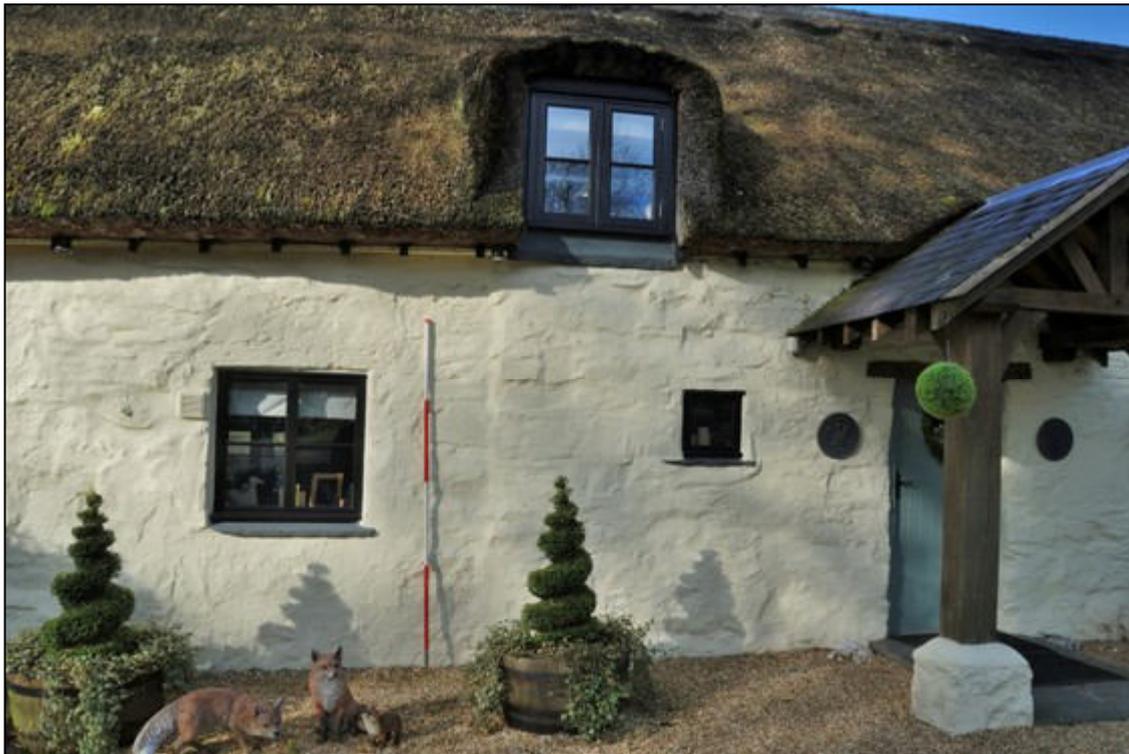
Plate 5: Detail of the break in the masonry on the front elevation

The later phases of the building include its division into two cottages as is shown by the photograph in the regional inventory (RCAHMCWM 1914) before the re-incorporation into a single building. There is a clear break in the stonework of the front elevation at this point, together with the replacement of Truss 2 and the cut off beam attached to the bressumer in the kitchen all of which suggesting major works were undertaken to either divide or re-combine the two cottages. It is also clear that there are multiple phase of modification to the room including changes to the pitch and the probable construction of the dormers, the sequence of which is unclear.

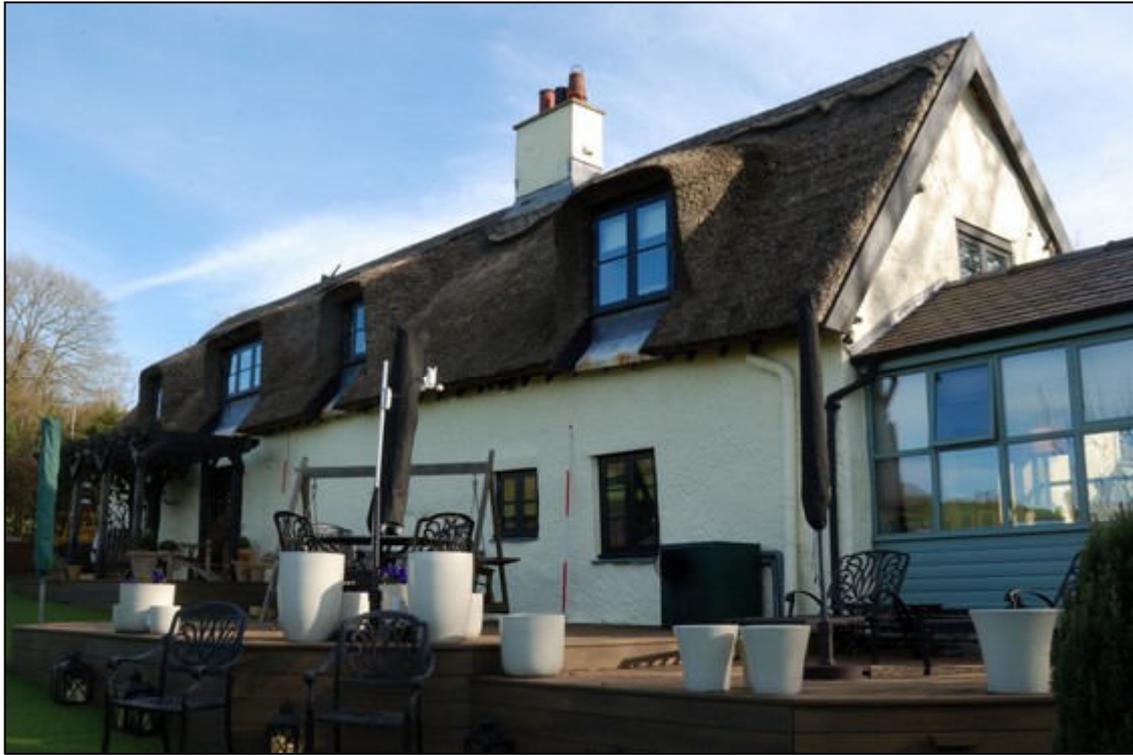
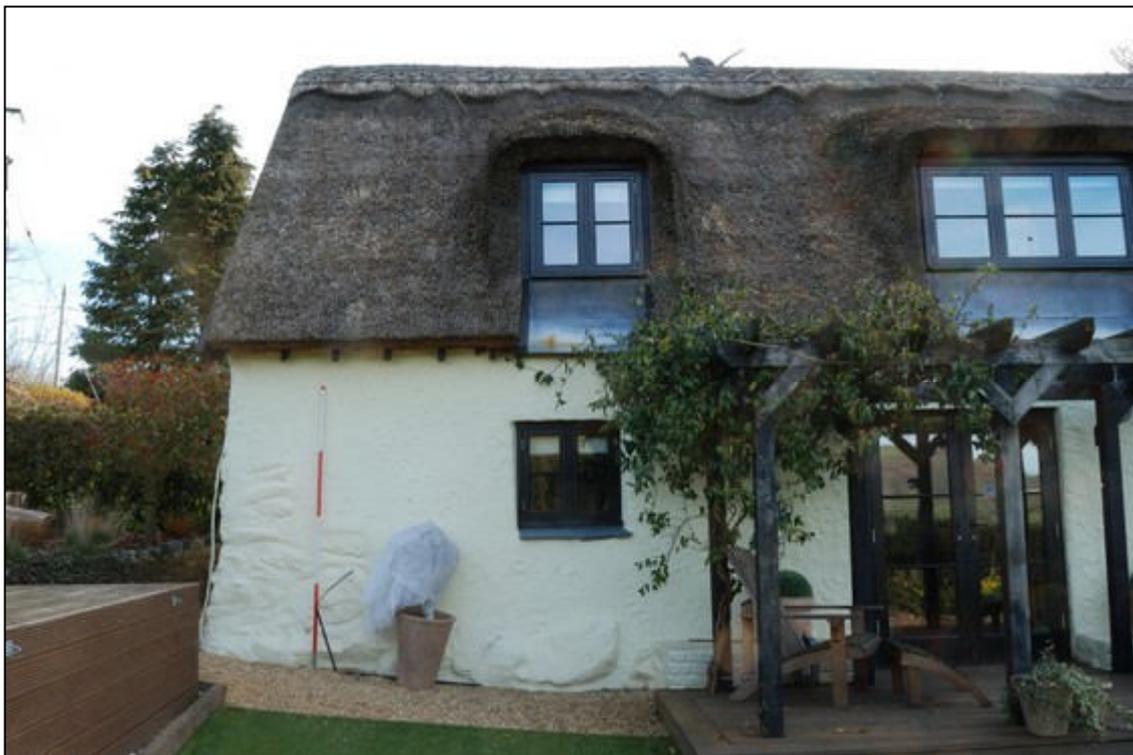
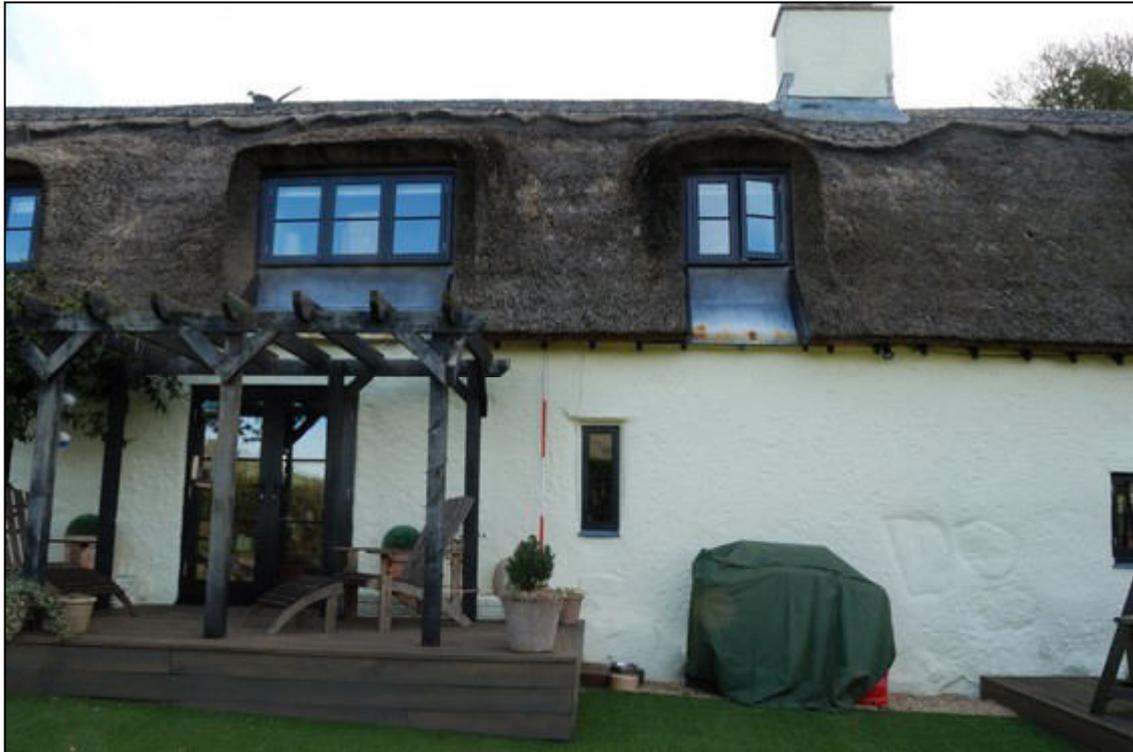
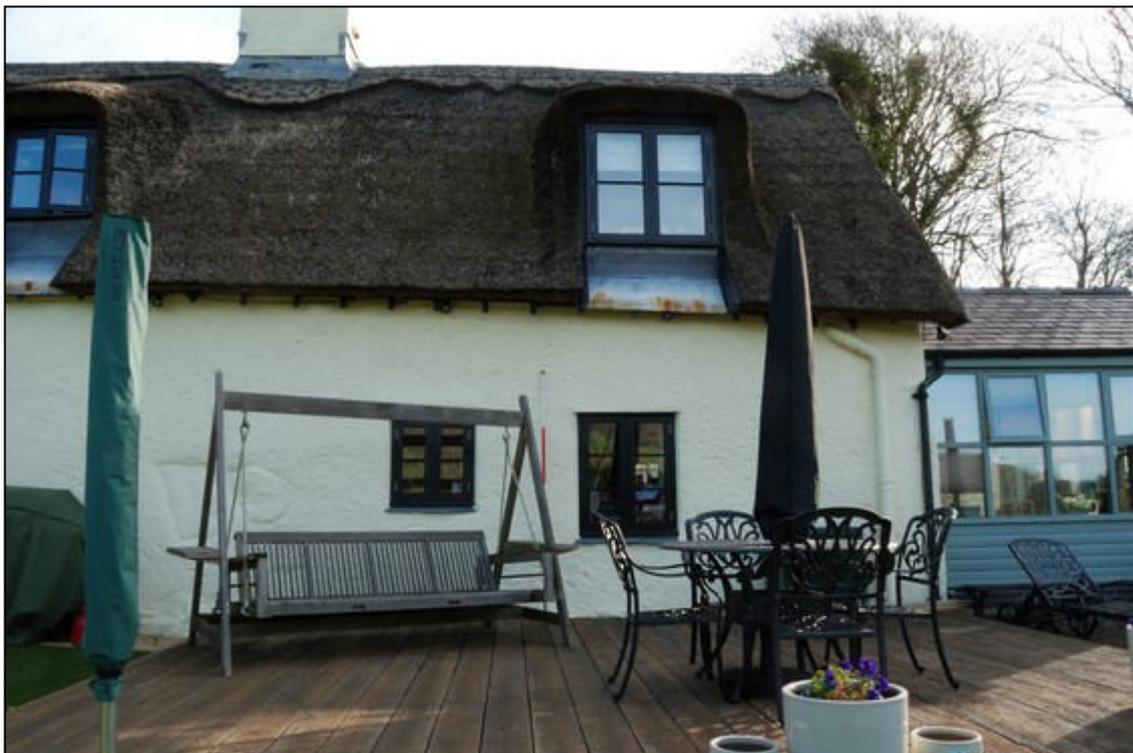
The rear elevation (Plates 7 – 10) is more highly disturbed with the insertion of patio doors and large dormer windows. The elevation is also covered by a thicker, better finished, layer of render which obscures the stonework. The south eastern gable is largely obscured by a modern conservatory.

Plate 7: Rear elevation looking north

Plate 8: Northern end of the rear elevation

Plate 9: Middle section of the rear elevation

Plate 10: Southern section of the rear elevation

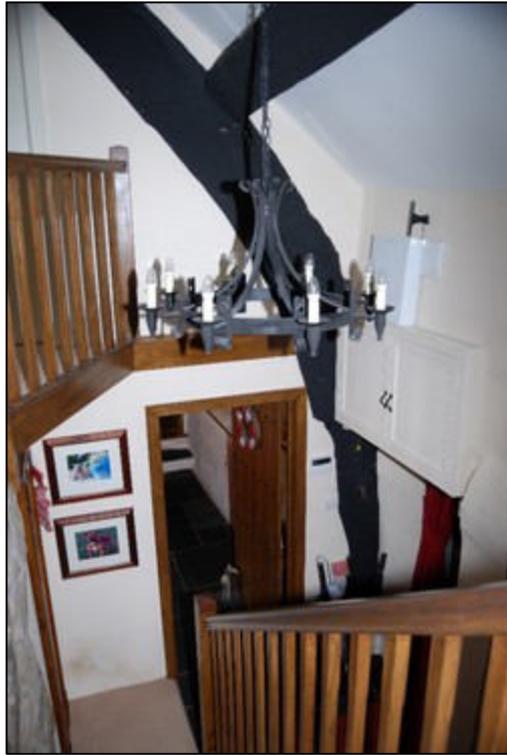
Plate 11: Lower section of the northern blade of Truss 3

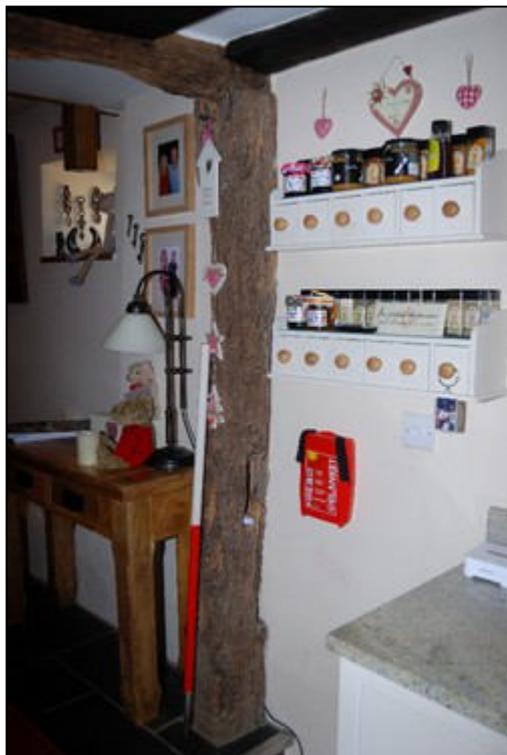
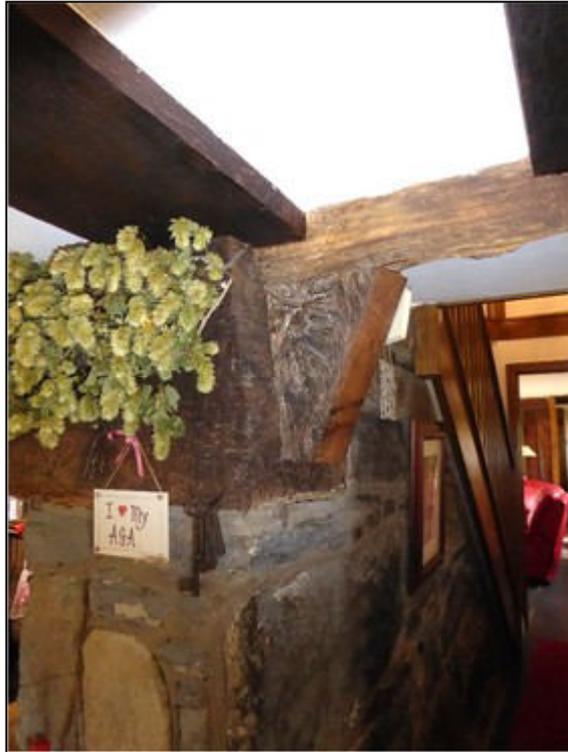
To the south of the entrance lobby is a room currently occupied by the kitchen. The entrance to this room is marked by a post (Plate 12) which supports the eastern end of a beam which is crudely attached to the bressumer over the fireplace (Plate 13). At its western end, the beam rests on a large wooden support which is attached to the end of the bressumer over the kitchen fireplace (Plate 14). This support appears to be the cut off end of a major beam which was presumably a tie beam for an earlier cruck frame, now lost. The post has a mortice at a height of approximately 1.0 m above the floor in the lobby and the top of the post is recessed to take the end of the beam. This would tend to suggest a the house was originally a wooden framed structure, however, the post and beam do not sit comfortably in the structure and may be later insertions, possibly when the house was re-united as a single structure.

Plate 12: Post between the lobby and the kitchen

Plate 13: Joint between the kitchen bressumer and the beam separating the lobby from the kitchen

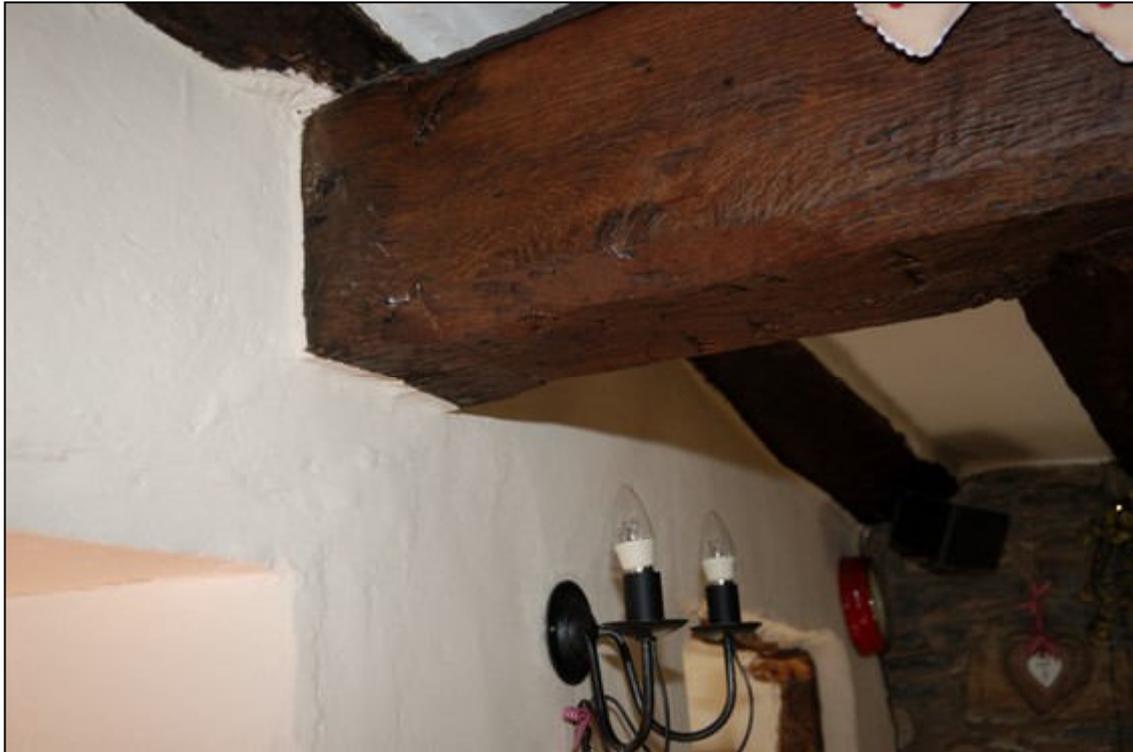
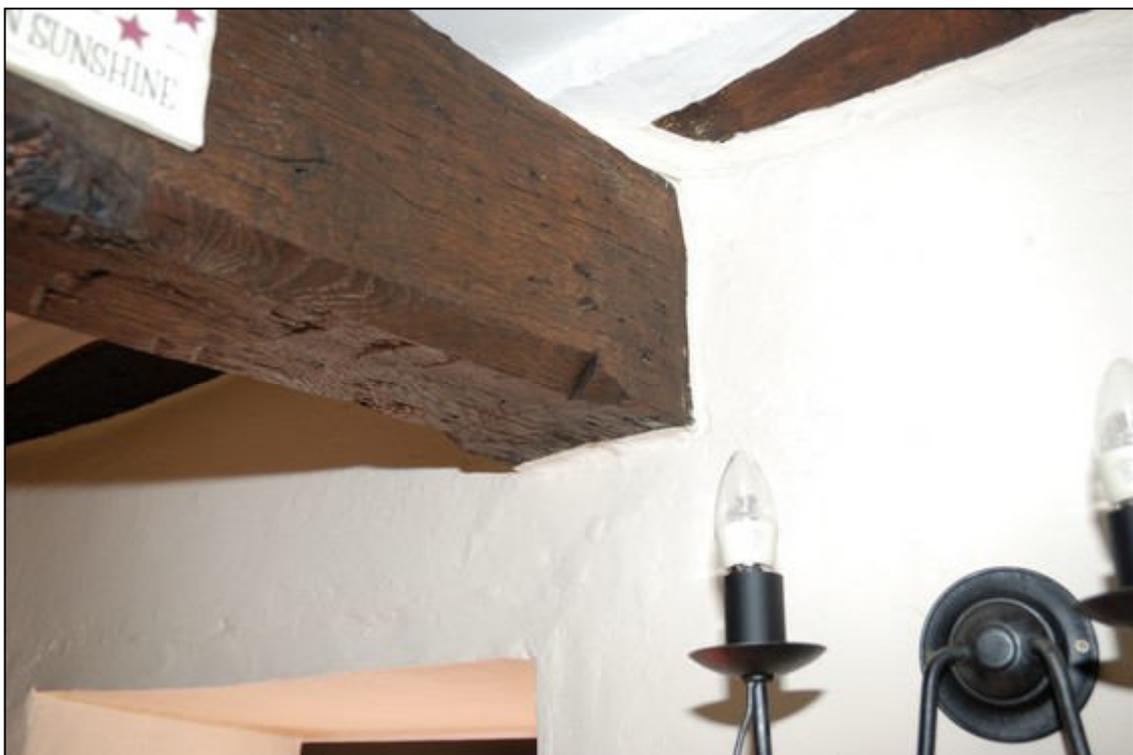
There is a single transverse ceiling beam which is moderately chamfered and has run our stops at its western end (Plate 15) and stepped stops at the eastern end (Plate 16) it supports a series of wide, flat joists which rest on top of the beam without any recesses. The window in the western wall (Plate 17) has a

Plate 15: Western end of the kitchen ceiling beam

Plate 16: Eastern end of the kitchen ceiling beam

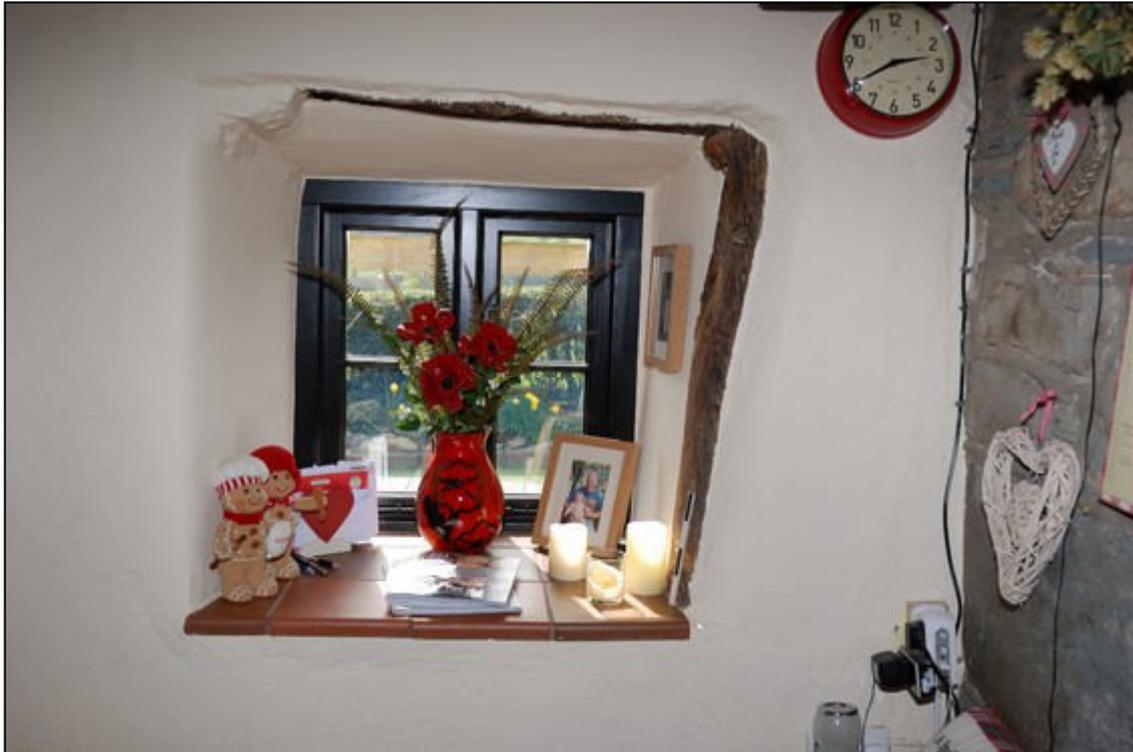
crude wooden inner frame, although the current window is a modern replacement.

Plate 17: The western window in the kitchen

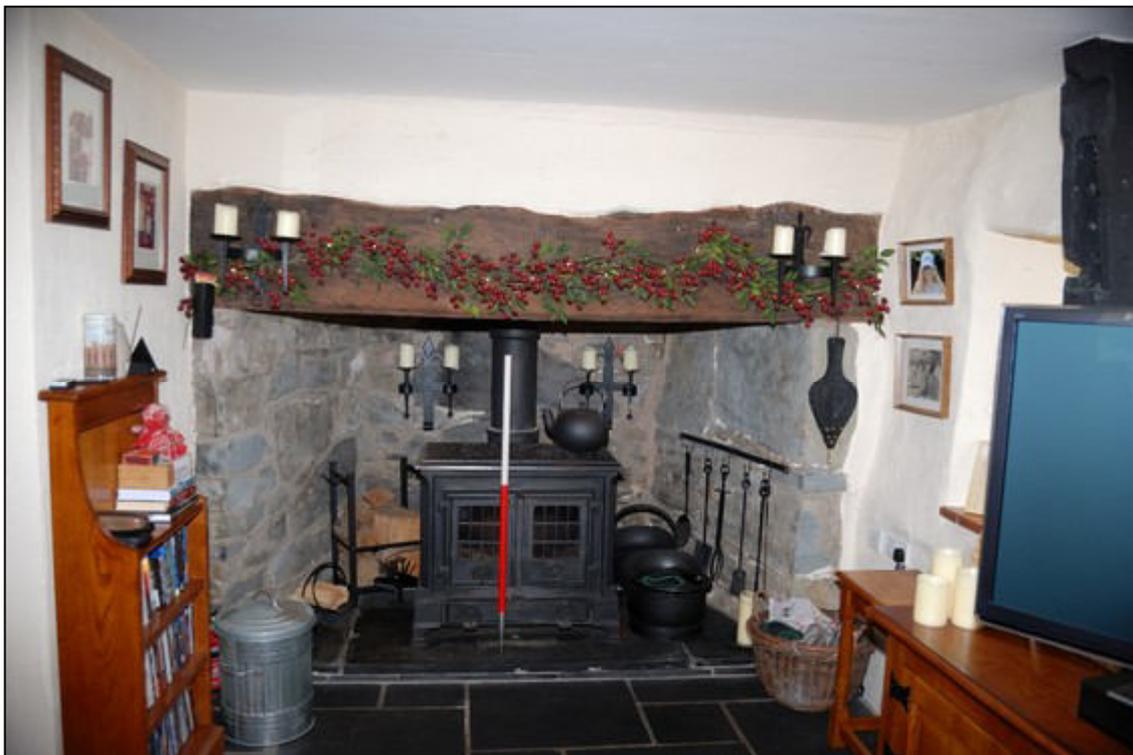
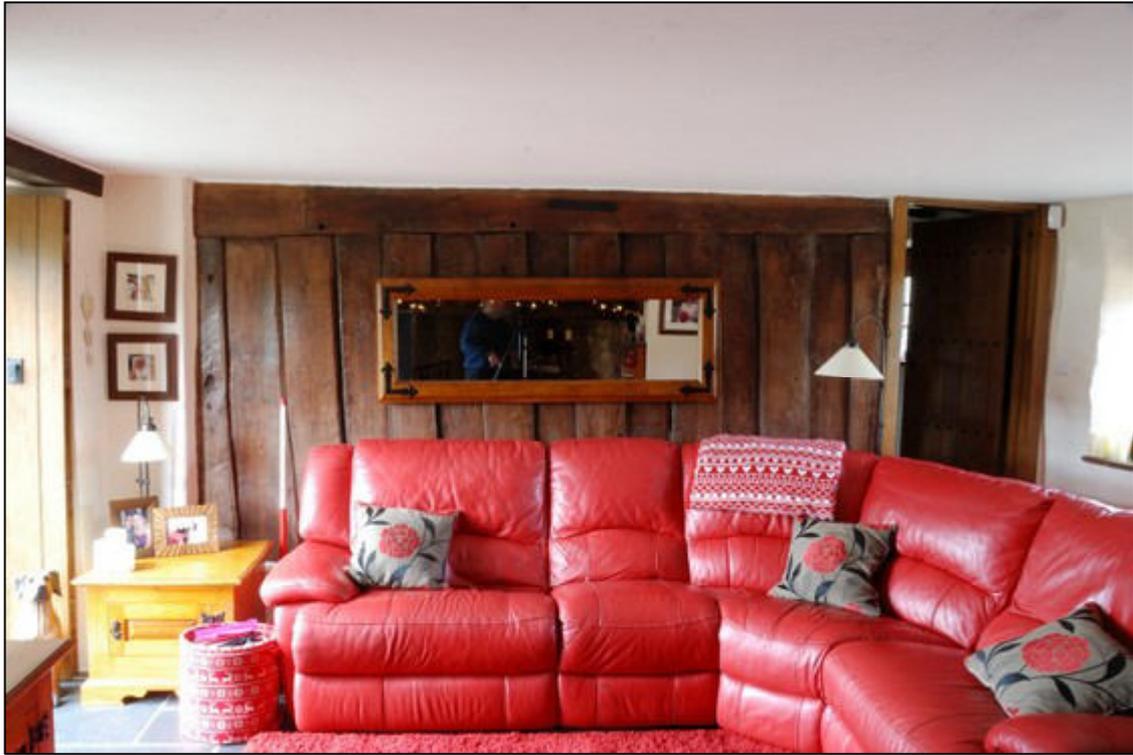
Plate 18: The fireplace in the Hall

Plate 19: Post and panel partition in the Hall

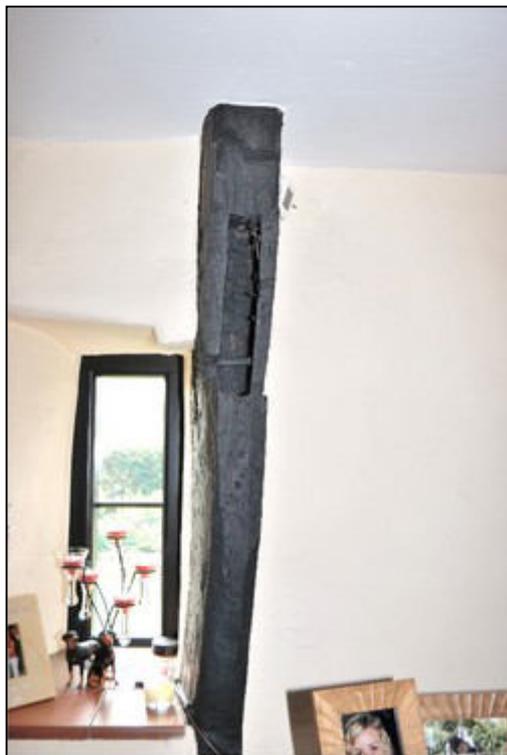
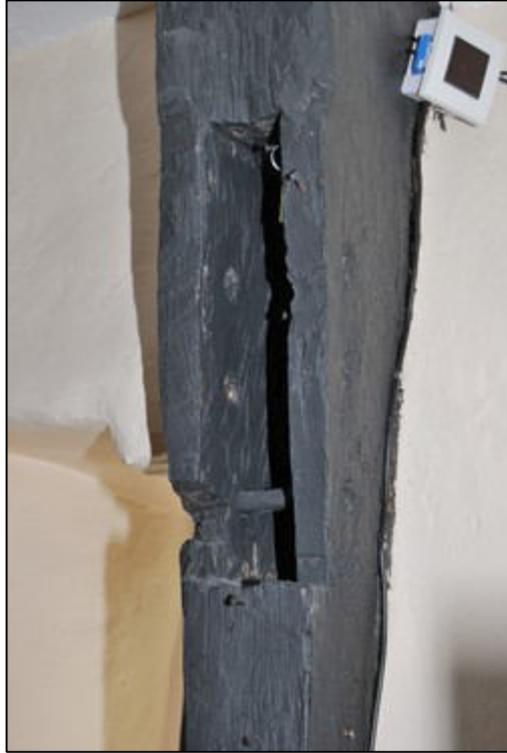
Plate 22: Lower section of Truss 3 on the western side of the hall

Plate 23: Detail of the mortice on the lower, western blade of Truss 3
