# **Coed-y-Foel, Derwen, Corwen Denbighshire**

**EAS Client Report 2016/03**

## **Coed-y-Foel, Derwen, Corwen**

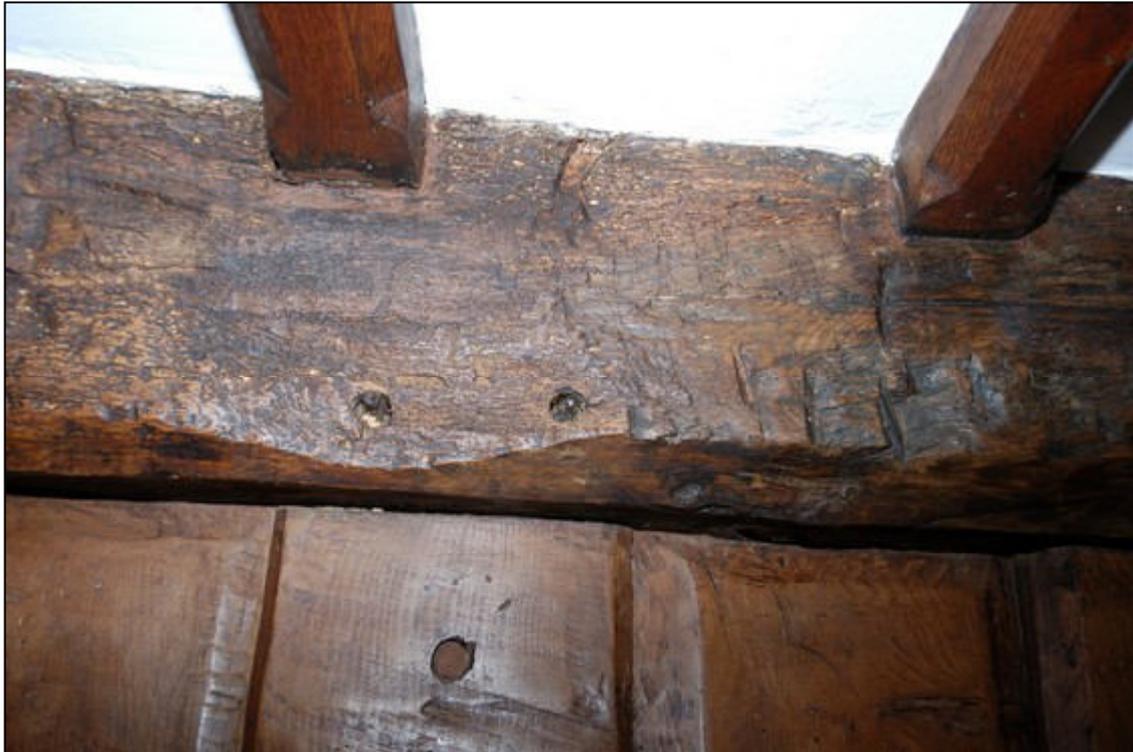
The joists in the chambers are trenched into the headrail of the lateral partition and have moderate chamfering and runout stops (Plate 25), however their appearance would suggest that they are later replacements.

Plate 25: Joists in the chambers

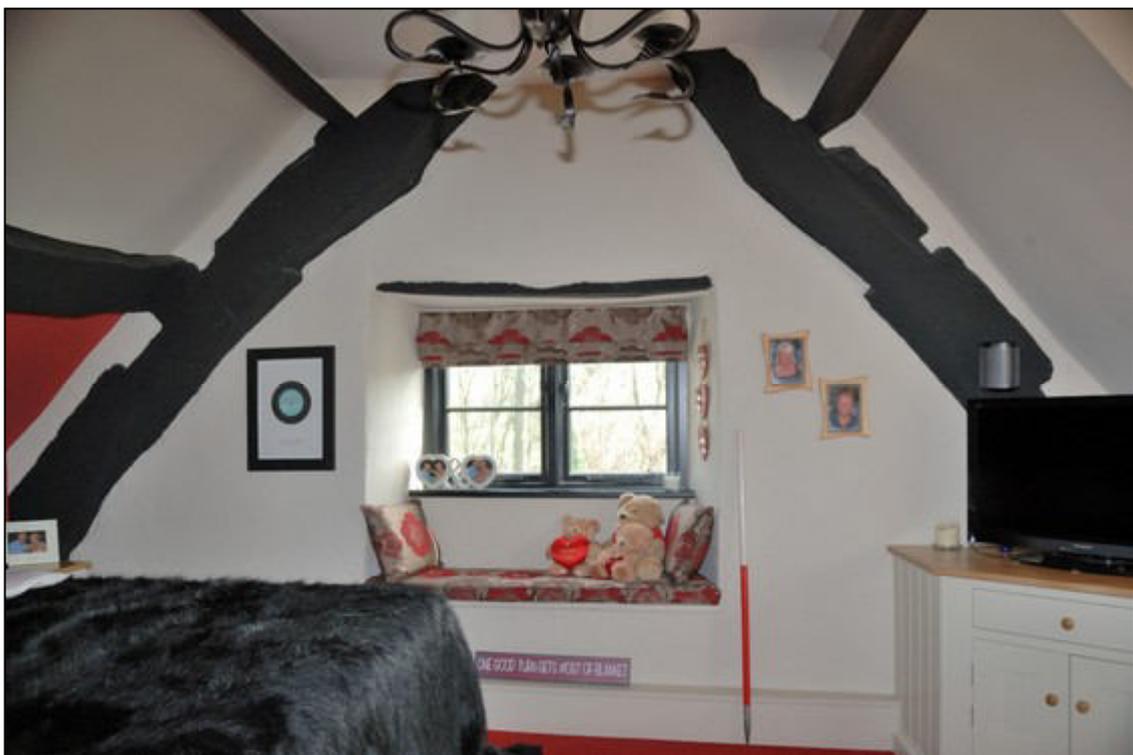
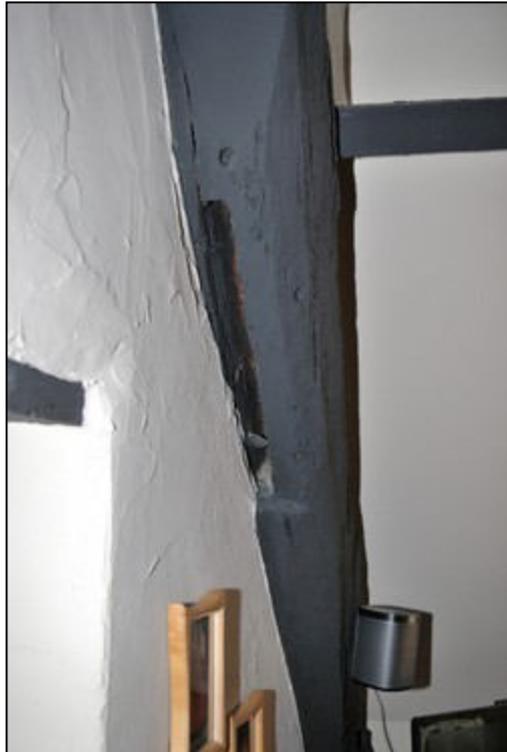
On the first floor, Truss 1 (Plate 26, Figure 5) is exposed in the south eastern gable end of the house. It is clearly the upper section of cruck frame, although the number of modifications to its upper surfaces would suggest the roof level has been modified several times. The truss is also missing its collar, which was presumably removed to accommodate the window in the gable wall. Its position

is marked by a mortice (Plate 27) in each of the blades. Above this the underside of the blades are shaped and there is the remains of blocked mortices near to the current ceiling level, possibly suggesting decorative cusping once occupied the peak of the truss. The upper purlins are late in the development of the roof and relate to a change in the profile of the roof. The one surviving lower purlin (Plate 28), however, is a plank lying parallel with the line of the roof whose line can be traced through to Truss 3. This sits on top of the truss and there are a series of trenches in the top surfaces of both of the blades which suggests that there have been multiple phases of purlins and roof modifications.

Plate 26: Truss 1

Plate 27: Mortise for the collar to Truss 1

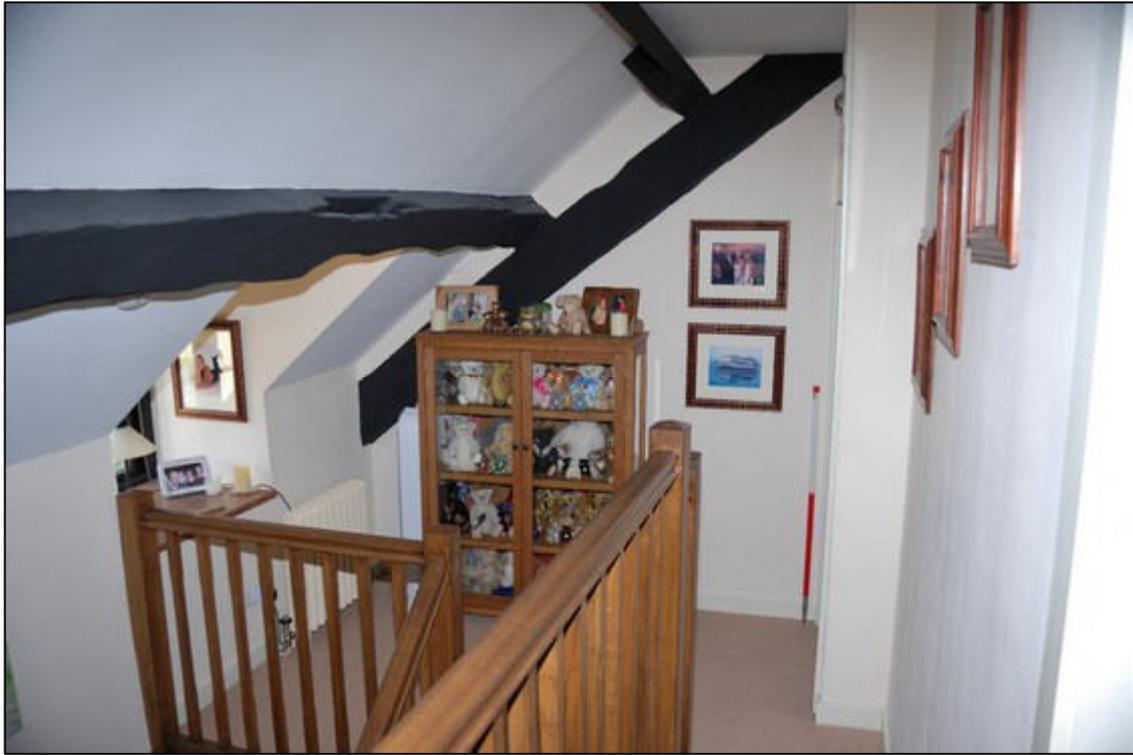
Truss 2 is only exposed on the landing (Plate 29, with only one, straight principal rafter and a diagonal brace exposed (the diagonal brace is hidden behind the display cabinet). Clearly not an original truss this feature is directly over the break between the lobby and the kitchen and is probably related to either the division of the property into two cottages, or the reversion of the cottages to a single property. The lower purlin, however, would appear to be an original feature which has the mortice for a windbrace in its upper surface.

Plate 29: Truss 2

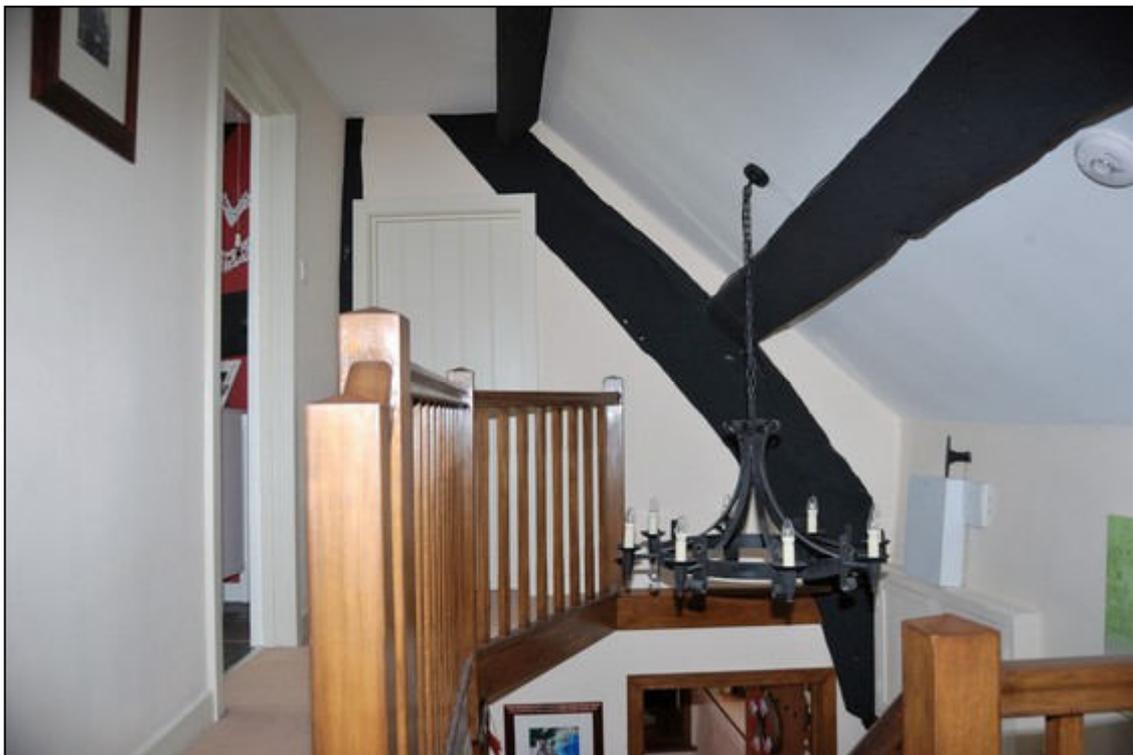
Truss 3, is exposed at the other end of the landing and in the bathroom (Plates 30 and 31, Figure 6) as well as on the ground floor (see above). The truss is a cruck frame which originally had a cranked collar, although this has been truncated by the insertion of the door to Bedroom 2. There are, however, peg holes in the north eastern principal rafter which marks its position. The cut end of the collar is supported by a post which appears to run between the tie beam and the peak of the truss. The north eastern principal rafter has two, trenched, purlins, the upper of which is set at right angles to the line of the roof and is probably a late insertion modifying the line of the roof. The south eastern blade of the cruck has two, empty, trenches for purlins together with the surviving upper purlin which is also trenched.

Plate 30: Truss 3 in the area of the landing

Plate 31: Truss 3 in the bathroom

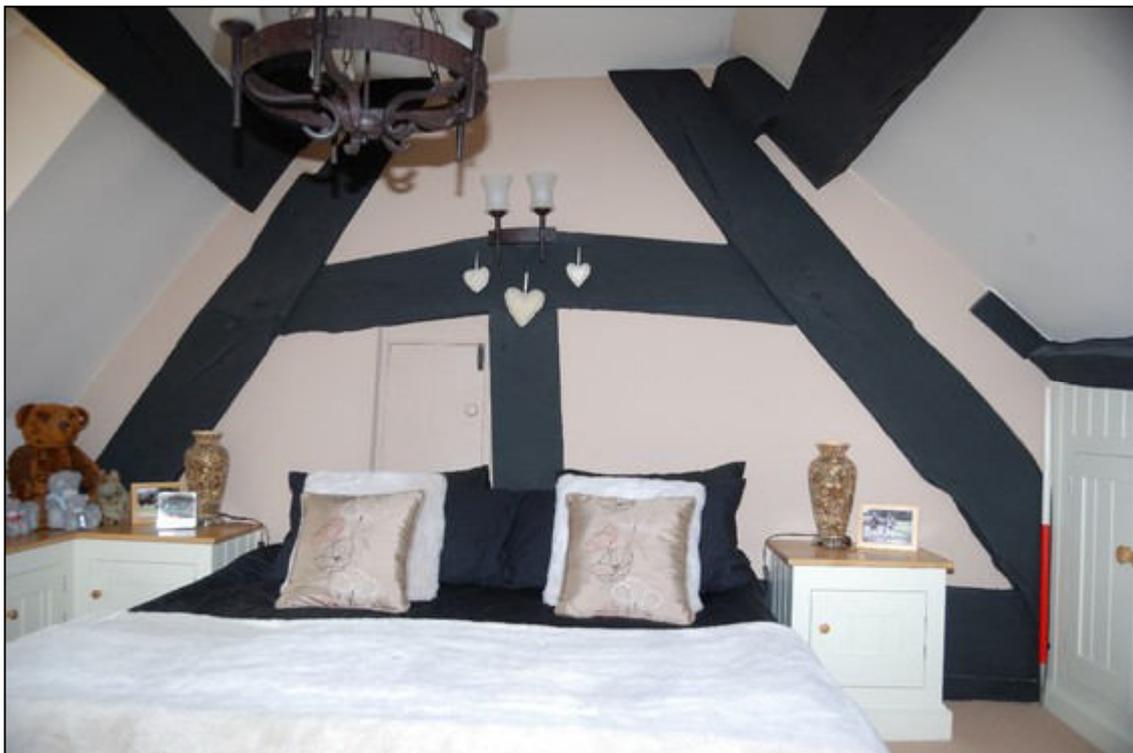
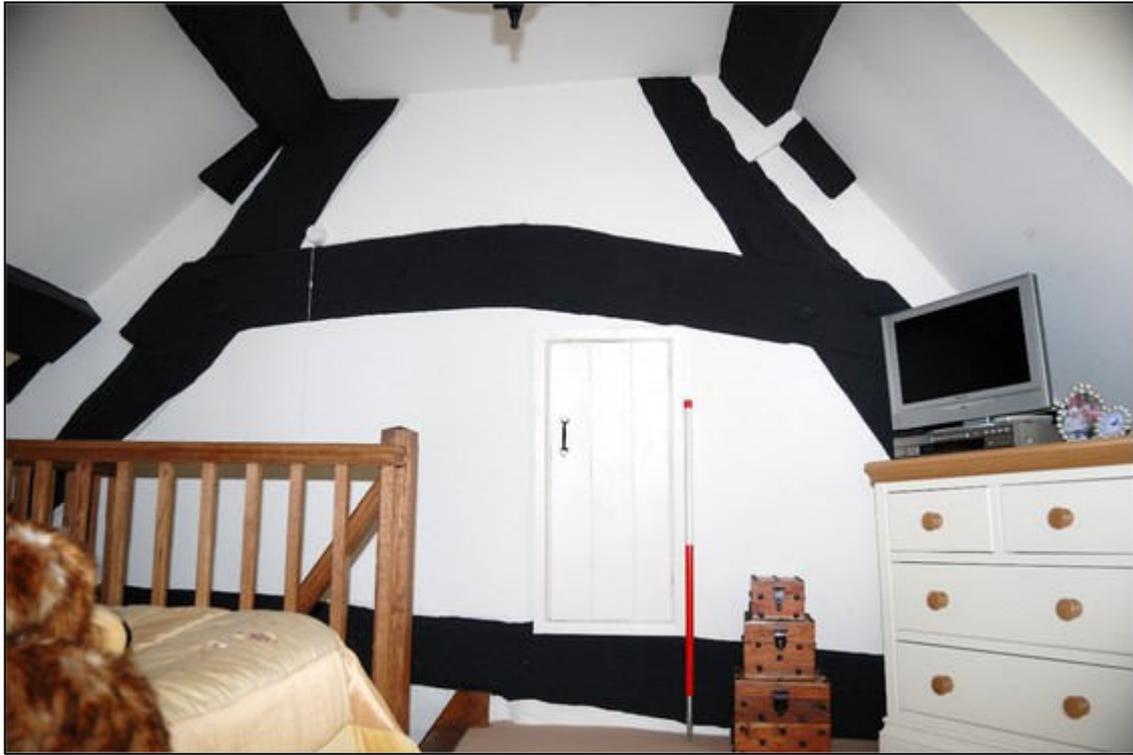
Truss 4 (Plates 32 and 33, Figure 7) incorporates the main, lateral, partition at the north western end of the hall (see above) and marks the separation between Bedrooms 2 and 3. Once again it is a cruck frame with a cranked collar and a tie beam. There is also a short stud between the collar and the tie beam which is centrally placed. The insertion of a plaster ceiling in the hall has hidden the relationship between the tie beam and the head rail of the partition, however a single stud, exposed in the stairwell to Bedroom 3 (Plate 34) suggests there are a series of short studs linking these two elements. The south western principal rafter has one, empty trench which presumably originally held an upper purlin. The north eastern principal rafter, however, has one trenched purlin which overlaps with another purlin which sits on top of the principle rafter. The lower purlin on this side of the house is set well away from the principle rafter and represents a change in the slope of the roof.

Plate 32: Truss 4 in Bedroom 2

Plate 33: Truss 4 in Bedroom 3
