Hafod yr Afr Cynwyd

Historic Buildings Record

Martin Cherry and Ross Cook

April 2024

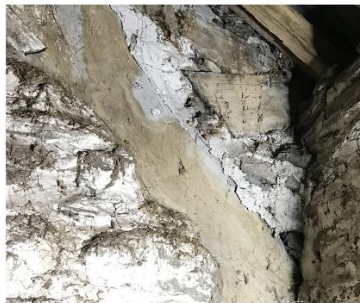
Fig 1 The original house was timber-framed. The cruck truss blades would have been secured to the wall plate by a spur, removed when the stone walls were built. Amazingly, although the wall plate has gone, one spur survives, out of kilter and no longer of much use.

Top: the cruck blade of T2 with the spur displaced. Bottom left, detail of cruck at Hafod yr Afr; bottom right, a spur in place (marked as 'p').

(1) It is common to find medieval houses in North-East Wales that were originally timber-framed, the walls later being rebuilt in stone. At Hafod yr Afr, the cruck trusses extend fully down to the ground (the feet of the north blades of both T1 and T2 are visible externally). The crucks would have been attached to the wall plate by 'cruck spurs' and, remarkably, one of these survives (although displaced)—see Fig 1. The re-casing of houses in stone, which often involved the flooring over of the open hall and the provision of enclosed fireplaces with chimneys, usually followed on considerably later. But here, the lower end of the hall was floored over almost as soon as the house was finished, perhaps even during its construction.

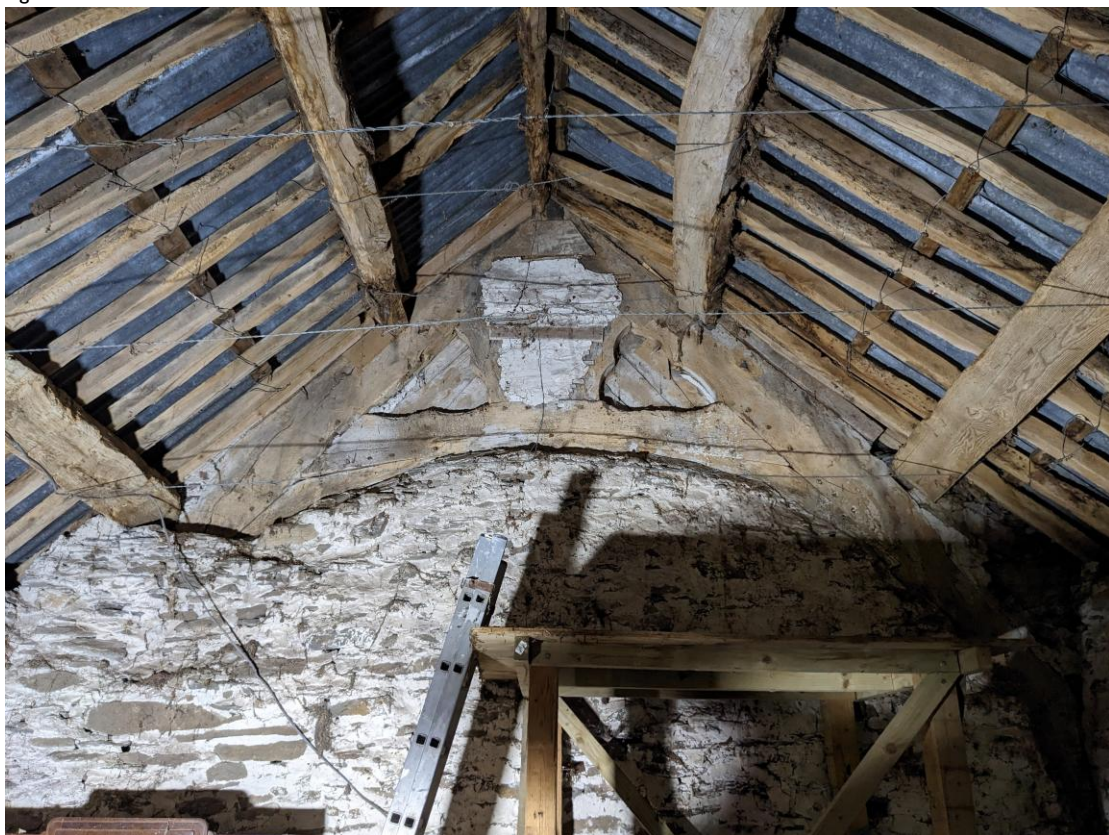
Fig. 6 – Central cruck to hall; cusped trefoils survive, but note the lefthand missing cusp, which was never formed.
