# **North West Wales Dendrochronology Project Ty Mawr, Druid, Denbighshire**

**EAS Client Report 2009/15  
December 2009**

## **Ty Mawr, Druid, House and Barn**

**SJ 0354 4314**

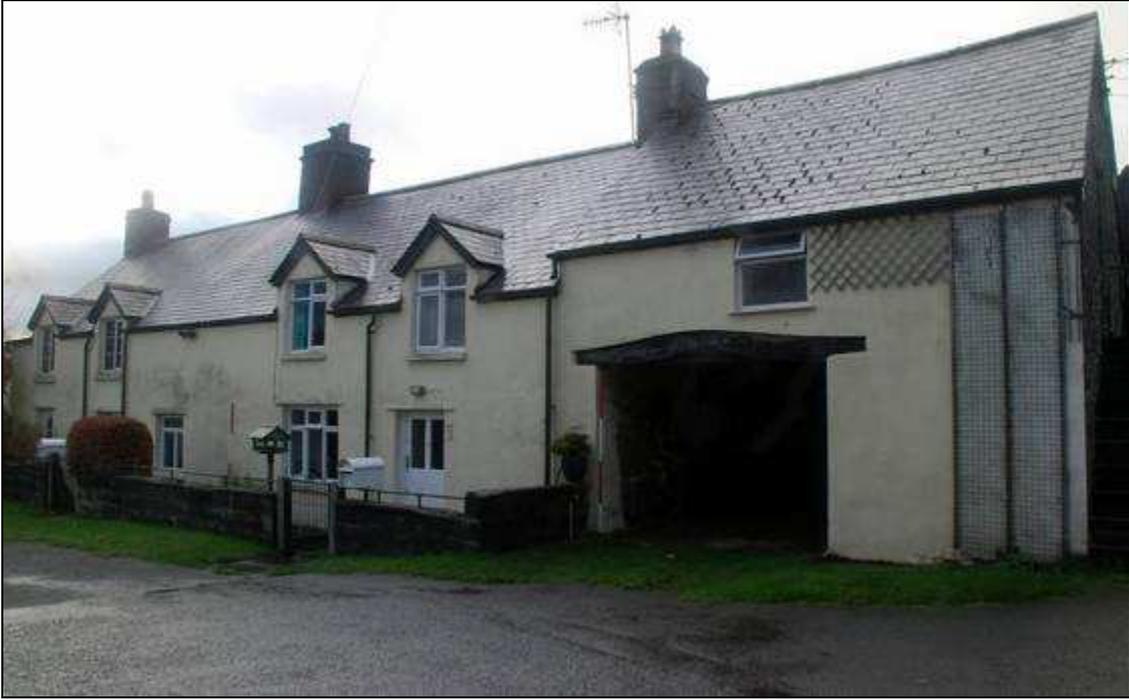
Plate 1: Front elevation looking SW.

Externally the house at Ty Mawr would appear to be an end terrace of a short row of houses (Plate 1). It is one and a half stories high, with rendered walls and a slate roof. Two chimneys are evident, one on the gable end and the other at the division between Ty Mawr and its neighbour. The windows and door are all modern replacements, the two upper front windows sitting within partial dormers with the windows partly below the eaves. Attached to the northern end of the house is an agricultural building, originally a cart shed, although now being used as a garage. This building is not part of this survey and is thought to be an eighteenth or nineteenth century addition.

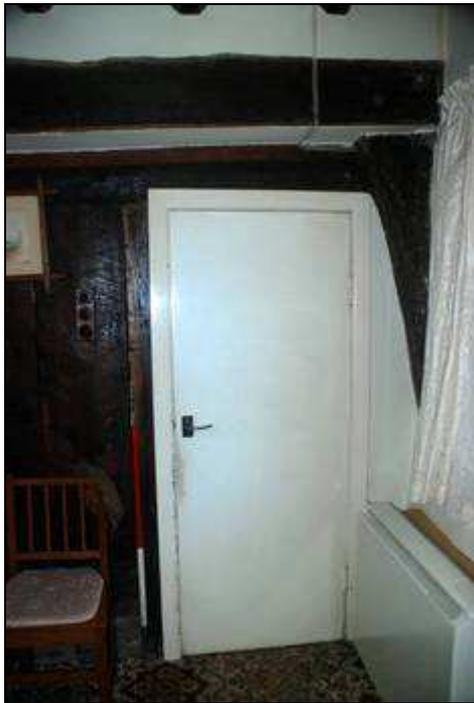
Plate 2: Base of the northern cruck frame, west side of house, looking NNE

The ground floor is divided into two principal rooms (a kitchen and parlour) with a small entrance hall from which the stairs to the upper floor are accessed (Figure 2). The kitchen has been improved and shows no features suggestive of an early date. The main room, however, has a number of features which demonstrate the development of the house. Along the northern wall of the room the foot of a cruck frame is evident which is partly embedded in the walls of the house (Plates 2 and 3, Figure 3). Both blades appear to extend up into the upper storey; however, they could not be easily traced in the wall dividing the southern bedroom from the stairwell. Set between the blades of the cruck is the remains of a post and plank partition (Plate 4, Figure 3). Each of the posts is approximately 0.30 m wide set with a separation of approximately 0.25 m. The posts and planks are set between two horizontal rails, the upper of which is jointed to the cruck frame. Two blocked slots in the upper corners of the partition and a number of empty peg holes may suggest the position of a dais canopy along this wall.

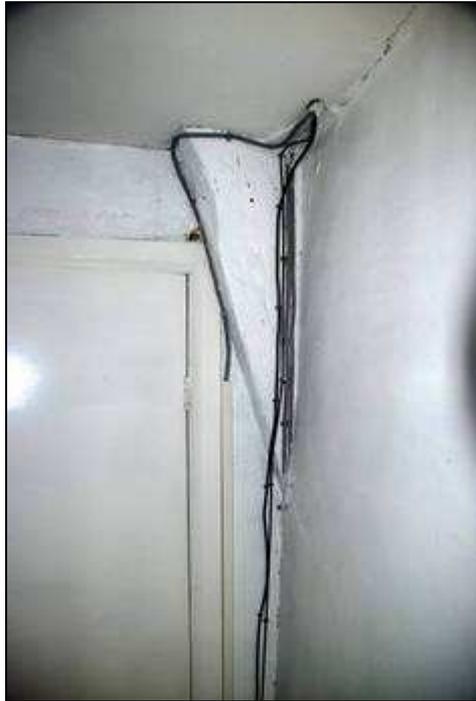
Plate 5: Base of the southern cruck frame, looking NNE

A second pair of cruck blades was located over the large fireplace in the southern end of the main room. Exposed on the ground floor in a corridor leading along the eastern side of the chimney breast (Plate 5), this frame was evident in a space over the chimney stack behind the southern wall of the southern bedroom. Here it could be seen that both blades of the cruck survive together with at least one pair of butt-purlins on the eastern side of the house (Figure 4, Plates 6-8) The purlins appear to have been truncated at the cruck frame, presumably this occurred when the roof was heightened and to allow for more room in the bedrooms.

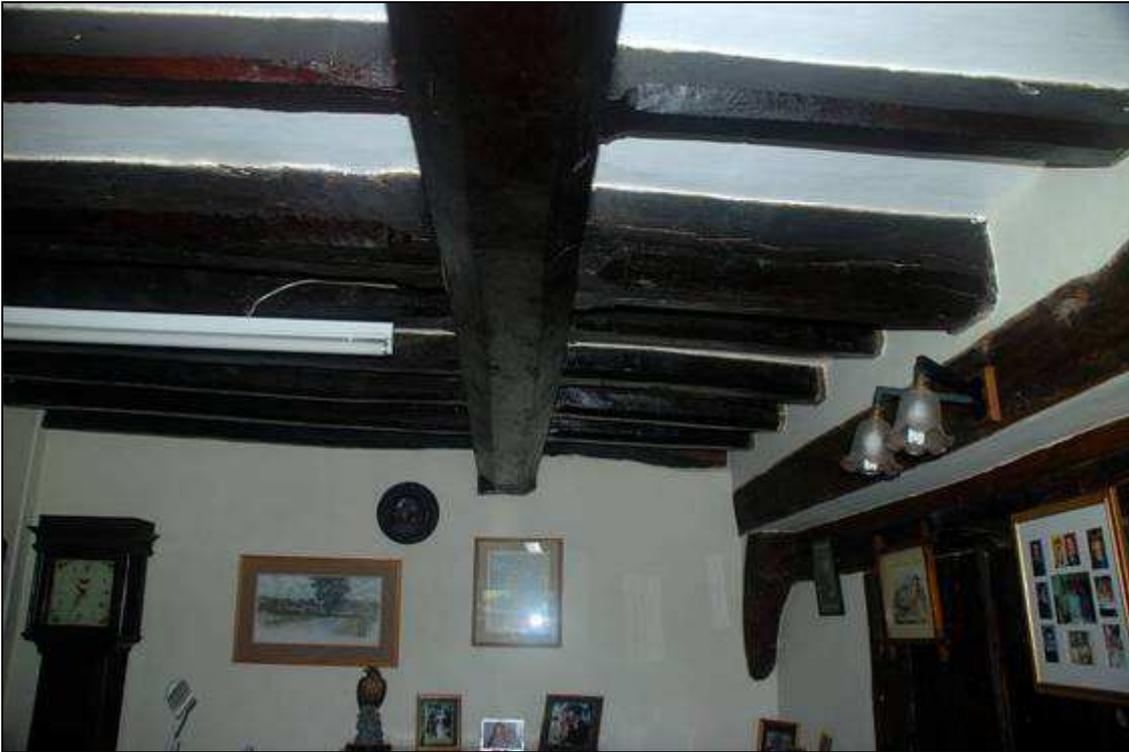
Plate 9: Beamed ceiling in the main ground floor room, looking NW

The main ground floor room has a beamed ceiling (Plate 9) consisting of a main cross beam running across the main axis of the house with a longitudinal beam running from the chimney breast to the wall containing the post and plank partition. The remaining space is further divided by a series of joists with bevelled housed joints into the main cross beam (Plate 10). Both beams and the joists are chamfered. The cross beam having curved stops at both ends of the beam. The longitudinal beam is only stopped at its joints to the cross beam and where it meets the northern wall of the room with stepped stops (Plate 11). The joists are stopped only where they meet the cross beam with curved and slightly stepped stops (Plate 12).

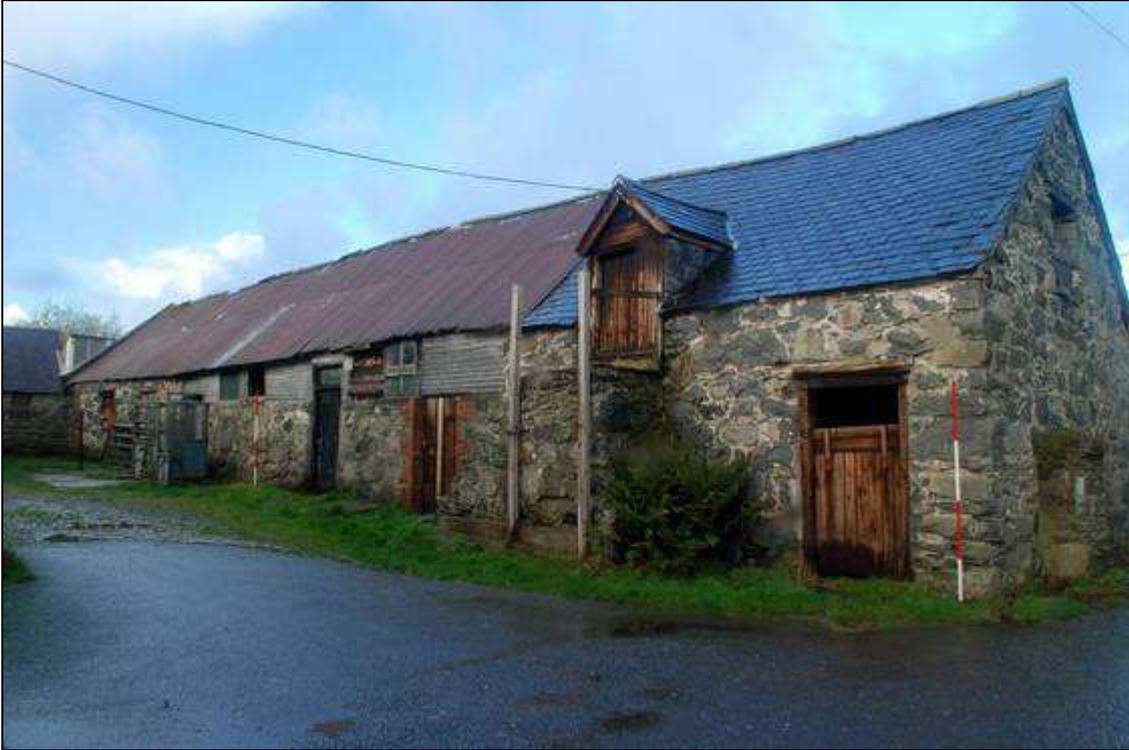
Plate 13: Barn looking west.

The barn is aligned along with the A494 and is part of a range of agricultural buildings assumed to once be associated with the house, although now under different ownership. The sampled barn is the central section of a longer range extending both to the west and east of the original building (Figure 5). Externally the barn is constructed of random stonework standing to a height of 1.8 m which is lower than the flanking buildings in the range (Plate 13). Currently it has a corrugated iron roof covering. Three doorways pierce the southern wall, the most easterly of which is clearly inserted as it has a modern brick casing. Two air vents

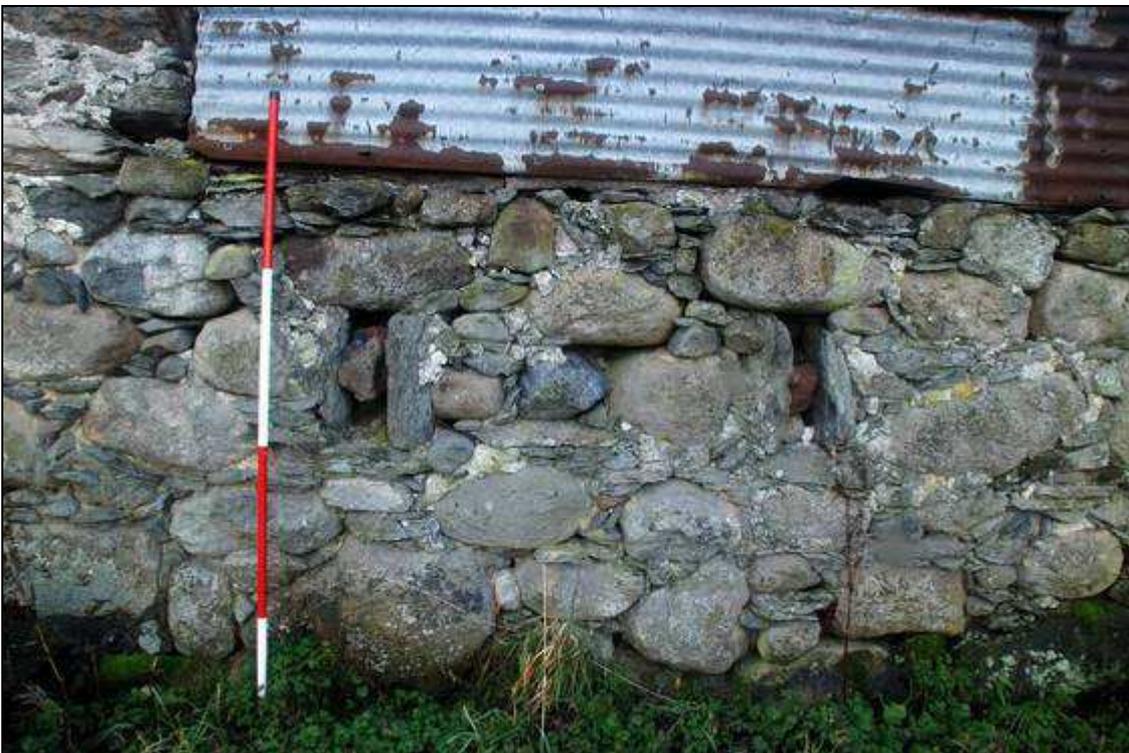
Plate 14: Air vents in the northern wall of the barn, looking SE

are evident, externally in the northern wall of the barn (Plate 14). The barn attached to the north has an external stair leading to a hay loft. This also gives access to the gable end of the original building.

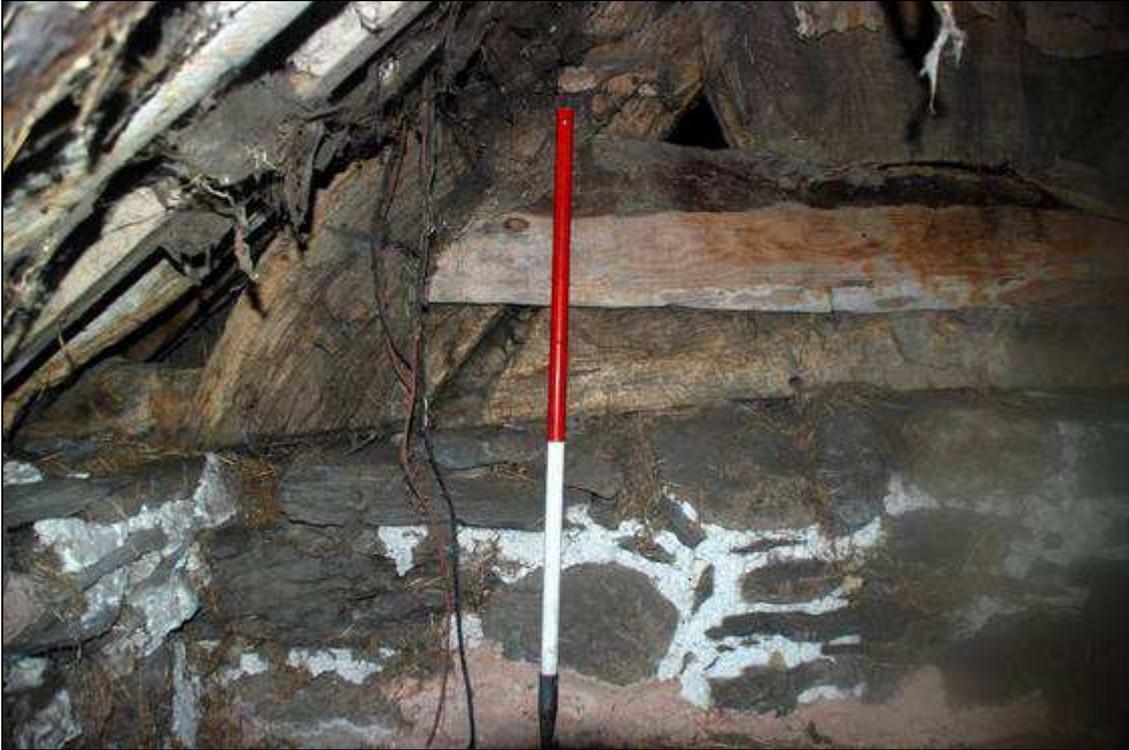
Plate 15: Half lap joint between the principal rafter and tie beam on the barn gable end truss looking SE

Three original trusses were located within the barn, two of which were sampled by Oxford Dendrochronology. The eastern gable end has a truss resting on the stone walling (Figure 6). The slight curving at the base of the principal rafters would suggest this may have originally been a cruck frame. There is a tie-beam sitting on the stone wall and a higher collar linked by queen struts. The tie-beam extends beyond the extent of the principal rafters, onto the side walls of the barn. It has half lap joints with the principal rafters which are pegged (Plate 15). The truss was obscured by a sacking screen; however it was possible to determine that there were cut outs for two pairs of purlins which are occupied by butt purlins, probably of a later date (Plate 16). There was also a ridge purlin.

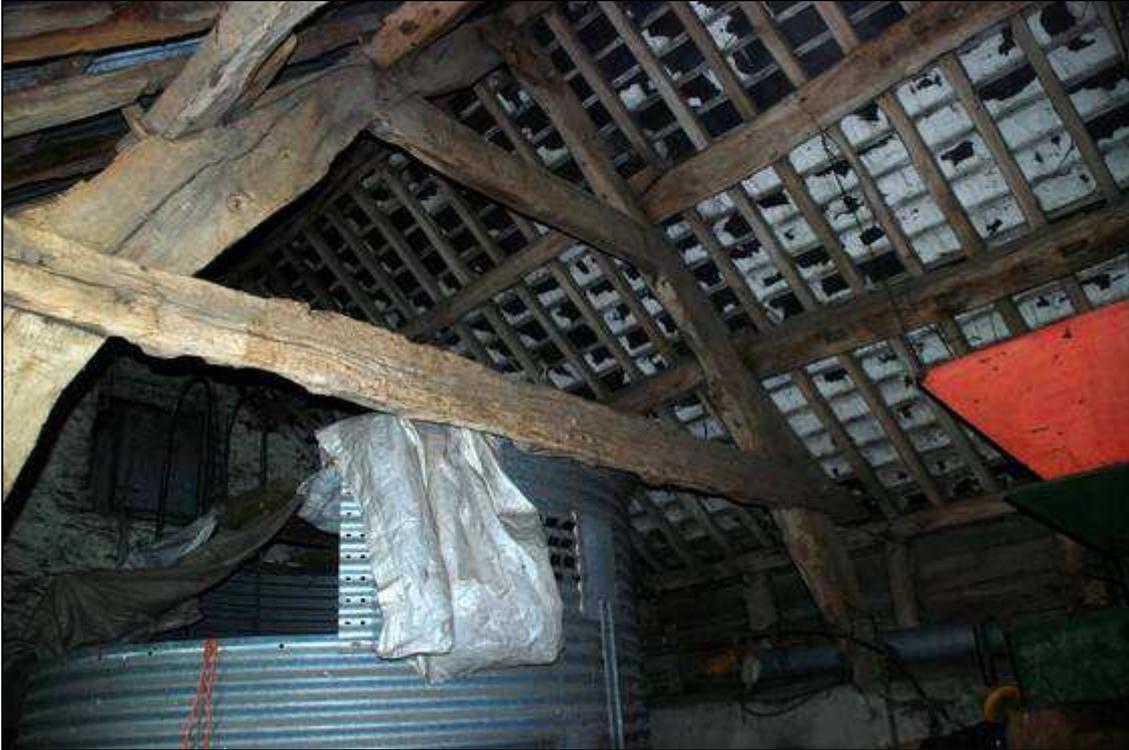
Plate 17: Barn truss 1 looking west

The internal trusses were clearly of cruck construction, both sitting on the dwarf stone walls. Truss 1 (Figures 5 and 7, Plate 17) has a collar and a wooden staple across the joint where the principal rafters join which are both assumed to be original. There is also a lower tie-beam which is clearly of a later date being only pegged to the face of the truss (Plate 18). The original (higher) collar is tenoned and pegged into the principal rafters and has two mortice holes and a series of dowel holes (Plate 19) on its underside suggesting the possible position of a division within the building. Similar dowel holes in the principal rafters also suggest this division extended above the collar.

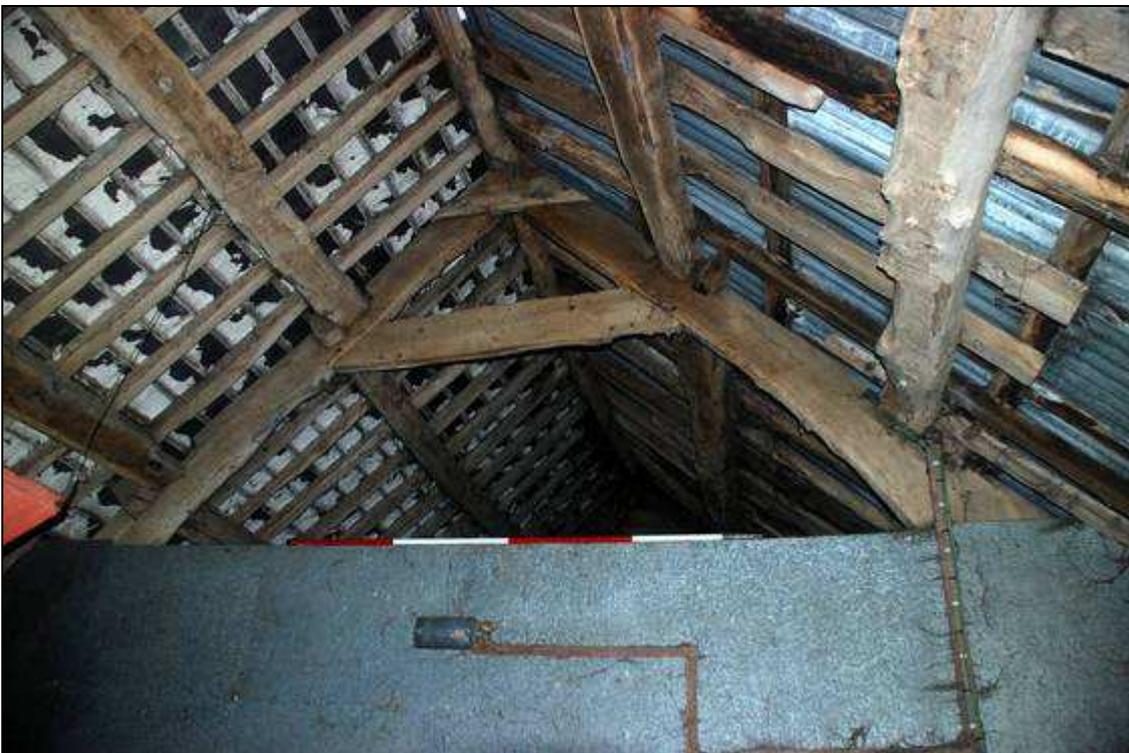
Plate 20: Barn truss 2, looking NE

Truss 2 (Plate 20) is similar to Truss 1. Its full extent is partly obscured by the insertion of a hay loft between Truss 2 and the gable end truss which is supported by a later tie-beam (Plate 21). Once again there are two mortice holes and a series of dowel holes on the underside of the collar suggesting a division within the building.

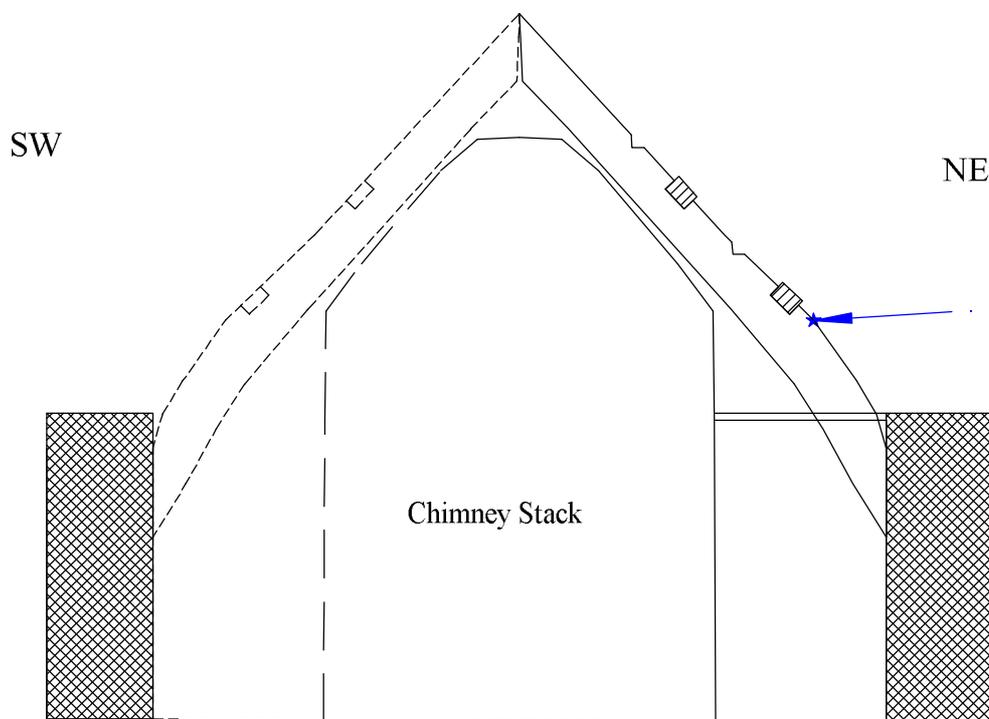
Figure 4: Ty Mawr, Druid: Cruck Frame Over Chimney  
Scale 1:50 (approx)

Truss over inserted fireplace
