# Ty Gwyn

Bryn Eglwys, Corwen,

## Architectural Record 2017

## Final Report

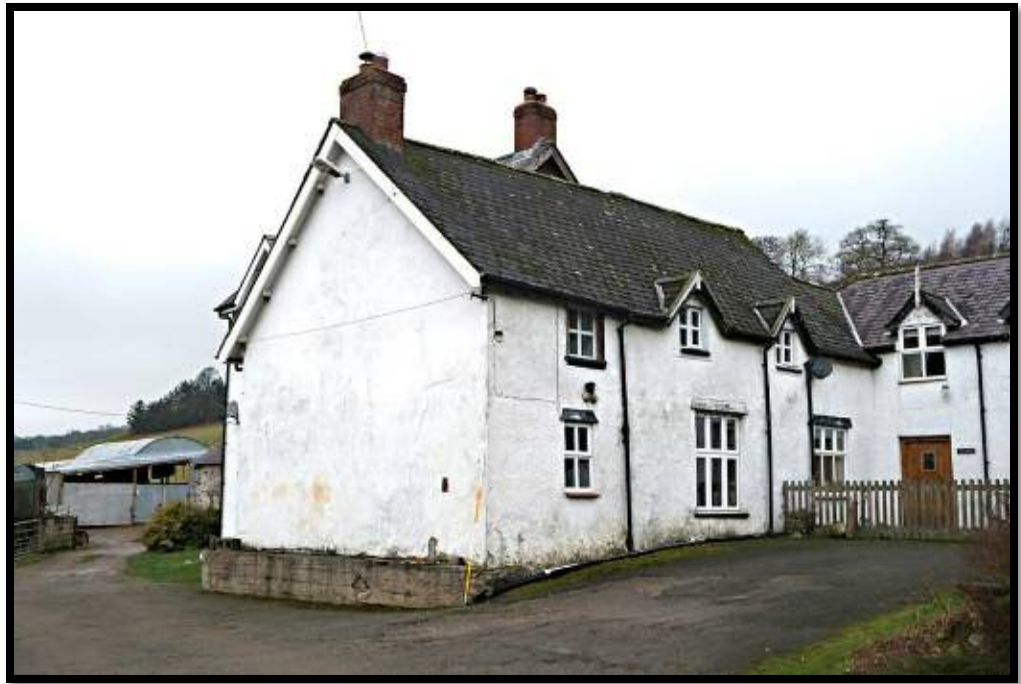
Figure 3: Ty Gwyn from SE.

This report will concentrate on the older part of the building, the main 2 storey section. (Fig 3) and the historic fabric contained within.

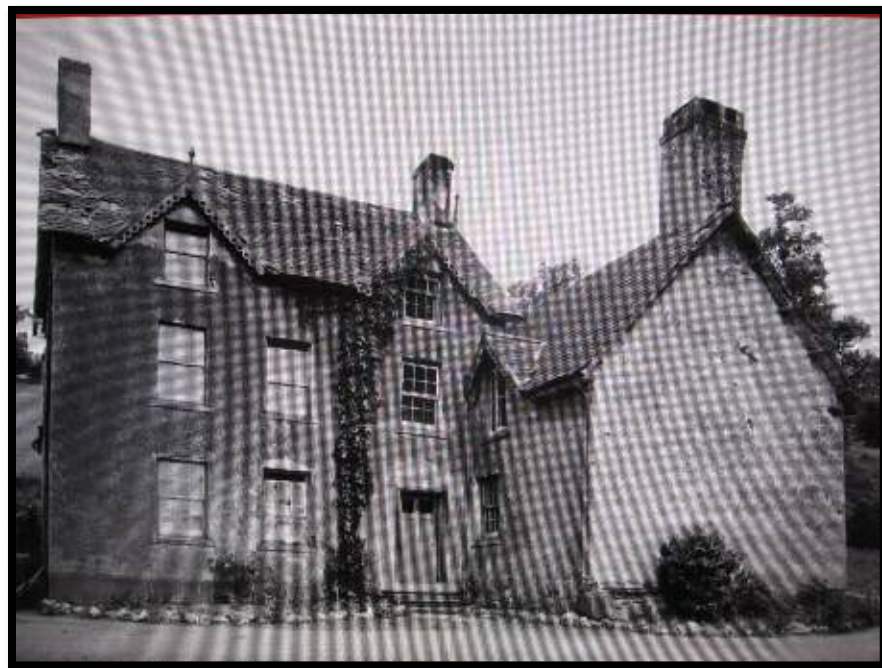
Figure 4: 1952 image of Ty Gwyn. Coflein RCAHMW

4.1.2 The front presents the south-east gable end of the building. This was placed on a sharp downhill slope which defined its construction. The gable is of plain render over random stone and is bounded at the bottom by what appears to be a large plinth but is actually a modern shuttered concrete buttress to shore up deteriorating stone work at the wall constructed and within living memory. (pers. Con, owner Richard Davies) Modern, small, red brick chimney and oversailing verges with PVCU barge boards. Re-roofed in thin slates probably late 19th or 20th century. Much taller chimney seen in 1952 photograph but still of brick so the height of that chimney may have been reduced but roof construction is as we see it today. (Fig 4)

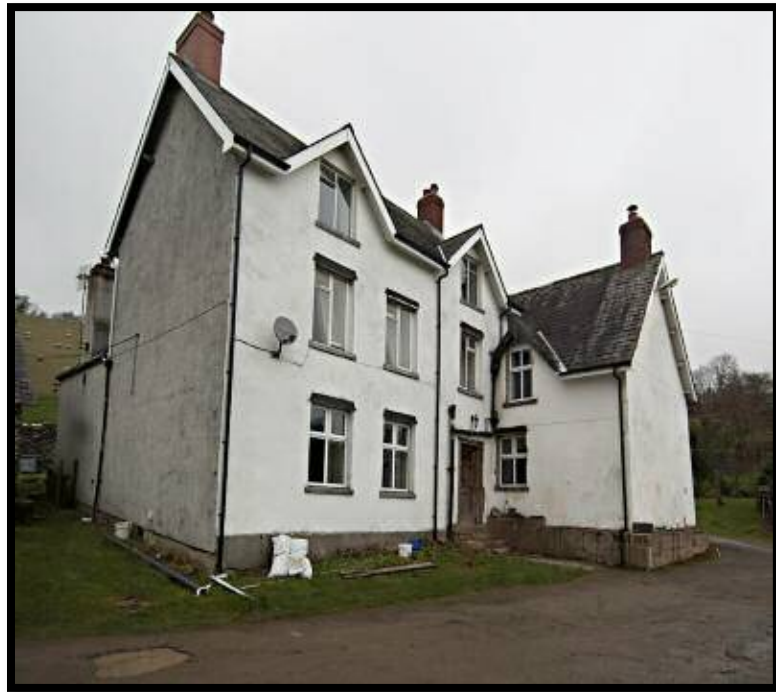
Figure 5: From SW and 18th C wing.

4.1.3 The south-western elevation is mainly obscured by the 18th century wing (fig 5) but there is one ground floor window and one with gabled dormer-head. Both windows have been replaced in PVCU. The 1952 image shows a four- light casement above and a box sash frame at first floor level. Entry to the house is now made through the wing extension to right. The original external wall continues within the building and now forms a part wall with the 18th century wing.

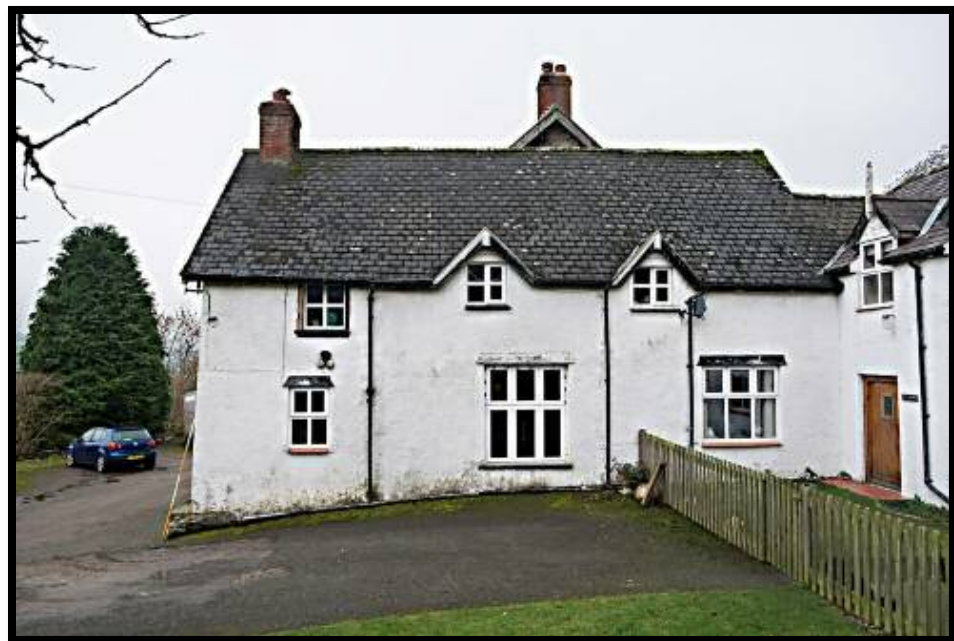
Figure 6: From the east.

4.1.4 The north-eastern elevation (fig 6 ) reveals the full length of the early building and the additional units are clear. The ground level exhibits 3 windows of three different sizes, now installed and the first floor has three smaller windows of comparable size, all fitted windows with PVCU

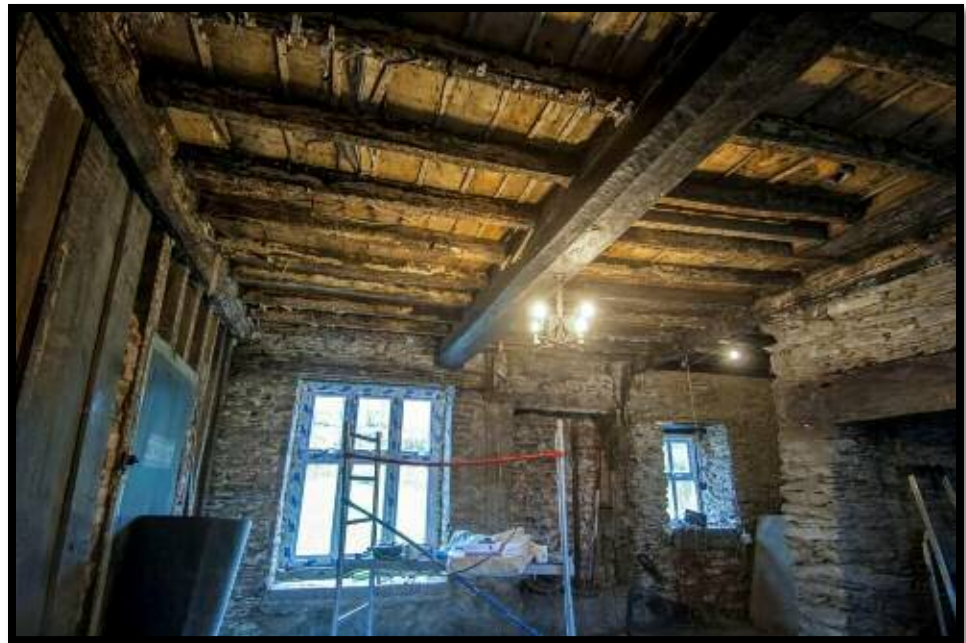
Figure 7: The hall in Ty Gwyn.

- 4.2.1 Entry to the early phase of the house is via the door (**Fig 23 Ground Floor Plan GF1**) into the 18th century wing and immediately to right a paneled door opens into what was the original hall. (Fig 7) As this room has been divested of its later accretions we are able examine it as it would have been before an earlier alteration, but not in its original condition but it does reveal some earlier stages of its development, perhaps prior to a later refurbishment. All the walls have been stripped bare, as have the ceilings, but a beautiful ceramic floor, said to be laid during WWII by POWs, survives and is going to be preserved. ( Fig 8)

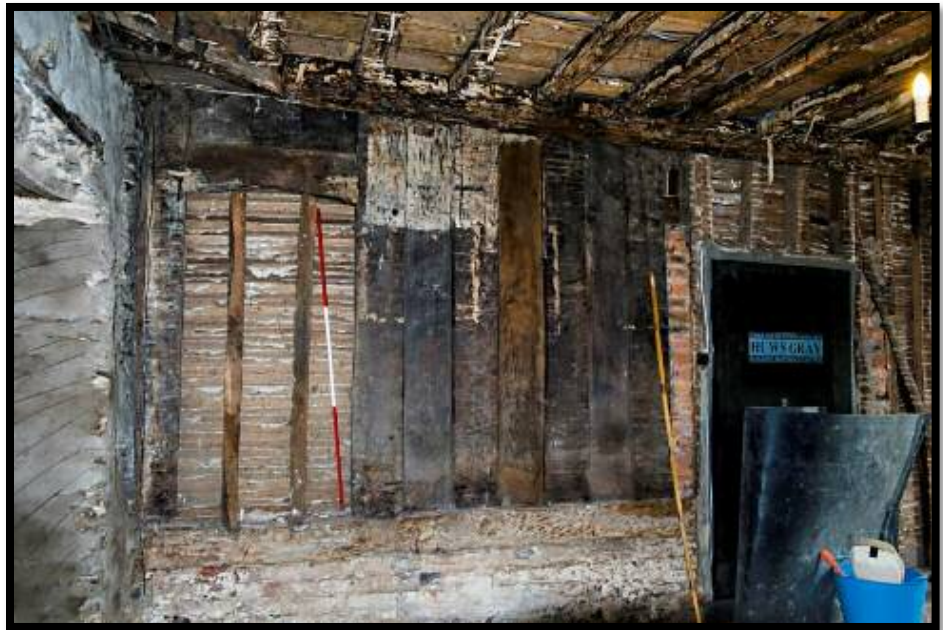
Figure 9: Remnant of plank & muntin screen.

- The wall to the left consists of a timber screen that comprises a doorway and 7 panels of a plank and muntin screen in good condition. (**Figs 9, 27 Screen**) The doorway has two posts, left 170mm and right 280mm wide with a door head tenoned and jointed into the posts. Bottom of door head shaped to form a four-centred arched doorway typical of the 16th to 17th centuries. Above the door head one short muntin divides two planks. Doorway was later blocked with two posts and lath and lime plaster added to rear face – i.e. facing into adjacent room. Continuing right, a further 3 muntins (260mm) hold 3 more planks on average 250-270mm wide visible. This section of the wall is jointed into a cill beam (220mm) on top of a 490mm high cill-wall of stone and brick. The right-hand end of this wall was removed and replaced with sawn posts to hold lath and lime plaster both sides and a new doorway with paneled door inserted. Steel beams have been inserted longitudinally and transversely so some structural deterioration must have occurred. This timber screen, including the later post and lath partition rise up behind the ceiling beam in the hall to locate into what was a ceiling or tie beam for a closed truss that is located here. It is important to note that the doorway passes through the partition at the same ground level as the hall with just a step up of just over 160mm. Initial impressions that the hall floor was much lower were due to the elevated position of the original door in the timber screen being 600mm of the ground. As the later door was sealed, entry to the adjacent room was from another entry. These initial impressions that the floor was elevated were revised but asks the question why the timber partition was on a high masonry cill and was this originally continued across the room, which would provide a considerable obstacle? The position of the door, some 600mm of the floor level is also curious. Was the floor lowered?

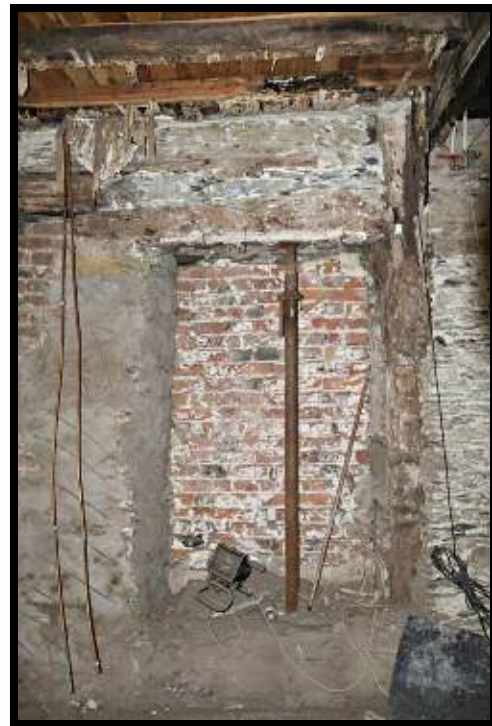
Figure 10: Blocked doorway?

opening, of door height, with a deep aperture and a step up of 400mm. This sits under another oak lintel of re-used oak. To the right, within this aperture, running the full height through to ceiling is the left hand blade of Truss 1 (fig 10 ). This cruck is truncated and now sits on either a replacement for a removed section or was a raised cruck originally. The matching blade on the other side is buried in mortar so this cannot be determined. To the right of the cruck blade is a window under a relatively thin lintel (65mm). Disturbed masonry.

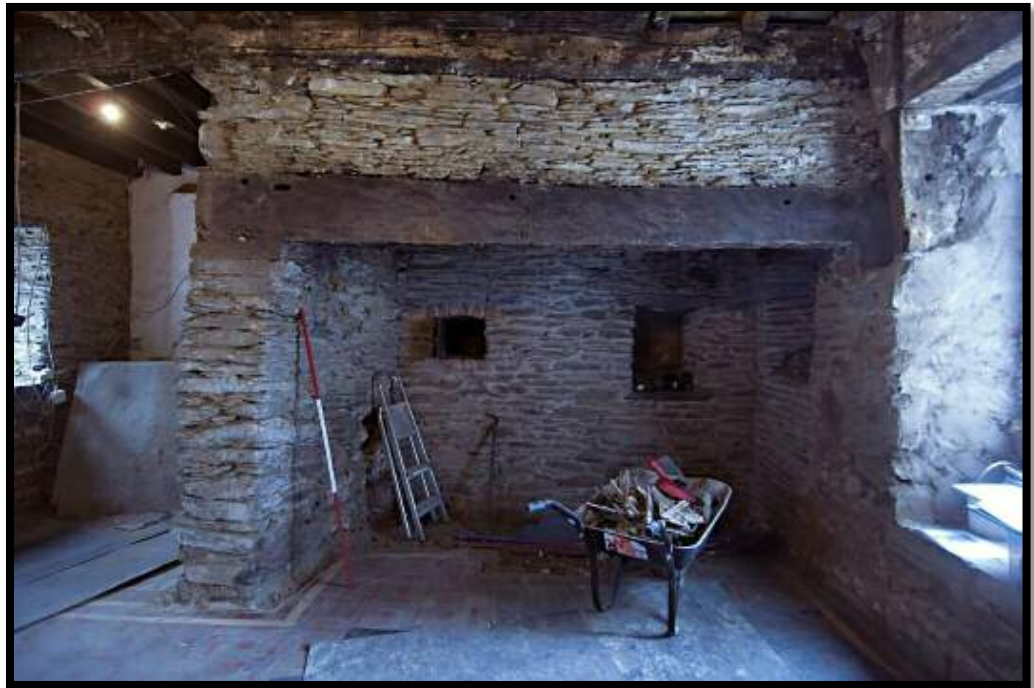
Figure 11: Inserted fireplace in hall.

The next wall to the right sees a large recess which has been created by the insertion of an impressive fireplace in the southern gable wall. (Fig 11) A large bressummer creates the fireplace opening. This has been reduced in dimension from the original and has no chamfers or stops, possibly removed. On top the masonry chimney breast a ceiling beam runs the width of the room transversely. It has a deep chamfer where it corresponds to the width of the chimney breast but to the left this beam is mortised on the soffit for what appears to be a section of plank and muntin screen (fig,12). It is difficult to translate this. The joists that this beam supports to the gable end have been replaced with later timbers and there is a chamber 2m square and lit by a window. To the right and left the ceiling beam and chimney masonry is located behind the cruck truss and the conclusion is that the chimney was inserted after the initial phase of the open hall.

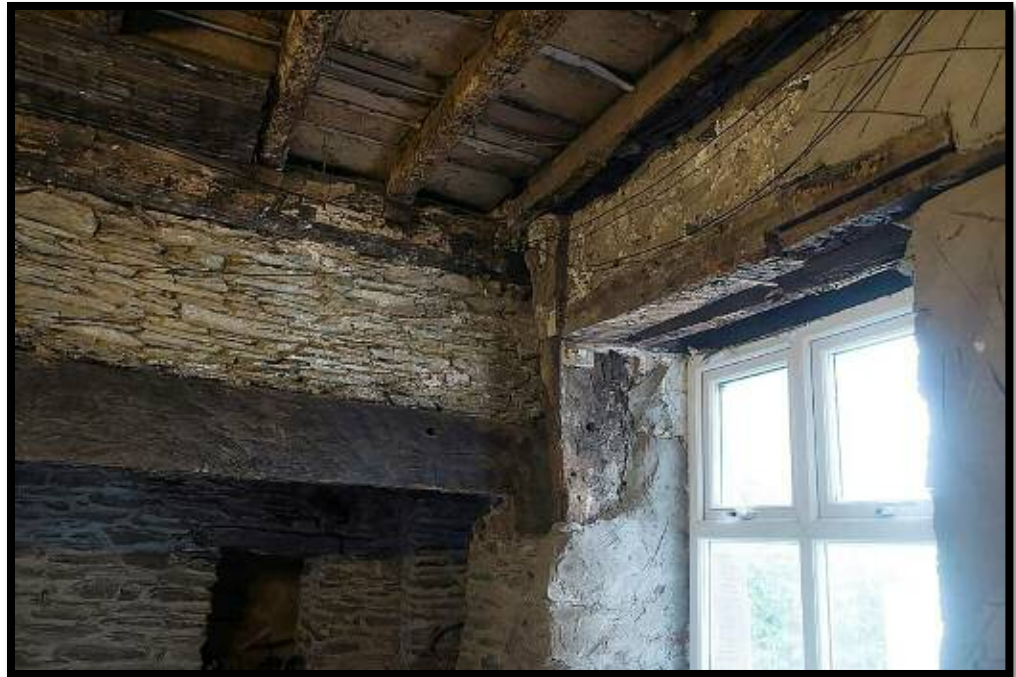
Figure 13: Fireplace and cruck.

The wall to right has little of feature but for the exposed right hand cruck blade. (Fig 13) A window to right. Although the wall is of stone the lintel is of deep section sawn timber on set edge. This suggests a later alteration. The door through which we entered is also made up of re-set stonework and various pieces of re-used timber, mostly oak. All display various notches, rebates and holes (fig 14) but the impression is that all the stonewalls have been repaired or remodeled or there is the possibility that the walls were originally timber framed and much of the original timber has been used in the remodeling.

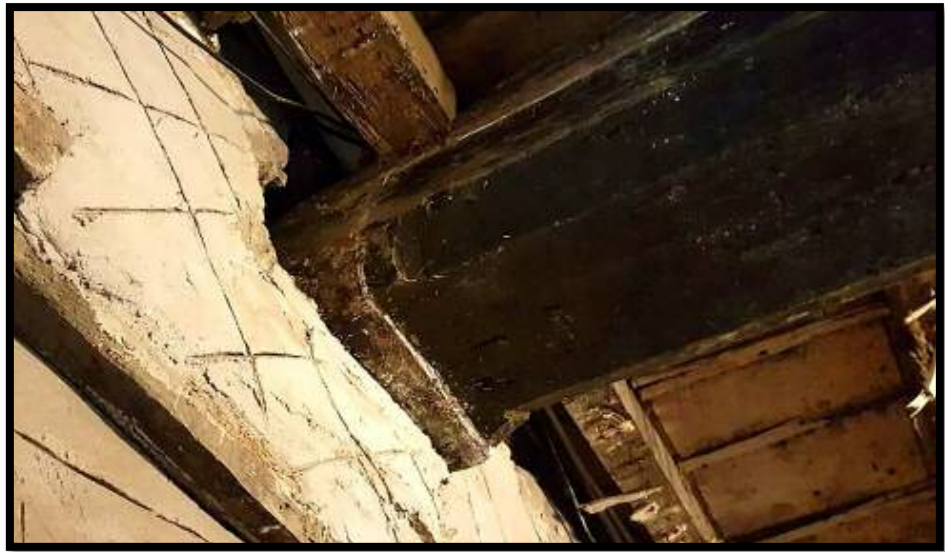
Figure 15: Main transverse beam with chamfers and stops.

The ceiling is impressive and shows some aspiration. The joists are supported in mortised sockets, on the left, as they are throughout, on a separate transverse beam (290mm x 180mm) and sits above and in front of the timber plank and muntin screen. This is located in front of the beam that supports the timber partition of the closed truss that rises from ground floor to roof apex. The joists (12) run longitudinally onto a central transverse beam (290mm x 270mm) and from this joists similarly cross to the ceiling beam over the fireplace. All joists are chamfered and stopped with simple step and hollow run out. The main beams have larger versions of these chamfers (70mm) and stops. (Fig 15)

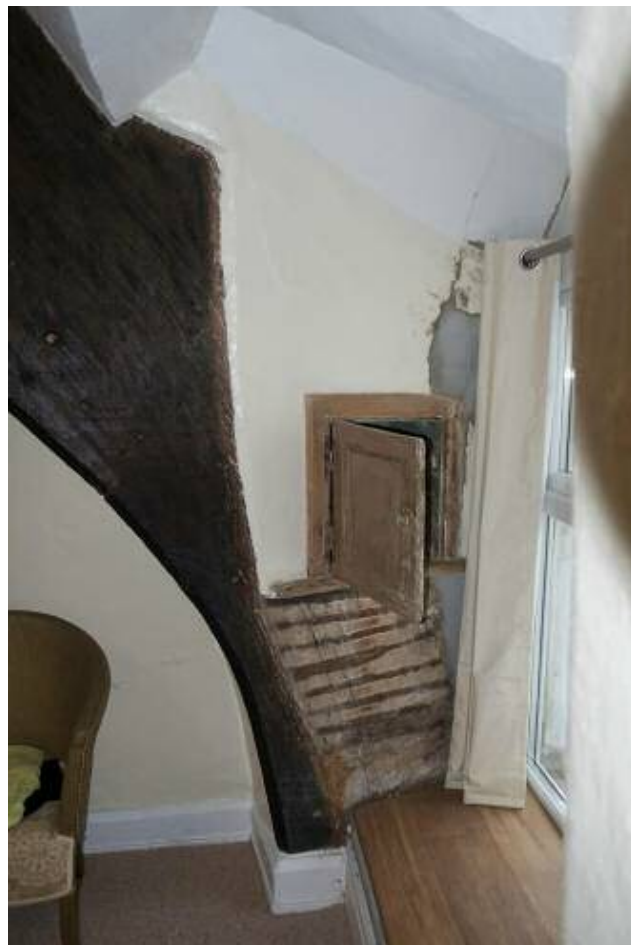
Figure 19: Cupboard carved from cruck.

- 4.3** The first floor is reached by a staircase built within the 18th century wing and enters the first floor over the position of the timber screen below. Two bedrooms occupy the space over the hall. A hugely impressive segment of cruck blade is open to view (Fig 16) with the left hand blade visible in the next room. Together they form the curve and apex of an arch-braced truss. (**Fig 24 Section AA Truss 1**) The brace is secured on its edge to the cruck blade by six pegs and on its top to the collar by eleven pegs. An extravagant or ostentatious use of carpentry. The right blade is imbedded in the masonry of the chimney below while the left blade stands free for part of its height. This allows us to examine the back of the truss and we find that the back has been further enhanced by more embellishment. For whatever reason a rebate has been removed from the face of the blade and arch next to the arch brace and a heavy chamfer applied, (Fig 17) suggesting that this side of the truss was meant to be on view rather than consigned to the low end of the building or, as now, buried within masonry as so often happened in this form of modification to an open hall when a chimney was inserted. This poses the question of plan form at this end of the building and if there might have been a further bay. The truss has been finished at the top of the arch, on the collar with a usual stub on the soffit, as if to accept a boss, but one does not now exist. There is also a horizontal mortise above this on the collar. This may have accepted a structural or decorative timber. (Fig 18) The complete truss has a 20mm chamfer running around the edge of the arch. Of interest, on the right cruck blade is the existence of a cupboard, with moulded door. The cupboard has been chiseled out of the cruck blade and must have been a labour of love. (fig 19)

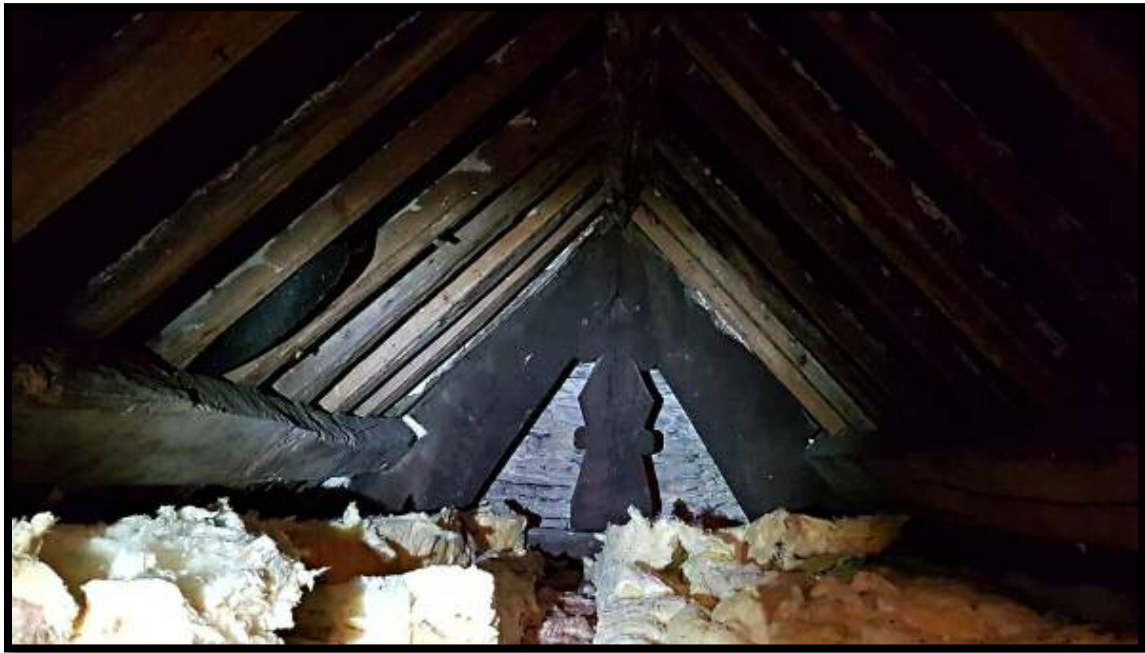
Figure 20: Unusual decorated king strut on Truss 1

- 4.3.1** Entry to the attic, next to **Fig 25: Truss 2 Section BB**, reveals the apex of (**Fig 24: Truss1 Section AA**) at far end of roof. Trenched purlins are carried on the cruck blades and the apex has the space above the collar decorated with an interestingly shaped king strut (Fig 20). The post, triangular at its top serves to tie the two cruck blades together and is pegged. There is little, or no evidence of smoke blackening which one would expect if an open hearth was used. However, the rear of the truss which faces the masonry of the chimney is completely pale oak in colour, rather than the dark oak colour on the inner face.

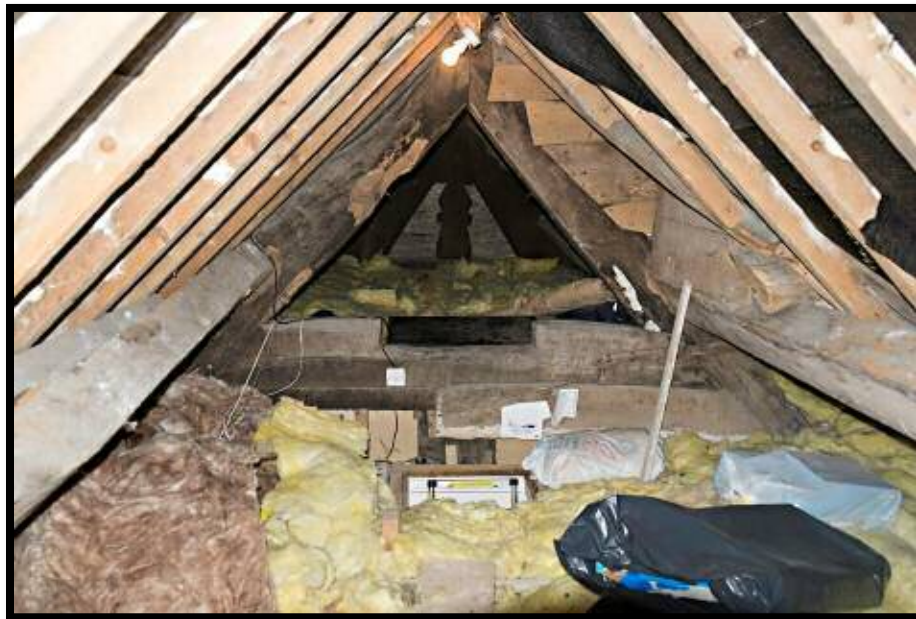
Figure 21: In Middle ground is Truss 2.

The central truss, above the screen in the hall, appears to be comprised of a further cruck or A-frame as part of a larger frame but this could not be ascertained. It would be quite a normal arrangement. This truss separates the two existing bays of the early house. It is constructed with similar dimension timber and from the collar one remaining post drops down below but there are further mortises. Two large, vacant mortises in the soffits of the cruck or A frame blades would accommodate two struts or, more likely, a diagonal block to tie the blades together. There are

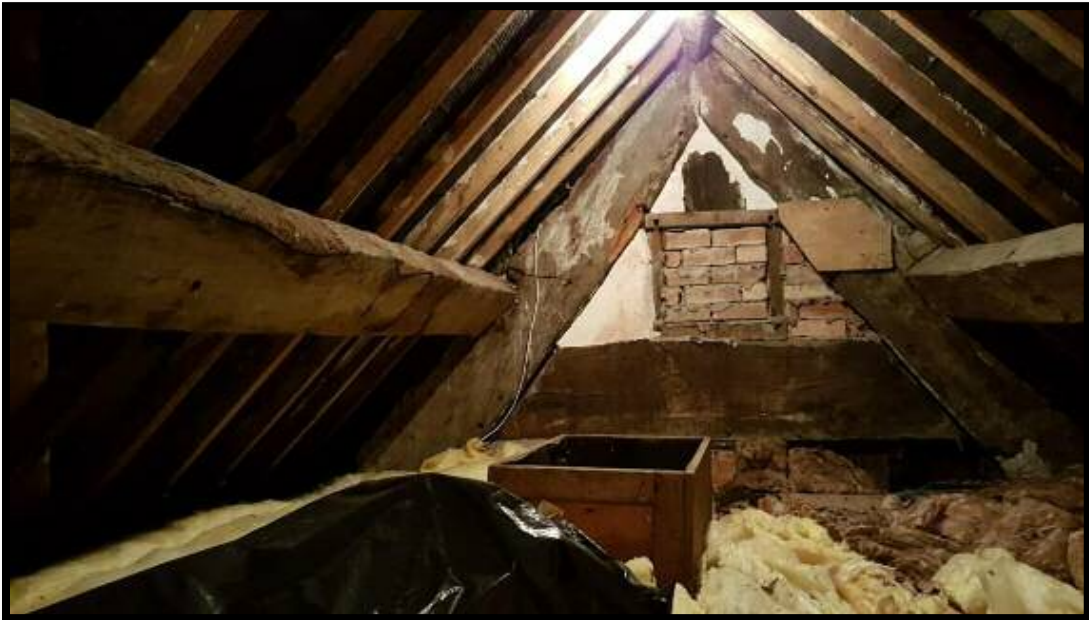
Figure 22: Truss 3. Central post at apex and several posts or studs drop from collar.

The last truss reveals the top, above the collar. It has been modified. Crucks fastened by a central triangular block, now missing. Several vertical posts, both from below collar but also above may point to timber framed walling (Fig 22) if this was the extent of the building in this direction. Appears to be oak window framing fitted into apex. Reverse face is extremely clean oak, viewed from attic of extension, reminiscent of exterior of truss 1.
