Pontrickett Ceiriog Ucha

Wrexham

Historic Buildings Record

September 2019

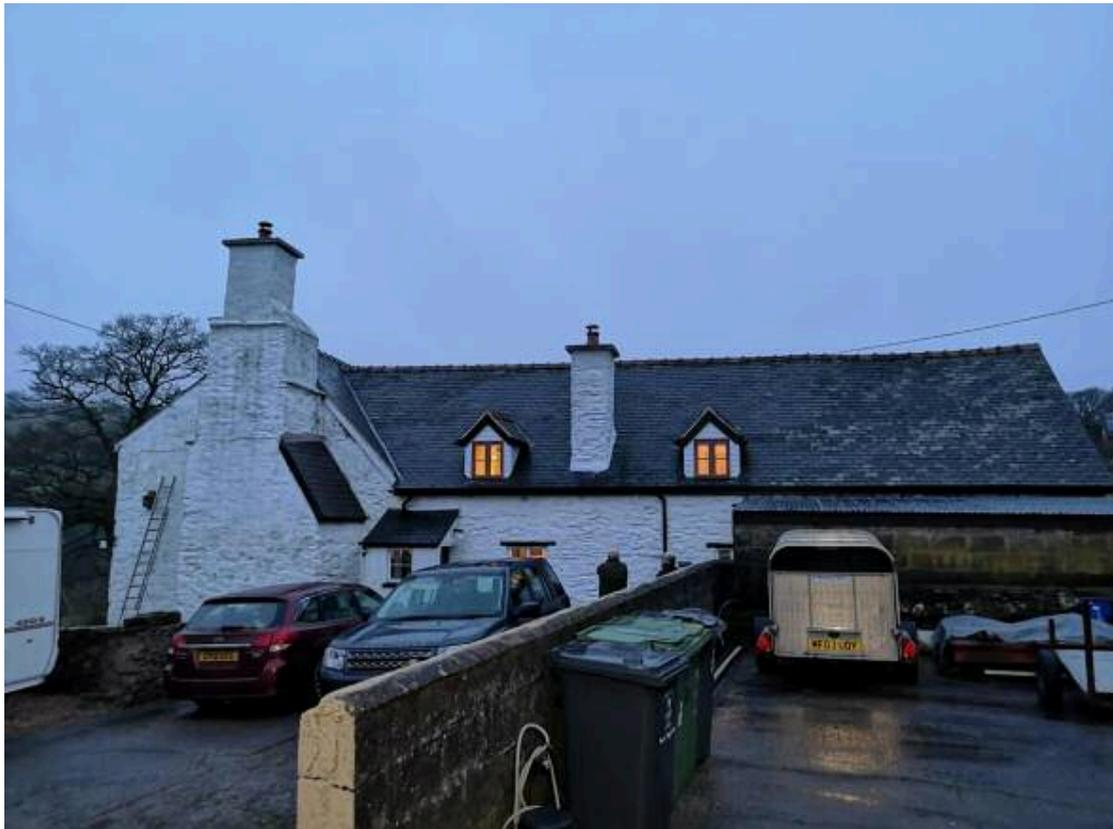
Fig. 1 – South elevation

Pontrickett is a good example of a late-medieval, downward sloping, cruck-framed, open-hall farmhouse that underwent a large number of significant adaptations that were contained broadly within the footprint of the original building (Fig. 1). Although the house went through the normal process of modernisation – insertion of a ceiling into the hall and a stack into the cross passage (probably in the late 16th century) and a further upgrading of the parlour (probably in the 17th century) – the detailed sequence is in fact surprisingly complex, perhaps reflecting the fact that while the occupants were prosperous enough to make piecemeal improvements, they lacked the resources to carry out major new work. Modernisation also reversed the hierarchical disposition of rooms – what (in status terms) had originally been the low end became the high end.

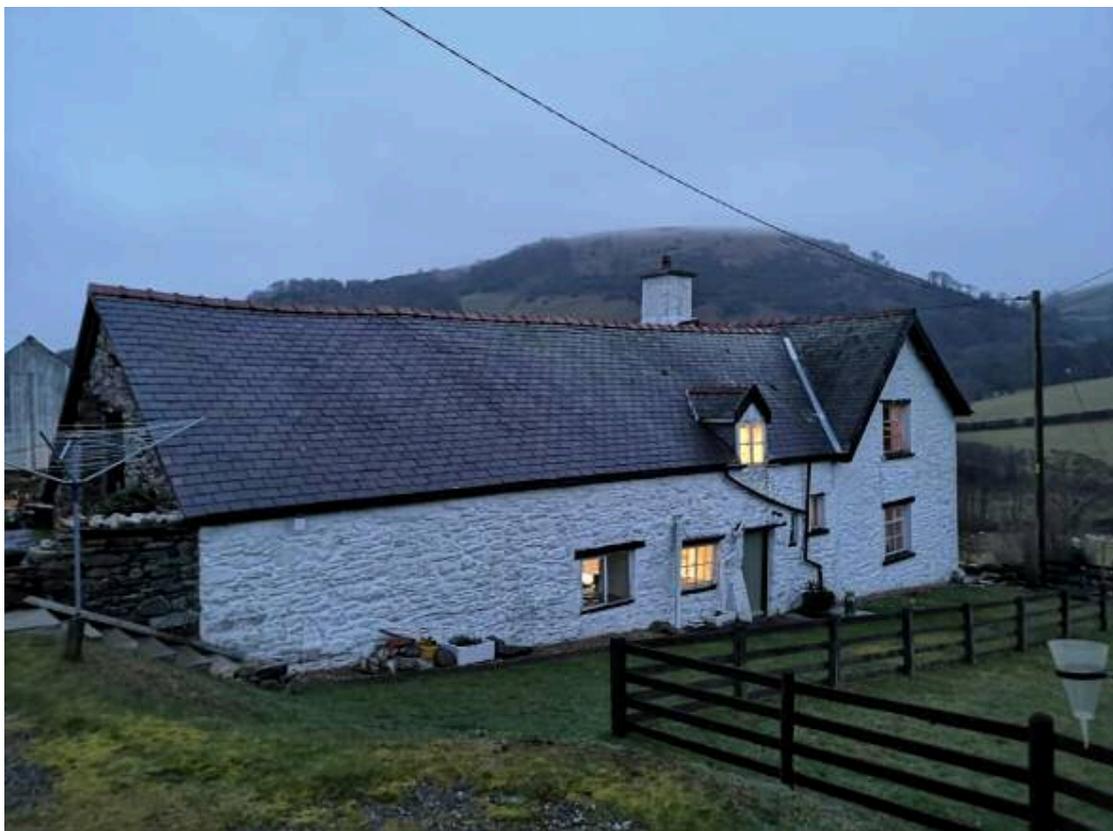
Fig. 2 – North elevation

A floor was inserted into the hall and a stack inserted into the cross-passage, creating a lobby-entrance plan, probably in the late sixteenth century. Subsequent events are difficult to reconstruct with confidence. At some point, perhaps at the same time as the stack and ceiling insertion (but see below), the low end was rebuilt as a timber-framed cross-wing. This intruded into the cross passage but, overall, remained within the original footprint of the cruck-framed house. This wing had two intercommunicating chambers. The ground-floor arrangements are now lost: heavy smoke-blackening within the roof space and to the wall framing of the northern chamber of this wing suggests that a fire caused damage severe enough to require significant modification, but not a total rebuild. The external structure, roof and first-floor partition were stabilised while a new parlour ceiling was inserted with cross-beams (chamfered with scroll stops) and—significantly—slip tenons, also chamfered and stopped. This created the elegant and spacious room we see now (Fig. 2). An external stone stack was added, probably later (see below and fig. 3).

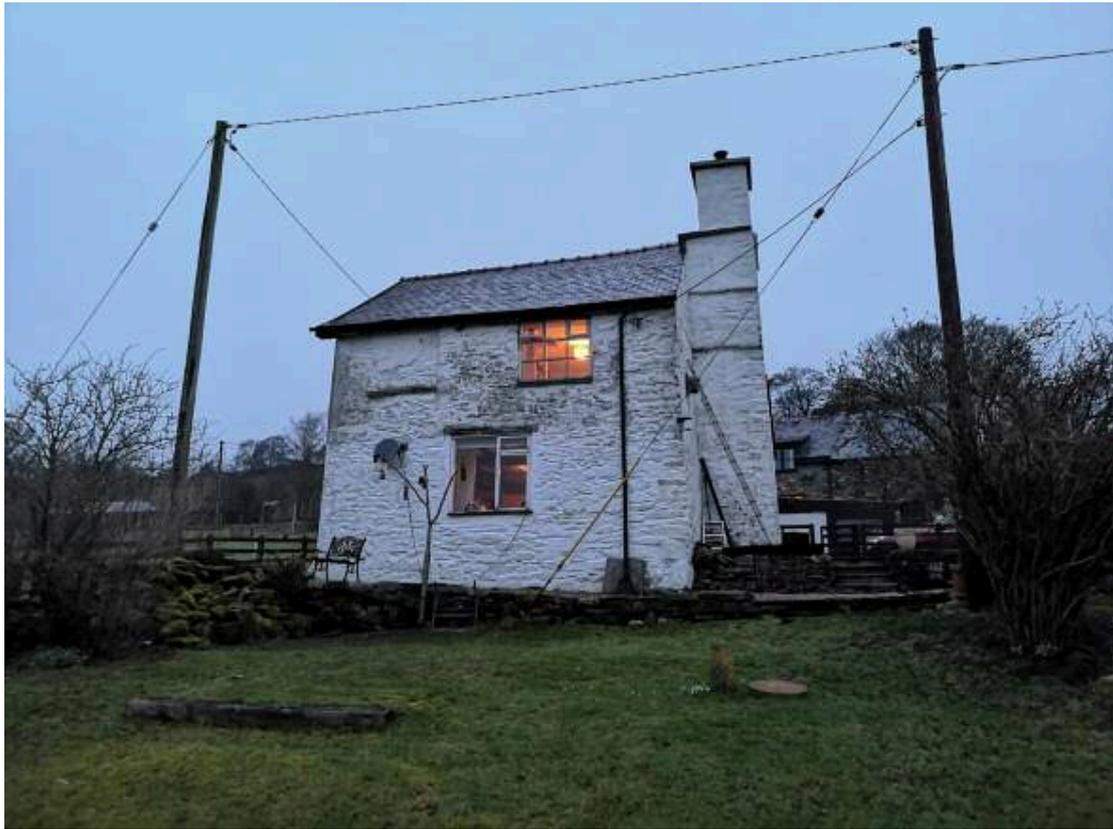
Fig. 3 – West elevation.

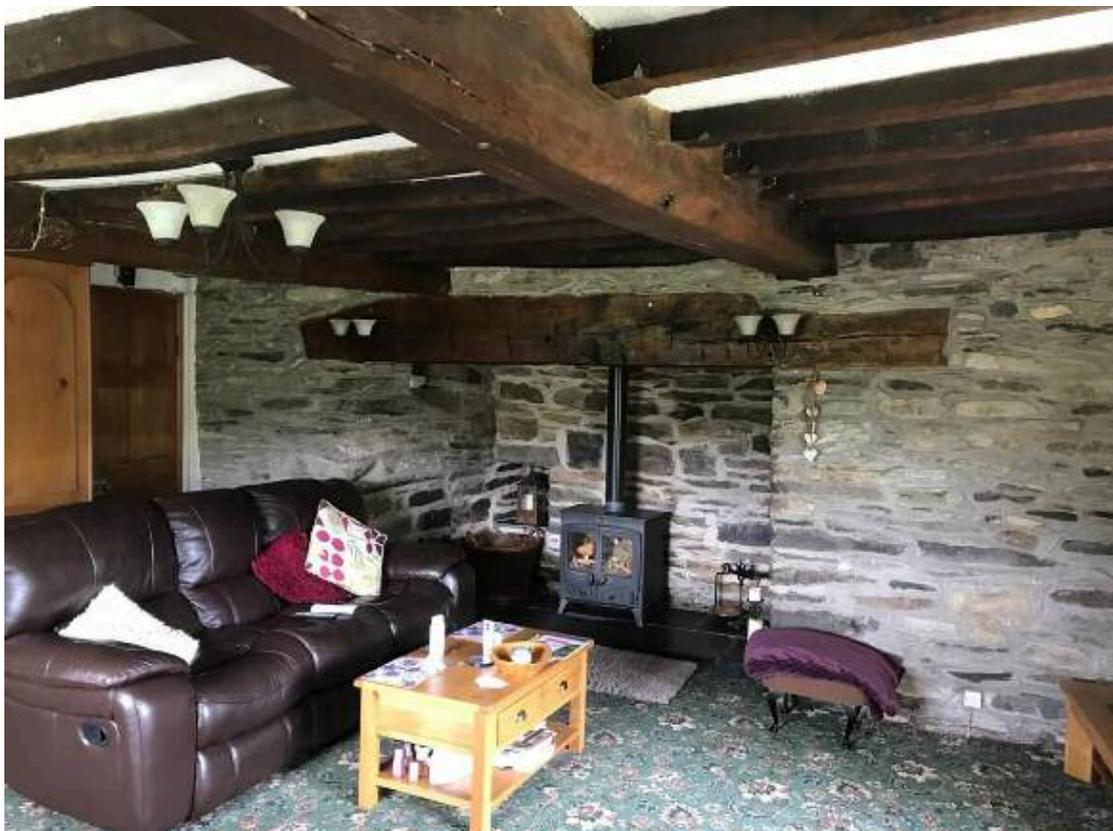
Fig. 4 – Parlour wing: ground-floor room, reconstructed after a fire, with slip tenoned joists. The chambers above this room were retained along with the principal rafter roof structure.

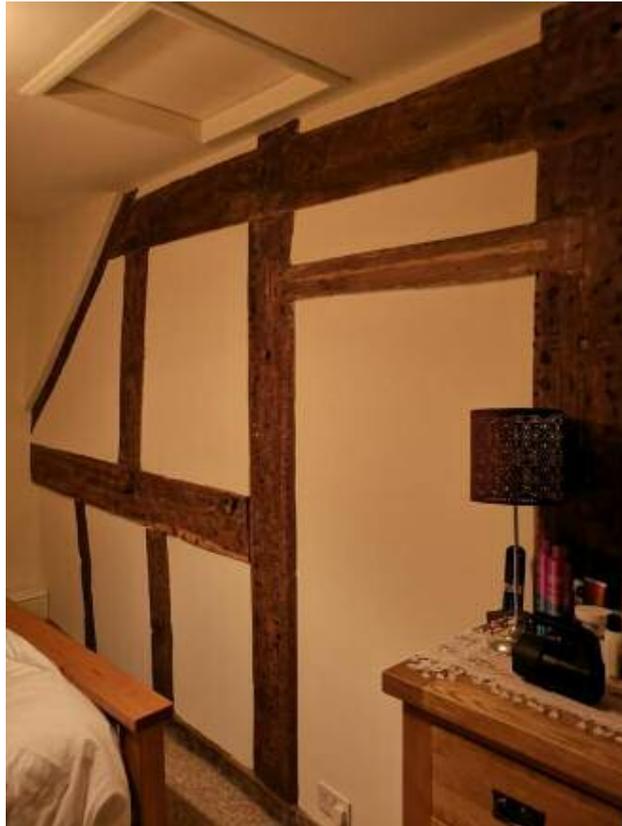
Fig. 5 – Wing partition framing at first floor.

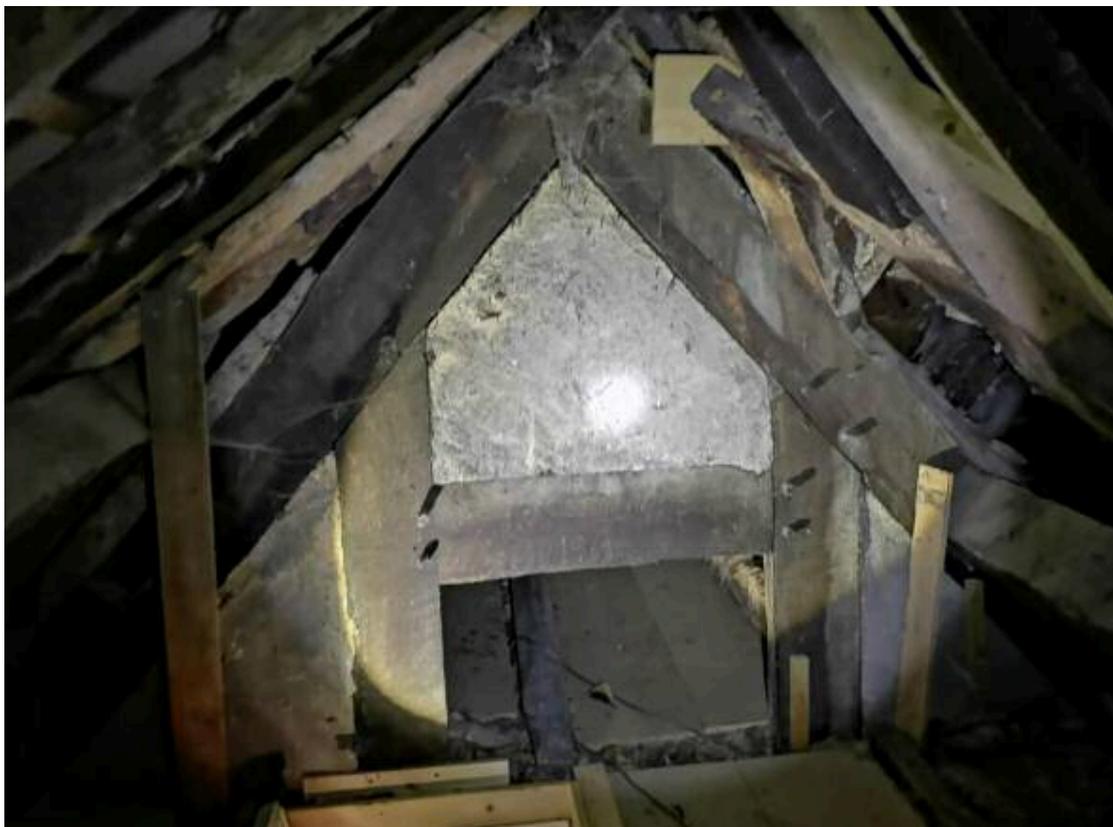
Fig. 6 - Wing partition framing in attic.

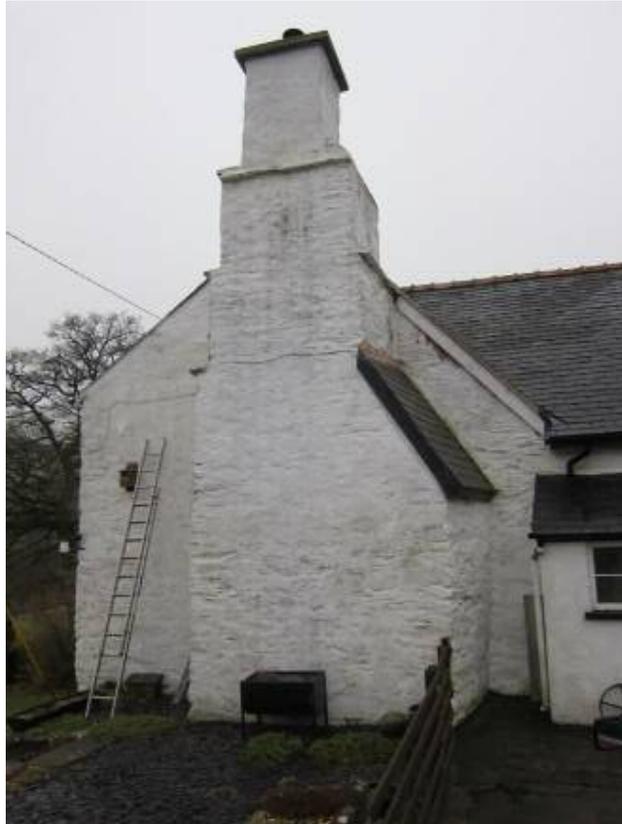
Fig. 7 - The external stone stack added to the parlour wing that was otherwise rebuilt within the footprint of the original cruck-framed hall house.
