Discovering Old Welsh Houses

North West Wales Dendrochronology Project
DATING OLD WELSH HOUSES

Bryn yr Odyn
Cwm Cynfal
Maentwrog
C16th 'Snowdonia' house

*David Longley
for North West Wales Dendrochronology Project
September 2011*

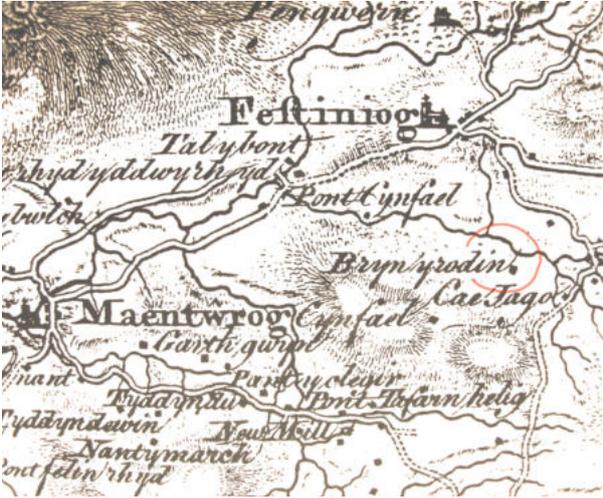
Bryn yr Odyn in the 1790s

Bryn yr Odyn is mapped prominently on John Evans' map in the 1790s. It was recorded in the tithe survey of 1840, holding 132 acres. Morris Griffiths was the tenant farmer. In 1891 David Jones farmed the land with his wife Elizabeth and his three children.

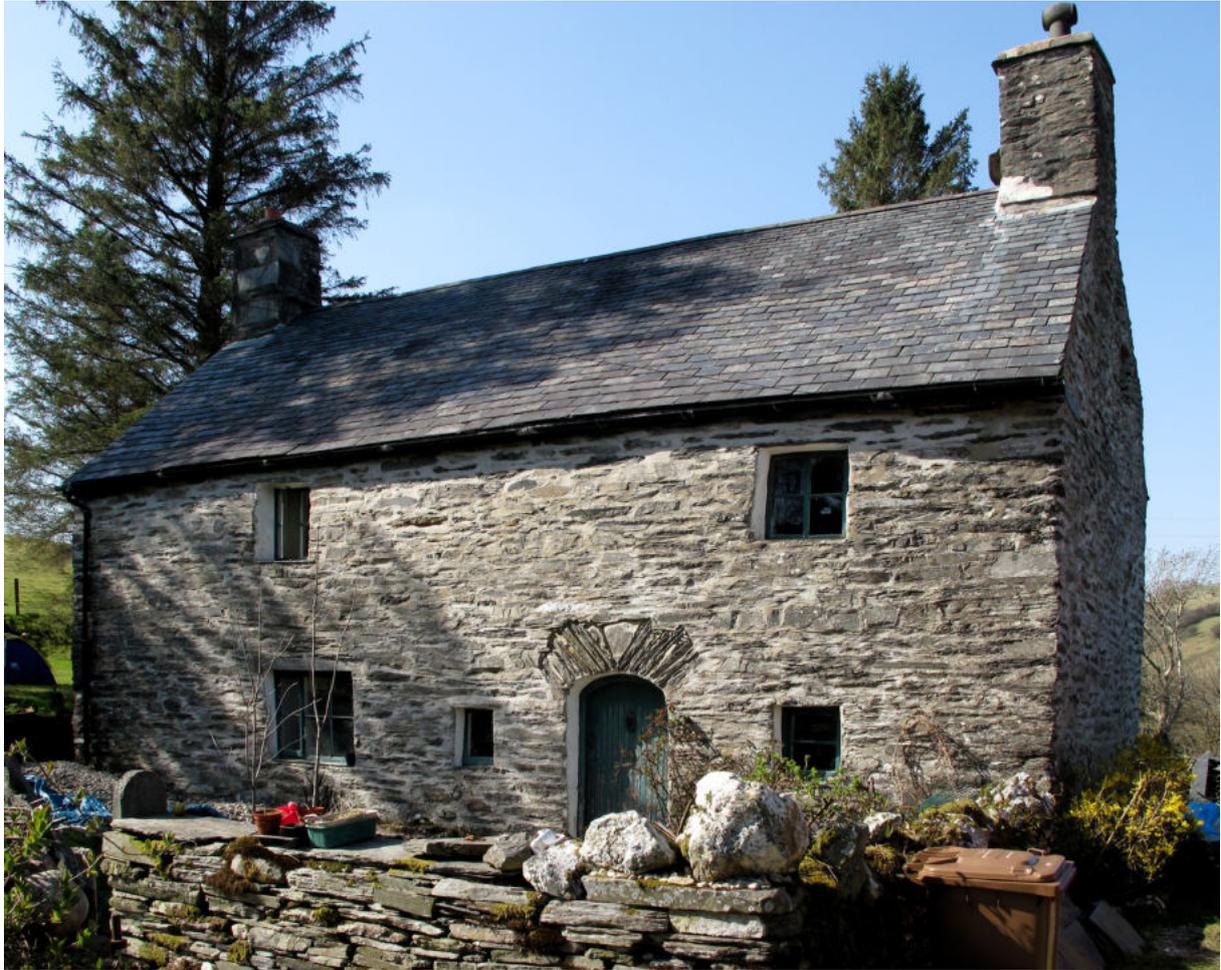
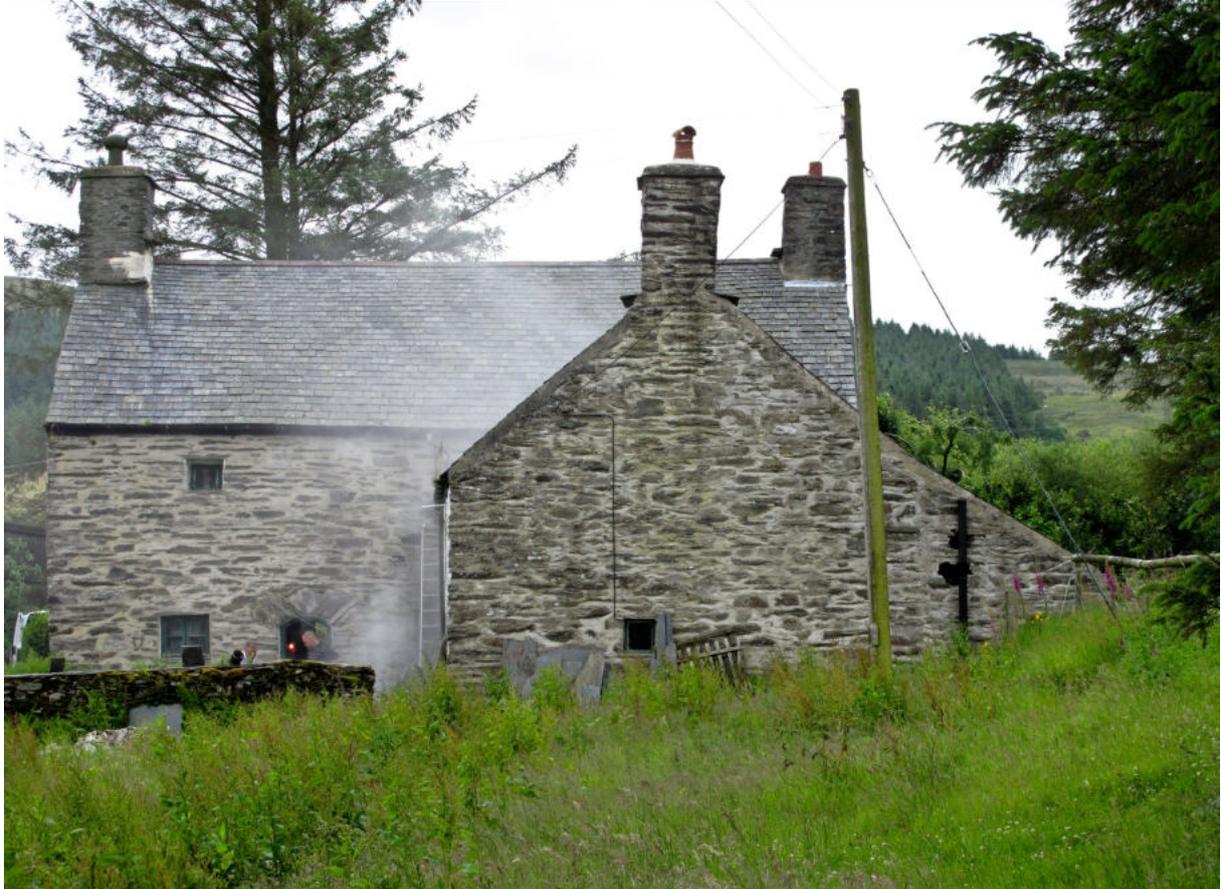
Bryn yr Odyn, front and back

Bryn yr Odyn is a compact but substantial stone built two-unit, two-storey and attic, end-chimney sub-medieval house of the first half of the sixteenth century. A kitchen wing was added on the north side, a generation later.

The main house is rectangular, on a west-east axis. The external length of the house is 12.7 m and 7.4 m. wide. The thickness of the walls at ground level is, on average, 950 mm. Access to the ground floor is achieved from the outside into a passage defined by oak partitions on each side. There are doors at each end of the passage. The south door is slightly larger than the north door and the passage floor (1.5 m wide) slopes down towards the north, confirming that the south door is the main door. The arch above is formed by slate voussoirs.

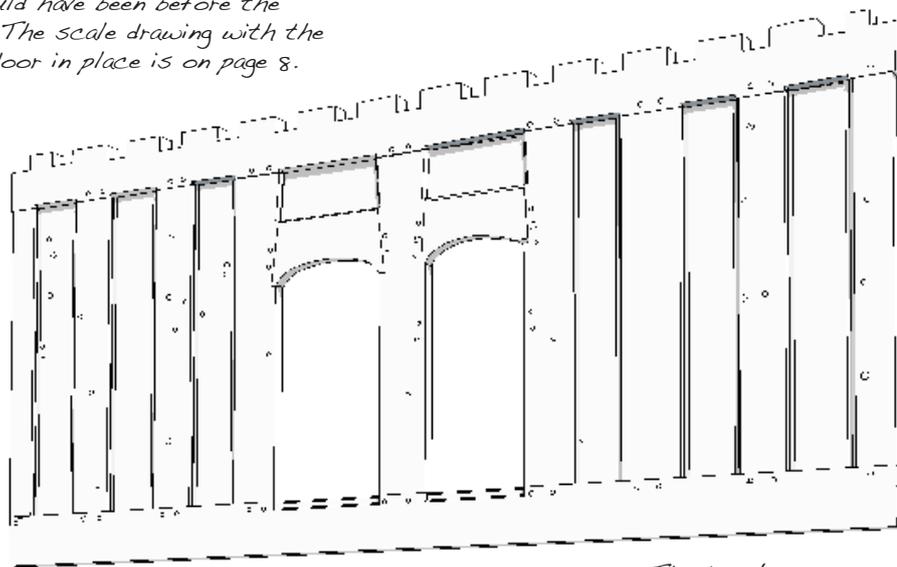
East partition, facing in towards the passage. The left hand door is drawn as it would have been before the blocking. The scale drawing with the blocked door in place is on page 8.

The top beams carry trenched mortices for ceiling joists continuing the rows of joists across the passage and the rooms behind.

There were two doorways in the eastern partition, leading to two rooms at the eastern end. One door is now blocked but the position of its former partner is identifiable by the distinctive remaining jambs. The remaining

original door is a complete example - a low arched head, quasi four-centred, tenoned into morticed and pegged angled rebates in the sides of the jambs.

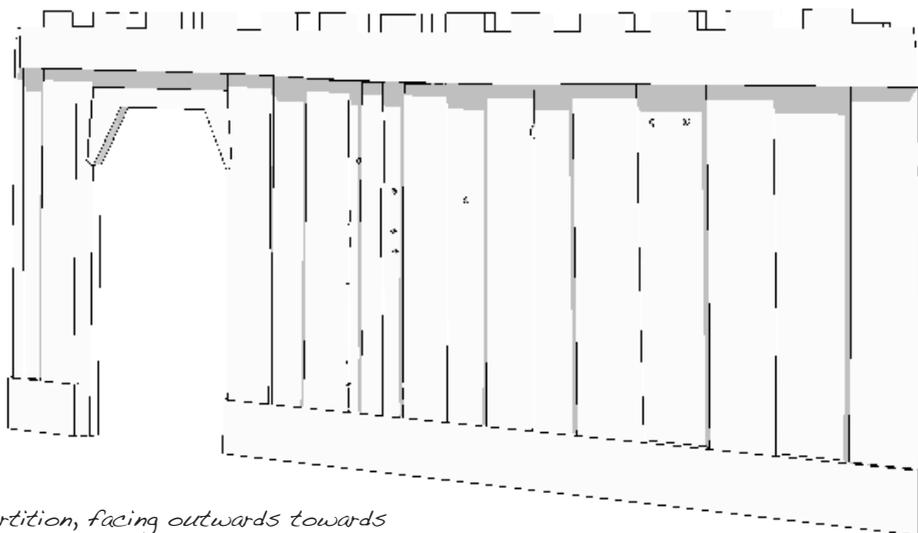
West partition, facing outwards towards the hall. The door is a modern pastiche. The central area had a wide opening before blocking.

A modern door has been inserted at the north end of the west partition and this is now the access to the hall. Nevertheless, there are clear indications of a former large central opening, now blocked, which originally would have made an impressive entrance.

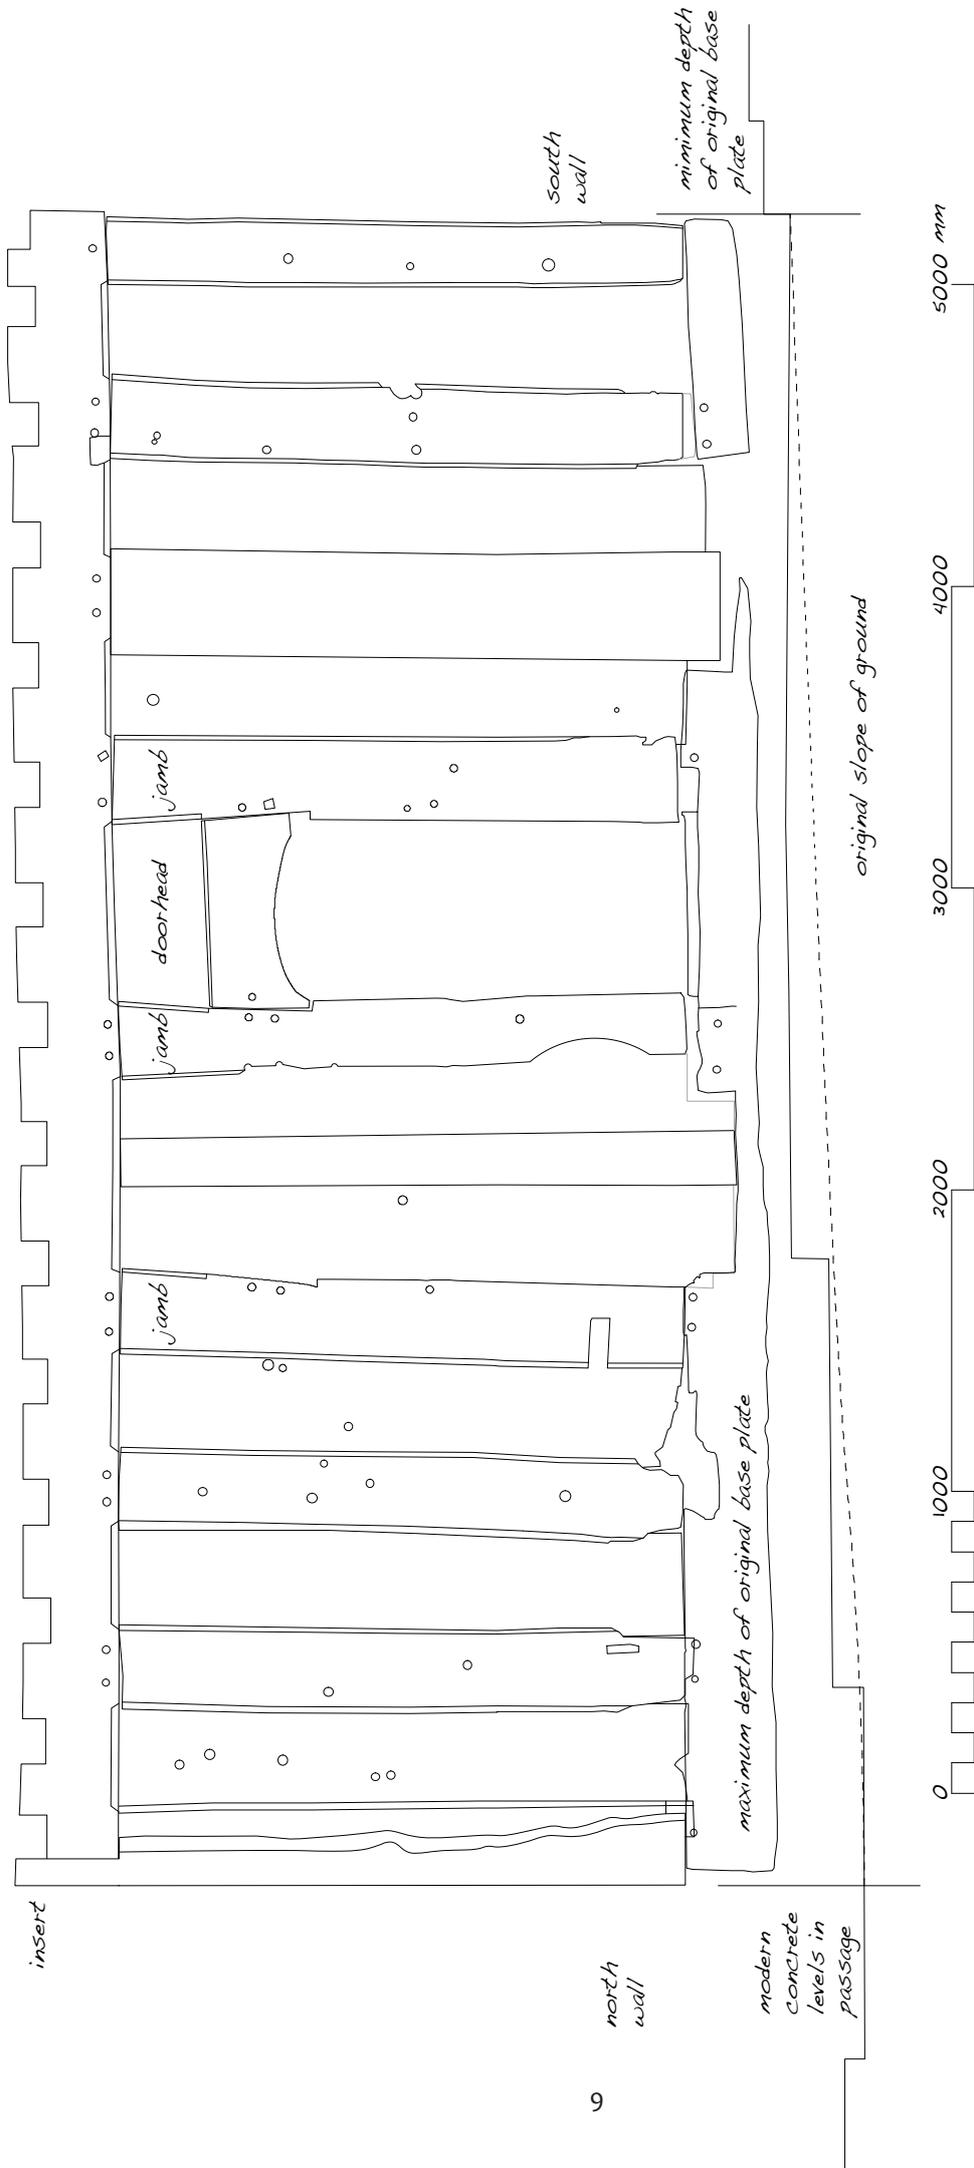
Bryn yr Odyn, base plate and level/s, east side of passage
 Scale: 1:25

The top and sill-beams are roughly horizontal. The height of the muntins, grooved on their edges to receive chamfer-edged planks are, on average, 1.8 m. tall. The muntins are pegged (2 pegs) and tenoned into mortices on the top and sill-beams. The planks are not pegged. The depth of the sills vary as the ground slopes. The maximum and minimum heights of the partitions above the original passage floor are 2.5 m and 2.4 m. The top-beams are 112 mm. thick with 14 mortices trenched along the top to receive joists of 150 mm. x 100 mm. (approximately 6 in. x 4 in.).

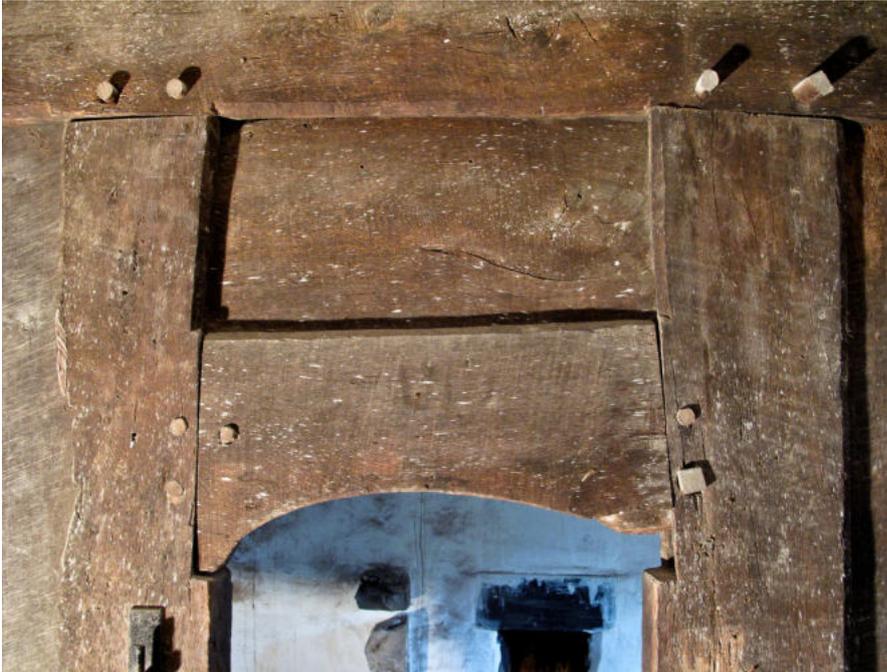
door rebates, pegs, chamfered edges

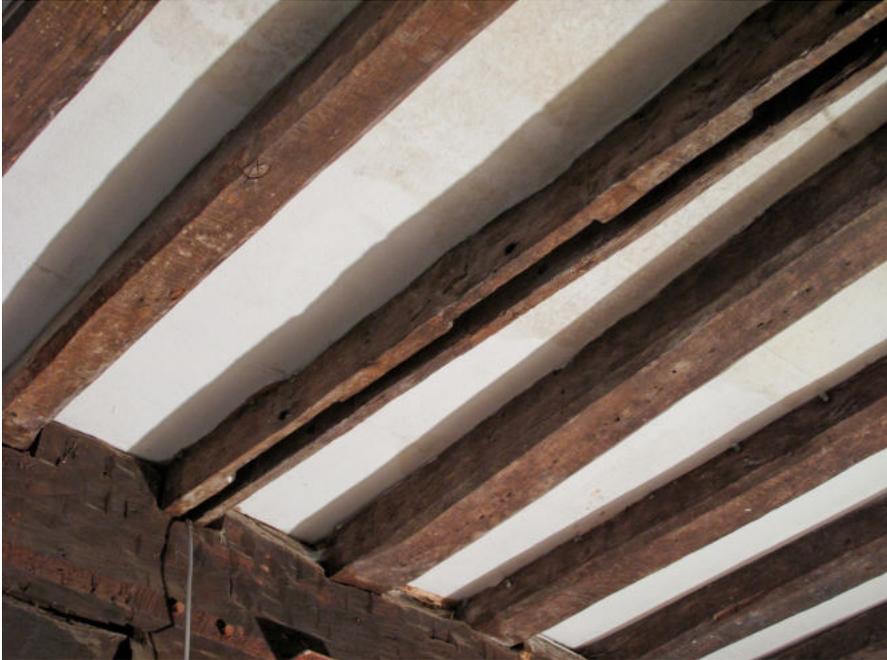
top rail dividing the two lower/back rooms

A perpendicular top rail, morticed for a muntin and plank division, but now removed, indicates the division of the two back rooms - probably a parlour and a store. There is a small fireplace in the south room behind the screen but it is not certain that it was original. The fireplace in the chamber above is certainly original.

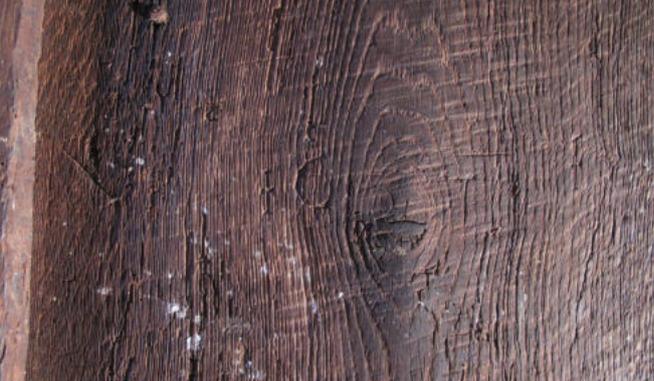
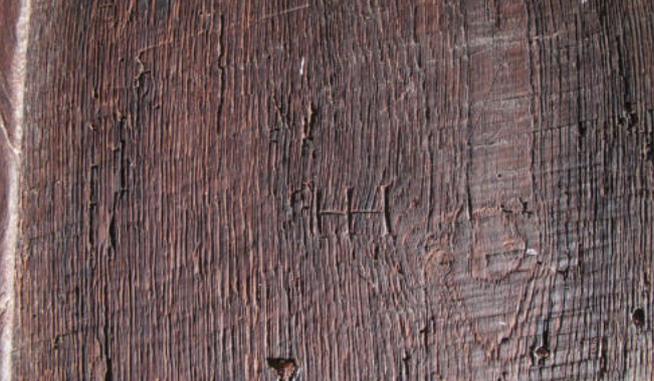
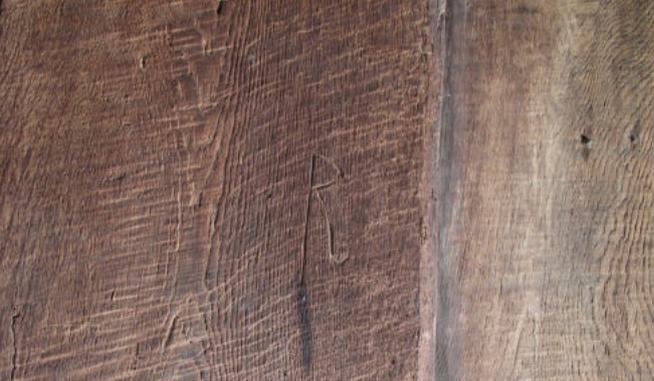
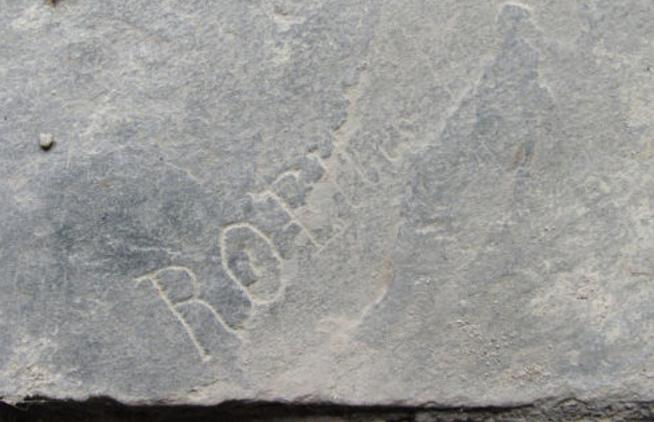
There are four legible inscribed graffiti on the boards facing the passage on the western side. There may be others.

On the second board from the south, there is an inscribed date, 1615. On the third board there are the capital letters RI (not illustrated). On the fourth board there are two ligatured capital letters HH. On the fifth board there is the single capital letter R. On a slab of slate, part of a window sill, there is the legend R O Ellis. There are also carpenters' marks which are illustrated, among others, on page 17.

There are two splayed windows in the south wall, now with modern casements. The eastern of the two windows carries a graffito on a slate ledge with the legend R O Ellis.

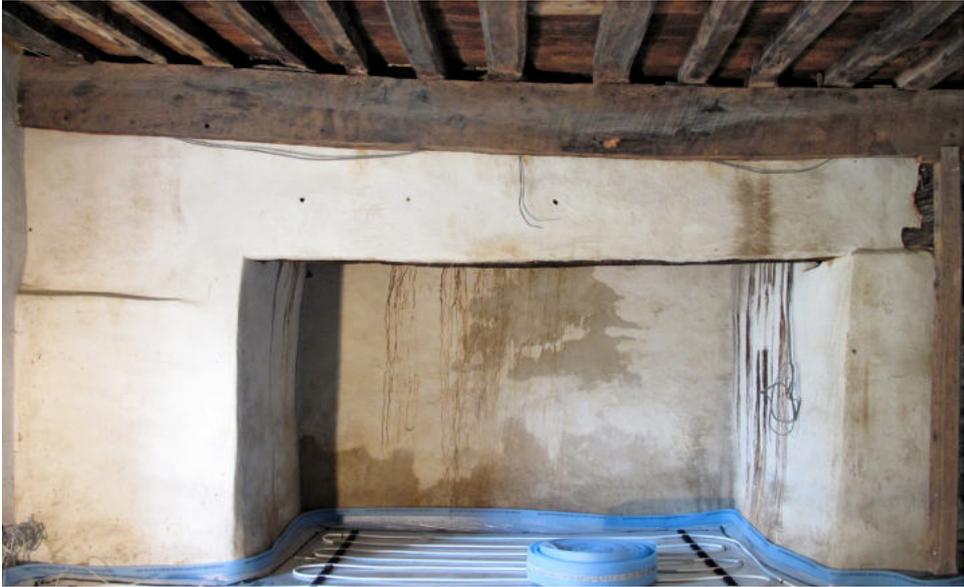
The hall fireplace

The joists in the hall rise above and rest on a flat beam above the fireplace. The bressummer above the fireplace opening is now masked behind plaster. It is 450 mm wide and 480 mm deep, chamfered on the lower front face

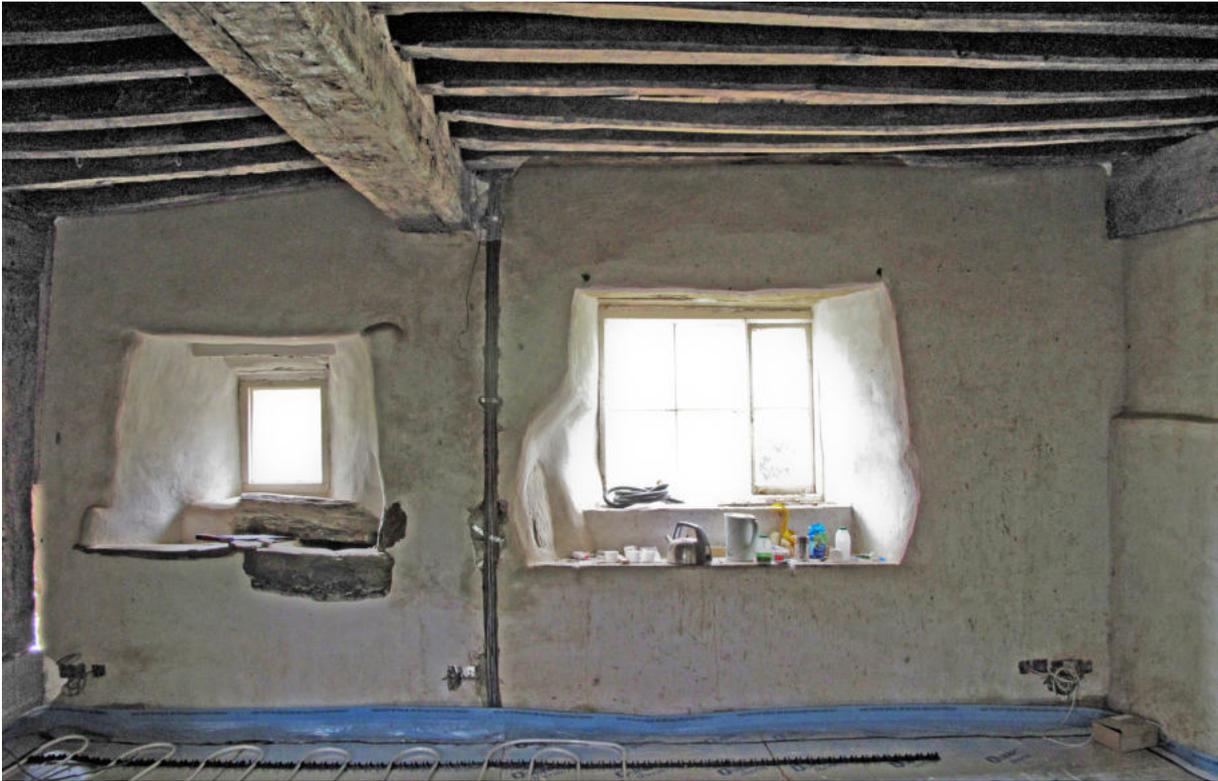
windows in the south wall

There are two windows on the south wall either side of the ceiling beam. Both have relatively wide displays. That closest to the partition has a recessed bowl shape in a deep slate slab, the purpose of the which is not clear.

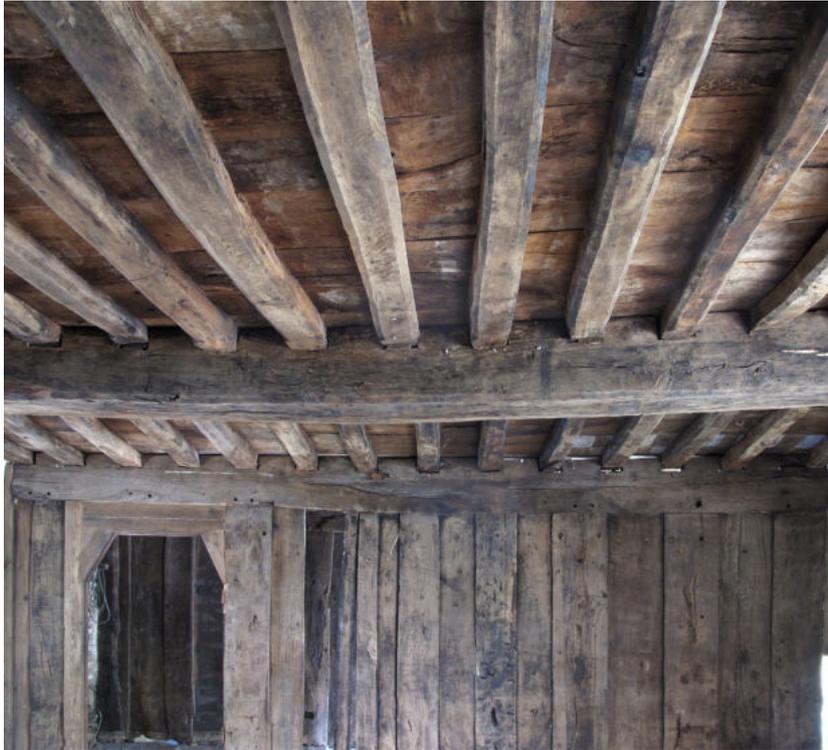
The western partition and the central hall beam and joists

A large transverse beam 350 mm wide and 335 mm deep extends across the room 3.2 m from the west wall and 1.6 m from the partition. The beam spans 5.46 m. and supports 14 trenched mortices either side for joists. The joists, 140 x 100 mm are chamfered with plain stops.

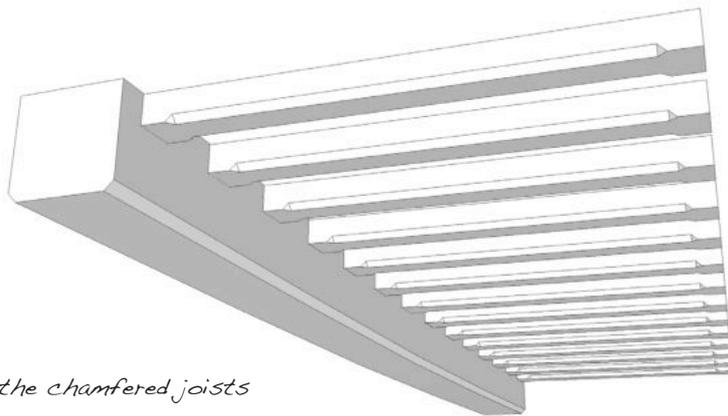
The hall beam and the chamfered joists

The hall beam is slightly higher than the cross passage beams

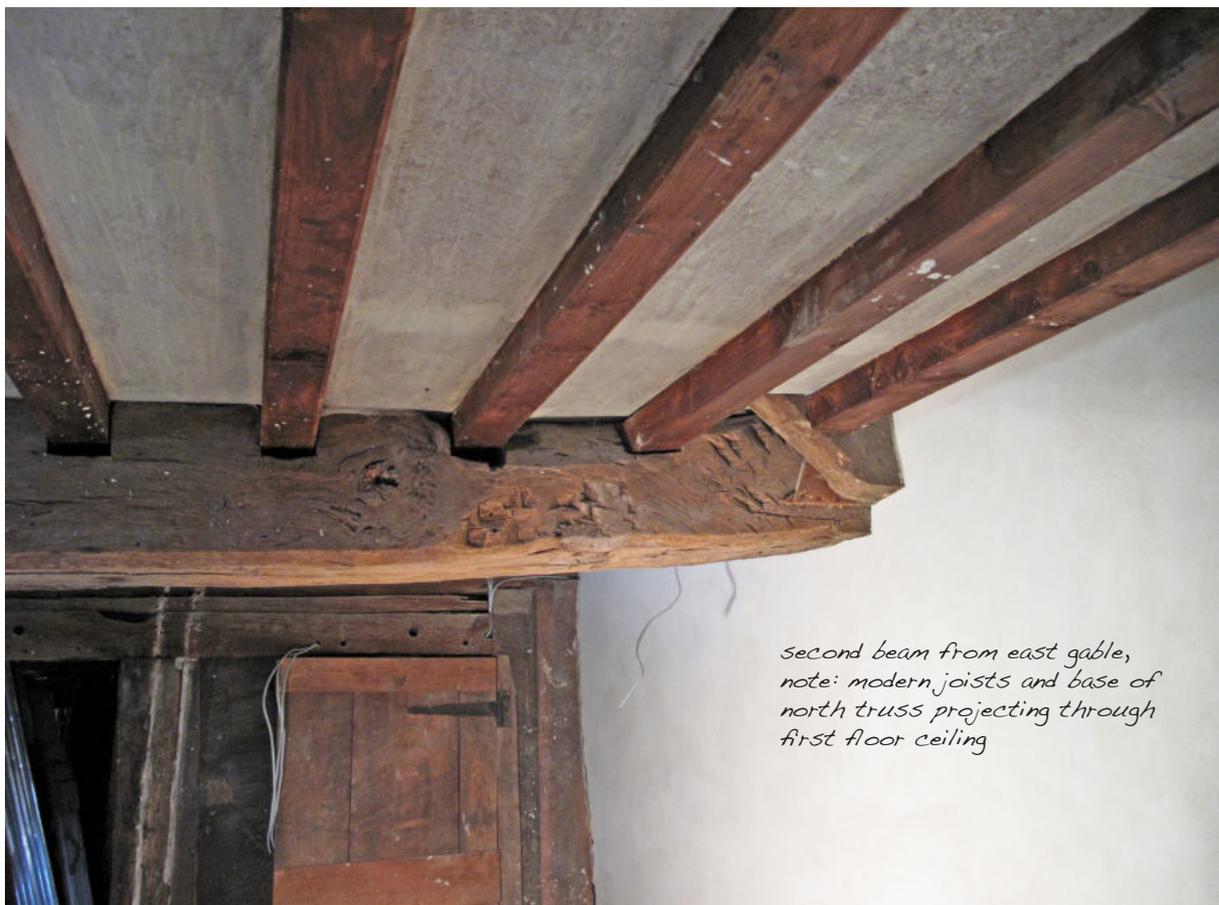
*Second beam from east gable,
note: modern joists and base of
north truss projecting through
first floor ceiling*

- The east beam is has an irregular profile, 200 mm. wide, on average and 200 mm. deep.
- The second beam is more massive, 293 mm. wide and 306 mm. deep; 2.2 m. from the east gable beam.
- The third beam is roughly central to the 1st floor space but is considerably slighter at 115 mm thick and 200 mm deep; 1.8 m between the second beam and the third, over the partition.
- The fourth beam is 280 mm wide and 210 mm deep; 2.2 m. between the third beam and the fourth beam and 2.2 m. to the west gable.

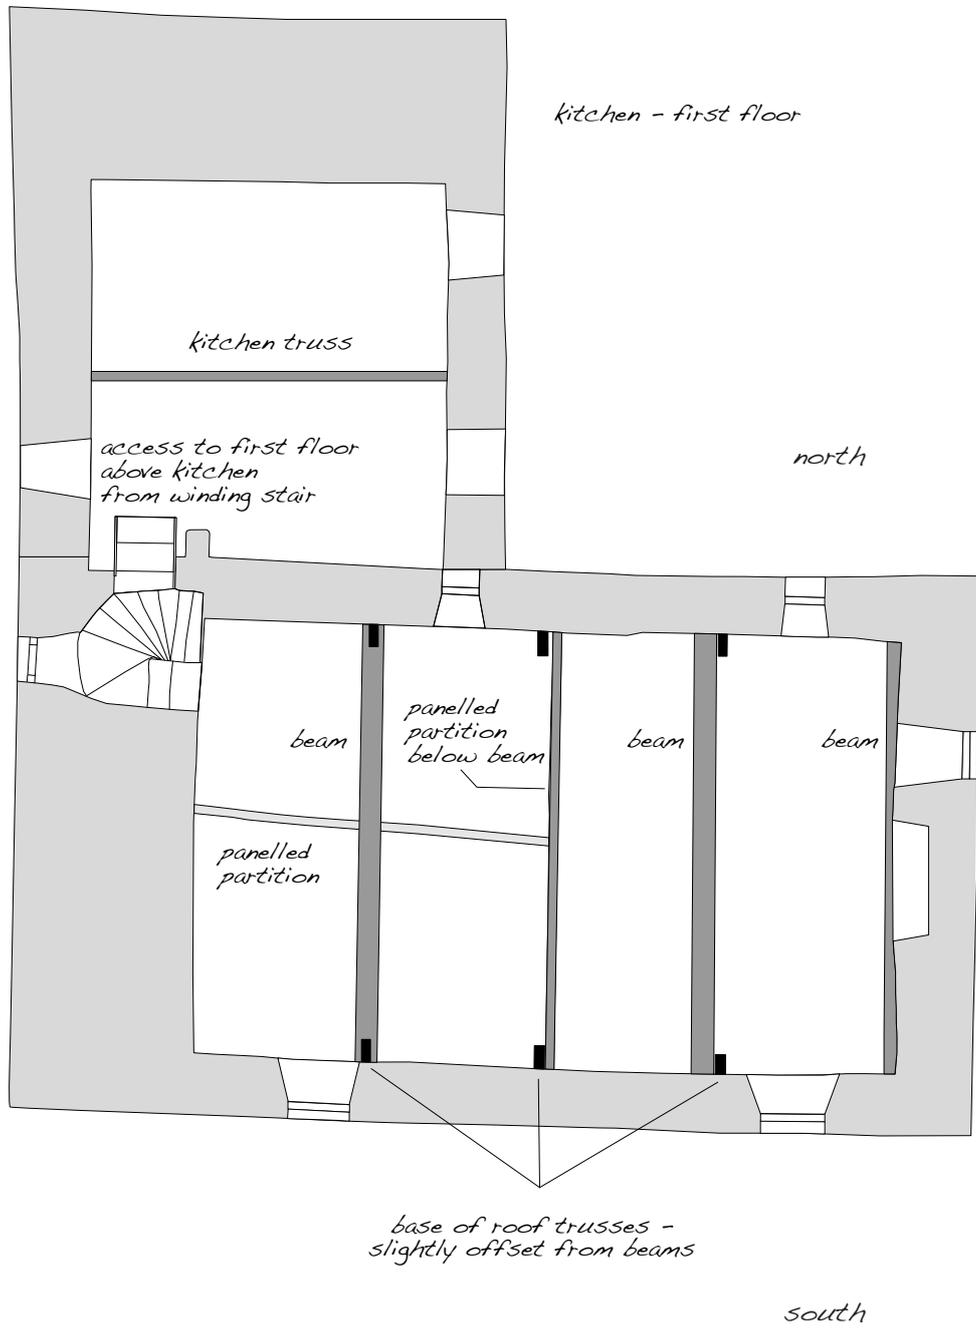
Fig. 3 *Bryn yr Odyn first floor*
1:100

There are two oak partitions on the first floor. One partition crosses the width of the floor space, 5.8m. in the centre. An additional partition stands perpendicular to the first and is a later and secondary feature. The first partition is a plank and muntin screen with pegged and grooved muntins. The boards carry carpenters' marks (Roman numerals) very similar to those on the screens on the ground floor. The ground and lateral first floor screens are probably contemporary.

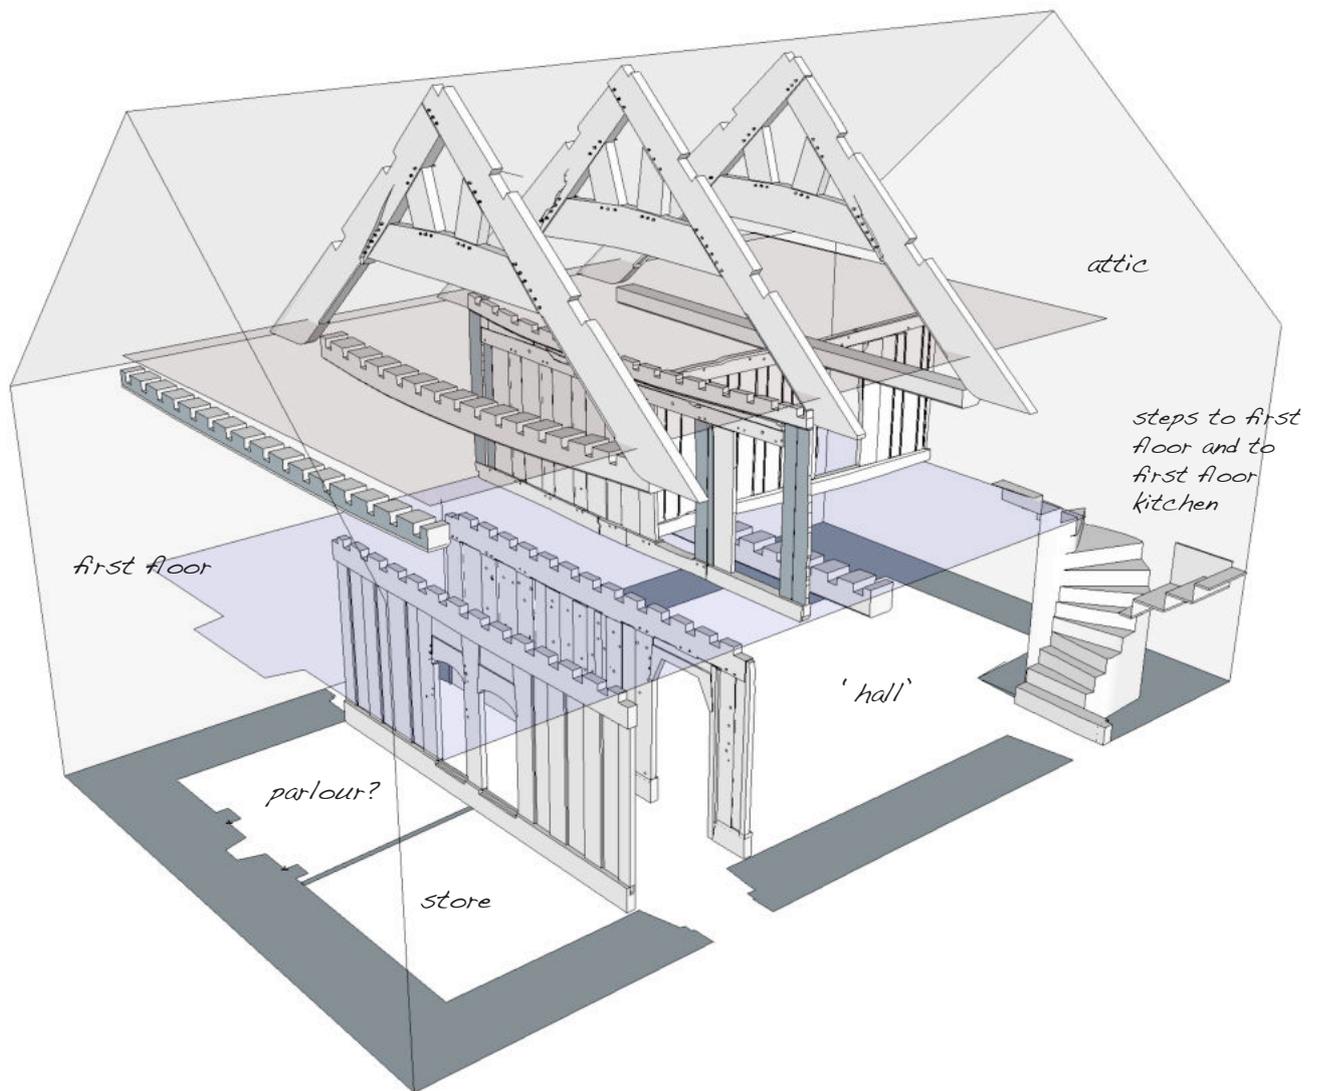
This drawing illustrates the sequence through ground, first and attic floors, showing the position of the screens and trusses. It also shows the relationship of the trusses, first floor beams and the attic floors. See also p. 21 for a hypothetical alternative for the original arrangement of the first floor and the roof trusses

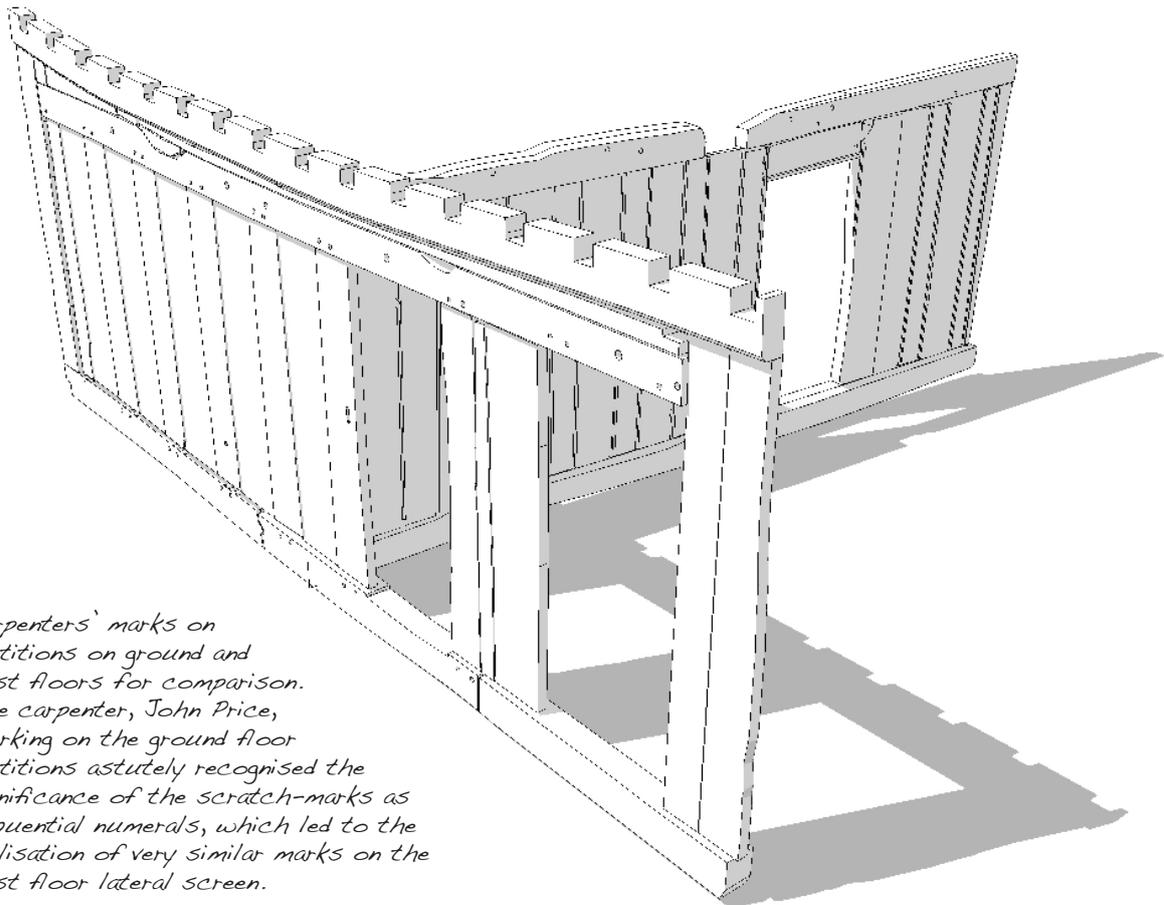
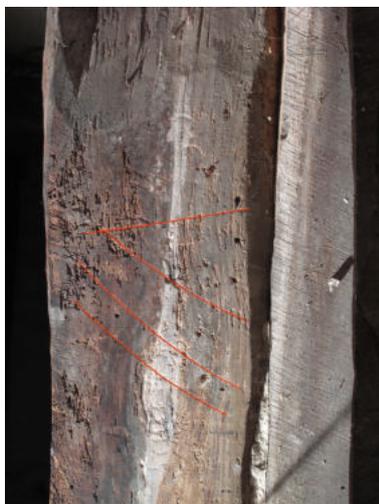
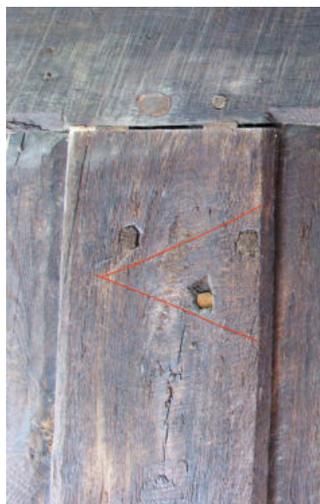
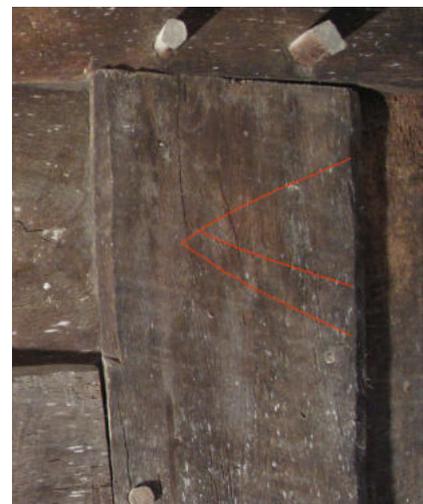
Carpenters' marks on partitions on ground and first floors for comparison. The carpenter, John Price, working on the ground floor partitions astutely recognised the significance of the scratch-marks as sequential numerals, which led to the realisation of very similar marks on the first floor lateral screen.

lateral partition, first floor

west partition, ground floor

east partition, ground floor

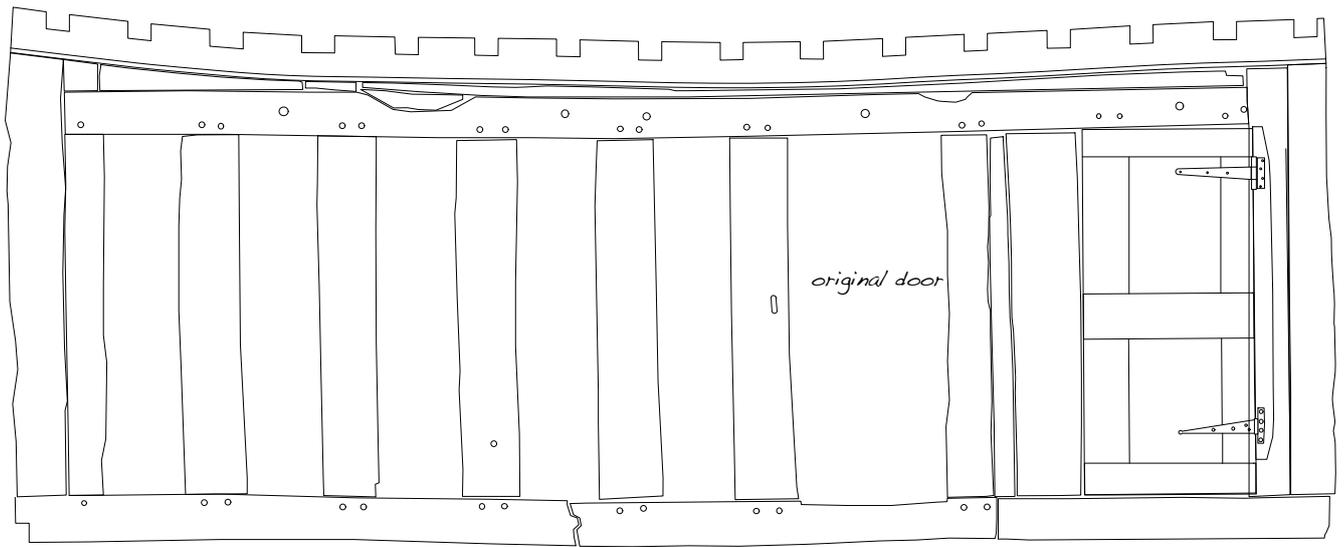
○ Bryn yr Odyn, first floor lateral partition

Scale drawings of the lateral partition and perpendicular partition on the first floor. The boards are not chamfered; the perpendicular partition has reeded embellishment on the edges

profile of lateral partition where it is joined by the perpendicular partition

joists resting on partition beam and fourth beam

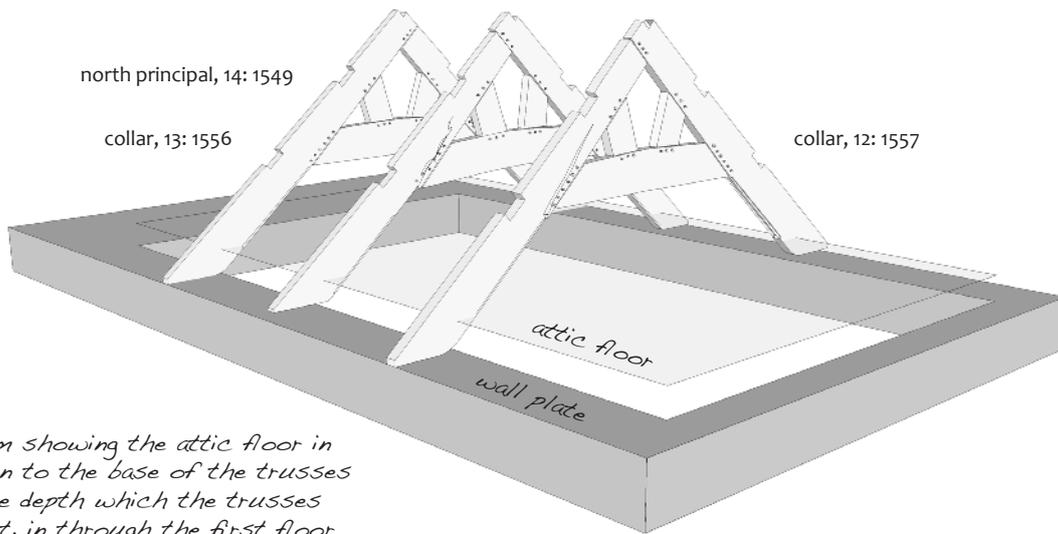
Diagram showing the attic floor in relation to the base of the trusses and the depth which the trusses project, in through the first floor ceiling. The distance between the attic floor and the wall plate is about 300 mm.

The trusses, at present, project 330 mm. below the attic surface, approximately the depth of the ceiling beams.

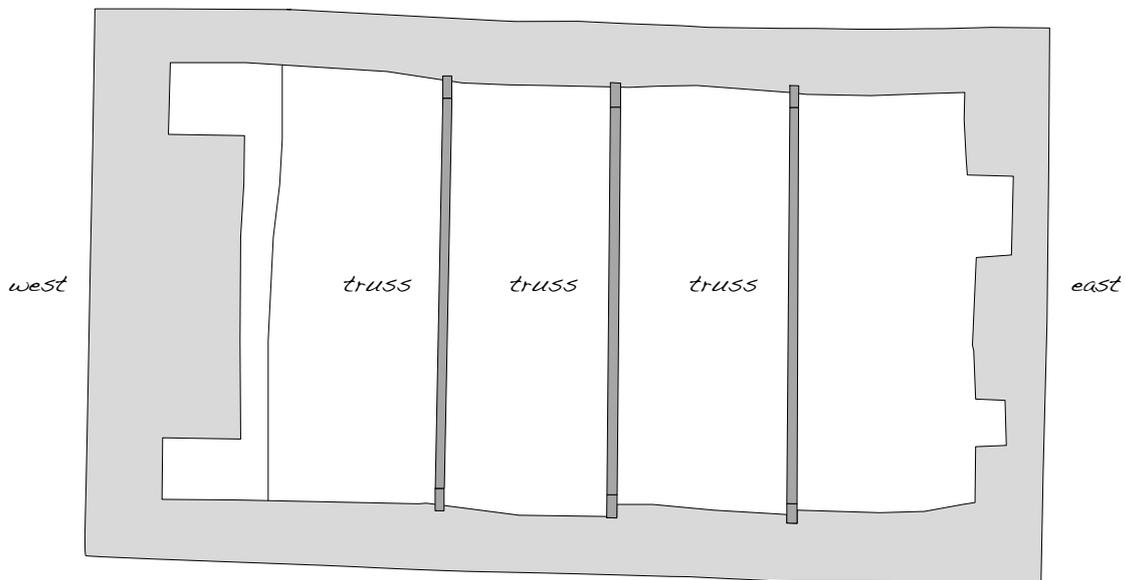
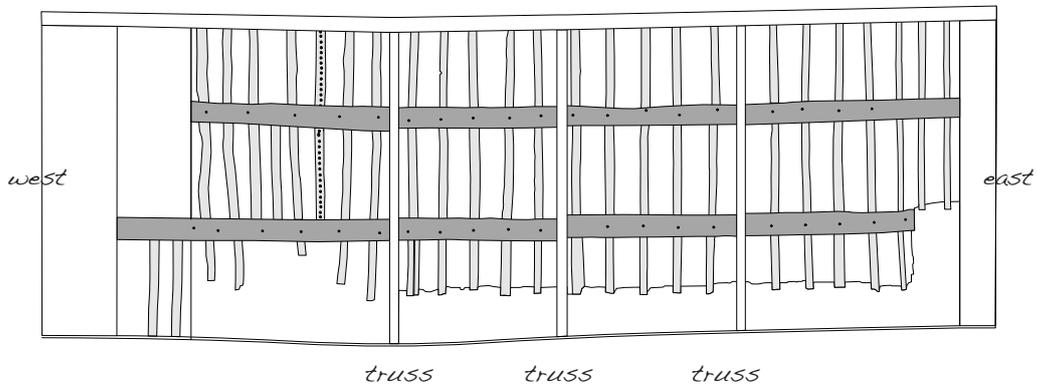
Exploded view of the north side of the roof showing pegged purlins and rafters. The grouping of the rafters in the western bay, out of line with the purlin peg-holes and the introduction of a dowelled rail is a product of the attachment of the roof of the kitchen wing

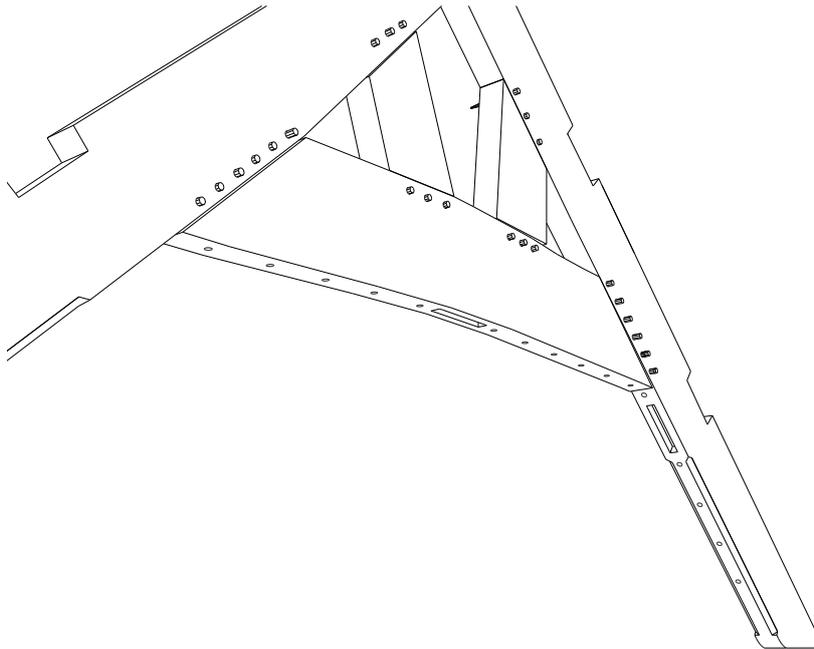
Mortices and staff holes beneath the collar of the central truss. They were intended to be blocked with wattle and plastered but arrangement may not have been implemented.

The central truss has mortices at the underside of the collar and at the underside of each principal below the collar. One each side of the mortices there are dowel or staff holes. This can only have been meant to attach studs to a beam below while the staves and wattle filled in the spaces.

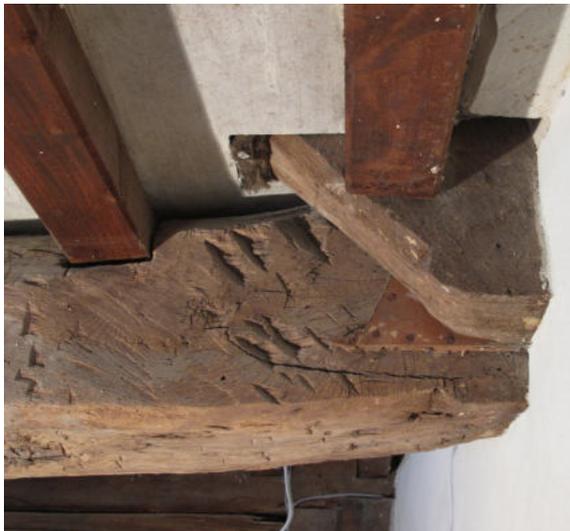
The base of the eastern truss, on the north side is visible below the first floor ceiling/attic floor adjacent to the second beam from the east.

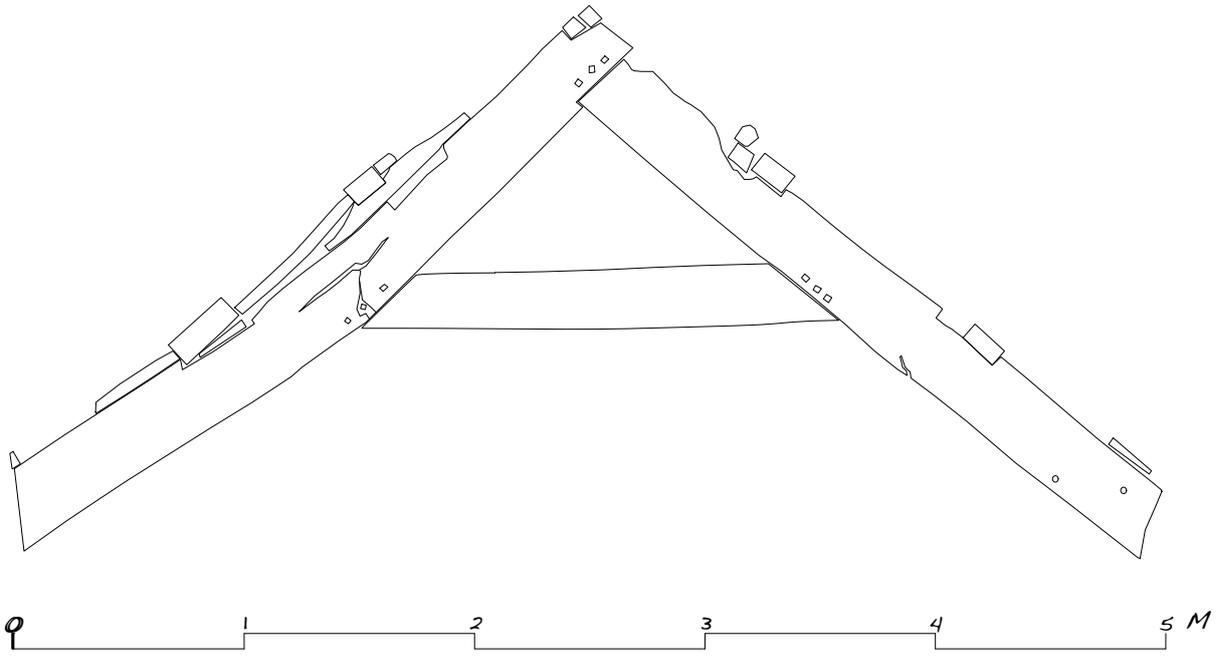
○ *Bryn yr Odyn kitchen truss*
Scale: 1:33

The main feature of the room is the large single collar beam truss which stands centrally within the roof space. The principals rest on the wall plates at 1.3 m. above the first floor on the west side and 1.4 m. on the east. The ridge is 3.7 m. above the floor. The north principal has a tension fracture causing some splaying on that side. Several modifications and repairs have been made. The purlins are not all original, not quite in the right place and have been lifted by chocks on the west side. At least two different sets of beams have been used as purlins. The upper row on the west side, comprise two beams, scarf-jointed. The purlin on the south may be original, with peg holes for rafters. The northern purlin has clearly been removed from another location. It carries a row of mortices which suggest an original use in supporting joists. The lower row also comprises a mixture of mortice beams and pegged purlins but in the opposite order. The purlins on the eastern principal may be original.

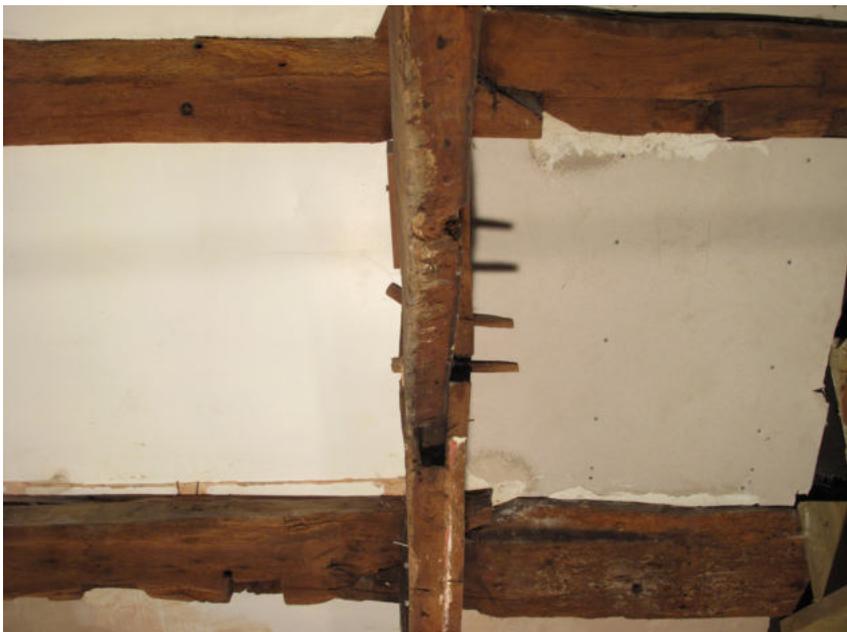
Purlins on west side of kitchen truss principal. The purlins are scarfed at the principal with a mixture of peg-hole beams and re-used trenched, morticed, beams
