North West Wales Dendrochronology Project Plas y Ddualt, Maentwrog, Gwynedd

**EAS Client Report 2011/16
September 2011**

**North West Wales Dendrochronology Project
Plas y Dduallt, Maentwrog,
Gwynedd**

Plas y Dduallt

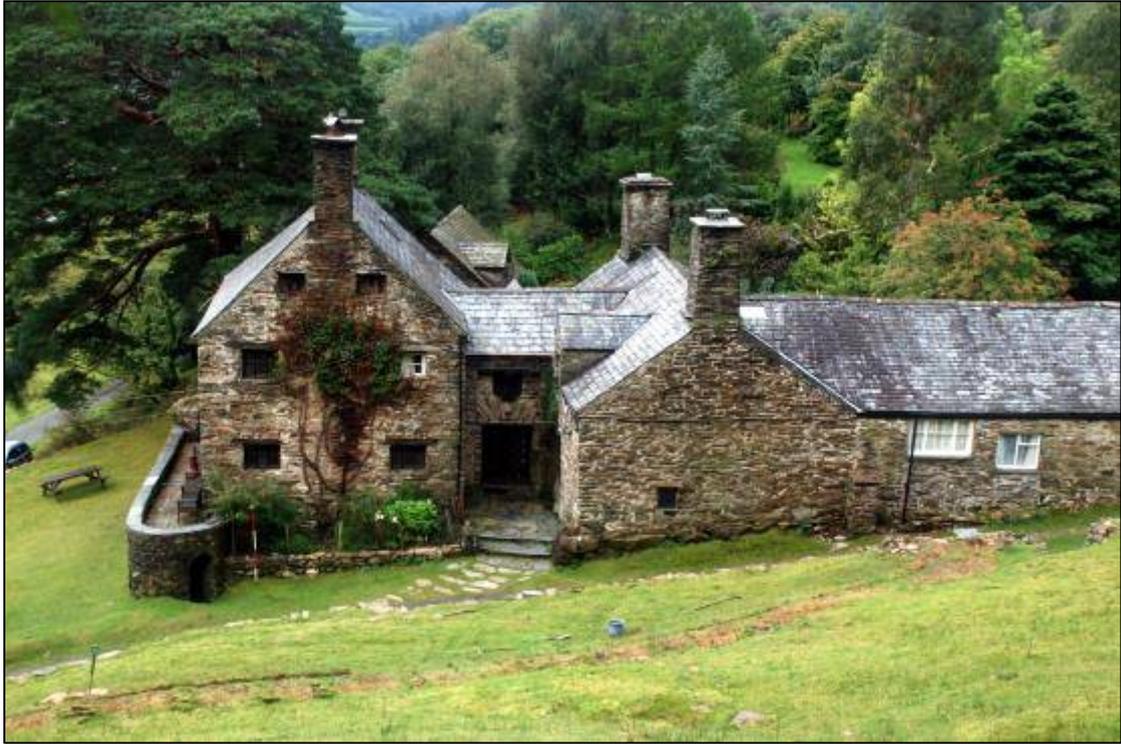
Plate 1: General view of Plas y Dduallt

The core of the house has two parallel wings linked with a storey and a half lobby (Plate 1). To this is attached an agricultural wing to the north, a kitchen to the west and a cellar extension to the south. The southern wing is a two and a half storey building aligned approximately north-east to south-west. Constructed of poorly coursed stone, it has two, stone built, gable end chimneys and a slate roof with ceramic ridge tiles. The north eastern elevation has two windows on each storey (Plate 2). Three of the windows on the first two floors match with heavy wooden mullions and transoms, whilst the fourth is a modern replacement. Those windows in the attic space have plain, diamond, wooden mullions. The south eastern elevation sits over the later cellar extension (Plate 3). It has two centrally placed windows which have three lights separated by wooden mullions. The lower window has a stone hood mould. There is also a doorway with an arched head and small stone

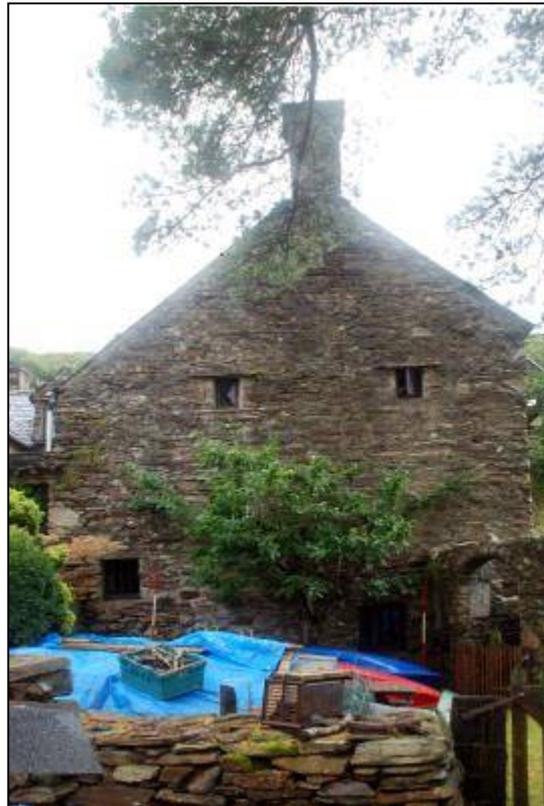
Plate 4: The south western elevation of the southern range

voussoirs, but no keystone. Below the main house is an extension to the cellar of poorly coursed slabby construction with mock arrow slot windows. The south western elevation (Plate 4) has a single window lighting the cellar, another for the ground floor and two lighting the first floor. All of the windows are relatively small in size, particularly those giving light to the first and ground floors. The ground floor window has a series of wooden mullions as does the cellar window, whilst the first floor windows are single pane casement windows with leaded lights

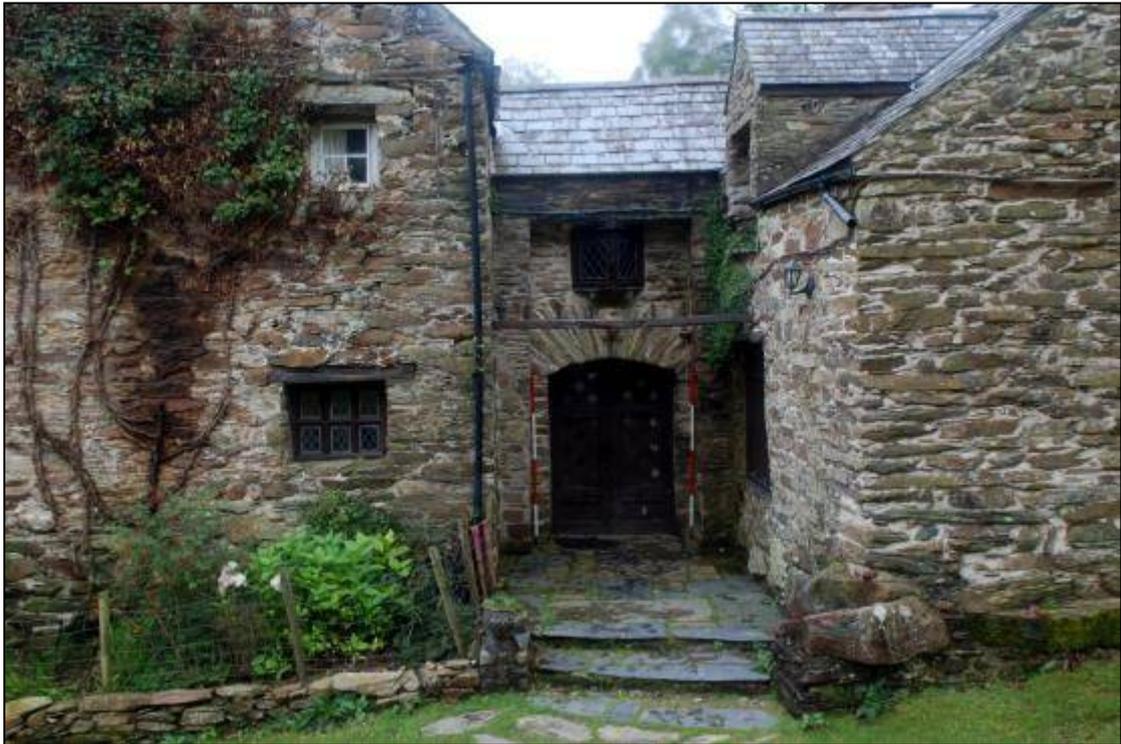
Plate 5: The front elevation of the lobby

The lobby has double door under a depressed arched with stone voussoirs (Plate 5). Above this is a triangular planned, oriel window with leaded lights. The rear elevation has a single six pane window with leaded lights on the ground floor and dormer with a two pane leaded window (Plate 6).

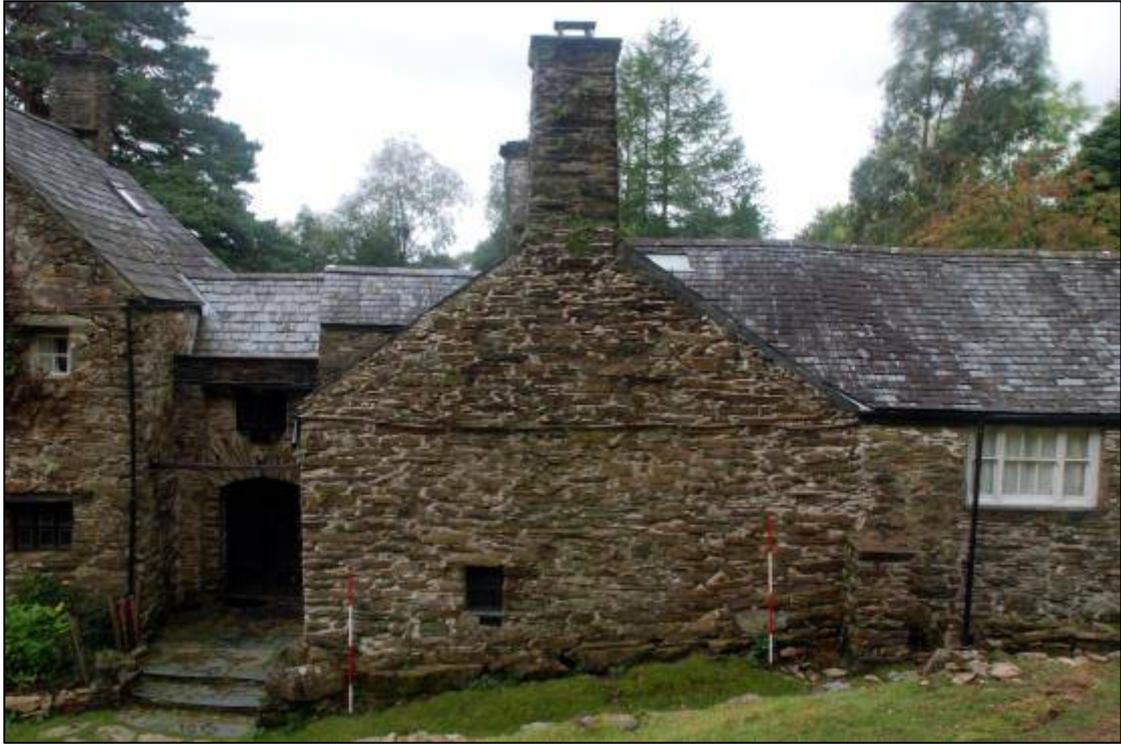
Plate 7: The front elevation of the northern range.

The northern wing is a storey and a half block with gable end chimneys and a slate roof with ceramic ridge tiles. It is constructed of slabby stone blocks, roughly coursed, with no emphasis at the quoins. The front elevation (Plate 7) has a single small window set low on the ground floor below which is a letter-box. There is a straight joint to the agricultural range to the north west and a later, small buttress, which obscures the base of this joint. The south eastern elevation (Plate 8) has a large window with six, leaded panes on the ground floor, adjacent to the front door. Above is a smaller, three pane window within a dormer. Both of the windows have wooden mullions and the lower window also has a wooden transom. At the north eastern foot of the wall there is a large rounded boulder with a series of small slabby stones which is distinct from the construction style of the main wall. Whilst it is possible that this is part of the foundations of the house it appears to be distinct and therefore may hint at an earlier structure.

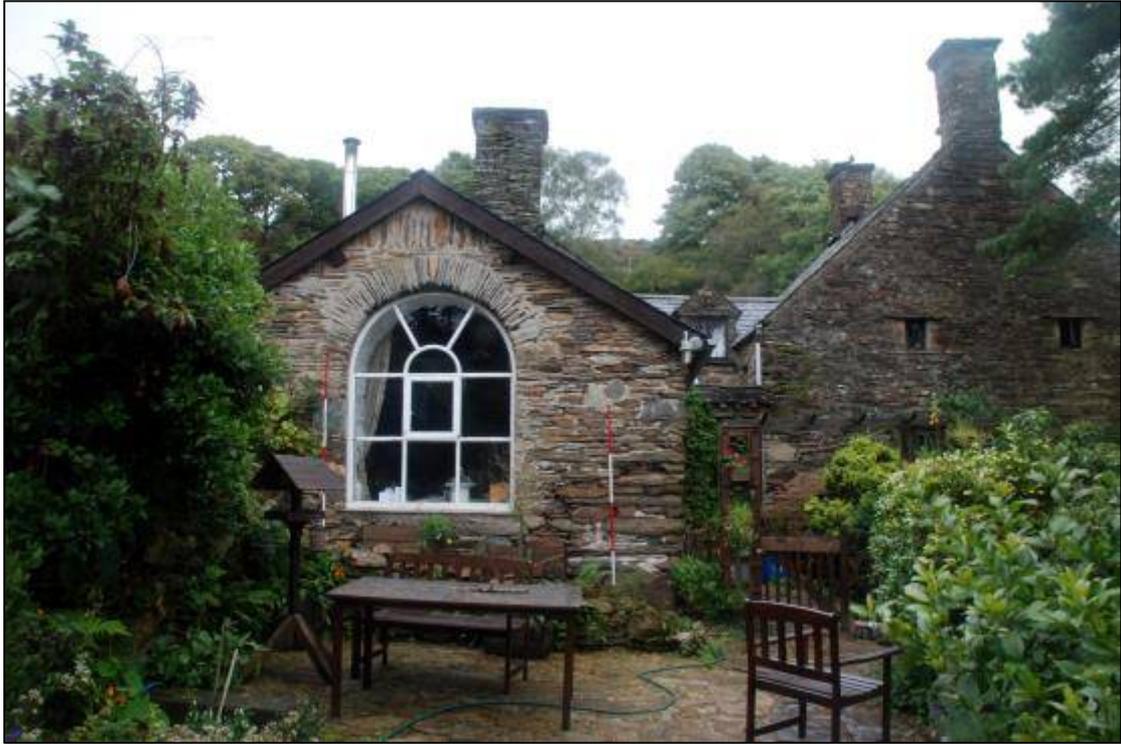
Plate 9: The kitchen extension

To the rear of the northern range, there is a later, kitchen range (Plate 9). This is constructed of roughly coursed stonework. There is a change in the stonework on the rear wall which is associated with the large, arched window. The later stonework is of smaller stones and its position, and relationship to the earlier stonework, suggests that much of the gable end has been replaced.

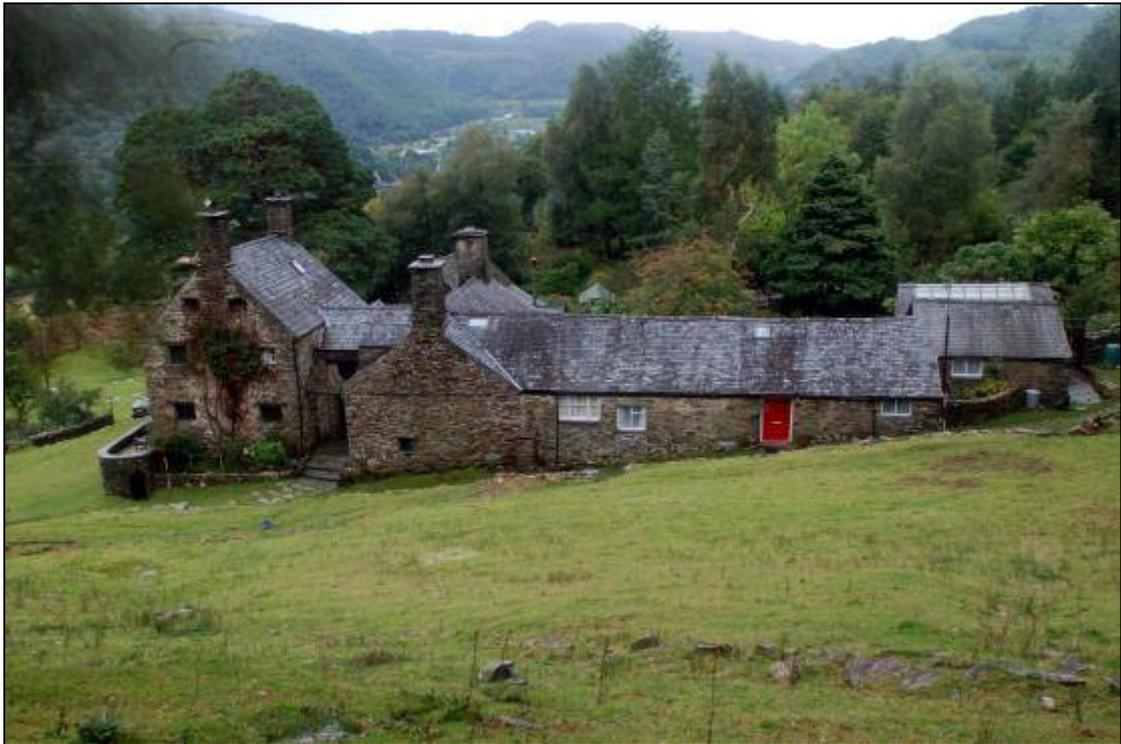
Plate 10: The agricultural range

The agricultural range (Plate 10) has been largely converted into holiday accommodation, although access to the first floor rooms of the northern range is via the south eastern end of the agricultural range. The converted section of the agricultural range is not part of this study.

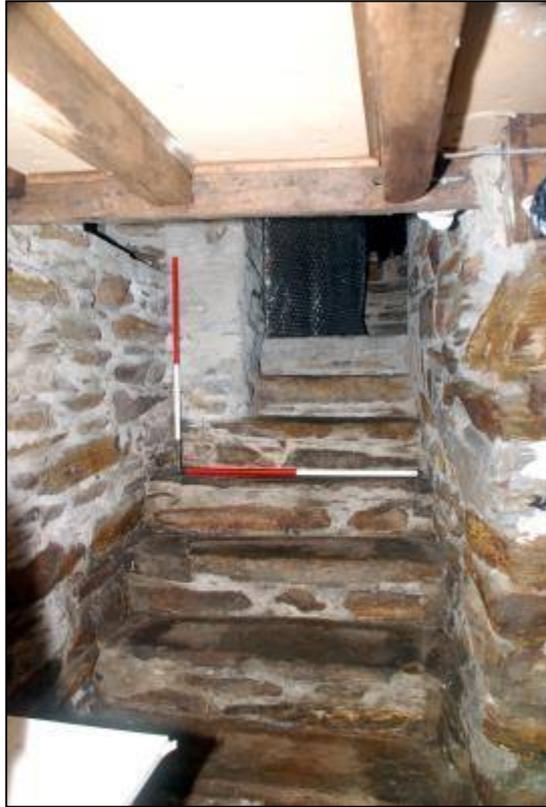
Plate 11: The cellar steps

Inside; the southern range has a cellar (Figure 3), ground floor parlour, first floor and attic bedrooms. The cellar is accessed from the lobby via a straight flight of stone steps (Plate 11) and had two windows in the south eastern wall. One gives light to the cellar head at ground floor level, whilst the other lights the main body of the cellar. There are two elements to the cellar, the main body and a passageway along the north eastern side. The main body of the cellar appears to be original and has the timberwork for the floor of the parlour above exposed (Plate 12). The main beam whilst embedded in the wall at its north western end is supported by a stone corbel at the south eastern end (Plate 13). The passageway is clearly later in date. It is accessed from the

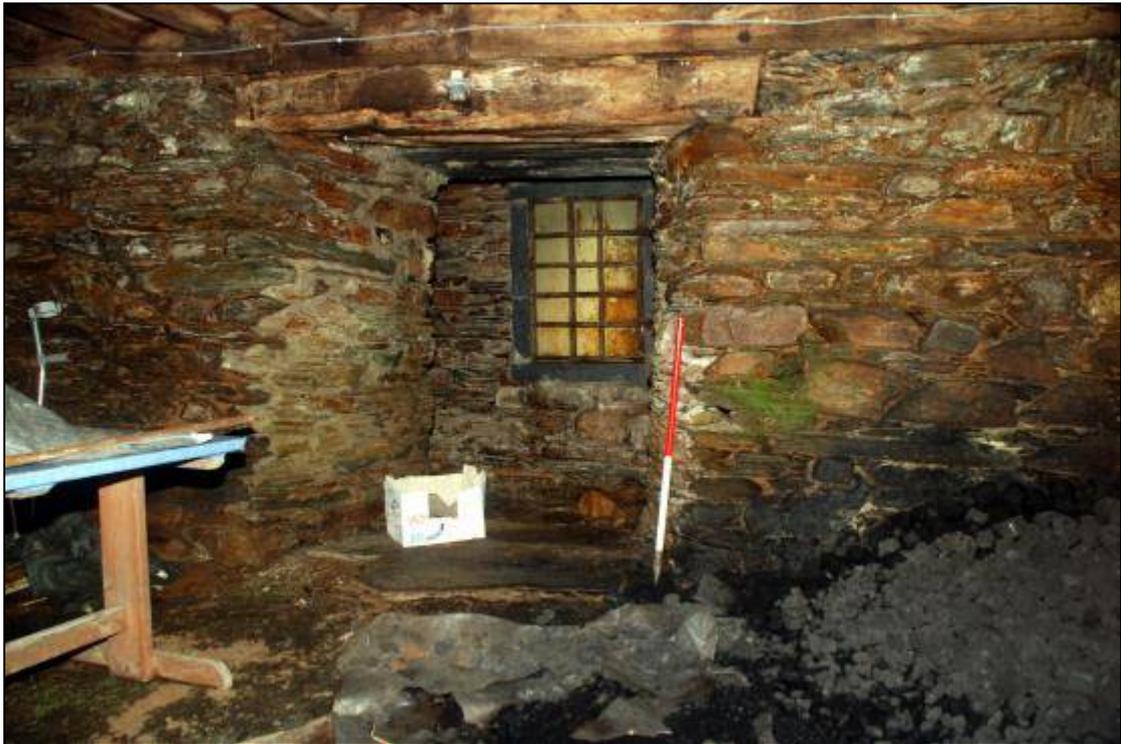
Plate 14: The “doorway” between the two cellars

main cellar via a splayed doorway (Plate 14) cut through the main cellar wall. The passage (Plate 15) leads to an external doorway and has a series of splayed, narrow slot type windows.

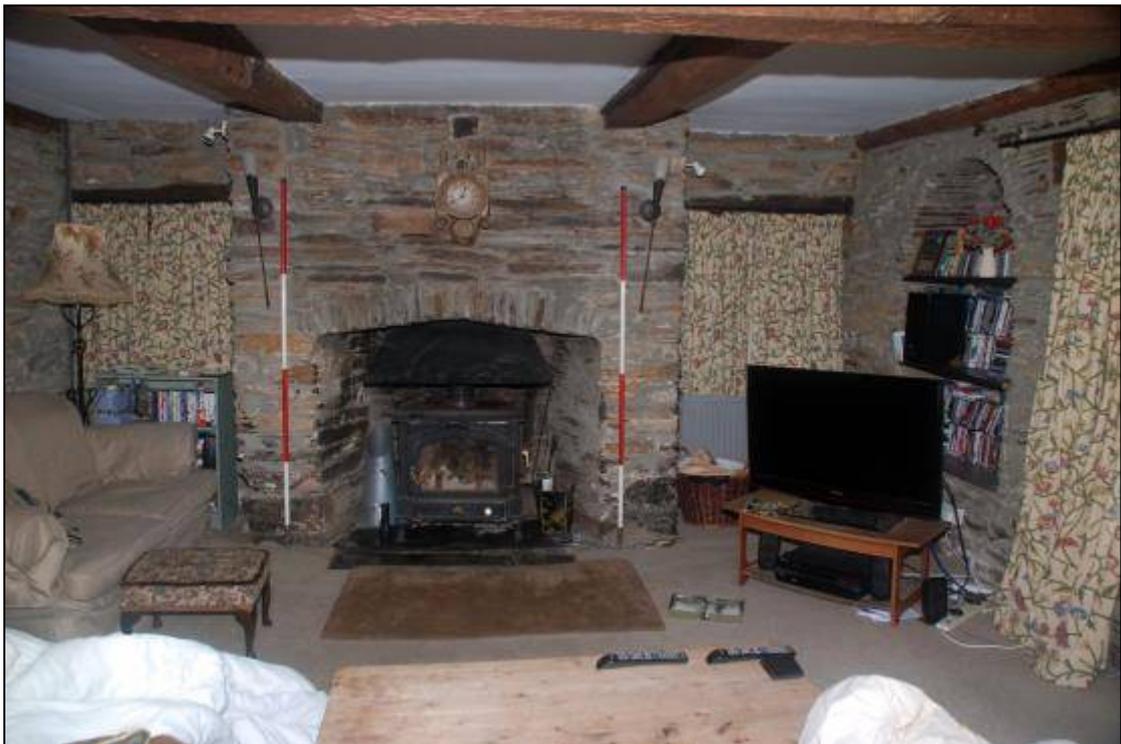
Plate 16: The chimney breast in the parlour

The parlour (Figure 4) has a stone built chimney breast at the north western end of the room (Plate 16). The ceiling has a main lateral beam and two longitudinal beams, but no joists. All of the beams are chamfered and stopped with straight cut stops (Plates 17 and 18). There is evidence, however that there were joists in the south eastern end of the room (Plate 19), but these have since been removed. There is also evidence that there was a partition below the western end of the northern longitudinal beam with a series of mortice holes on the underside of this beam (Plate 20). The western end of the longitudinal beam is supported by a corbelled support (Plate 21) consisting of a large stone beam supported by three corbelled blocks. On the north western wall there are two doorways, with arched doorheads formed with stone voussoirs with no keystone, whilst one of which gives access to the lobby, the other gives access to a stone stair case (Plate 22). The south eastern window frame has a series of graffiti on both the cill and mullion. On the mullion there are a series of initials above a daisy wheel (Plate 23). The initials are "I LL", below which is the letter "W" with a horizontal line. Below this is "RH II" and then an "I". At the bottom of the mullion is a daisy wheel design (Plate 24). On the cill are a scratched shield and the initials "RH II" (Plate 25).

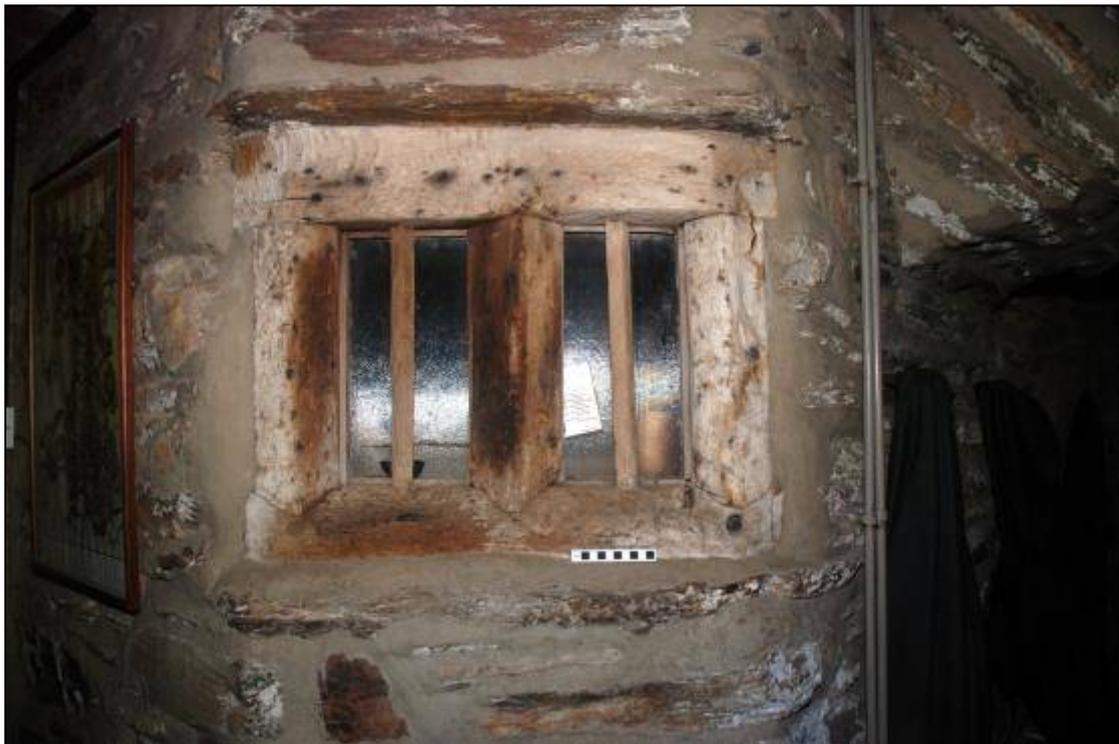
Plate 26: The window between the staircase and the lobby

The staircase has stone steps forming a winder staircase to the first floor. There are two windows lighting the staircase, the lower of which gives light from the lobby. This window has a diamond mullion, glazing stanchions and a heavy frame (Plate 26). The relationship between the parlour block and the lobby is not entirely clear. The lower window of the staircase may suggest that the lobby is a later feature linking the two ranges. If so, the staircase is contained by an external stair tower, however this would mean that the access to the cellar would have been via an external door.

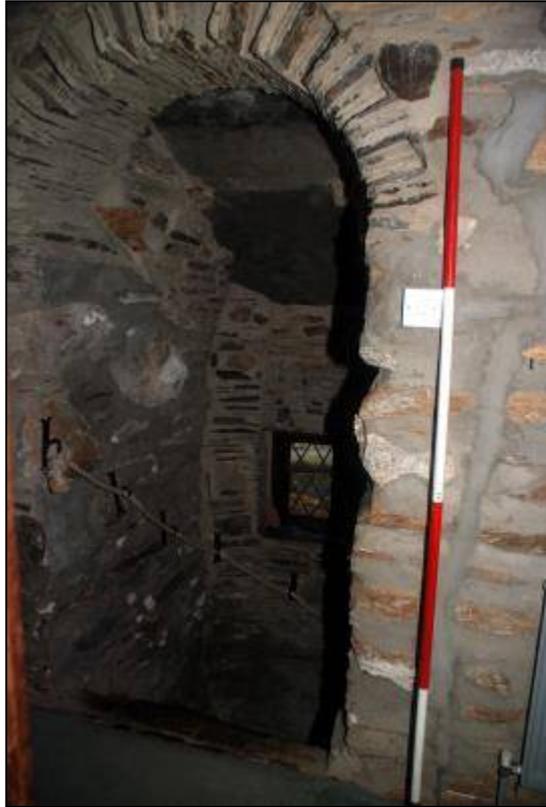
Plate 27: First floor access to the staircase

The staircase reaches the first floor (Figure 5) of the parlour range through an arched opening with stone voussoirs and no keystone (Plate 27). There is a corridor which links to the first floor of the lobby (Plate 28). Off this corridor is a bedroom, the access to attic, a cupboard and a bathroom. The bedroom has a timbered ceiling with two transverse beams supporting a series of joists (Plate 29). Both the joists (Plate 30) and the beams (Plate 31) are chamfered and stopped with straight cut stops. At the south western end of the bedroom, there is a partly blocked fireplace with a carved wooden lintel (Plate 32). This lintel is part of the restoration of the property carried out in the 1960's by Colonel Campbell

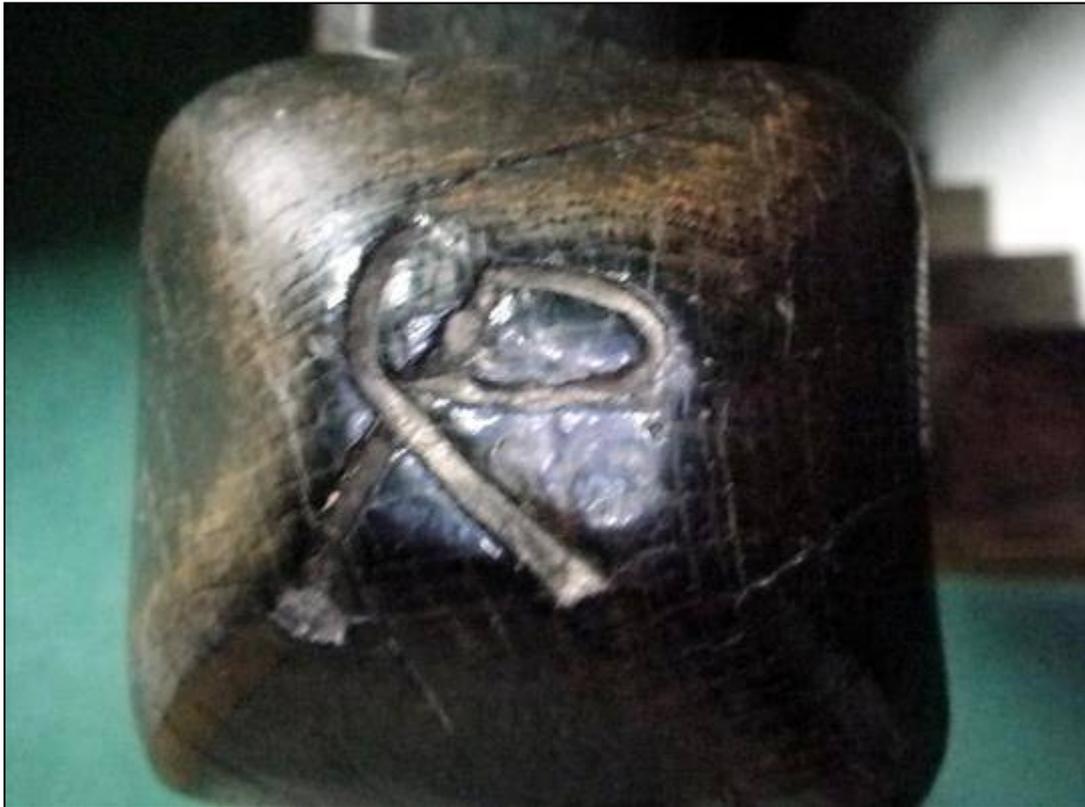
Plate 33: The carving on the cap of the attic newel post

The attic (Figure 6) was accessed by a steep flight of wooden stairs. One of the newel post at the head of the stairs, appears to have a design carved into its cap (Plate 33). This would appear to be two crossed "P" designs. The attic has two trusses (Figures 7 and 8). Both Trusses 1 (Plate 34) and 2 are relatively simple trusses with straight principal rafters which are lapped. Whilst Truss 2 retains its collar, Truss 1 has had the collar removed to allow the space to be used as a bedroom (Plate 35). There are two pairs of purlins which were originally trenched, although there are now packing pieces which

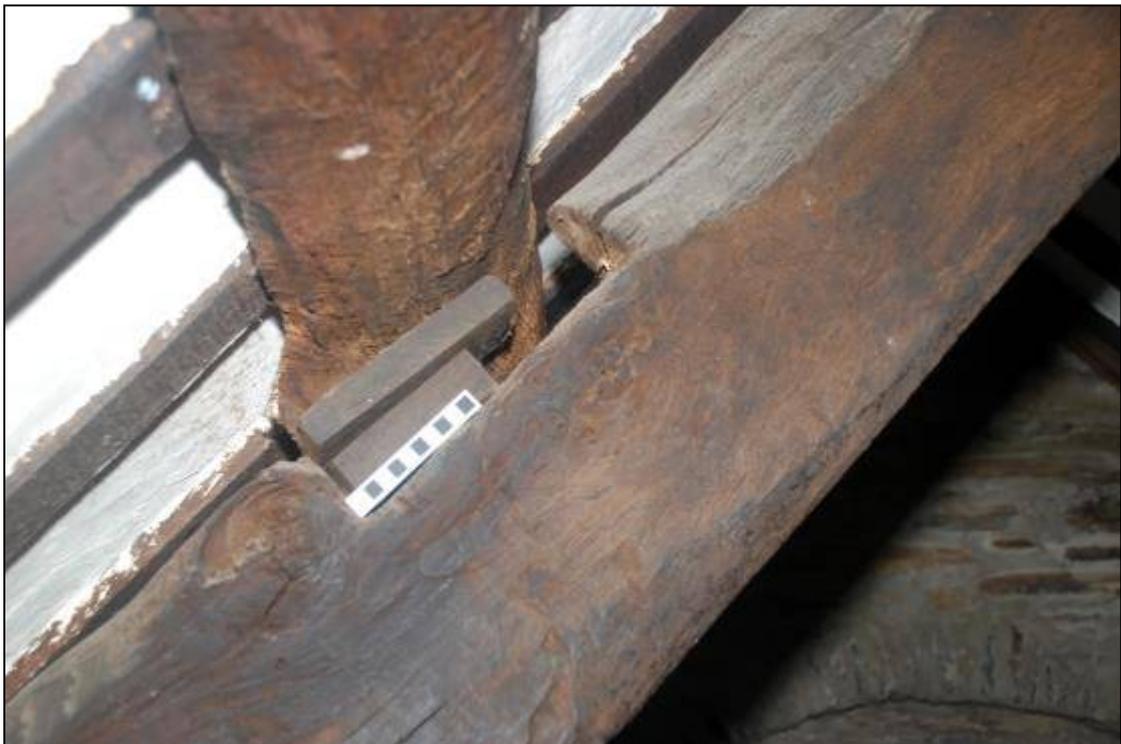
Plate 36: Trenching for the purlin in the attic

have slightly raised the level of the roof (Plate 36). Below Truss 2 there is a partition dividing the attic into a bedroom and a storage area. There is a doorway between the two spaces (Plate 37) which has been clearly added at a later date.

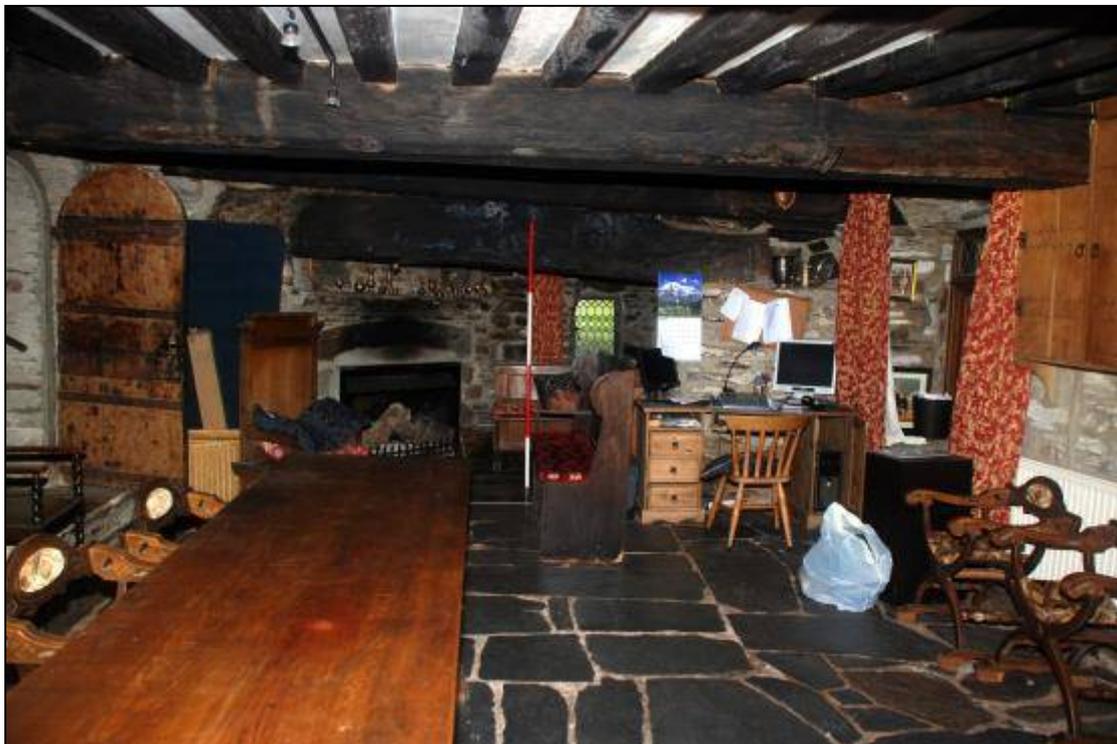
Plate 38: The north eastern end of the hall

The ground floor of the hall block (northern range) consists of a single room with large, partly blocked, hearth at the north eastern end (Plate 38). There is a large bressumer (Plate 39) which defines the extent of the original fireplace. The south western end of the hall (Plate 40) gives access the kitchen. The ceiling has two transverse beams crossing the room together with two further transverse beams at each gable end. The western beam is supported by stone pillars which are slightly corbelled (Plate 41). This beam is slightly lighter than the other transverse beams and may be a replacement. Partly hidden by the end of this beam and largely encased within the walls are vertical timbers which are assumed to be the extensions of the principal rafters for the cruck truss above (Plate 42). The beams are chamfered and have run out stops (Plate 43), whilst the joists are also chamfered and have straight cut stops (Plate 44).
