North West Wales Dendrochronology Project:

Gronant, Holyhead

Report No. 854

March, 2010

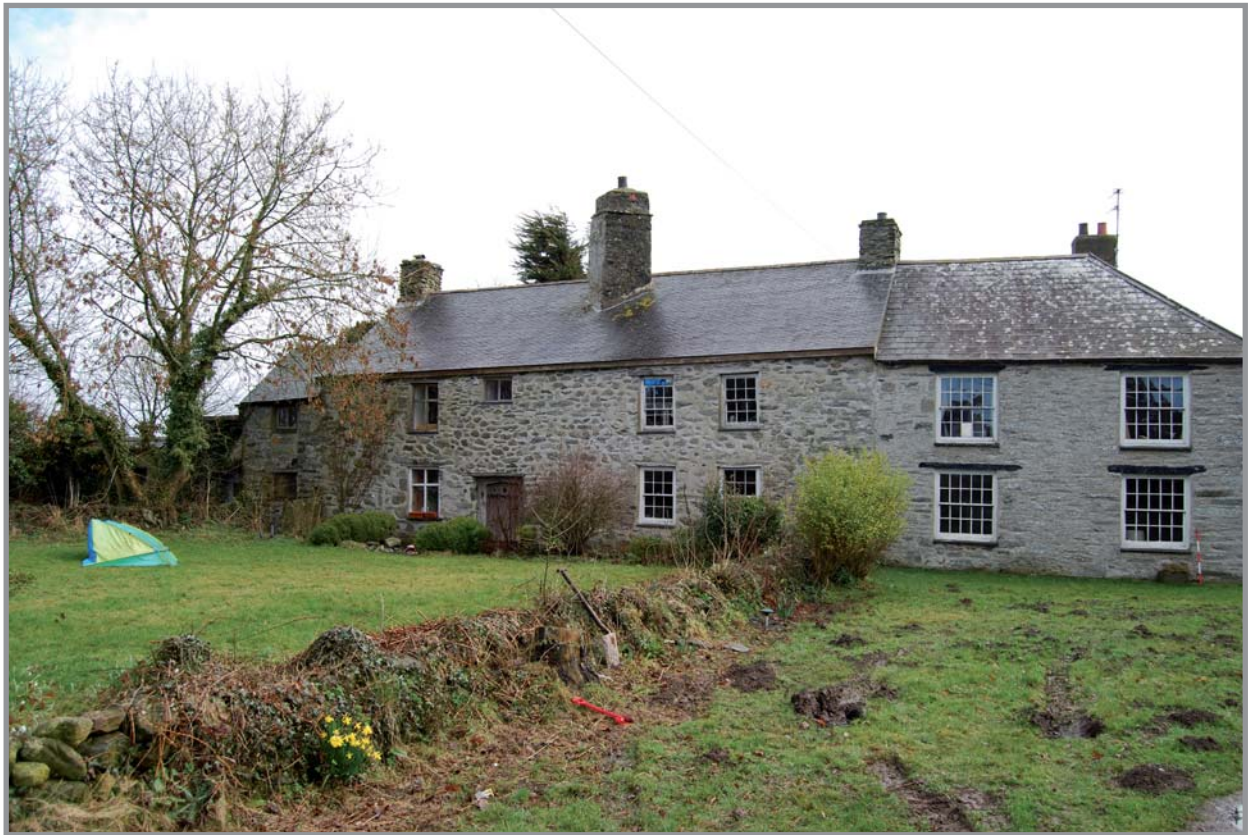
Plate 1: Gronant west facing elevation showing building A to the north and the 19th century infill extension to the south.

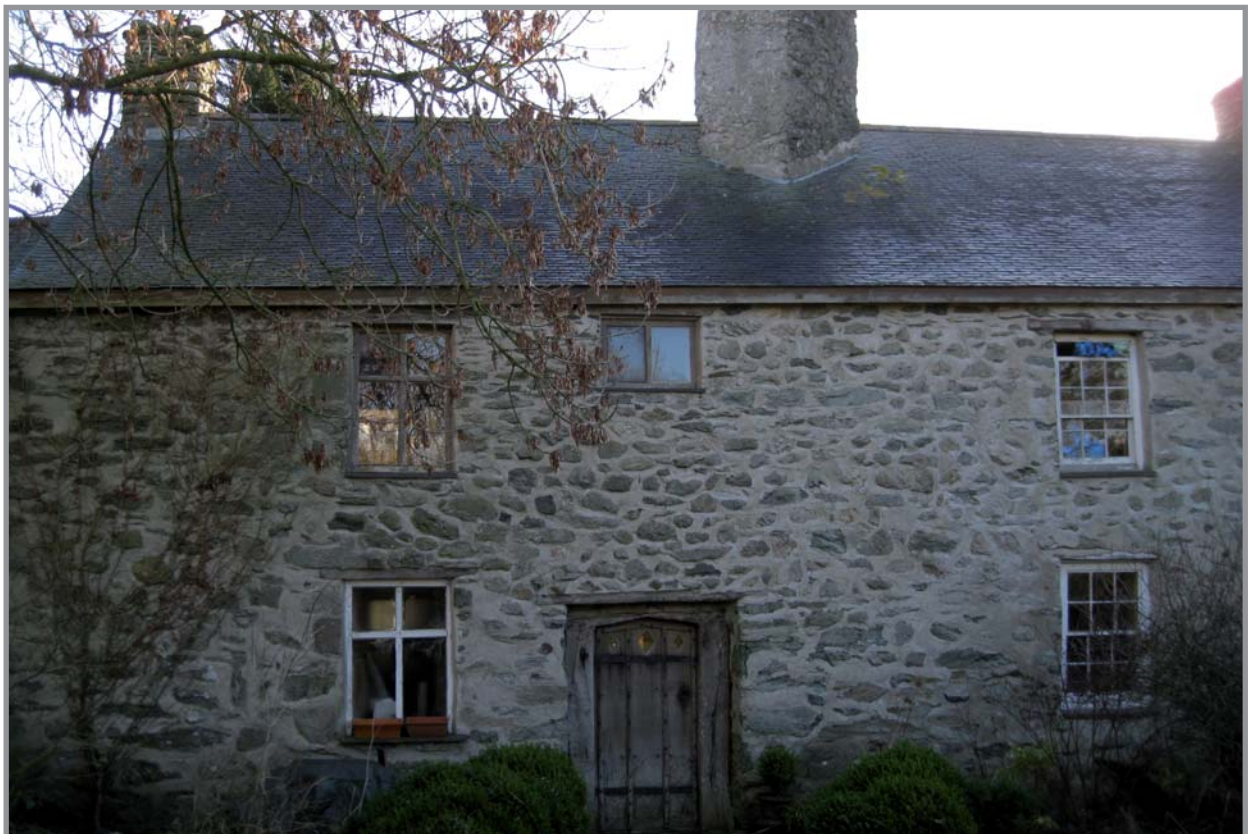
Plate 2: Gronant west facing elevation of building A, showing doorway which leads into the west passage, which retains its original frame supporting a tudor arched lintel

The ground floor interior contains the through passage, hall to south and outer room to north. The interior was largely used for storage, and not all details were visible during the visit. The through passage, however, had the stone wall of the chimney to the south and the remains of a post and panel partition to the north. The west passage doorway retains its original frame, partly repaired, of wooden posts either side supporting a Tudor arched lintel. On the inside is a moulded wooden lintel. Similar moulded lintels can be seen over the west doorway and over the windows in the hall and outer bay.

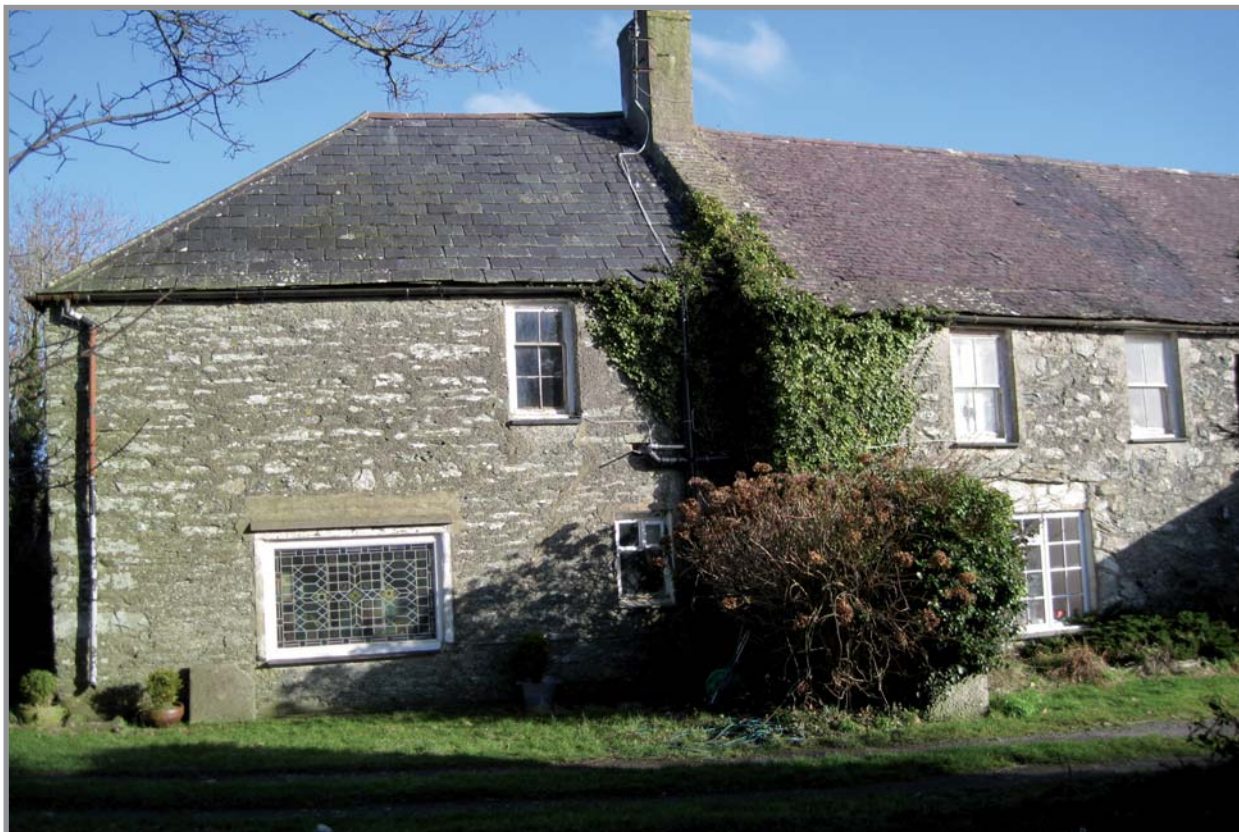
Plate 3: Gronant south facing elevation showing connecting 19th century wing, with re-set stained glass window and building B

The connecting wing, possibly of early 19th century date, links the south gable wall of House A with the west gable wall of House B. The south roof gable is hipped. 20-pane sash windows light the rooms from west, whilst the south elevation contains a horizontal re-set stained glass window. The east elevation has a small 4-pane sash window which lights the stairs, with a pitched-roof bell-tower rising from the wall above. Internally this range is accessible only from House B, though there is a blocked door in House A which would have formerly led into it. The range contains a large west facing room, the stairs to House B and a small lavatory.

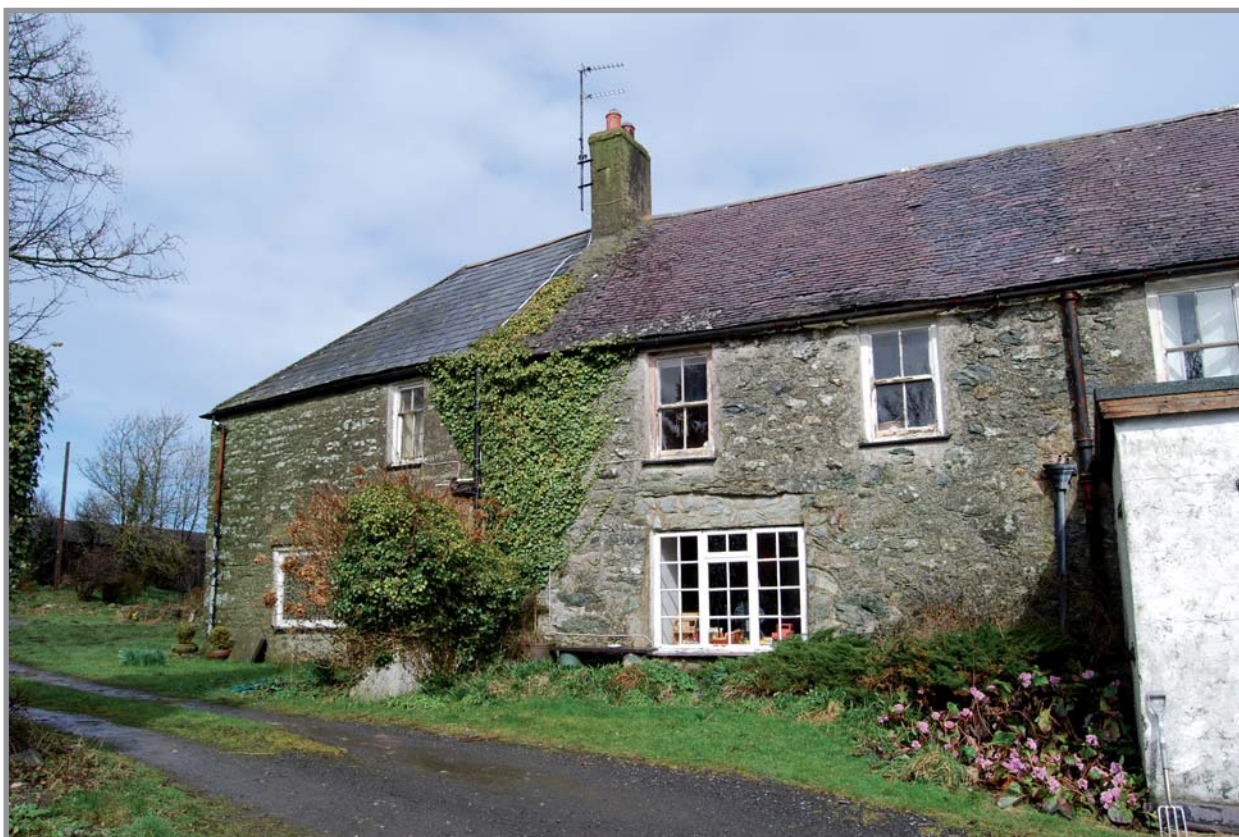
Plate 4: Gronant south facing elevation of building B, showing a large single window on the ground floor and three windows above which are now four-pane sash

The south front has a modern porch in front of an off-set door. To the left is a large single window. Above are three windows, now four-pane sash, all off-set to the left. The north front contains a nearly opposing doorway, a single window east and three windows to the west. Above are four equally spaced four-pane sash windows. Changes in the masonry suggest the window openings are partly a later insertion. On the ground floor the window west of the door was also formerly a door.

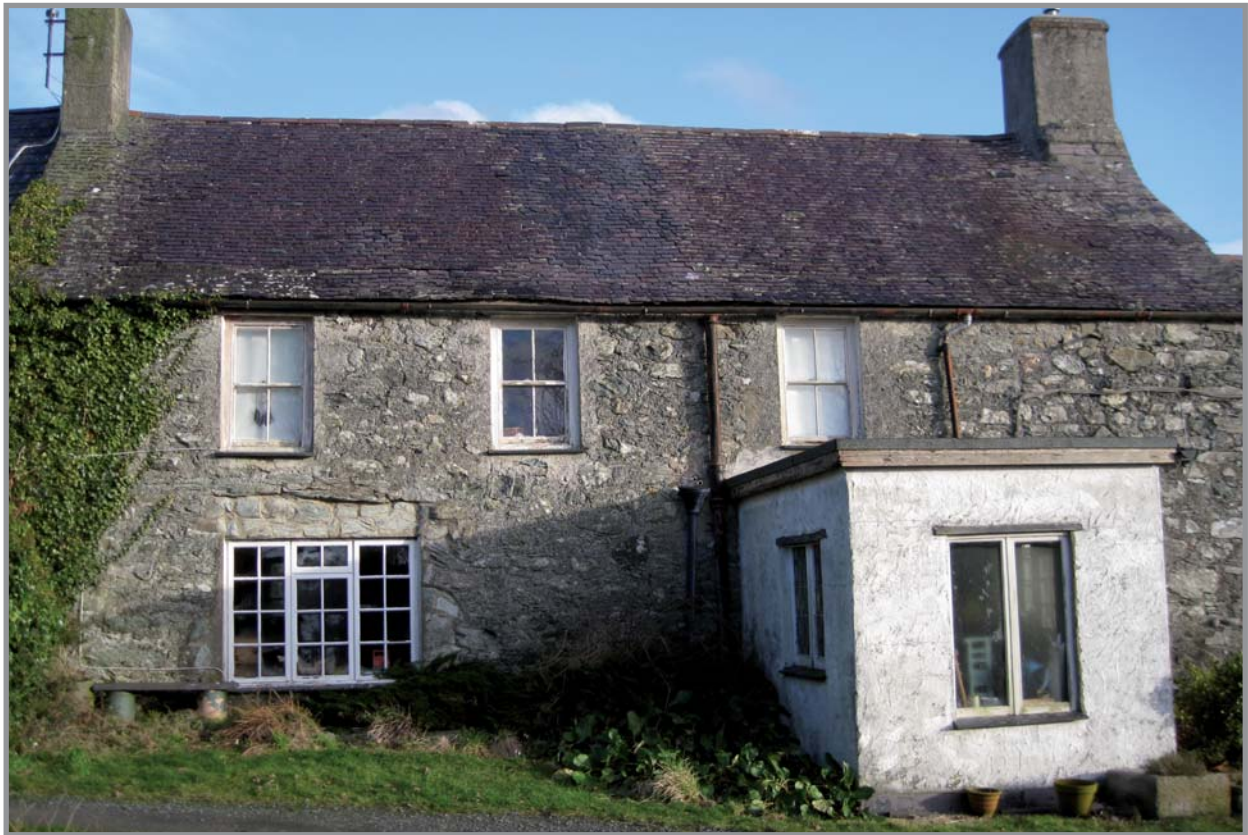
Plate 5: Gronant south facing elevation showing building B and the modern porch

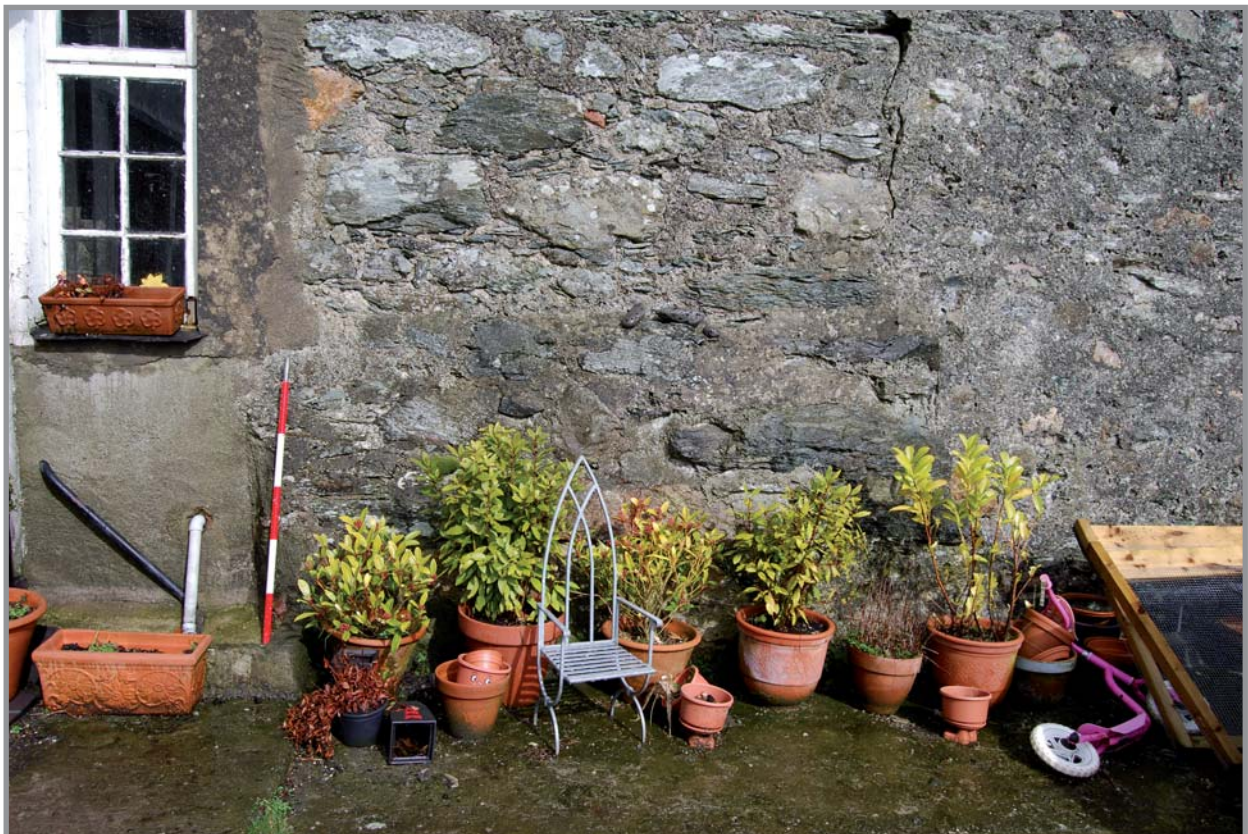
Plate 6: Gronant south facing elevation of building B, showing possible original foundations

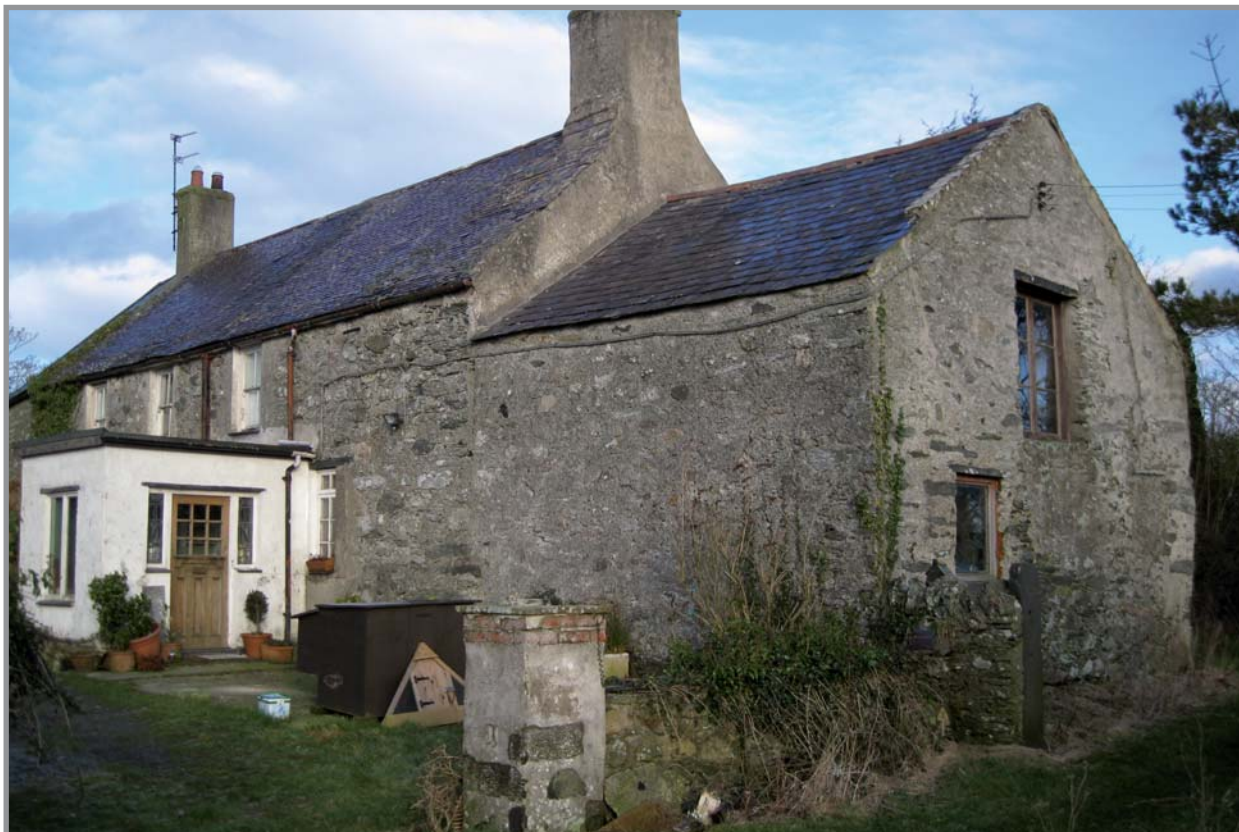
Plate 7: Gronant south facing elevation showing building B and the attached lower former stable and loft

House B lies on an approximate east-west axis, at the south-east corner of House A. On its west end it joins the connecting range, whilst attached to the east gable is a lower former stable and loft, whilst attached to the north side on the east end is another 2-storey extension, a former carriage house and loft.

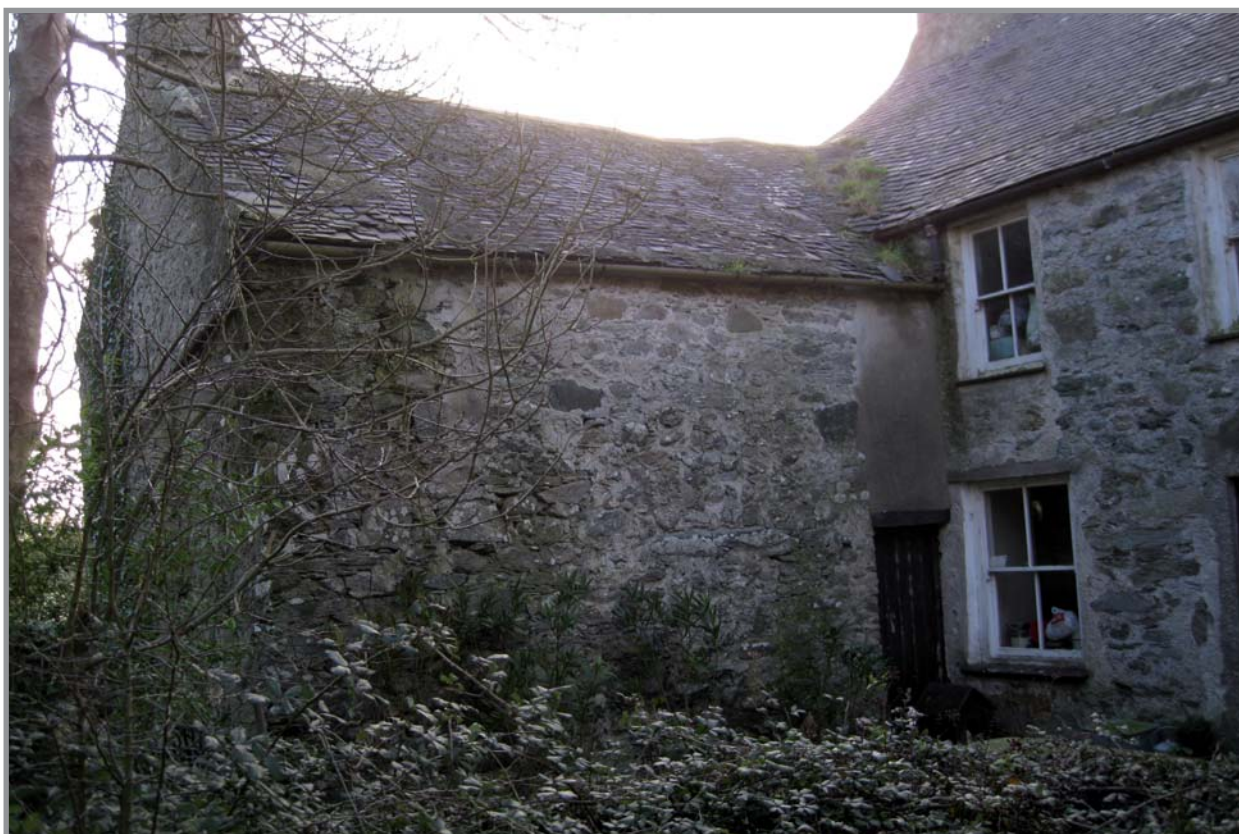
Plate 8: Gronant west facing elevation of building B and the attached 2 storey building

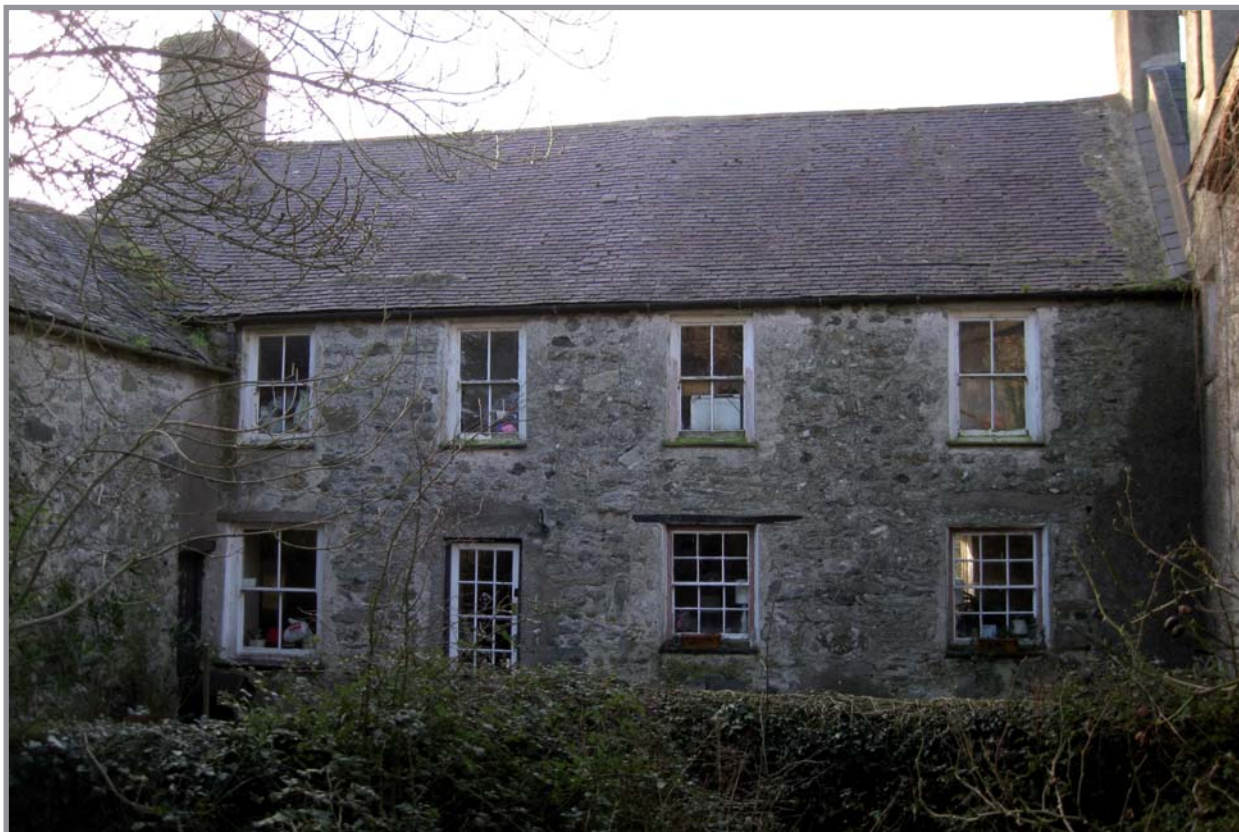
Plate 9: Gronant north facing elevation showing building B with four sash windows on the first floor, two 12-pane windows to the east and a four pane to the west. The change in masonry shows that the window east of the door was once a door

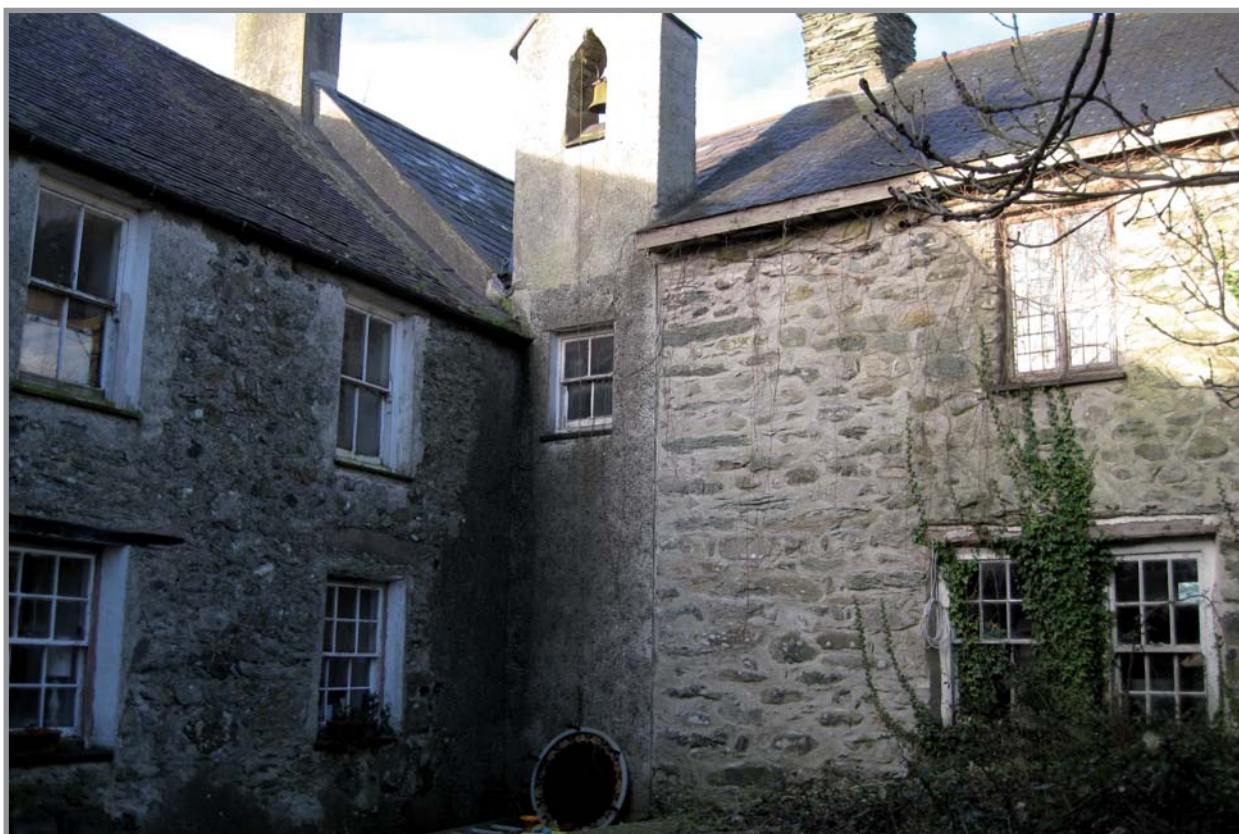
Plate 10: Gronant facing north-east showing building A and B and the 19th century connecting wing bell tower with a small four pane sash window

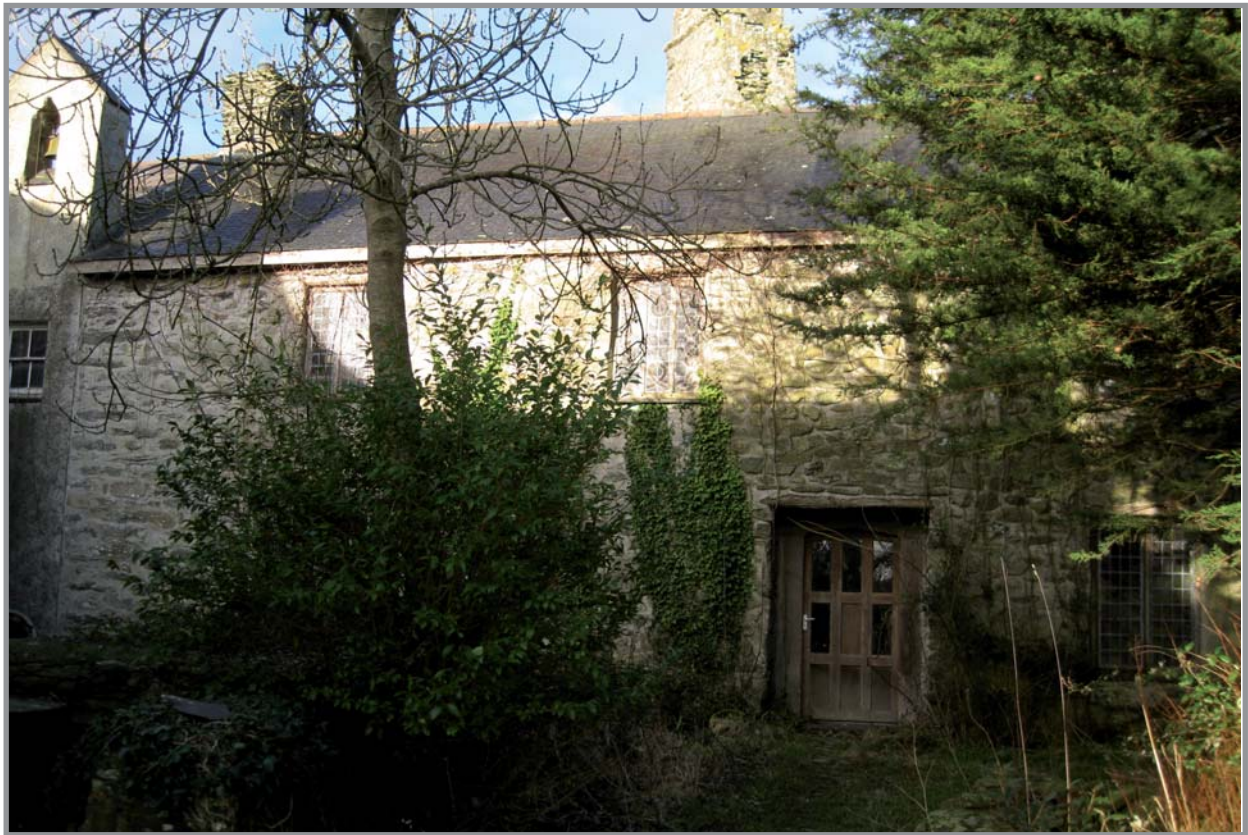
Plate 11: Gronant east facing elevation of building A

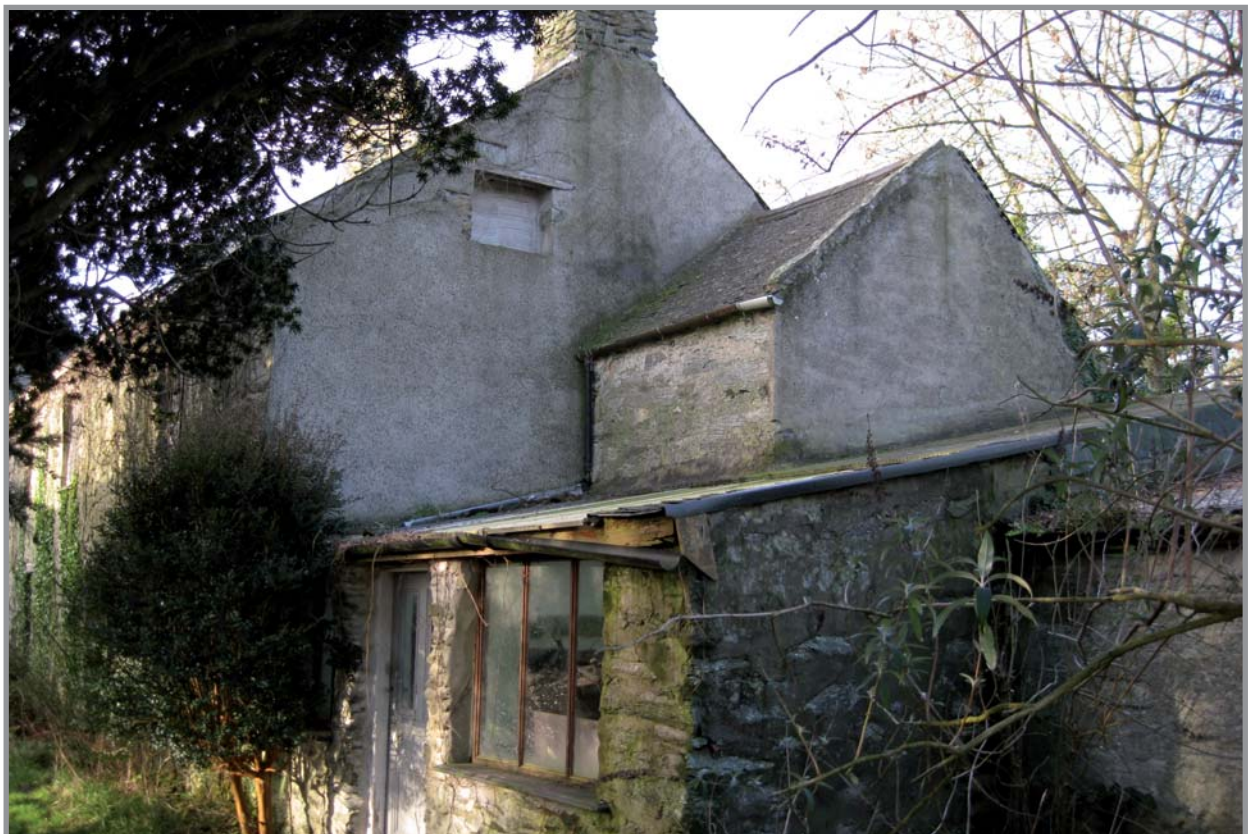
Plate 12: Gronant south-west facing image showing later extensions to building A

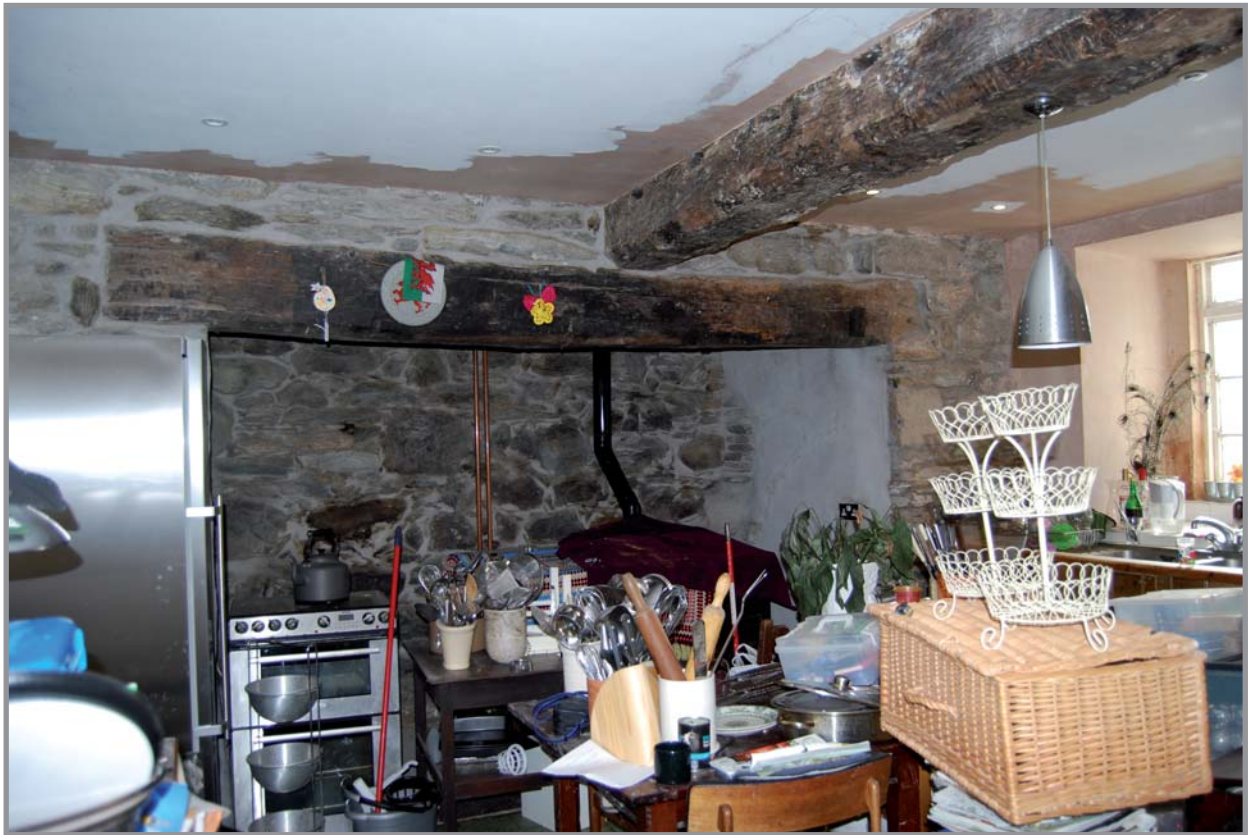
Plate 13: Gronant building B kitchen facing south west showing a large fireplace and axial beam

Internally the house is of two rooms. To the east is a kitchen, and to the west a single large hall. A large square axial beam runs longitudinally from east to west across the two rooms, though it may be two timbers joined within the dividing wall. This supports a later ceiling. A large fireplace occupies the east wall of the kitchen, the chimney supported on a large beam. These are the only two early timbers visible in the house. The west gable wall shows no evidence of an internal fireplace, however the external face (now enclosed by the connecting wing) is some 1.5m wide, and appears to include a chimney which would originally have been external. This is used by a fireplace in the connecting wing.

The principal ceiling beam in the kitchen is chamfered and has clear mortise holes for supporting former joists, though the present joists are supported on top of the beam. There is no evidence of a former partition. The beam in the adjoining room has no similar joist holes – this is also chamfered, and again with no evidence for a screen.

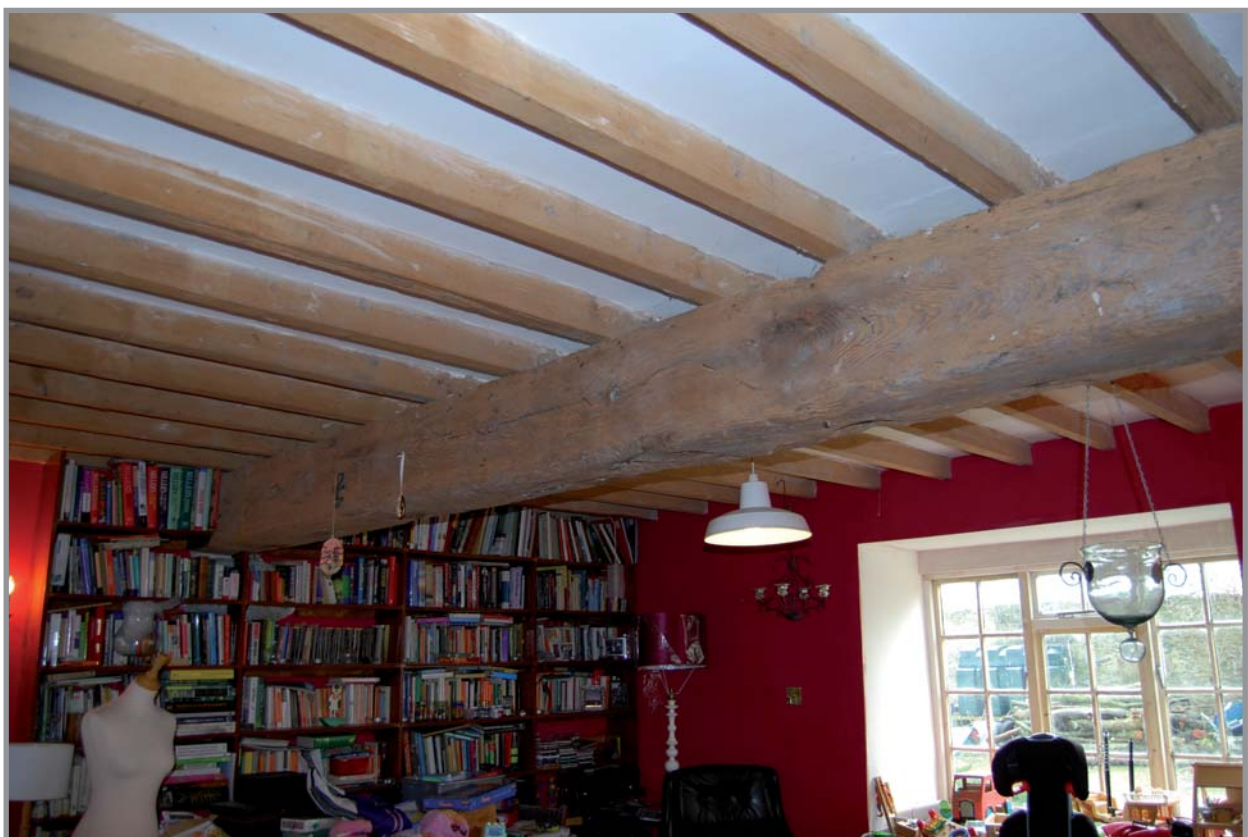
Plate 14: Gronant building B living room facing south west showing the large square axial beam which runs east to west across the entire of building B

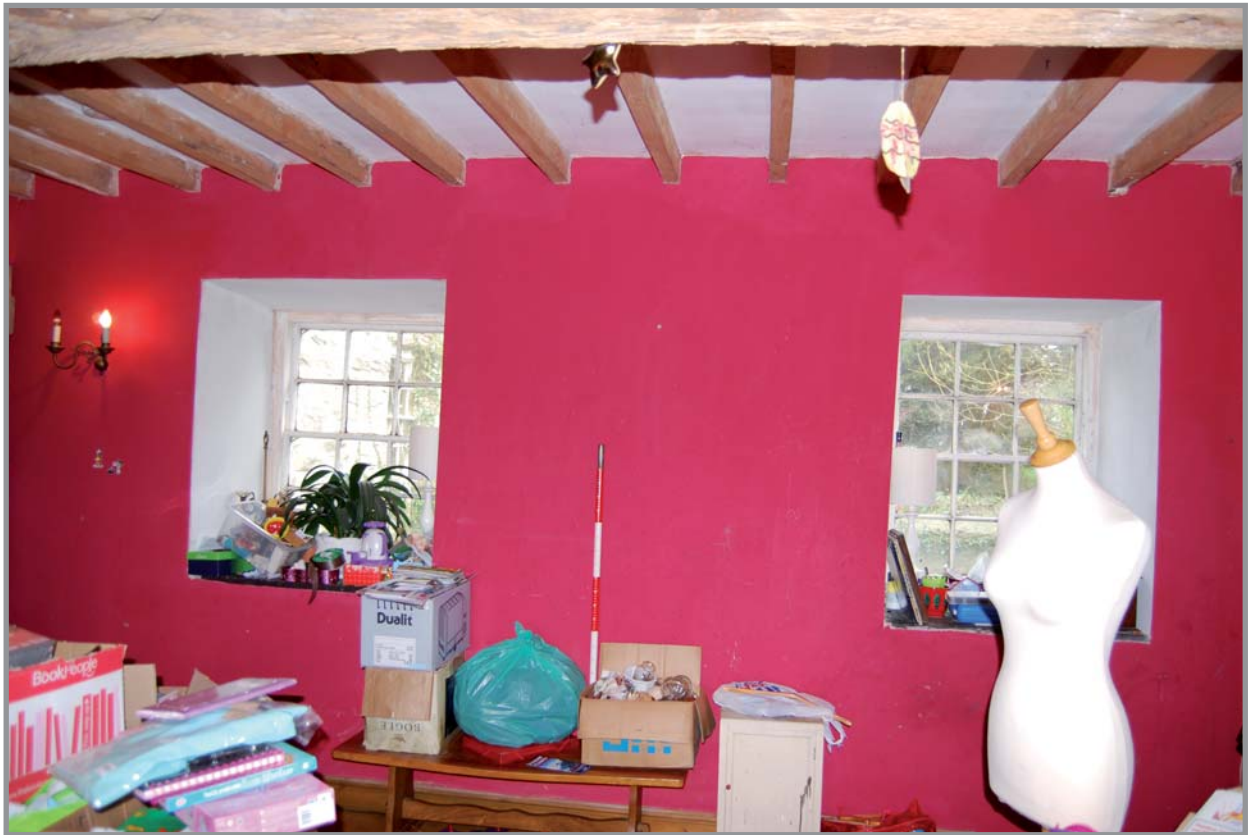
Plate 15: Gronant building B living room facing south showing two 12 pane sash windows

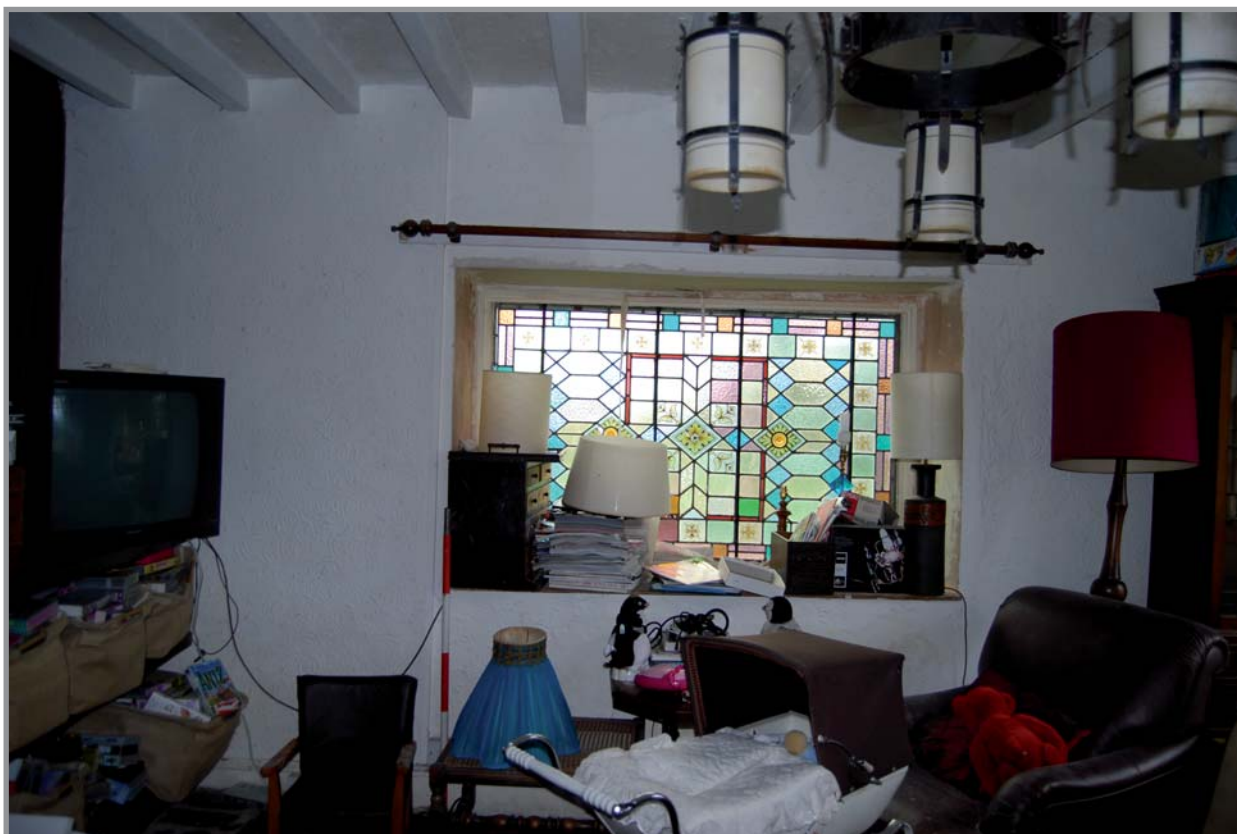
Plate 17: Gronant connecting 19th century wing facing south, showing re-set stained glass window

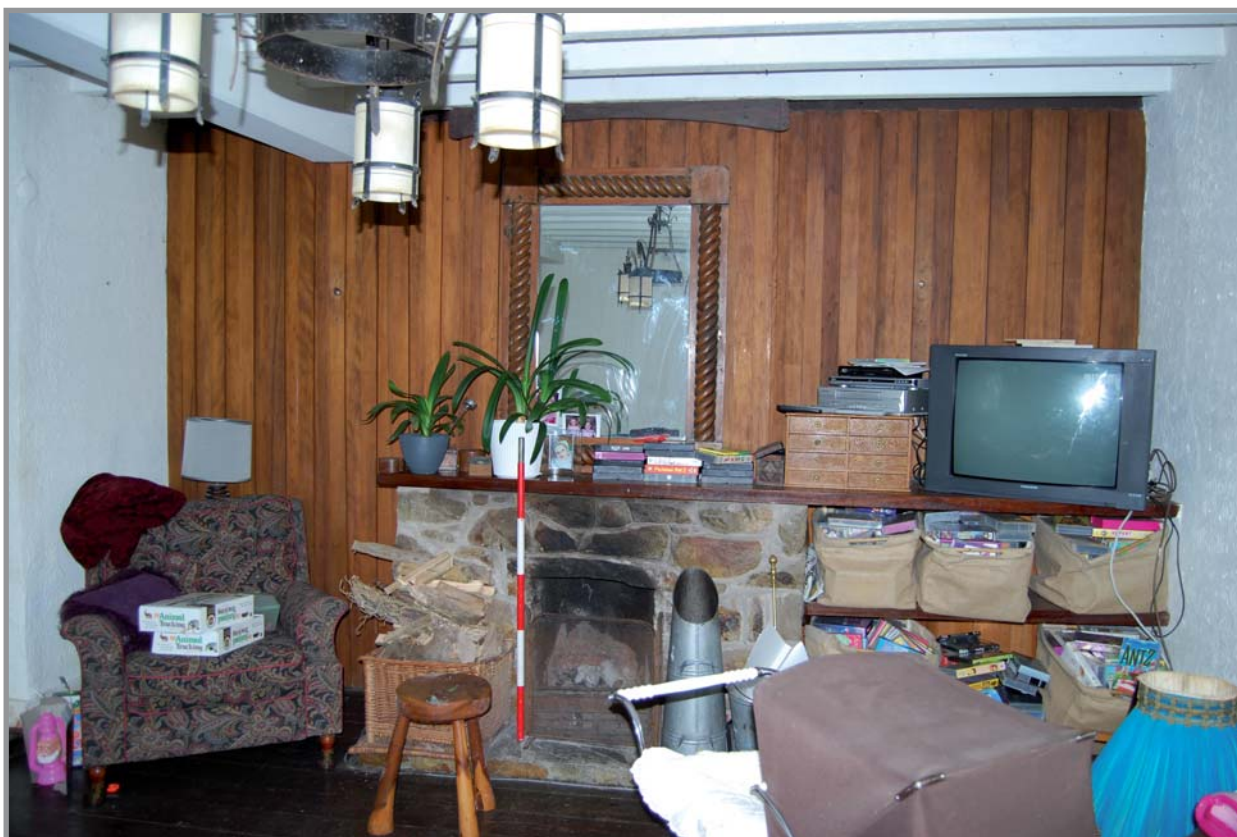
Plate 18: Gronant connecting 19th century wing facing west, showing fireplace

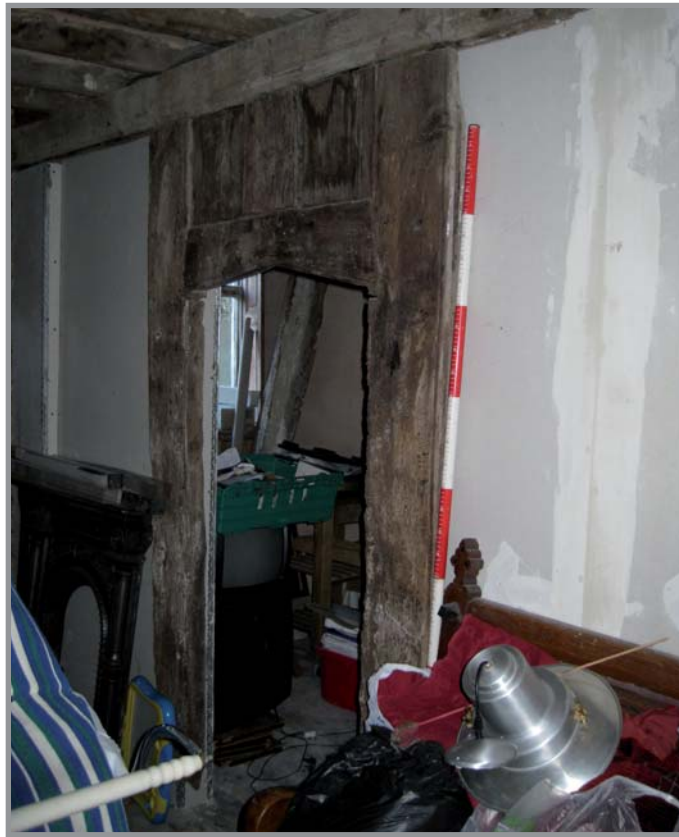
Plate 19: Gronant building A. Post and panel screen

Plate 20: Gronant building A. Post and panel screen, detail

The post and panel screen has lost most of its timbers. The top and bottom rails remain, and so does the single door into the outer bay. The top rail is moulded on the lower corner, the moulding pierced by peg holes for the posts and panels. Towards the west end of the passage the two posts either side the door into the outer bay survive, with the lintel forming a Tudor (shallow pointed) arch. Above the lintel is a central post with two panels either side. The top rail is in to parts, the east side being narrower than the west side. The ceiling joists lie on top of the top rail.

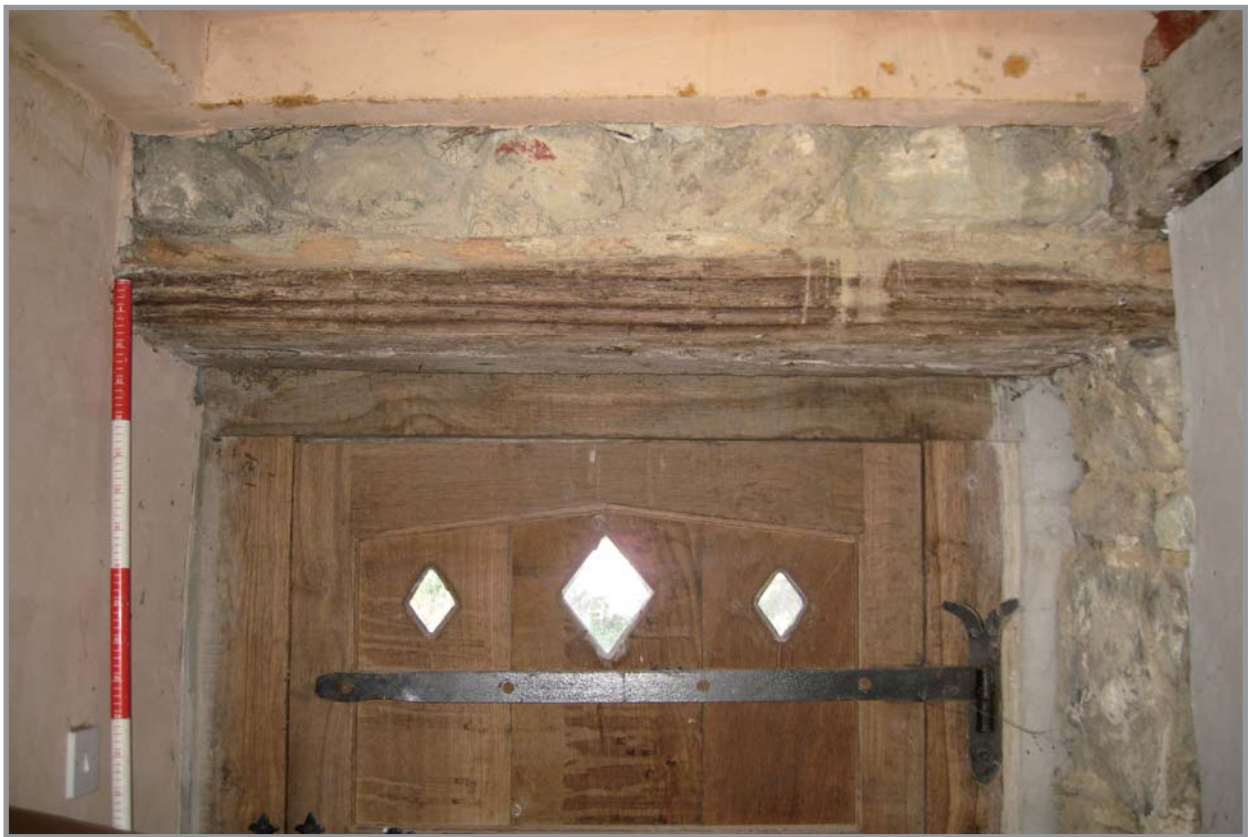
Plate 21: Gronant building A. West passage door detail facing east.

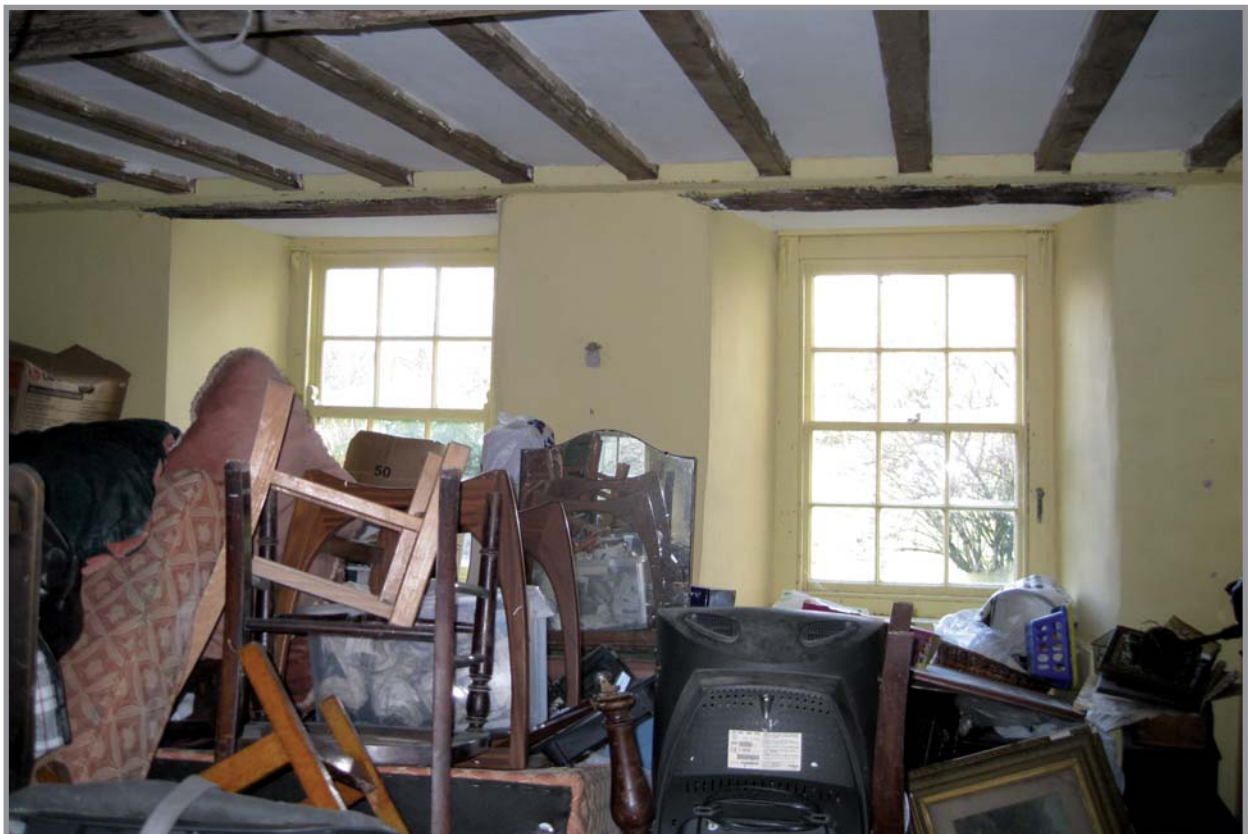
Plate 22: Gronant building A, ground floor 12-pane sash windows facing east

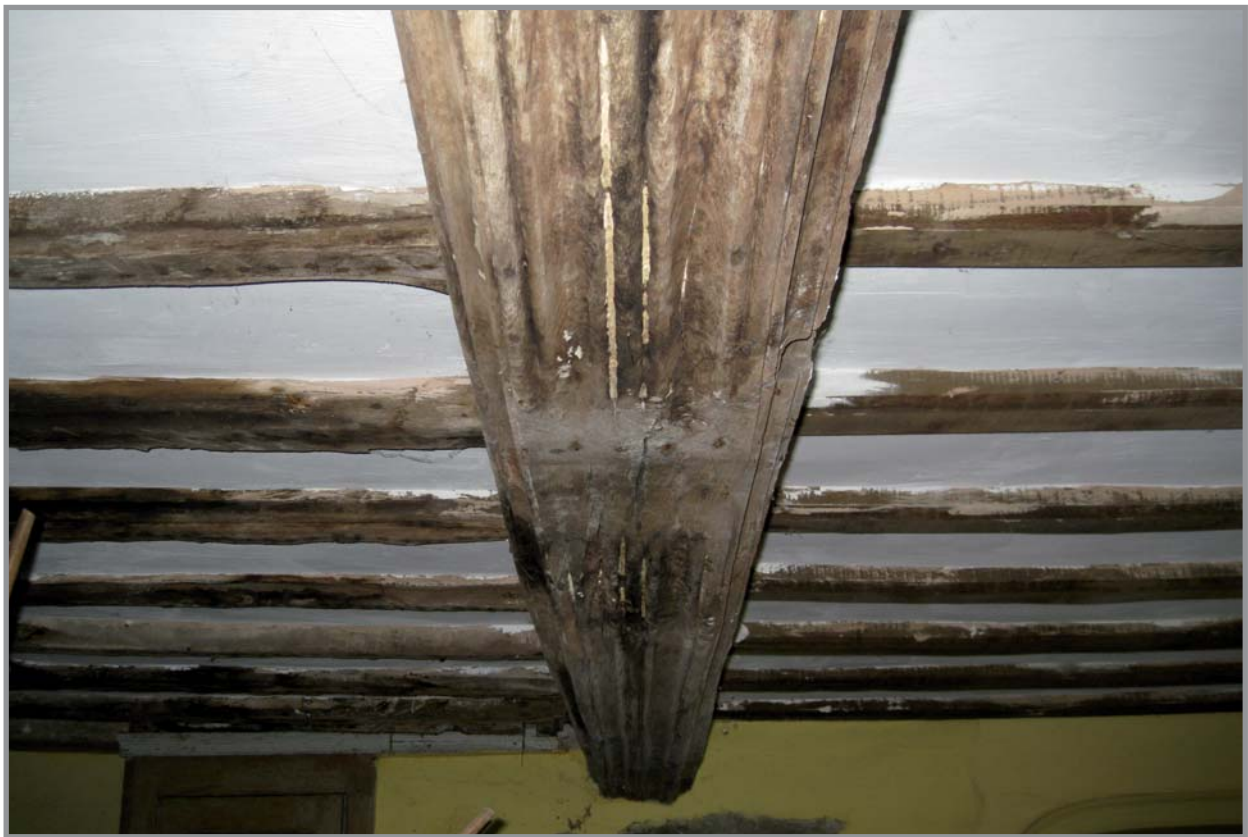
Plate 23: Gronant building A. Heavily moulded beam

The hall is entered on the north side of the fireplace. The ceiling is supported on a heavily moulded beam which runs the length of the room from north to south, from the east wall of the fireplace through to the south gable wall. The largely original joists lie on top of the beam. Access to the fireplace was not possible, nor was the south side of the room clearly visible. The two closely spaced 12 pane sash windows on the east and those more widely spaced on the west both have heavily moulded internal lintels. The south wall contained a small fireplace, with a wide arched full
