North West Wales Dendrochronology Project:

Gronant, Holyhead

Report No. 854

March, 2010

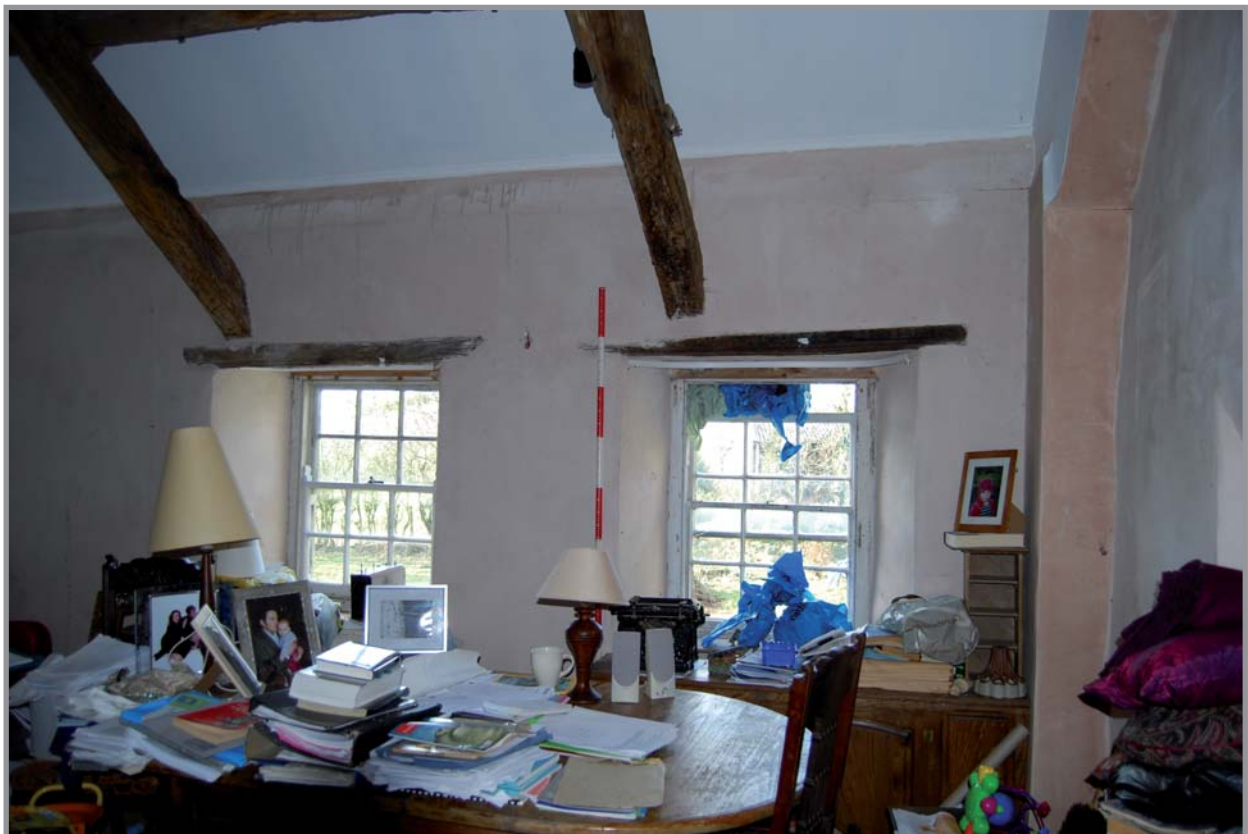
Plate 24: Gronant building A, first floor 12-pane sash windows facing east

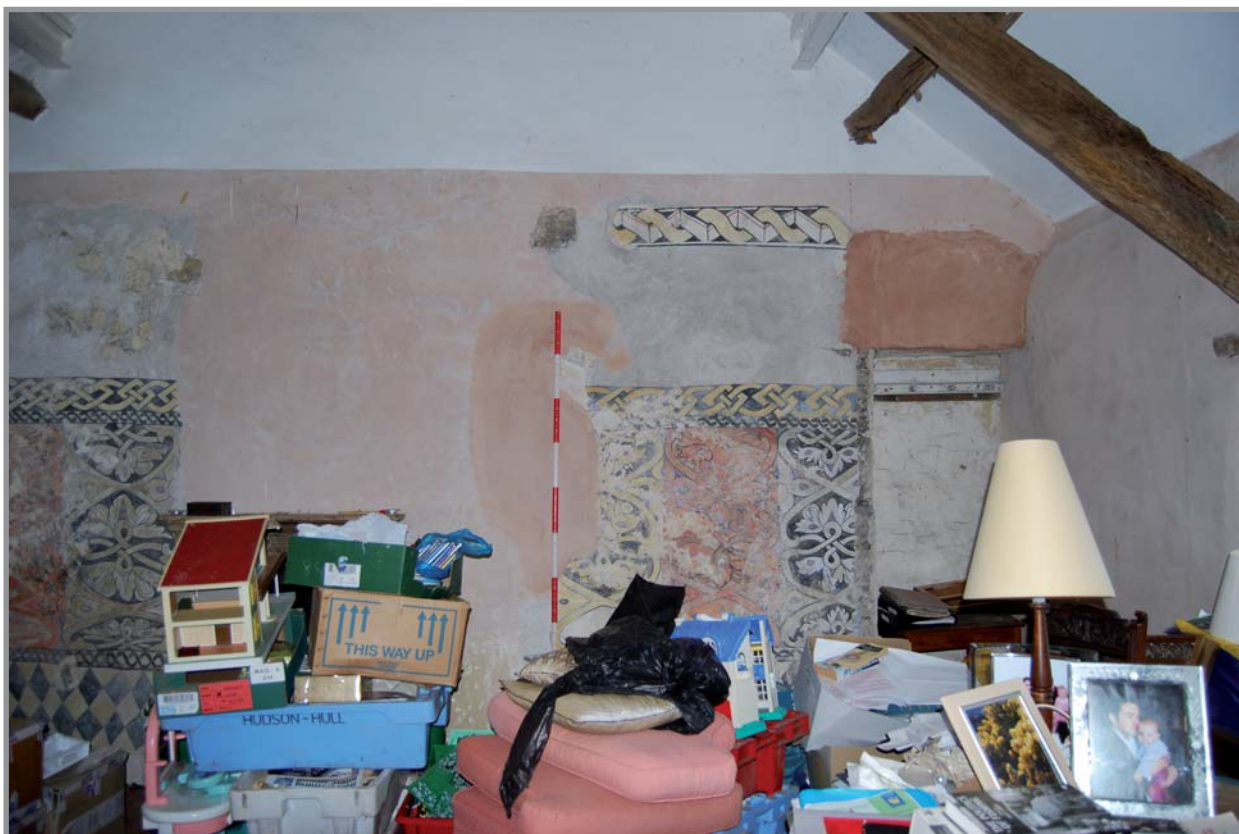
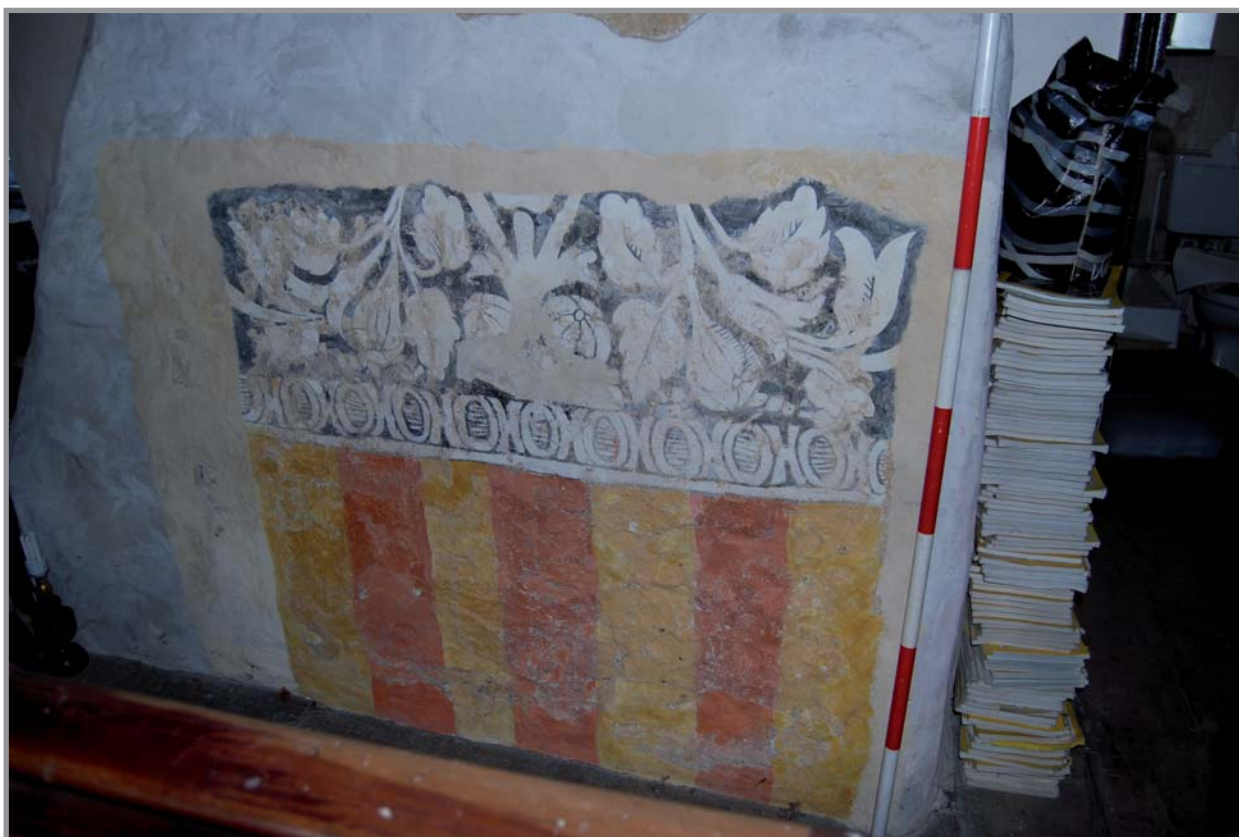
Plate 25: Gronant building A, first floor. Wall paintings discovered and restored in c. 1986. Facing south.

Plate 26: Gronant building A, first floor. Wall paintings discovered and restored in c. 1986. Facing west.

Modern stairs lead from the north-east corner of the hall to the first-floor chamber above. The room above the hall is a single room open to the roof, of three bays separated by two collar beam trusses with raking struts. The original purlins are no longer present, though the notches in the trusses survive, and later square section trusses (no longer load bearing) sit within them. The trusses are no longer load bearing, as the weight of the modern roof is carried on steel girders that stretch the length of the building. A ridge beam is carried in a notch at the apex, but this may be secondary, perhaps the same date as the later purlins. The chimney takes up a large part of the north wall. Between the east wall of the chimney and the east wall of the house the roof was supported by single beams which carried purlins. Again the original purlins are gone, and these beams are no longer load bearing. Wall paintings, discovered and restored c. 1986, can be seen on the east chimney wall and the south wall. From dado level below the paintings are largely of vertical stripes in yellow and red, with a foliage pattern in grey above, the two separated by an egg and tongue border. A more complex large foliage pattern with an interlaced border lies on the south wall.

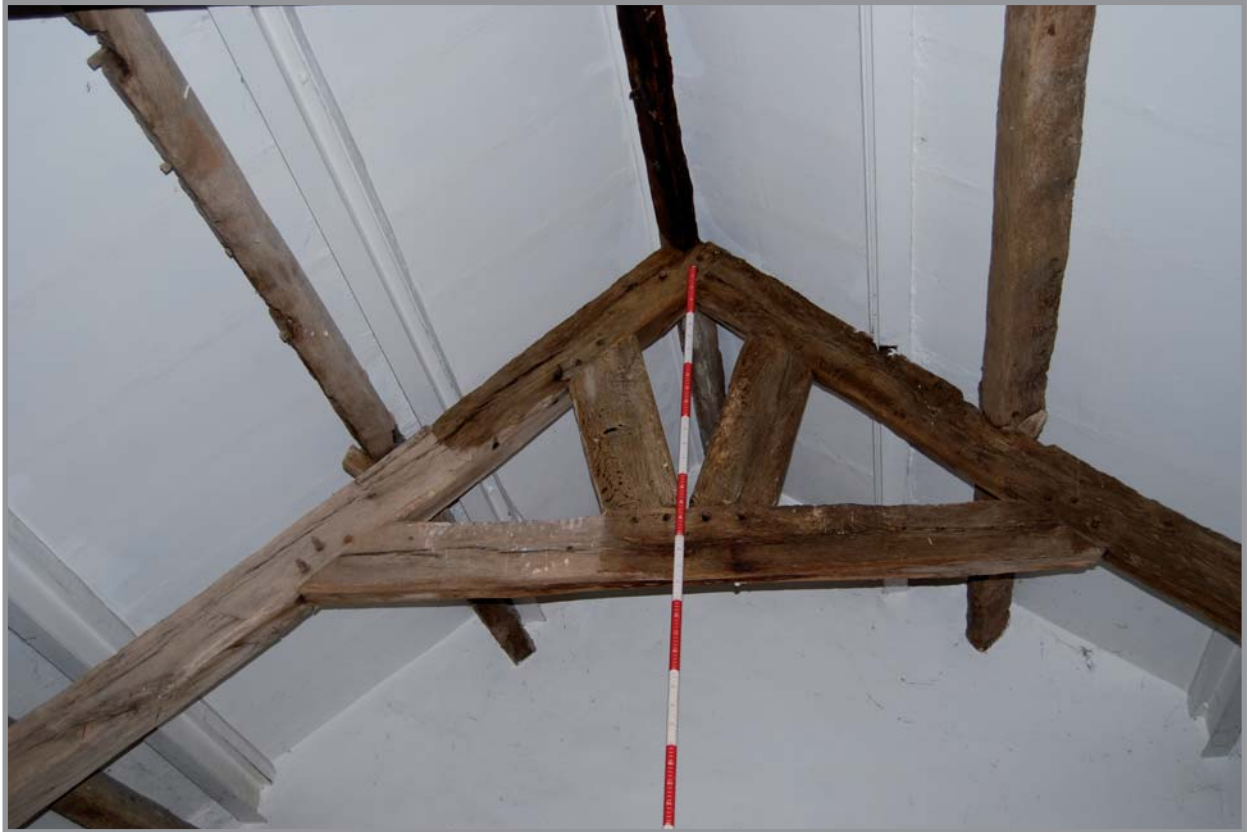
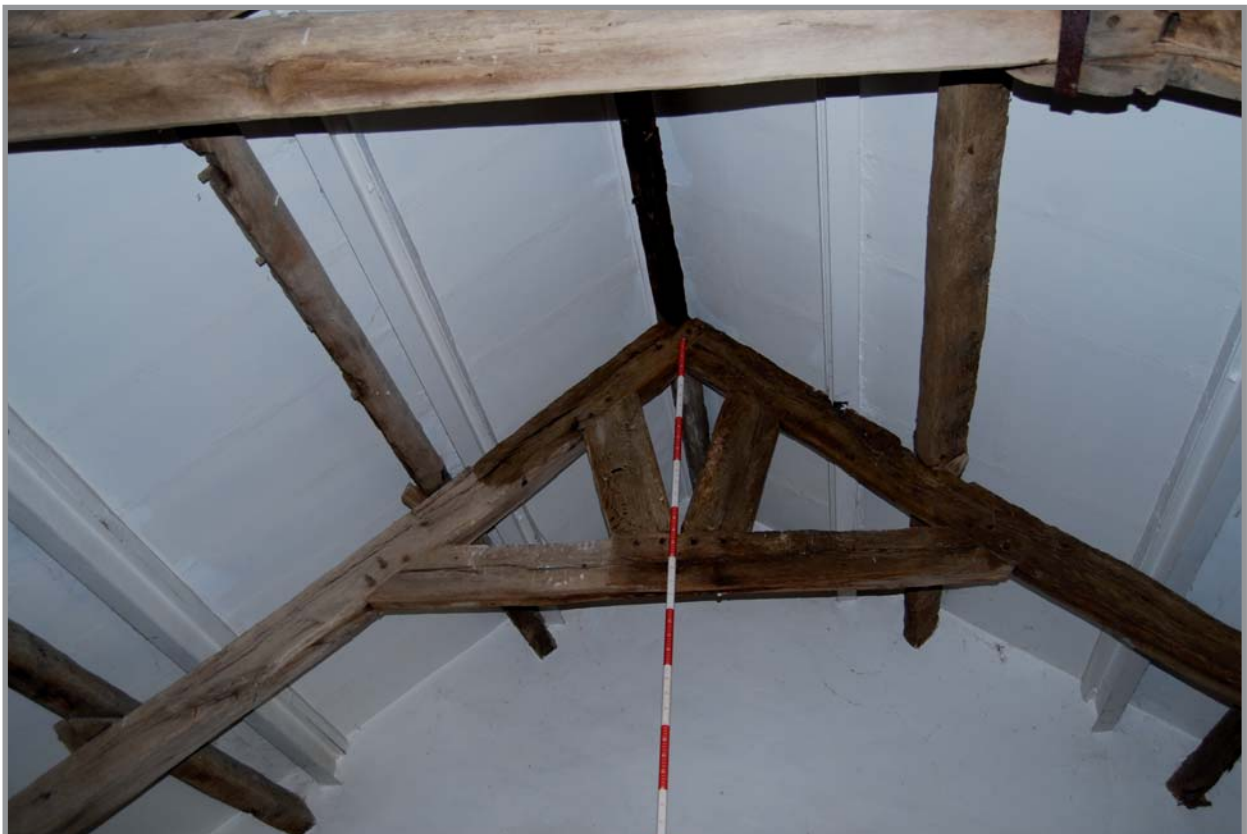
Plate 27: Gronant building A, first floor. Truss 1 facing south

Plate 28: Gronant building A, first floor. Truss 2 facing north
