North West Wales Dendrochronology Project  
**DATING OLD WELSH HOUSES**

**Creigir Isaf, Llanengan, Gwynedd**

**ARCHITECTURAL RECORD**

## Creigir Isaf, Llanengan

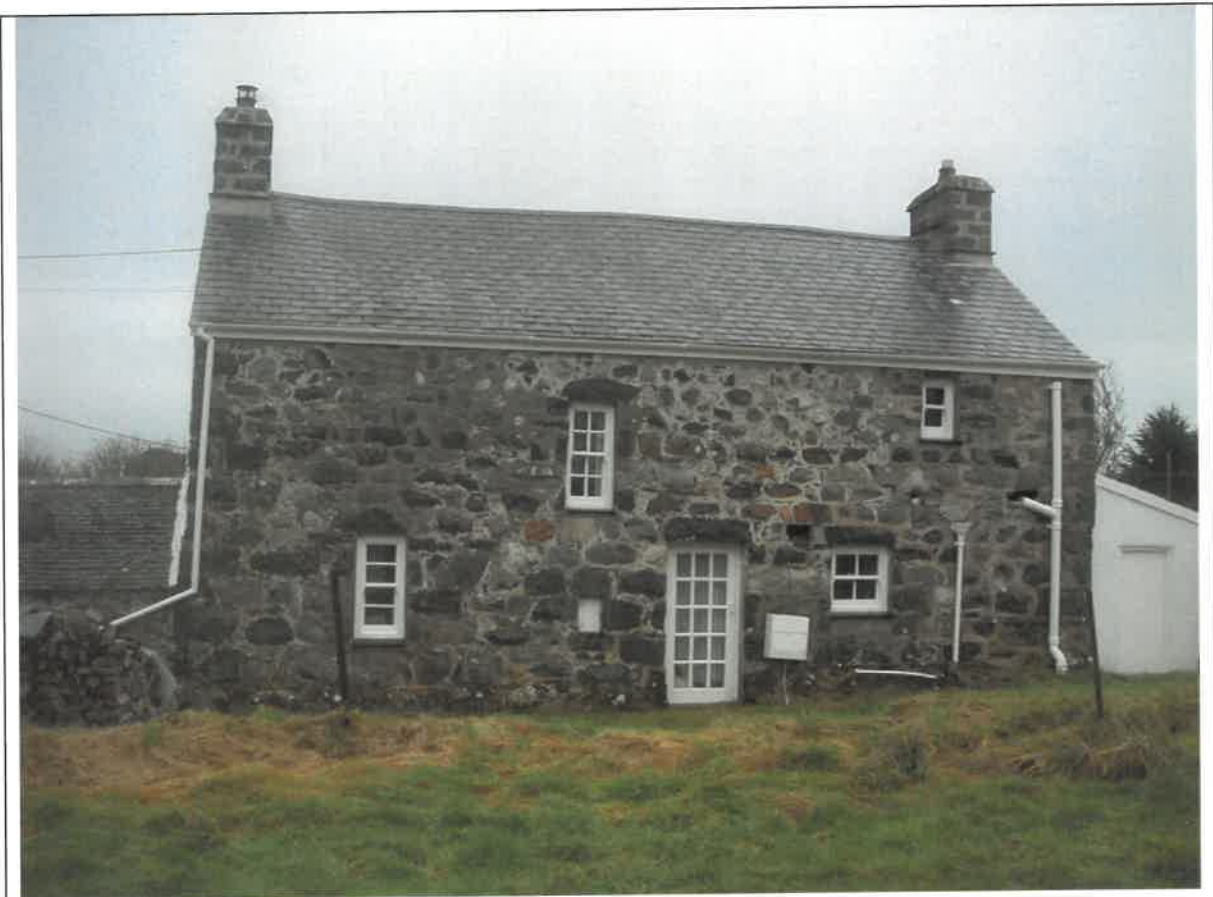
Plate 1 Rear (NW) elevation

The window and door openings appear to be of eighteenth- or nineteenth-century date, with rough stone slab lintels externally. The front and back doors do not align as one might expect in the typical cross-passage plan; the front door is central in the hall but the back door is shifted so that it is hard against the partition and beam. There is no evidence in the stonework of the rear elevation that there was a previous central doorway here. The windows and doors, of timber (but with some uPVC replacements) are modern.

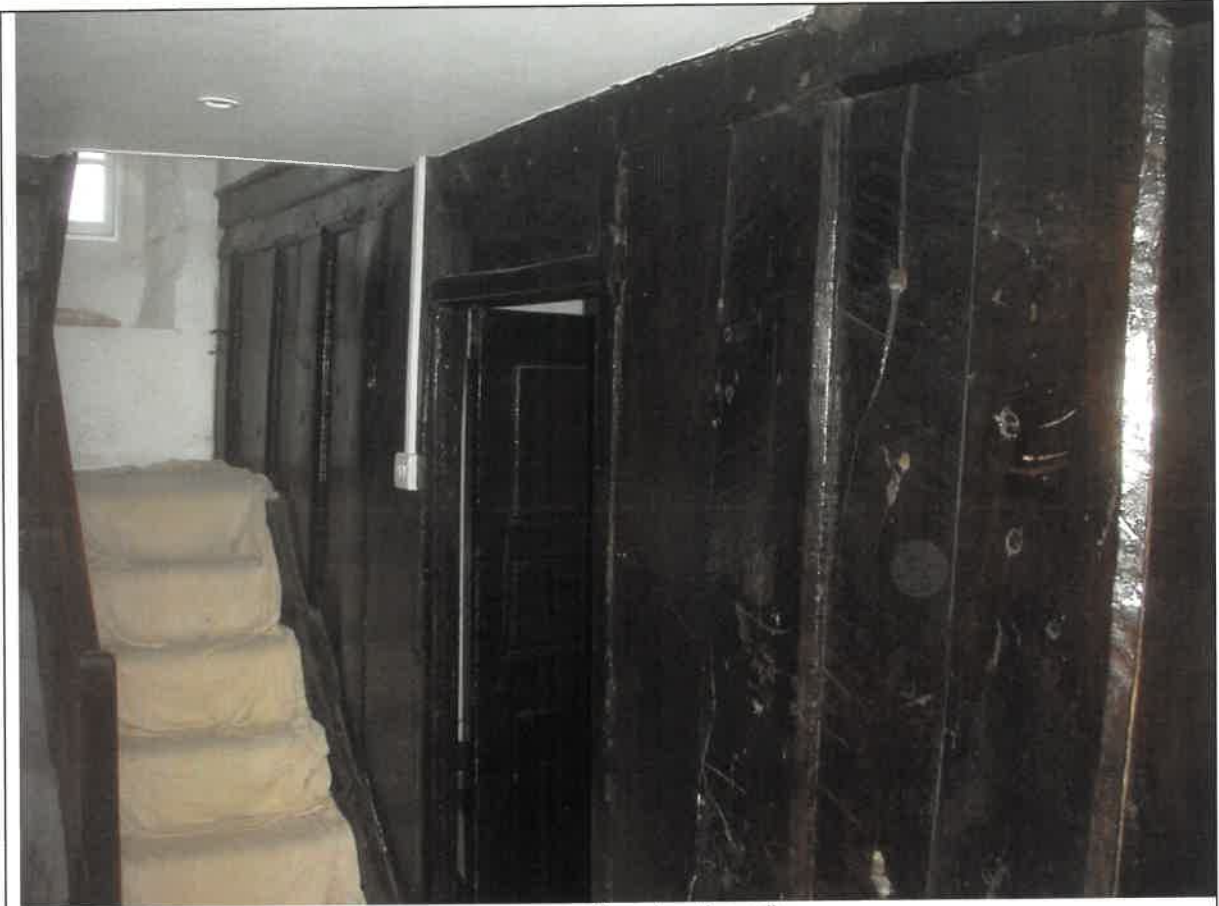
Plate 4 Partition (north end)

Upstairs all the partitions are modern. Downstairs they are similar apart from the post-and-panel partition between the hall and the living room, the chief feature of significance surviving in the house and probably sixteenth-century in date. This has posts and panels of approximately equal width (about 10"), the posts with 1" chamfers that are continued in the head, into which they are fixed with a pair of pegs. Some of the sill beam survives but there is no primary beam visible above the partition. The central doorway in the partition is not original since there is evidence of a pair of earlier, lower doorways to each side, probably leading to a pair of service rooms. These have been filled in with mortar or plaster either side of the existing doorway. The panelled door looks eighteenth century; the timber, dog-leg staircase looks mostly modern.

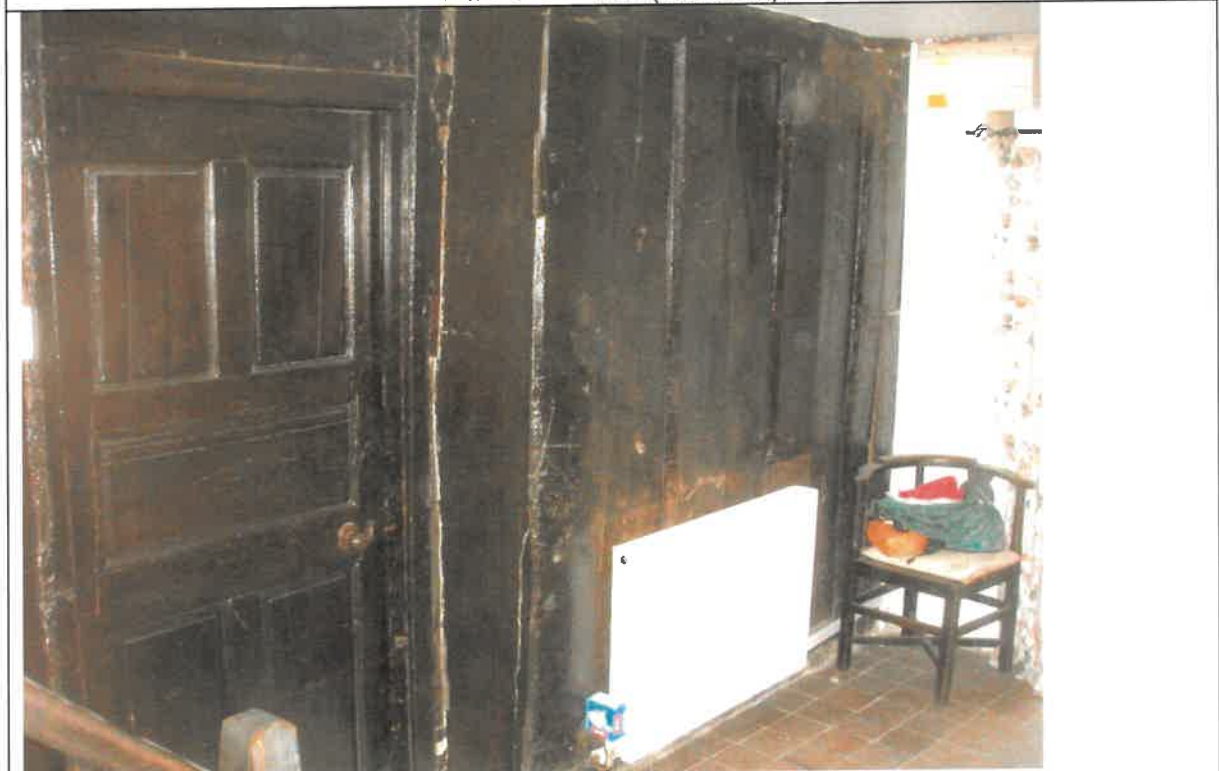
Plate 5 Partition (S end)
