North West Wales Dendrochronology Project Pen-y-Bryn, Edern, Gwynedd

**EAS Client Report 2010/05
March 2010**

**Commissioned by
Margaret Dunn
For
North West Wales Dendrochronology Project**

**By
I.P. Brooks and K. Laws**

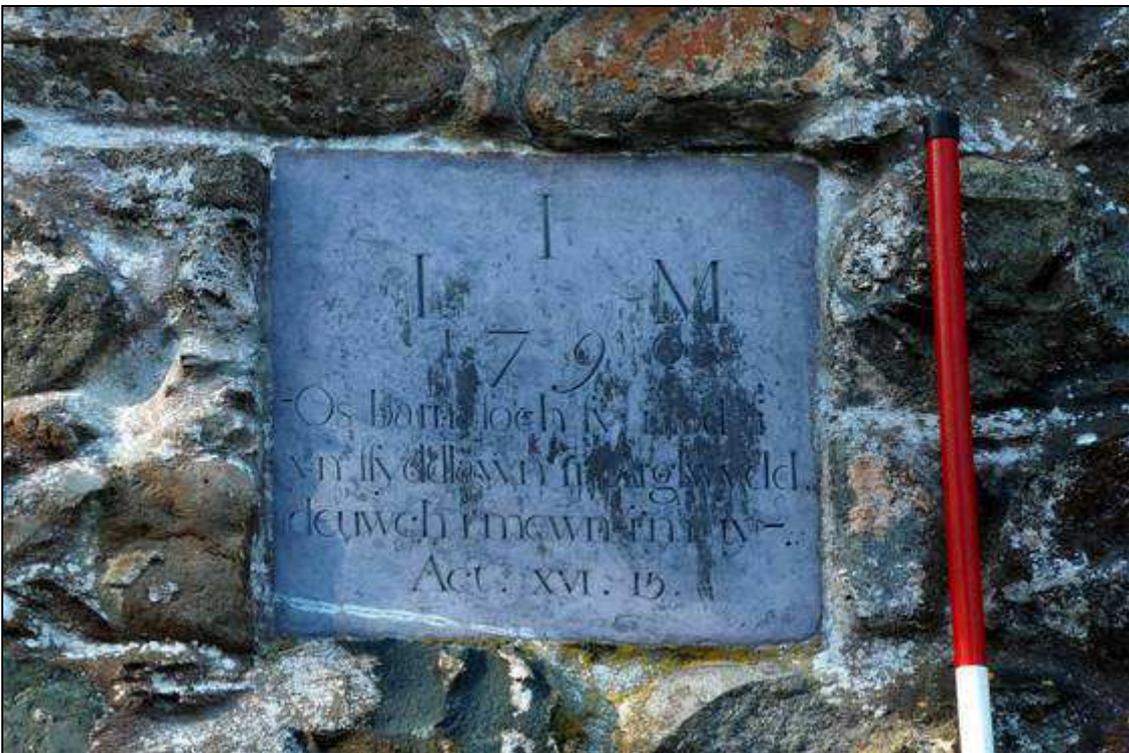
Plate 4: Inscription

Pen-y-Bryn, Edern is located approximately 375 m south of the centre of the village of Edern at a height of approximately 31 m OD. The building recorded is the primary phase of a house with at least two major, later phases of extension. The earliest of these was a kitchen range, in a lean-to extension, to the rear of the property (Plate 3) and the second a single storey extension on the north end of the building. The primary phase consists of a storey and a half house (Plates 1 and 2) with a gable end chimney at each end. The house is built of roughly coursed rubble to front with a rendered southern gable end, under a roof of small slates. The chimneys are ashlar built. There are three gabled, half dormers, irregularly spaced on the front elevation. Two of these dormers occupy the northern half of the front elevation with only a single dormer in the southern half. The middle dormer is directly above the front door to the property. Between this dormer and the front door is a slate plaque (Plate 4). This has the initials I^lM, the date 1790 and a biblical quote in Welsh. The full inscription reads:

I
I M
1790

Os barnasoch fy mod i
Yn ffyddlaw'n I'r Arglwydd
Deuwch i mewn I'm ty-
Act. XVI. 15.

In English this would be "If you judge me to be faithful to the Lord come inside my house."

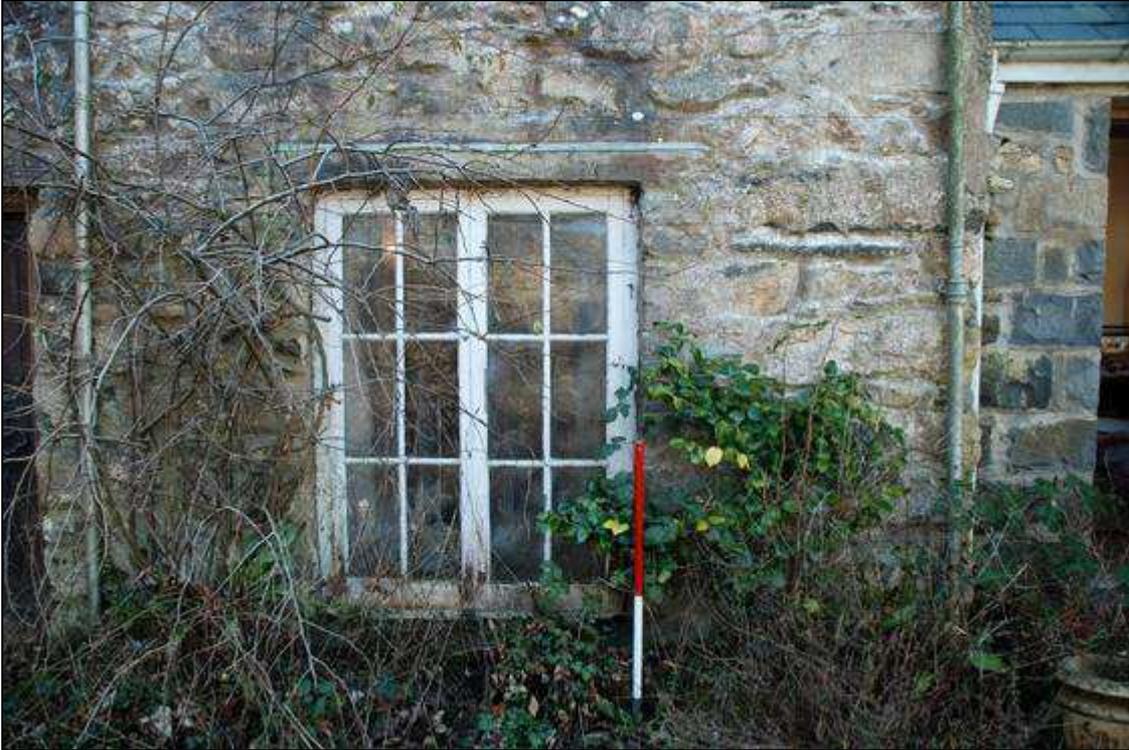
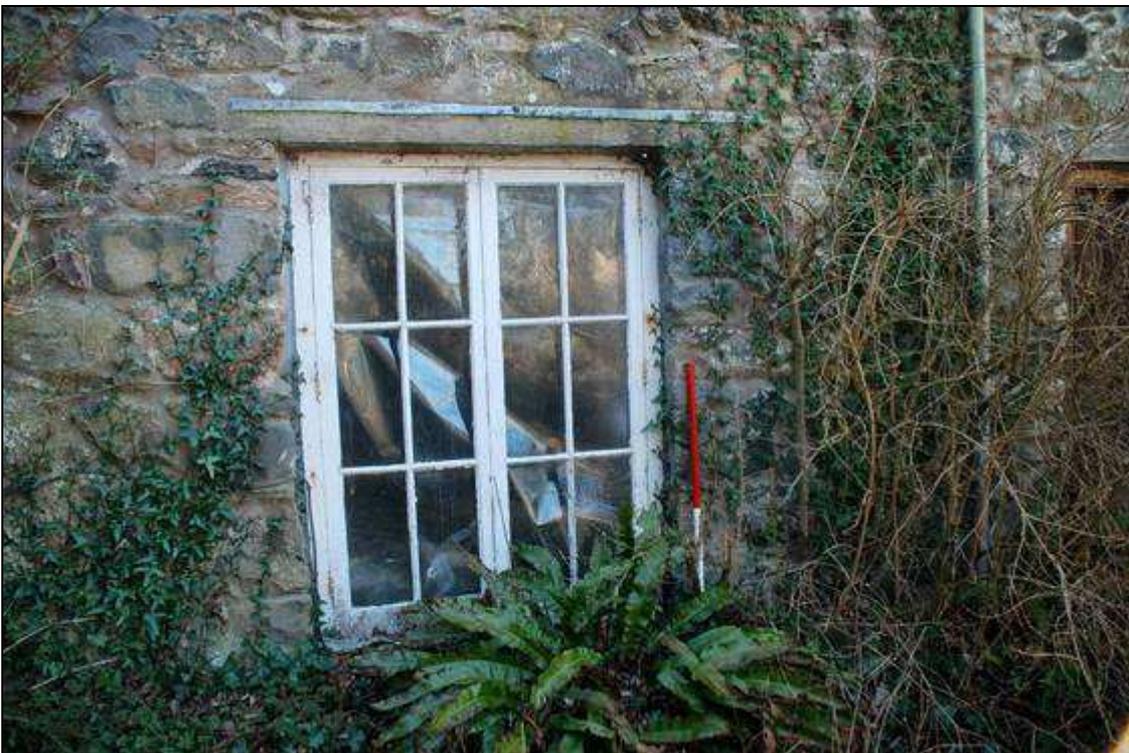
The widows in the dormer are relatively small, two pane casement windows with diamond leaded panes. The lower windows, however, have been replaced with pairs of six pane casement doors. The modification required to insert these doors is shown by the inclusion of granite blocks in the door surrounds (Plates 5 and 6).

Plate 5: Southern ground floor window

Plate 6: Northern ground floor window

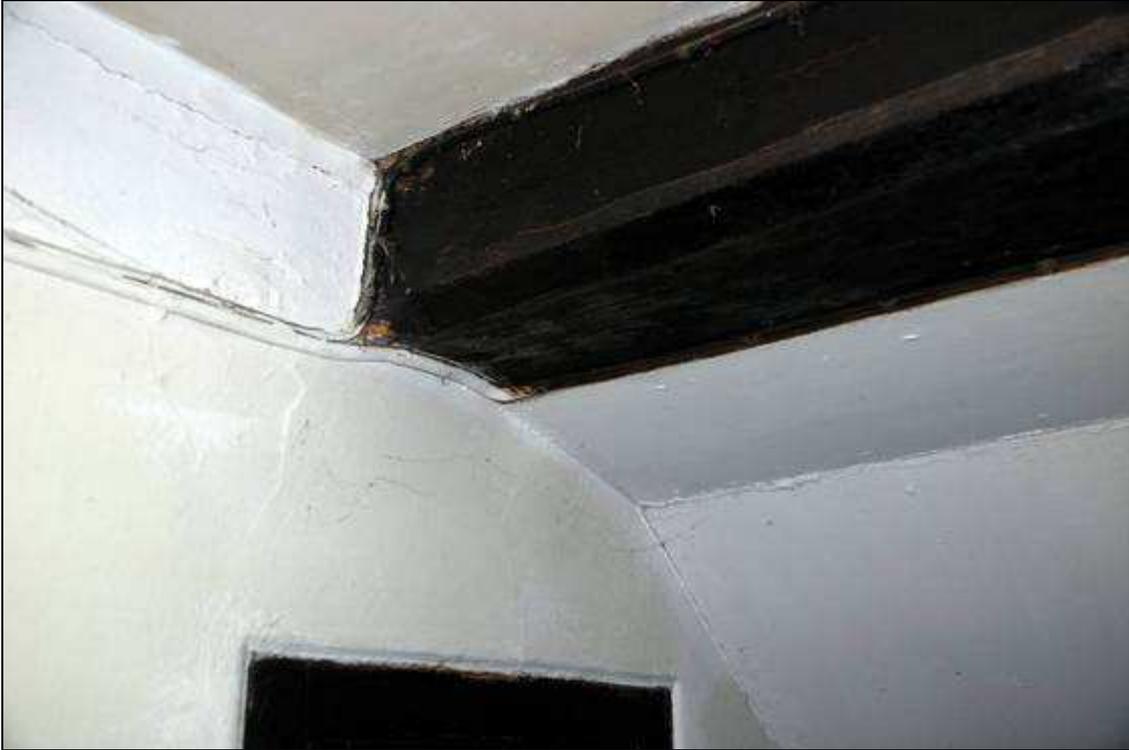
Plate 7: Tie beam, looking north west

Internally the ground floor now consists of a single room, although it was divided into two rooms separated by a transverse corridor to an earlier staircase in living memory (James-Robertson *pers. comm.*). Two original tie beams are present, both of which are chamfered and have plain stops (Plate 7). There is a third, much smaller tie beam which is relatively modern.

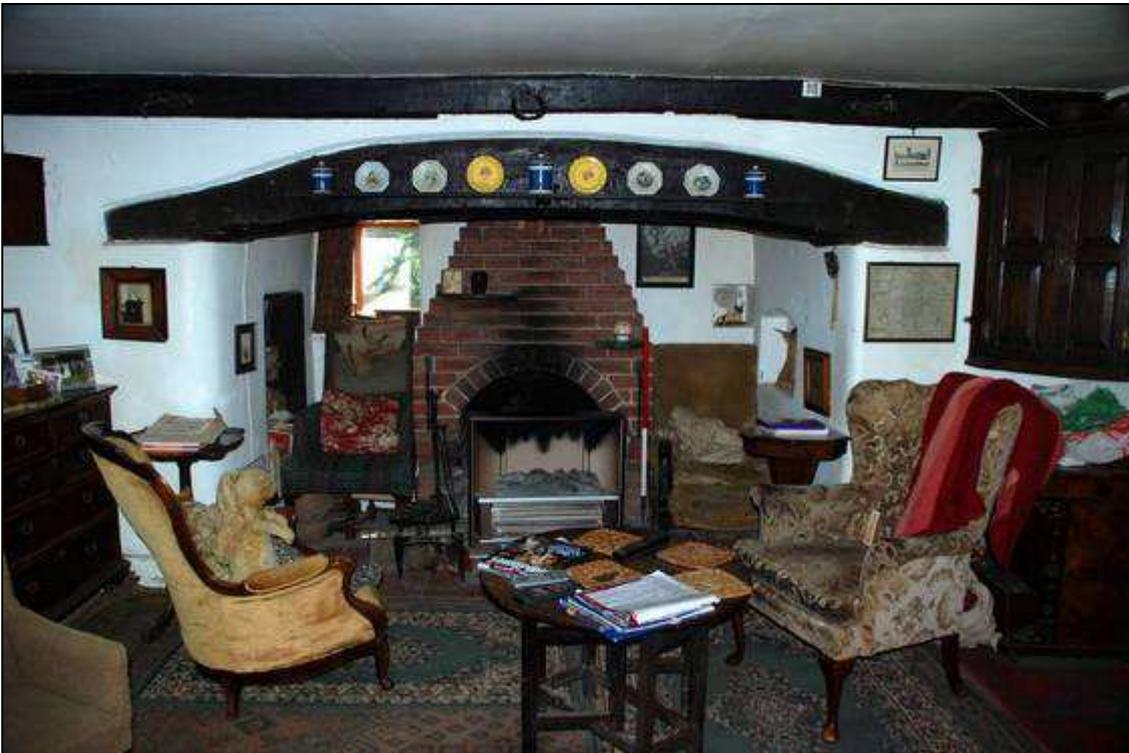
Plate 8: Southern fireplace

The southern fireplace (Plate 8) has a large, slightly arched bressumer with some chamfering. The rear of this beam is heavily damaged and has been repaired with cement (Plate 9). In the western side of the fireplace is a circular, brick lined bread oven with a recessed opening (Plate 10). There is also a niche adjacent to the bread oven in the southern wall of the fireplace. There are also two, more recent modifications with the insertion of a window in the south east corner of the fireplace and a recess for a bookcase in the eastern wall. The northern fireplace has been largely removed, although evidence from the roof space would suggest that it was considerably smaller than the main (southern) fireplace.

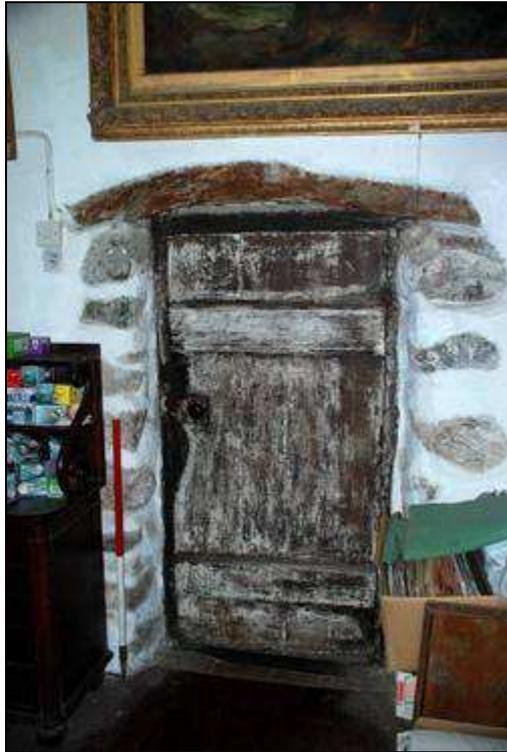
Plate 11: Western doorway, looking east

The door in the western wall which leads to the lean-to extension once occupied by the kitchen has a wooden lintel on its western side. This lintel has a marked upward curve, possibly suggesting that this door originally had a curved head (Plate 11).

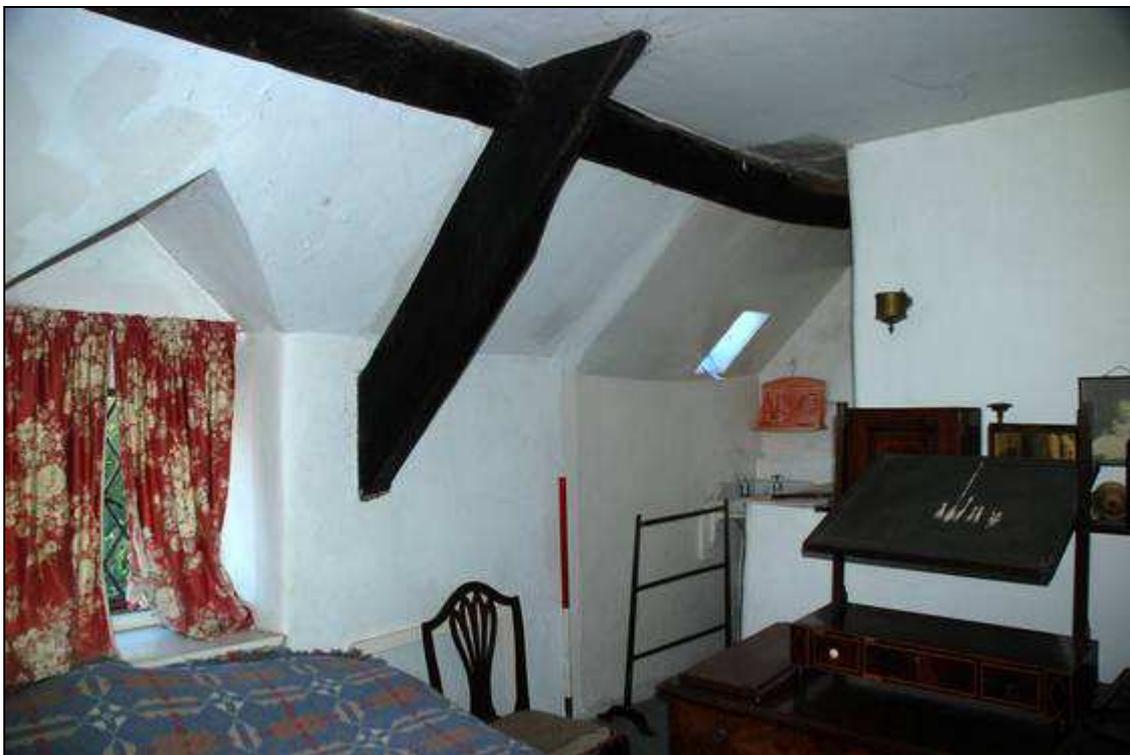
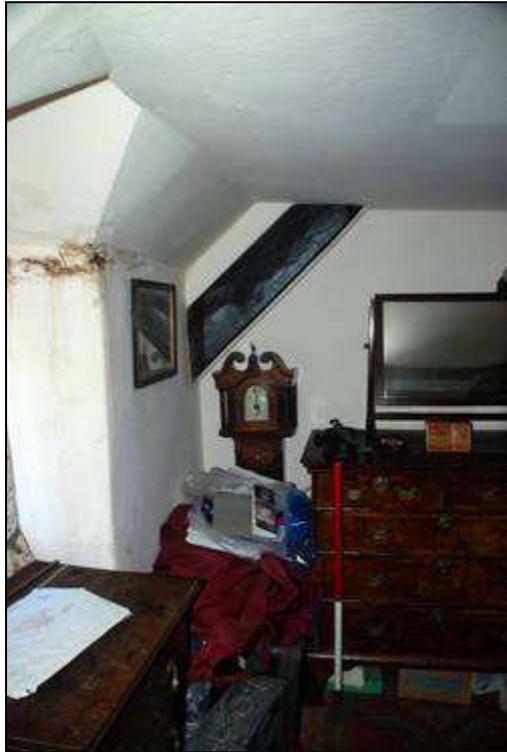
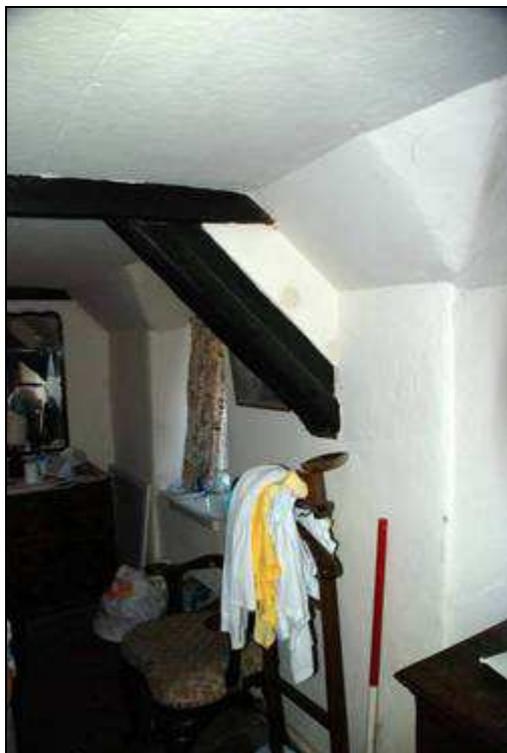
The arrangement of the first floor, with three bedrooms and small landing is modern; however the feet of three trusses protrude into this space (Plates 12 – 14). The foot of Truss 3, has been repaired by the addition of an iron strip, held in place by bolts. The floor ceiling of the southern, master, bedroom has been heightened revealing the lower purlins in the ceiling of this room. Both of the purlins have a noticeable bend between Truss 1 and the gable wall of the

Plate 12: Base of Truss 1, looking SE

Plate 13: Base of Truss 2, looking south

Plate 14: Base of Truss 3, looking north

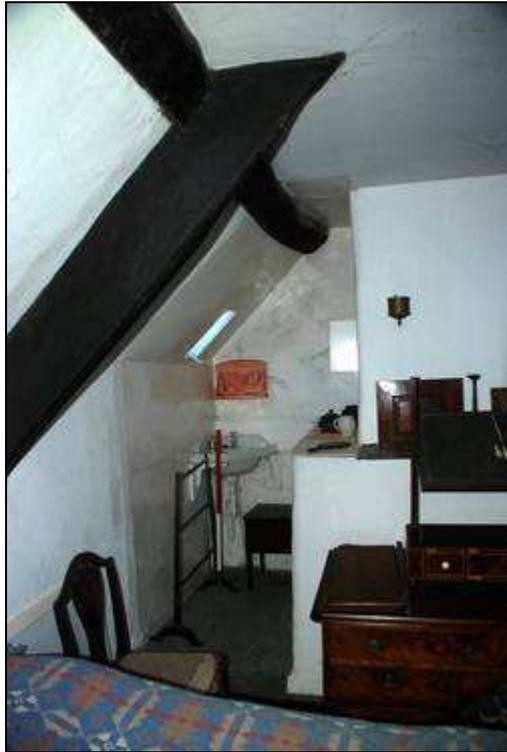
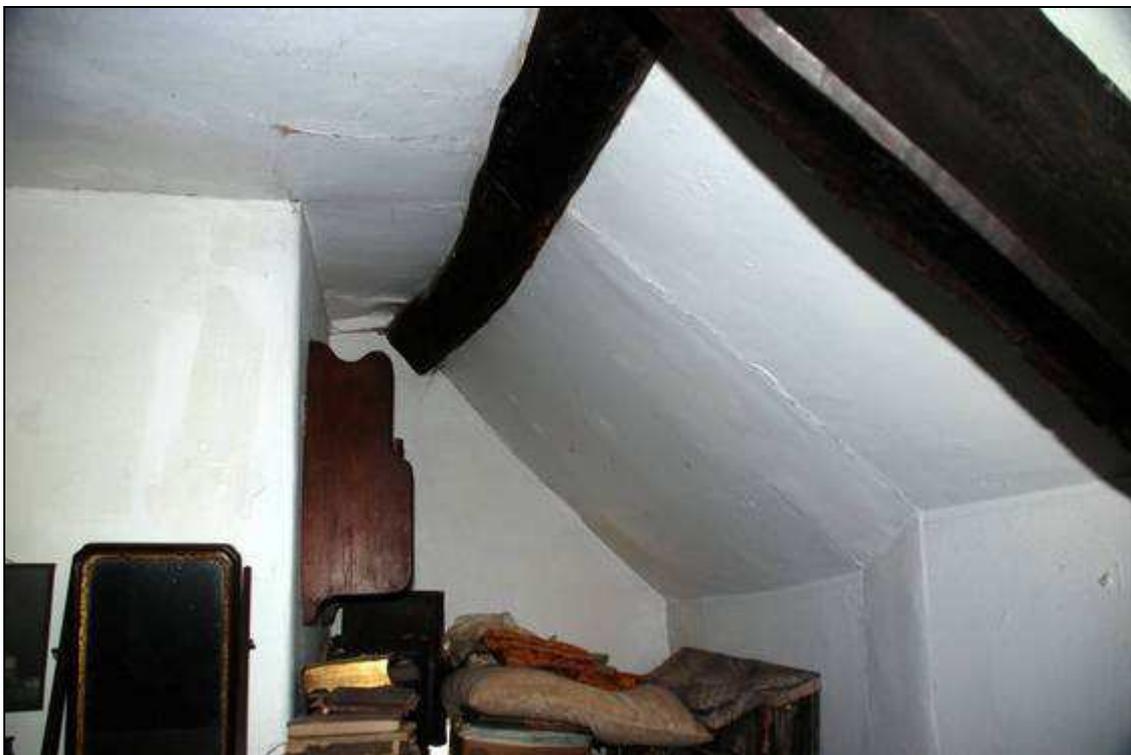
building, possibly because of the weight of the roof with its small slates (Plate 15 – 16). In the roof space all three trusses proved to be similar with arched collars which extend beyond the line of the principal rafters (Figure 4, Plates 17 – 19). These are held in place by large wooden pegs, some of which appear to have square heads. All of the purlins are constructed of relatively short timbers, with each length only running from one truss to the next. Each length of each purlin is joined to the next with a splayed scarf joint (Plate 20) which is pegged into the principal rafters.

Plate 15: Lower, front purlin, looking south

Plate 16: Lower rear purlin, looking south

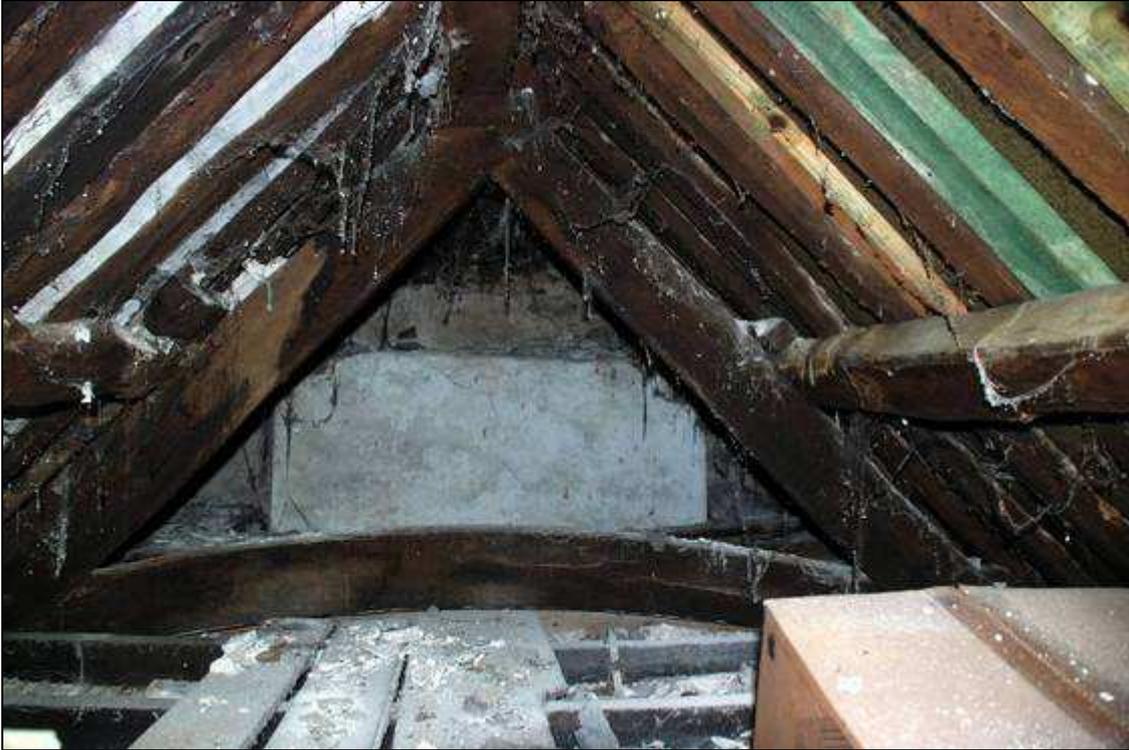
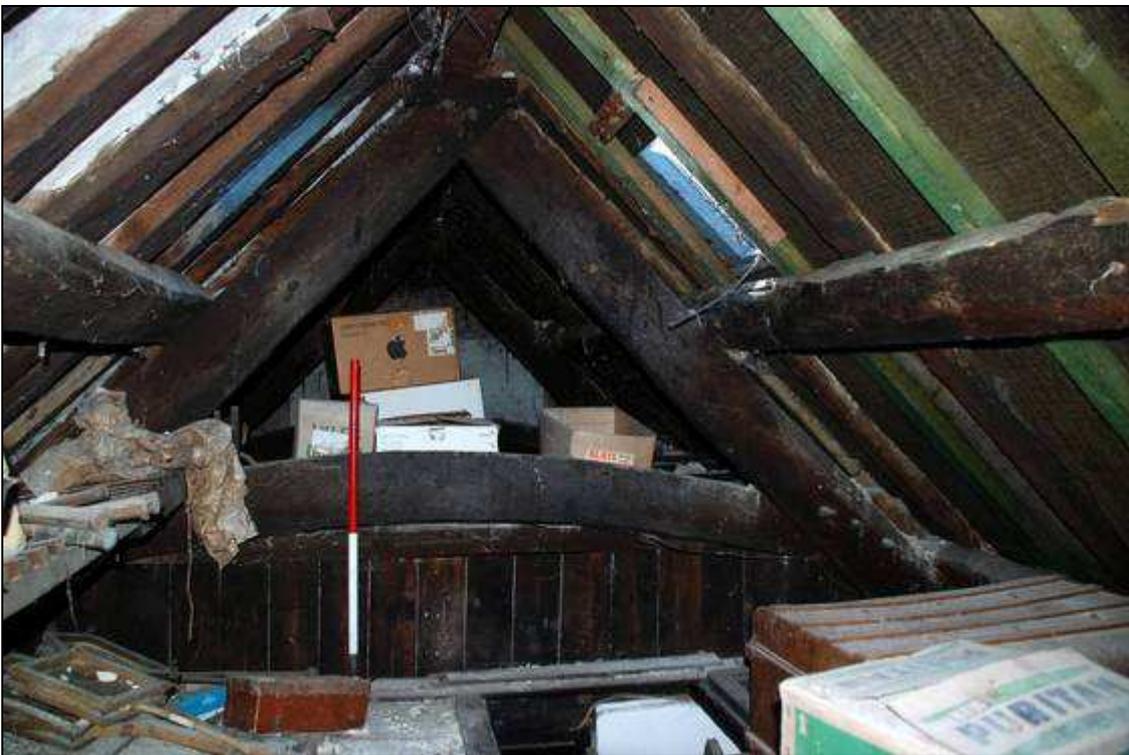
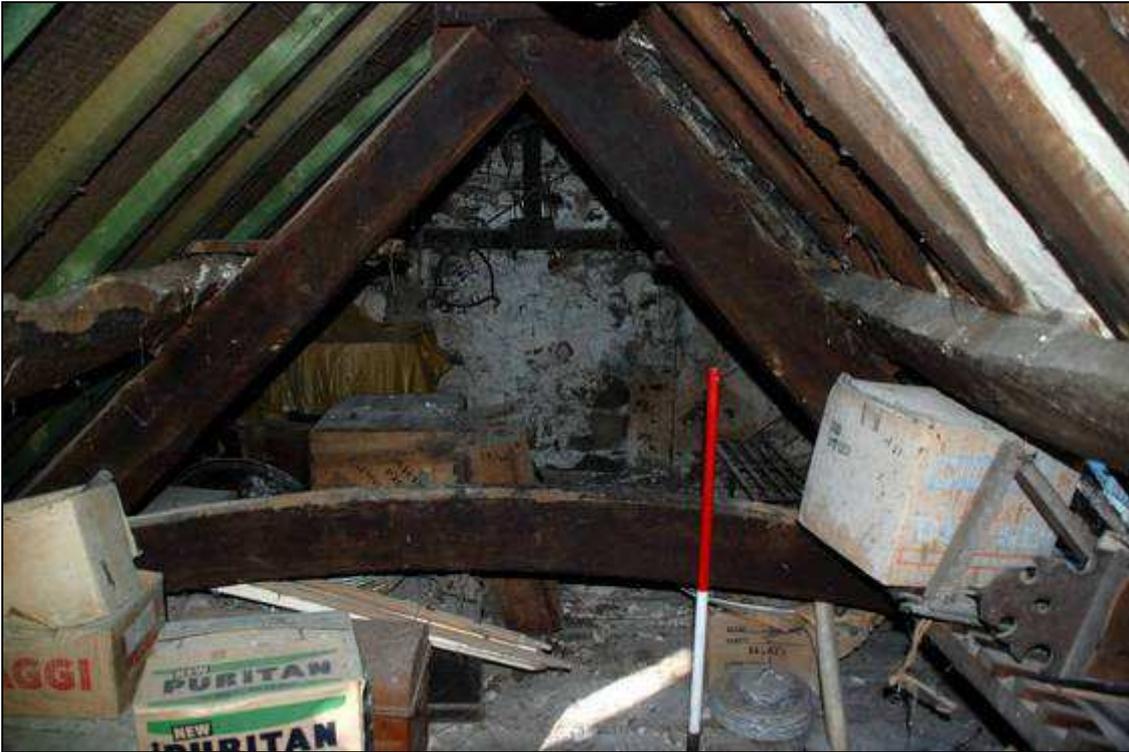
Plate 17: Truss 1, looking south

Plate 18: Truss 2, looking south

Plate 19: Truss 3, looking north

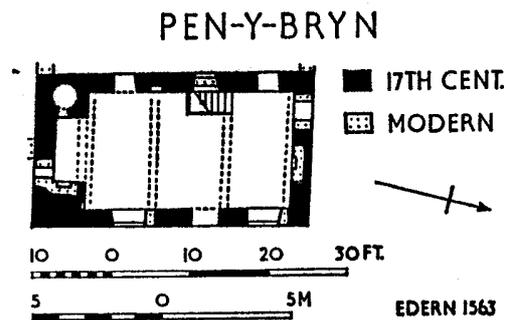
FIG. 60

(1563) Pen-y-bryn (Fig. 60, Plate 45), a single rectangular block of two storeys, the upper lighted by three dormers on the E. front. The walls are of roughly coursed rubble, partly rendered, with an original ashlar chimney stack at each gable, square and capped. Though almost every ground-floor opening has been altered, the dormer windows are original and suggest that the house was built late in the 17th century.

The interior forms one room on the ground floor without any trace of former subdivision; the entry in the N. gable is modern. The ceiling beams have plain chamfers and stops. At the S. gable the wide fireplace has a cambered and chamfered bressummer, and beside it a brick-lined circular oven. The arrangement of the upper floor is modern. The three roof trusses have arched collars pegged to the principals and projecting beyond them.

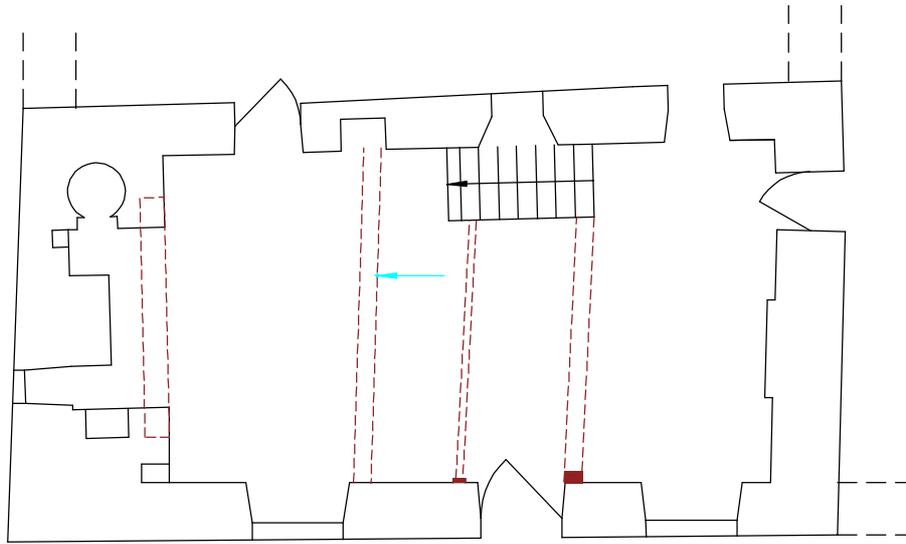
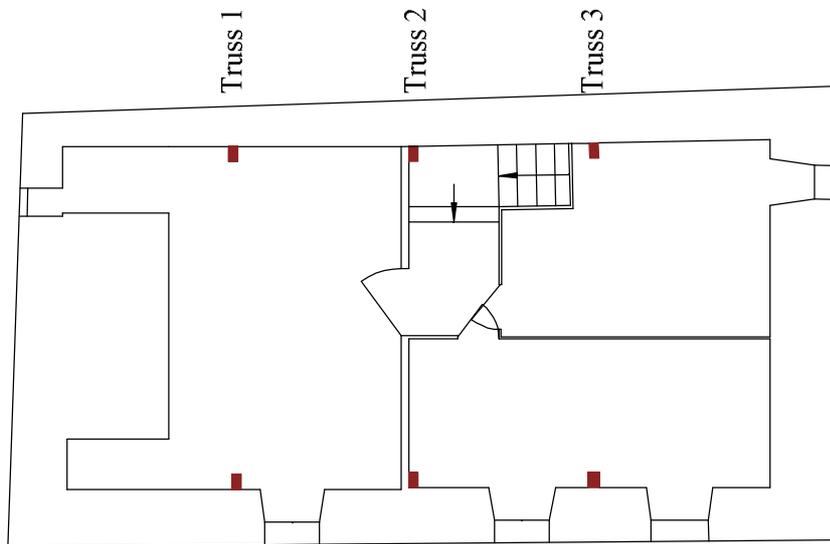
Figure 3: Pen-y-Bryn, Edern
Plan
Scale 1:100

The ground floor plan, produced by the Royal Commission on the Ancient and Historical Monuments in Wales for the Caernarvonshire Inventory (1964), was used as the base for the study of this house. It was slightly adjusted to include modifications made after the survey. The first storey plan was made by direct measurement. The drawings of the timberwork were carried out by direct measurement at a scale of 1:20. Photographs were taken with a Nikon D80 digital SLR camera at a resolution of 10.2 mega pixels. Where practical all the photographs included a metric scale.

Ground Floor

← Dendrochronological Sample

First Floor

Five sample sites were recorded, two each from Trusses 2 and 3 and one from the southern tie beam on the ground floor. Of these the tie-beam, two samples from Truss 3 and one from Truss 2 were analysed.

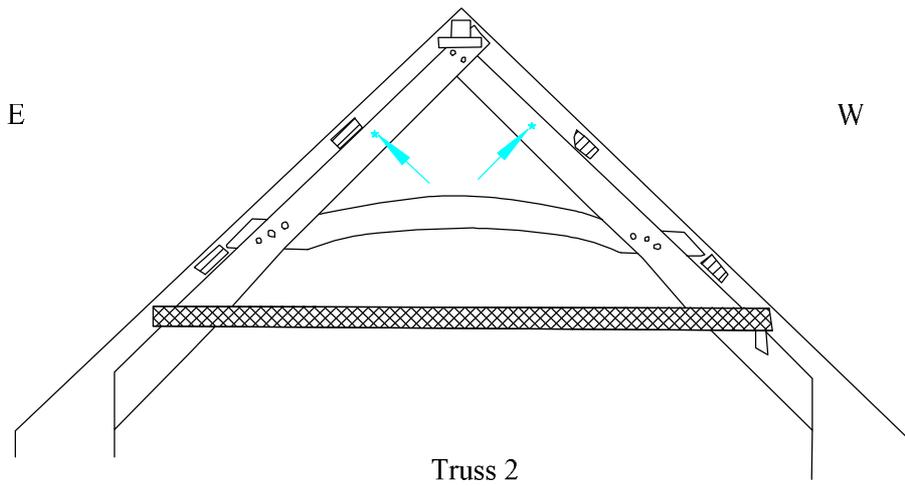
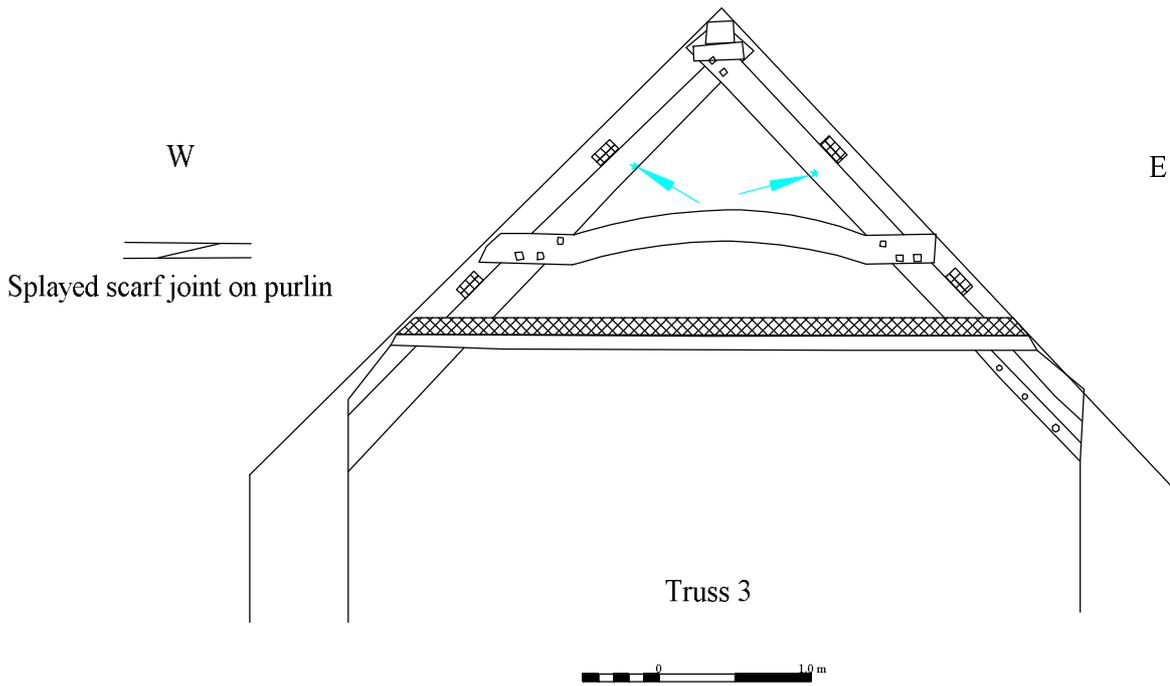
Figure 4: Pen-y-Bryn, Edern
Trusses
Scale 1:50

Dendrochronological sample
