North West Wales Dendrochronology Project Ty'n Twr, Bethesda, Gwynedd

**EAS Client Report 2010/01
February 2010**

EAS Client Report 2010/01

**By
I.P. Brooks and K. Laws**

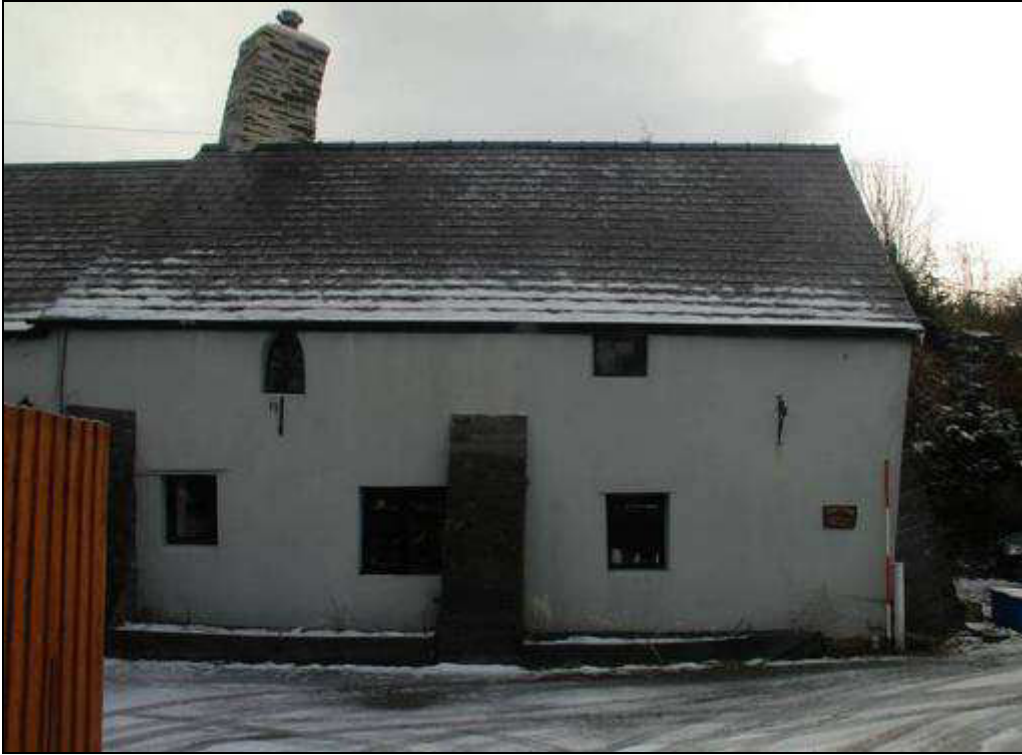
Plate 1: Front elevation

Externally the house consists of two ranges set at right angles, although only the south west end of the main range contains the original structure of the property. This range is a two storey range under a modern slate roof (Plate 1). Now rendered, the original stonework is not available for inspection. There are a series of modern slate buttresses supporting the front elevation and the south west gable end, both of which tend to lean out. The windows in the front elevation contain modern wooden frames; however one of the first floor windows is pointed (Plate 2). The windows also appear to occupy original openings on the front elevation, although the first floor windows in the rear elevations are later additions.

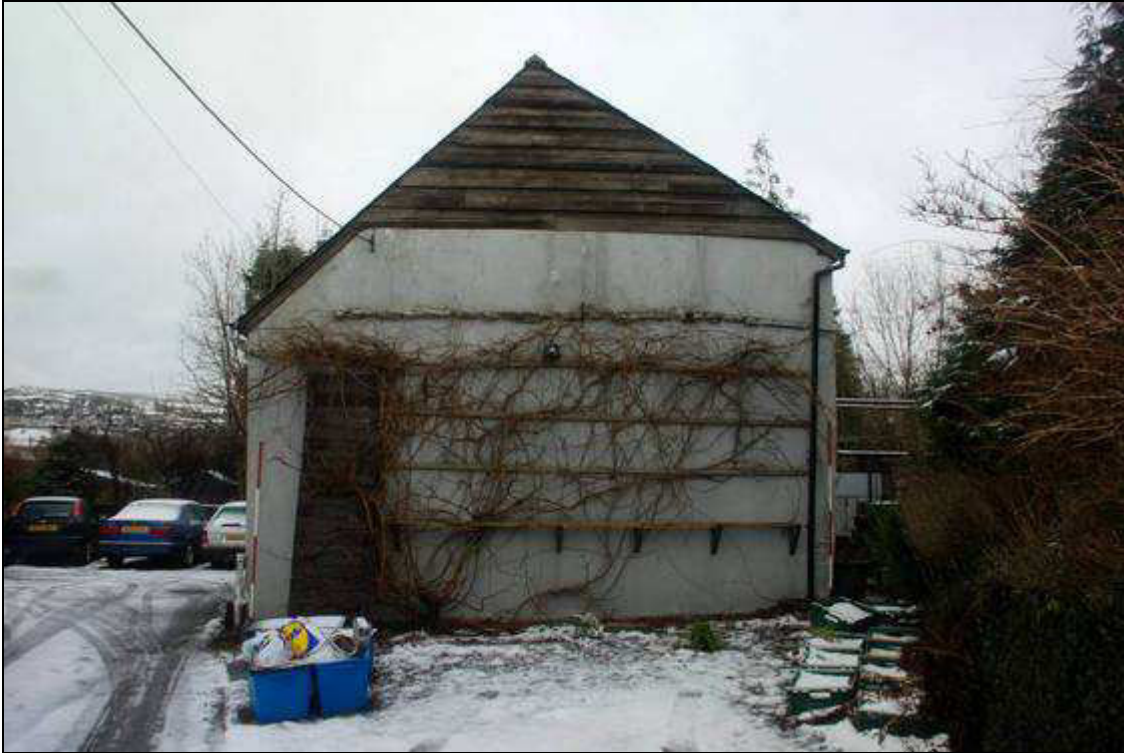
Plate 3: South west gable end

The south west gable end is rendered and has weatherboarding on its upper section, however a line of stones projecting from the surface presumably mark the position of a lean-to, now lost (Plate 3). To the rear of the building a line of stone is exposed at the base of the wall marking the line of the foundations at this point (Plate 4). The chimney is set just off the ridge and is set diagonally (Plate 5). It is constructed of roughly courses stone rubble.

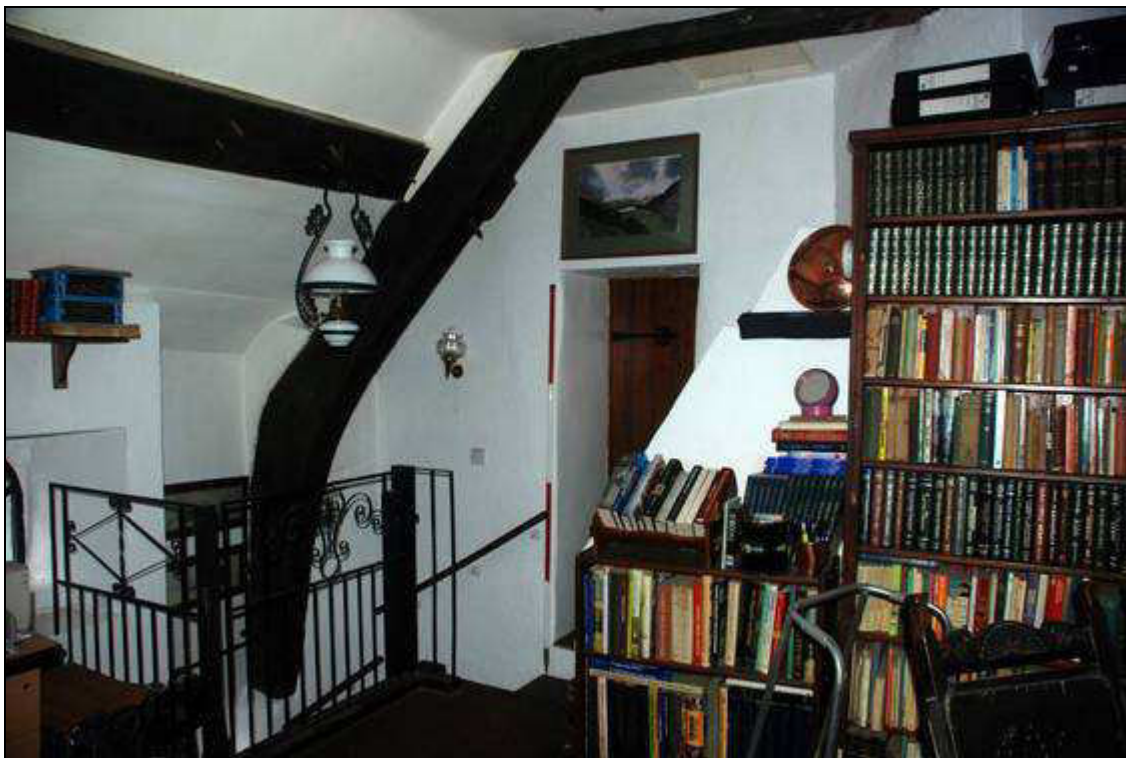
Plate 6: Truss 1, looking north

Internally two cruck trusses have been recorded, both of which have their feet buried in the walls of the house. Truss 1 (Figure 4.1, Plates 6 and 7) has cruck frames with a collar and two pairs of massive purlins. This truss sits over the inserted fireplace and is exposed in the stairwell and first floor only. There has been some movement between the front cruck frame and the lower purlin, however this allows for the trenched joint in the purlin to be seen (Plate 8). The apex of the truss is butt jointed, with a rectangular recess for a ridge piece. Originally there were windbraces between both the cruck frames and at least the lower purlins, one of which survives between Truss 1 and the lower front purlin (Plate 8). The windbrace (Figure 5.2) is decorated with double ogee cusping. The lower front purlin has the mortice holes for the missing windbraces, but it also has a series of wooden pegs at approximately 0.5 – 0.55 m intervals which presumably mark the positions of the common rafters (Figure 5.1, Plate 9). Some of these common rafters appear to survive in the roof space, although they are no longer functional (Plate 10).

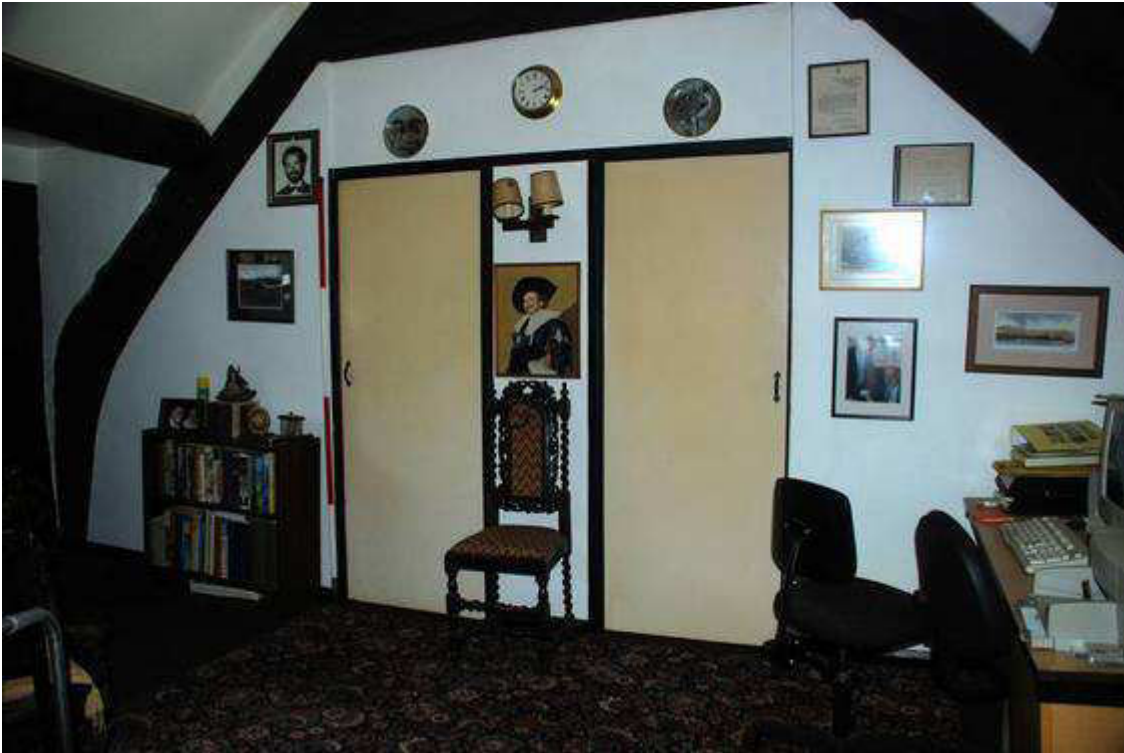
Plate 11: Truss 2 looking north

Truss 2 (Figure 4.2, Plates 11-13) is of similar design to Truss 1, a cruck frame with its feet buried in the walls, with a collar and two pairs of purlins. The collar has been supported by the addition of iron plates, presumably to stabilise the structure. On the ground floor, however, it contains the remains of a post and plank partition (Plates 14 and 15). Now only occupying the central section of the room this feature originally extended to both walls and had a doorway at its south eastern end. The surviving partition has a series of four post, each approximately 0.3 m wide and 70 mm thick, linked by planks 40 mm thick (Figure 5.3). Each of the posts has bevelled edges. The positions of both the missing and surviving posts are marked by a series of carpenters marks both on the beam forming the top of the partition and on the surviving posts themselves. The marks consist of roman numerals running from two to seven from north west to south east. The numerals are made of simple chisel cuts. The marks of "II" (Plate 16) and "III"

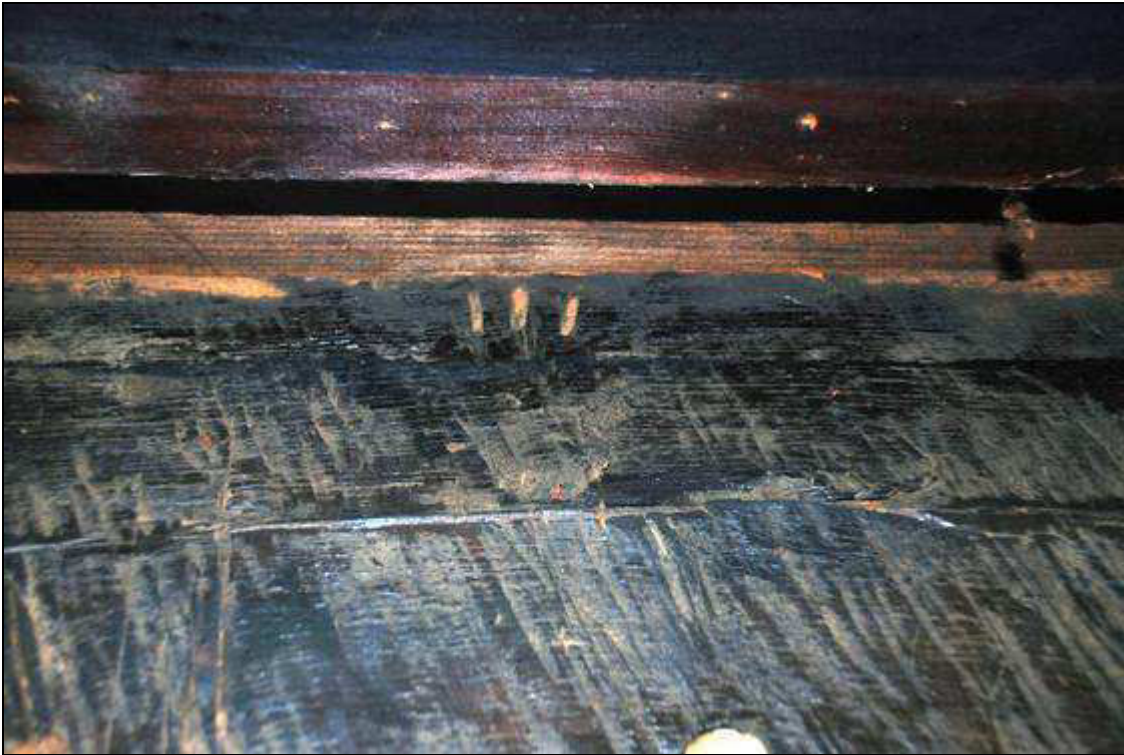
Plate 17: Carpenter's mark of "III" on partition

(Plate 17) mark the positions of missing posts. "IIII" is the first of the surviving posts and is marked on both the post and the rail (Plate 18), whilst the marks for "V" are missing, but would be below the transverse beam. The mark for six is "VI" (Plate 19) and for seven "VII" (Plate 20). There are also a series of peg holes in the posts and planks of the partition which may mark the positions of furniture or a canopy attached to this partition. Below the lower rail of the partition has been supported with modern cement loosing the relationship with any floor levels.

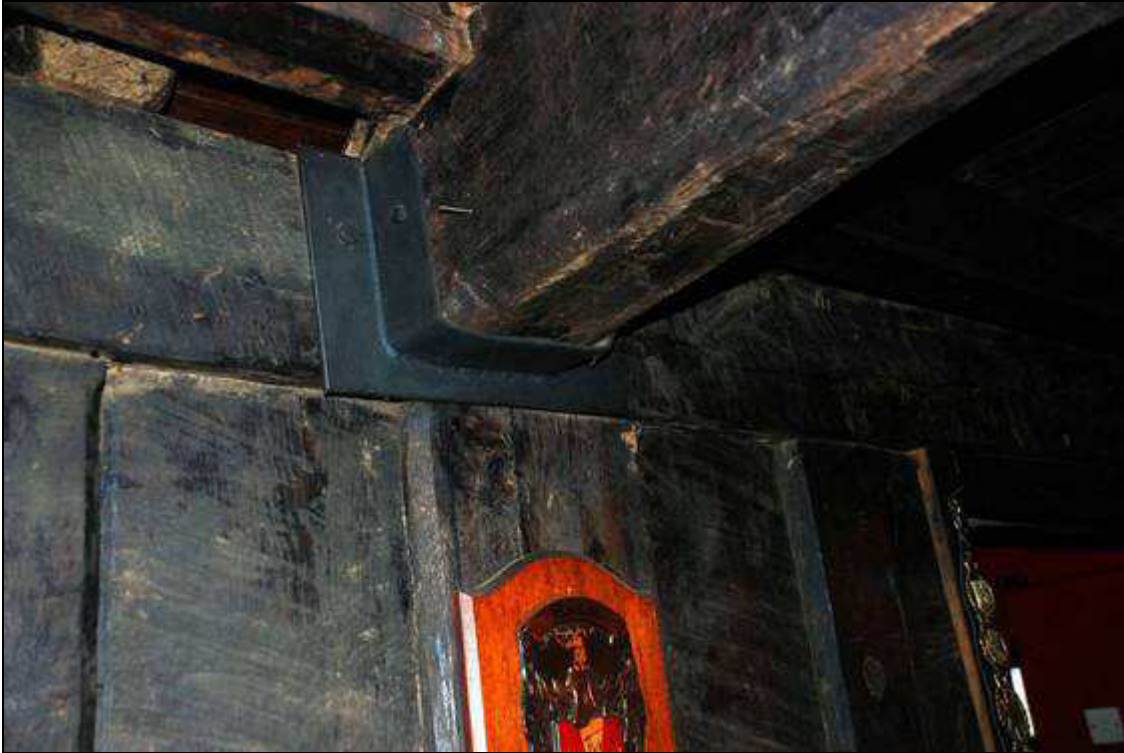
Plate 21: Transverse beam in lower NE room, looking west

It is assumed that the chimney and the floors have been inserted into the pre-existing structure. The fireplace has a large wooden lintel, approximately 0.4 m thick and 3.15 m long. The ceiling of the ground floor north eastern room has a transverse beam, approximately 230mm square with chamfered sides and flat stops at both ends (Plate 21). The joists are largely contemporary with each other, except for the two in the south west corner of the room which are of pine and are clearly replacements. The remaining joists are chamfered and have ogee stops at both ends (Plate 22).

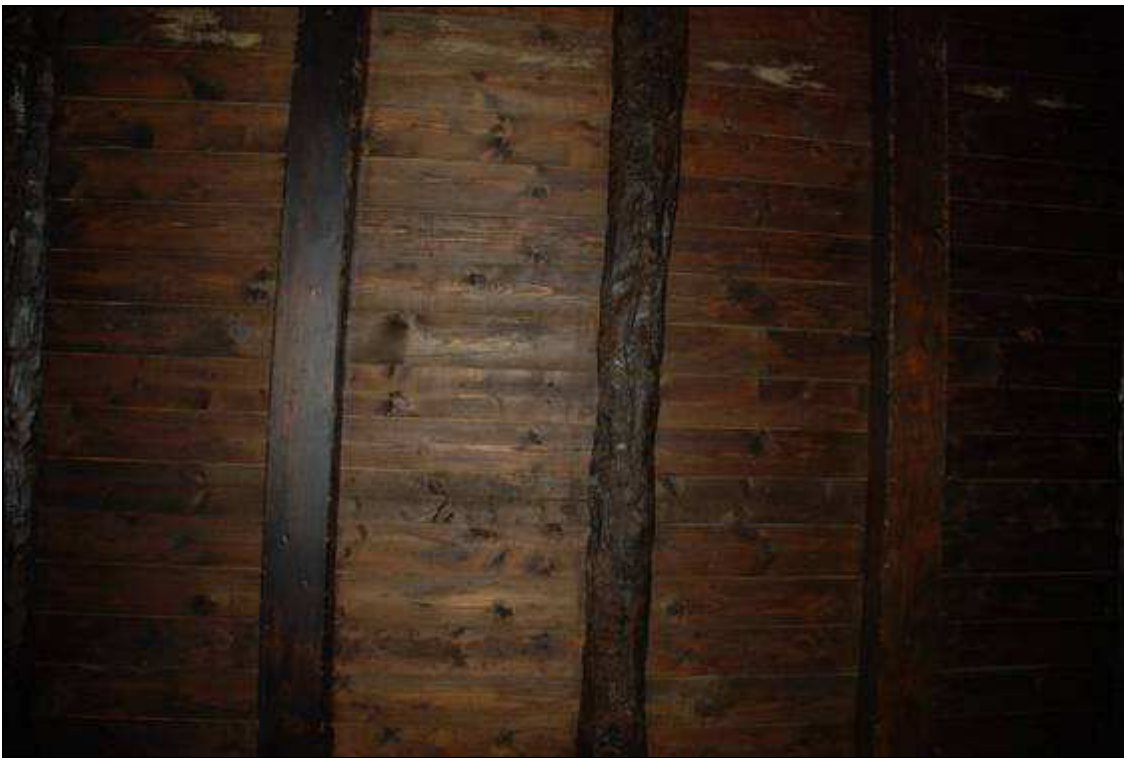
Plate 24: Variation between the ceiling joists in the SW ground floor room

The lower south western room has a rail running adjacent to the gable wall. Originally this rail would have been in contact with the wall, but the movement of the structure has detached the rail from the wall. The rail is chamfered and stopped on its front face, although the face originally in the wall retains its natural, curved, profile. At the south eastern end of the rail there is a cut out, chamfering approximately a 0.7 m length of the top of the rail (Plate 23). It is assumed that this feature marks the position of an earlier ladder access to the loft. The floor joists run between this rail and the partition. They vary between rough cut timbers and squared timbers (Plate 24) reflecting at least one phase of replacement. It is assumed that the square cut joists are later, although this remains speculative.

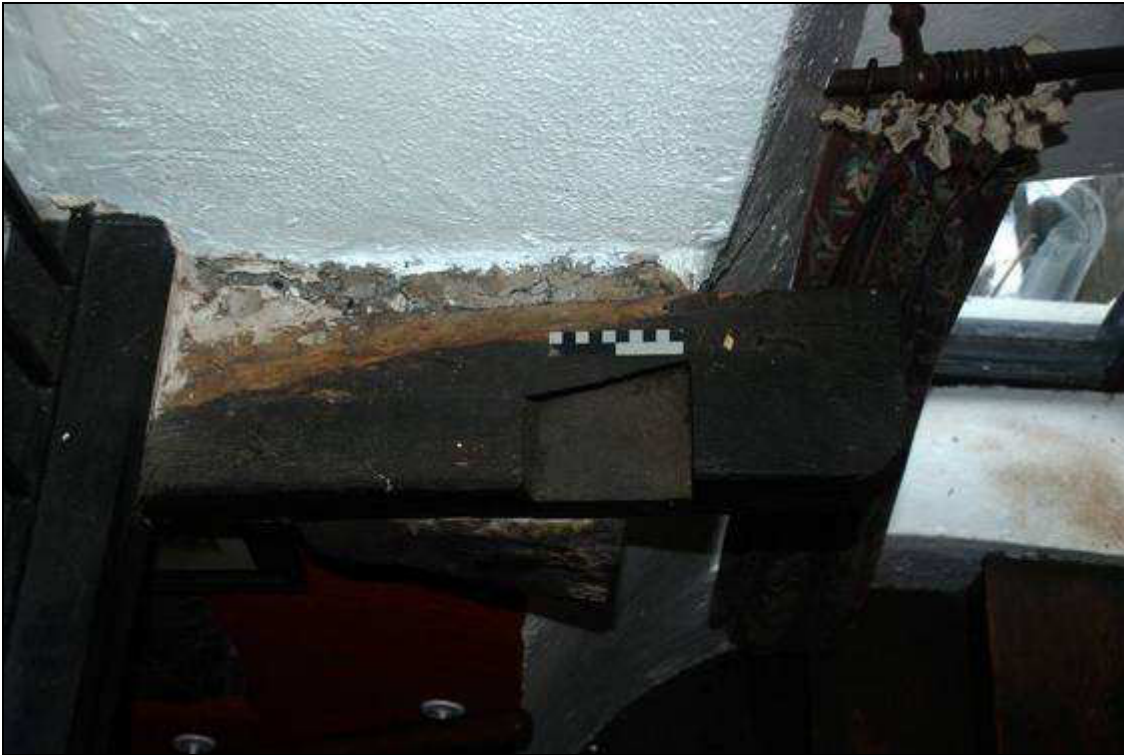
Plate 25: Rail truncated by the insertion of the stair case, looking down

The current staircase is in the northern corner of the north east ground floor room. This is clearly a modern structure, cutting the rail supporting the floor joists on the front wall (Plate 25), but it partly occupies a marked curved recess in the front wall of the property which may have held an earlier staircase (Plate 26).

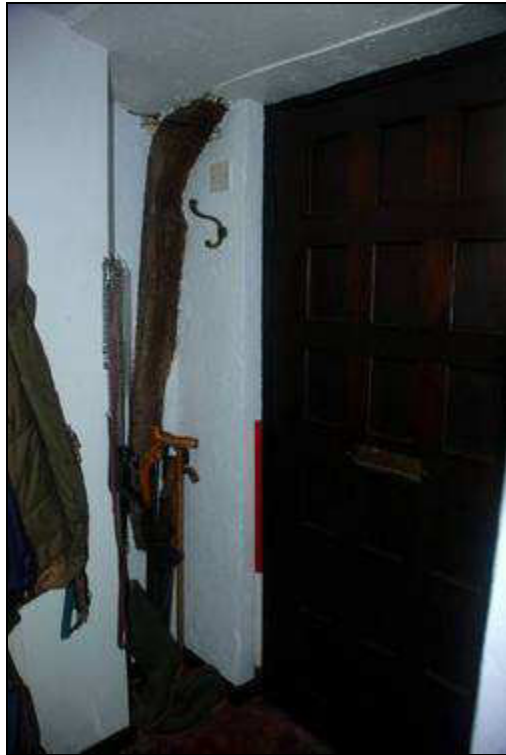
Plate 27: Re-sited door timber, looking west

Within the re-built section of the house, adjacent to the front door is a curved timber (Figure 5.4, Plate 27) which is assumed to be part of the original door structure and has been returned to its original position (Parkinson 1992). It is very worn, but appears to be shaped at its top, possibly suggesting a curved or pointed door head.

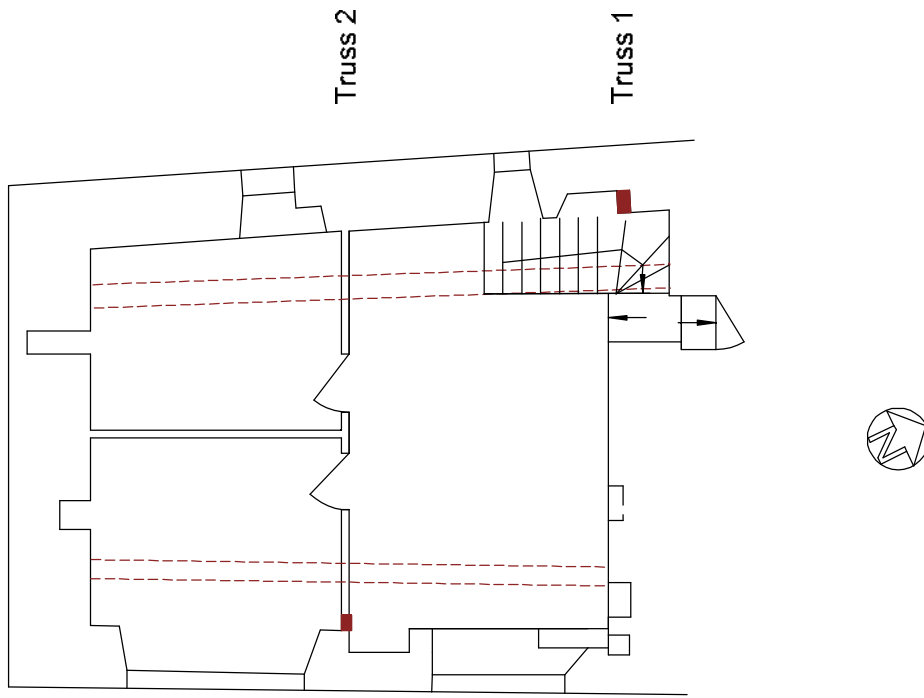
Figure 3: Ty'n Twr, Bethesda
Plan
Scale 1:100

3.1 First Floor

3.2 Ground Floor

The plan produced by A.J Parkinson in 1992 was used as the base for the study of this house. It was slightly modified to include a window which was in the rear wall of the property and to account for slight modifications of the house made since the plan. The first storey plan was made by direct measurement. The drawings of the timberwork were carried out by direct measurement at a scale of 1:20 with the exception of the windbrace which was drawn at a scale of 1:10. Photographs were taken with a Nikon D80 digital SLR camera at a resolution of 10.2 mega pixels. Where practical all the photographs included a metric scale.

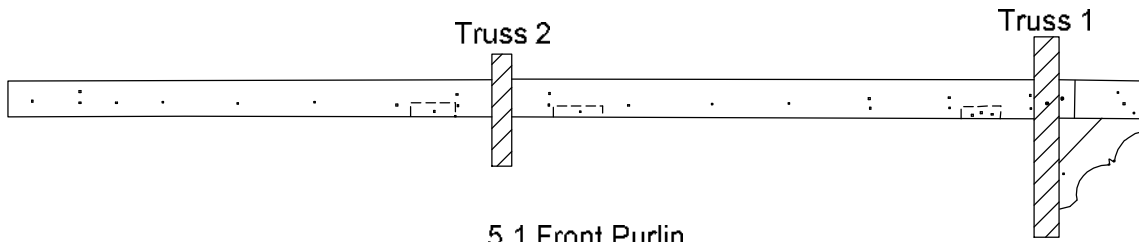
Figure 5: Ty'n Twr
Detailed drawings

5.1 Front Purlin
Scale 1:50

5.2 Detail of Windbrace
Scale 1:20

5.3 Section through the post and plank partition
Scale 1:20

5.4 Timber near Door
Scale 1:50
