North West Wales Dendrochronology Project Ty'n Llwyn, Llangar, Denbighshire

**EAS Client Report 2009/17
December 2009**

EAS Client Report 2009/17

Ty'n Llwyn, Llangar

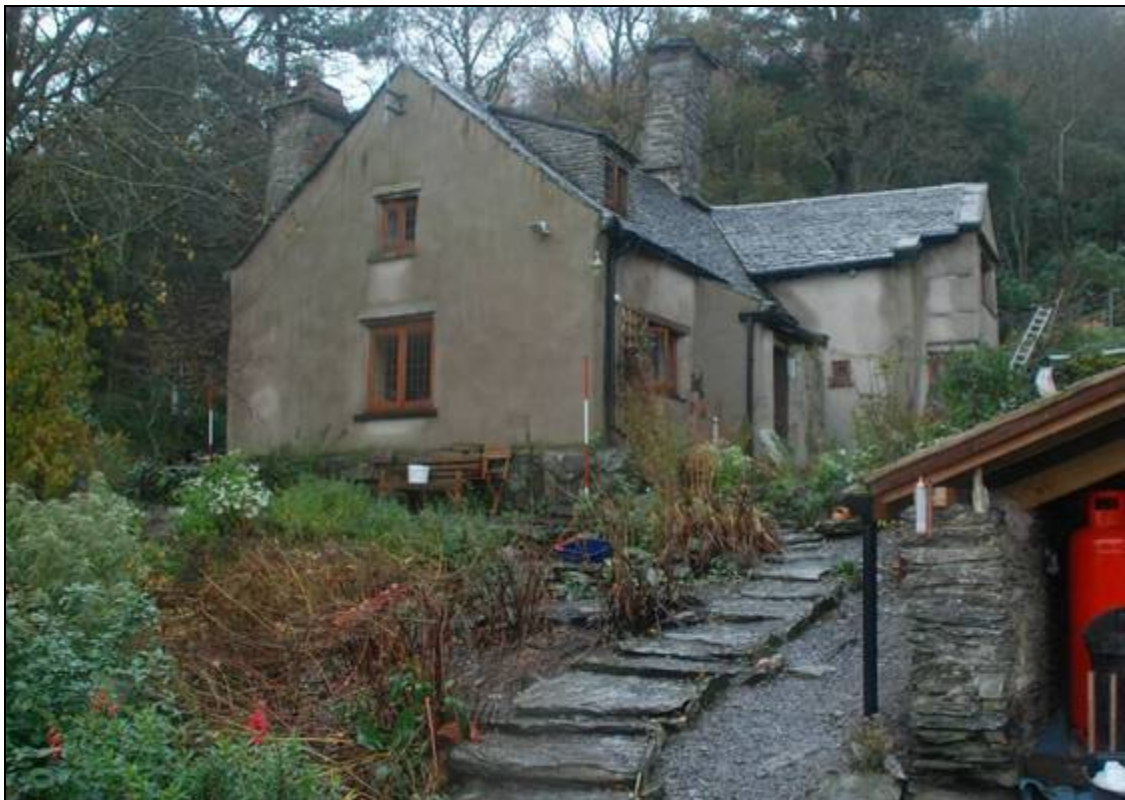
Plate 2: Ty'n Llwyn looking NE

Externally the house appears to be a storey and a half range running at right angles to the hillside with a short wing on the northern side (Figure 2, Plate 2). The walls are rendered, although small areas of exposed walling on the southern side of the property would suggest that they are constructed of randomly built stonework. The roof is covered by small slates and there is a tall central chimney projecting from the ridge. This chimney has a noticeable lean to the west (Plate 3). A secondary chimney protrudes from the southeast corner of the property. There are also a series of gabled and external dormer windows in the upper storey on both sides of the house which are assume to be later additions.

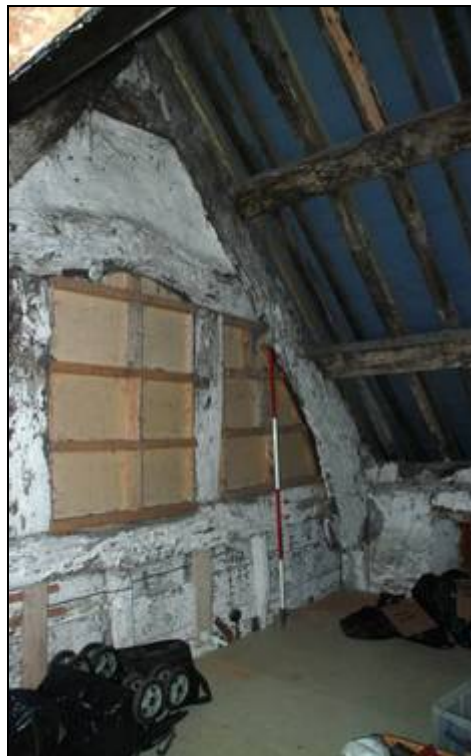
Plate 4: Truss 1 looking NW

Three, probably original, trusses were located within the main range of the building (Figure 2). Truss 1 was exposed, both in a first floor storage room at the west end of the property and in the master bedroom adjacent. The clearest exposure; however, was in the storage room. It consists of a cruck frame with a tie-beam, slightly curved collar and queen struts (Figure 3, Plates 4 and 5). A mortice in the foot of the current extent of the northern principal rafter (Figure 4, Plate 6) may suggest that this sat on a post and therefore could have been a raised cruck. Between the curved collar and a high straight collar, near to the peak of the truss was a panel of white washed lime plaster, assume to be a surviving wattle and daub partition (Plate 7). Two pairs of butt purlins and a ridge purlin were also noted. A series of peg holes along the lower side of the tie-beam mark the positions of a series of studs, presumably from an original partition, now lost. A cut out on the northern principal rafter is assumed to mark the position of a later modification, possibly a partition, now lost (Plate 8).

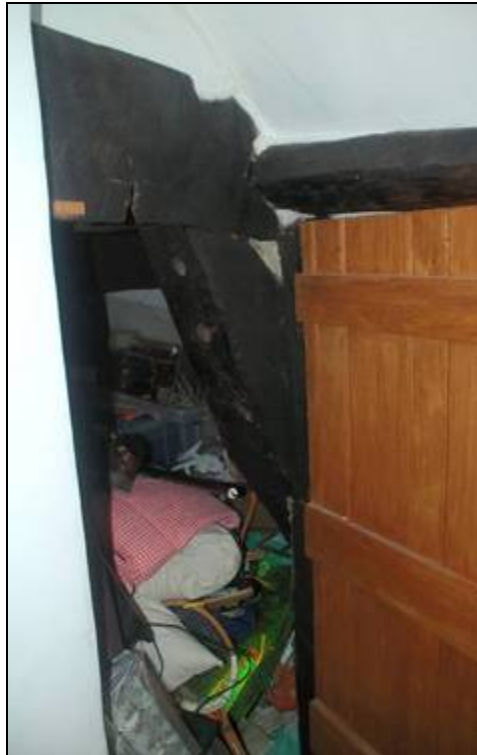
Plate 9: Truss 2, looking NW

There is only limited exposure of Truss 2, in a cupboard off the north side of master bedroom (Plate 9). It extends over the front of the main chimney breast. It is assumed that the chimney was inserted against this pre-existing feature.

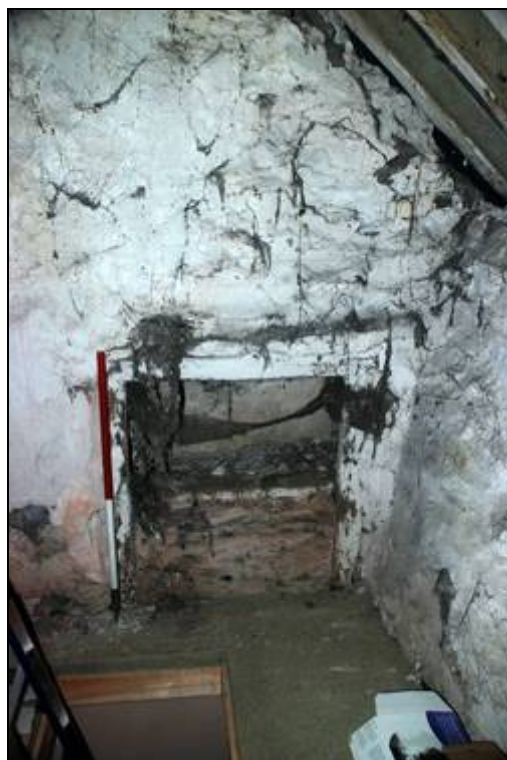
Plate 10: Blocked opening in western gable end, looking east.

Truss 1 sits above two posts which appear to be replacements. On both sides are iron pintels, presumably recording double doors below this truss at some point. Probably related to these pintels are two blocked openings in the gable wall (Plate 10) which appear to be agricultural in nature. Below the tie-beam of the truss are a series of three wide planks supported by modern wooden studs and jointed by an iron fishplate.

There is some indication that the western end of the building may have been used for agricultural purposes. The extent of agricultural use is uncertain, however the presence of pintels below Truss 1 and blocked openings in the eastern gable wall suggest that this was at least the area to the east of Truss 1. This may relate to the construction of Brynllwyn.

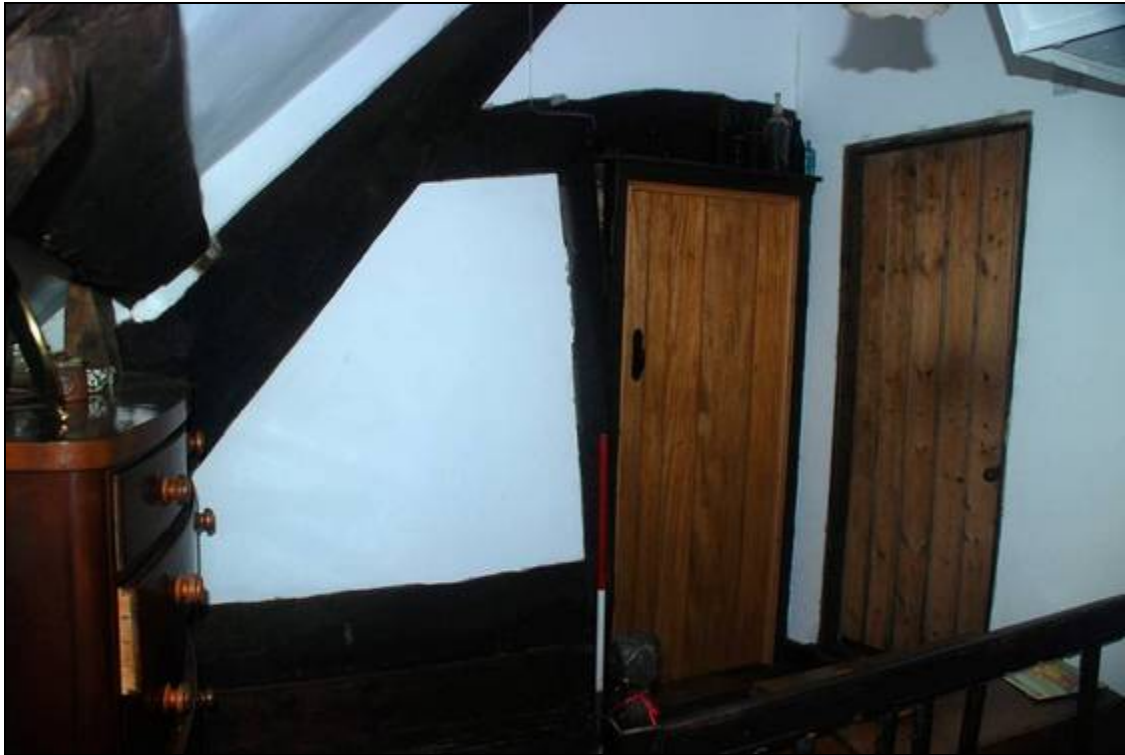
Plate 11: Truss 3 looking west.

Truss 3 appears to mark the western side of the cross passage, separating the hallway from the kitchen (Figure 3). The principal rafters have a slight curve at their base suggesting they may have been cruck frames (Plate 11). Once again there is a tie-beam and a slightly curved collar. The queen struts have been damaged by the insertion of a door, below the collar and between the queen struts. The relationship between the tie-beam the southern queen strut and the underlying post has been revealed by the insertion of the door (Figure 4). There is some indication that there have been windbraces linking this truss to the lower purlin in the form of an open socket on the upper surface of the purlin (Plate 12). On the ground floor there is a stud and rail partition on the southern side of the house (Plate 13). The post forming the southern side of the partition has its lower end removed at a height of 0.6 m above the current floor level which has been supported by two short studs supporting a short rail. Peg holes on the post suggest that the main middle rail of the partition may have continued.

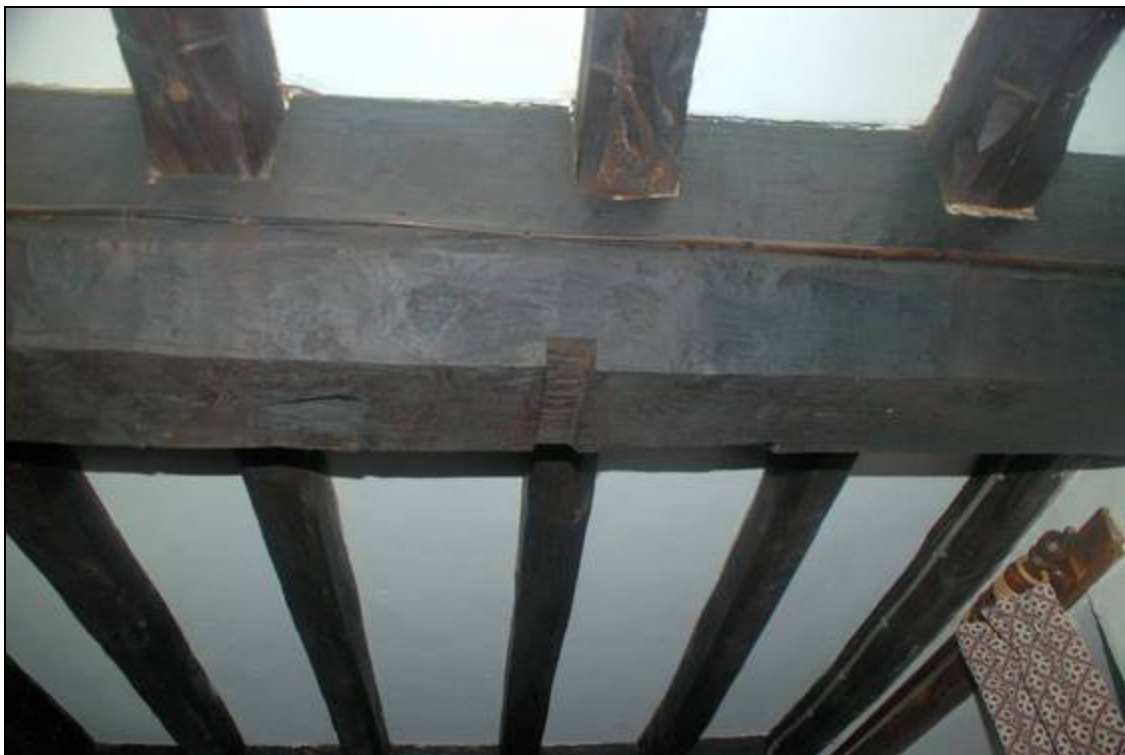
Plate 14: Main room ceiling beam and housed joists, looking west.

The chimney and upper floor are inserted into an earlier structure. The fireplace was inserted against the central truss, preserving the probable extent of the original passageway. Graffiti on the side of the fireplace of 1656 presumably gives a *terminus post quem* for the insertion of the fireplace and the upper floor. The floor in the main room consists of a main beam and a series of housed joists (Plate 14). Both the joists and the beam are moderately chamfered (Figure 4) and are stopped at both ends. The beam has flat stops (Plate 15) whilst the joists

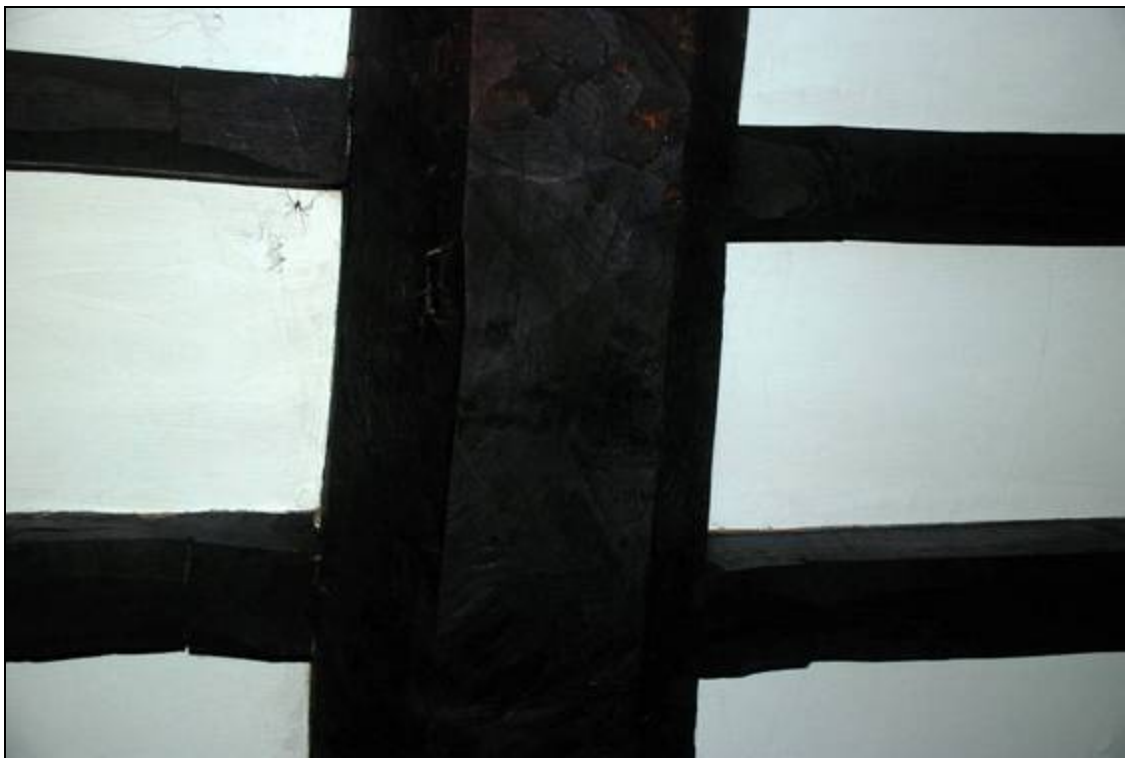
Plate 16: Chamfer and stops on the joists in the main room, looking up

have stepped stops (Plate 16). A slot cut into the main beam (Plate 17) suggests the position of a temporary division of the room.

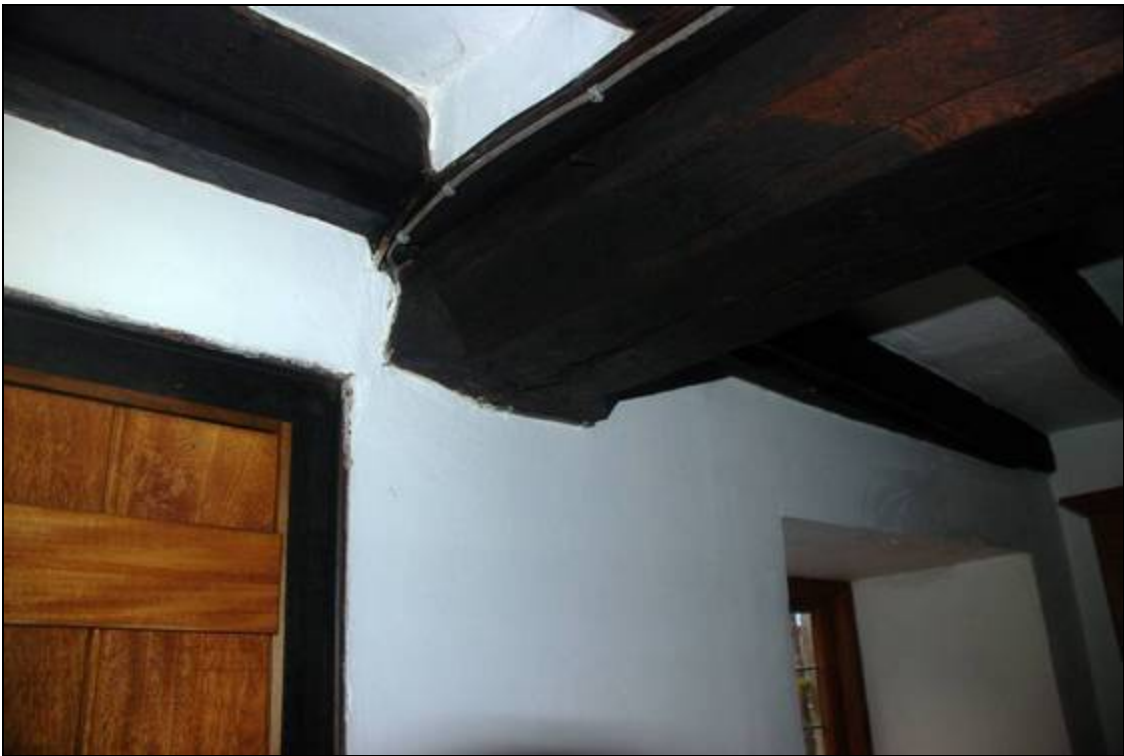
Plate 18: Form of the ceiling beam in the kitchen, looking south

The room currently used as the kitchen also has an inserted ceiling consisting of a central chamfered beam with squared cheek pieces on either side of the beam (Figure 4). Both the beam and the joists have angled run-out stops (Plates 18 and 19). The beam also has a daisy-wheel (Plate 20) inscribed on its eastern side near to the current external door to this room. It is likely that this floor was added in the eighteenth century and may relate to a cupboard door carved with a date of 1735.
