**EAS Client Report 2015/02
February 2015**

**Dating Old Welsh Houses Group
Gwerclas, Rhug, Denbighshire
SJ 05296 42144**

EAS Client Report 2015/02

Gwerclas Out Building

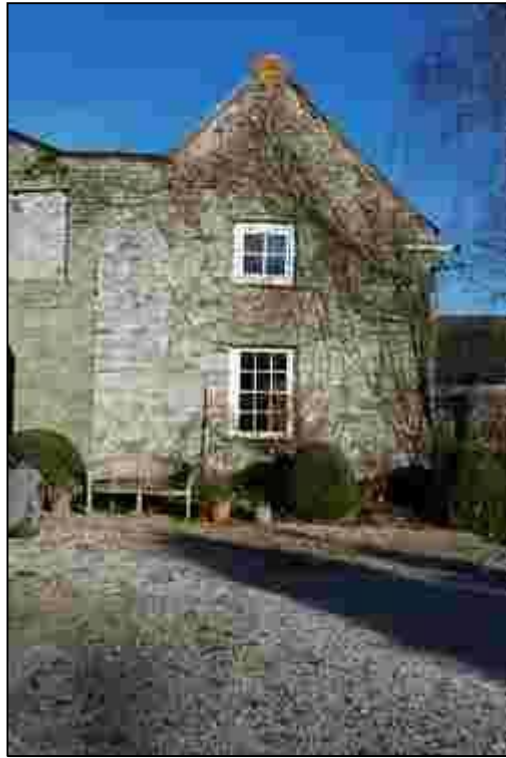
Plate 1: Southern gable end

The recorded building is a storeyed, stone built range constructed of roughly coursed, sub-rounded blocks with slightly larger quoins. The southern gable end (Plate 1) has two centrally placed windows, one for each floor. The ground floor window is a twelve paned sash window with a stone lintel, whilst that on the first floor is four paned casement window also with a stone lintel. The small brick chimney is clearly of a later date than the rest of the gable and it appears to have been constructed with handmade bricks of a size typical in the eighteenth century. The linking corridor to the main house (Plate 7) is a later addition, with its southern facade being finished in squares, coursed blocks. The arched

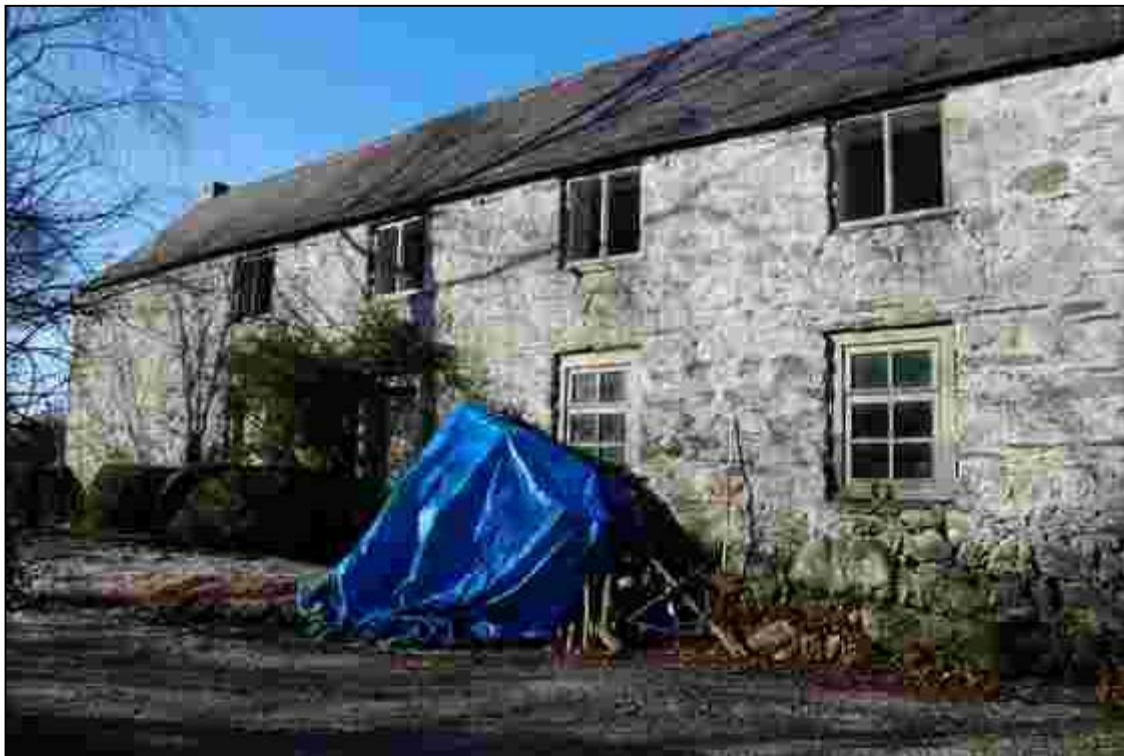
Plate 2: Eastern elevation

The eastern elevation has two doorways set in its southern half (Plate 2). The northern of these is roughly central to the elevation, whilst the southern doorway is closer to the central doorway than the southern gable. Both of these have modern ledged doors. The windows on the ground floor are of a common form with a four paned casement being set below two panes. The first floor windows now only contain empty frames with a central wooden mullion. All of the openings have stone lintels and the windows also have stone sills. At the northern end of the eastern elevation the boulder footings are exposed (Plate 3) suggesting that this end of the building was originally partly terraced into the natural slope.

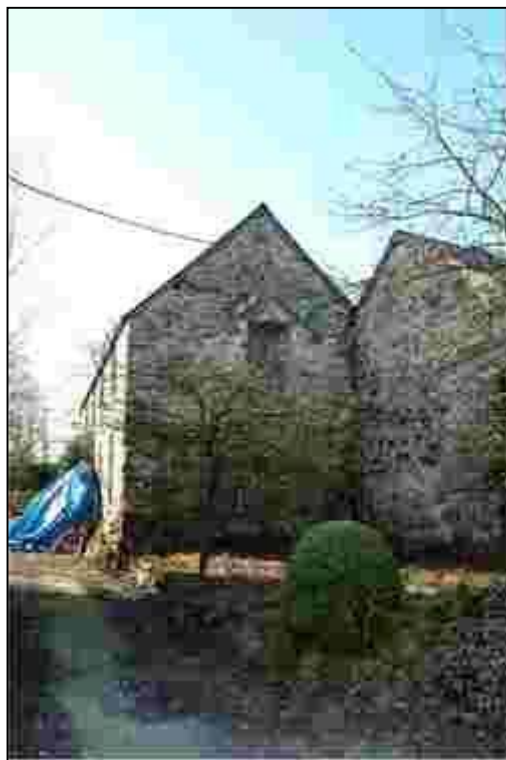
Plate 4: Northern gable end

The northern gable (Plate 4) has a door-sized pitching hole set at first floor level which is filled with a six-planked ledged door. The opening has a wooden lintel and there is the scar of a canopy above. There is a straight joint between this range and the barn forming the northern end of the courtyard suggesting that the barn is of a later date.

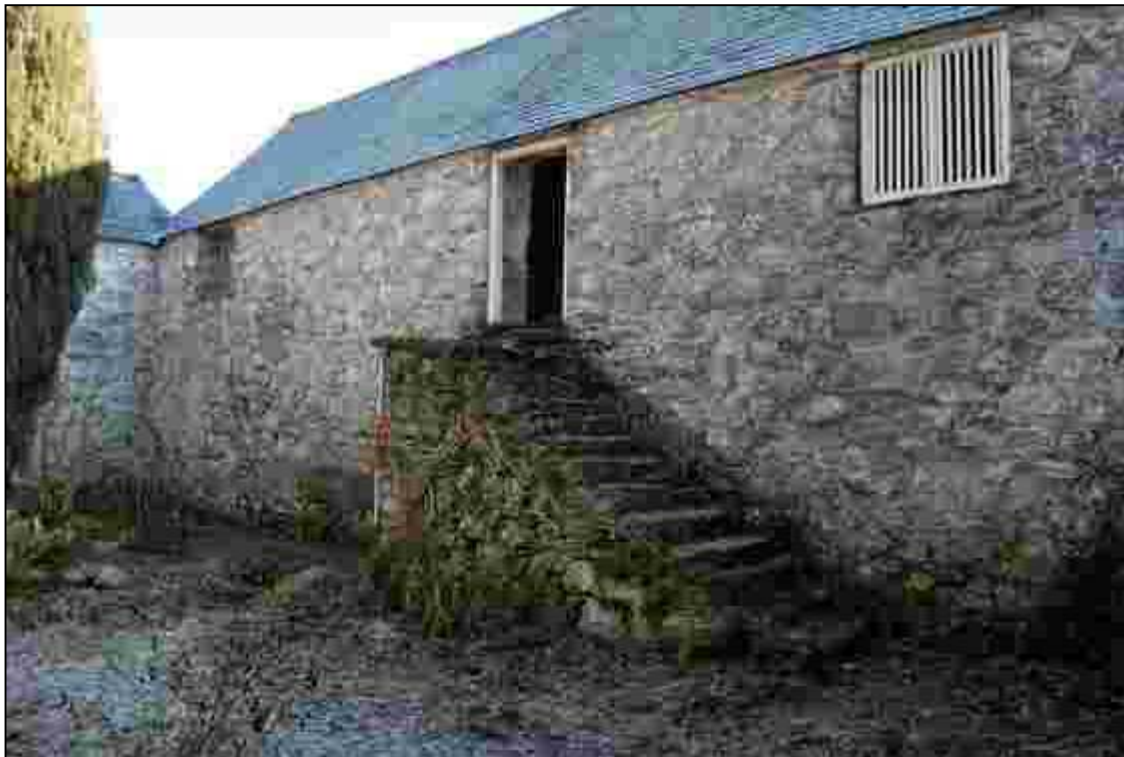
Plate 5: Western elevation

Within the courtyard, the western elevation (Plate 5) has three openings, all at first floor level. The centrally placed doorway is accessed by means of a set of external stone steps (Plate 6). It has a six-planked ledged door below a wooden lintel. There are also a series of square stone quoins on either side of the opening suggesting this doorway may be a later opening. The two windows are filled with modern wooden louvers and have sawn wooden lintels. The northern face of the linking corridor (Plate 8) demonstrates the working nature of this side of the corridor. Unlike the southern elevation it is constructed of poorly coursed, rough, stonework. There is also a partially blocked arched opening in this elevation which unlike the southern elevation does not have stone voussoirs. The blocking is with brick.

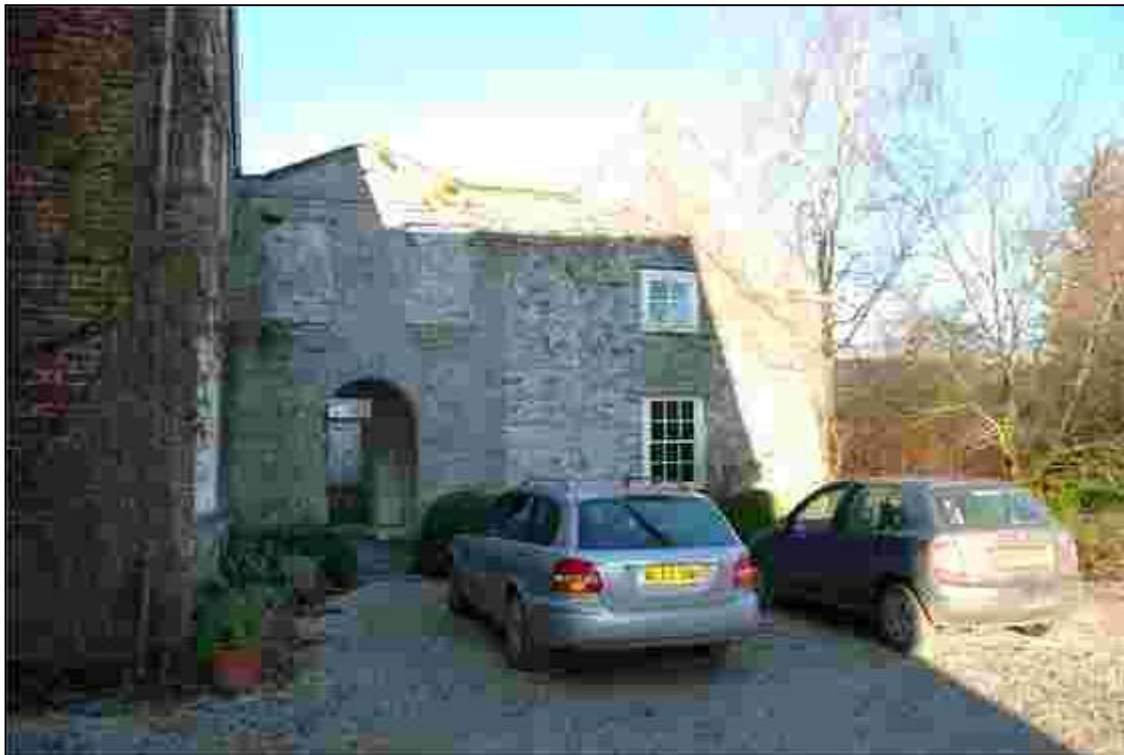
Plate 7: Linking corridor

Gwerclas is located approximately 3.6 Km, NNW of the village of Cynwyd, Denbighshire, on the western banks of the Afon Dyfrdwy (River Dee) (Figure 1). The building recorded forms the eastern side of a small courtyard (Figure 2), approximately 15 x 7 m in size, which is bounded to the west by a stone built range attached to the main house; to the north a barn and to the south by a, stone built, linking corridor (Plate 7).

entrance with its stone voussoirs and triangular pediment gives this structure a classical appearance.

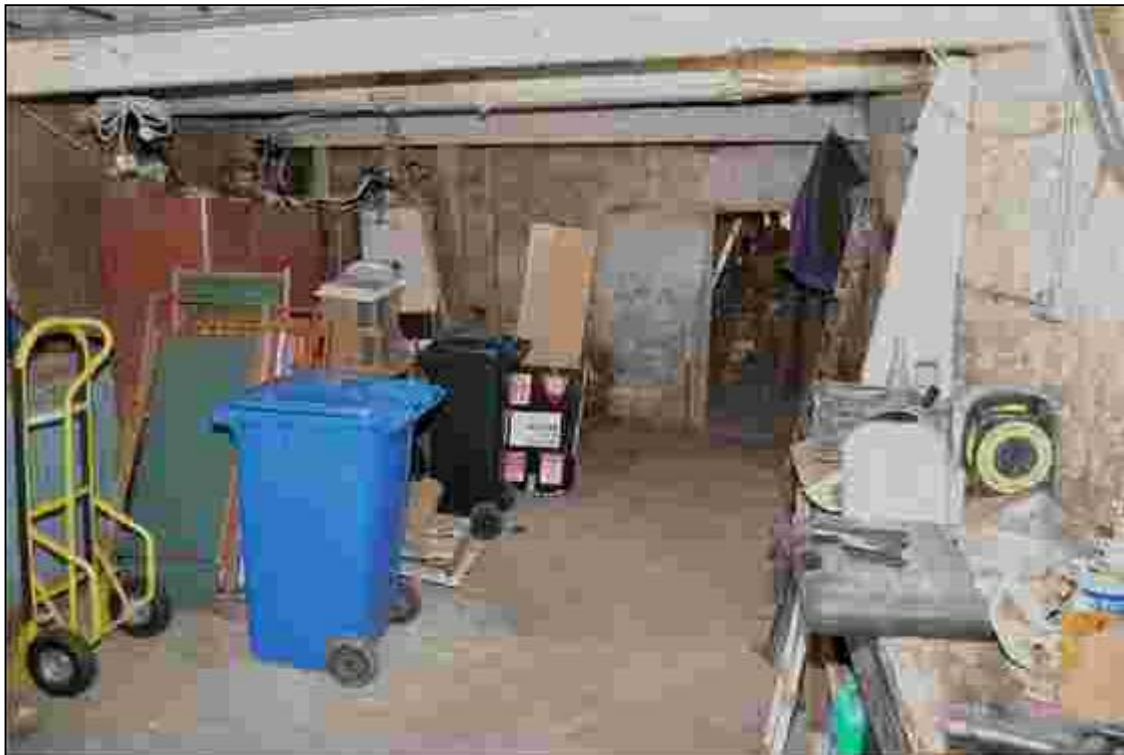
Plate 9: The southern, ground floor room

On the ground floor (Figure 3) the building is divided into two rooms by a later brick dividing wall. The southern room (Plate 9) has two larger transverse ceiling beams separated by later, smaller, sawn beams. Both of the larger beams are moderately chamfered and the southern beam has straight stops (Plate 10) and a series of mortice holes (Plate 11) suggesting that there has been a partition below this beam. There is also a series of three scratch marks below one of the joists which appears to be a carpenter's mark (Plate 12). The northern beam has run-out stops at its western end (Plate 13) and stepped stops at its eastern end (Plate 14).

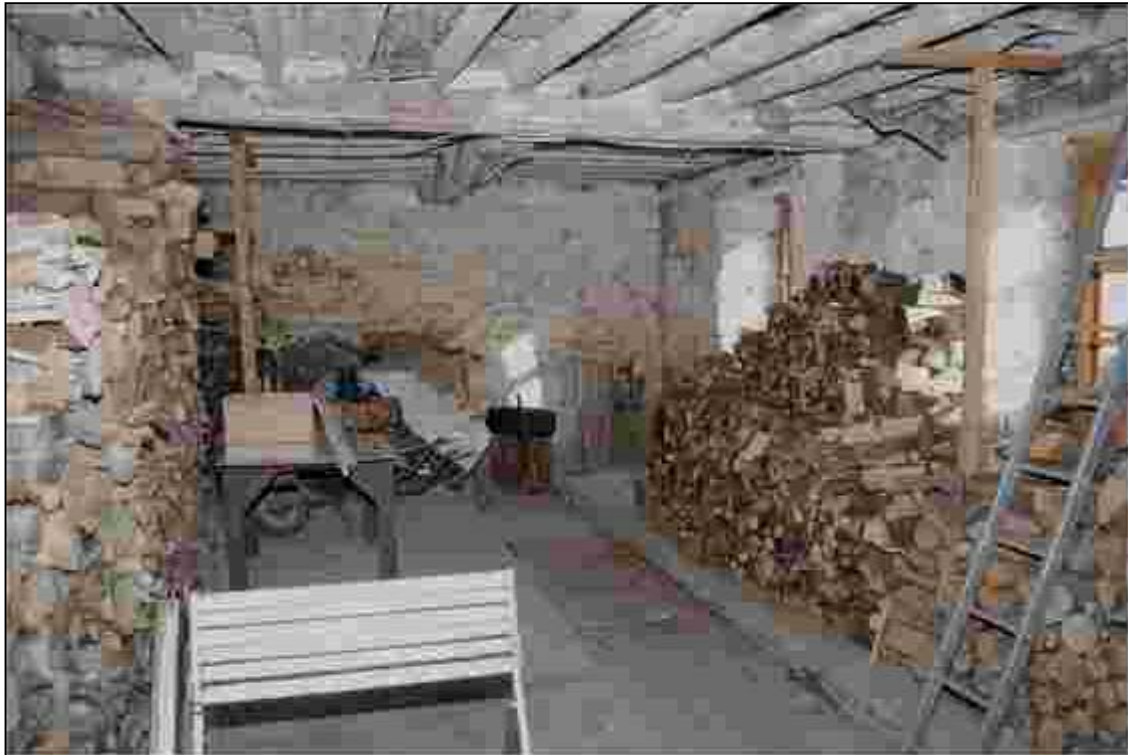
Plate 15: The northern ground floor room

The northern room (Plate 15) has two transverse beams and a lateral beam between the northern gable wall and the northern lateral beam. These beams are moderately chamfered and have straight stops (Plate 16). The northern transverse beam also has a series of mortice holes suggesting there was a partition below this beam (Plate 17). Adjacent to the dividing wall is a blocked opening (Plate 18) which appears to have been a doorway. This is directly

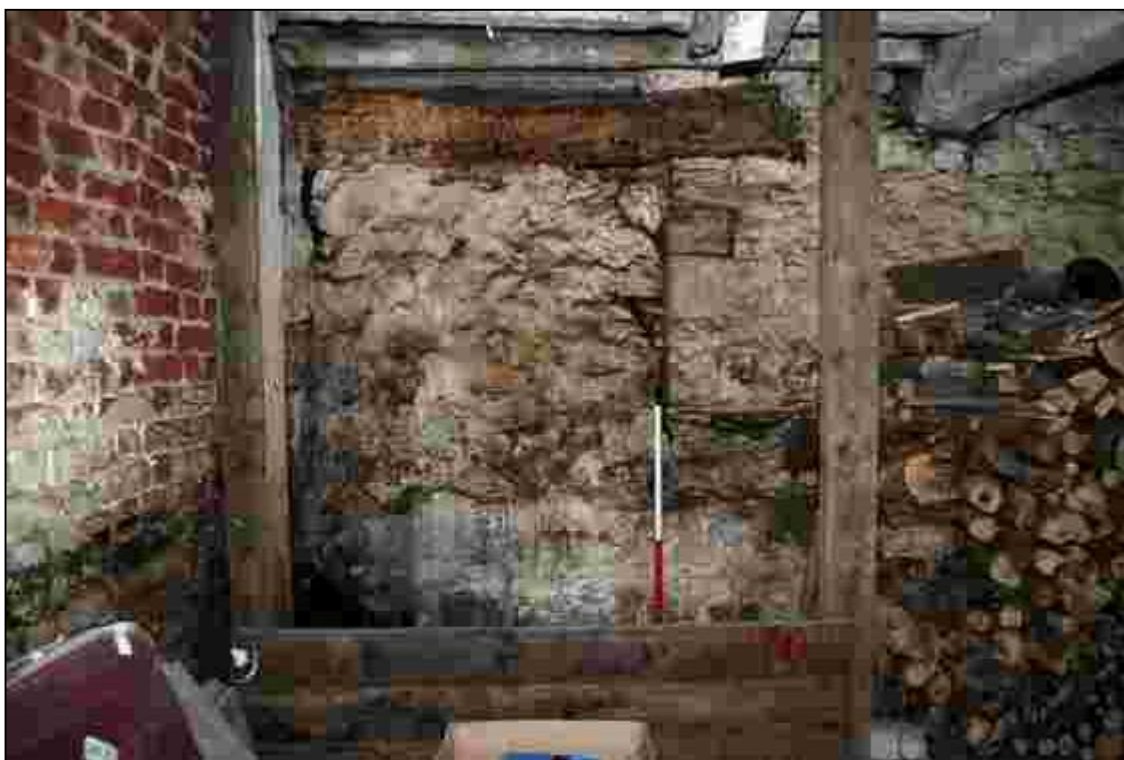
Plate 18: Blocked doorway

opposite the centrally placed doorway in the eastern wall and behind the external stone stairs to the first floor suggesting this door was blocked when the first floor entrance was added. The opening had a large wooden lintel and squared stone quoins. Prior to its current use as a store, this room appears to have been used as a cow house and the remains of the feed rack survives at the northern end of the building (Plate 19).

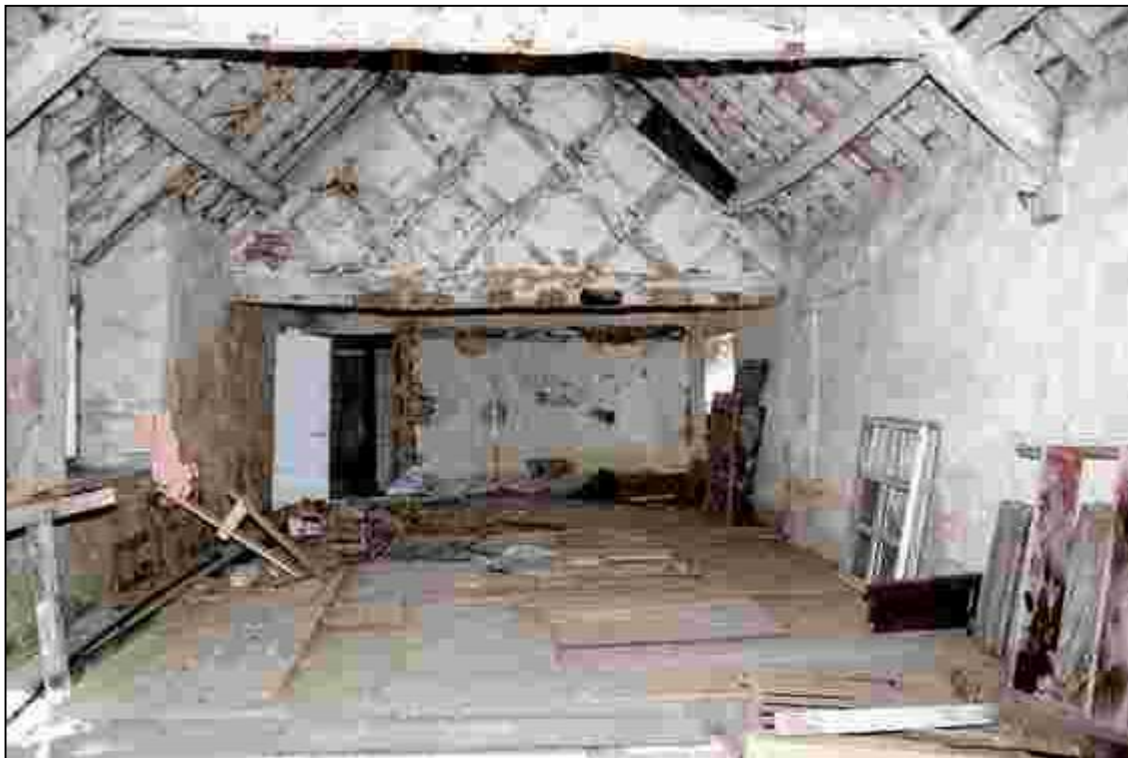
Plate 20: Southern, first floor room, looking north

The first floor is divided into five bays by the four trusses (Figure 4). There is a further division into two rooms with the addition of a plank and muntin screen below Truss 3. The southern room (Plate 20) has a partial attic between Trusses 2 and 3, however, the majority of the building has an open space to the roof structure. There is a blocked opening on the eastern wall which appears to have been a window with a wooden lintel (Plate 21). Truss 1 (Plate 22) has a tie beam and two, slightly curved, raking struts. It also has trenched purlins.

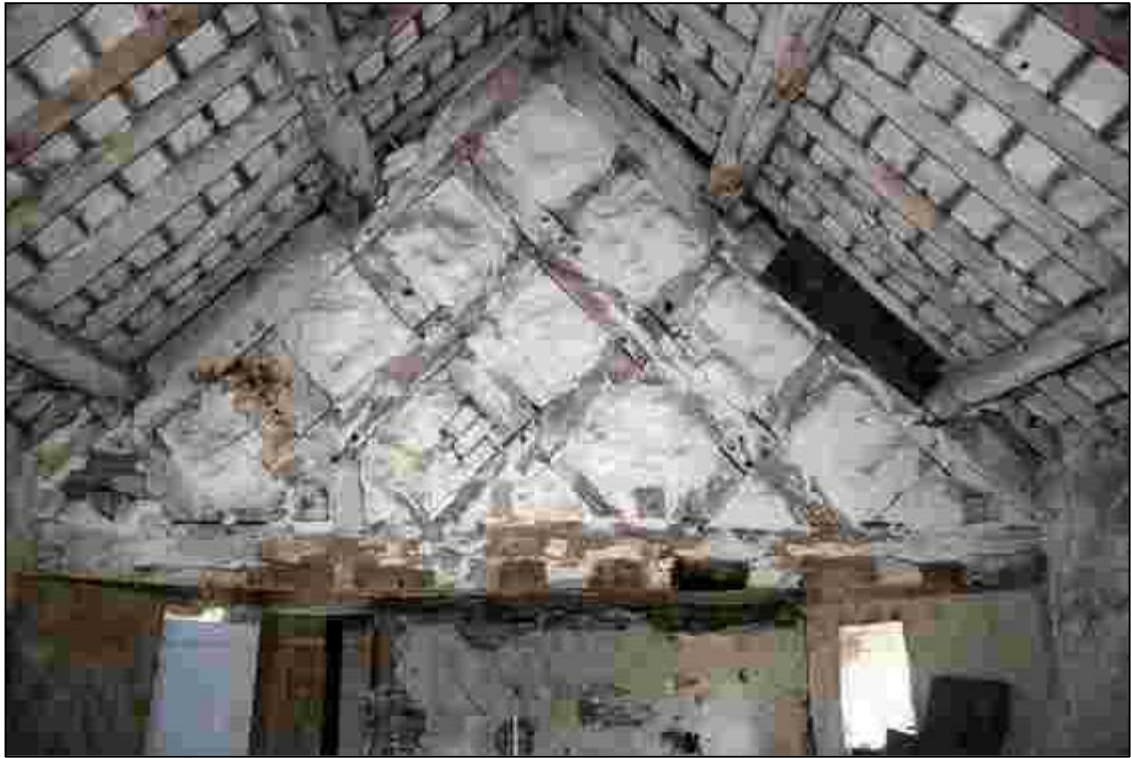
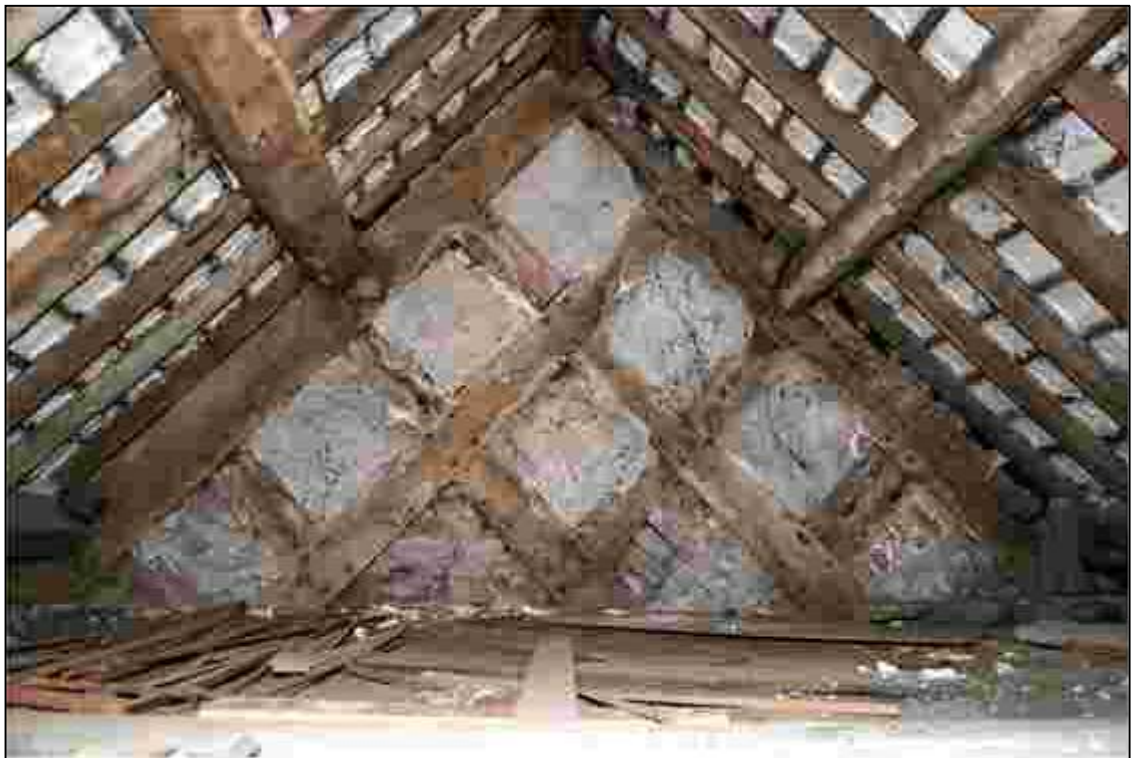
Plate 23: Truss 2

Truss 2 (Figure 5, Plates 23 – 24) is distinctive with a lattice of timbers filling the space above the tie-beam. The spaces between the lattice timbers is filled with hand-made bricks which were between 55 and 70 mm thick. The majority of the panels had their bricks set parallel with east leaning struts, however one panel has the bricks set horizontally. Both sides of this partition had been rendered with lime mortar, however the render on the southern face may also have covered some of the timberwork. Three of the lattice timbers have carpenters marks at their lower ends being marked “III” (Plate 25), “V” and “VI” (Plate 26). The strut marked “VI”, at its base, is also marked “III” at its top end. The tie beam also has matching marks for the beams marked “III” and “VI”. The underside of the tie-beam also has a series of mortice and dowel holes (Plate 27) suggesting that there was a partition below this truss. At least four vertical timbers were separated by a series of dowels suggesting panels of wattle and daub between the timber supports.

It has been argued that the lattice infill within Truss 2 was originally an end truss with the decorative latticework being visible from the main house (Bridge and Miles 2014). The mortice holes and dowel holes below the tie-beam, however, would suggest that there was a timber and wattle and daub partition below the truss of a form not usually associated with an external wall. It is noticeable that this partition contained panels of wattle and daub, rather than the brickwork present within the truss itself.

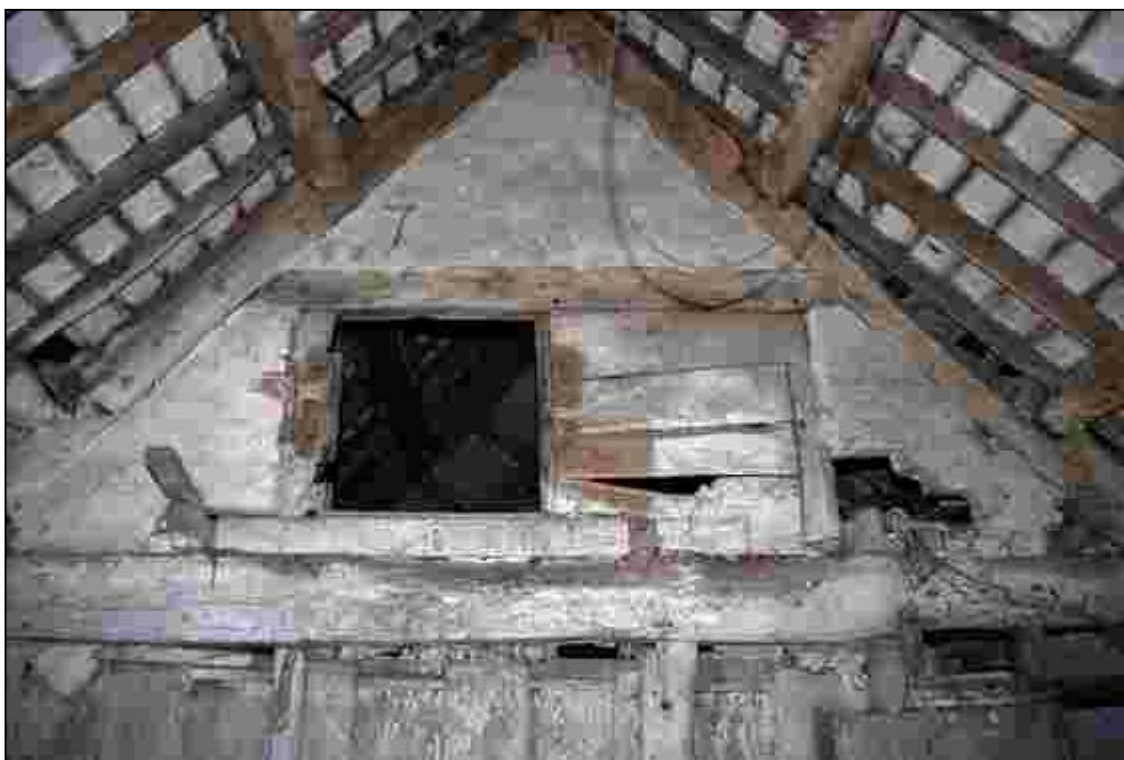
Plate 28: Truss 3 and the access to the attic

Between Truss 2 and 3 is a partial attic which had an access hatch through Truss 3 (Plate 28). Although partly filled by brickwork Truss 3 (Figure 6) essentially has a queen post structure, however there is also a central vertical strut between the tie-beam and the collar. The hatch occupies the space between the eastern queen post and the central strut, whilst the area between the central post and the western queen post is blocked with rough planks. The panels either side of the queen posts and above the collar are filled with hand-made bricks which have been rendered with lime mortar. Below the tie-beam are a series of mortice holes suggesting there was a partition below this truss, probably with a doorway towards its western side. This is not, however, the plank and muntin screen which is occupying the space currently (Plate 29). This partition appears to have been re-used and is effectively leaning against the southern side of the tie-beam for Truss 3 and is being held in place by two short timbers lodged into the mortice holes for the original partition. There are two vertical slots in one of the planks (Plate 30) which presumably held a structure originally attached to the partition in its original position. At the western end of the partition a gap is partly filled with a re-used window shutter (Plate 31) which has “H-hinges” linking the panels.

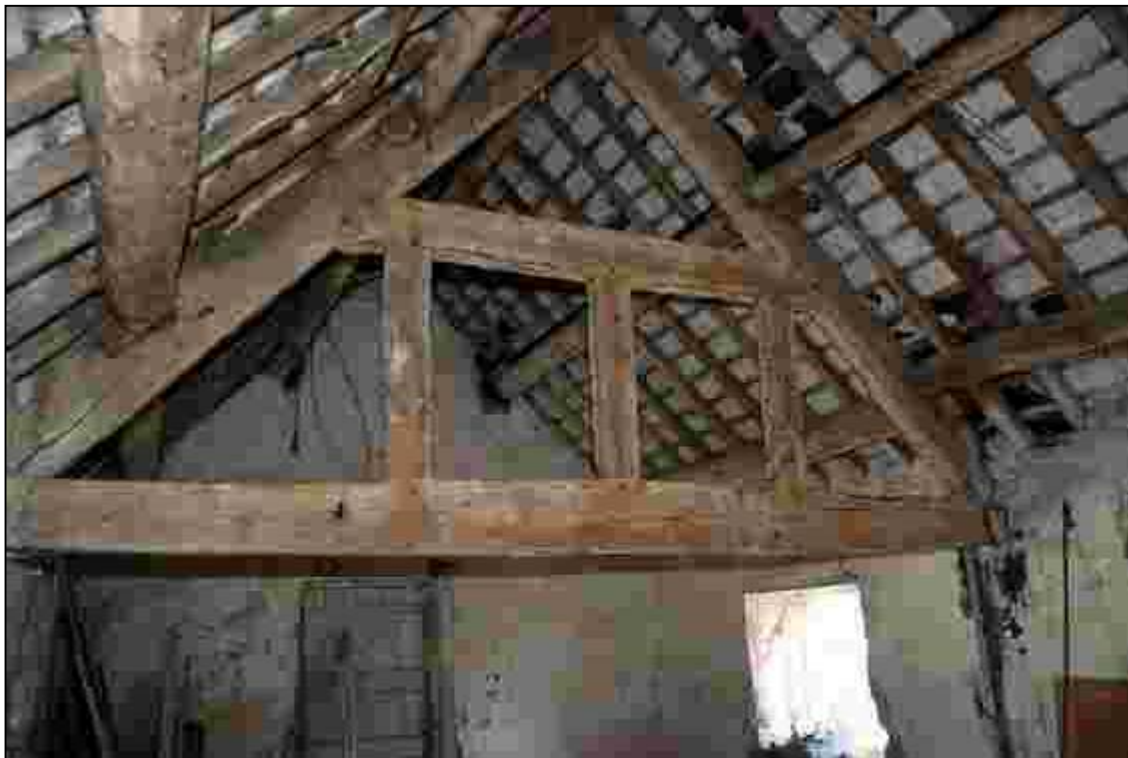
Plate 32: Truss 4, looking north

Truss 4 (Plate 32) is of a similar design to Truss 3, however it contains none of the blocking features, nor evidence of a partition below.

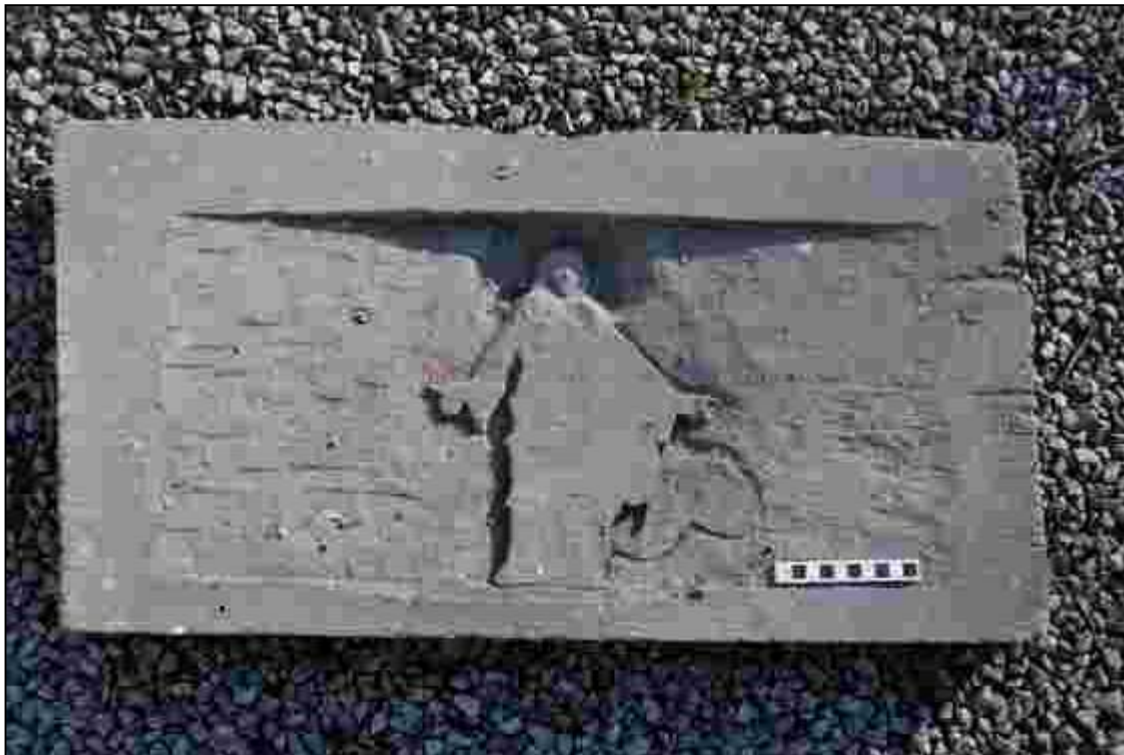
Plate 33: Carved wooden plaque

Whilst not directly related to the structure of the building, a wooden plaque was found covering a hole in the floor of the first floor southern room (Plate 33). This depicts a bearded man, the face of which was the only area which has been defined in any detail. The date and original function of the plaque is uncertain, however the face has some similarities to late 17th century carvings.
