# **Pontrickett Ceiriog Ucha**

## **Historic Buildings Record**

Martin Cherry and Ross Cook

September 2019

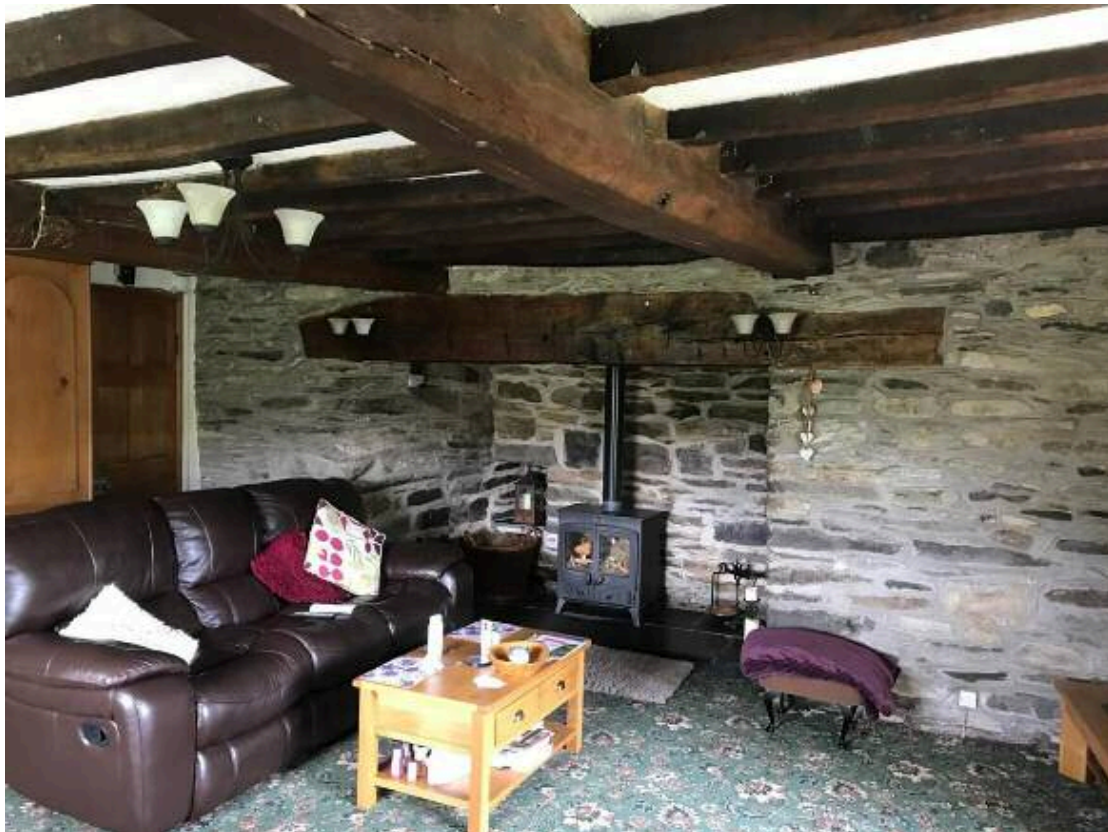
Fig. 4 – Parlour wing: ground-floor room, reconstructed after a fire, with slip tenoned joists. The chambers above this room were retained along with the principal rafter roof structure.

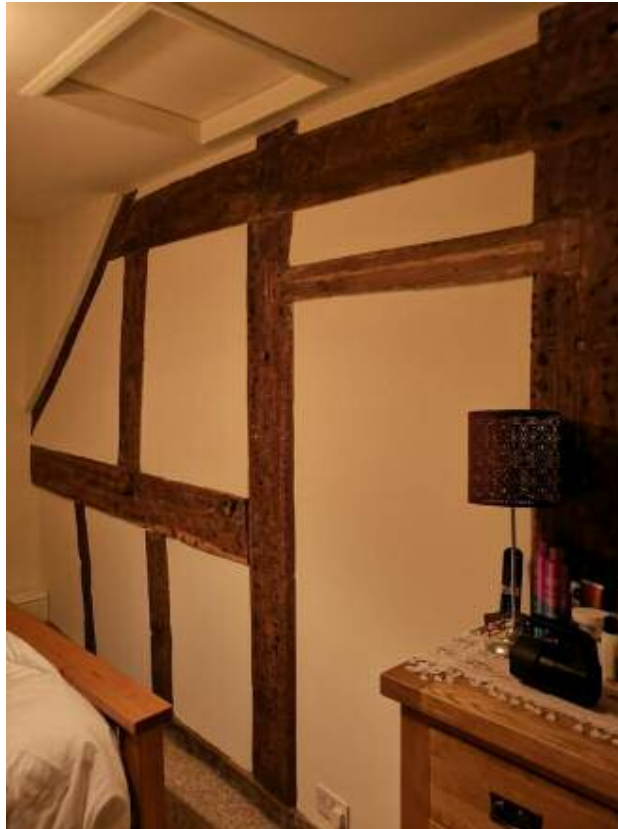
Fig. 5 – Wing partition framing at first floor.

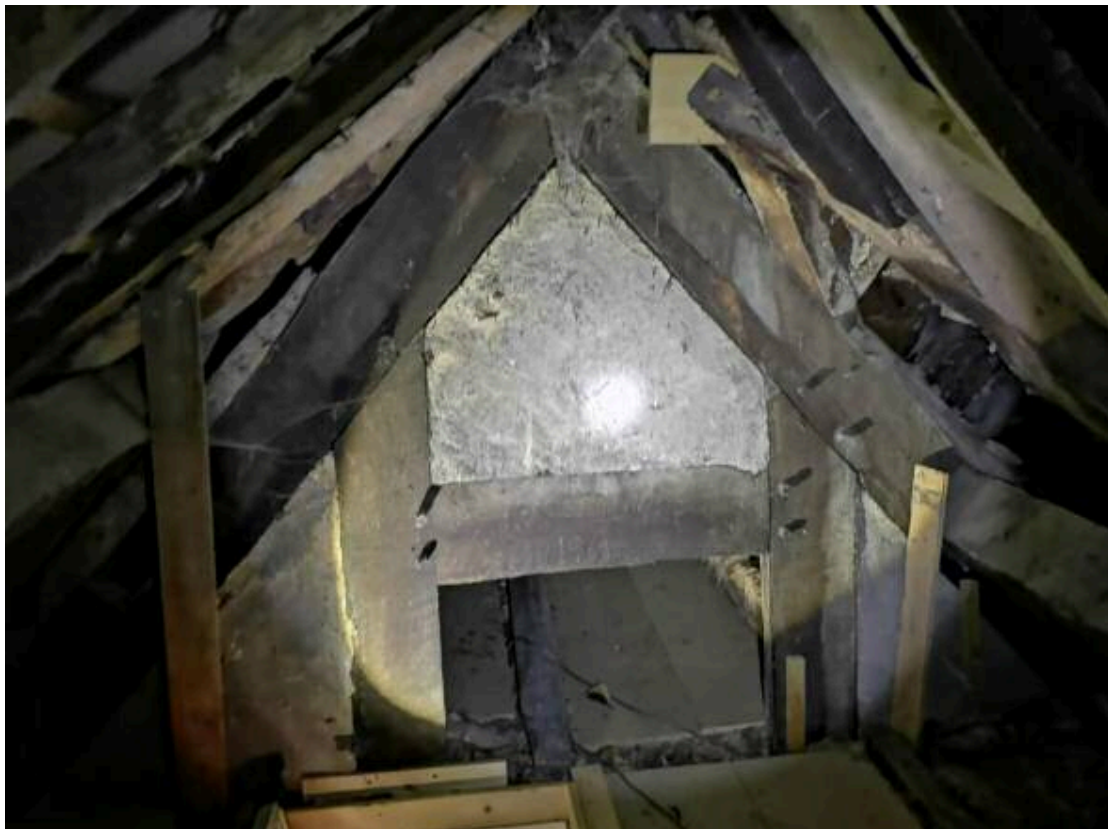
Fig. 6 - Wing partition framing in attic.

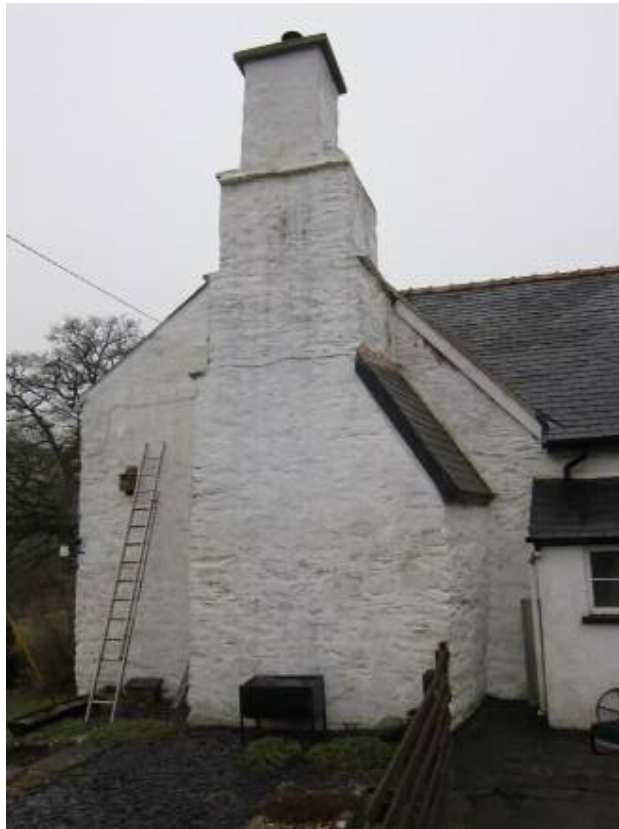
Fig. 7 - The external stone stack added to the parlour wing that was otherwise rebuilt within the footprint of the original cruck-framed hall house.
