**North West Wales Dendrochronology Project
Felin Moelfre, Llanaelhaearn,
Gwynedd**

**EAS Client Report 2010/07
March 2010**

**By
I.P. Brooks and K. Laws**

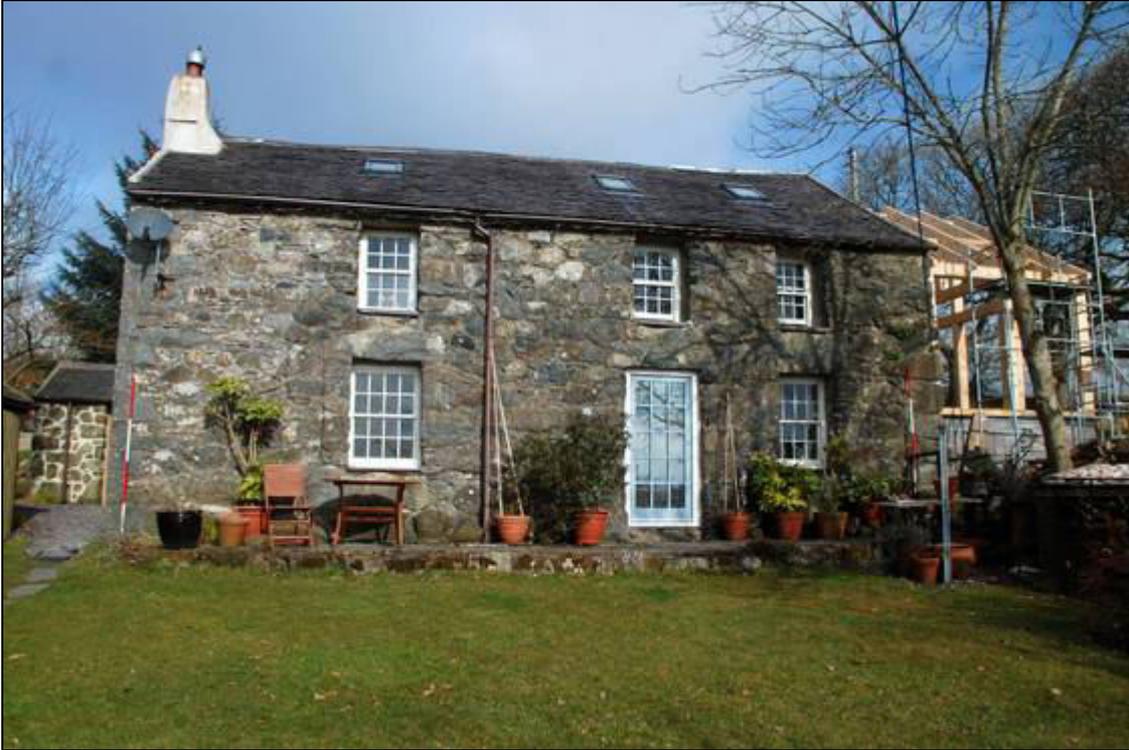
Plate 1: Front elevation

Externally the house has clearly been constructed in three major phases. An initial, two storey, house was approximately 11.2 x 8 m in size. This was constructed of roughly coursed stone boulders with large boulder quoins and lintels. It was aligned ENE WSW (Figure 3) at right angles to the lane to the farm buildings of Moelfre Fawr and to Moelfre bach. The door and windows in the front elevation (Plate 1) are offset to the east, allowing for a large fireplace in the western end of the original building. There are two ground floor windows, each of which are wooden, sixteen pane sash windows. The three first floor windows are smaller than those on the ground floor consisting of twelve pane sash windows. The door is clearly a modern fifteen pane glass door. The slate roof has three sky

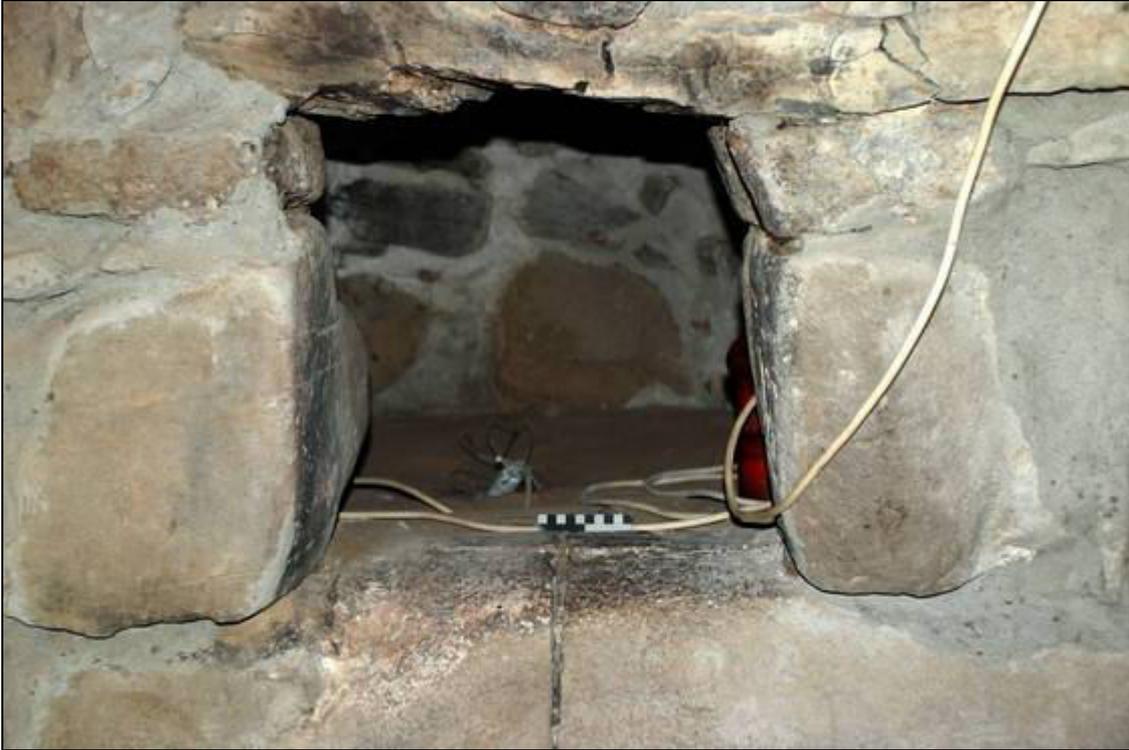
Plate 9: Oven, looking NW

The main range is now a single room, but was presumably sub-divided into at least two rooms with a dividing corridor leading to a staircase in the past. The room is dominated by the large fireplace at the western end with a large wooden bressumer (Plate 8). In the north western corner of the fireplace is an oven (Plate 9). The oven is roughly circular and has a disused mill stone as its base. This stone is a fine grit, top stone with a large eye (Plate 10). It is well worn, now being only 60 mm thick in places (Figure 4.2). It also has two rough holes which appear to have been chiselled into the stone after its use.

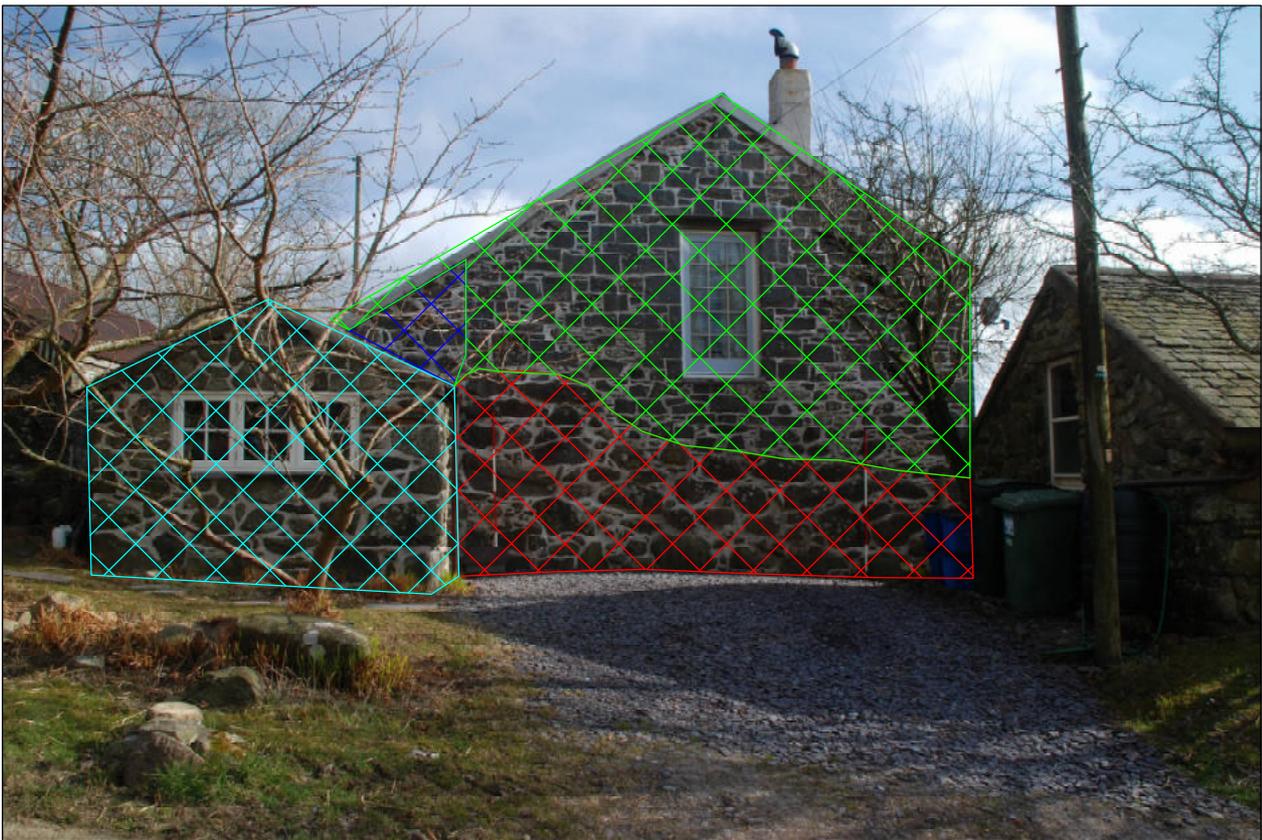
Western gable end

lights, but is a late replacement roof constructed after a period of collapse. This collapse is clearly seen at the western end of the building where much of the gable end (Plate 2) is constructed of roughly coursed, squared stone blocks. Given the degree of collapse it is likely that the chimney has also been reconstructed. There is also a partially blocked opening in the eastern gable end (Plates 4 and 6) which may have been a doorway.
