DATING OLD WELSH HOUSES GROUP

BRYNMAENLLWYD

TRAWSFYNEDD

Building Description

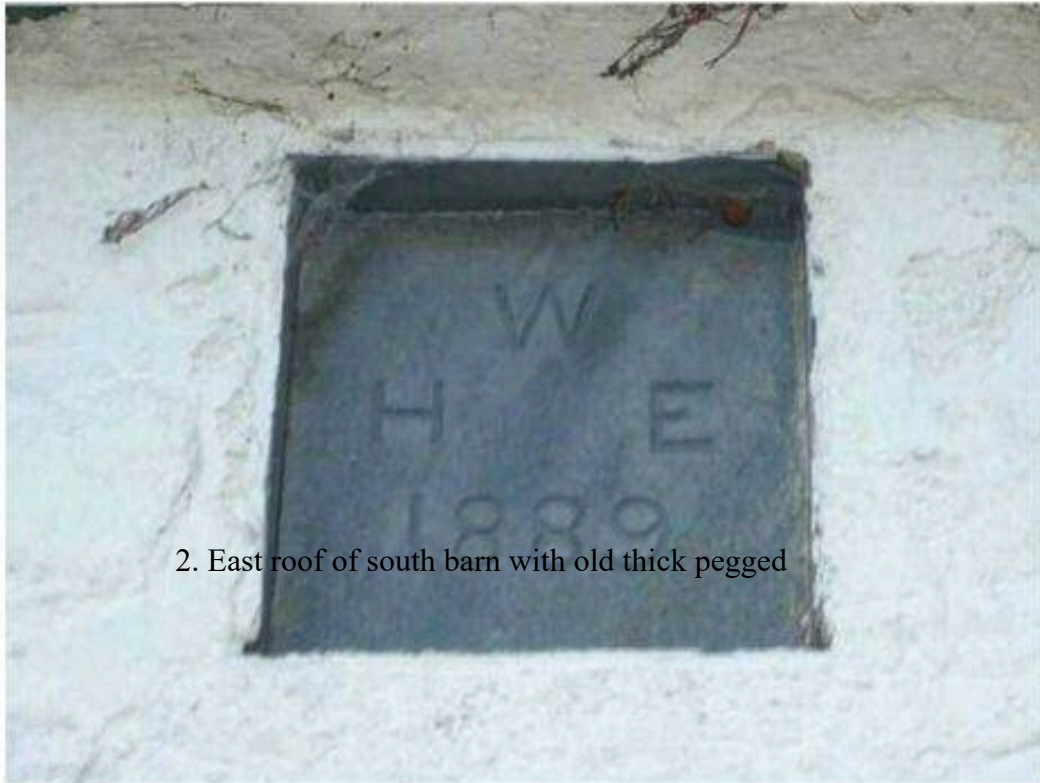
1. 1889 renovation plaque on east elevation under eaves.

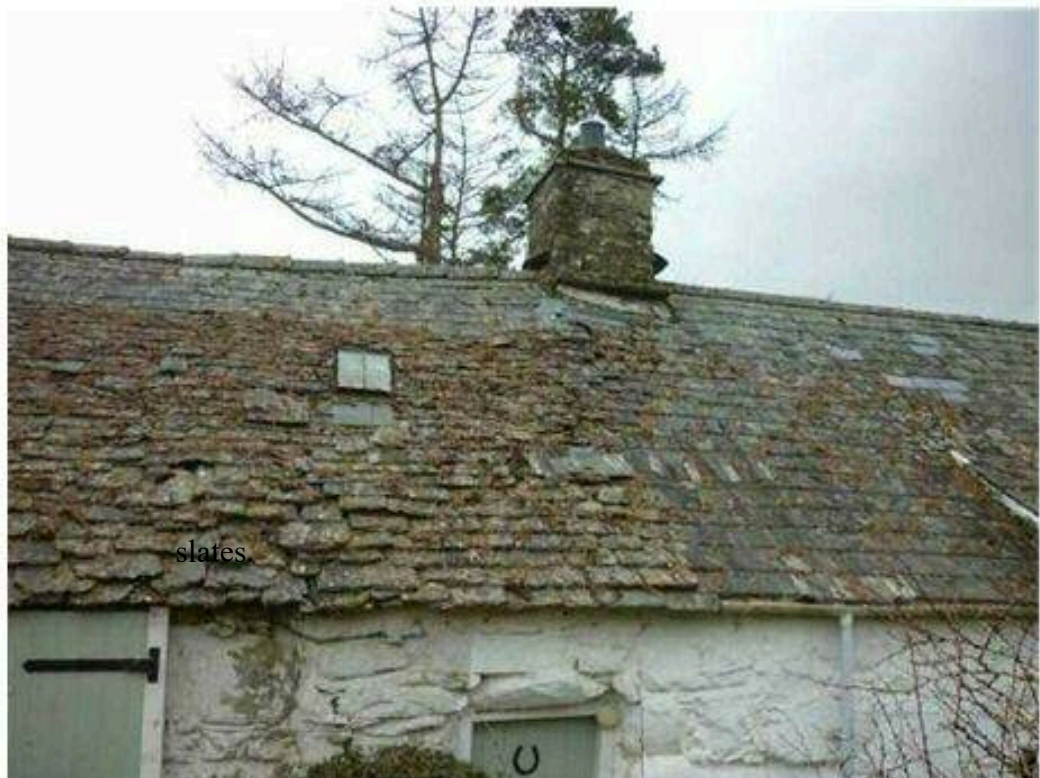
2. East roof of south barn with old thick pegged

slates

c) 1970s/80s Dr. Green's work: reconstruction of dormers including scarfing of new timber to N dormer roof, and of old part of S barn roof; guttering; insertion of hardboard linings between rafters upstairs; replacement of hardboard partitions with pine boards; construction of kitchen units, shelves and storage room; relocation of doorway to N room (now with kitchen recess W) from near the W wall to under stairs; removal of internal lobby; raising of part of N room floor, laid with imported slate slabs over concrete; exposure of inge-beam and inge by removal of modern fire installation, and construction of raised fireplace and slate hood; exposure of N ground-floor fireplace; installation of central heating/hot water system including boiler and large-capacity oil tank in S barn; demolition and rebuilding of part of S barn wall nearest house; remodelling of water intake in field above house with lined channel, dam, twin tanks, etc. (all of this work done personally by Dr Green, who also made the hinged brass curtain rods upstairs).

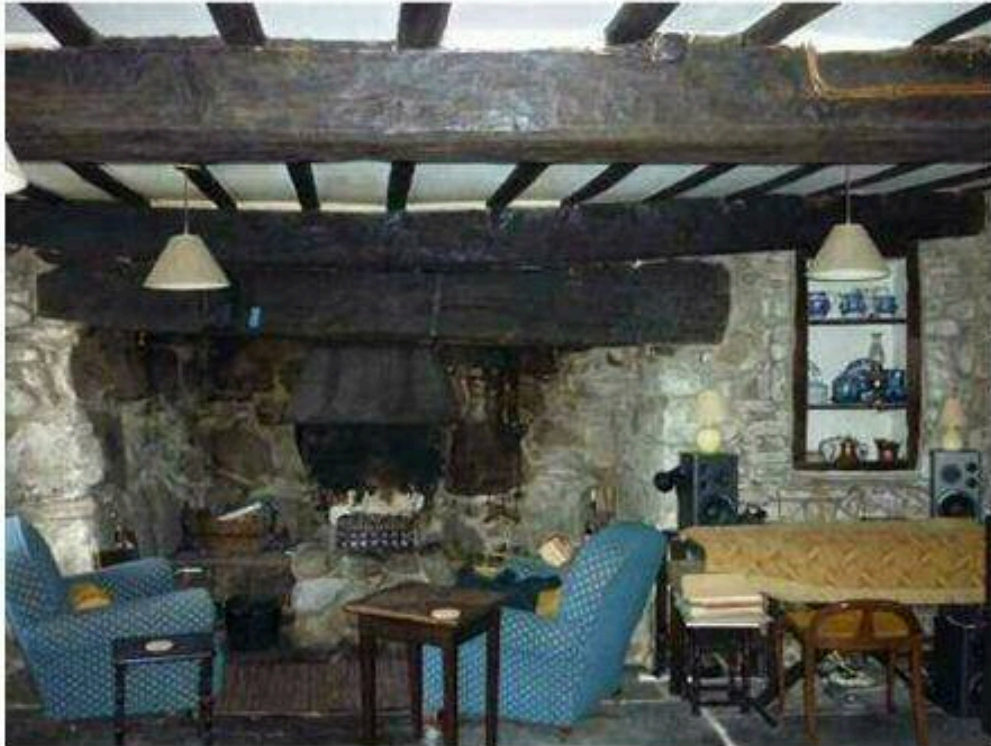
1. Main room, south. Tie-beams, ingle beam, and joists, designed to impress. The wall

cupboard, right (of 1889), closes the primary mural spiral stair.

The W wall inside the inglenook is of superior masonry, presumably to support the stone spiral stair W (now fronted with a C19 slate-shelved cupboard). The inglenook aperture is 9ft wide, 5ft 6in high to the bottom of the bressumer and 4ft deep. On the E side of the recess is an oven (18in high x 20in wide between large boulders, now blocked up; 1588 may be early for such an oven) with a high shelf above, perhaps for salt or to warm the dough as the oven was fired. The ground-floor chamber fireplace (N) has a low stone lintel (2ft 8in from original floor, 5ft wide and 16in deep, over a 3ft fireplace). Most of the ground floor is paved with very large rectangular flagstones with irregular surfaces, many 4x3ft, some 5ft long (part of the chamber floor was raised 5in with imported smaller slabs laid on concrete c.1980).

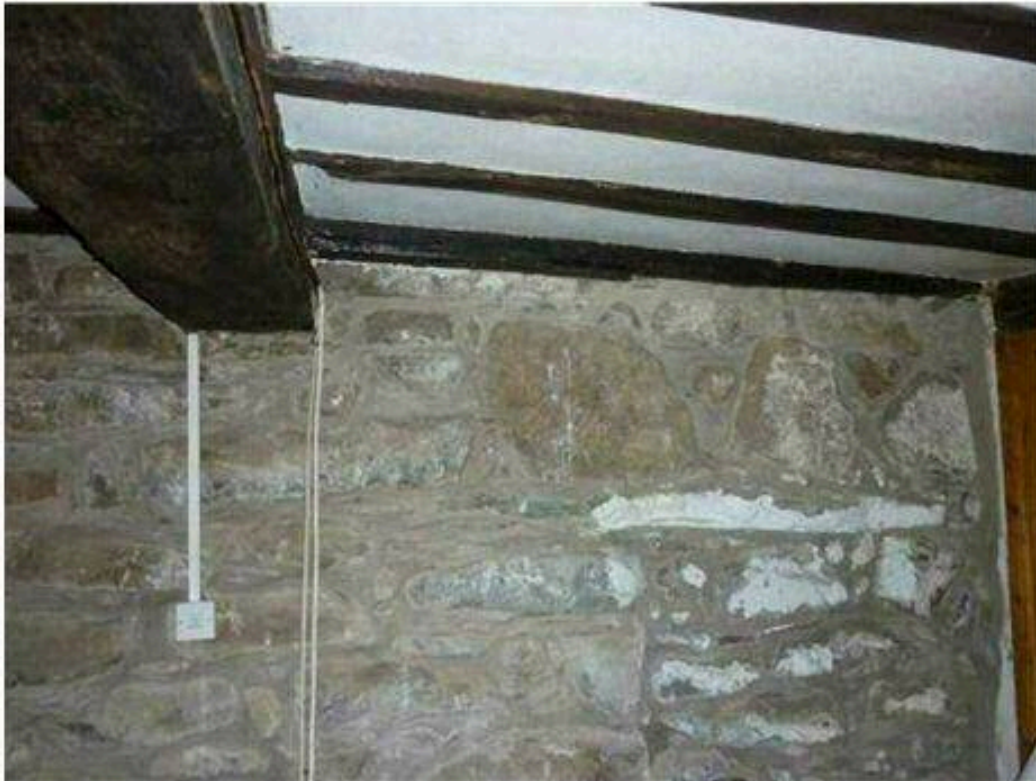
3. Lintel of the former back door visible opposite the front door.

Ground-floor openings seem original, with rectangular lintels. Fenestration apertures (3 E, 1 W) and the front doorway (E) survive; the W doorway was blocked up before the 1930s but is internally visible. The front door is bigger than the back door: an aperture 5ft 10in high by 3ft 9in wide, splayed to 4ft 2in, as against 5ft 3in by 3ft 3in internally. Each of the original ground-floor rooms was lit by one window; the apertures seem original, all of different sizes, with splayed reveals (less wide in the service rooms). The biggest window is in the hall (external aperture 3ft 6in x 3ft 6in, splayed to 5ft internal width), with a higher lintel and stepped sill. Others have level sills. The ground-floor chamber window is 3ft high x 2ft wide, splayed to 4ft 9in. The E service room window is 2ft 6in high x 3ft wide, splayed to 4ft 2in, and that for the W service room is 2ft 8in high x 3ft wide, splayed to 3ft 9in. Internal lintels include oak and stone (all frames are modern timber with opening fanlight, c.1980).

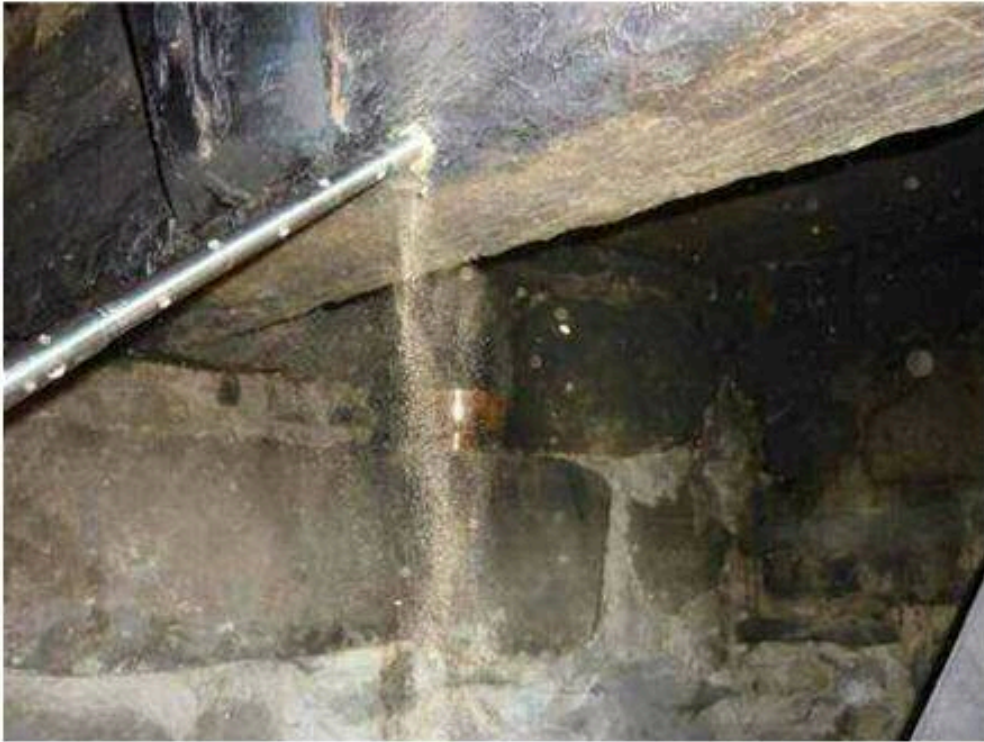
1. Drilling the ingle beam, January 2012.

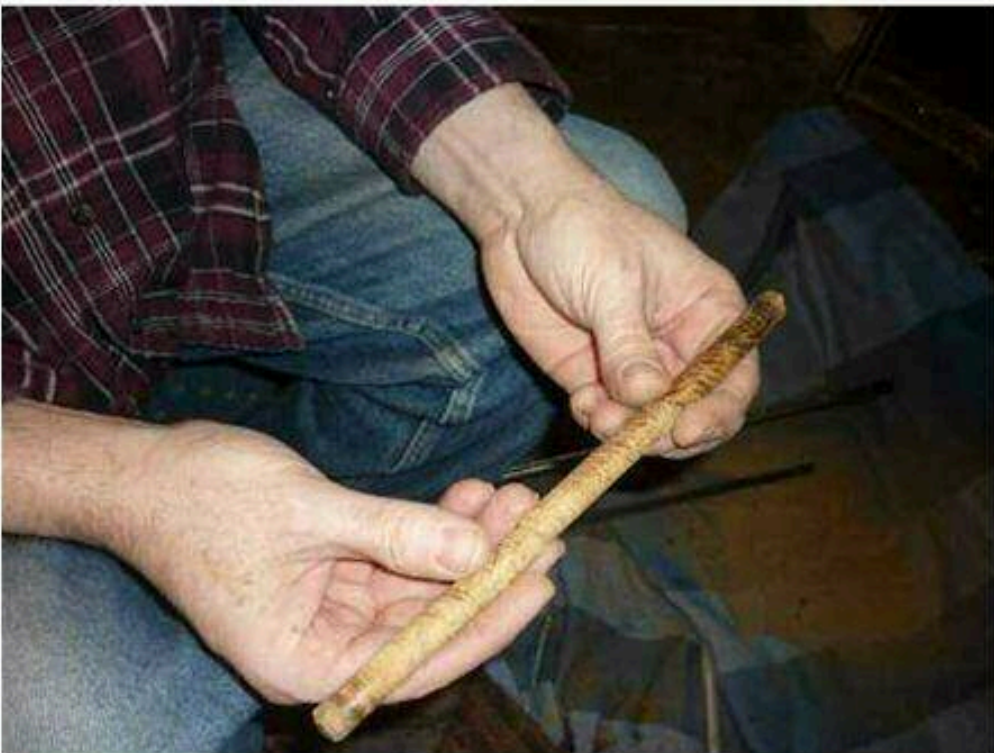
2. One of the drill cores.

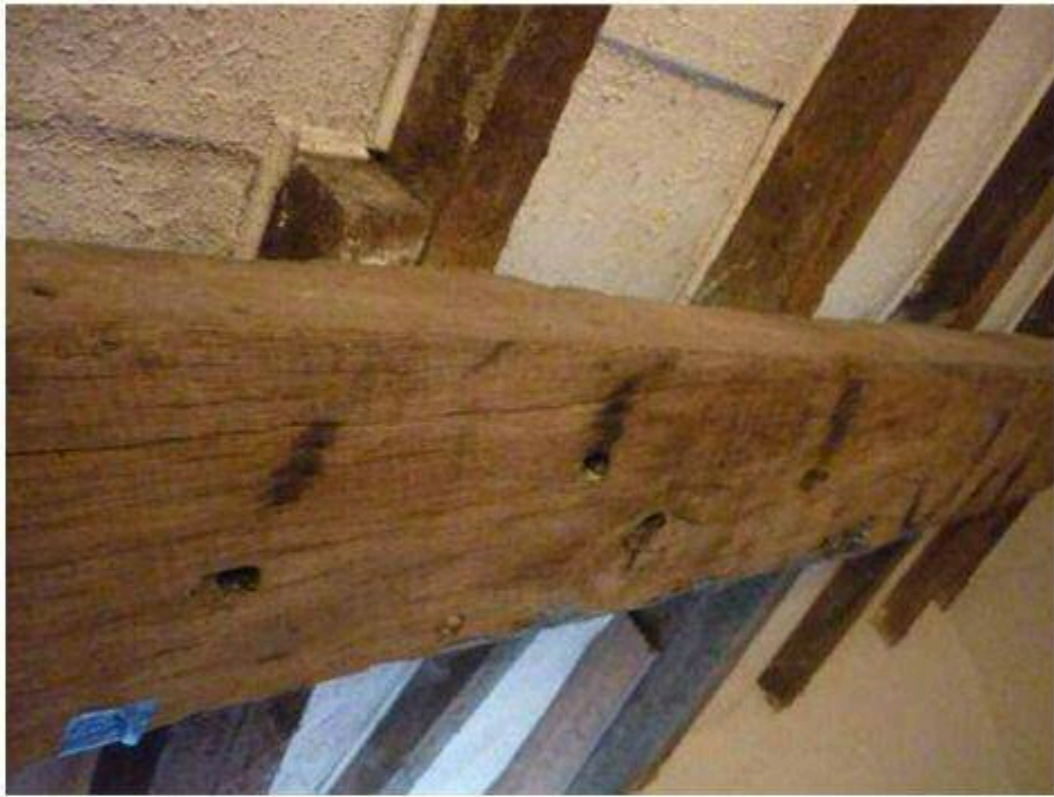
3. The purlin which gave a precise felling date of 1588. The blue sticker marks the drill site. Smoke marks indicate rush lights or candles used after the purlin was re-set against new trusses in 1665.

The two S roof trusses were replaced in 1665 but the original purlins (the E one dated to 1588) were reused. These long purlins, though well carpentered, are slimmer (c.10x3in) than those in the heated upper chamber, and have no chamfering. They are both trenched (each with a notch, 5in and 4in wide) indicating that they were originally placed edge-on to the primary trusses, which were evidently of less square section than the surviving N truss (presumably primary). (That this edge-on practice has continued is evident from the later purlin over the stairs and the relatively recent roof of the N barn.) In renewing the 2 S trusses it seems the opportunity was taken to increase the available room-space by placing their feet further apart, as a large square boss on the upper surface of the tie-beam in the floor, forward of the W foot of the present S truss, shows 4 sawn-off pegs presumably anchoring the original truss to the tie-beam below, rather than seating it in the wall as now. This suggests that the originally available timber was of barely adequate proportions for the planned size of the house, and that the attic space was compromised by the intruding beams.

The faces of the ground-floor beams are stained black; those upstairs are of natural colour untreated. Smoke marks in the SE bay of the main bedroom from rush lights or candles suggest perhaps work at a spinning wheel or loom (post 1665). Peg holes at regular intervals along the slim purlins may be fixings for side panelling (with storage space behind), as in the S barn which still has remnants of such panelling, indicating that the hayloft was slept in by farmhands (this was still the practice in the mid-C20. Pers.comm. Kit Price Jones). Upstairs flooring is of C19 6.5in pine boards (bathroom/landing 5.5in). C19 tongue-and-groove pine partitions (6.5in) subdivided the upper floor into 3 rooms (one presumably open to the stairwell, though the

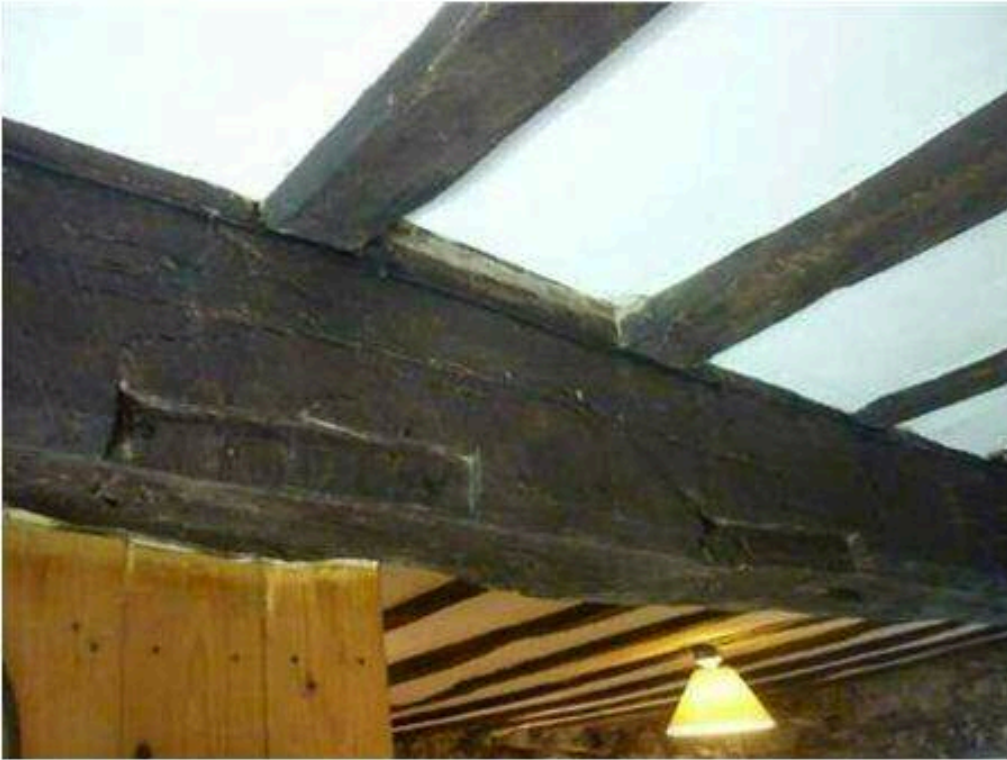
1. The north tie-beam cut for in-and-out boarding.

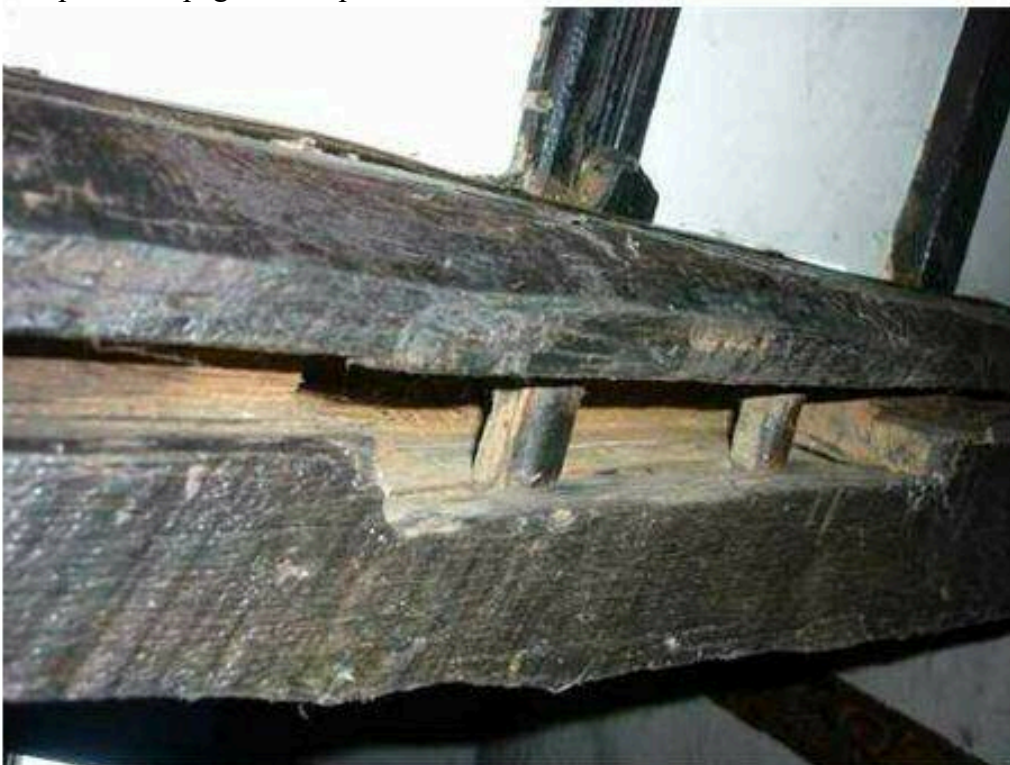
2. The tie-beam between main room and service rooms, grooved for a post-and-panel partition, pegs still in place.

The interior finish is of roughly squared boulders, some very large, pegged with small stones (since c.1990 largely exposed on the ground floor). The house's interior length is 37ft overall to the back of the ingle. Its interior width is 16ft 6in approx. The 4 bays are not of equal width. Distances between tie-beams are, from the S one at the ingle, 7ft 10in, 7ft 2in, 8ft 6in (service rooms), and 10ft 6in to the N wall (the chamber). The tie-beams may be closer together towards the S to enable a more impressive display of high-quality timber in the principal room, giving particular prominence to the fireplace with its massive ingle-beam and adjacent tie-beam (T1), the heavy central tie-beam (T2), the panelled partition (now absent) at T3 separating it from the service

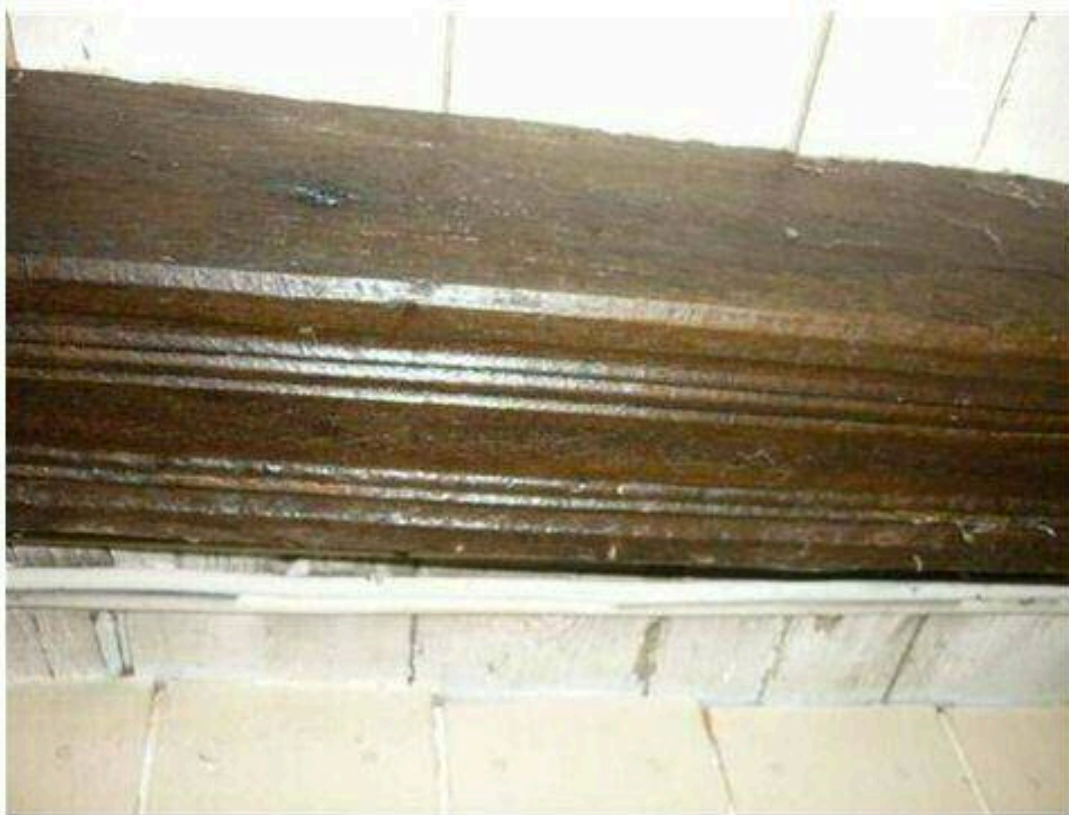
3. Reed-moulded joist like those of the main room ceiling; this one extended over the primary passageway between service rooms to the private chamber, and was not stained black.

rooms, and the 13 reed-moulded joists (centres 1ft 6in apart) which provide a boldly striped ceiling.

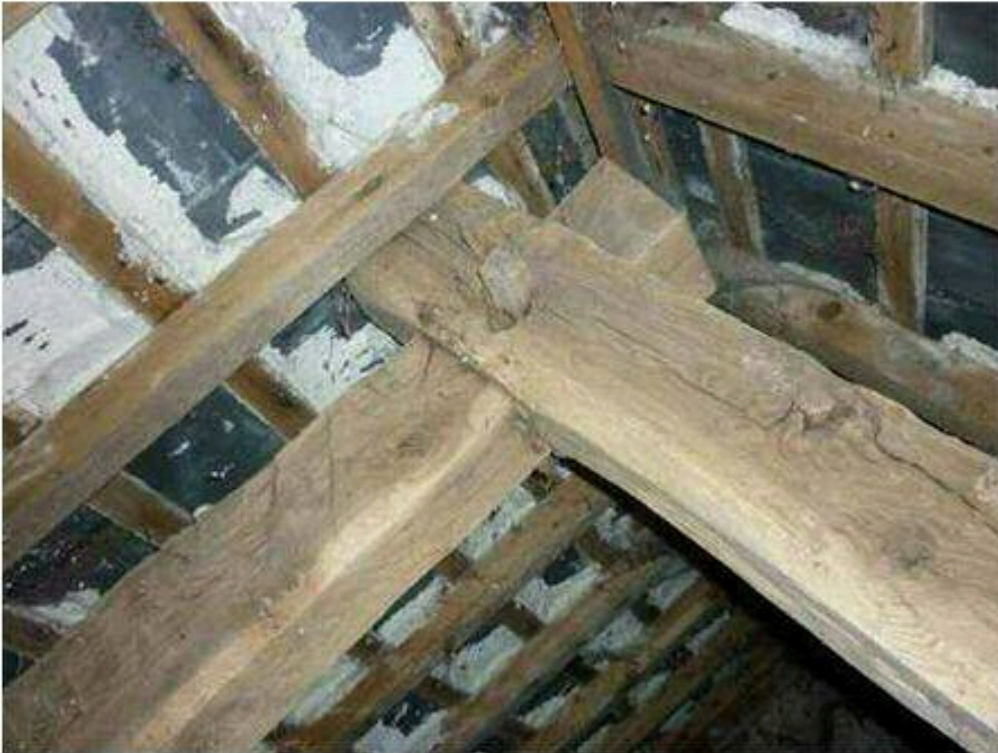
1. North truss: squared timbers crossed and simply pegged (not dated).

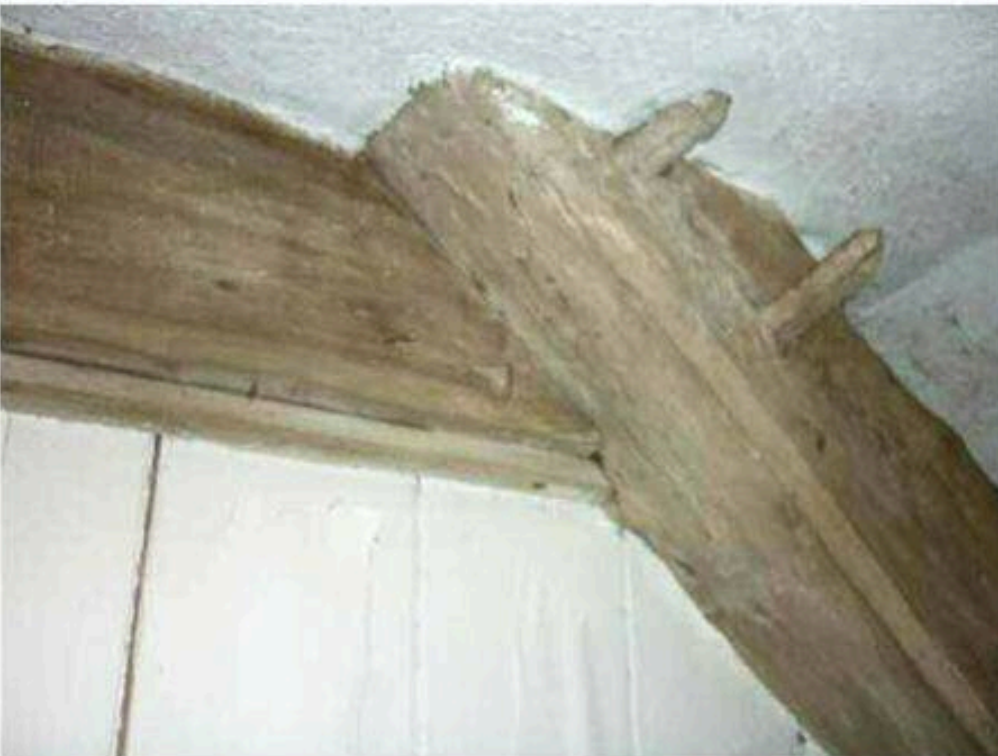
2. Collar to north truss (not dated).

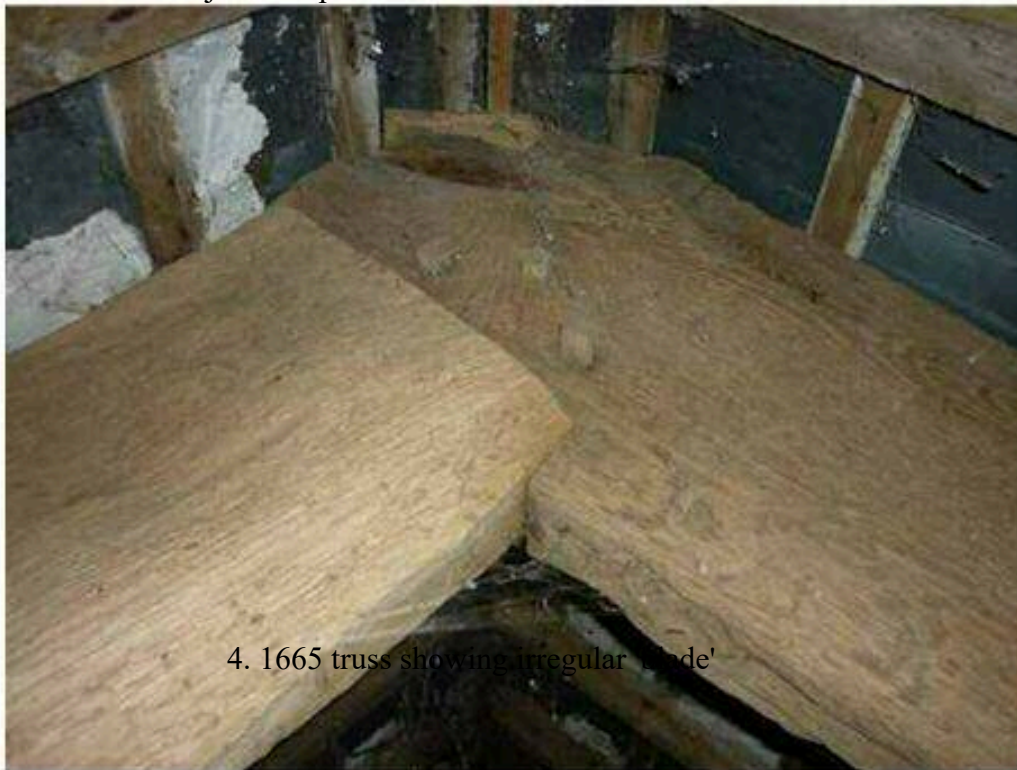
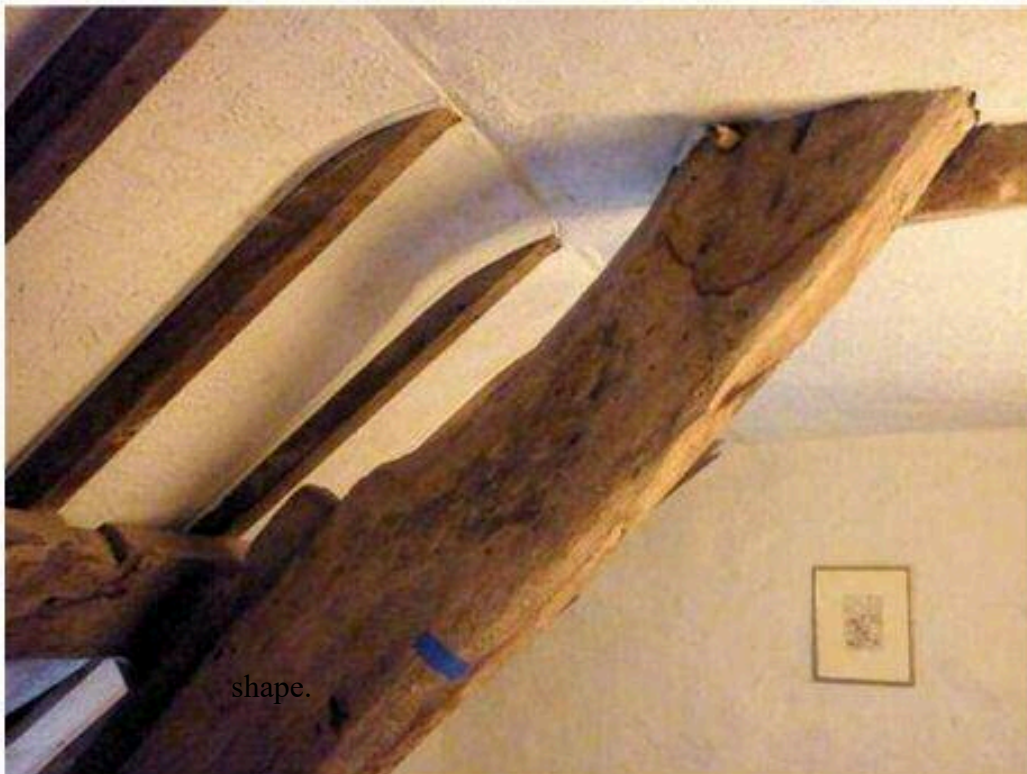
3. Central replacement truss of 1665: timbers of oblong section, with strong mortice and tenon joint at apex.

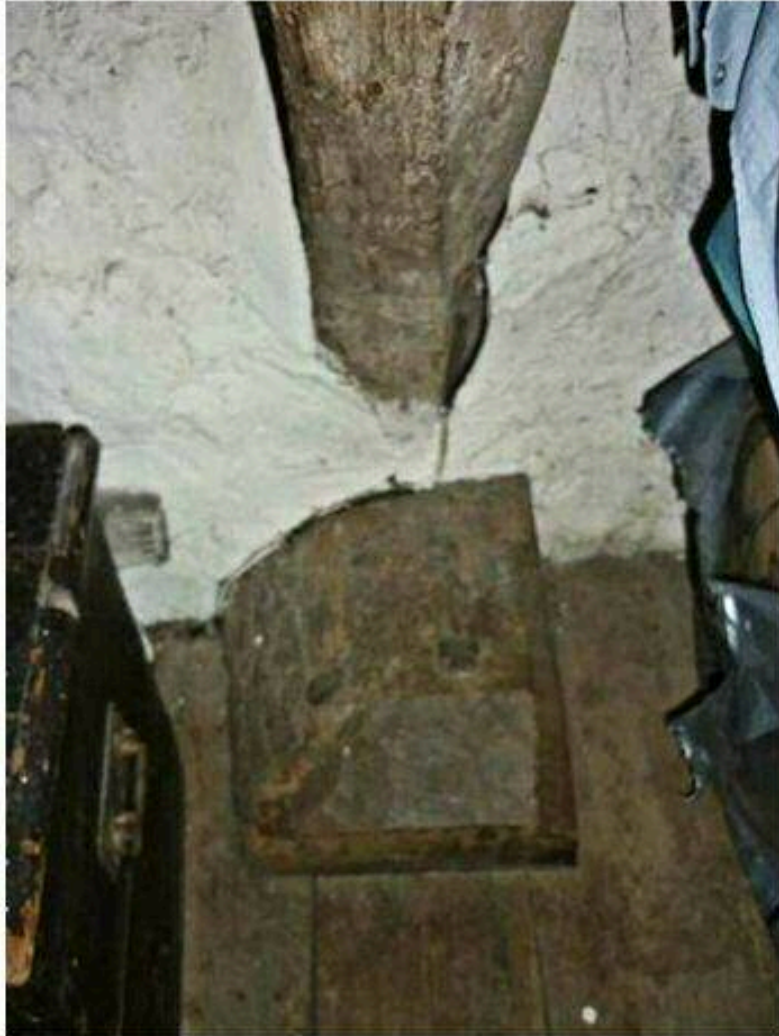
1. Boss in floor of upstairs south room: sawn off pegs indicate this was probably where original truss was seated. Present truss of 1665 seated in wall above, giving greater strength and more headroom.

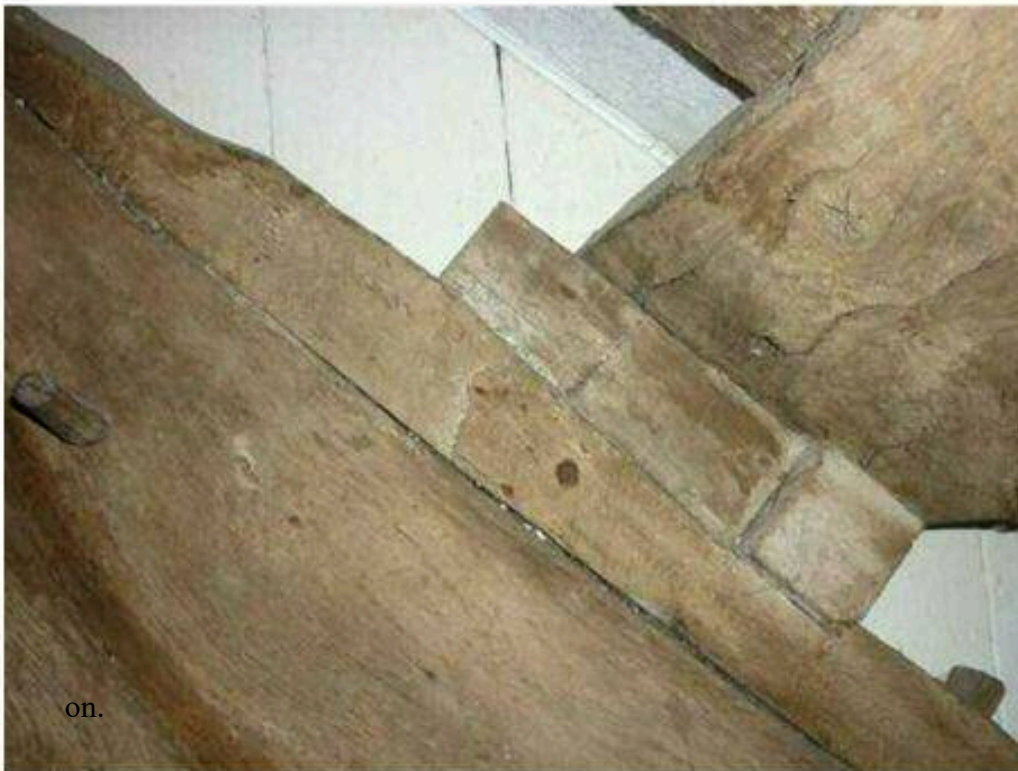
2. Central 1665 truss seated directly on the exceptionally deep tie-beam (undated), probably a contemporary replacement.

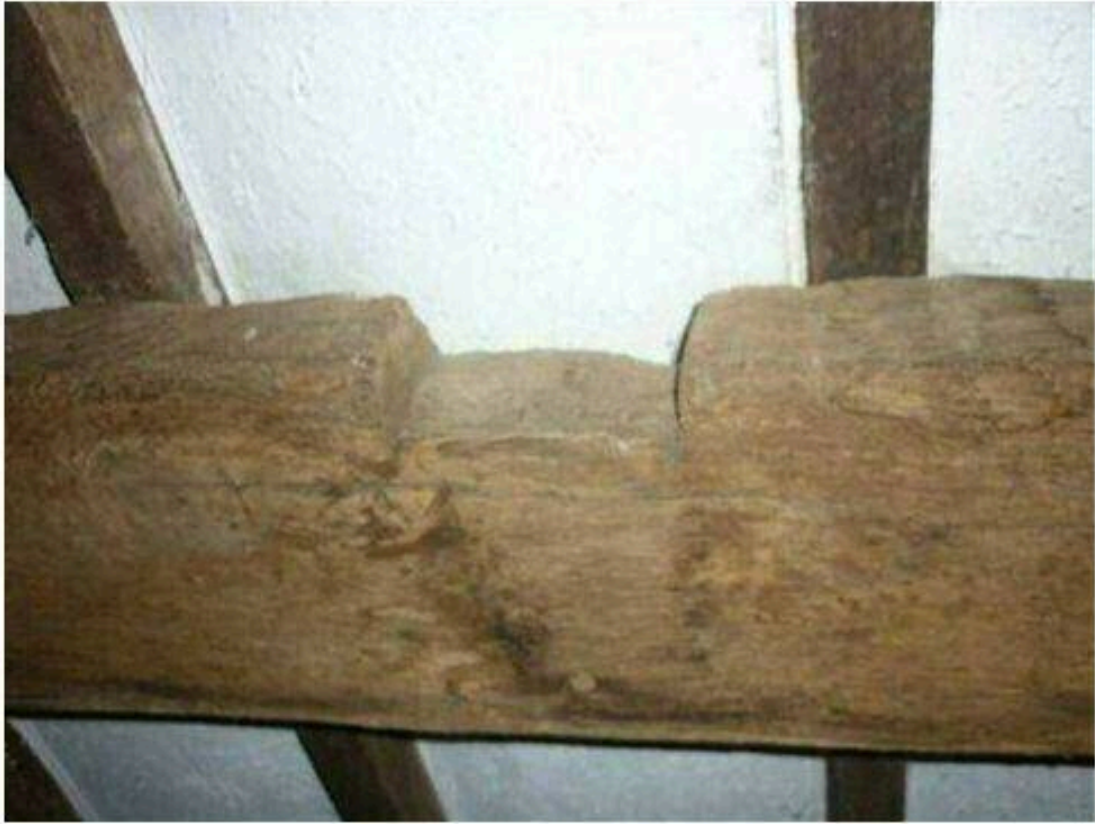
4. Trenching of the south purlins proves they were originally installed edge-on to their truss.

The two S trusses may have needed early renewal because of timber deterioration. That the long thin primary purlins (S) were prone to warping is shown by the section removed, presumably in 1889, from what at that date became the staircase bay, which now rests in the NW roofspace. It is possible that the original S trusses likewise either warped or developed serious splitting, like the inge beam. Dr Daniel Miles, the house's dendrochronologist, thought that the inge beam split had probably happened within 10 years of installation. Understandable concerns over the inge's stability may thus go back to the house's early life and account for a number of interventions, such as what looks like a stone buttress, cemented at the top, built out from the W flank, and attempted repairs: the inge beam was braced to the adjacent tie-beam with an oak splint (possibly in 1665), and an iron clamp (now sprung) was pinned round the split (probably in 1889 though perhaps earlier). However, after 400 years it seems likely to survive. The two S trusses were replaced after barely 80 years perhaps in part to reduce the roof load carried by the inge-beam. If the original trusses also split as they seasoned, in a way which crucially weakened the roof, replacement may have been the only course.

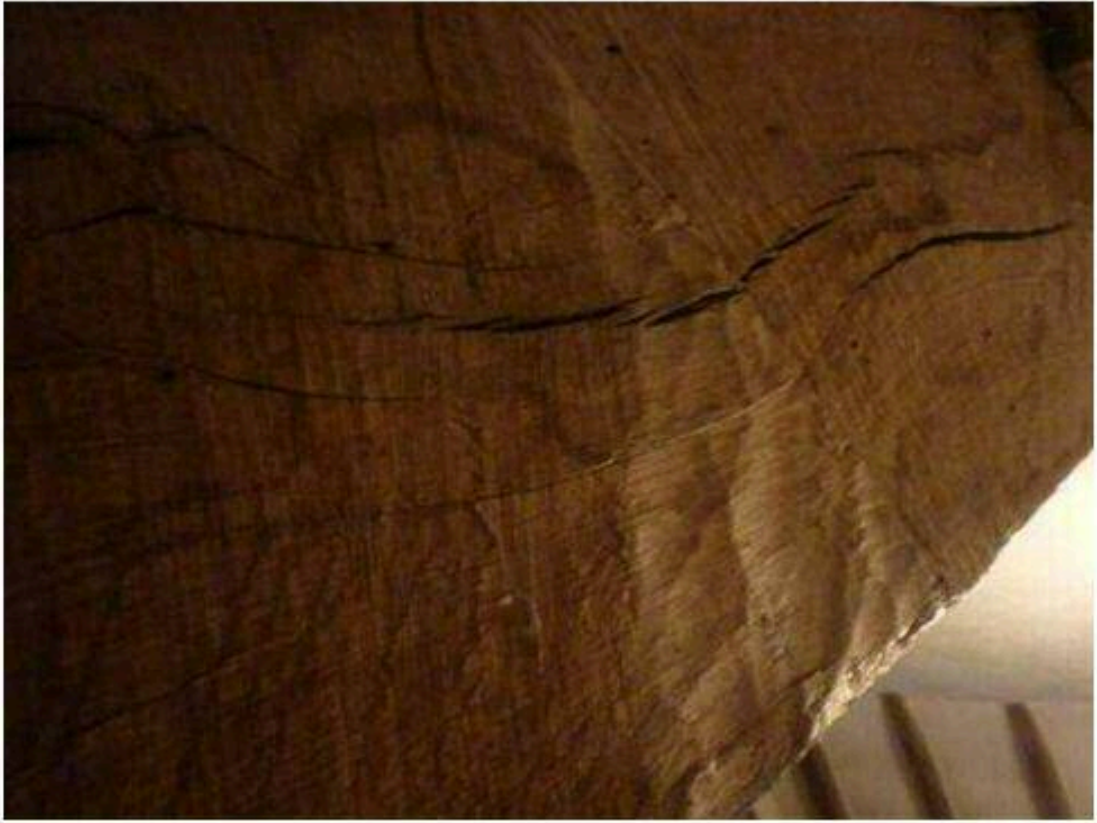
5. 1665 truss, trestle-sawn.
